**REPORT NUMBER: NCAP-KAR-12-034**

**NEW CAR ASSESSMENT PROGRAM (NCAP)  
FRONTAL BARRIER IMPACT TEST**

**KIA MOTORS CORPORATION  
2012 KIA SOUL 5-DOOR MPV**

**FINAL REPORT**

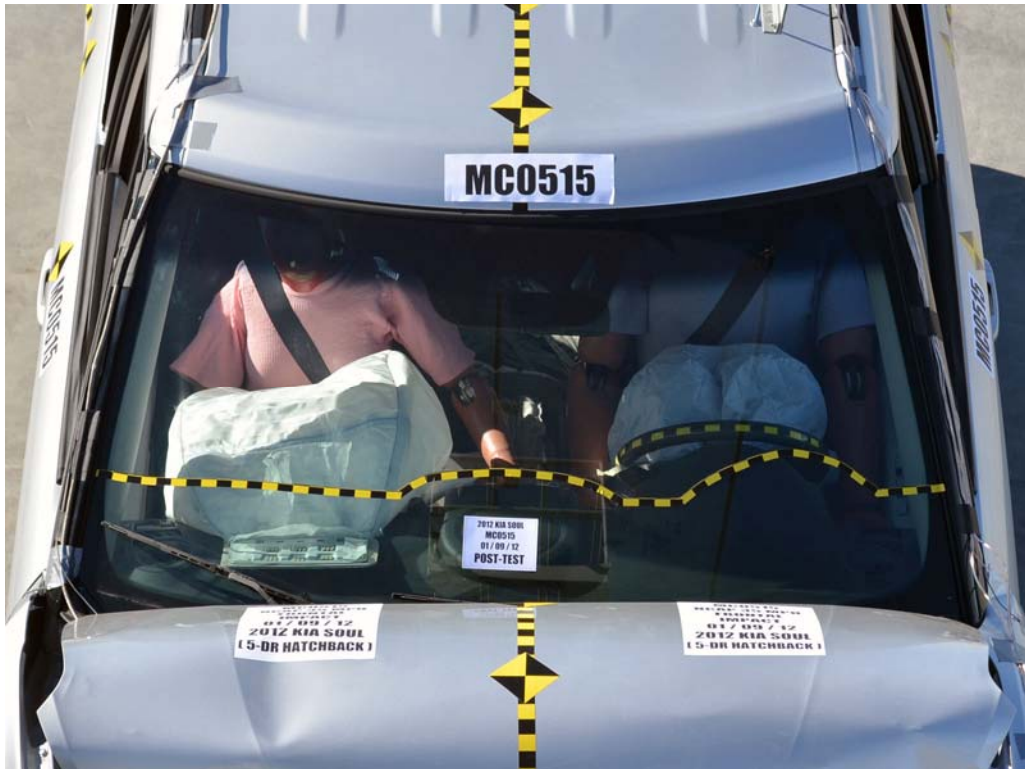
FIGURE 18. Post-Test Windshield View

There was 100% windshield retention and no intrusion into the protected zone of the windshield during the event. There was no Stoddard solvent leakage after the event or during any phase of the static rollover.

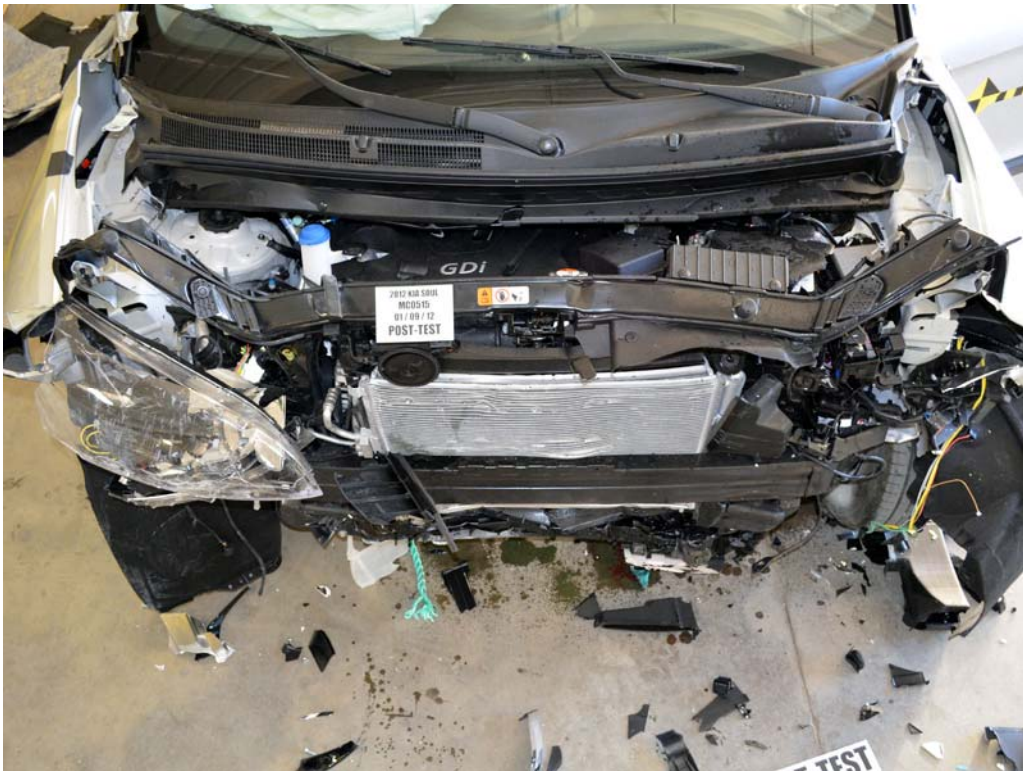
FIGURE 20. Post-Test Engine Compartment View

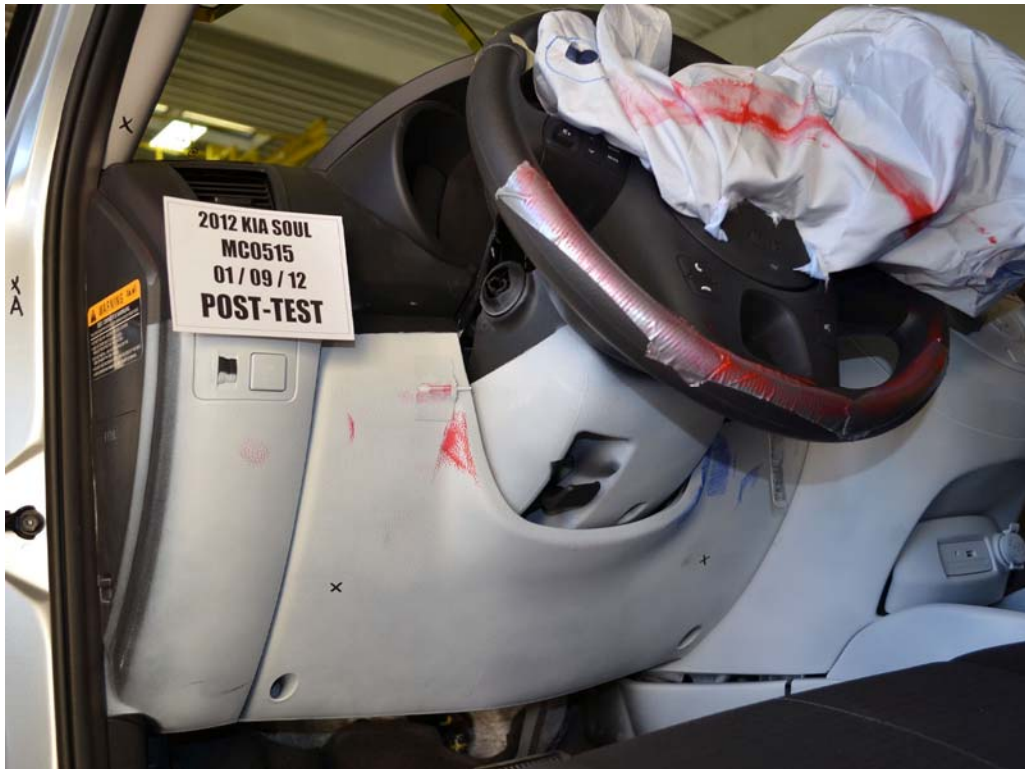
FIGURE 40. Post-Test Driver's Side Knee Bolster

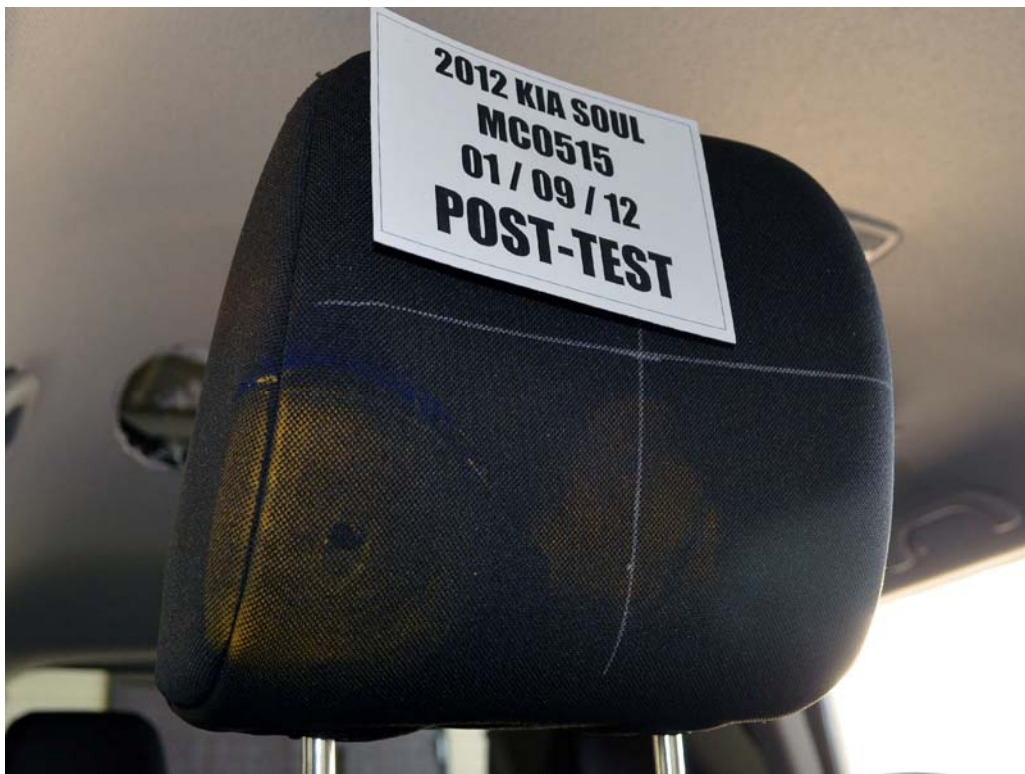
FIGURE 62a. Post-Test Passenger Dummy Contact With Headrest

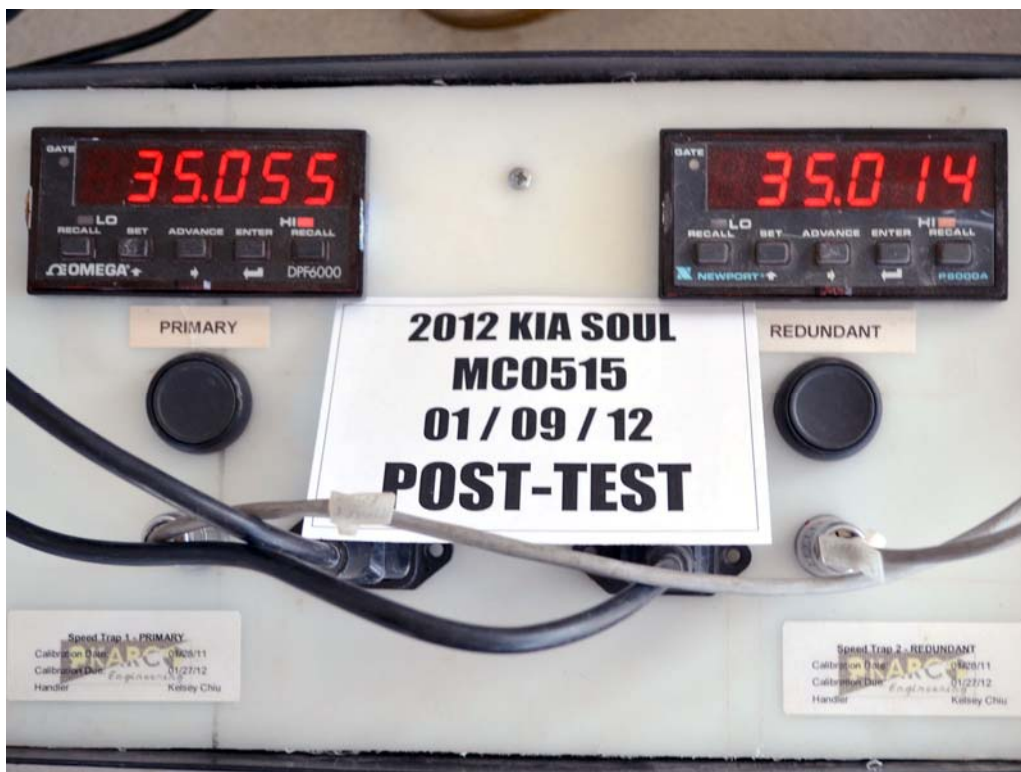
FIGURE 65. Post-Test Speed Trap Read Out

A load cell barrier consisting of 36 load cells was impacted by a 2012 Kia Soul 5-door MPV at a velocity of 56.38 km/h. The test was performed at KARCO Engineering, LLC. on January 9, 2012. Pre- and post-test photographs of the vehicle and dummies can be found in Appendix A of this report.

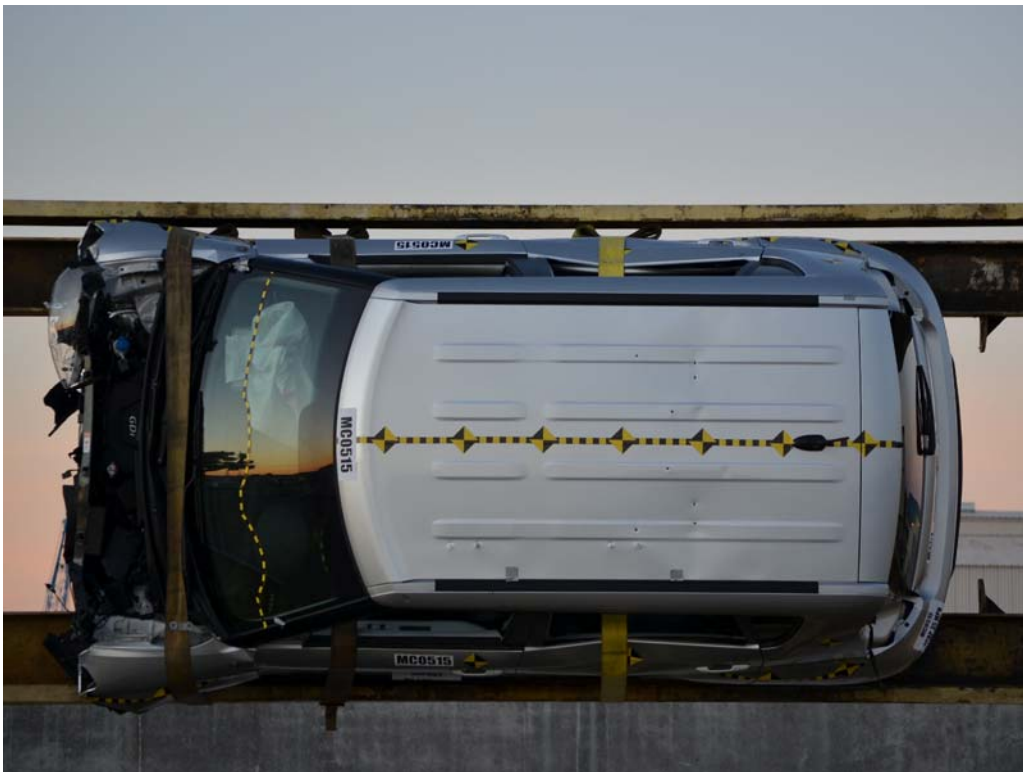
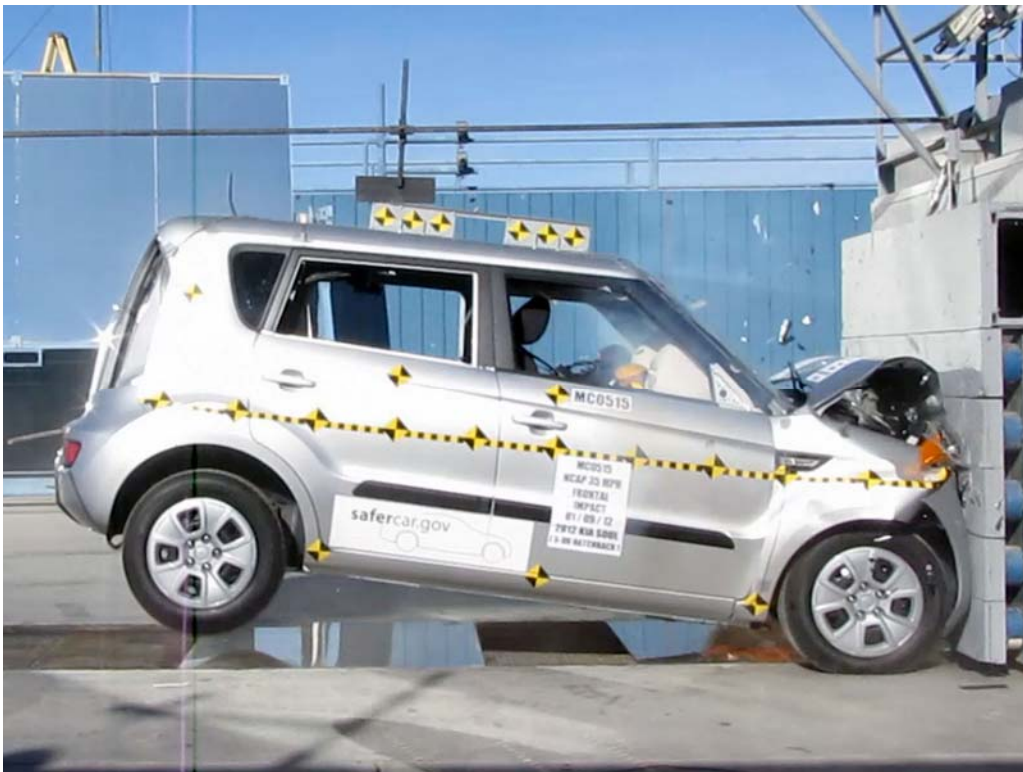
FIGURE 67. Vehicle at 90°on Static Rollover Device

FIGURE 69. Vehicle at 270°on Static Rollover Device

FIGURE 71. 2012 KIA Soul Frontal Impact Event
