**REPORT NUMBER: SINCAP-MGA-2012-052**

**NEW CAR ASSESSMENT PROGRAM (NCAP)  
Moving Deformable Barrier Side Impact Test**

**SUZUKI MOTOR CORPORATION  
2012 Suzuki SX4 LE 4-Dr Sedan  
NHTSA No.: MC0525**

**FINAL REPORT**

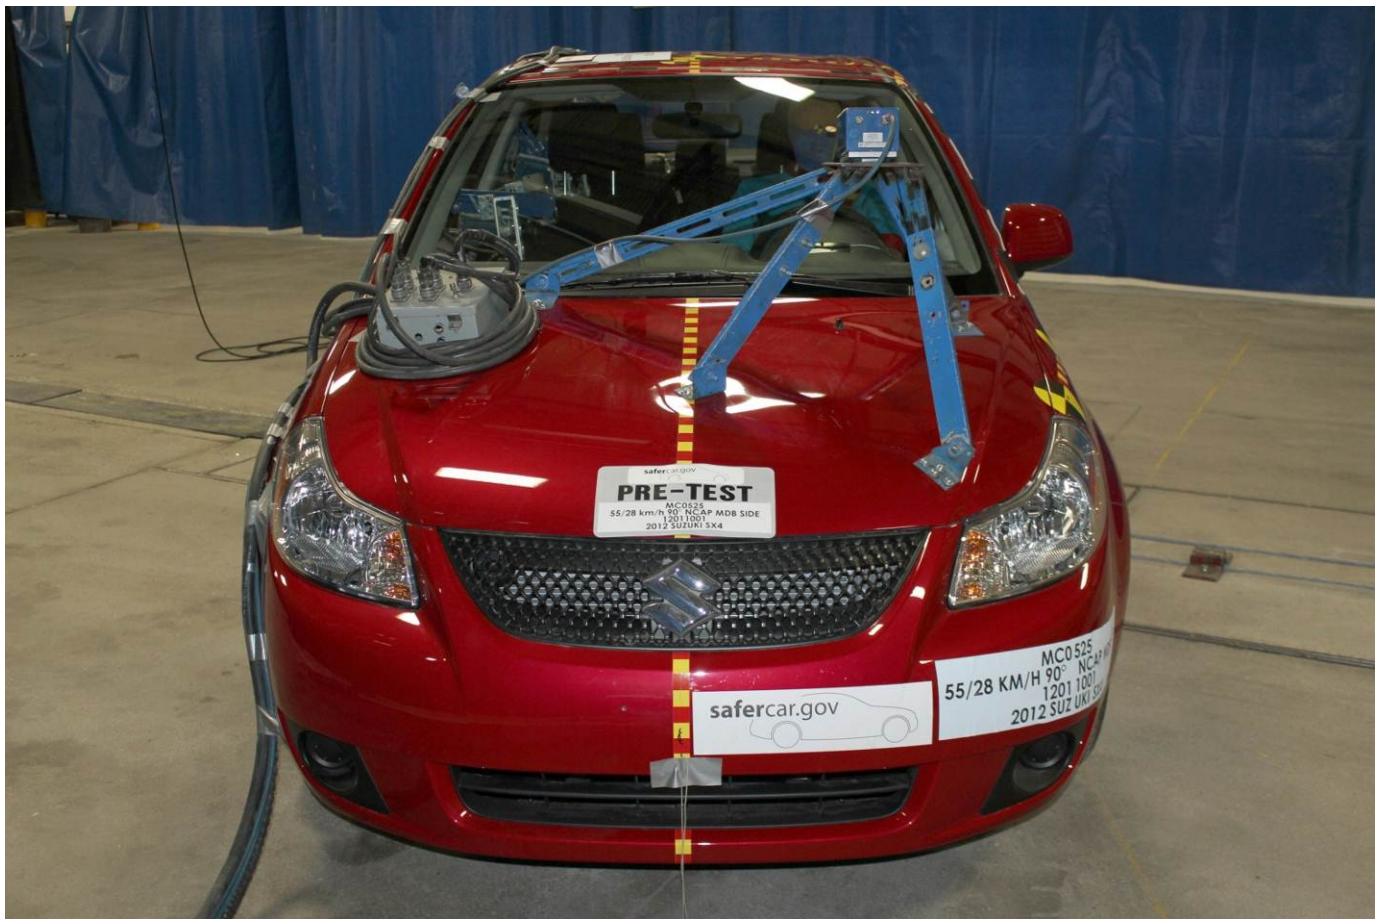
Pre-Test Frontal View of Test Vehicle

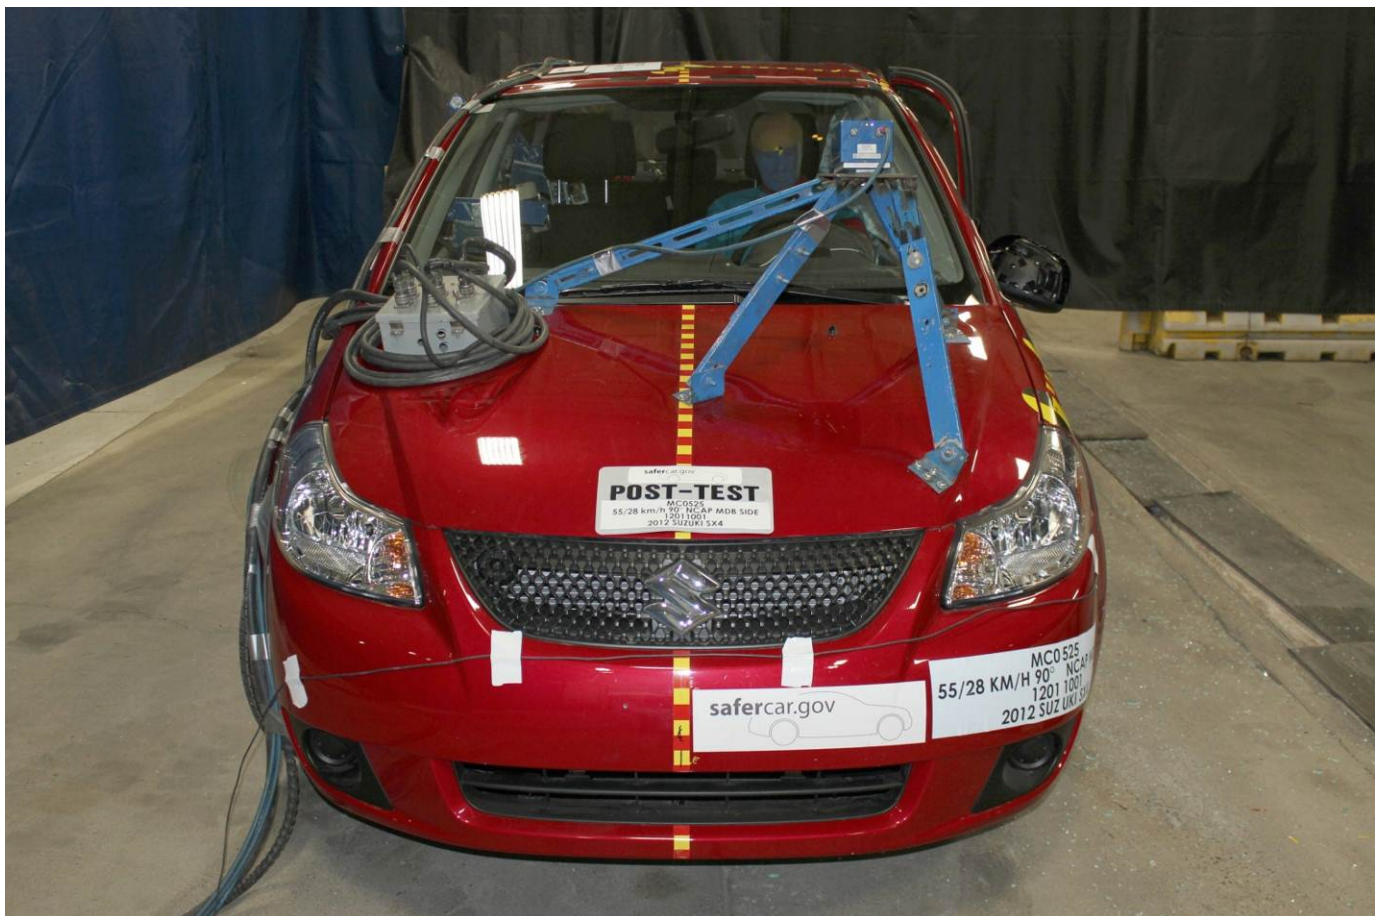
Post-Test Frontal View of Test Vehicle

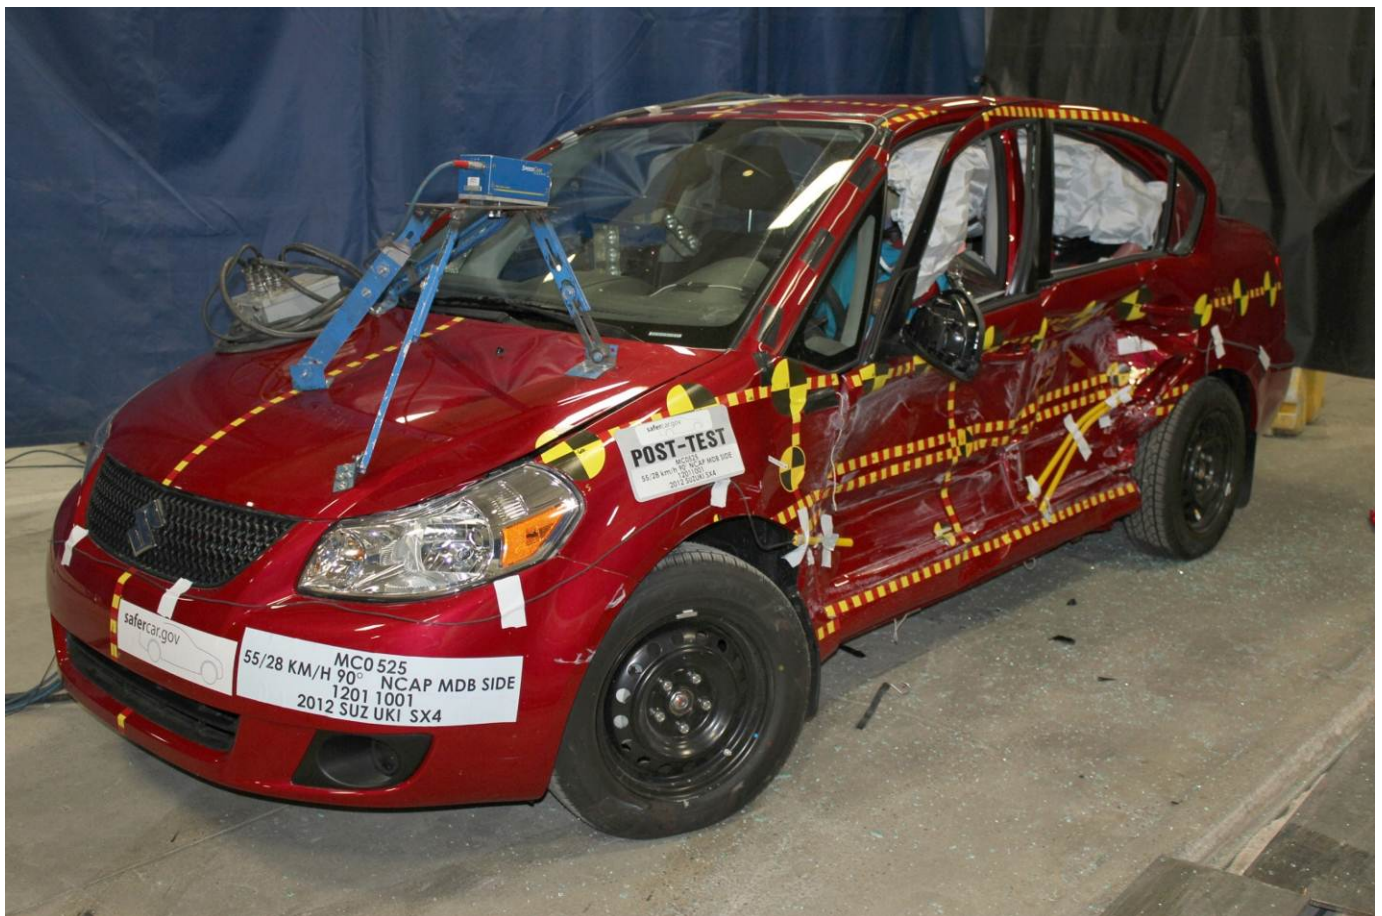
Post-Test Left Front Three-Quarter View of Test Vehicle

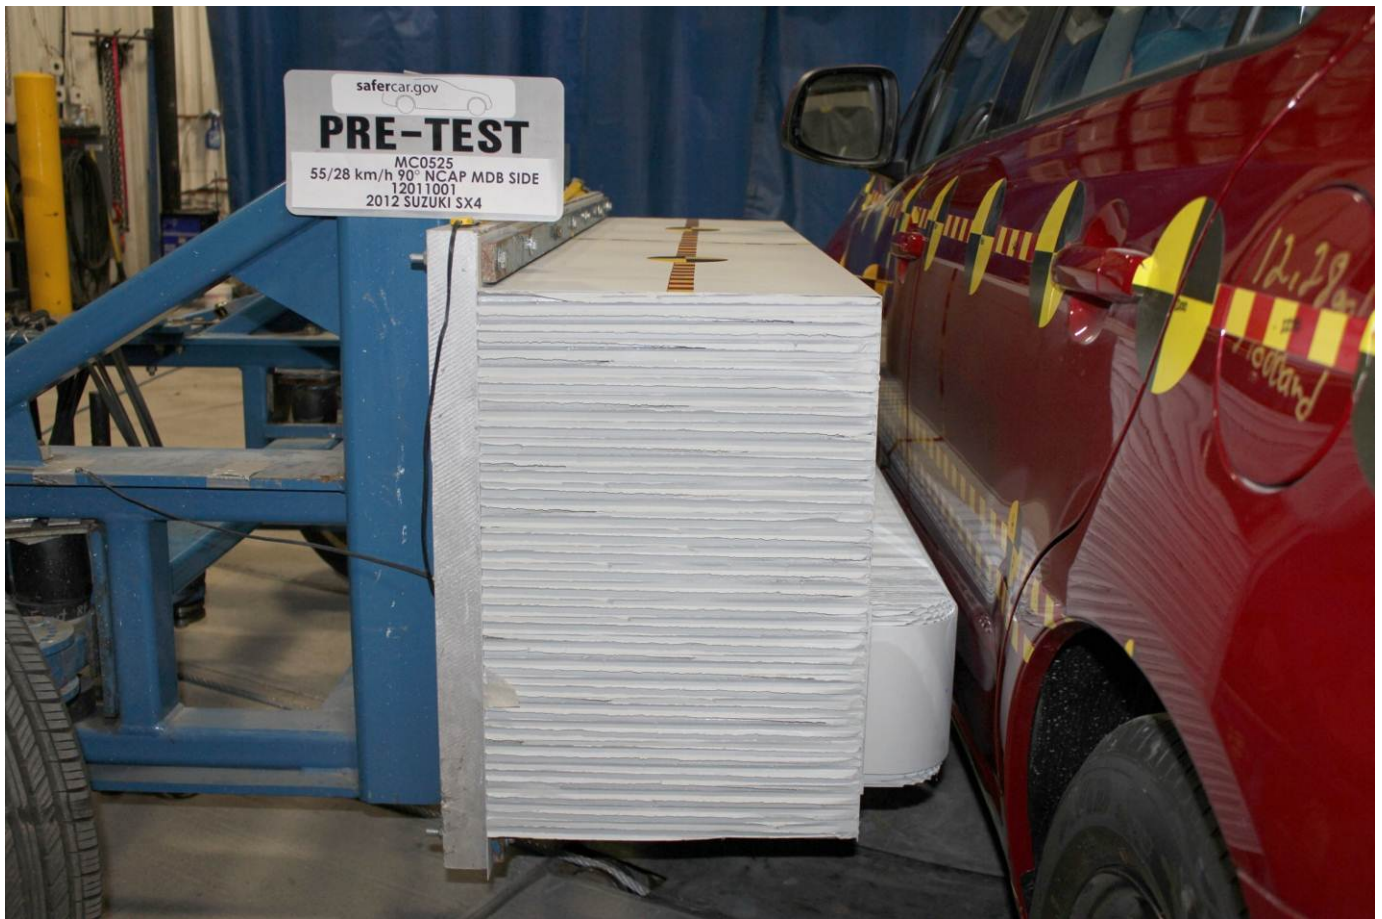
Pre-Test Right Side View of MDB Positioned Against Side of Test Vehicle

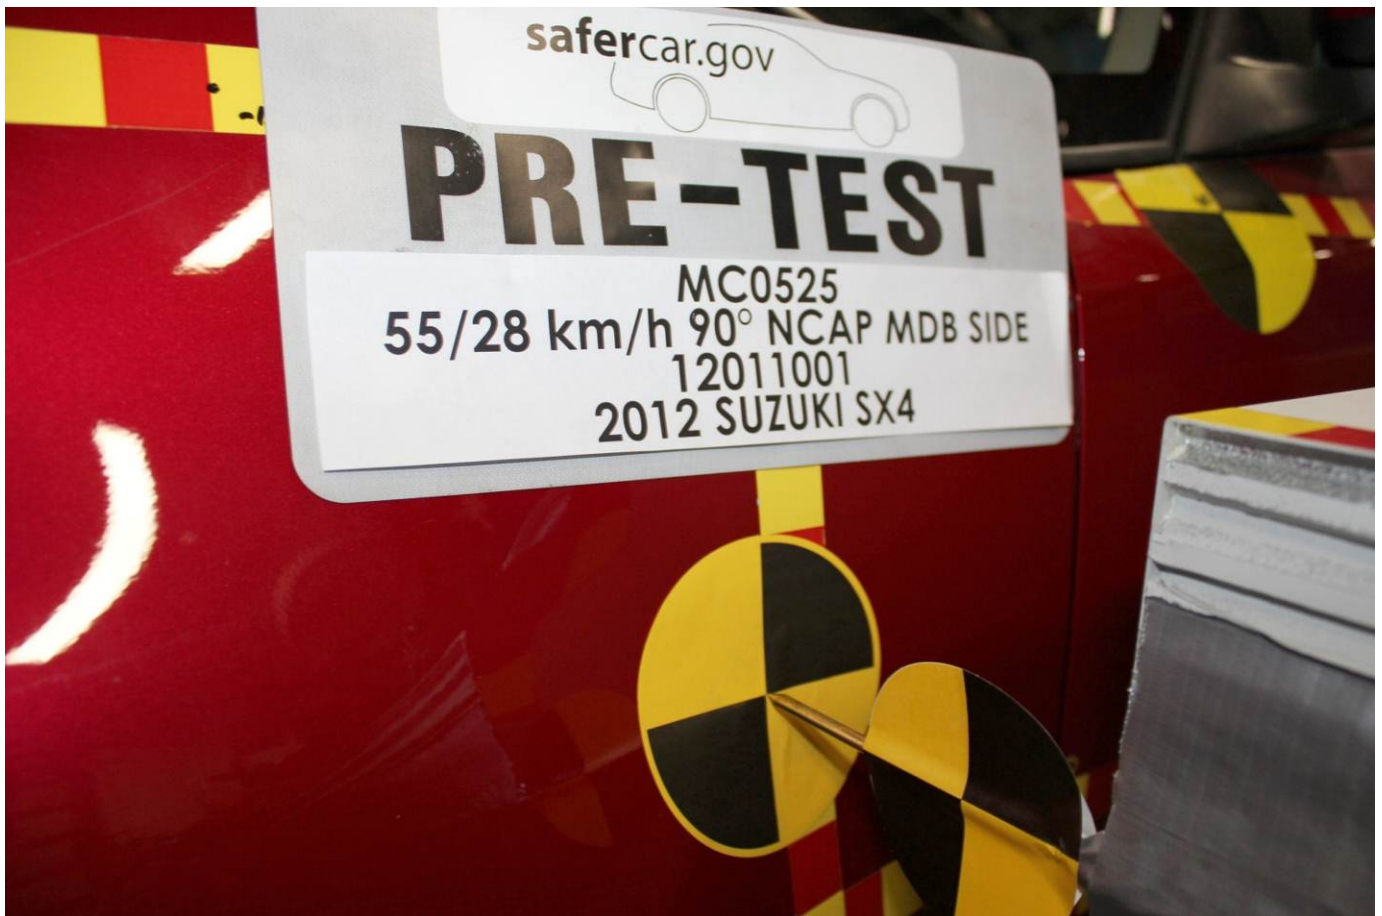
Pre-Test Close-Up View of Impact Point Target

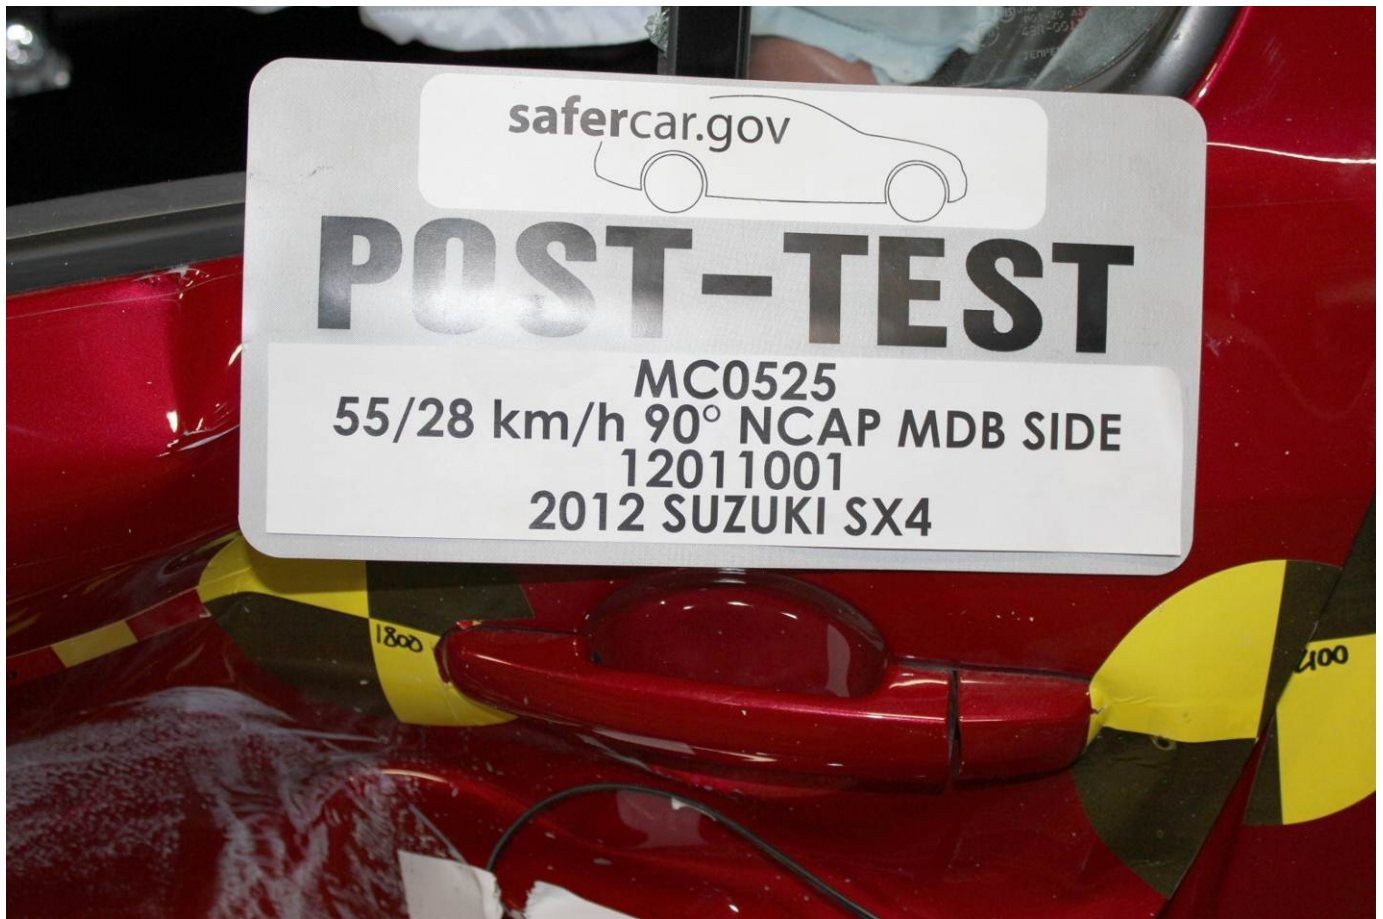
Post-Test Left Rear Door Latch Close-Up

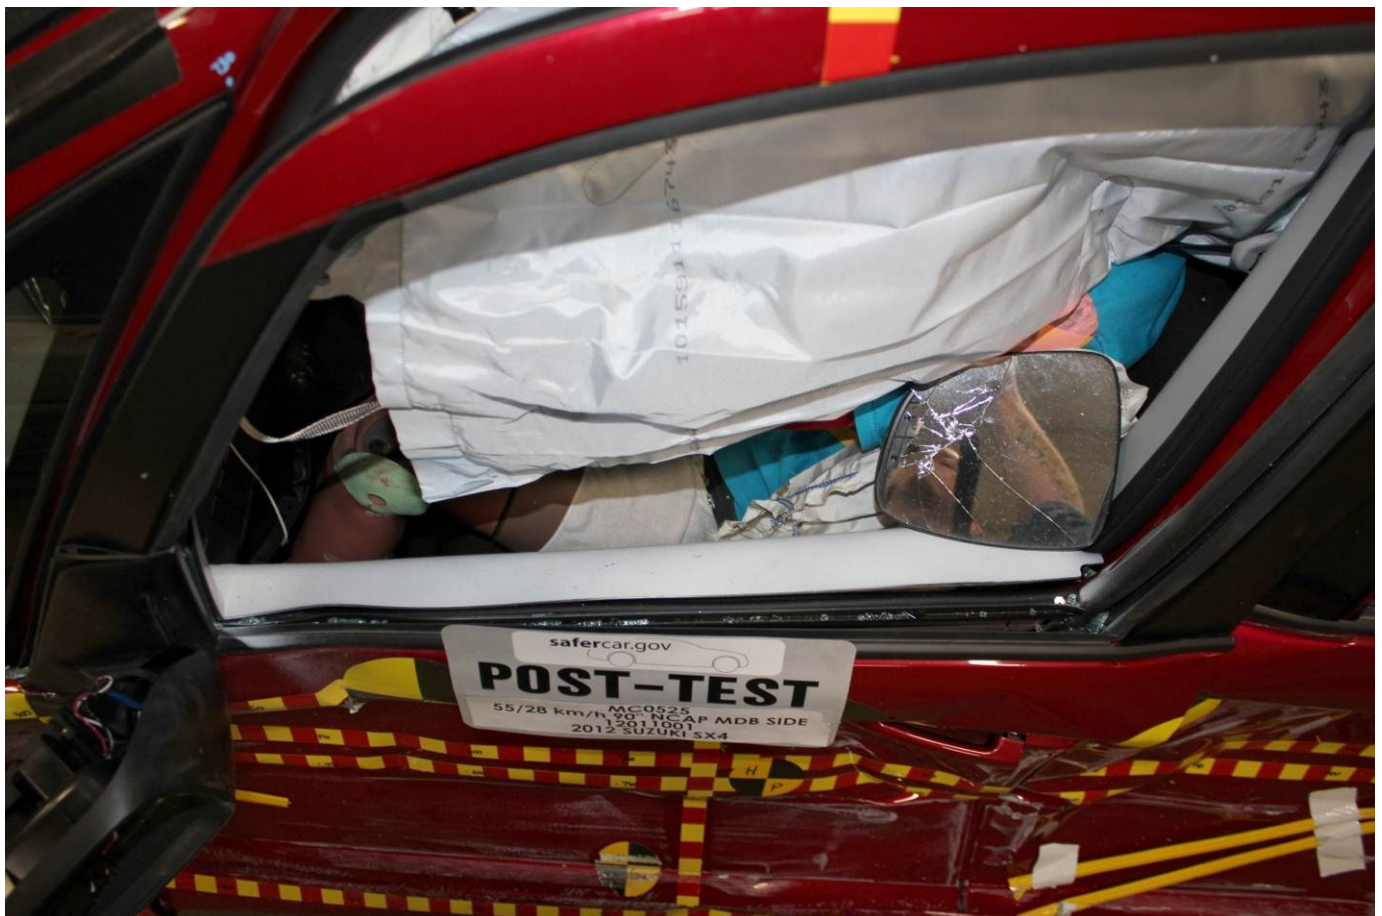
Post-Test Driver Dummy and Door Clearance View

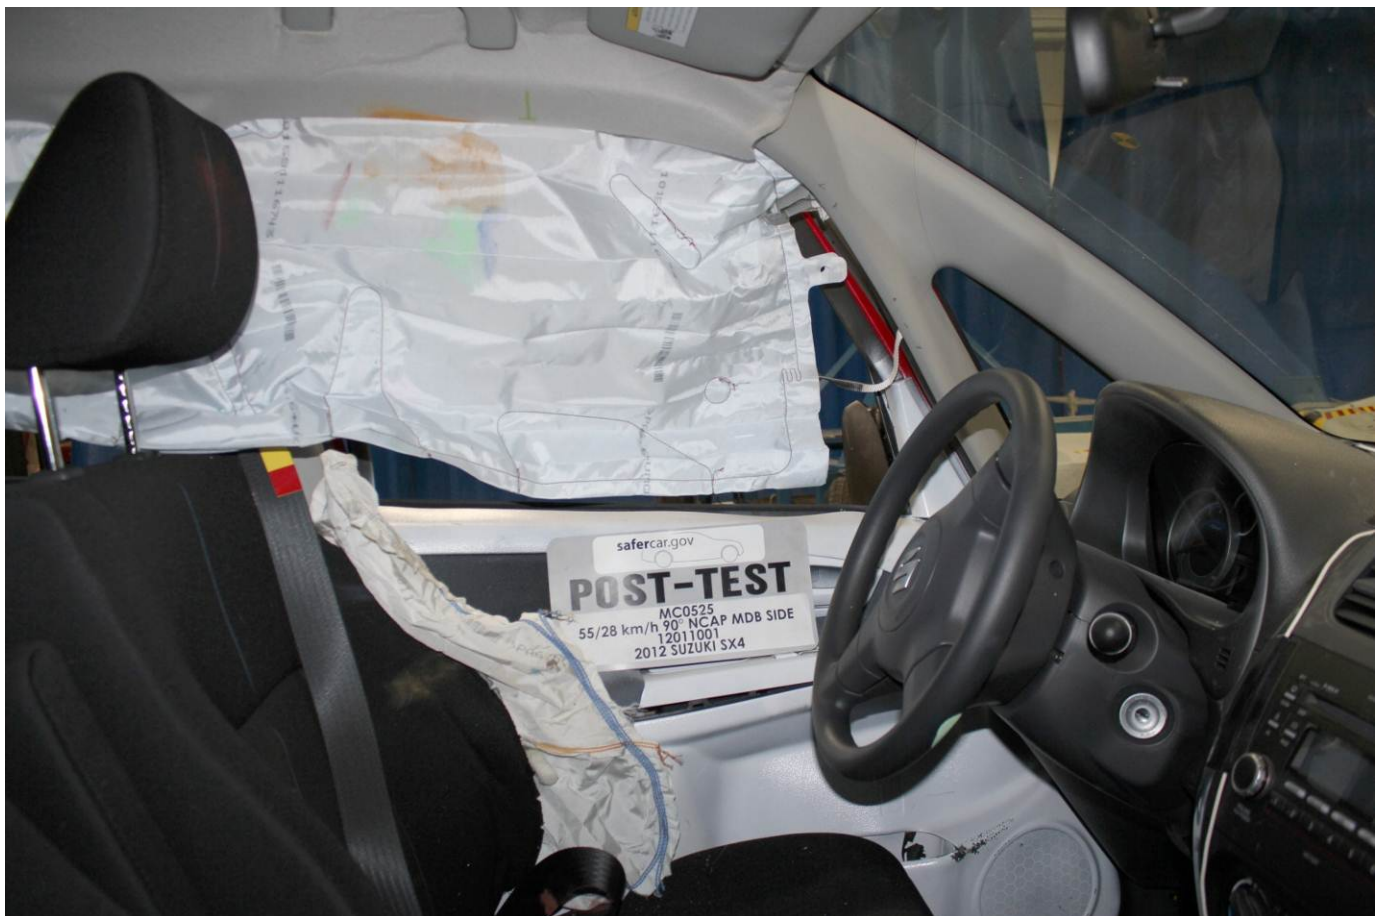
Post-Test Driver Inner Door Panel View

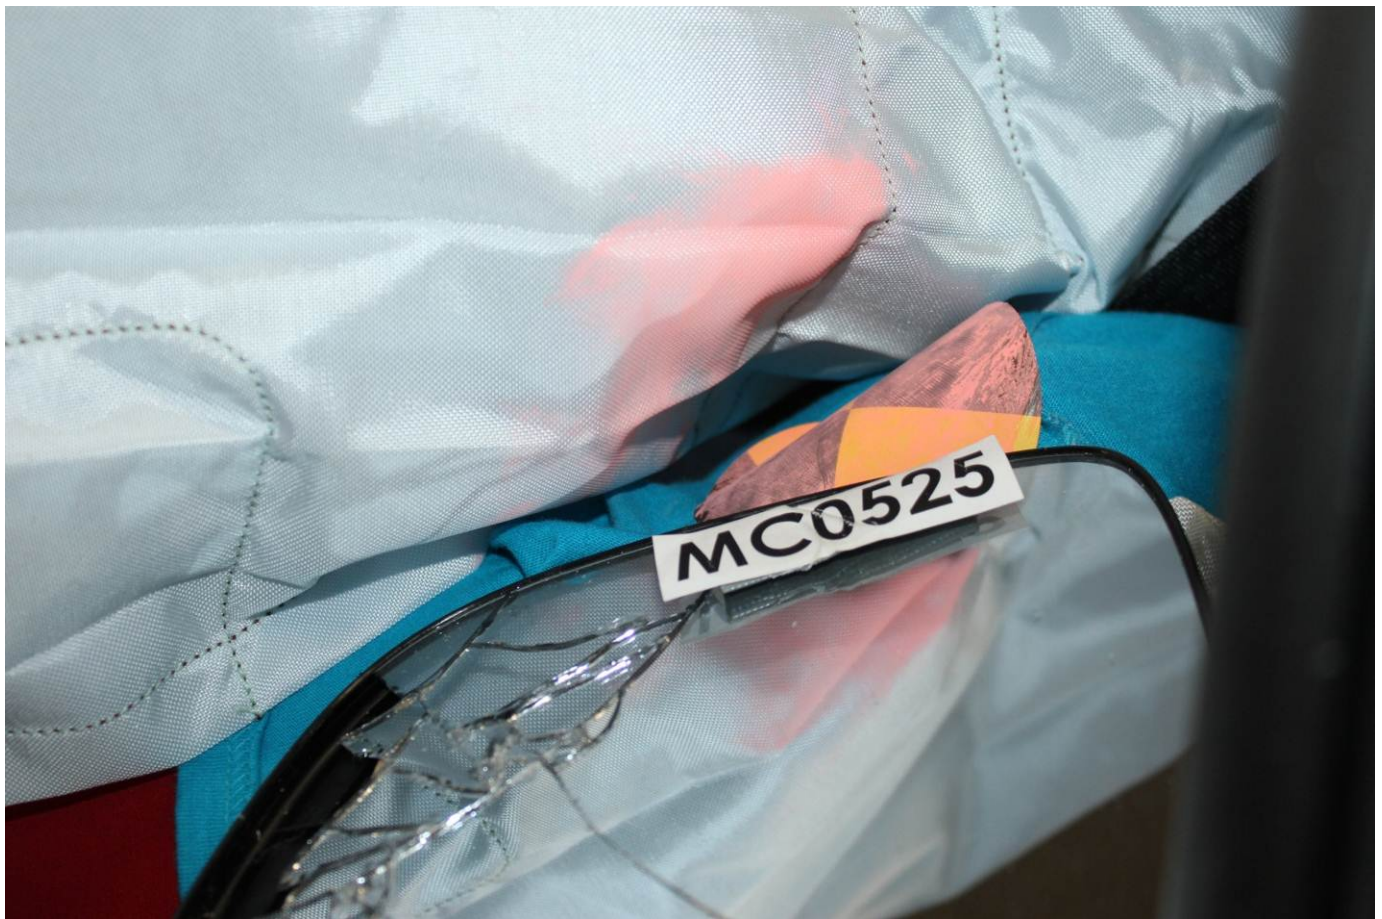
Post-Test Driver Dummy Close-up Torso Contact with Side Airbag View

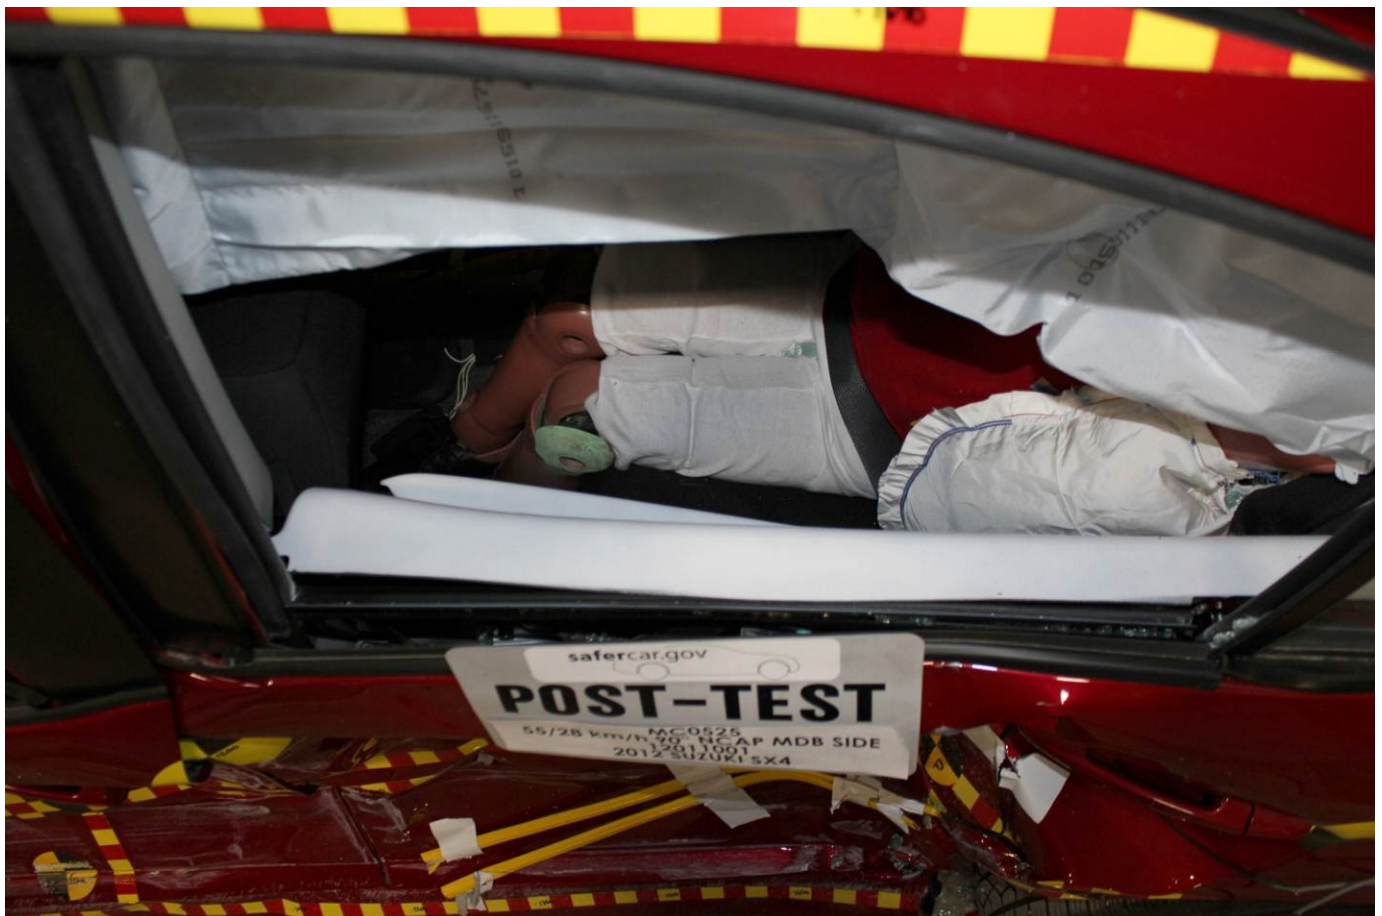
Post-Test Rear Passenger Dummy and Door Clearance View

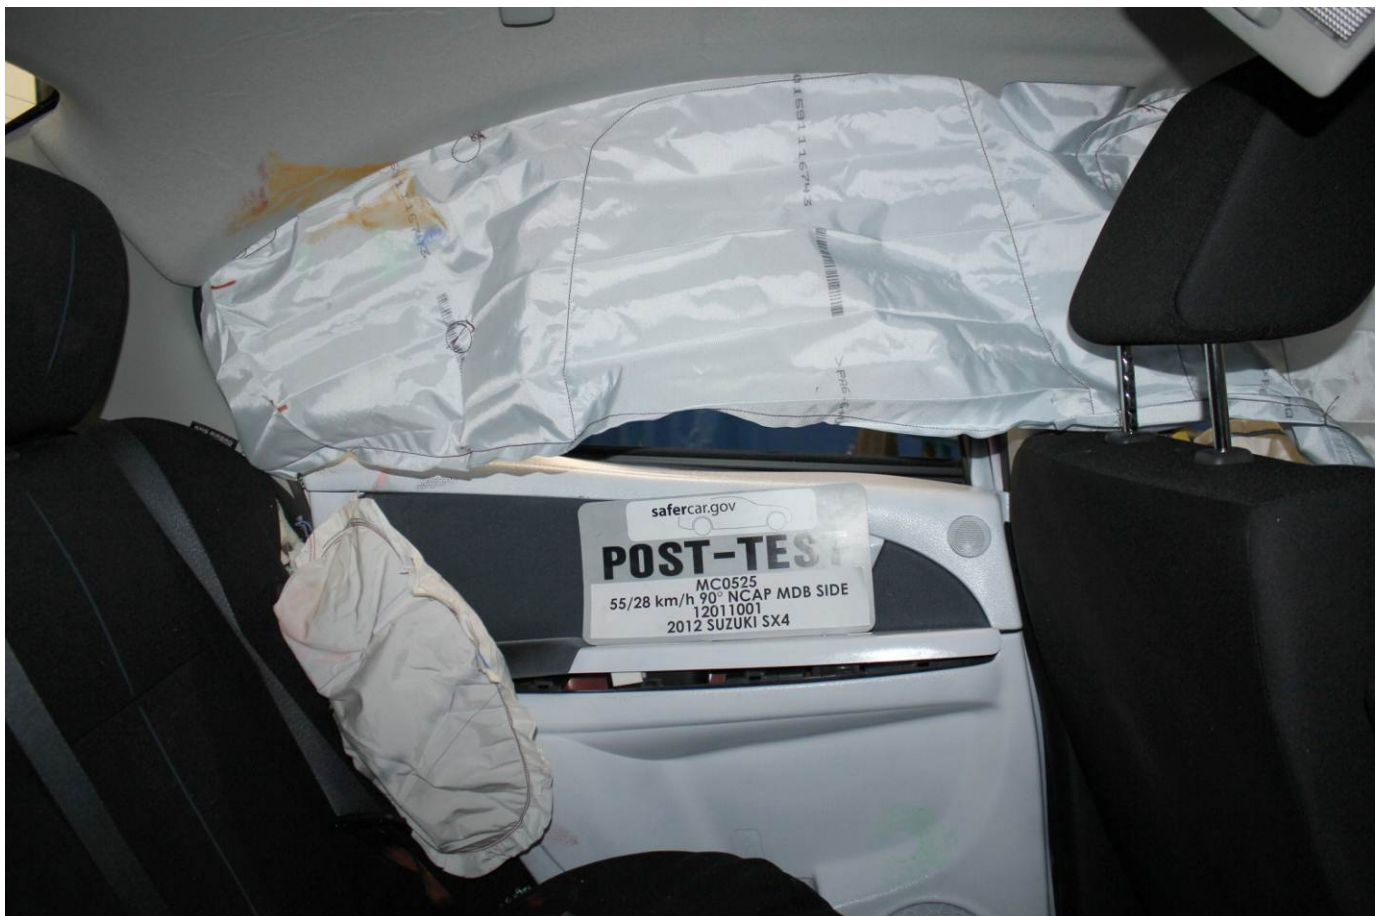
Post-Test Rear Passenger Inner Door Panel View

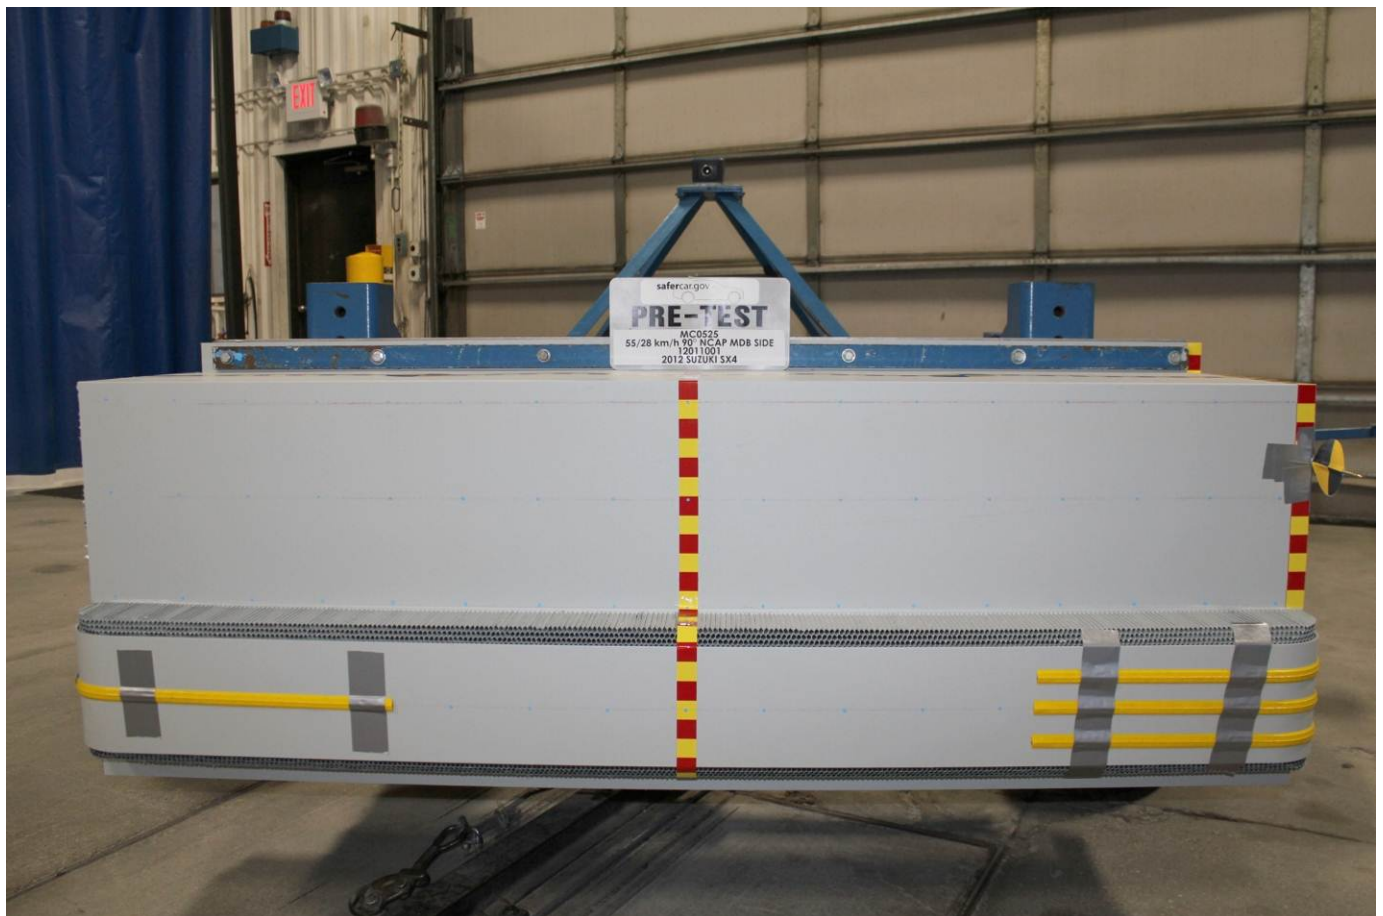
Pre-Test Front View of MDB Impactor Face
