**REPORT NUMBER: NCAP-CAL-12-023**

**NEW CAR ASSESSMENT PROGRAM (NCAP)  
FRONTAL BARRIER IMPACT TEST**

**Toyota Motor Manufacturing, Indiana, Inc  
2012 Toyota Sienna  
Minivan**

**FINAL REPORT**

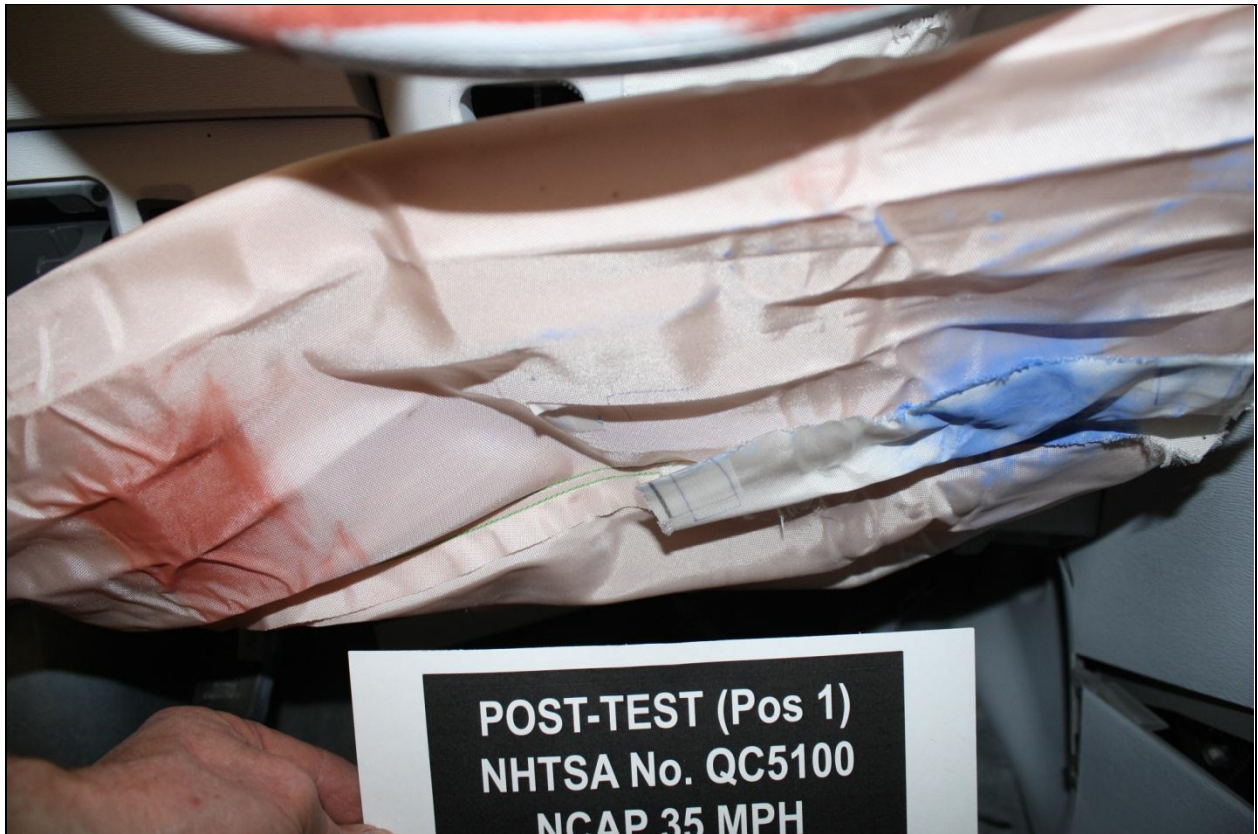
**Figure A-40: Post-Test Driver's Side Knee Bolster**

The driver's visible contact points were as follows: Face and Upper Torso with Frontal airbag, the head restraint became disconnected from the seat back and hit the back of head; both knees contacted the knee airbag.

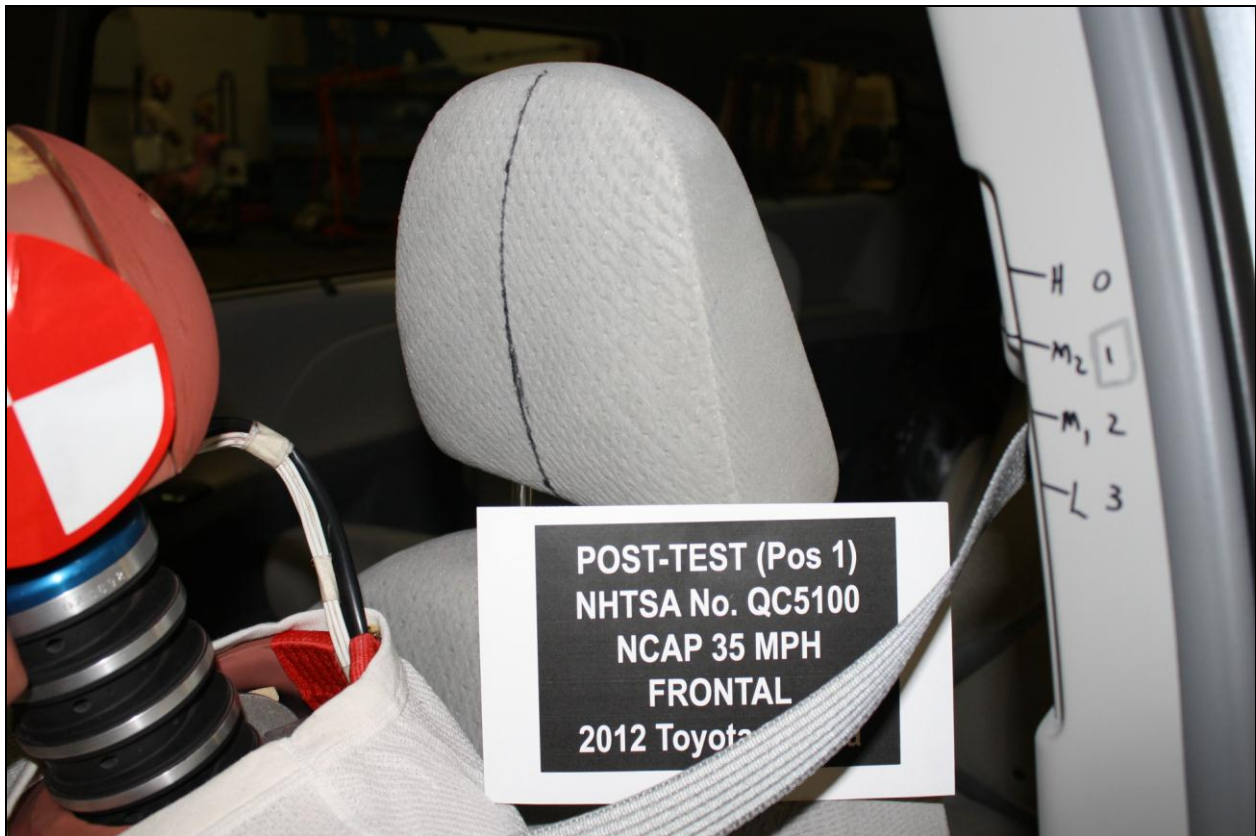
**Figure A-45: Post-Test Driver Dummy Contact with Headrest  
(Headrest disconnected from seatback during the event, Head hit the back of headrest)**

1. P1 Serial Number 064
2. P2 Serial Number 143
3. Camera No. 11 does not have a time stamp due to an internal malfunctions and needs to be sent back to the manufacturer for repair.
4. Driver's head restraint disconnected from the seat back during the impact event.

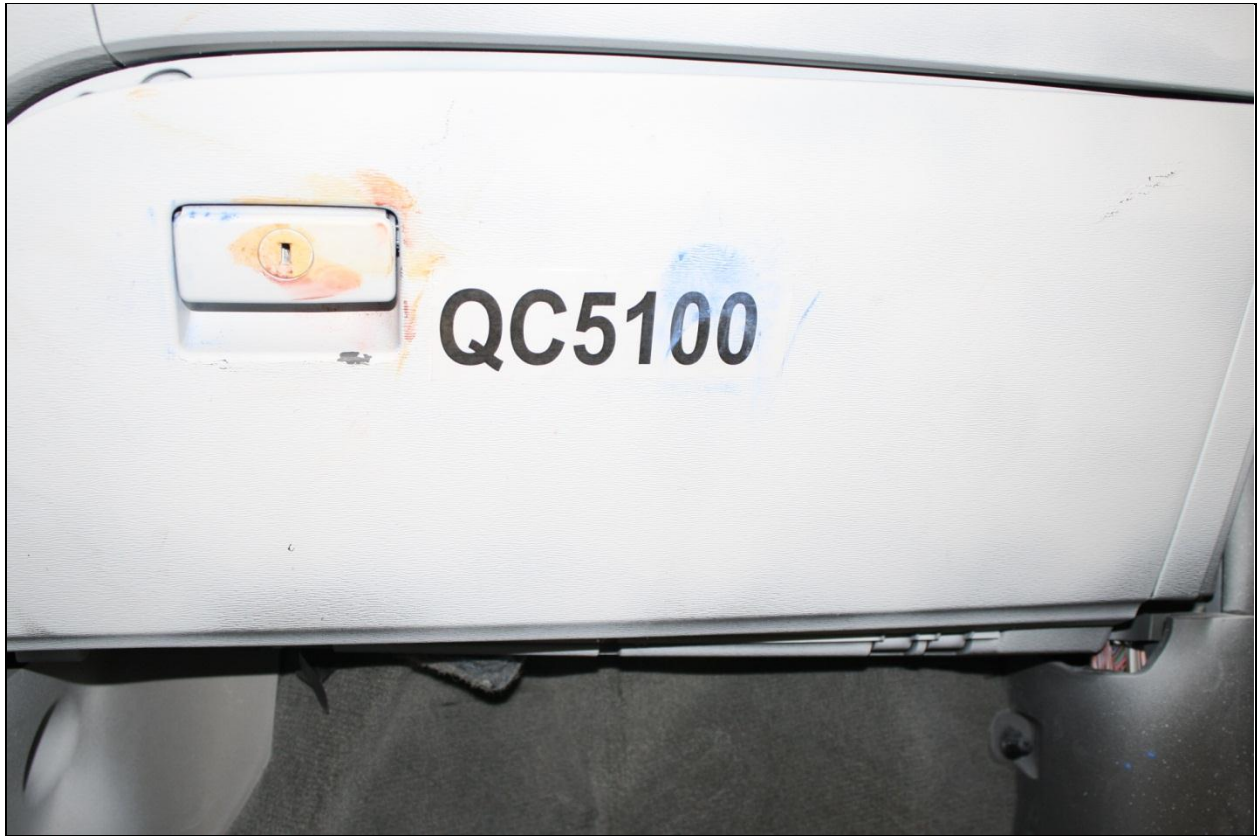
**Figure A-59: Post-Test Passenger's Side Knee Bolster**

The passenger's visible contact points were as follows: Face and Upper Torso with Frontal airbag with the back of head with the head restraint; both knees contacted the lower glovebox door.

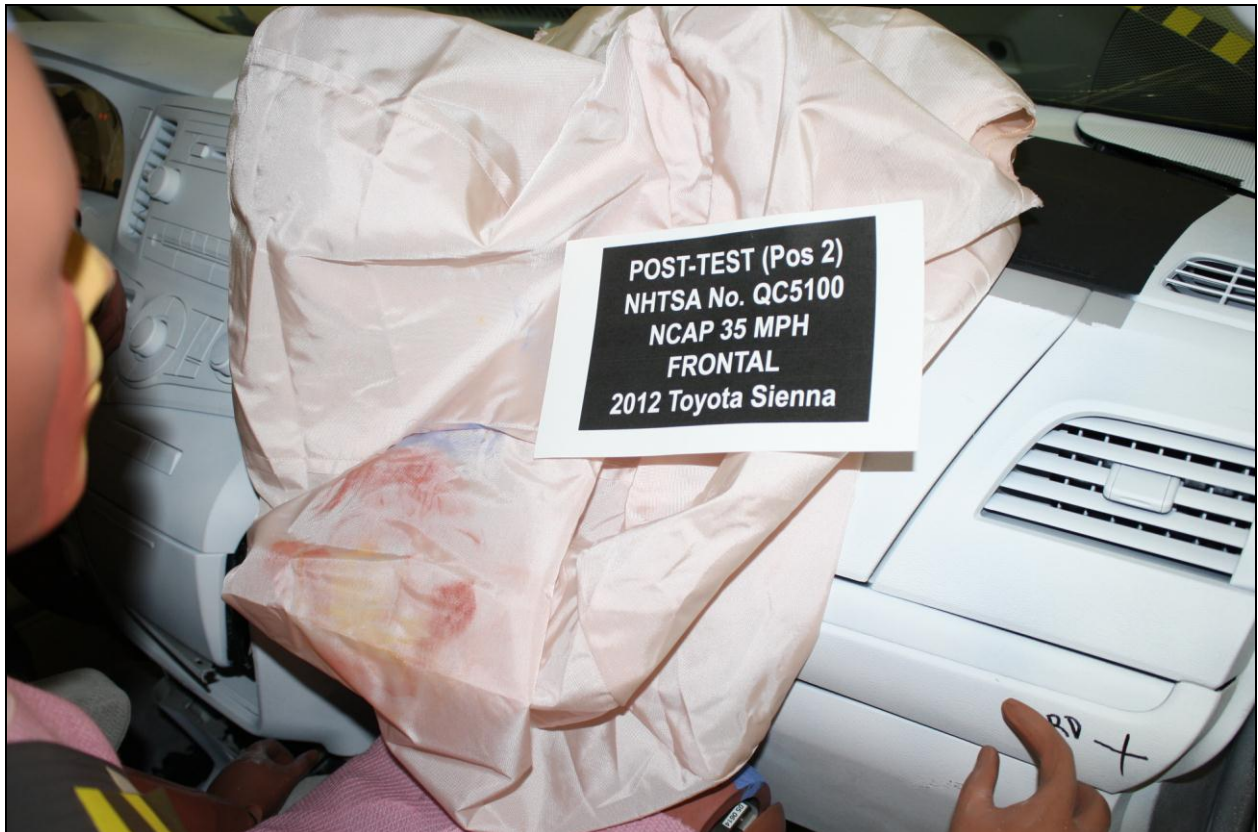
**Figure A-62: Post-Test Passenger Dummy Contact with Airbag**

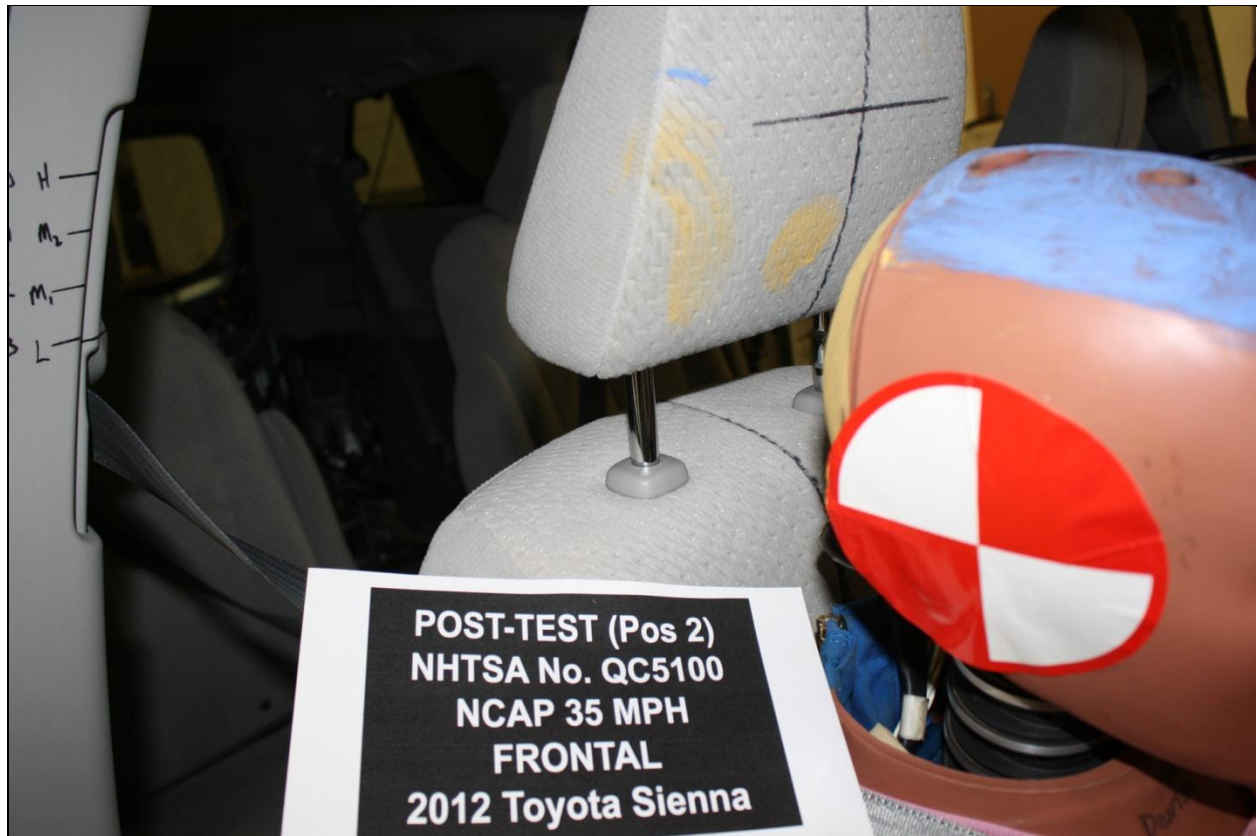
**Figure A-62a: Post-Test Passenger Dummy Contact with Headrest**

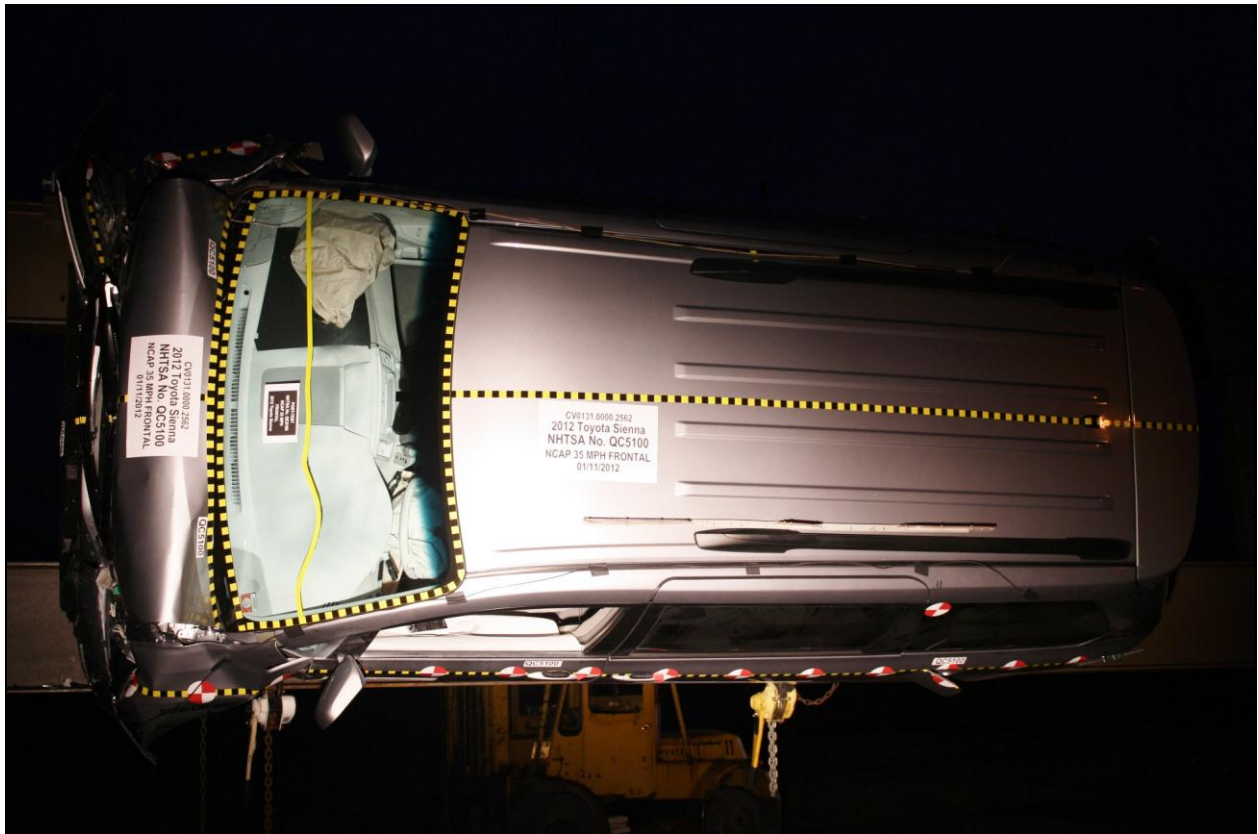
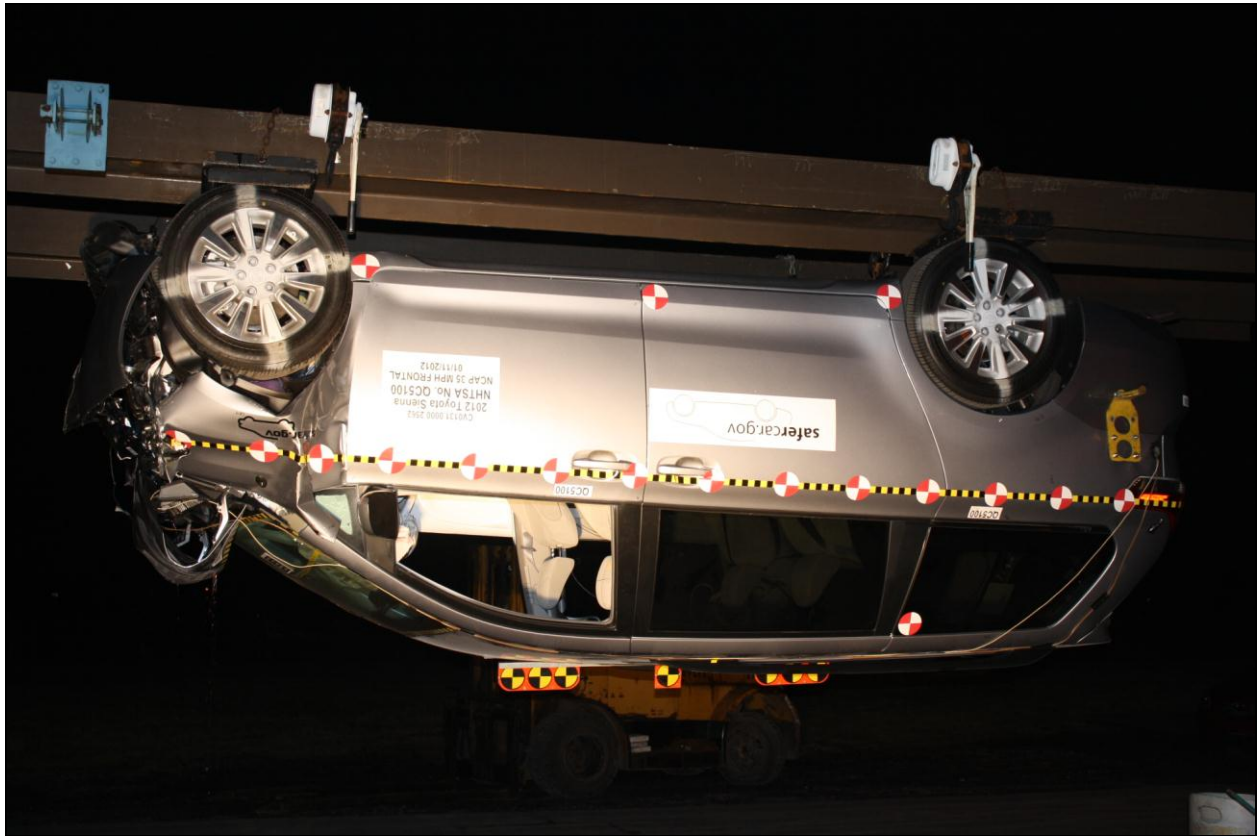
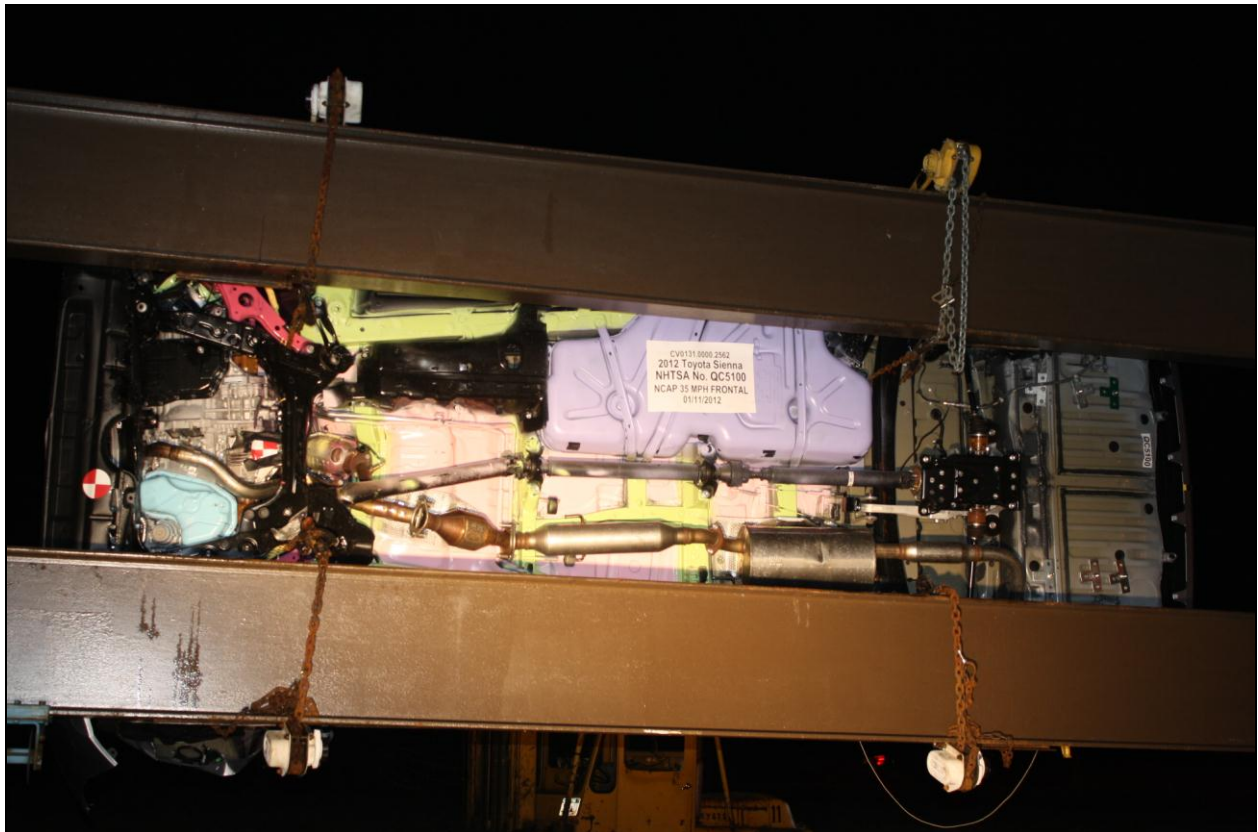
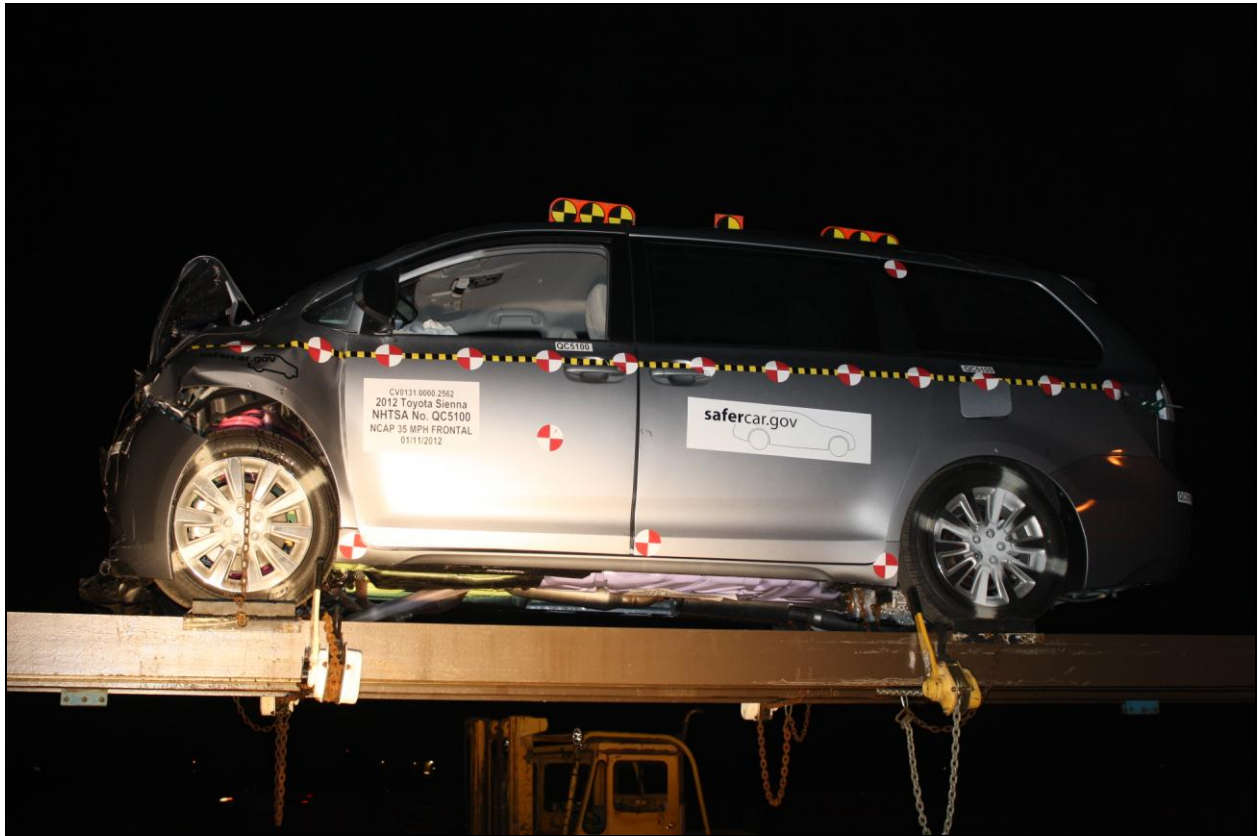
**Figure A-66: Vehicle at 0° on Static Rollover Device**

**Figure A-67: Vehicle at 90° on Static Rollover Device**

**Figure A-68: Vehicle at 180° on Static Rollover Device**

**Figure A-69: Vehicle at 270° on Static Rollover Device**

**Figure A-70: Vehicle at 360° on Static Rollover Device**

There was 100 percent windshield retention and no intrusion into the protected zone of the windshield during the event. There was no Stoddard solvent leakage after the event or during any phase of the static rollover.

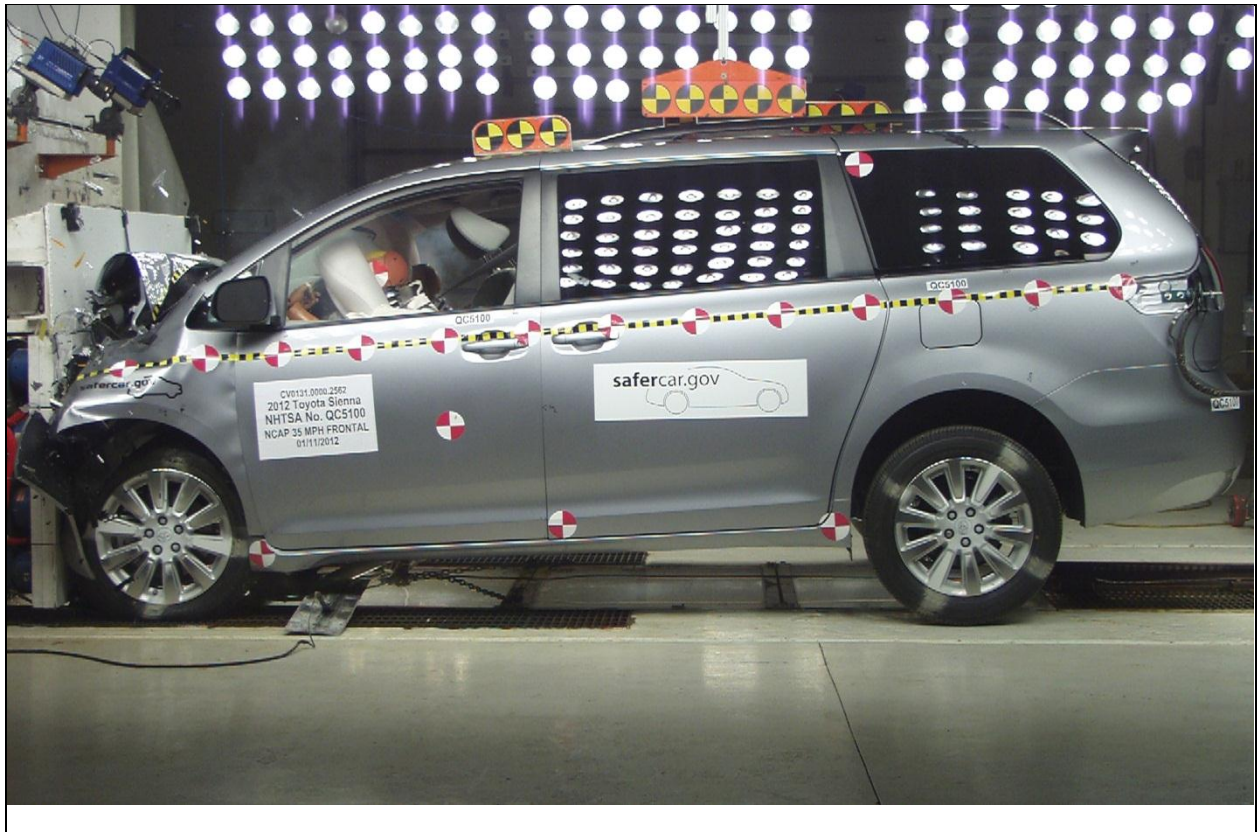
**Figure A-71: 2012 Toyota Sienna Frontal Impact Event**

A load cell barrier consisting of 36 load cells was impacted by a 2012 Toyota Sienna Minivan at a velocity of 56.18 kph. The test was performed at Calspan on 1/11/2012. Pre- and post-test photographs of the vehicle and dummies can be found in Appendix A.
