**REPORT NUMBER: NCAP-MGA-2012-053**

**NEW CAR ASSESSMENT PROGRAM (NCAP)  
Frontal Barrier Impact Test**

**SUZUKI MOTOR CORPORATION  
2012 Suzuki SX4 LE 4-Dr Sedan  
NHTSA No.: MC0524**

**FINAL REPORT**

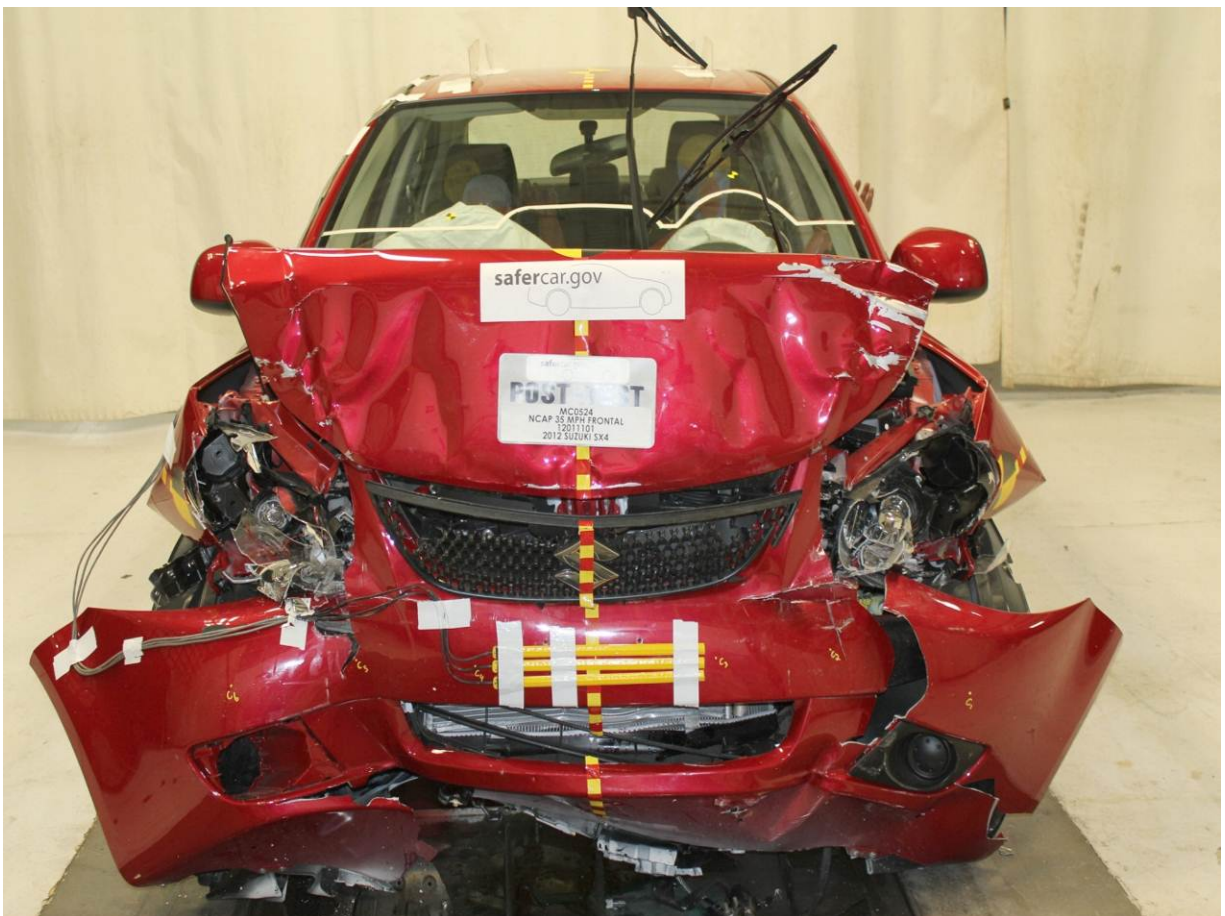
Post-Test Front View of Test Vehicle

The maximum static crush of the vehicle was 465 mm and both the driver and passenger side doors remained closed during the impact event and were operable after the impact.

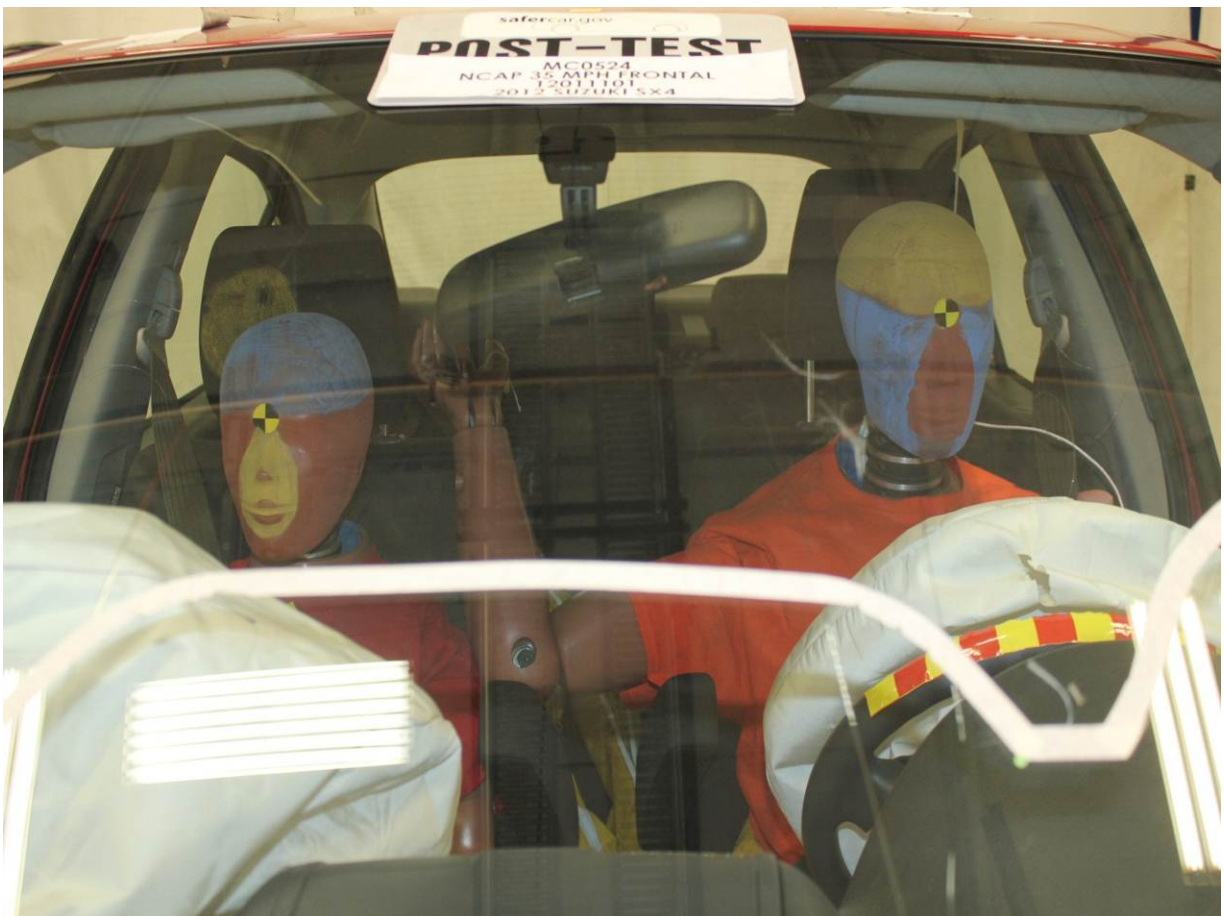
Post-Test Windshield View

There was 100 percent windshield retention and no intrusion into the protected zone of the windshield during the event. There was no Stoddard Solvent leakage after the event or during any phase of the static rollover.

| Critical Areas of Performance | Observations and Conclusions |
|---|---|
| Windshield Damage | Cracked |

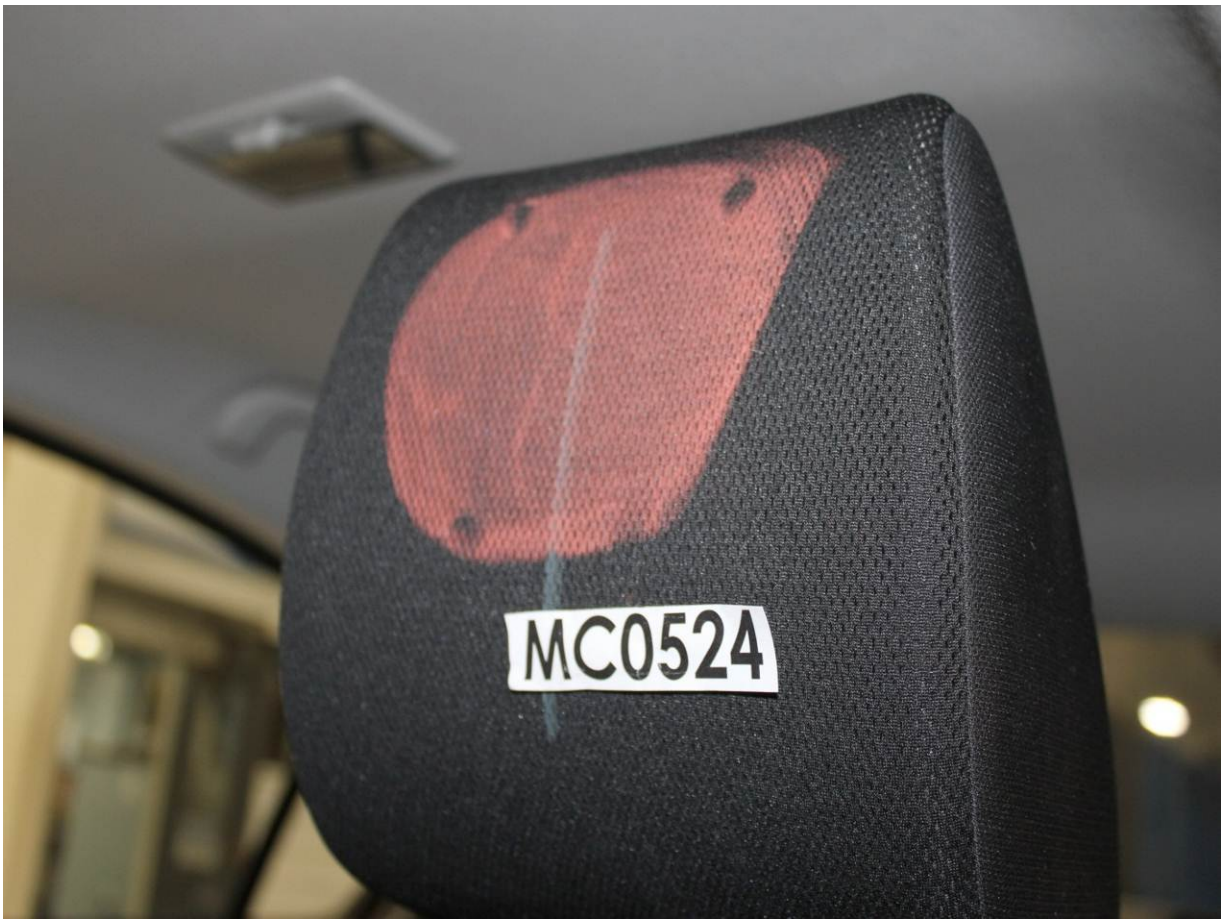
Post-Test Driver Dummy Contact with Headrest

The driver's visible contact points were as follows: The driver's head and chest contacted the airbag. The driver's head also contacted the headrest. The driver's knees contacted the knee bolster. The driver's right knee contacted the steering wheel. The passenger's visible contact points were as follows: The passenger's head and chest contacted the airbag. The passenger's head also contacted the headrest. The passenger's knees contacted the glove box.

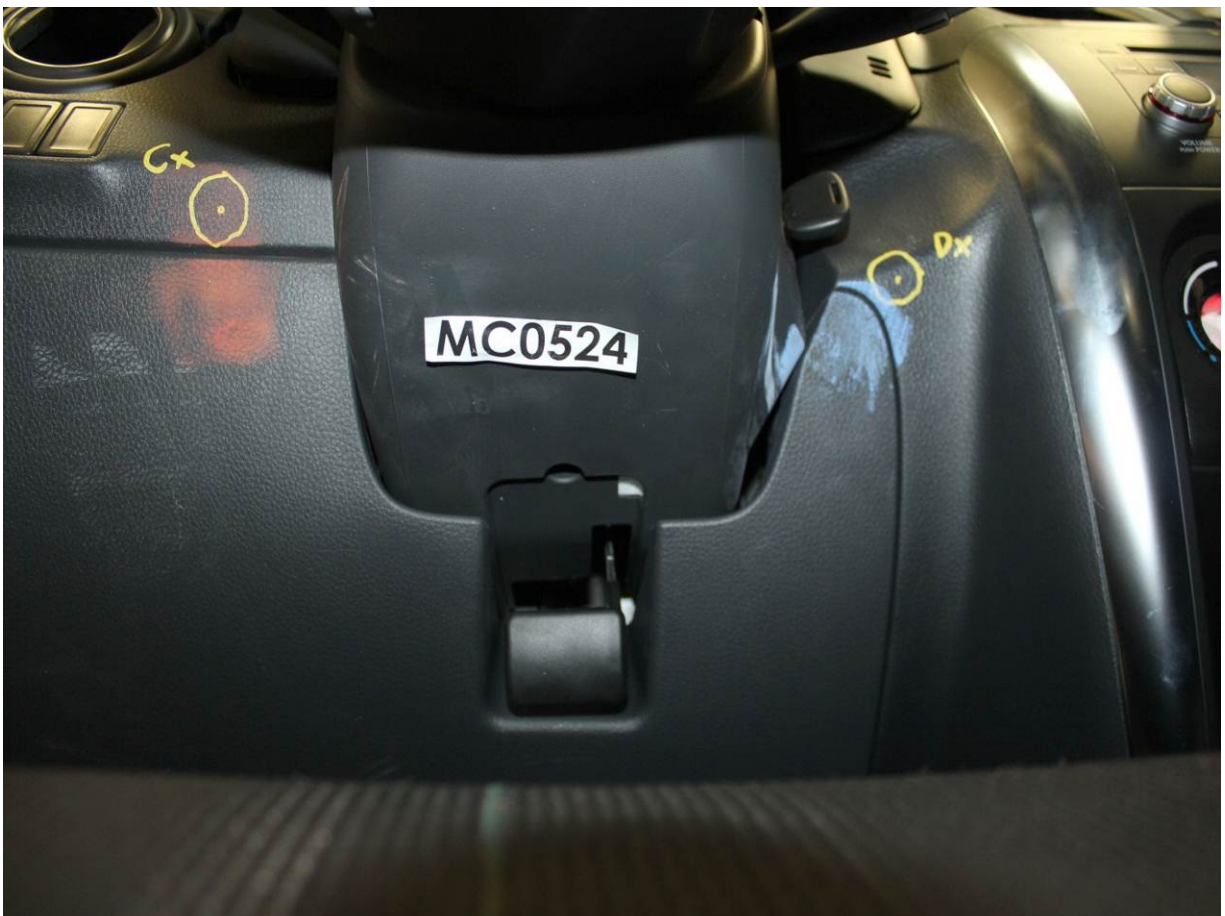
Post-Test Driver Dummy Contact with Knee Bolster

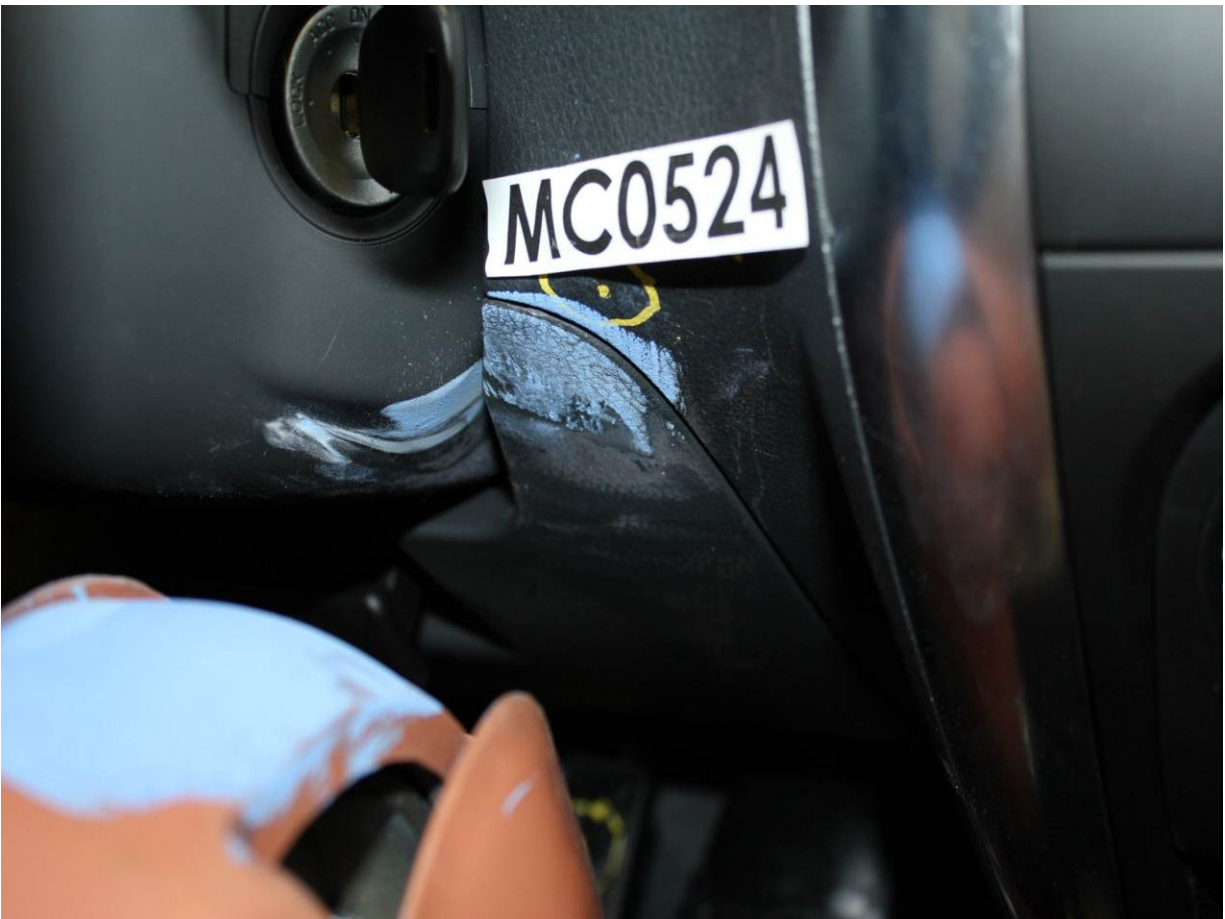
Post-Test Driver Dummy Contact with Steering Wheel

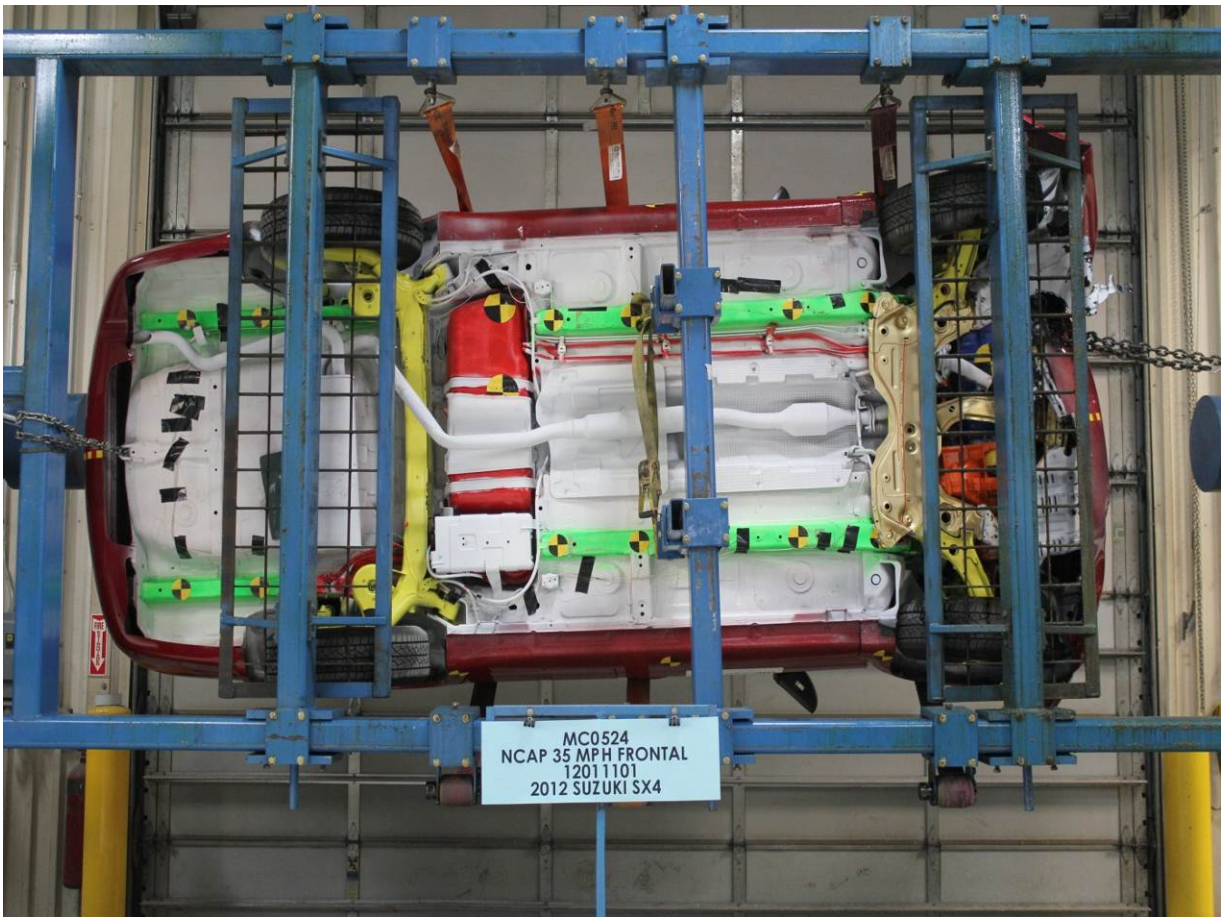
Vehicle at 90 Degrees on Static Rollover Device

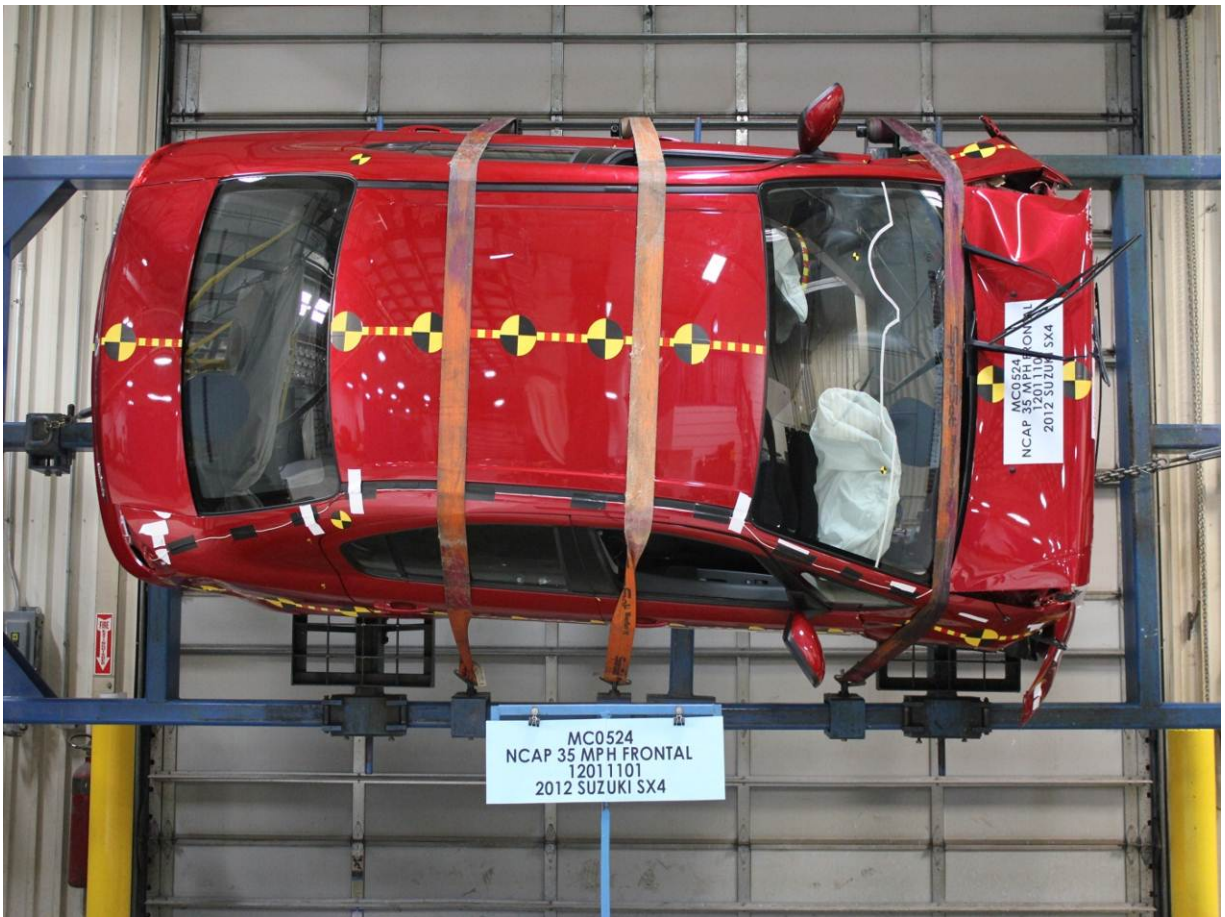
Vehicle at 270 Degrees on Static Rollover Device
