**REPORT NUMBER: NCAP-KAR-12-036**

**NEW CAR ASSESSMENT PROGRAM (NCAP)  
FRONTAL BARRIER IMPACT TEST**

**TOYOTA MOTOR CORPORATION  
2012 LEXUS ES350 4-DOOR SEDAN**

**FINAL REPORT**

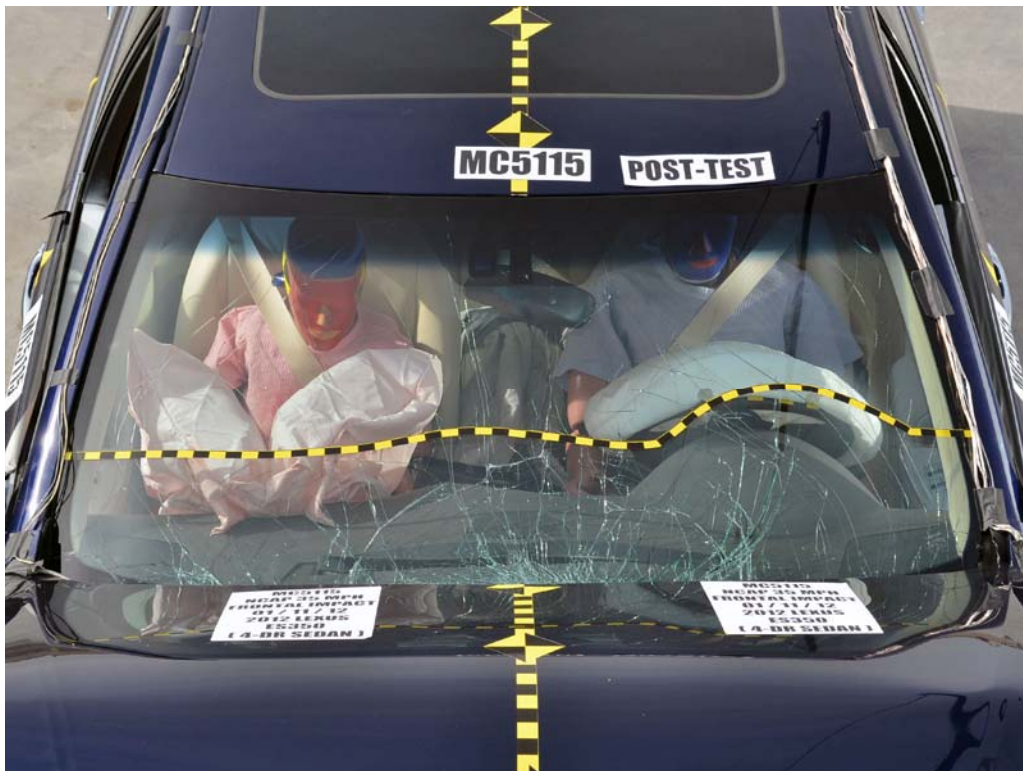
FIGURE 18. Post-Test Windshield View

There was 100% windshield retention and no intrusion into the protected zone of the windshield during the event. There was no Stoddard solvent leakage after the event or during any phase of the static rollover.

| Critical Areas of Performance | Observations and Conclusions |
|---|---|
| Windshield Damage | Broken |

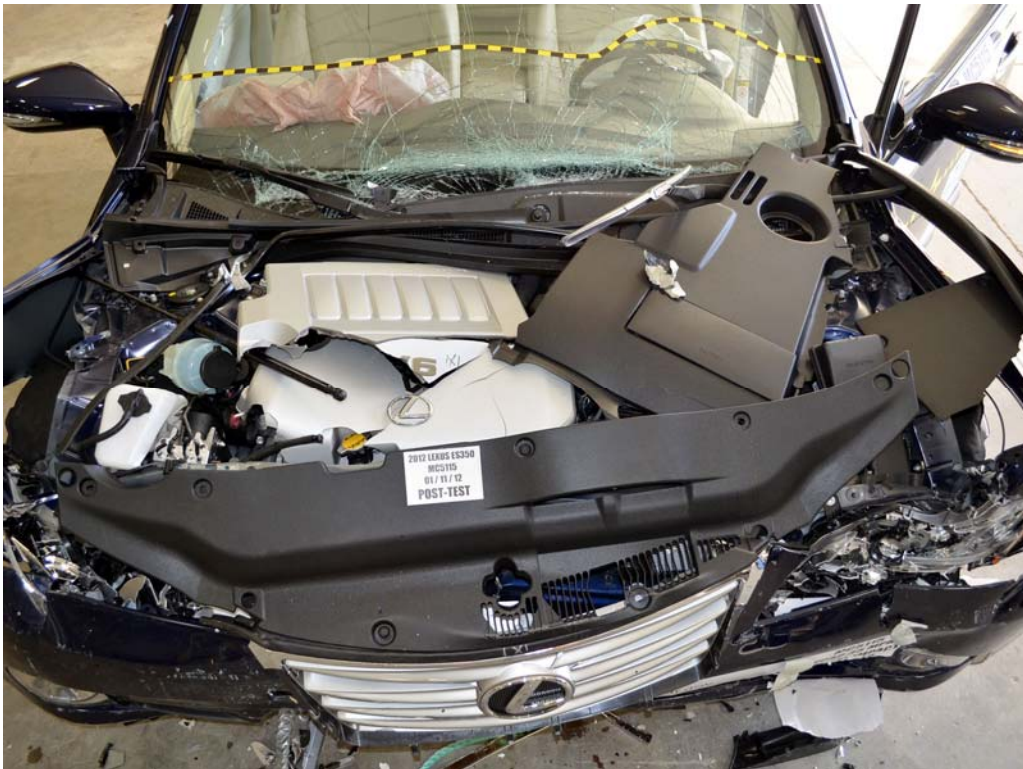
FIGURE 20. Post-Test Engine Compartment View

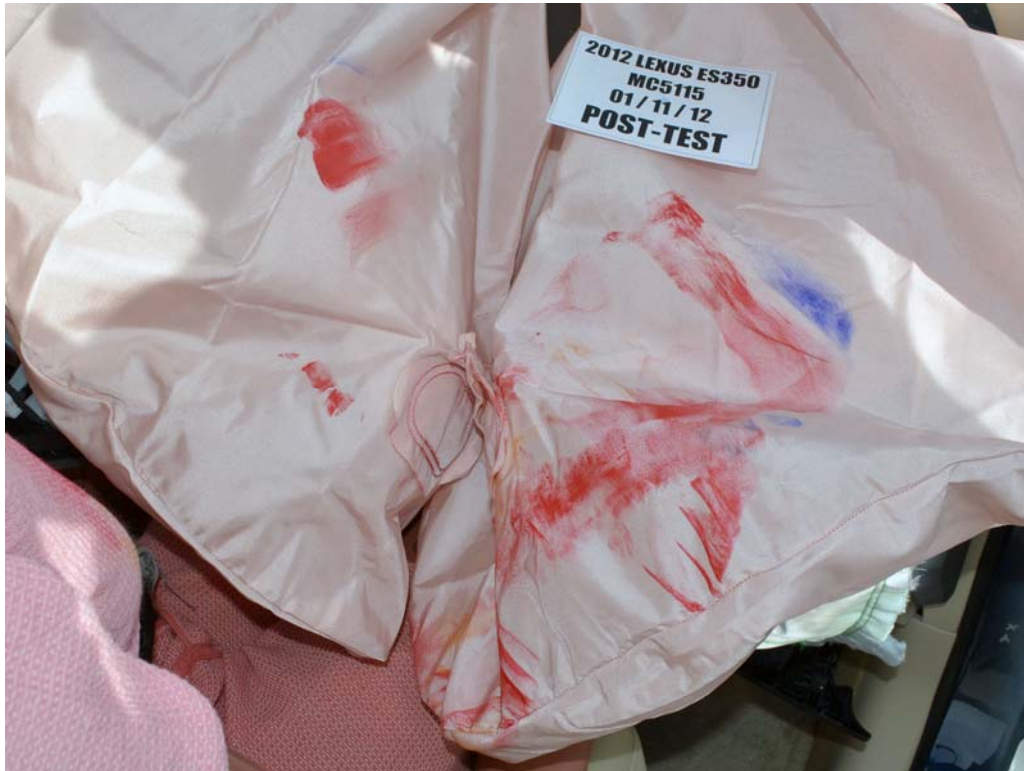
FIGURE 62. Post-Test Passenger Dummy Contact With Airbag

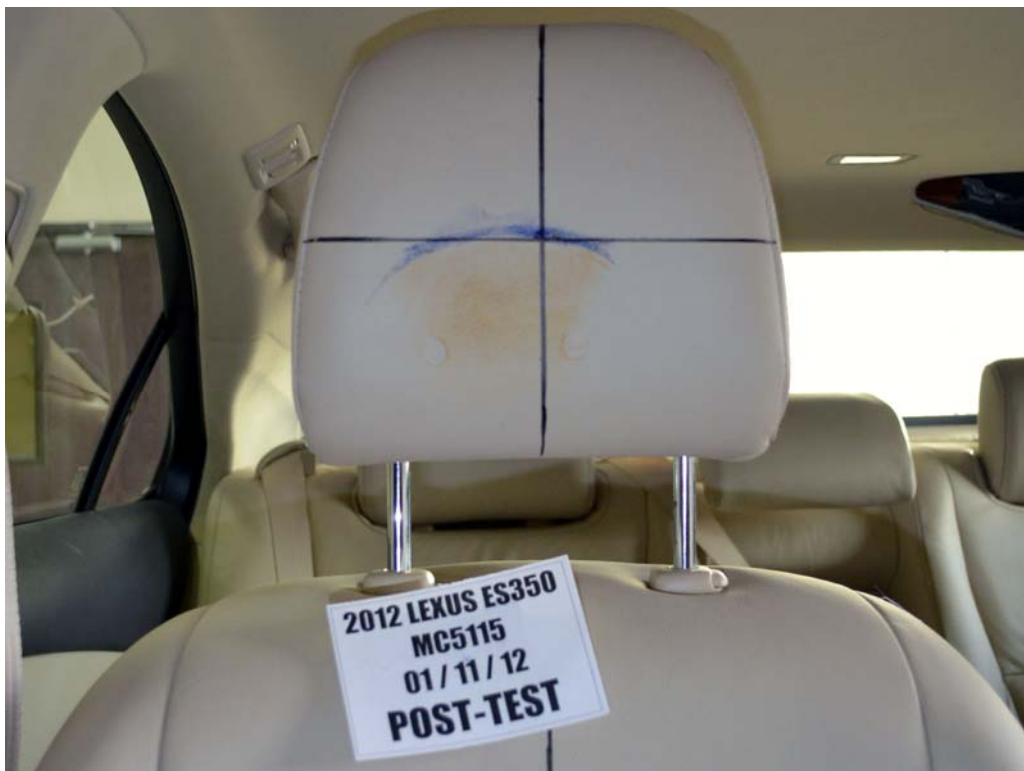
FIGURE 62a. Post-Test Passenger Dummy Contact With Headrest

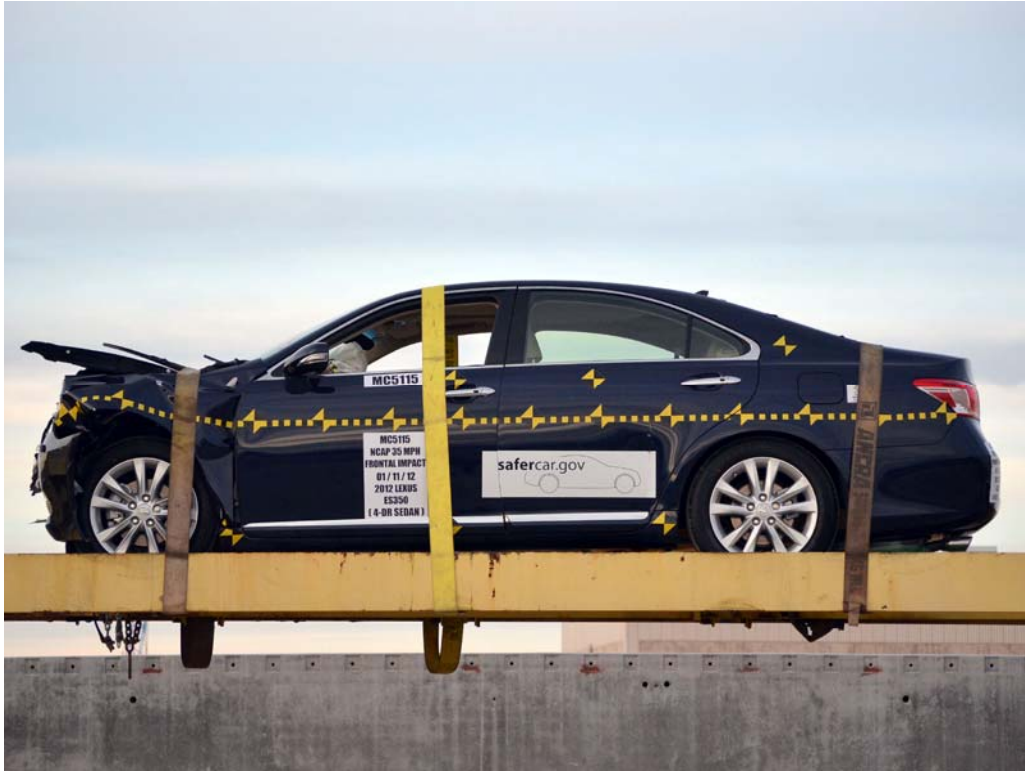
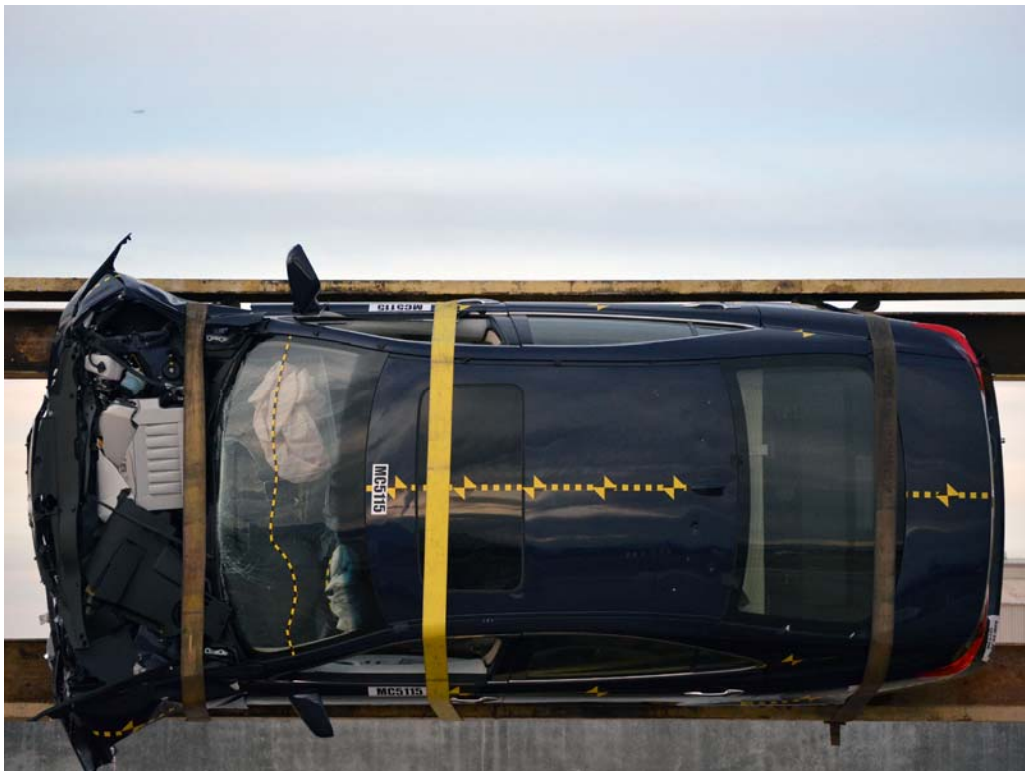
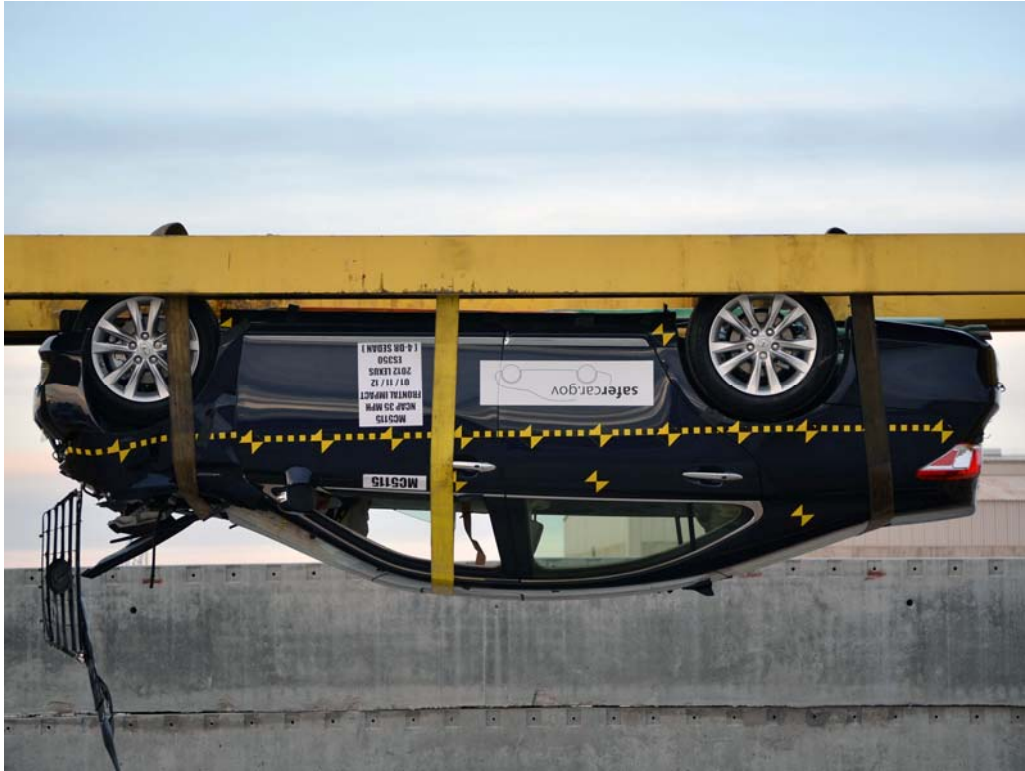
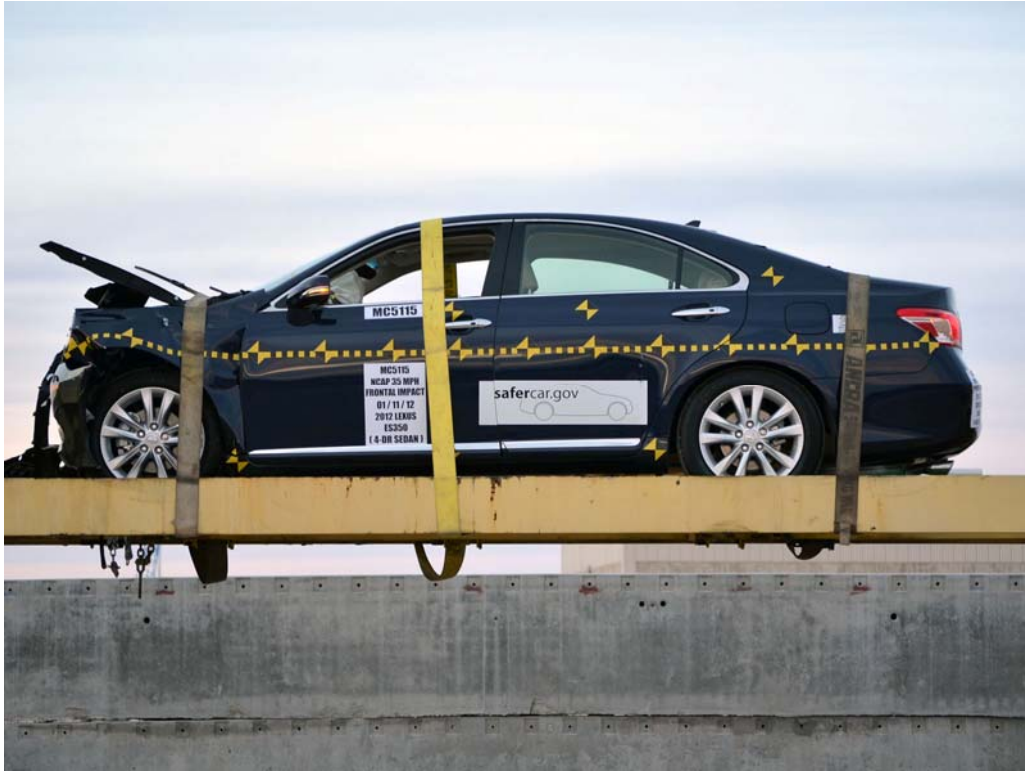
FIGURE 66. Vehicle at 0°on Static Rollover Device

FIGURE 67. Vehicle at 90°on Static Rollover Device

FIGURE 68. Vehicle at 180°on Static Rollover Device

FIGURE 69. Vehicle at 270°on Static Rollover Device

FIGURE 70. Vehicle at 360° on Static Rollover Device
