**REPORT NUMBER: NCAP-MGA-2012-054**

**NEW CAR ASSESSMENT PROGRAM (NCAP)  
Frontal Barrier Impact Test**

**HONDA MOTOR CO., LTD  
2012 Honda Civic IMA 4-Dr Sedan  
NHTSA No.: MC5300**

**FINAL REPORT**

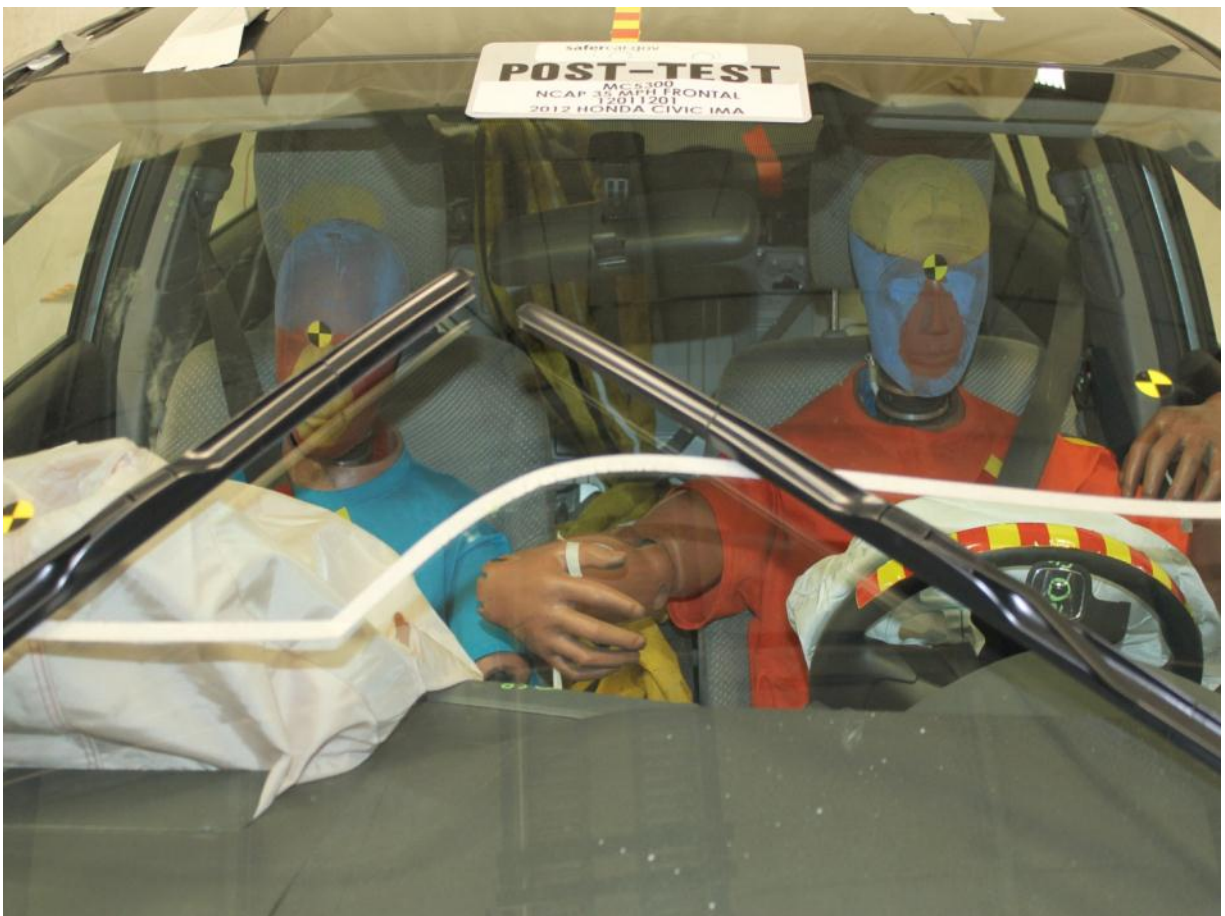
Post-Test Windshield View

There was 100 percent windshield retention and no intrusion into the protected zone of the windshield during the event. There was no Stoddard Solvent leakage after the event or during any phase of the static rollover.

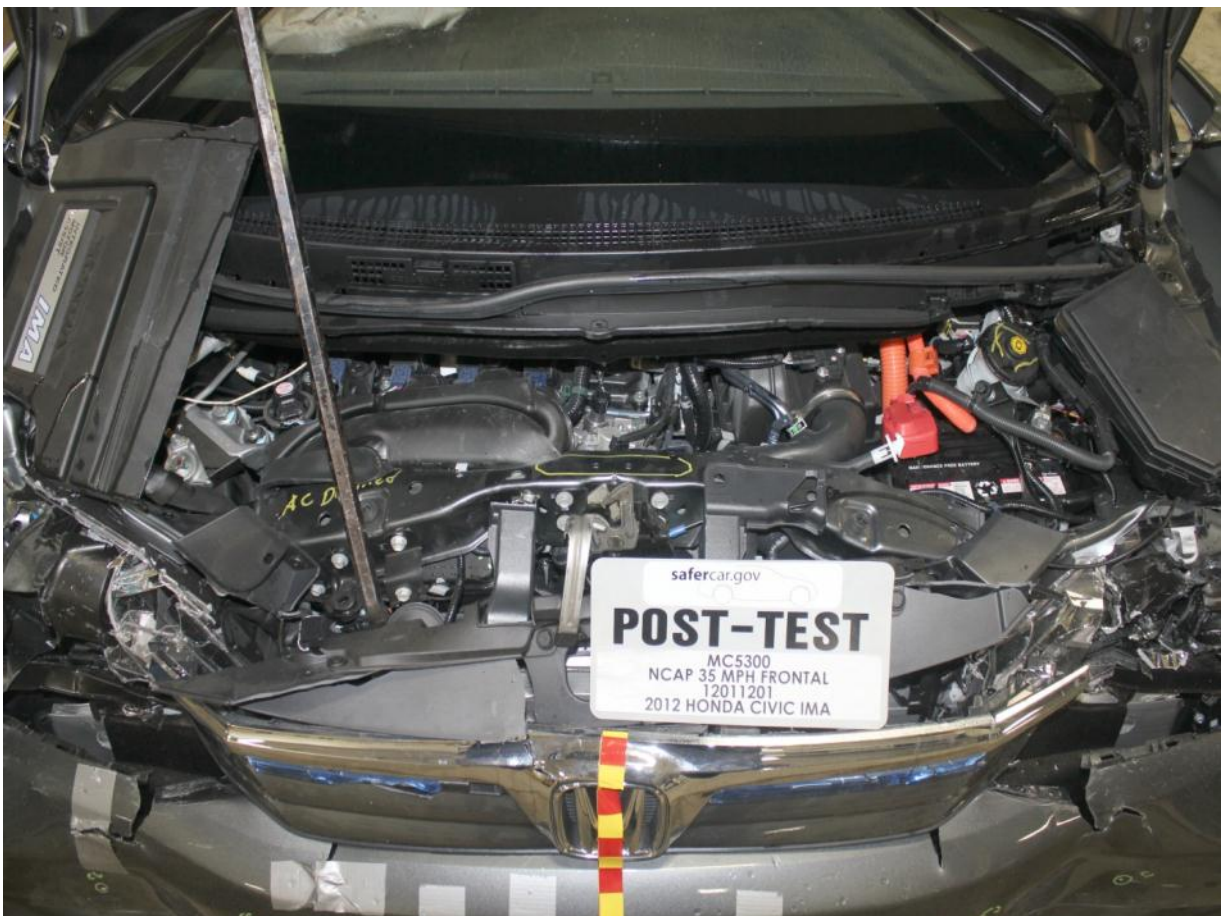
Post-Test Engine Compartment View

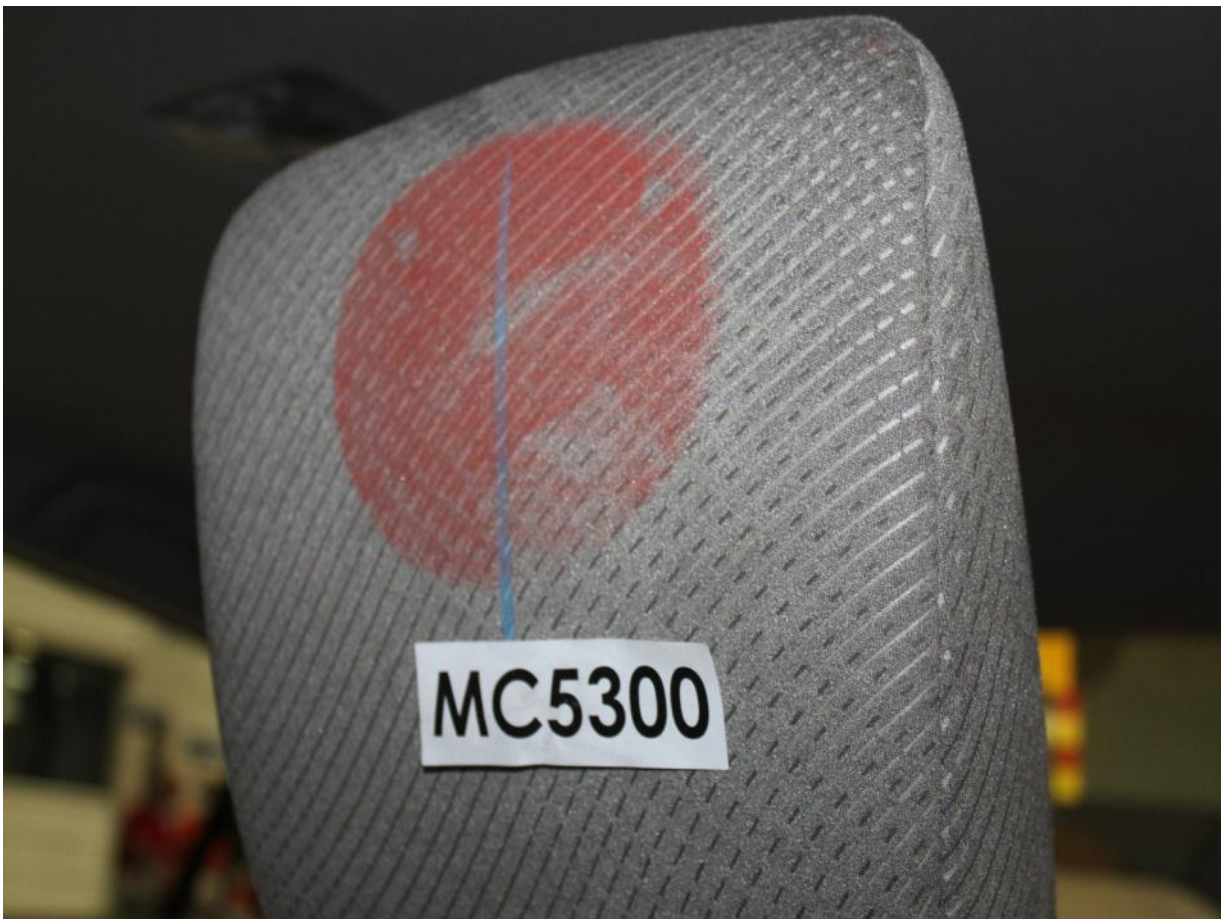
Post-Test Driver Dummy Contact with Headrest

The driver's visible contact points were as follows: The driver's head and chest contacted the airbag. The driver's head also contacted the headrest. The driver's knees contacted the knee bolster. The passenger's visible contact points were as follows: The passenger's head and chest contacted the airbag. The passenger's head also contacted the headrest. The passenger's knees contacted the glovebox.

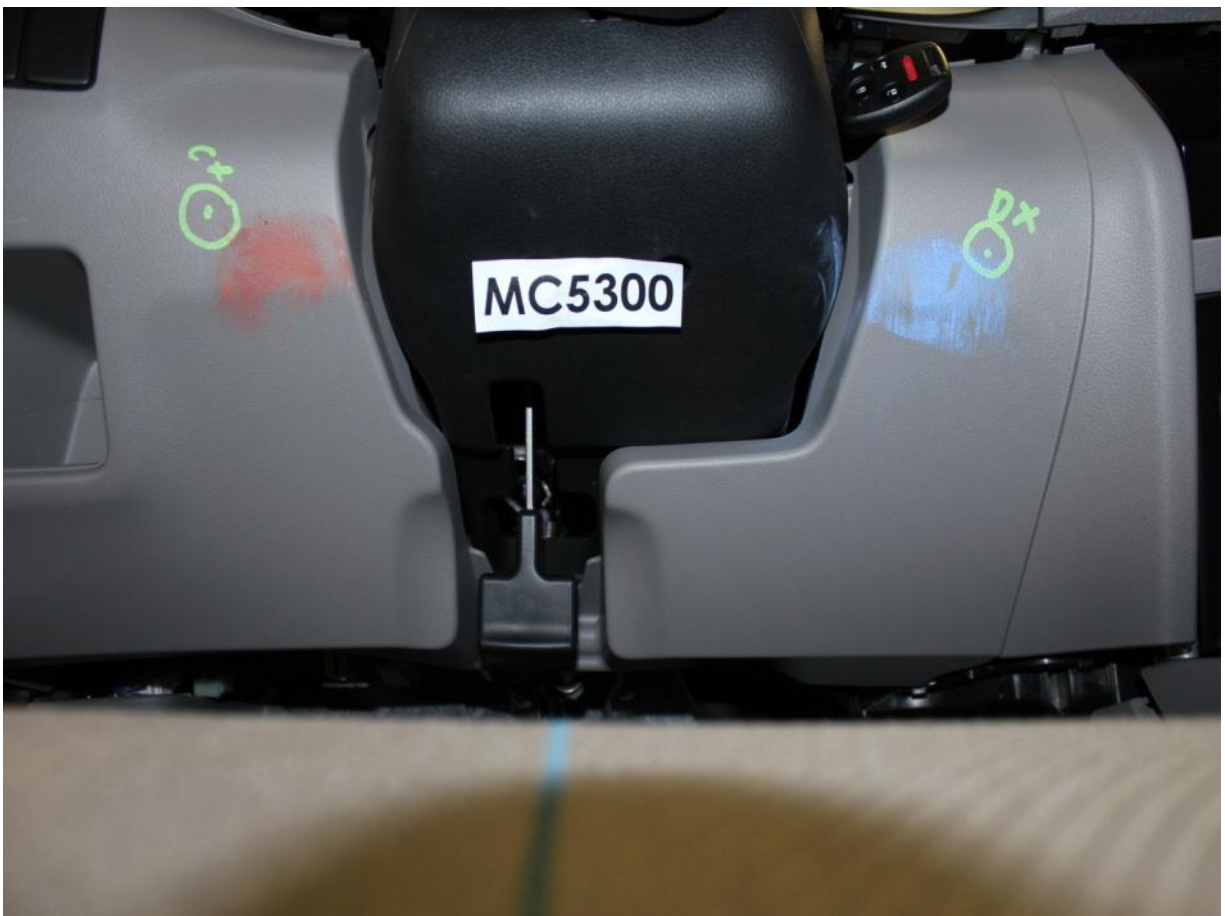
Post-Test Driver Dummy Contact with Knee Bolster

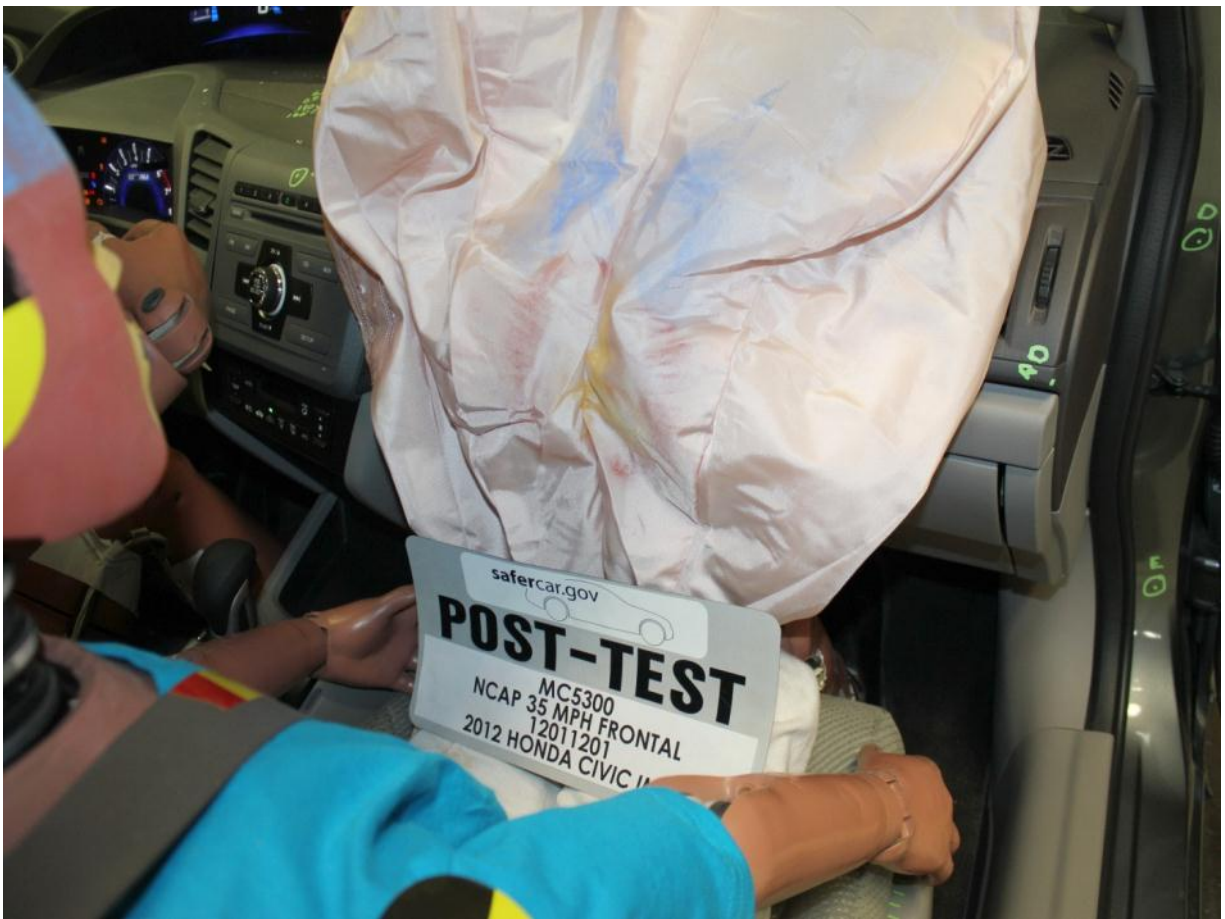
Post-Test Passenger Dummy Contact with Airbag

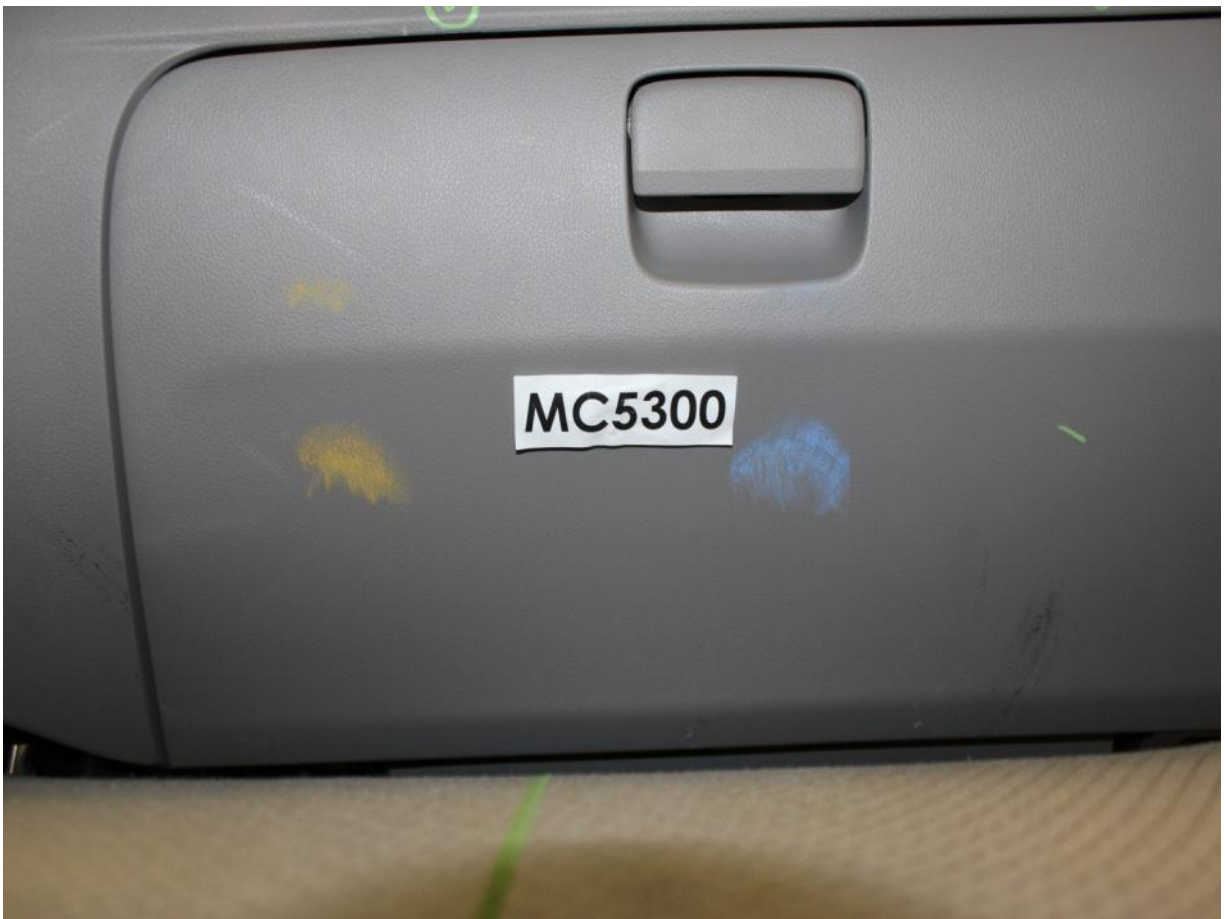
Post-Test Passenger Dummy Contact with Knee Bolster

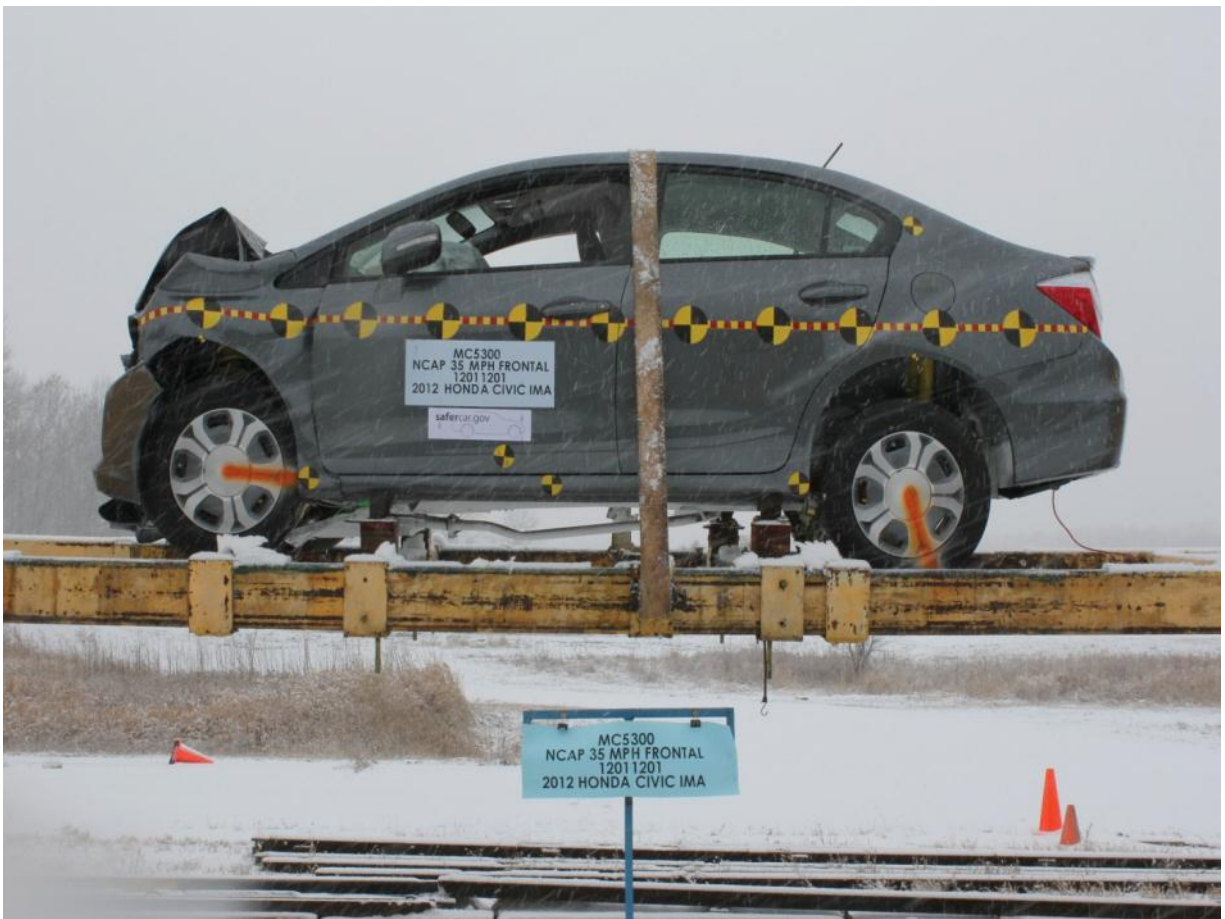
Vehicle at 0 Degrees on Static Rollover Device

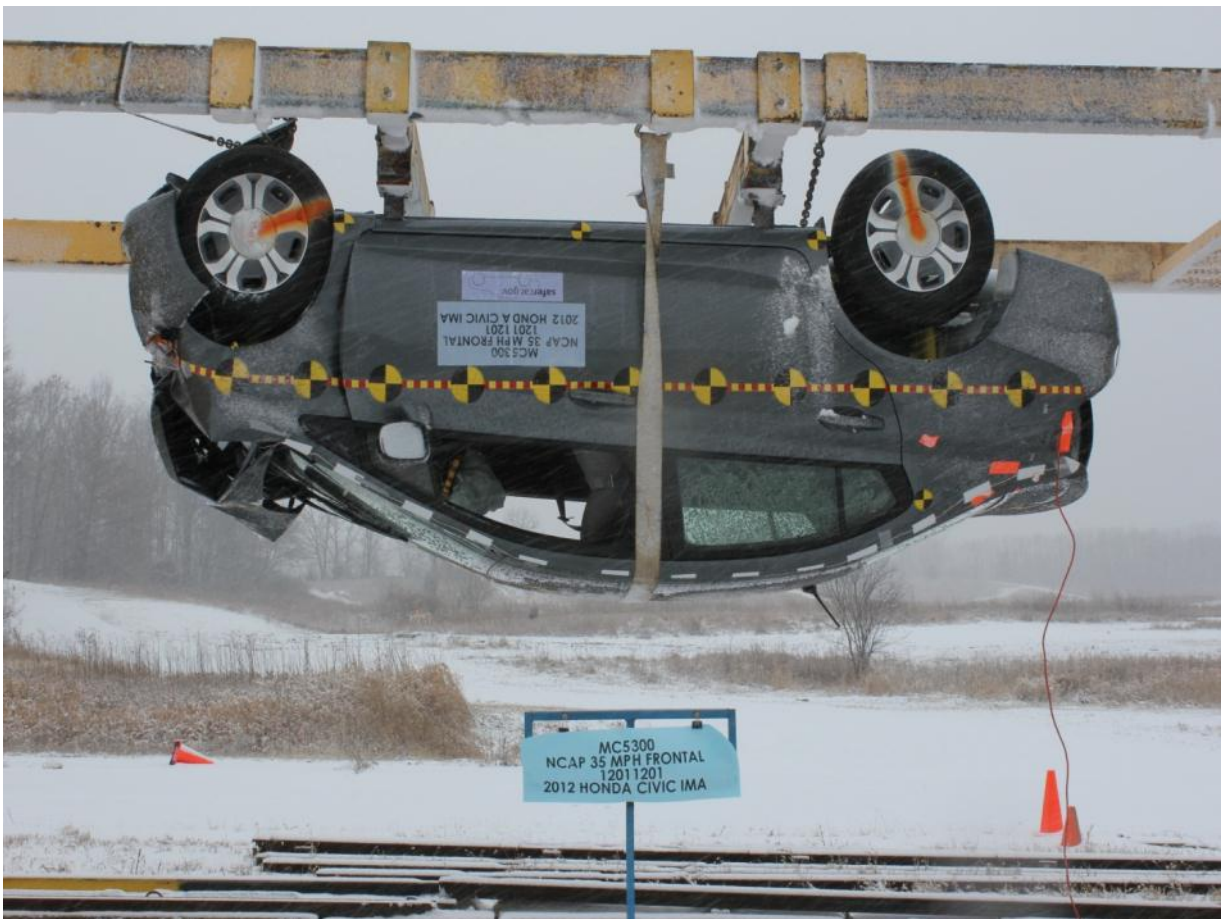
Vehicle at 180 Degrees on Static Rollover Device

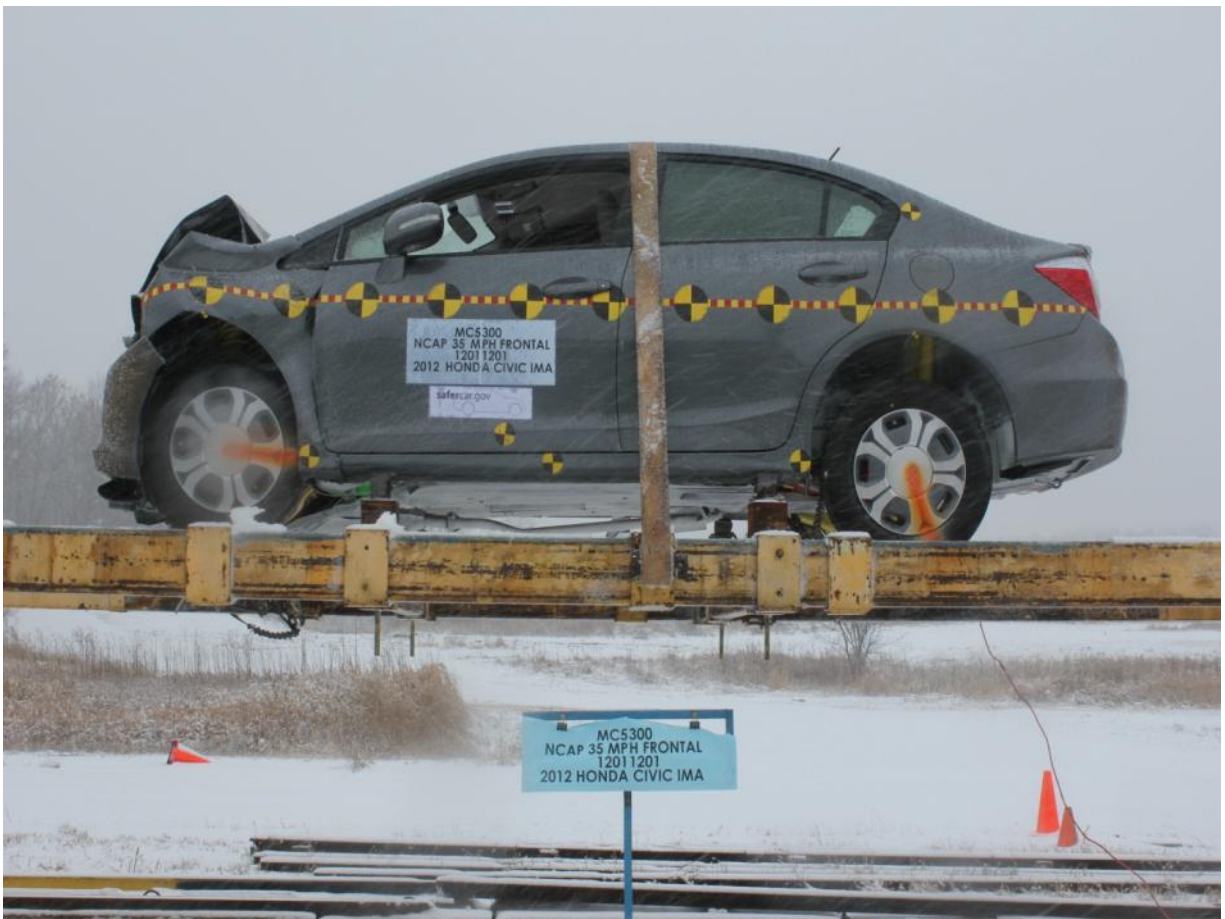
Vehicle at 360 Degrees on Static Rollover Device
