REPORT NUMBER TR-P32011-03-NC

**SIDE AIRBAG OCCUPANT RISK PROGRAM
OCCUPANT OUT-OF-POSITION TESTS**

**GENERAL MOTORS LLC
2012 FIAT 500 POP
3-DOOR HATCHBACK**

NHTSA NUMBER: MC0326TWG2

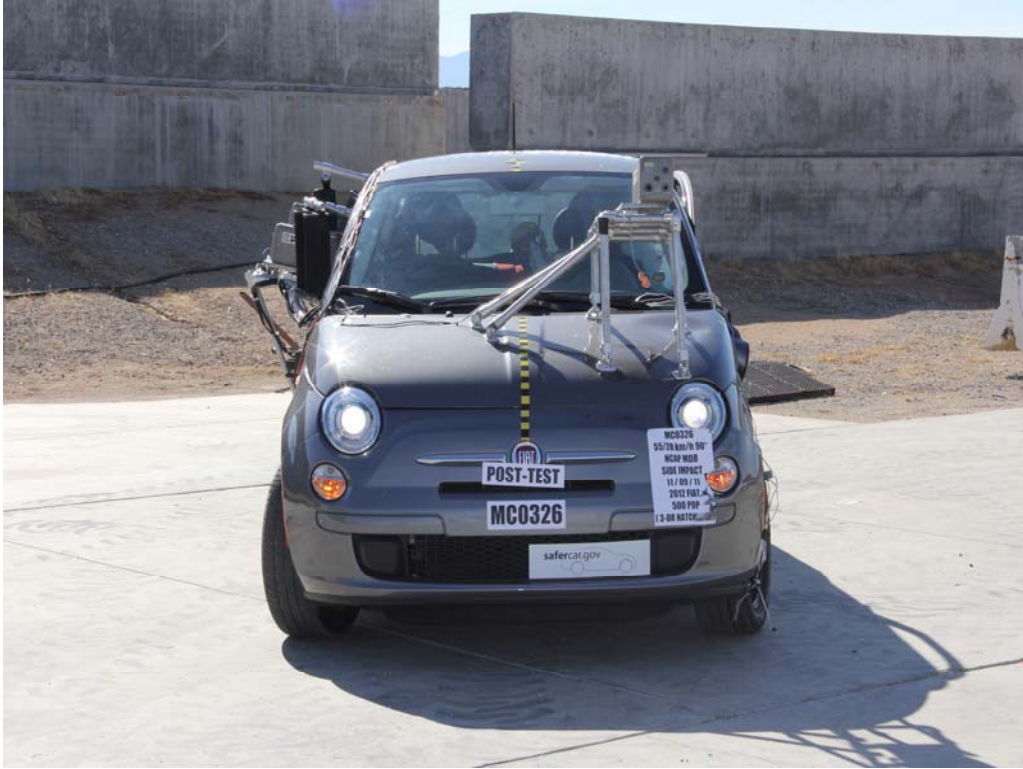
FIGURE 3. Post-Test Front View of NCAP Side Impact Test

* Vehicle had undergone New Car Assessment Program Side Impact Testing on November 9, 2011

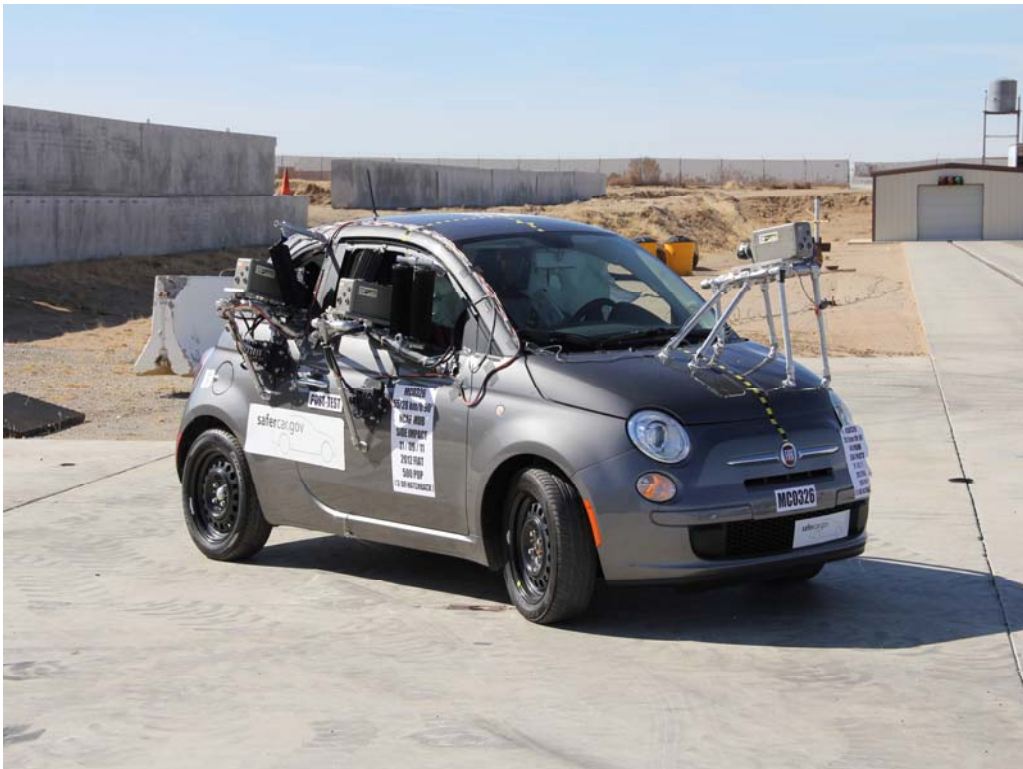
FIGURE 4. Post-Test Left Front 3/4 View of NCAP Side Impact Test

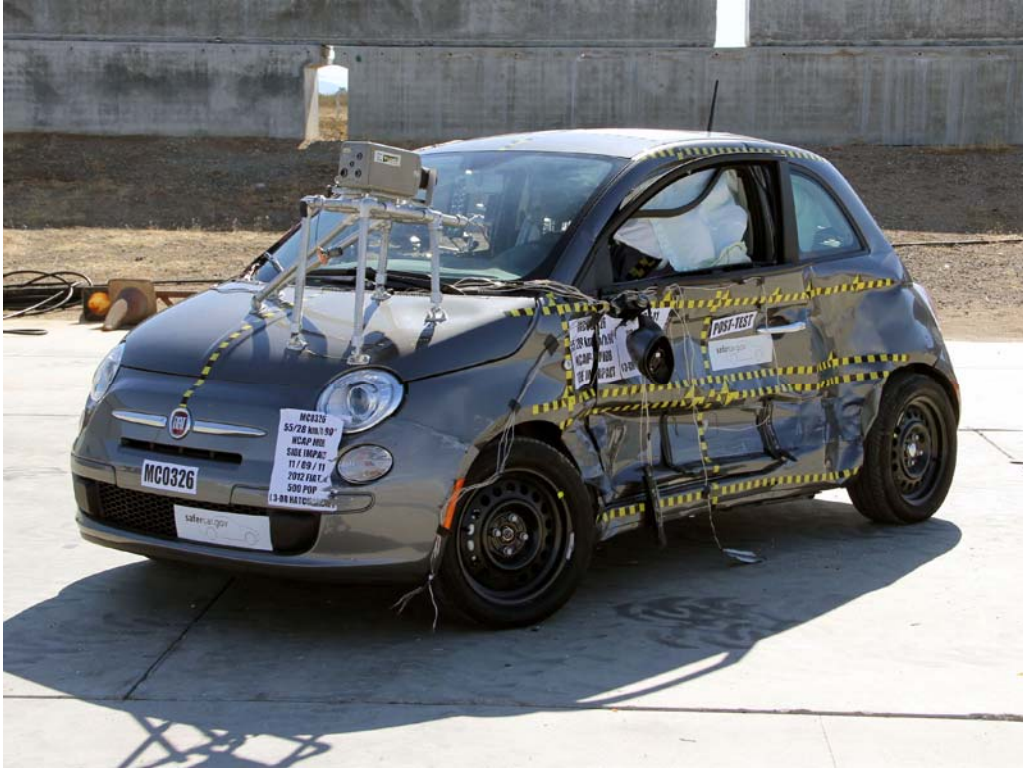
FIGURE 5. Post-Test Right Front 3/4 View of NCAP Side Impact Test

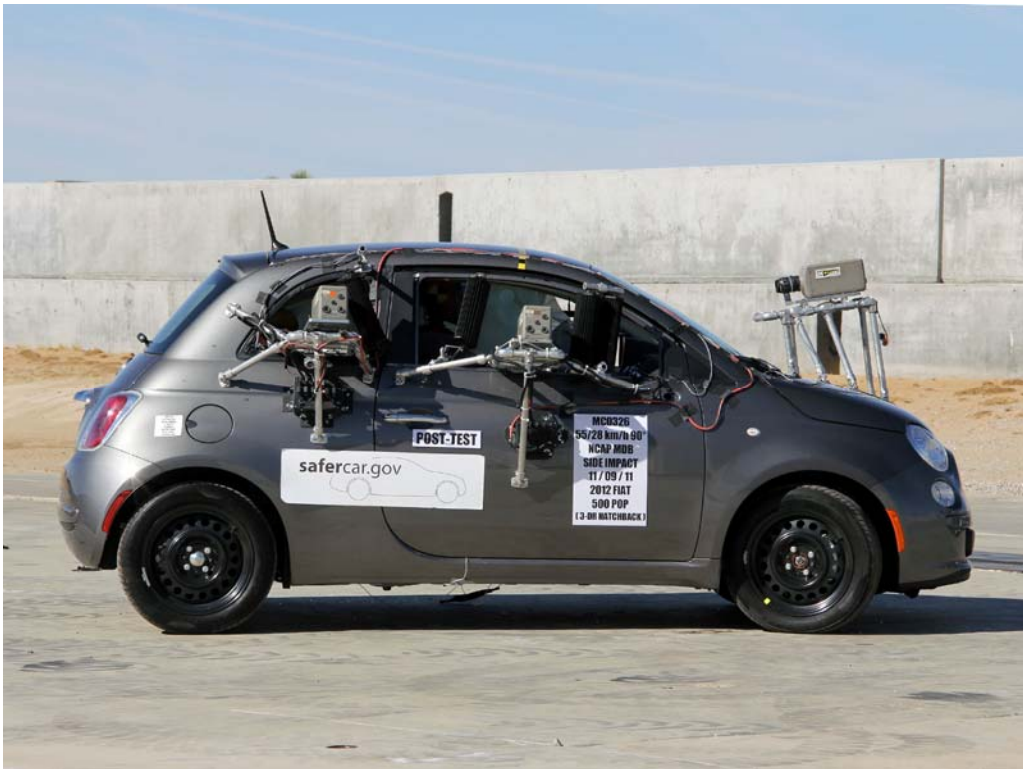
FIGURE 6. Post-Test Right Side View of NCAP Side Impact Test

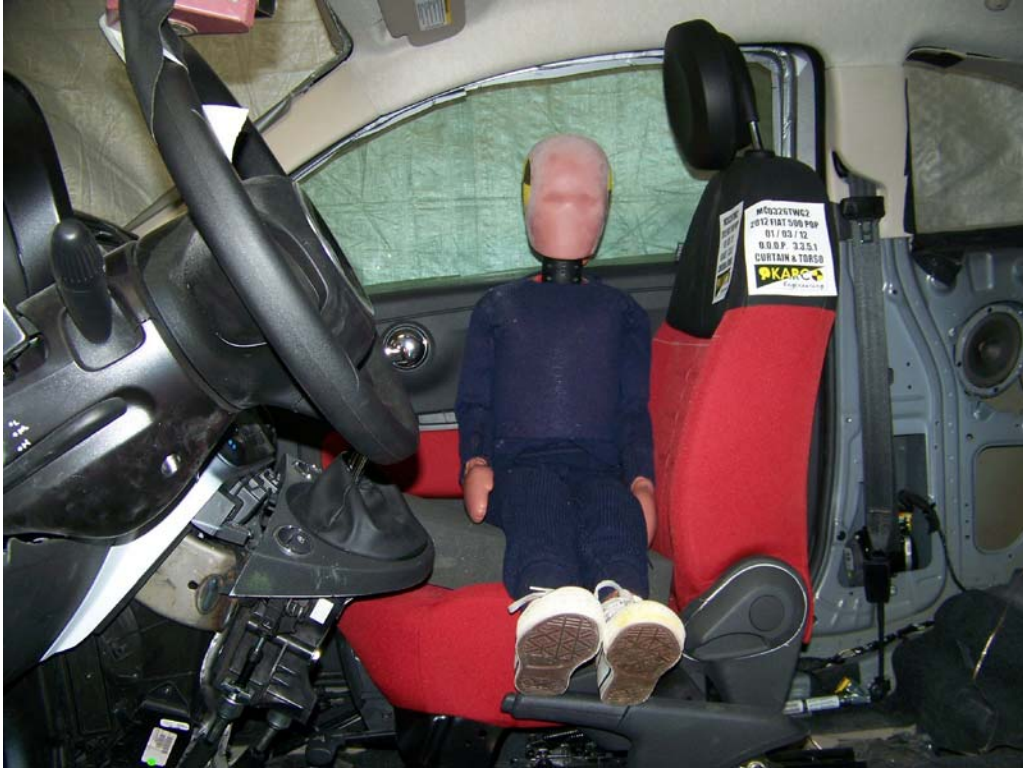
FIGURE 7. Pre-Test Dummy Position, Left Side View

Orientation of the 6 year old dummy was in the Inboard facing position leaning back against the front passenger door. The dummy's head centerline was aligned with the deploying trajectory of the curtain airbag. This orientation complies with section 3.3.5.1 of the Technical Working Group (TWG) recommendation in the Recommended Procedures for Evaluating Occupant Injury Risk from Deploying Side Airbags.

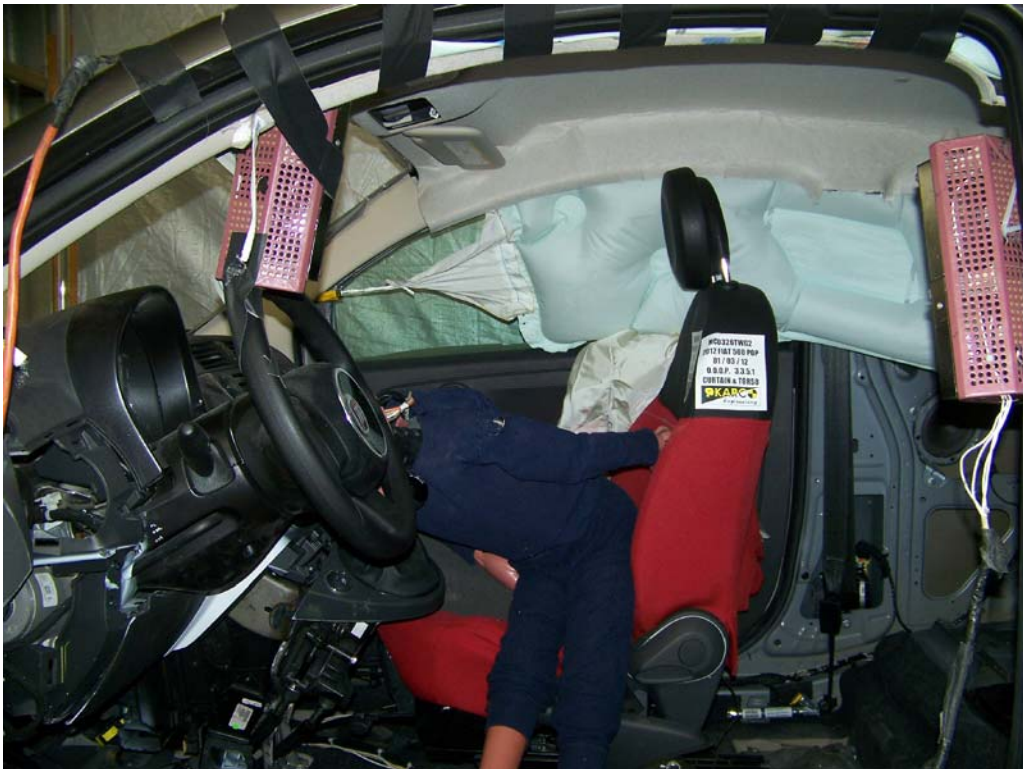
FIGURE 8. Post-Test Dummy Position, Left Side View

The 6 year old dummy's visible contact points were as follows: The curtain airbag contacted the ATD's head and the torso airbag contacted the ATD's back.

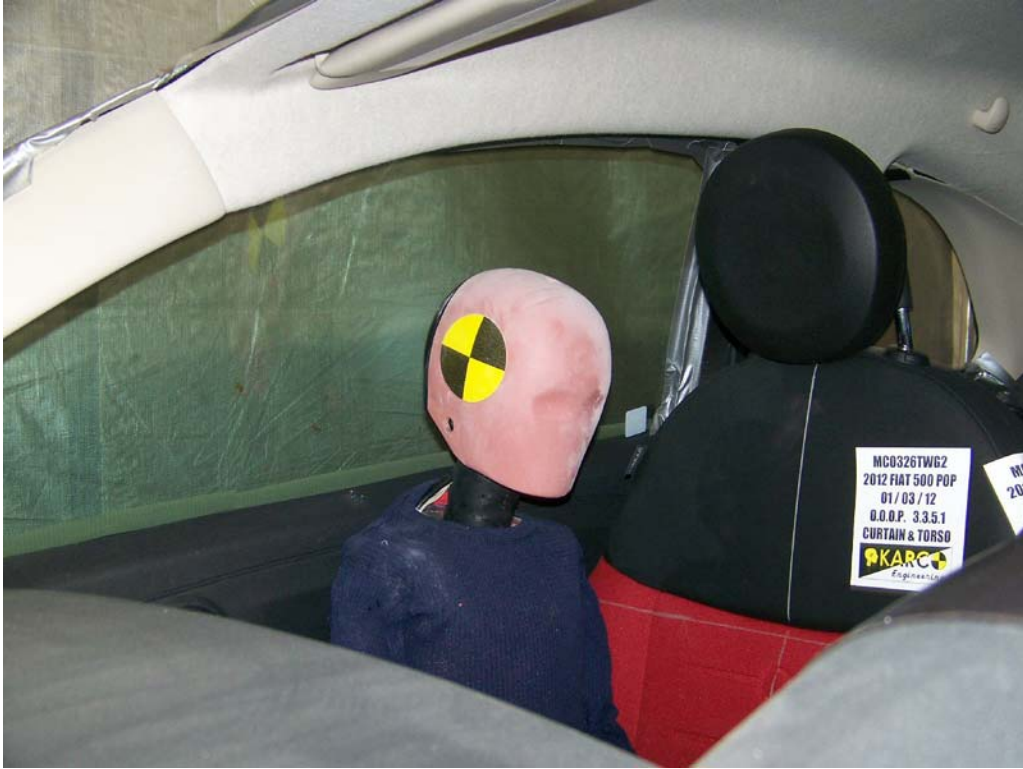
FIGURE 9. Pre-Test Dummy Position, $\frac{3}{4}$ View

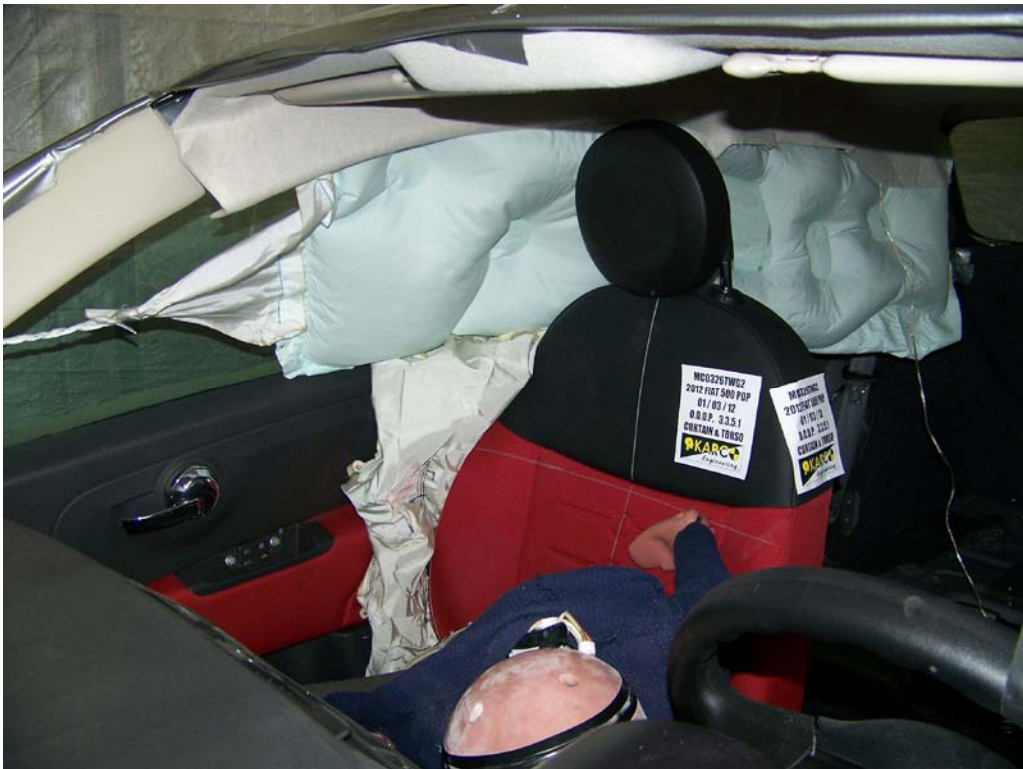
FIGURE 10. Post-Test Dummy Position, $\frac{3}{4}$ View

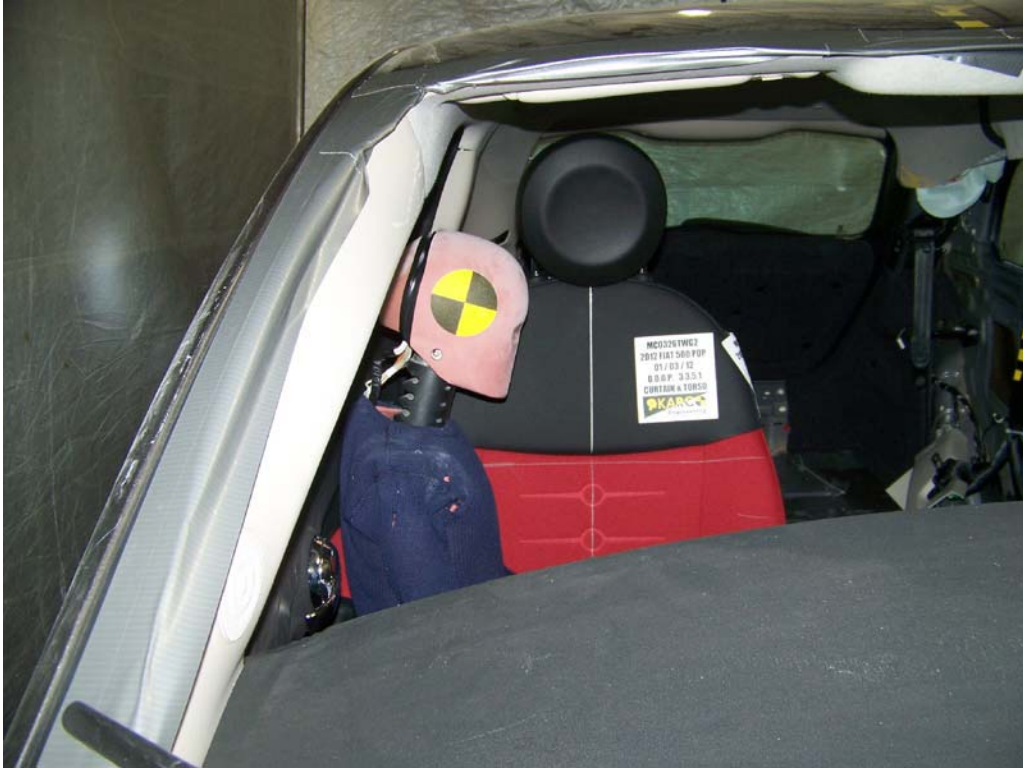
FIGURE 11. Pre-Test Dummy Position, Front View

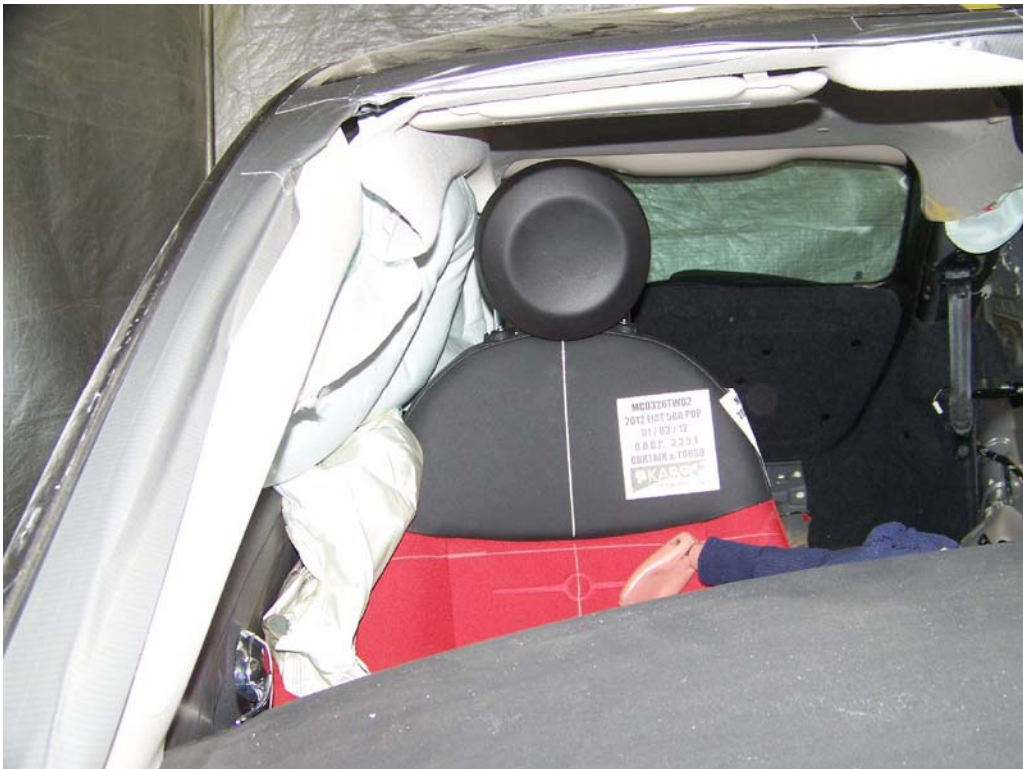
FIGURE 12. Post-Test Dummy Position, Front View

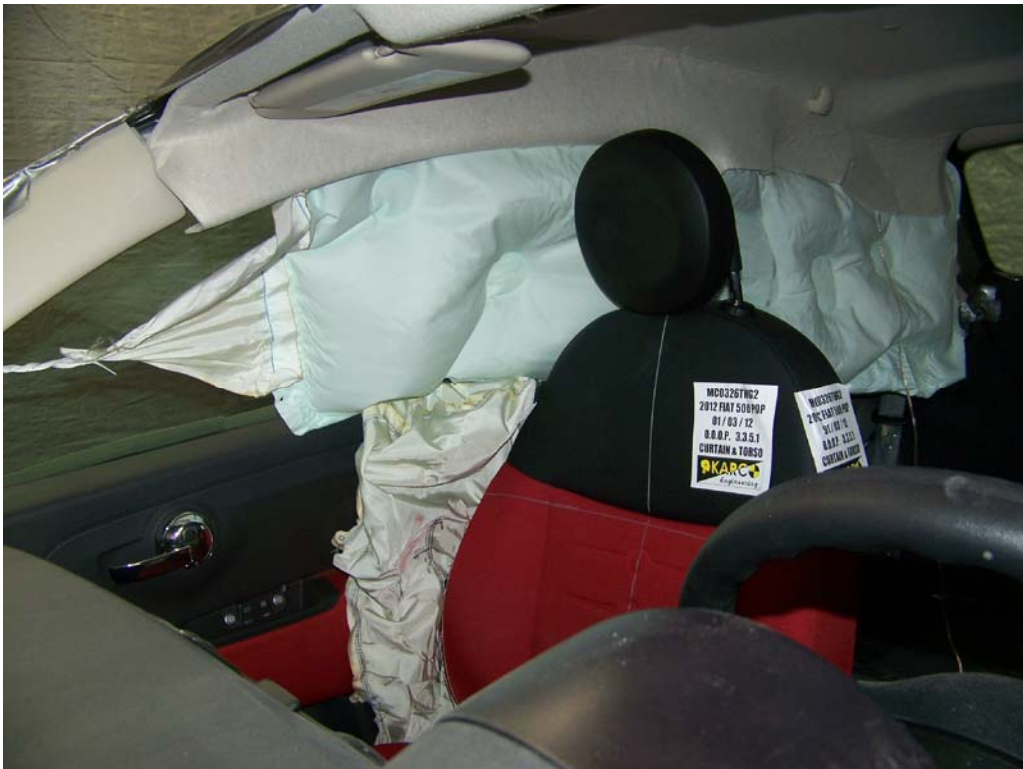
FIGURE 14. Post-Test Airbags, Left Front ¾ View

The front passenger side door remained closed during the deployment and was operable after the deployment.
