**REPORT NUMBER: SPNCAP-KAR-12-046**

**NEW CAR ASSESSMENT PROGRAM (NCAP)  
SIDE IMPACT POLE TEST**

**TOYOTA MOTOR CORPORATION  
2012 LEXUS ES350 4-DOOR SEDAN**

**FINAL REPORT**

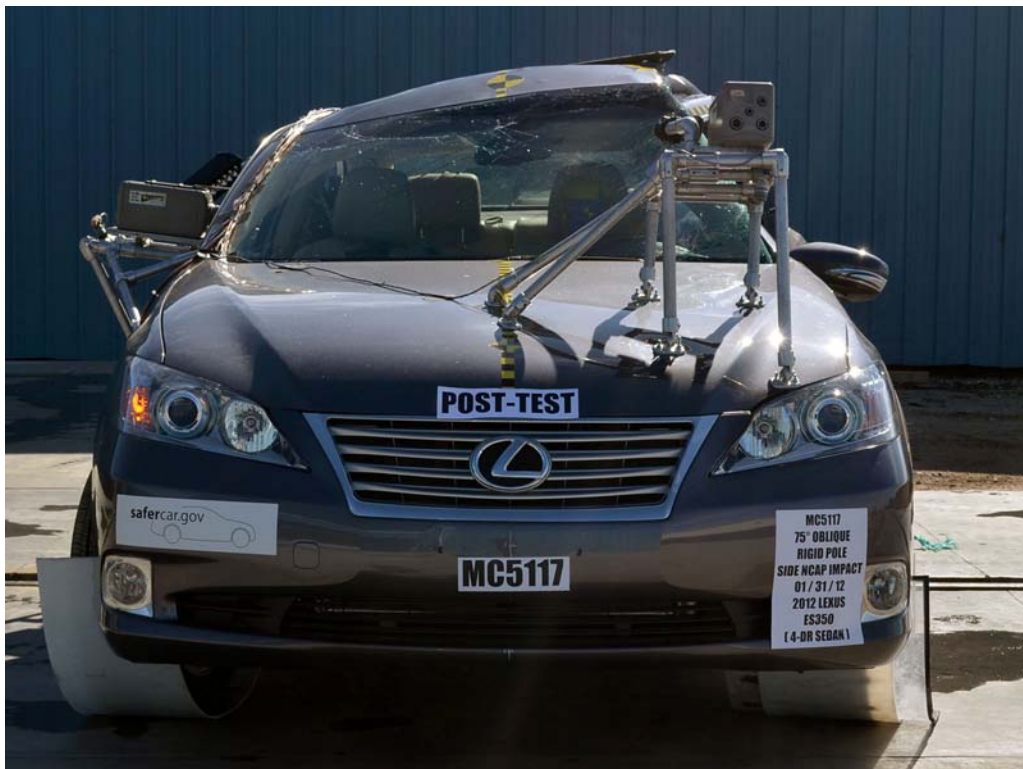
FIGURE 4. Post-Test Frontal View of Test Vehicle

| Critical Areas of Performance | Observations and Conclusions |
|---|---|
| Windshield Damage | Broken |

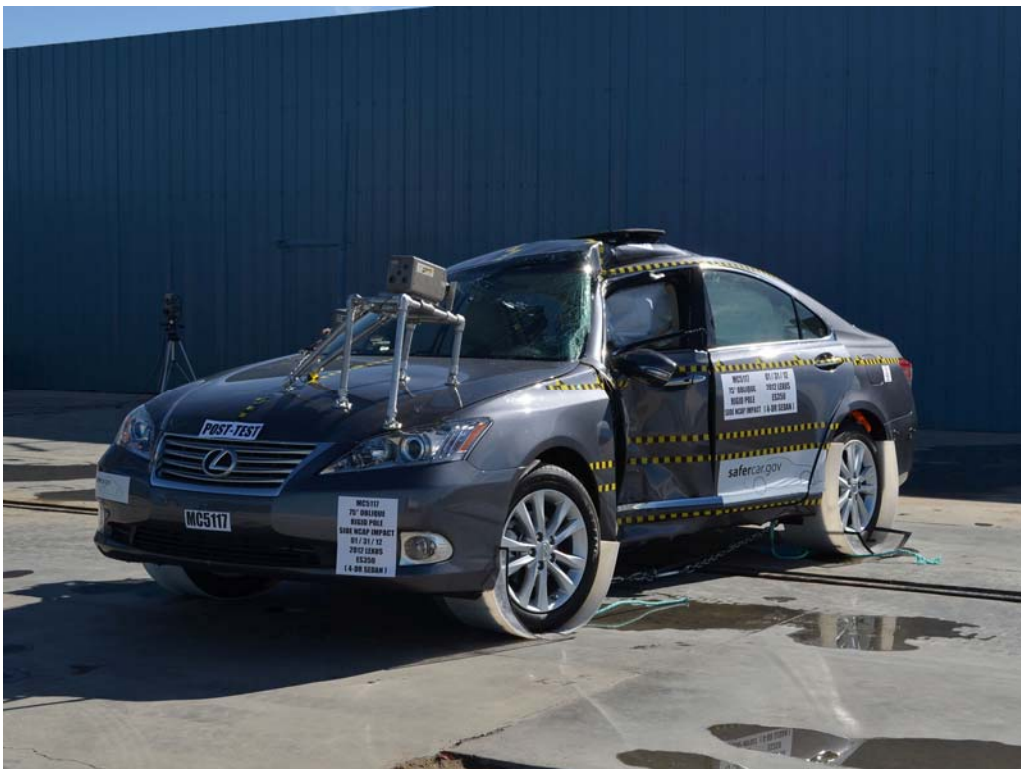
FIGURE 6. Post-Test Left Front Three-Quarter View of Test Vehicle

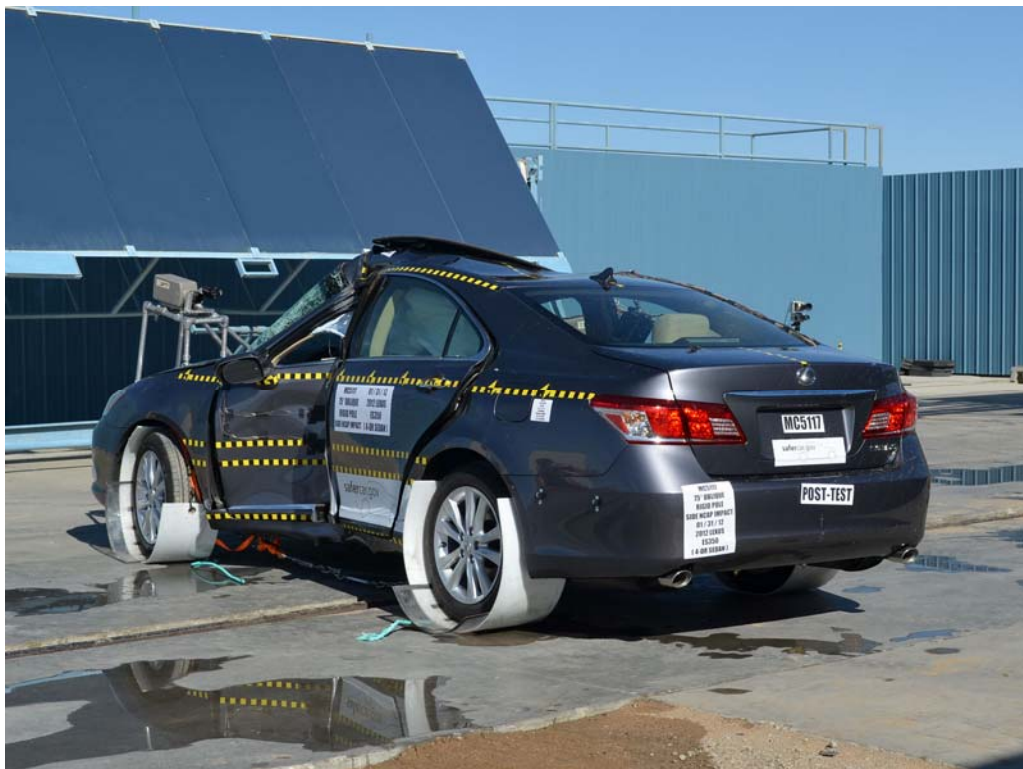
FIGURE 10. Post-Test Left Rear Three-Quarter View of Test Vehicle

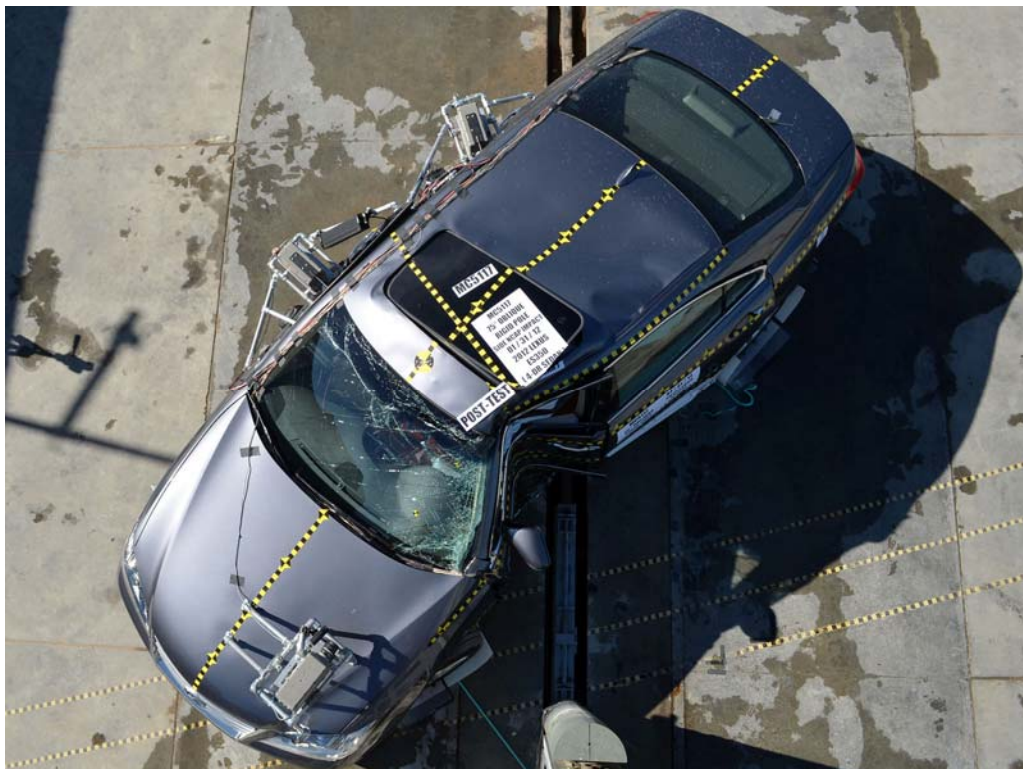
FIGURE 16. Post-Test Overhead View of Test Vehicle and Pole

A rigid pole side impact test was conducted on a 2012 Lexus ES350 4-door sedan. The subject vehicle was towed into the rigid pole at an angle of 74.8° and a velocity of 31.7 km/h. The test was conducted by KARCO Engineering, LLC. in Adelanto, California on January 31, 2012. Pre- and post-test photographs of the test vehicle and side impact dummy (SID-IIs) are included in Appendix A of this report.

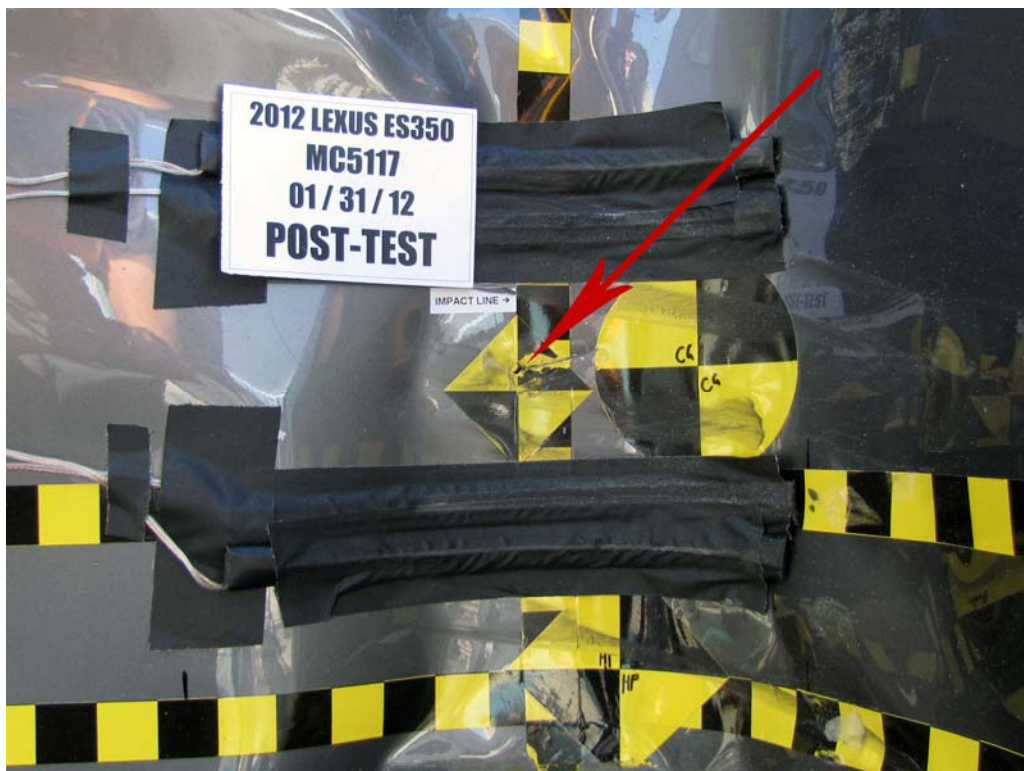
FIGURE 20. Post-Test Close-Up View of Impact Point Target Showing Impact Location

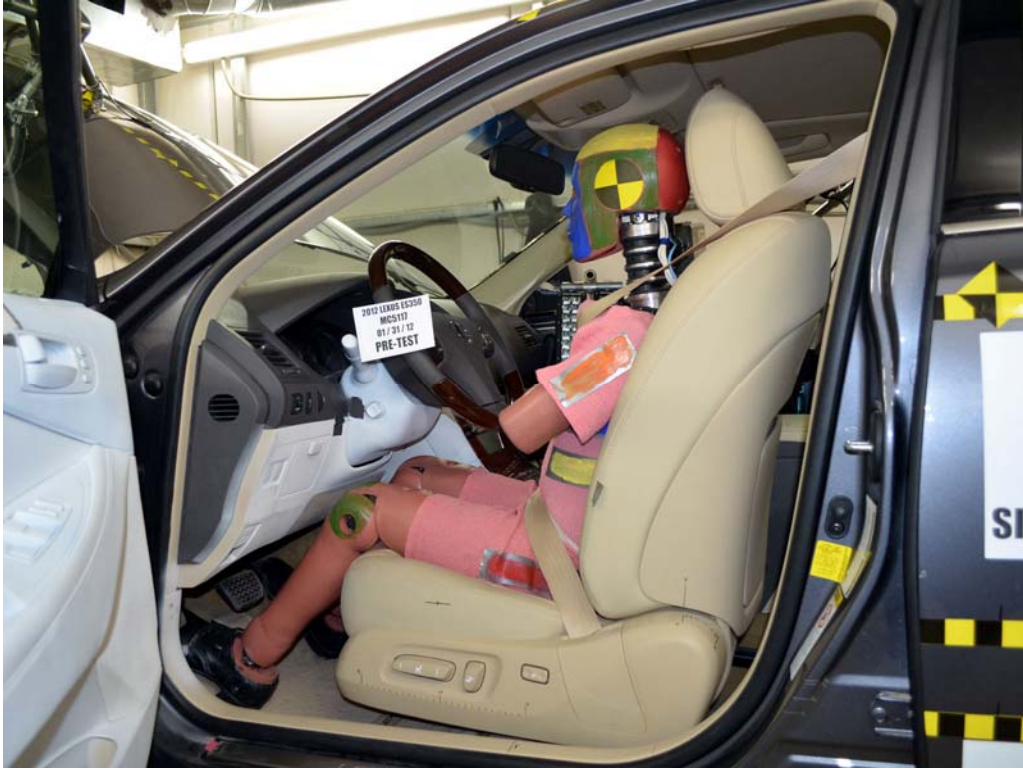
FIGURE 23. Pre-Test Left Side View of Dummy Showing Belt, Chalking, and Contact Switches

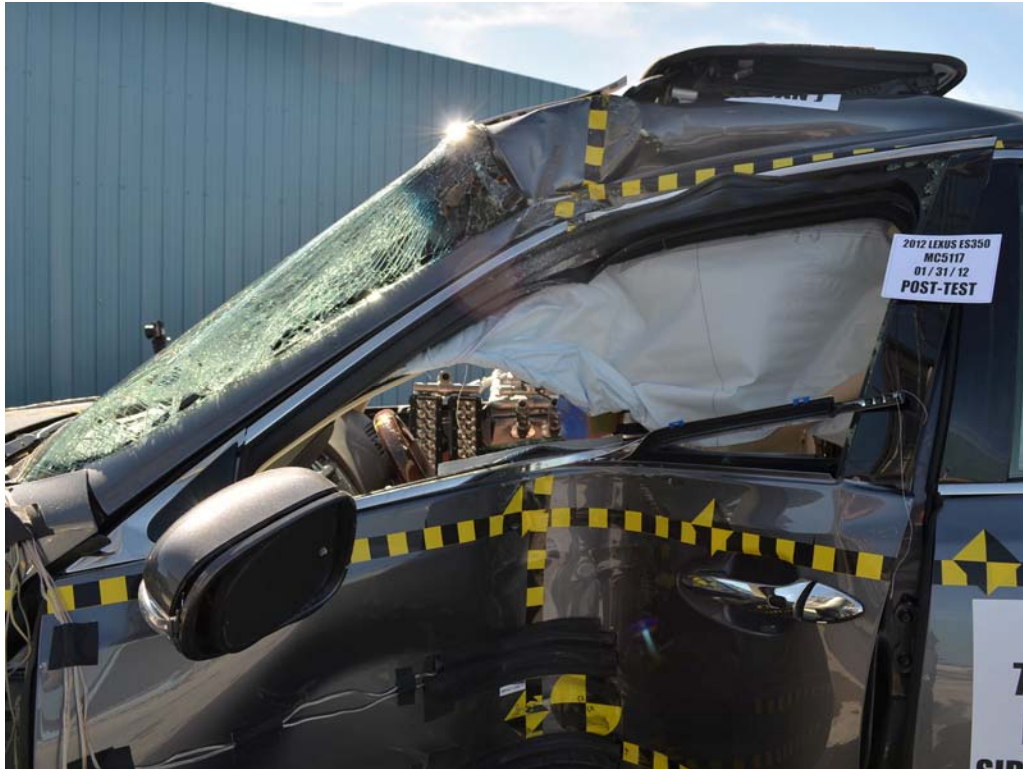
FIGURE 25. Post-Test Left Side View of Dummy Shoulder and Door Top View

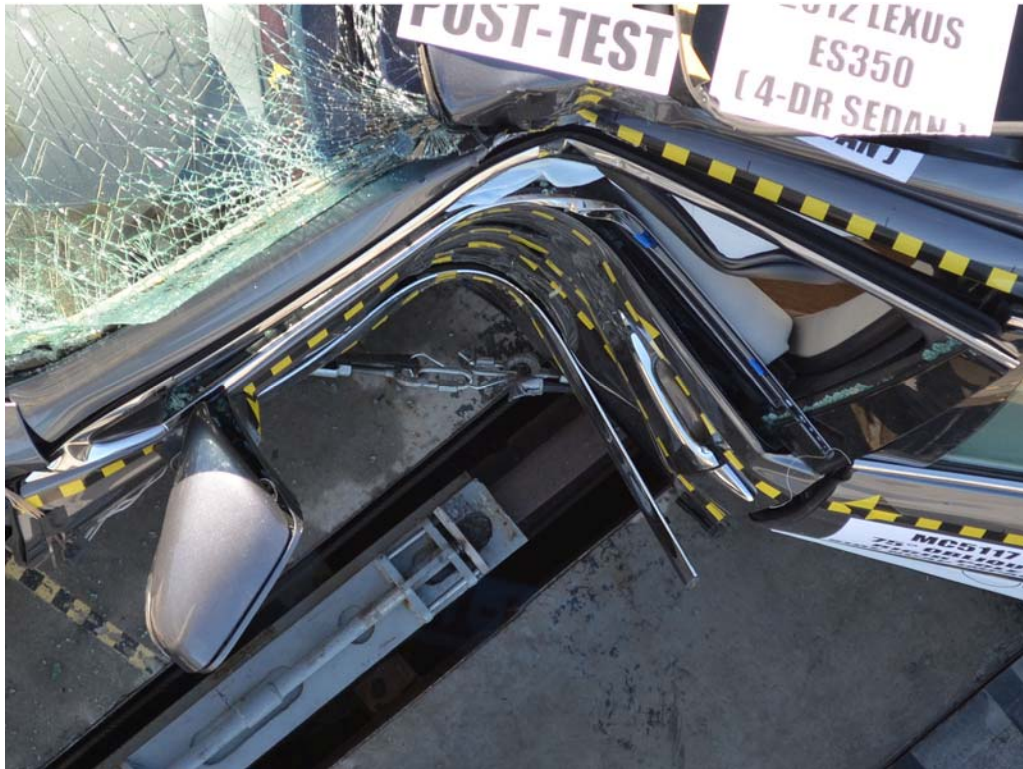
FIGURE 41. Post-Test Driver Dummy and Door Clearance

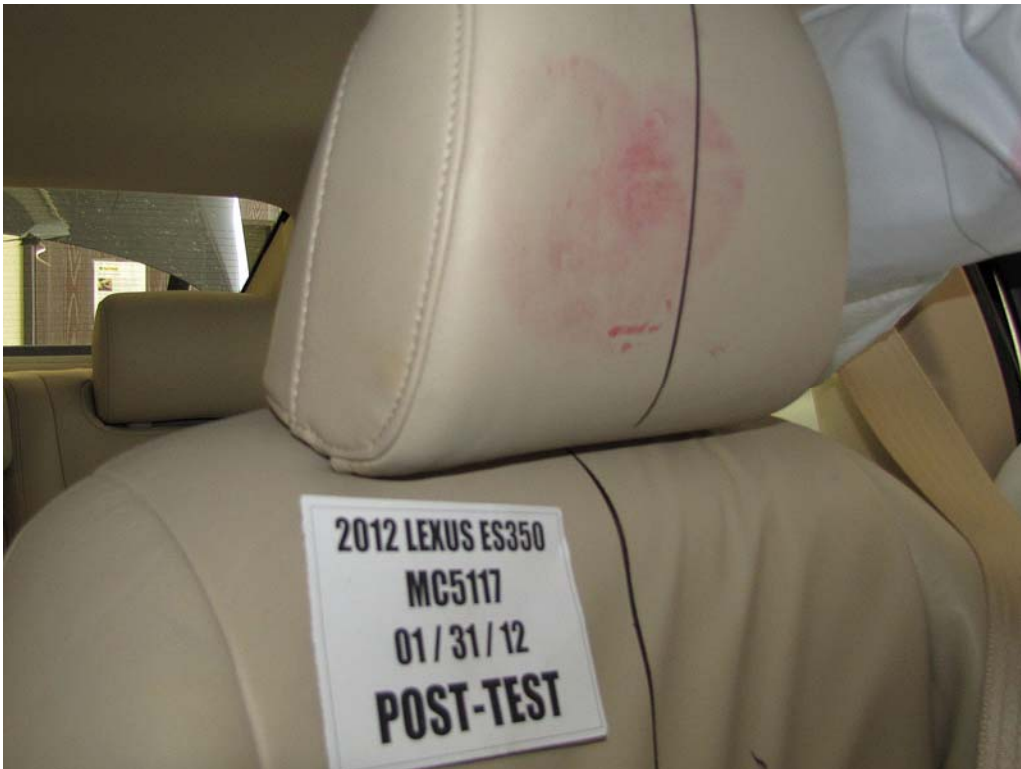
FIGURE 46. Post-Test Dummy Close-Up Head Contact with Vehicle Interior View

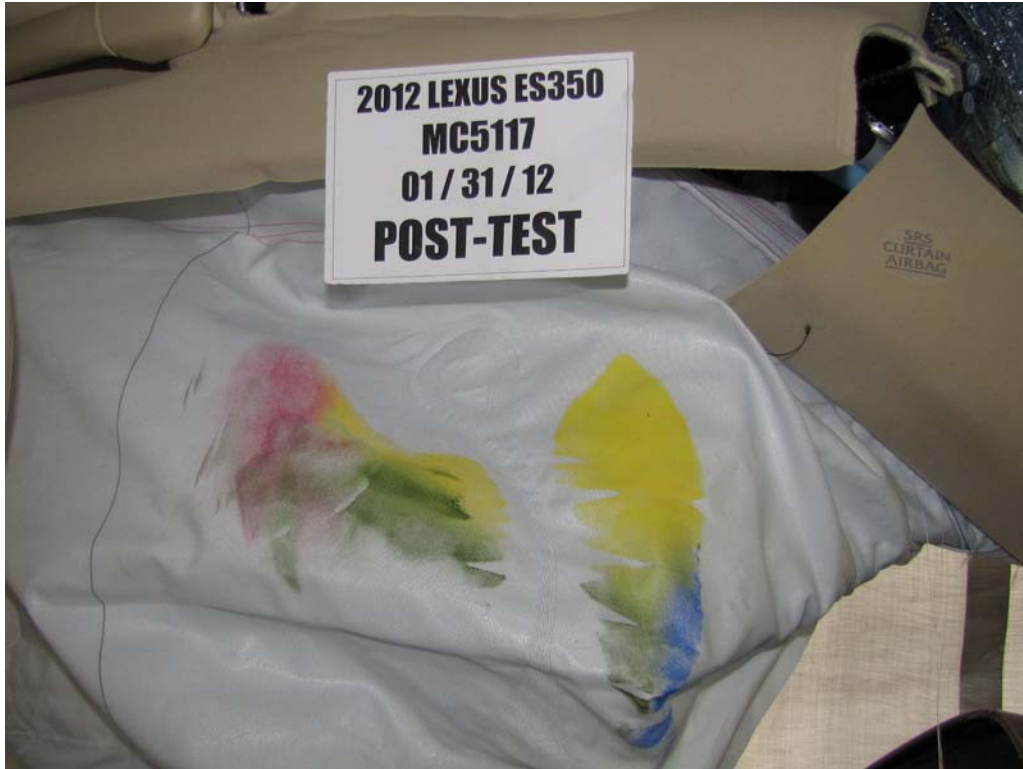
FIGURE 47. Post-Test Dummy Close-Up Head Contact with Side Airbag View

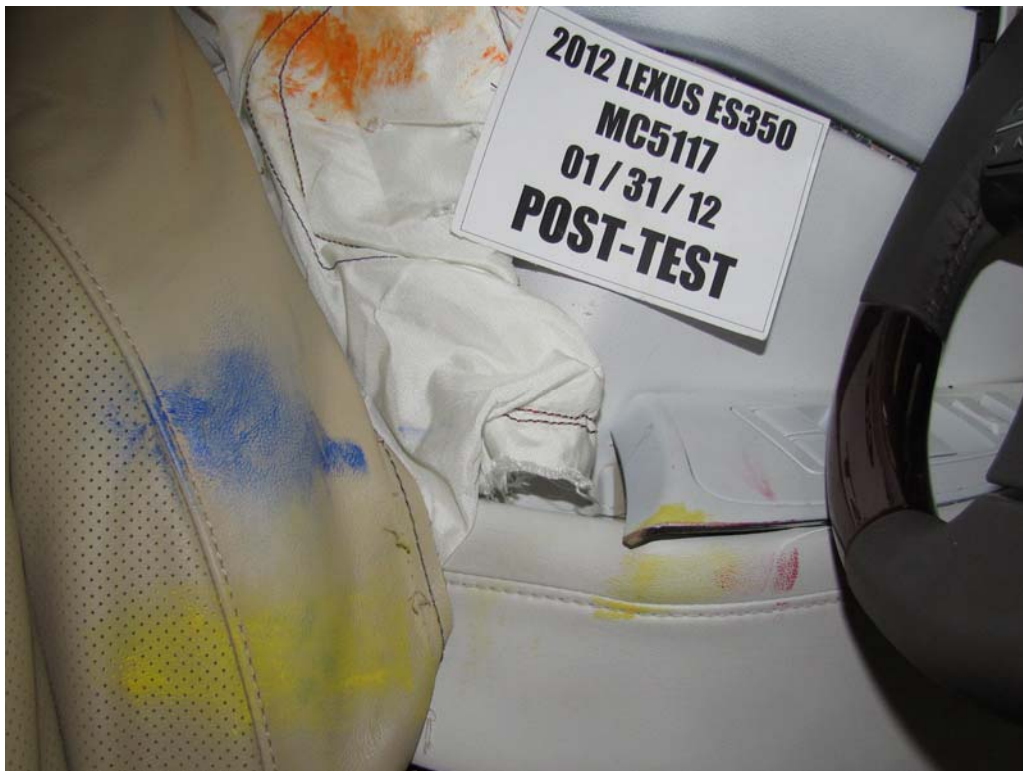
FIGURE 48. Post-Test Dummy Close-Up Torso Contact with Vehicle Interior View

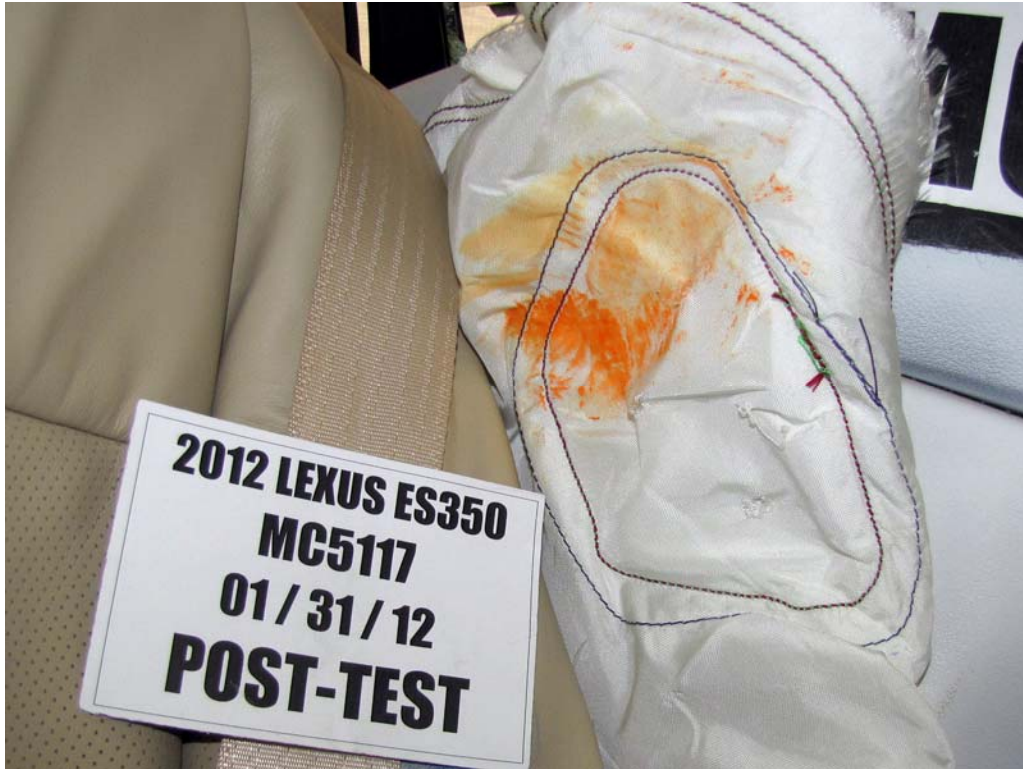
FIGURE 49. Post-Test Dummy Close-Up Torso Contact with Side Airbag View

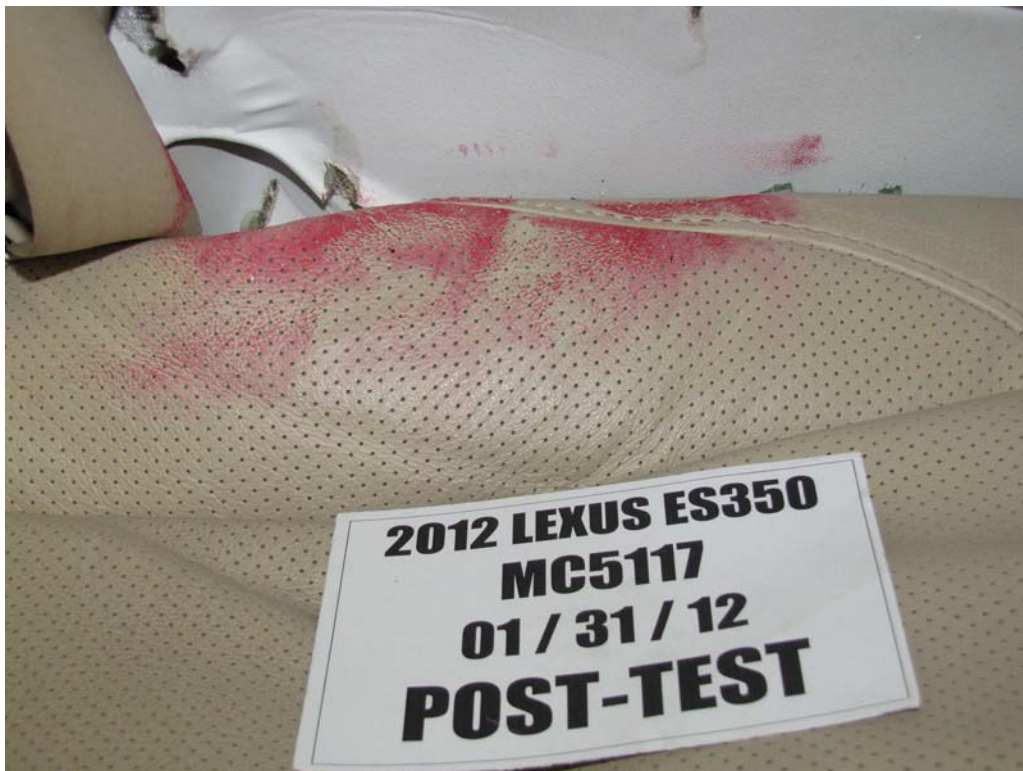
FIGURE 50. Post-Test Dummy Close-Up Pelvis Contact with Vehicle Interior View

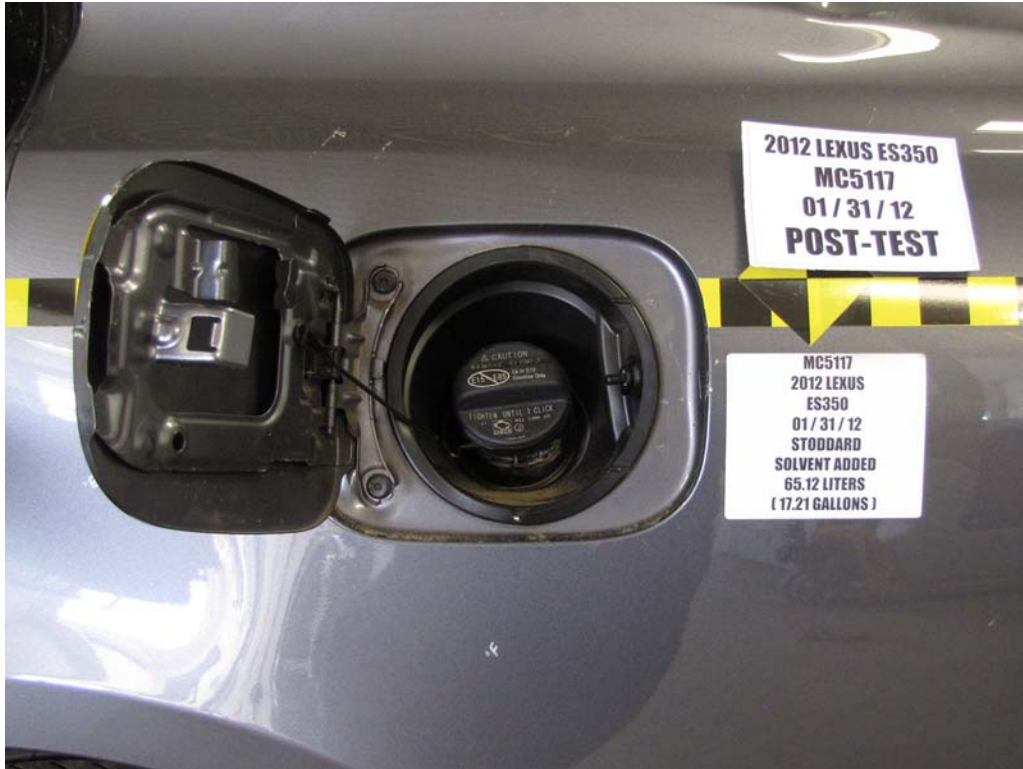
FIGURE 53. Post-Test View of Fuel Filler Cap or Fuel Filler Neck

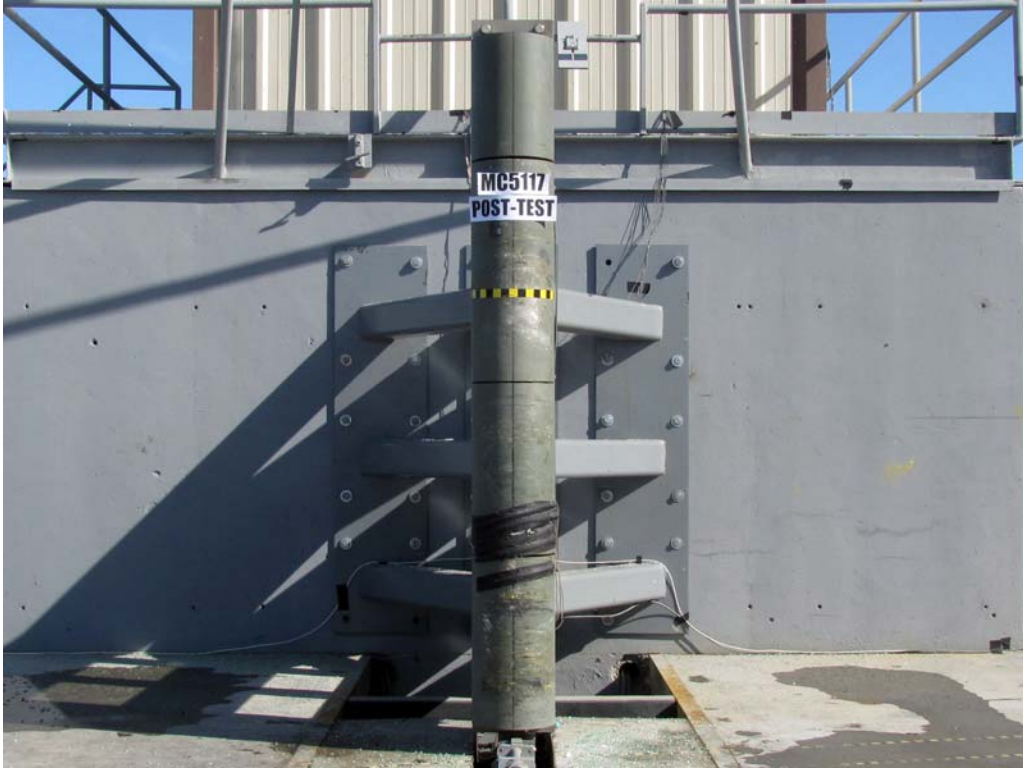
FIGURE 57. Post-Test Pole Barrier Front View

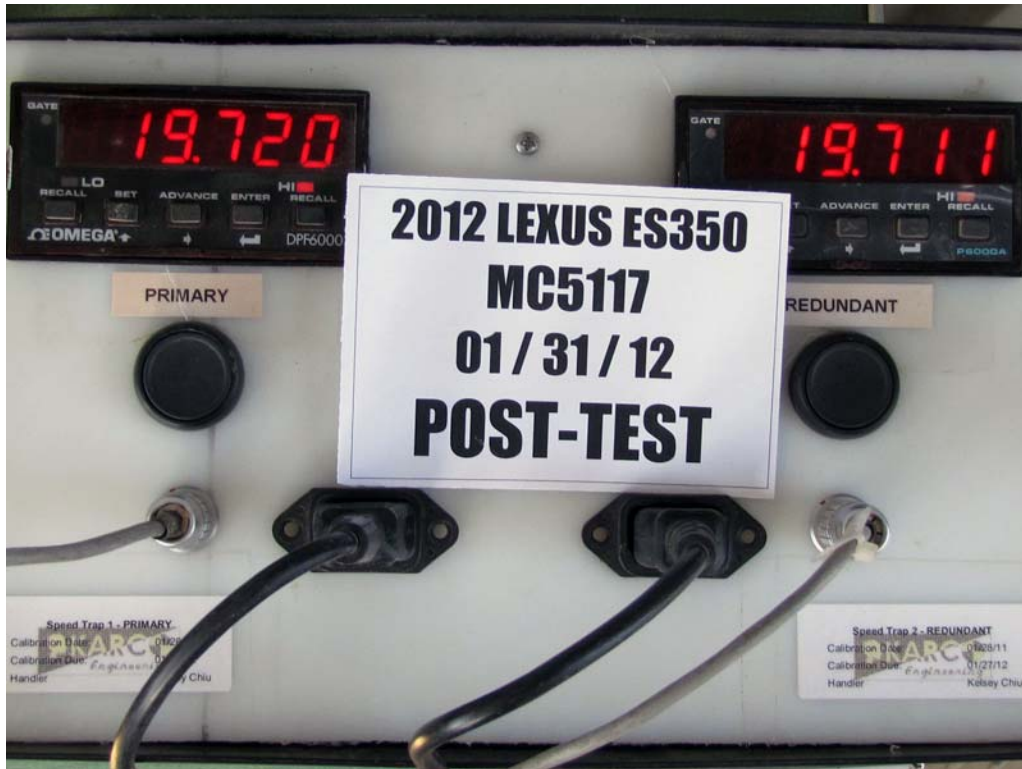
FIGURE 61. Post-Test Primary and Redundant Speed Trap Read-Out

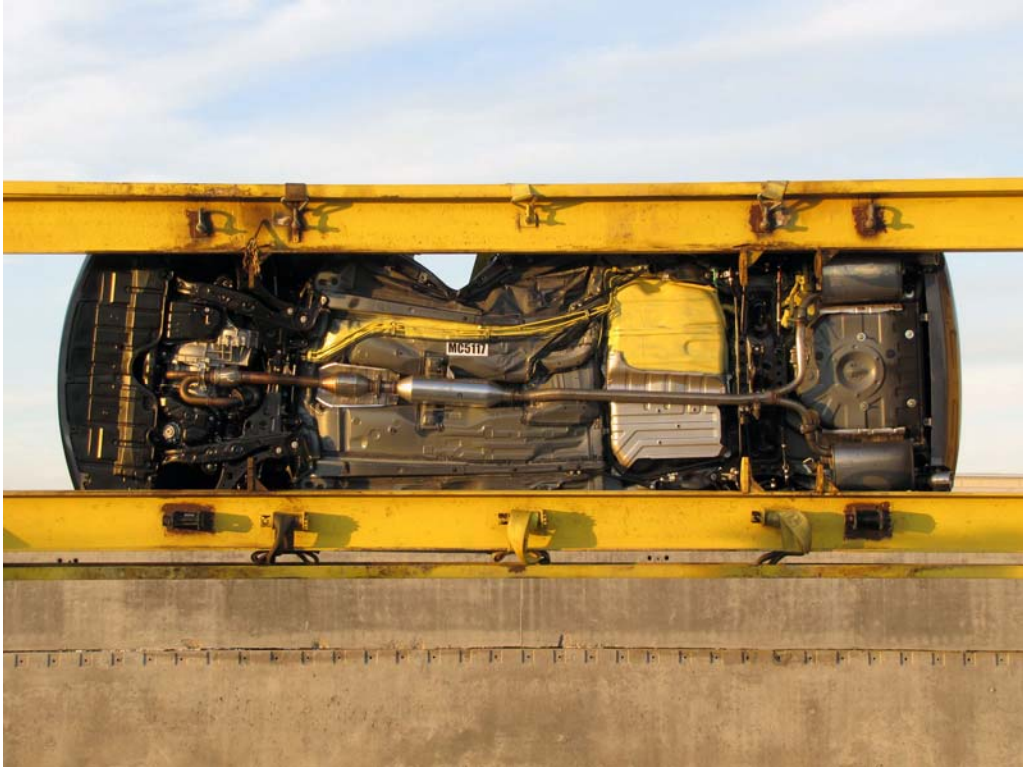
FIGURE 62. FMVSS No. 301-305 Rollover 0 Degrees

FIGURE 63. FMVSS No. 301-305 Rollover 90 Degrees

FIGURE 64. FMVSS No. 301-305 Rollover 180 Degrees

FIGURE 65. FMVSS No. 301-305 Rollover 270 Degrees

FIGURE 66. FMVSS No. 301-305 Rollover 360 Degrees
