**REPORT NUMBER: NCAP-MGA-2012-058**

**NEW CAR ASSESSMENT PROGRAM (NCAP)  
Frontal Barrier Impact Test**

**HYUNDAI MOTOR COMPANY  
2012 Hyundai Elantra GLS 4-Dr Sedan  
NHTSA No.: UC0500**

**FINAL REPORT**

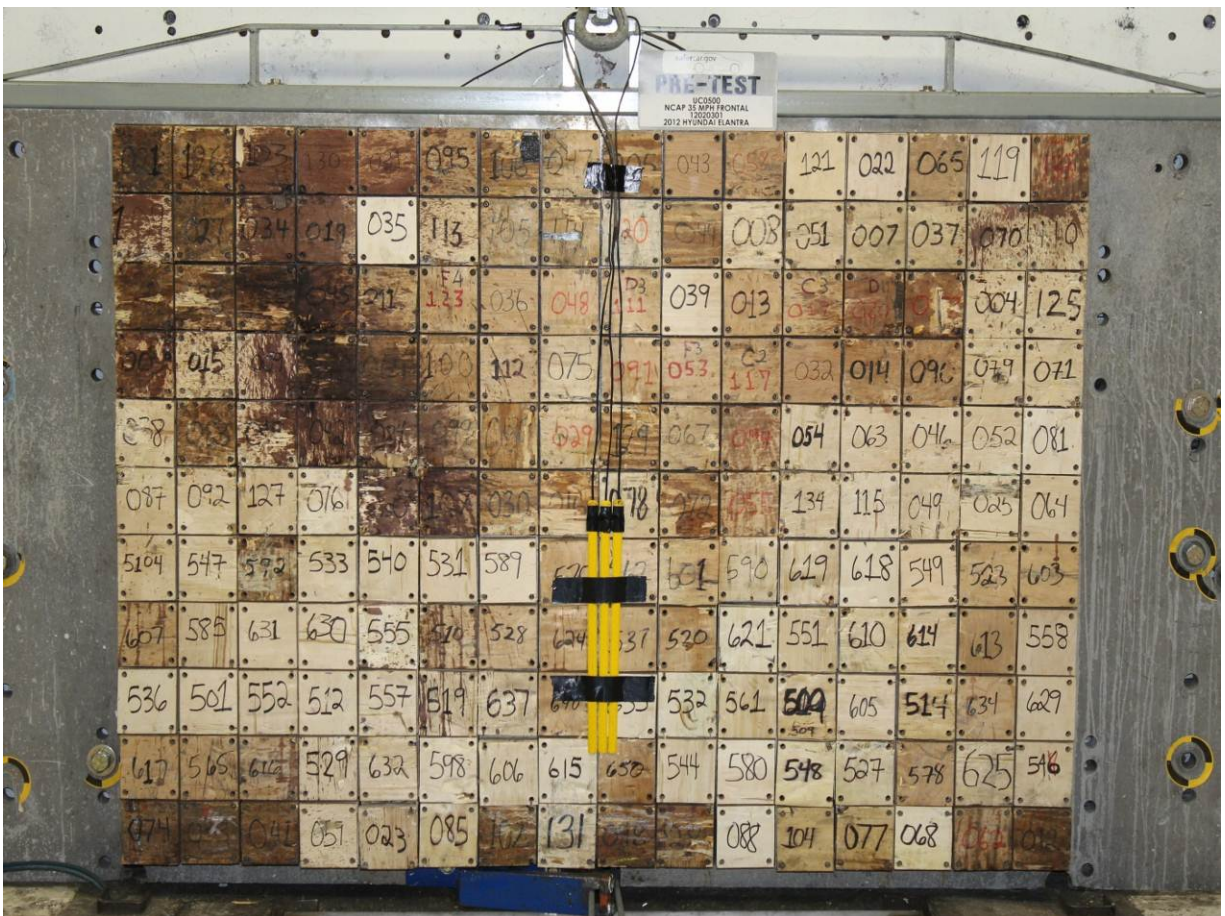
Load Cell Wall

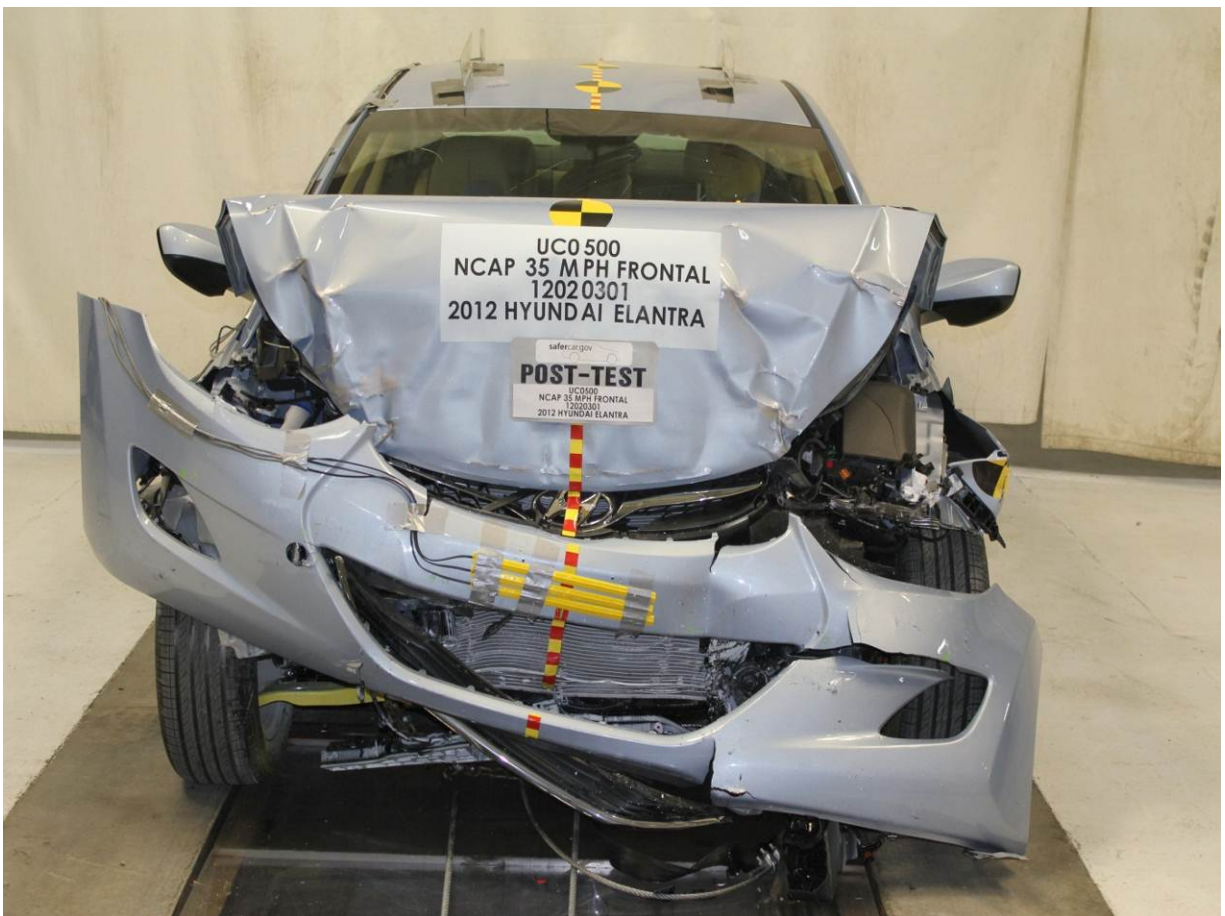
Post-Test Front View of Test Vehicle

The maximum static crush of the vehicle was 469 mm and both the driver and passenger side doors remained closed during the impact event and were operable after the impact.

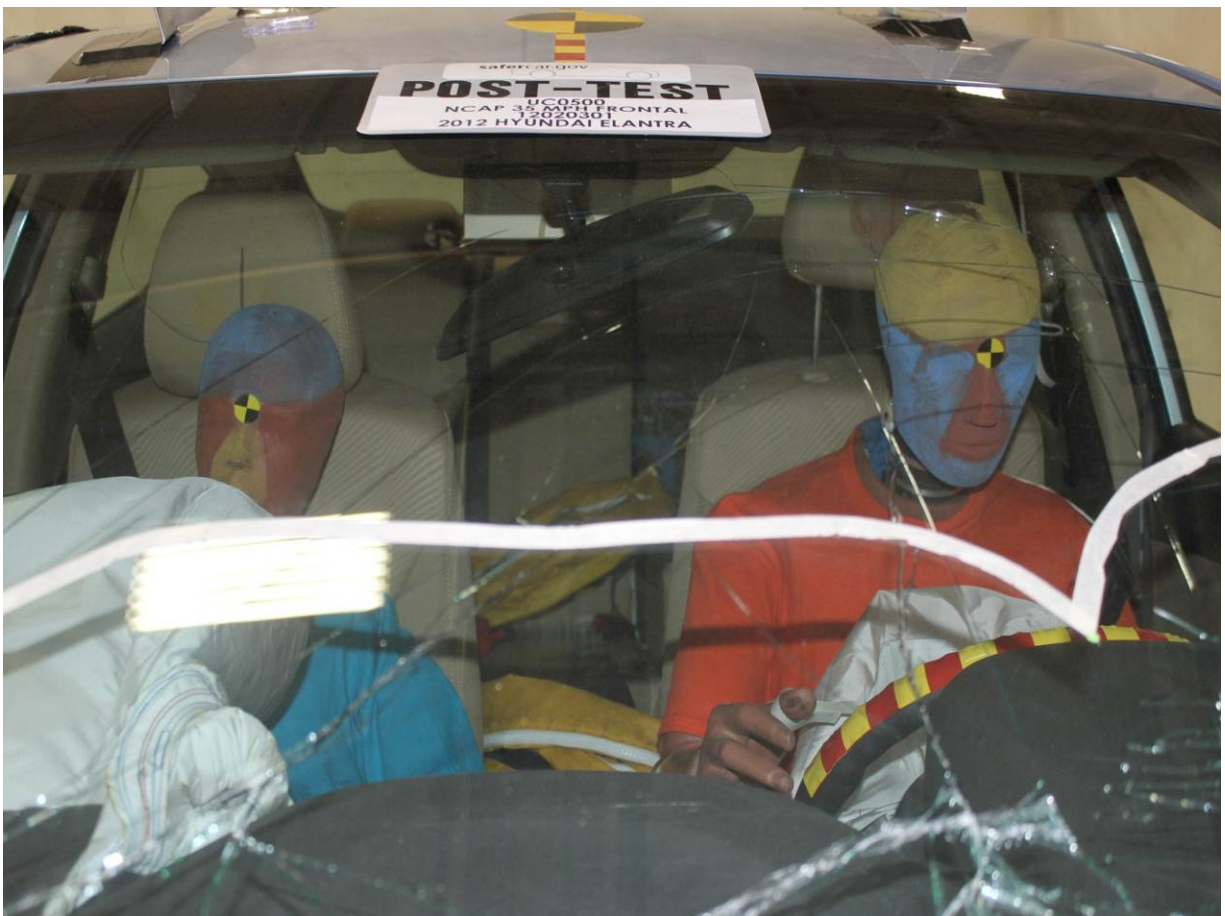
Post-Test Windshield View

There was 100 percent windshield retention and no intrusion into the protected zone of the windshield during the event. There was no Stoddard Solvent leakage after the event or during any phase of the static rollover.

| Critical Areas of Performance | Observations and Conclusions |
|---|---|
| Windshield Damage | Cracked |

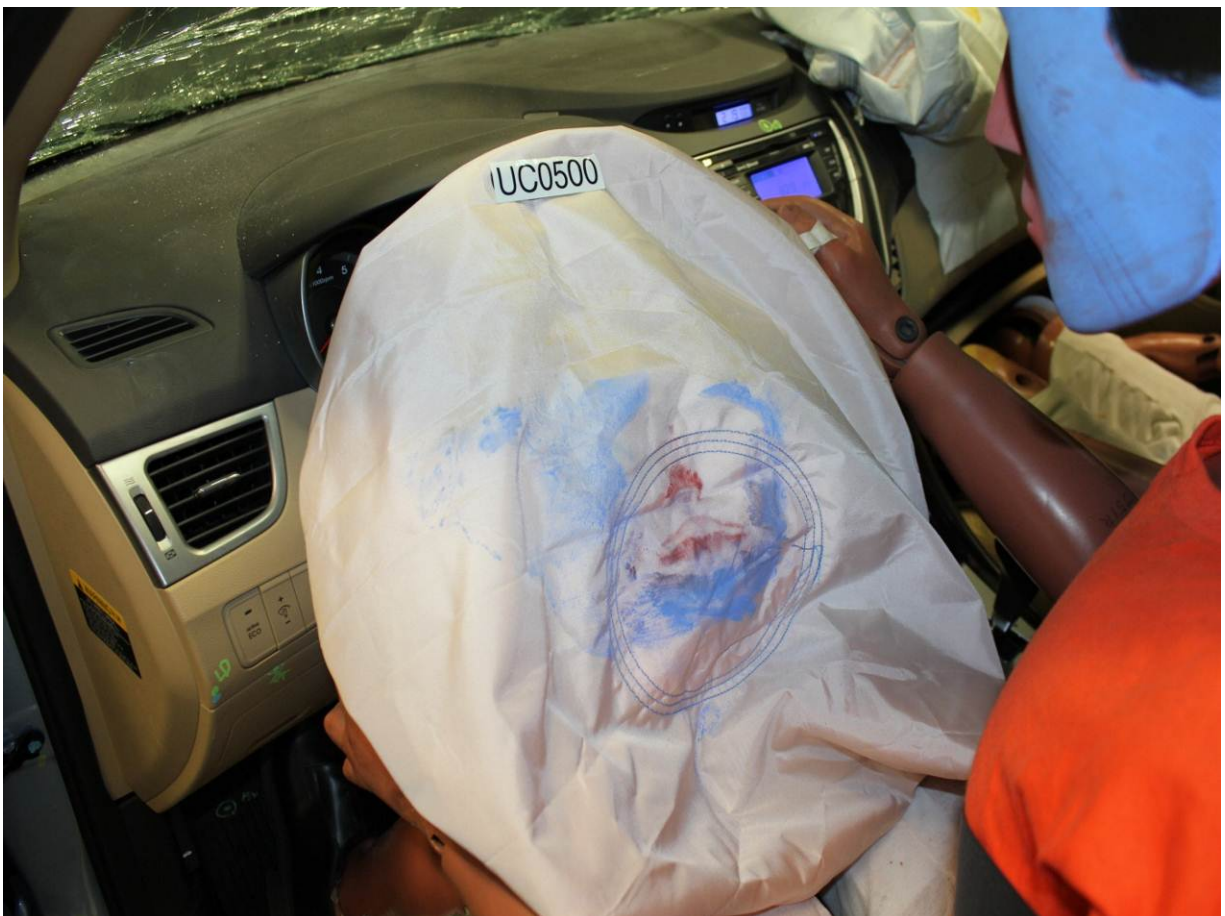
Post-Test Driver Dummy Contact with Airbag

The driver's visible contact points were as follows: The driver's head and chest contacted the airbag. The driver's head also contacted the headrest and visor. The driver's knees contacted the knee bolster. The passenger's visible contact points were as follows: The passenger's head and chest contacted the airbag. The passenger's head also contacted the headrest and seatback. The passenger's knees contacted the knee bolster and front airbag.

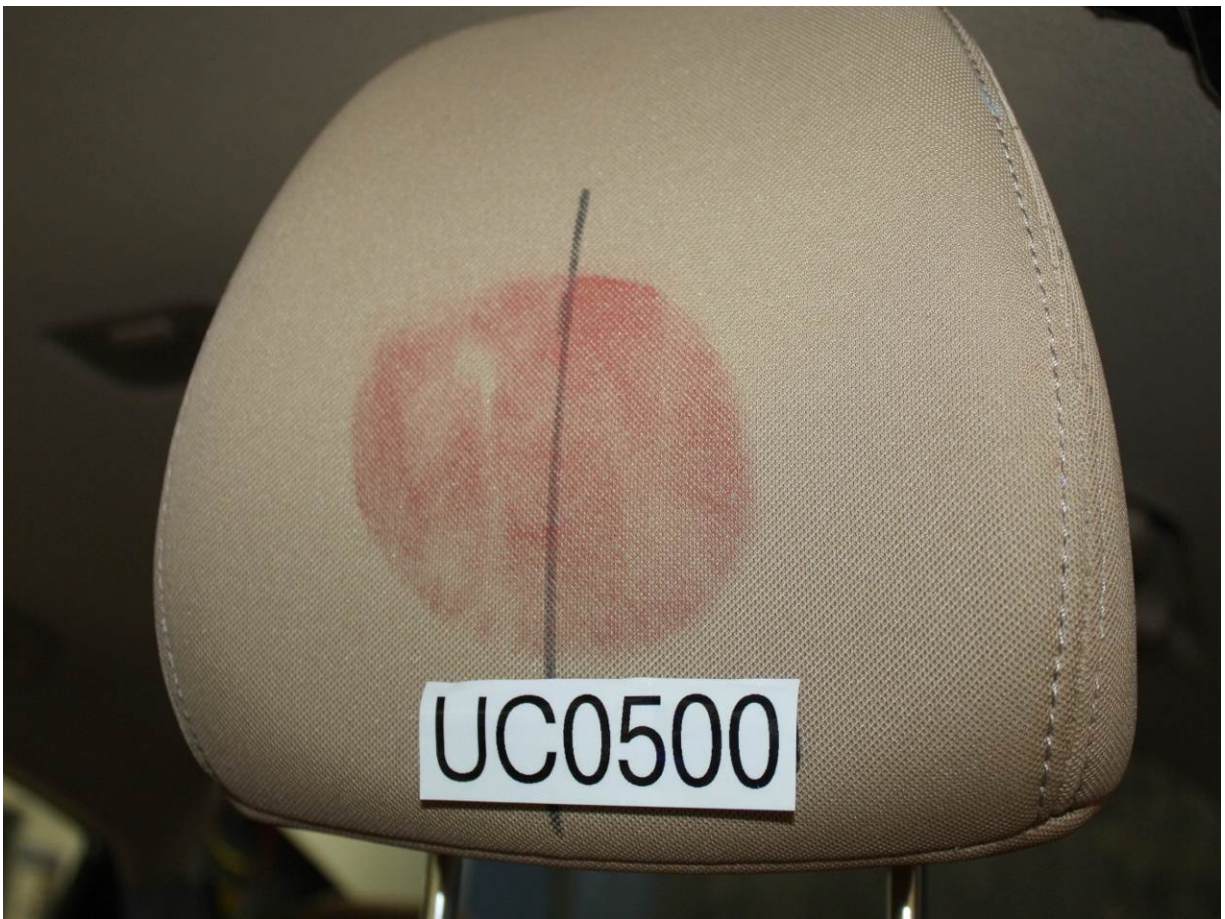
Post-Test Driver Dummy Contact with Headrest

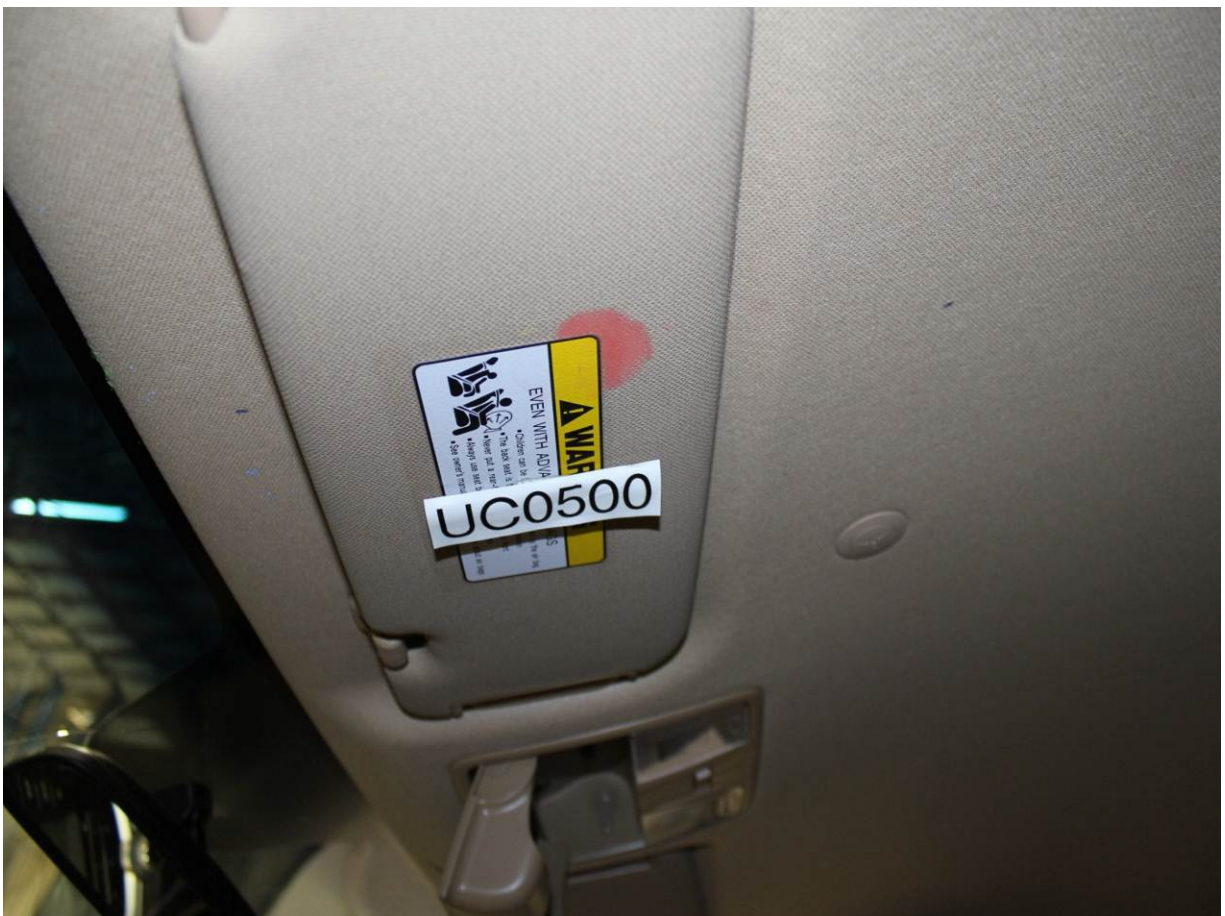
Post-Test Driver Dummy Contact with Visor

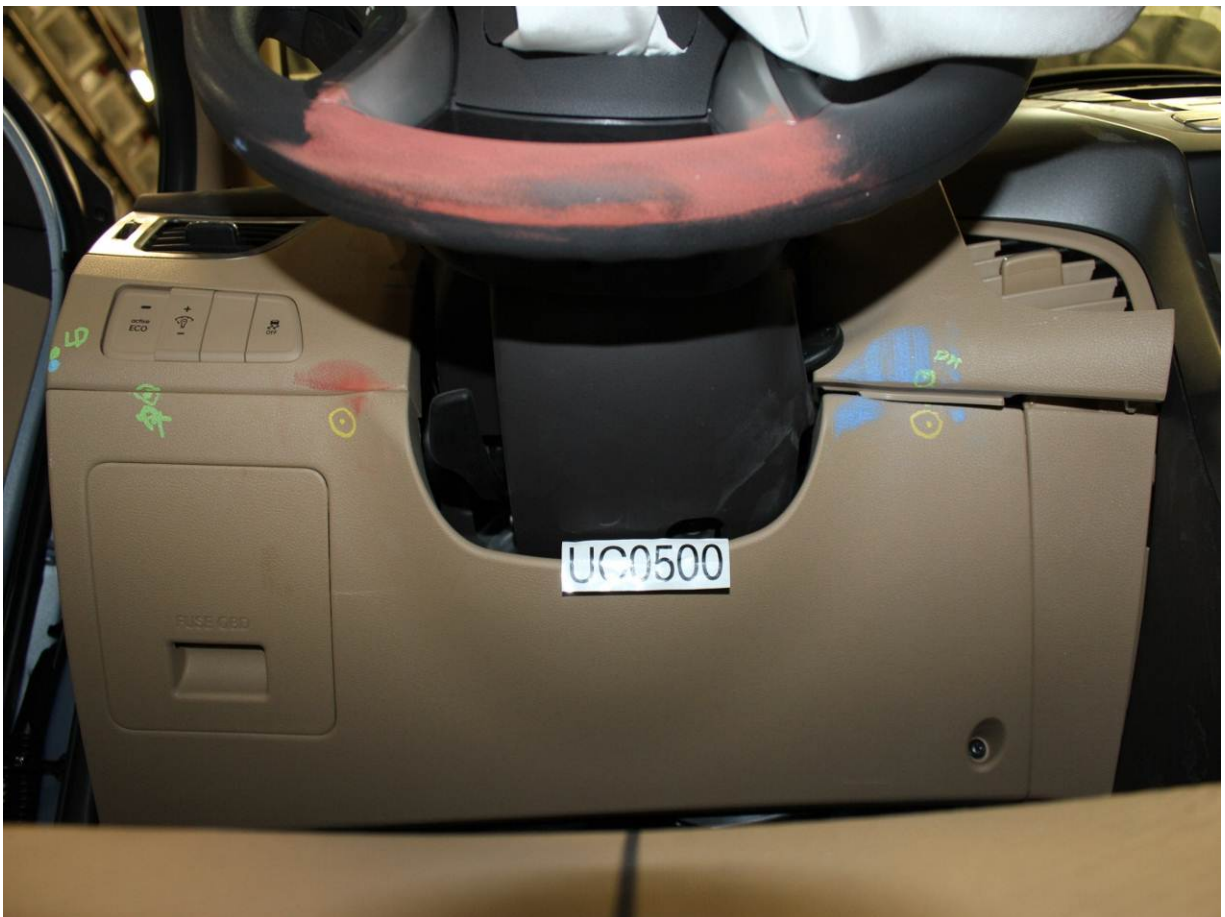
Post-Test Driver Dummy Contact with Knee Bolster

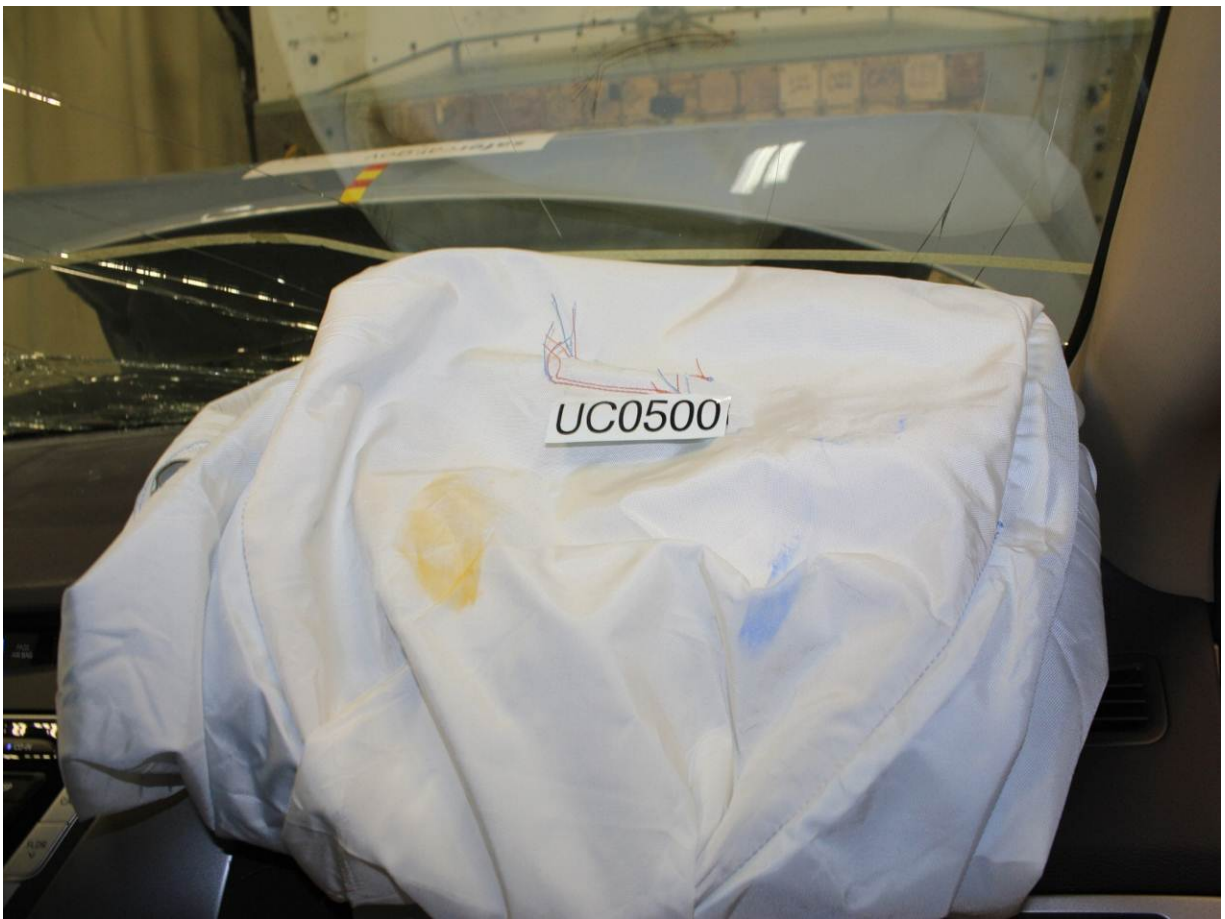
Post-Test Passenger Dummy Contact with Airbag

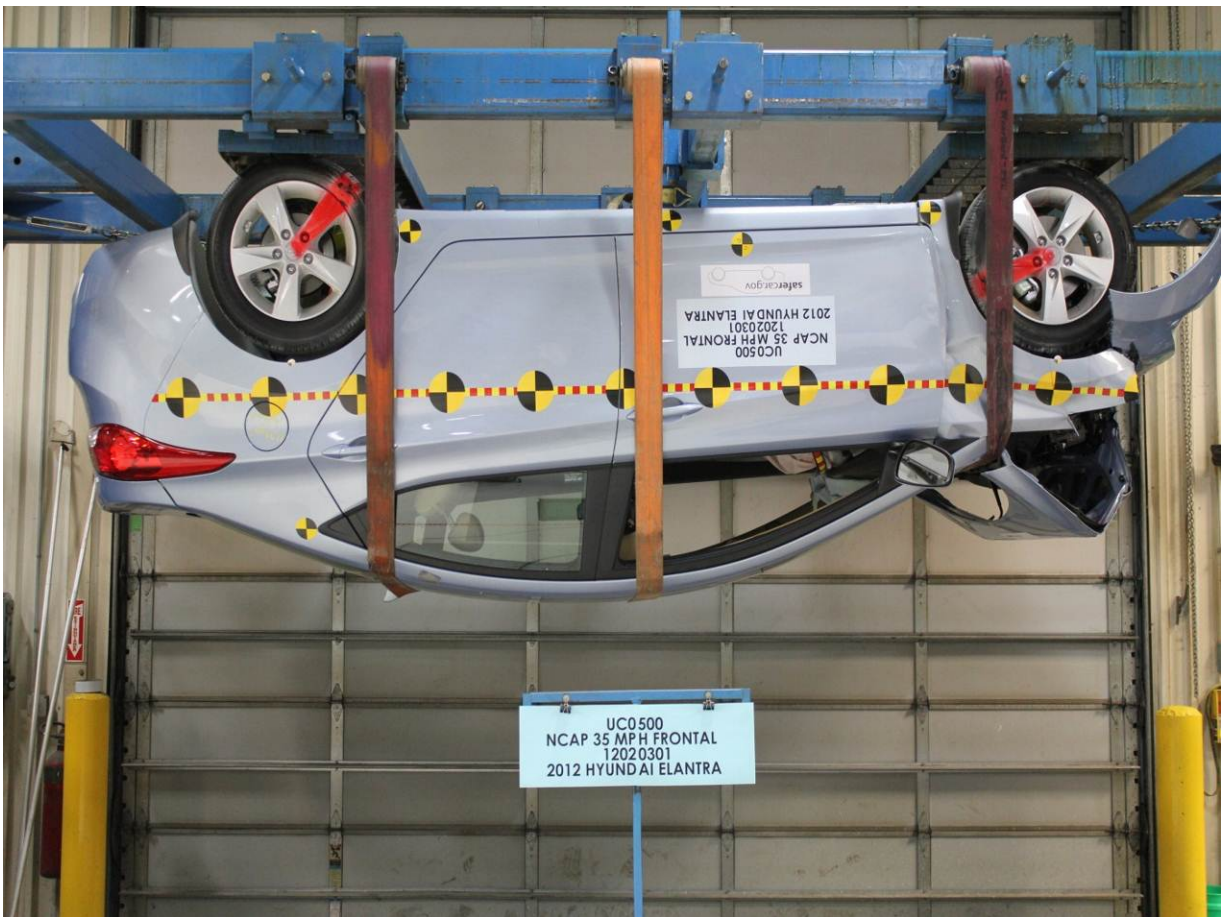
Vehicle at 0 Degrees on Static Rollover Device

Vehicle at 180 Degrees on Static Rollover Device

Vehicle at 360 Degrees on Static Rollover Device
