**REPORT NUMBER: TWG-MGA-2012-008**

**SIDE AIRBAG OUT-OF-POSITION INJURY  
TECHNICAL WORKING GROUP**

**CHRYSLER GROUP LLC  
2012 CHRYSLER 300 4-DR SEDAN  
NHTSA NO.: MC0332TWG2**

**FINAL REPORT**

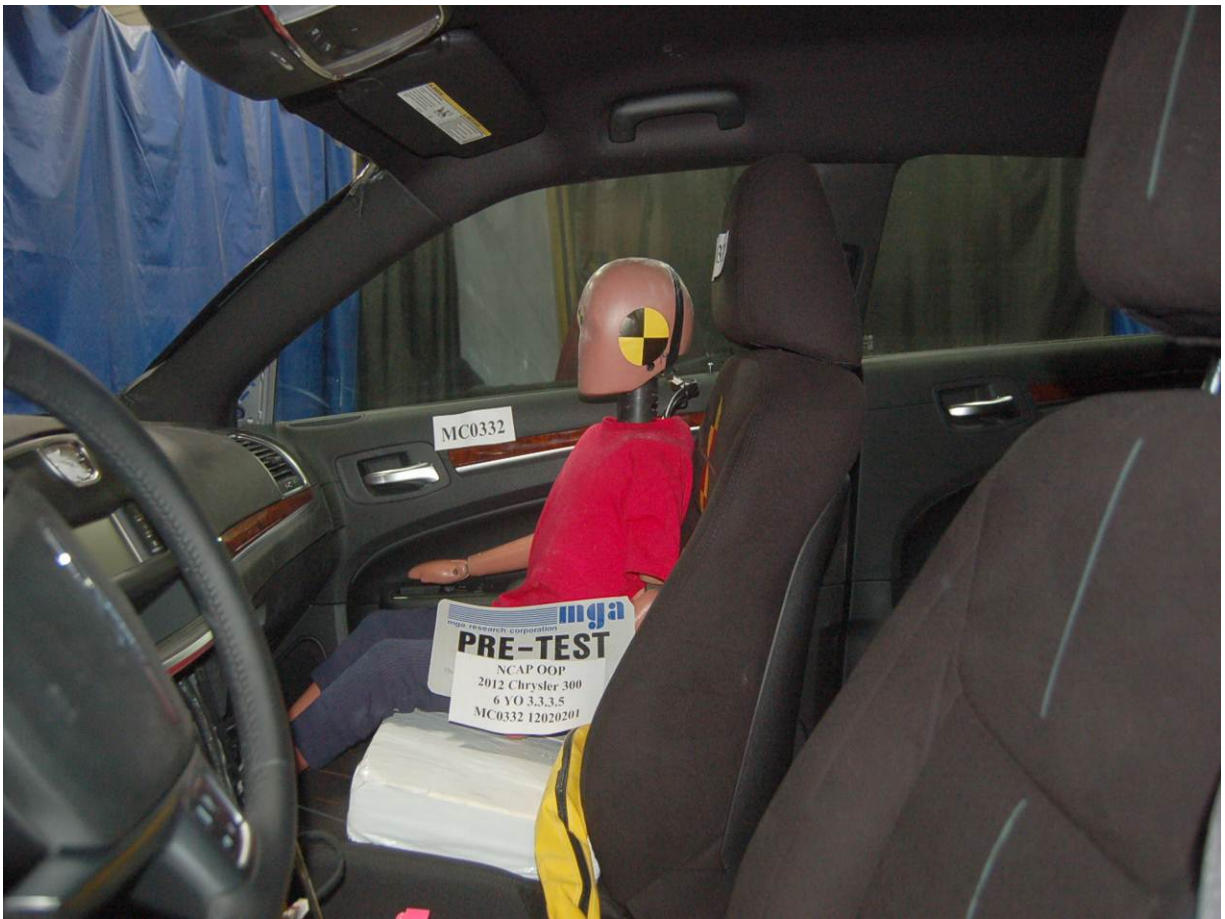
Pre-Test 6-Year-Old Child Dummy Left Side View

The Hybrid III 6-Year-Old child dummy was placed in the right front passenger seat along the outboard edge of the foam block, aligning the upper spine with the deployment trajectory of the airbag. The dummy's head was placed in between the seat bolster and pillar/side trim. The head remained in its neutral orientation. The legs were aligned so that they cross the heel placement points that were previously marked on the seat cushion. The feet were held in place and the pelvis slid forward and parallel to the centerline of the vehicle until the dummy's head/neck junction was aligned vertically with the top edge of the airbag module. The legs were then repositioned so that they cross the heel placement points. With the vehicle door closed, the dummy's outboard arm was raised to clear the armrest and the pelvis and upper torso was slid outboard until the pelvis or torso contacted the door. The outboard arm was placed on the armrest. The inboard arm was flexed so that the upper arm contacted the seat back and the fingertips contacted the foam block.

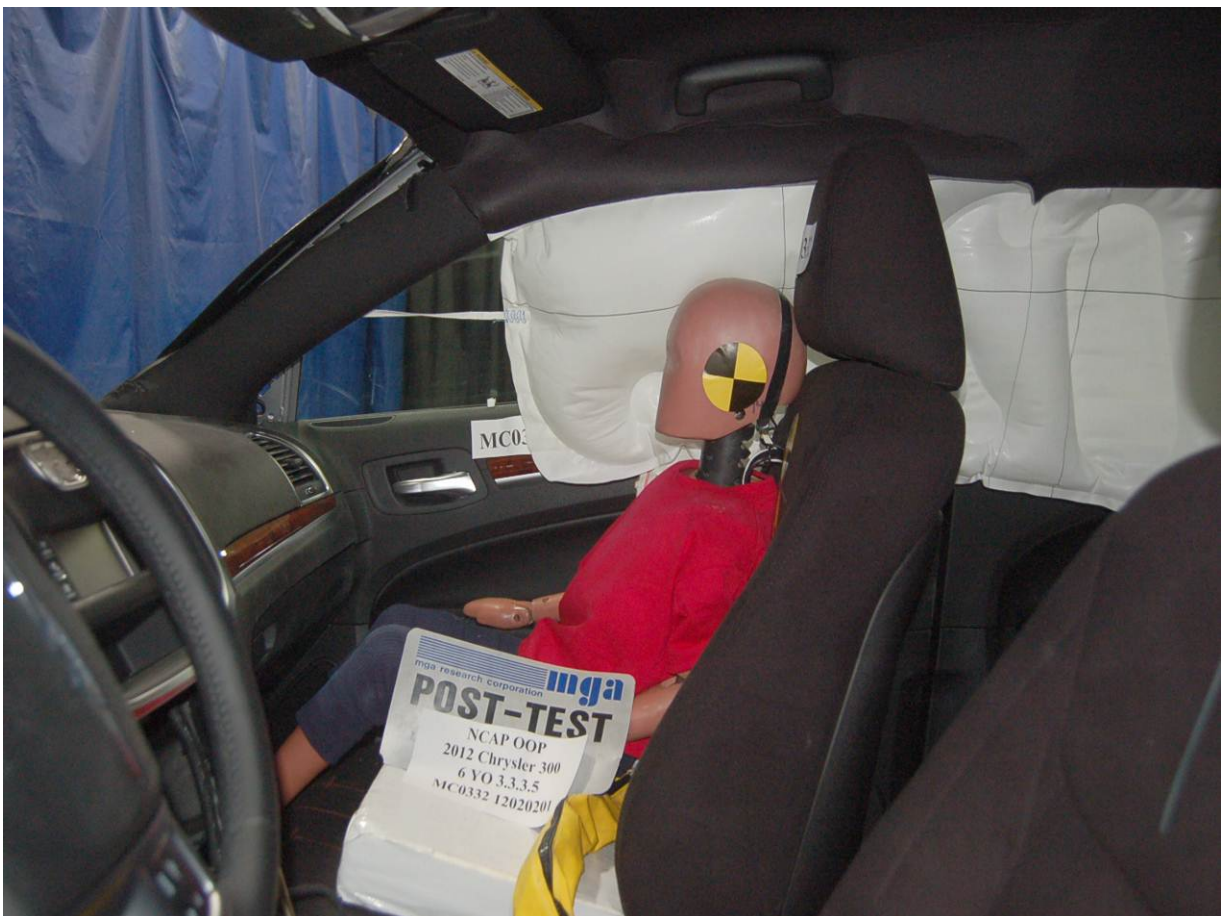
Post-Test 6-Year-Old Child Dummy Left Side View

- Side curtain airbag to top and right side of head
- Torso/Pelvis bag to right shoulder, torso, and pelvis

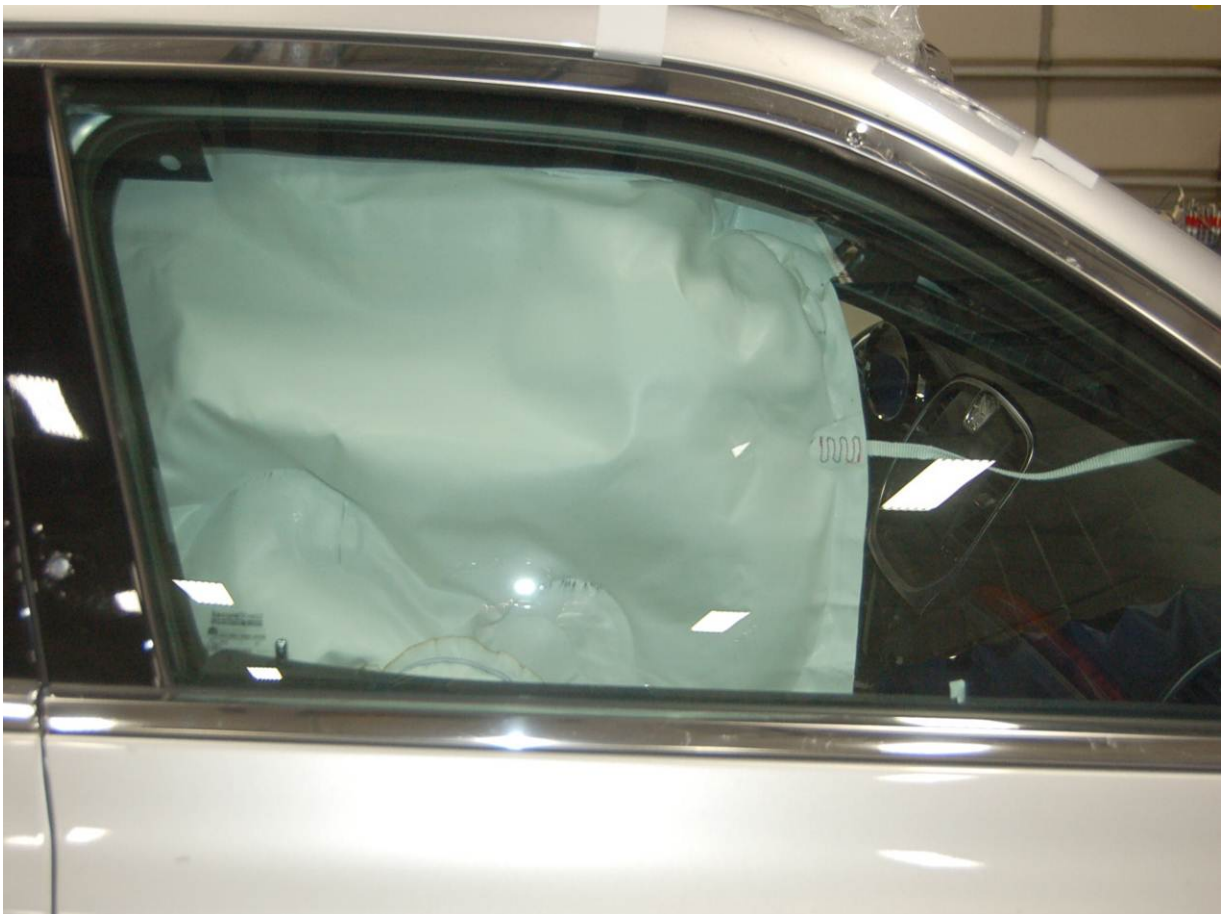
Post-Test 6-Year-Old Child Dummy Right Side View

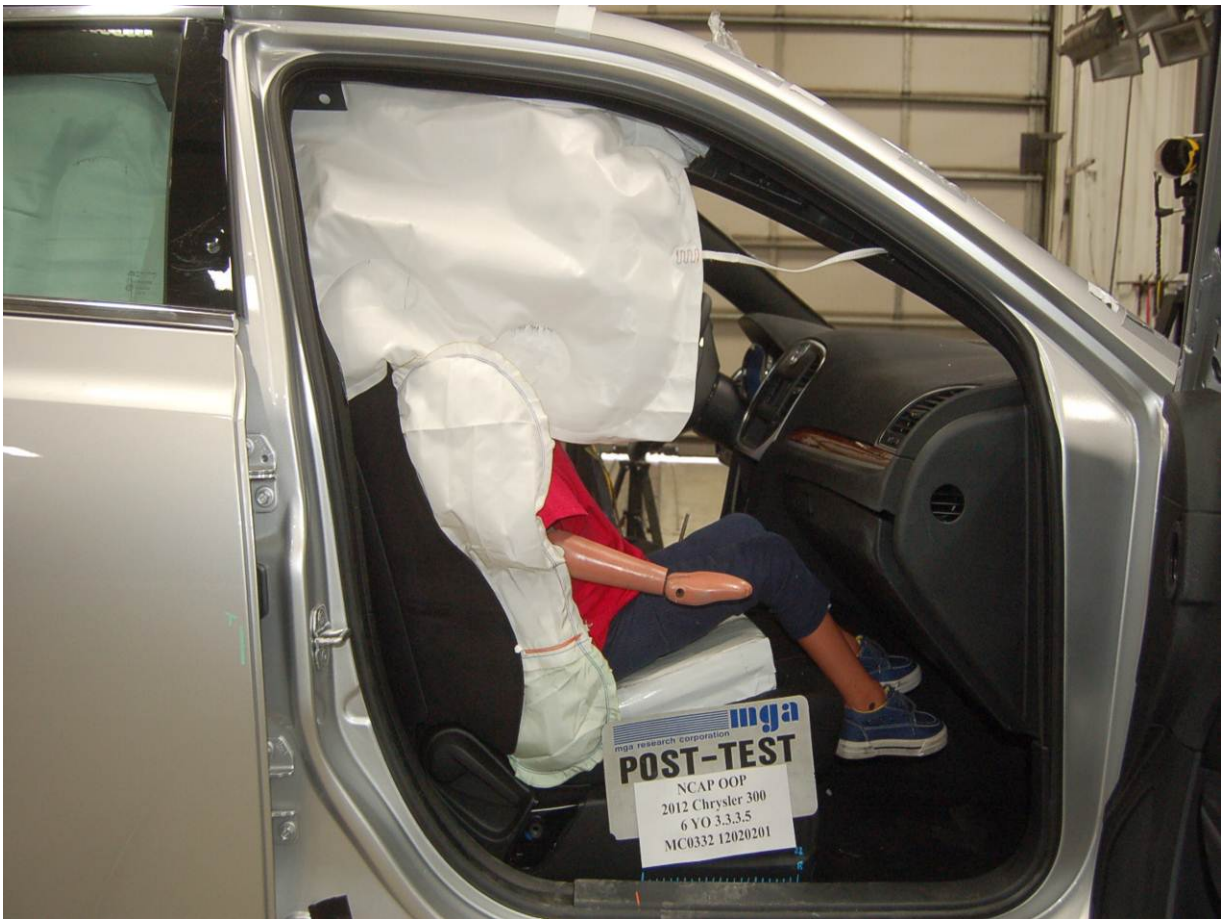
Post-Test 6-Year-Old Child Dummy Right Side View With Door Open

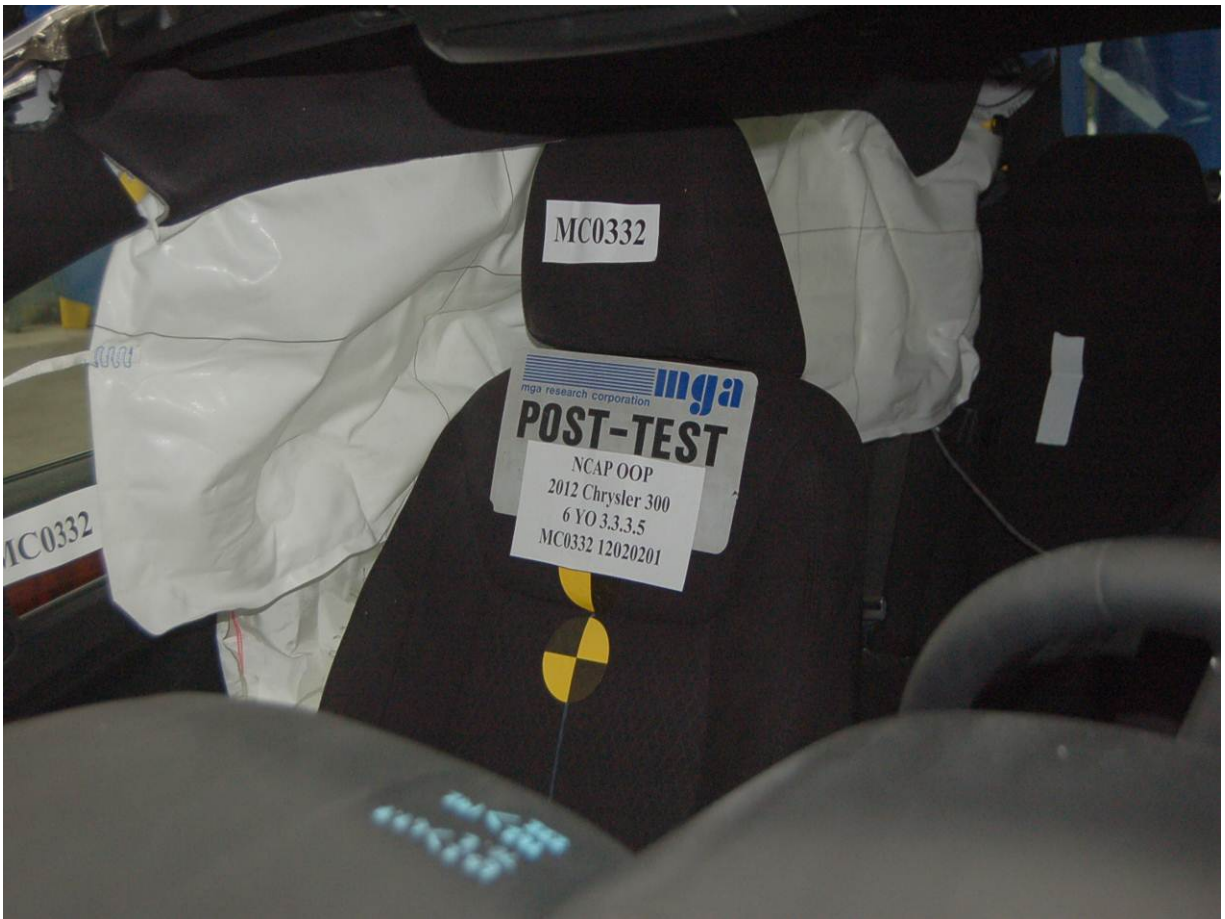
Post-Test Curtain Airbag Left ¾ Front View

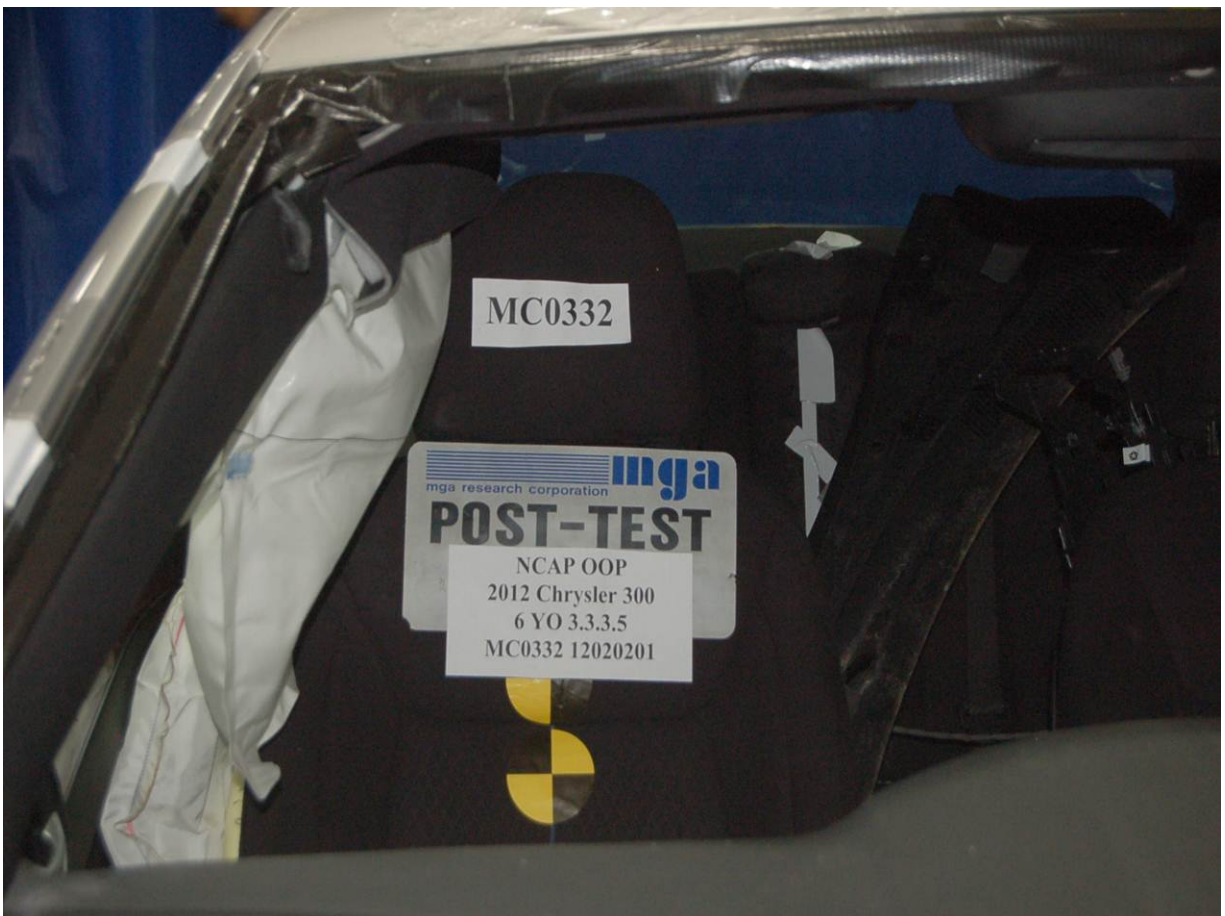
Post-Test Curtain Airbag Front View

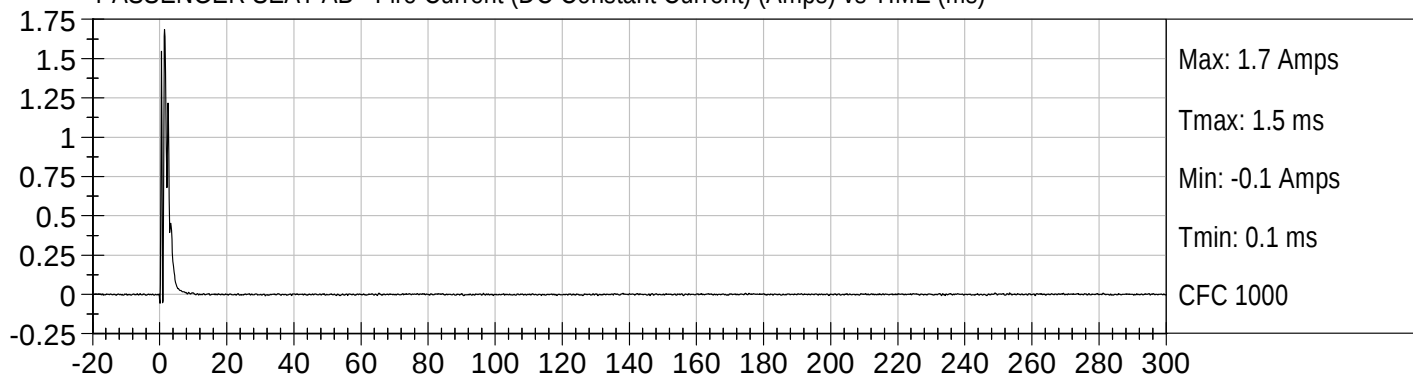
PASSENGER SEAT AB - Fire Current (DC Constant Current) (Amps) vs TIME (ms)
