REPORT NUMBER: SINCAP-CAL-12-027

**NEW CAR ASSESSMENT PROGRAM (NCAP)
Moving Deformable Barrier Side Impact Test**

**Ford Motor Co.
2012 Ford Transit Connect XLT Wagon**

NHTSA No: MC0217

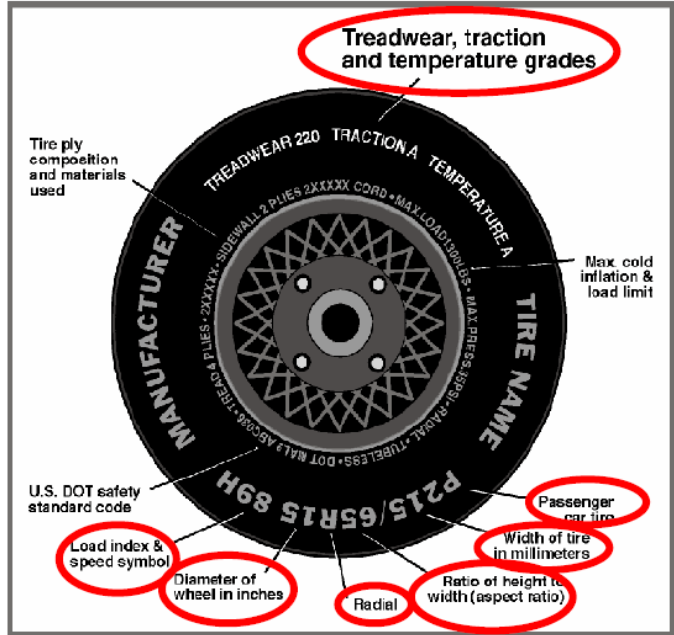
VEHICLE TIRE INFORMATION

Collect year, make, model, VIN, items circled in red, and tire manufacturer and tire name.

Measured Parameter	Front	Rear
Recommended Cold Tire Pressure (kPa)	275	340
Recommended Tire Size	P205/65R15	P205/65R15

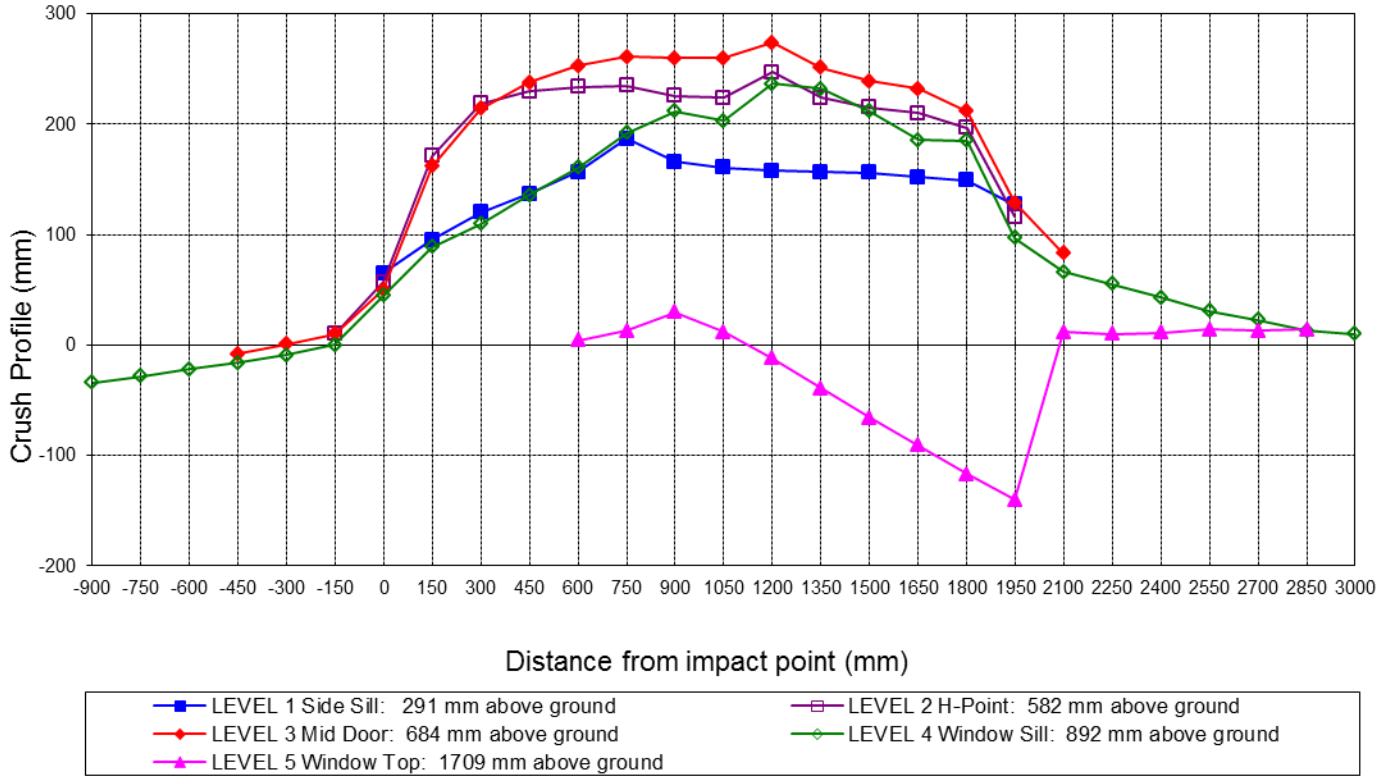
Vehicle Exterior Crush Measurements - Visual Representation

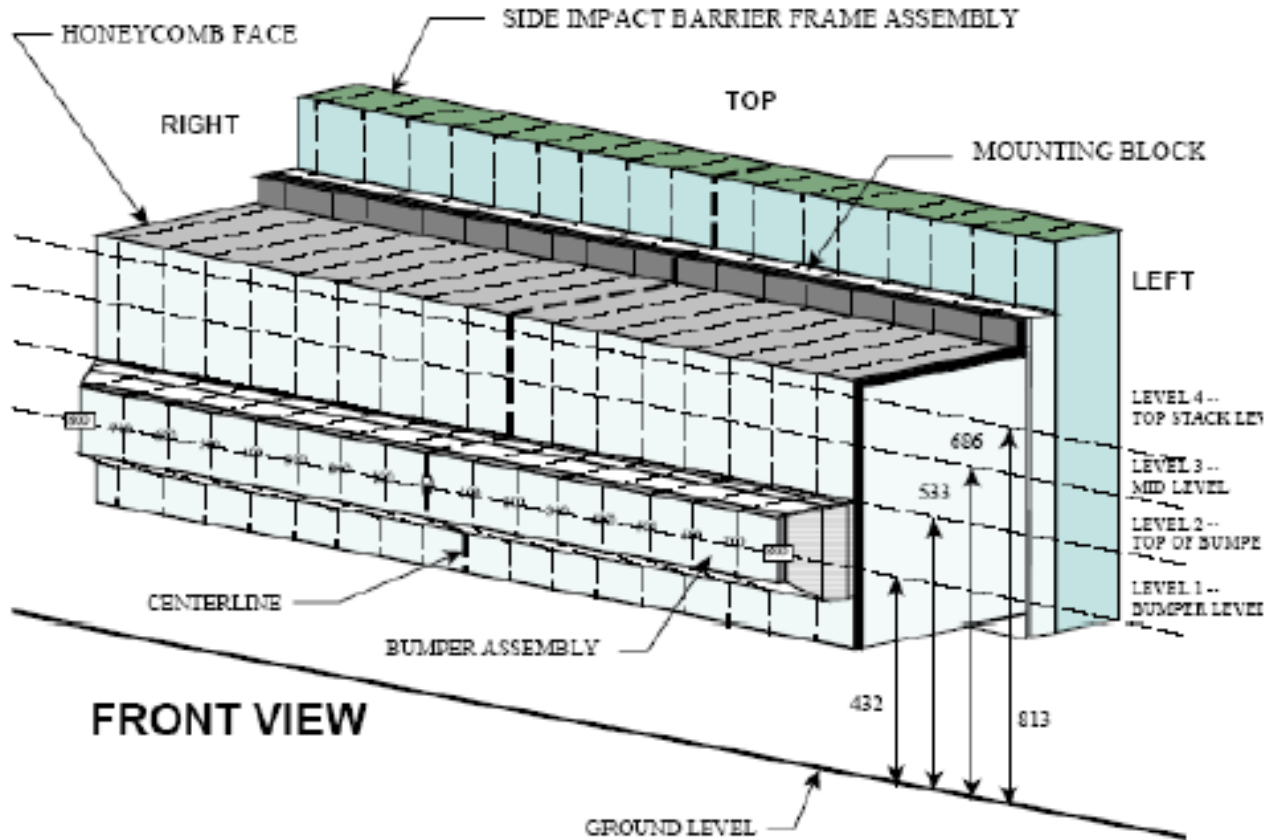
DATA SHEET NO. 12
MDB EXTERIOR STATIC CRUSH MEASUREMENTS

NOTE: Dimensions are shown in millimeters, mm

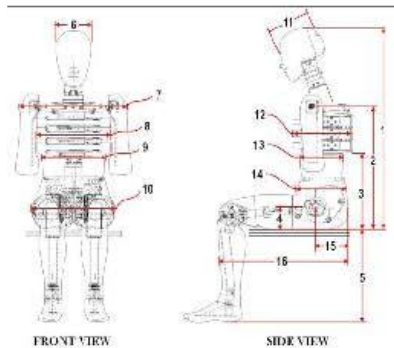
ES-2re External Measurements

Dim. No.	Description	Specification (mm)	Result (mm)	Pass/Fail
1	Sitting Height	900-918	915	Pass
2	Seat to Shoulder Joint	558-572	560	Pass
3	Seat to Lower Face of Thoracic Spine Box	346-356	355	Pass
4	Seat to Hip Joint (center of bolt)	97-103	98	Pass
5	Sole to Seat, Sitting	433-451	440	Pass
6	Head Width	152-158	154	Pass
7	Shoulder/Arm Width	461-479	465	Pass
8	Thorax Width	322-332	327	Pass
9	Abdomen Width	273-287	285	Pass
10	Pelvis Lap Width	359-373	369	Pass
11	Head Depth	196-206	199	Pass
12	Thorax Depth	262-272	268	Pass
13	Abdomen Depth	194-204	203	Pass
14	Pelvis Depth	235-245	239	Pass
15	Back of Buttocks to Hip Joint (center of bolt)	150-160	159	Pass
16	Back of Buttocks to Front Knee	597-615	605	Pass

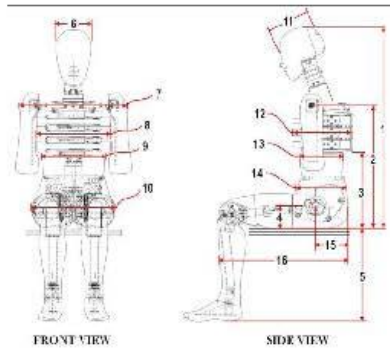
ES-2re External Measurements

Dim. No.	Description	Specification (mm)	Result (mm)	Pass/Fail
1	Sitting Height	900-918	915	Pass
2	Seat to Shoulder Joint	558-572	560	Pass
3	Seat to Lower Face of Thoracic Spine Box	346-356	355	Pass
4	Seat to Hip Joint (center of bolt)	97-103	98	Pass
5	Sole to Seat, Sitting	433-451	440	Pass
6	Head Width	152-158	154	Pass
7	Shoulder/Arm Width	461-479	465	Pass
8	Thorax Width	322-332	327	Pass
9	Abdomen Width	273-287	285	Pass
10	Pelvis Lap Width	359-373	369	Pass
11	Head Depth	196-206	199	Pass
12	Thorax Depth	262-272	268	Pass
13	Abdomen Depth	194-204	203	Pass
14	Pelvis Depth	235-245	239	Pass
15	Back of Buttocks to Hip Joint (center of bolt)	150-160	159	Pass
16	Back of Buttocks to Front Knee	597-615	605	Pass
