**REPORT NUMBER: SINCAP-KAR-12-048**

**NEW CAR ASSESSMENT PROGRAM (NCAP)  
MOVING DEFORMABLE BARRIER SIDE IMPACT TEST**

**HONDA OF CANADA MFG.  
2012 HONDA CIVIC LX 2-DOOR COUPE**

**NHTSA No: MC5311**

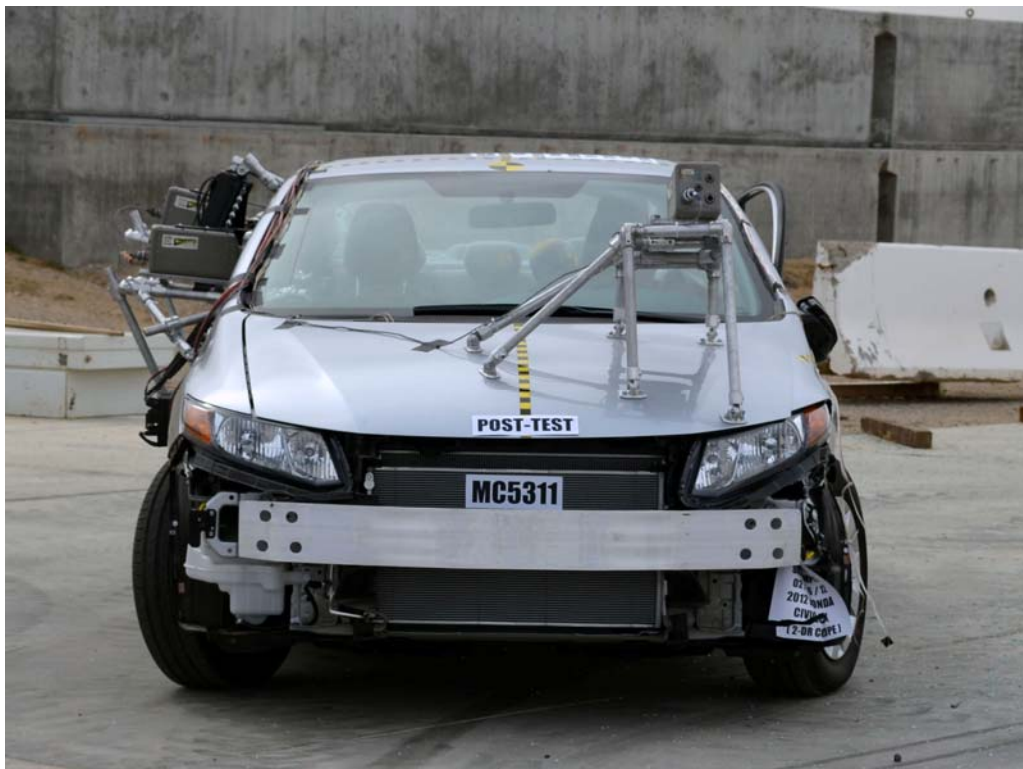
FIGURE 4. Post-Test Frontal View of Test Vehicle

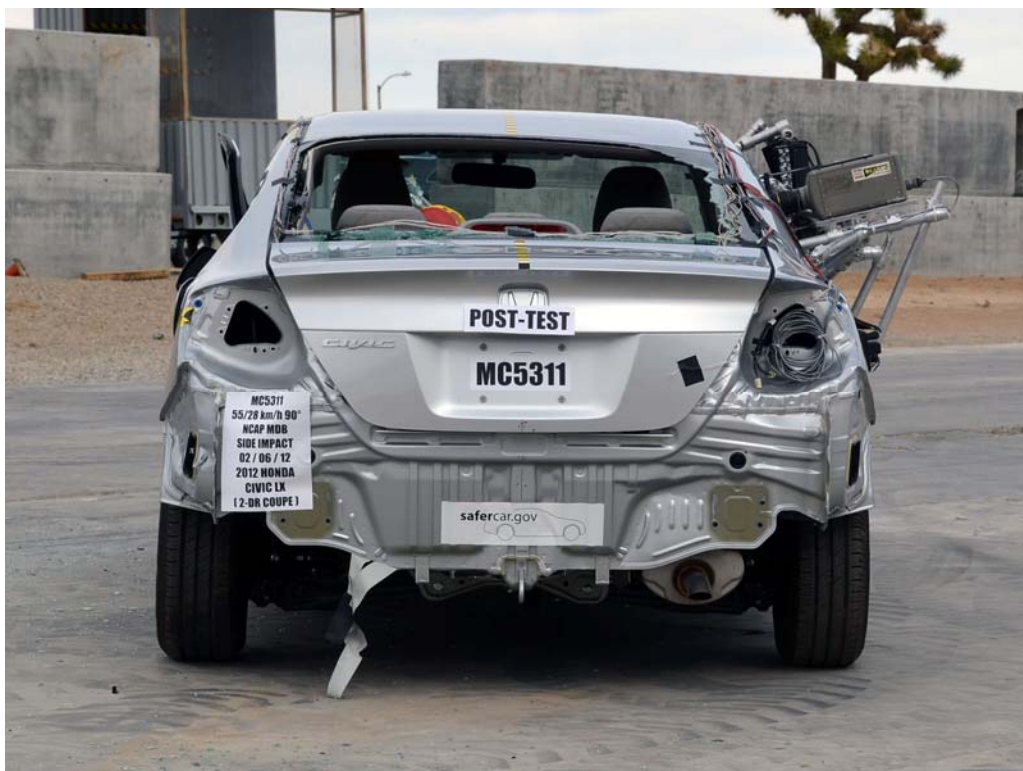
FIGURE 12. Post-Test Rear View of Test Vehicle

| Critical Areas of Performance | Observations and Conclusions |
|---|---|
| Other Notable Effects | Rear Window Broken |

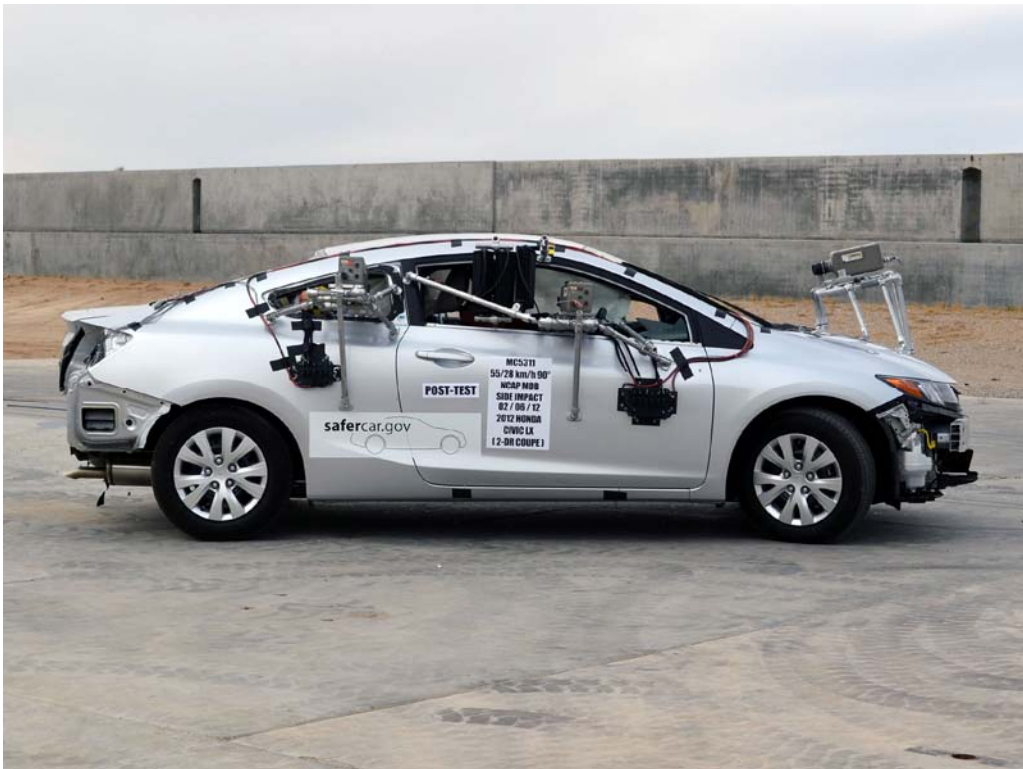
FIGURE 14. Post-Test Right Side View of Test Vehicle

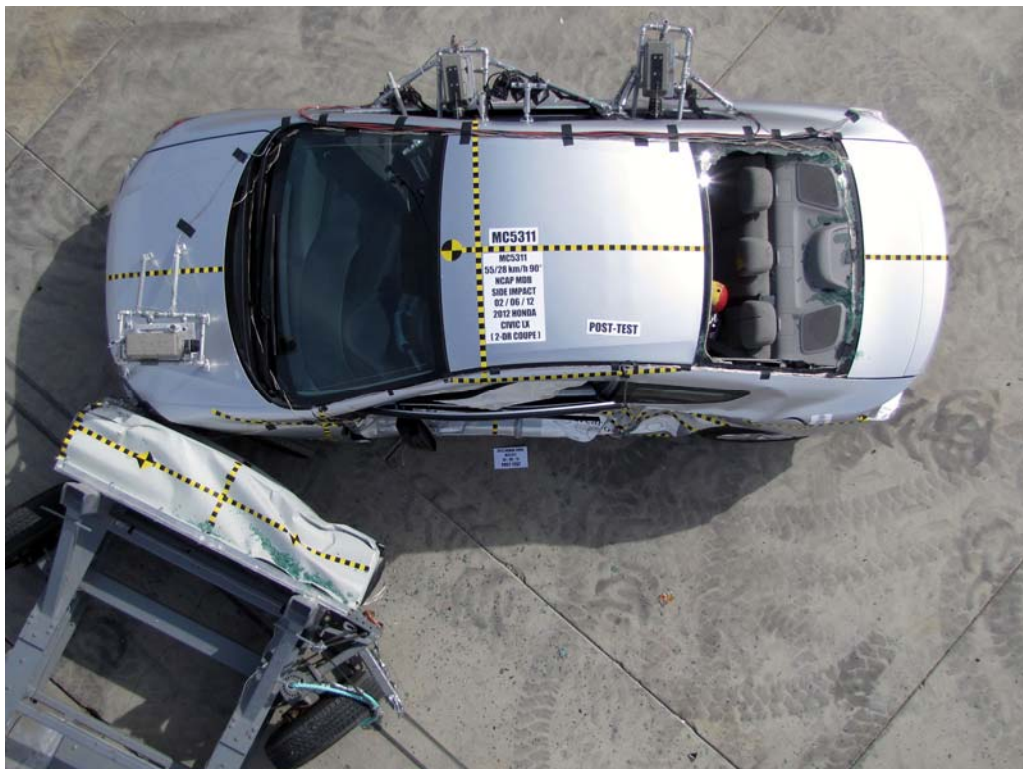
FIGURE 16. Post-Test Overhead View of Test Area

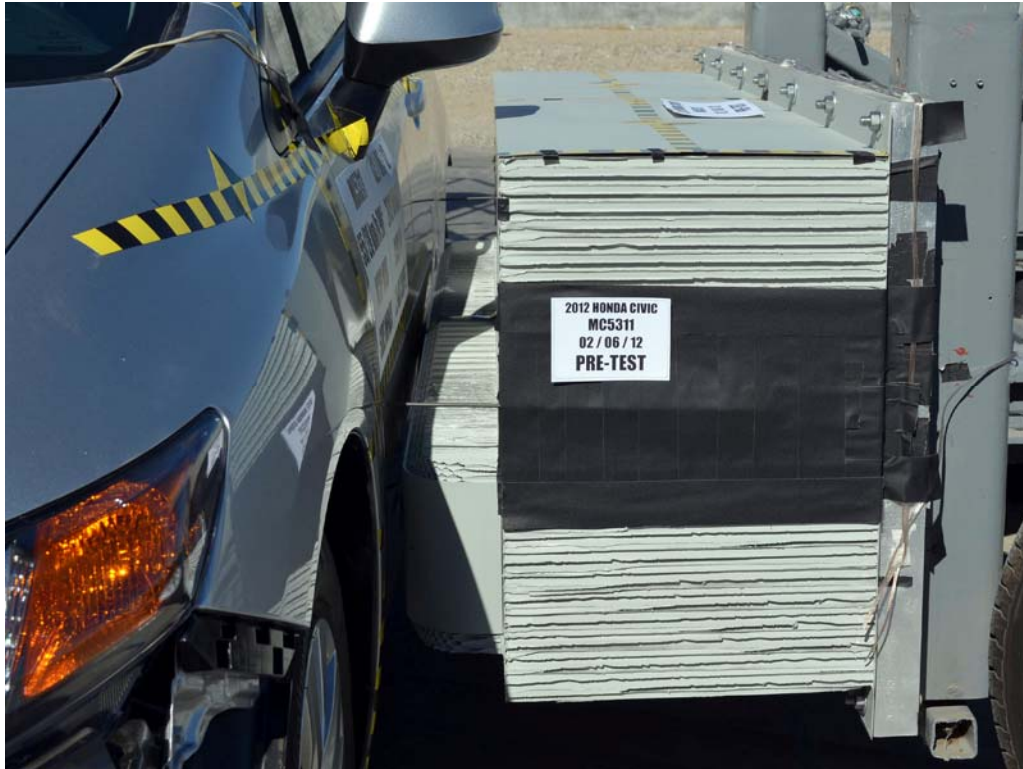
FIGURE 17. Pre-Test Left Side View of MDB Positioned  
Against Side of Test Vehicle

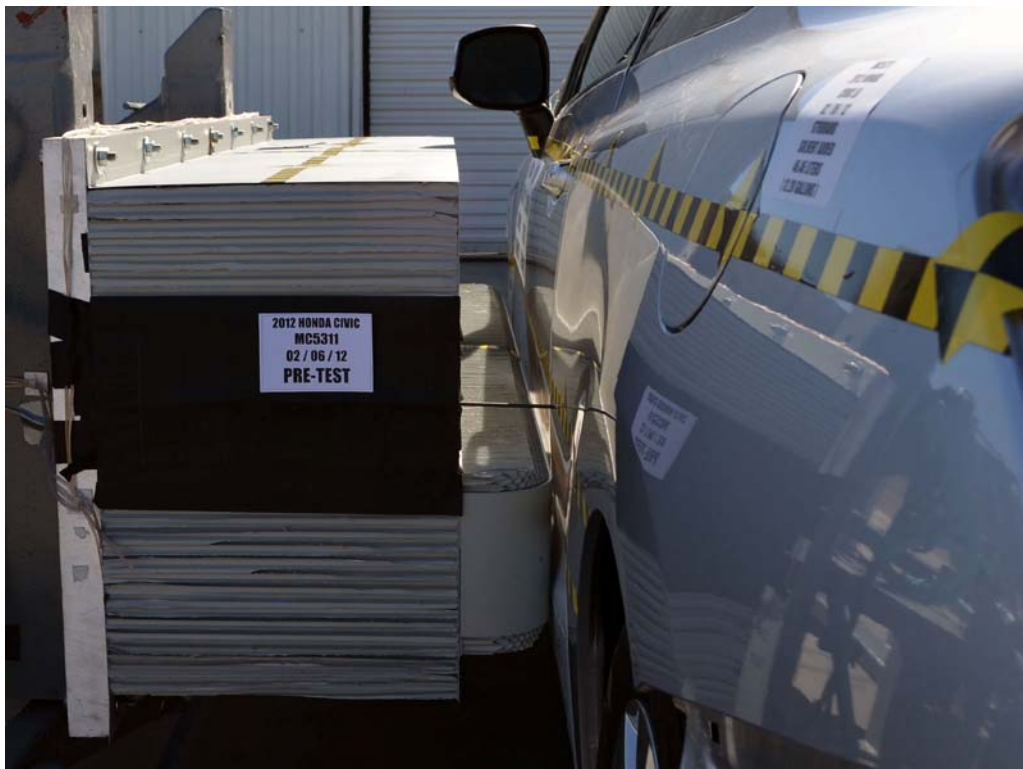
FIGURE 18. Pre-Test Right Side View of MDB Positioned  
Against Side of Test Vehicle

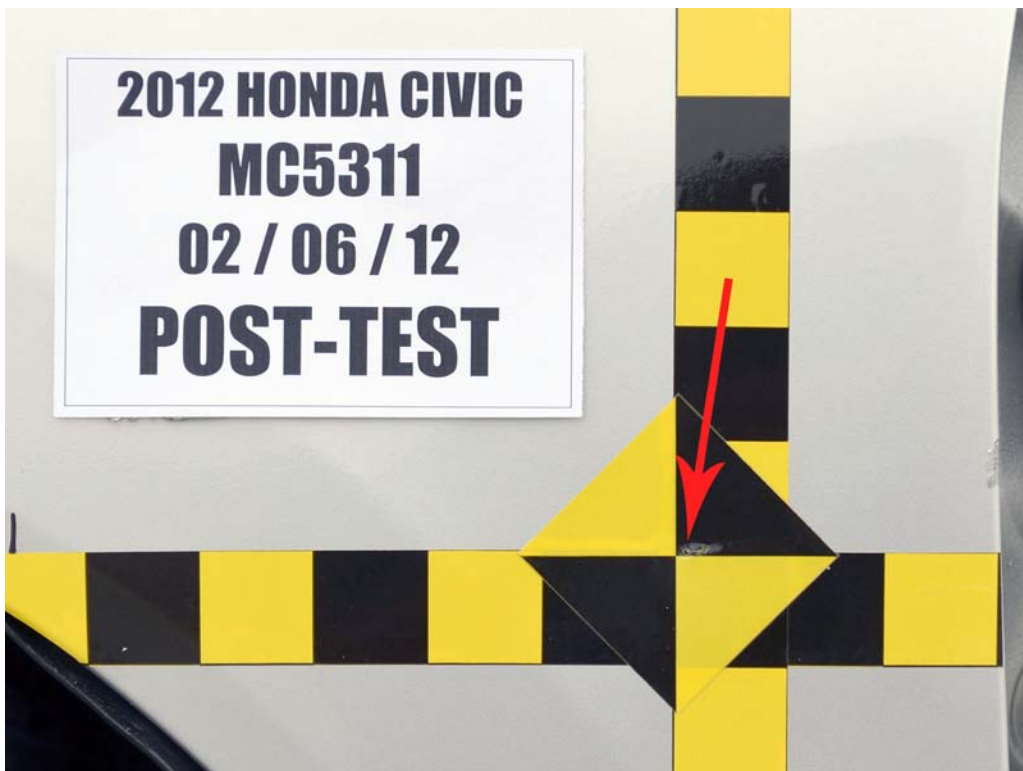
FIGURE 20. Post-Test Close-Up View of Impact Point Target  
Showing Impact Point Location

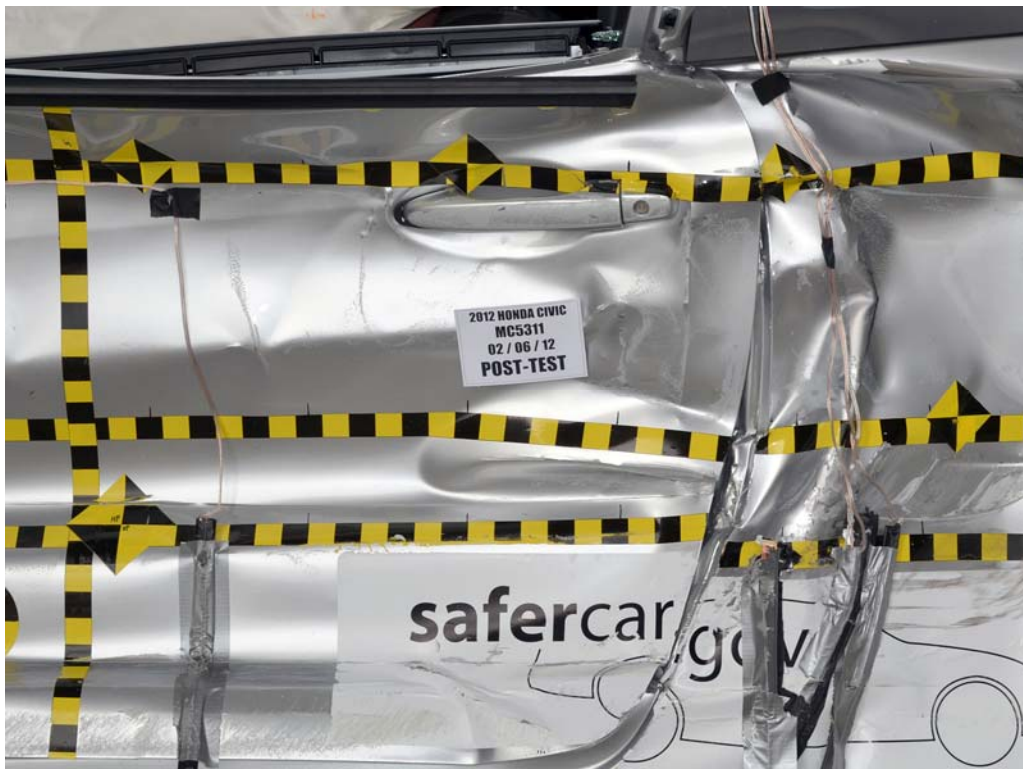
FIGURE 22. Post-Test Left Front Door Latch Close-Up

The door on the struck side of the vehicle did not separate from the body at the hinges or latches, and the opposite door did not open during the side impact event.

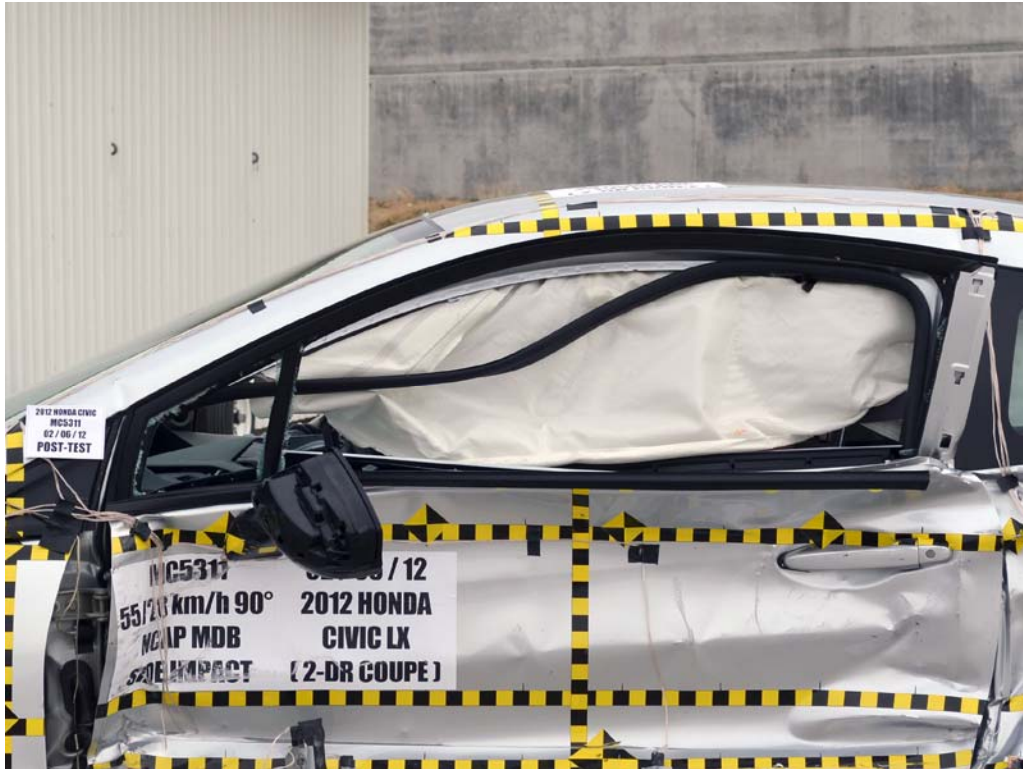
FIGURE 29. Post-Test Left Side View of Driver Dummy Shoulder and Door Top View

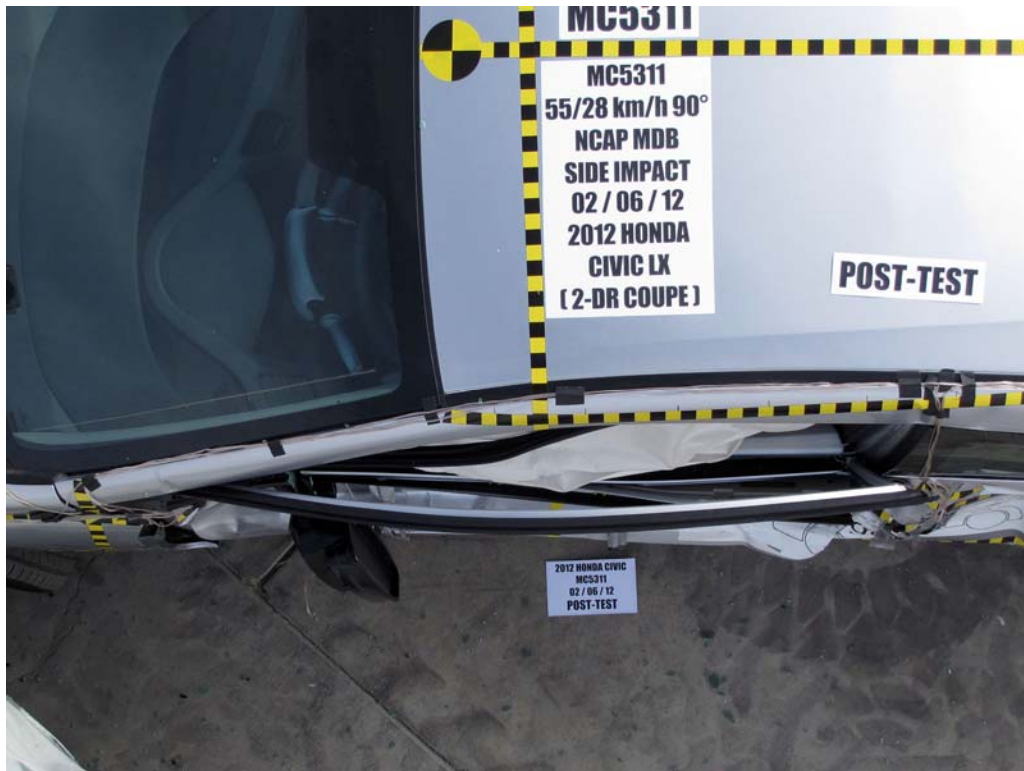
FIGURE 43. Post-Test Driver Dummy and Door Clearance View

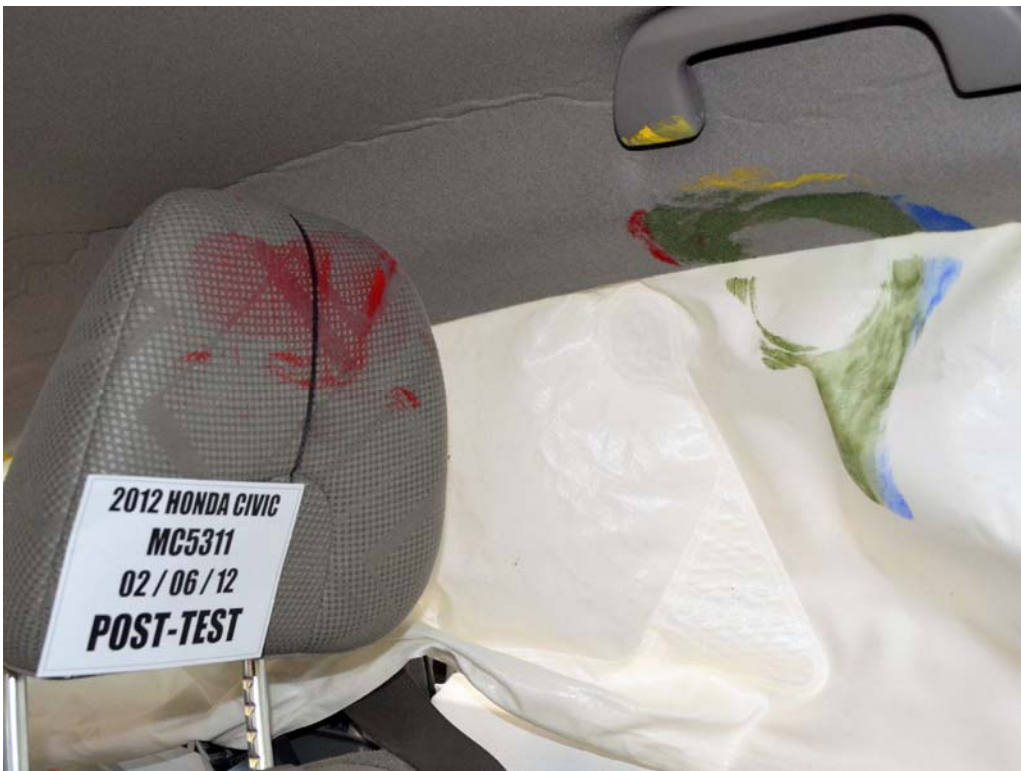
FIGURE 48. Post-Test Driver Dummy Close-Up Head Contact with Vehicle Interior View

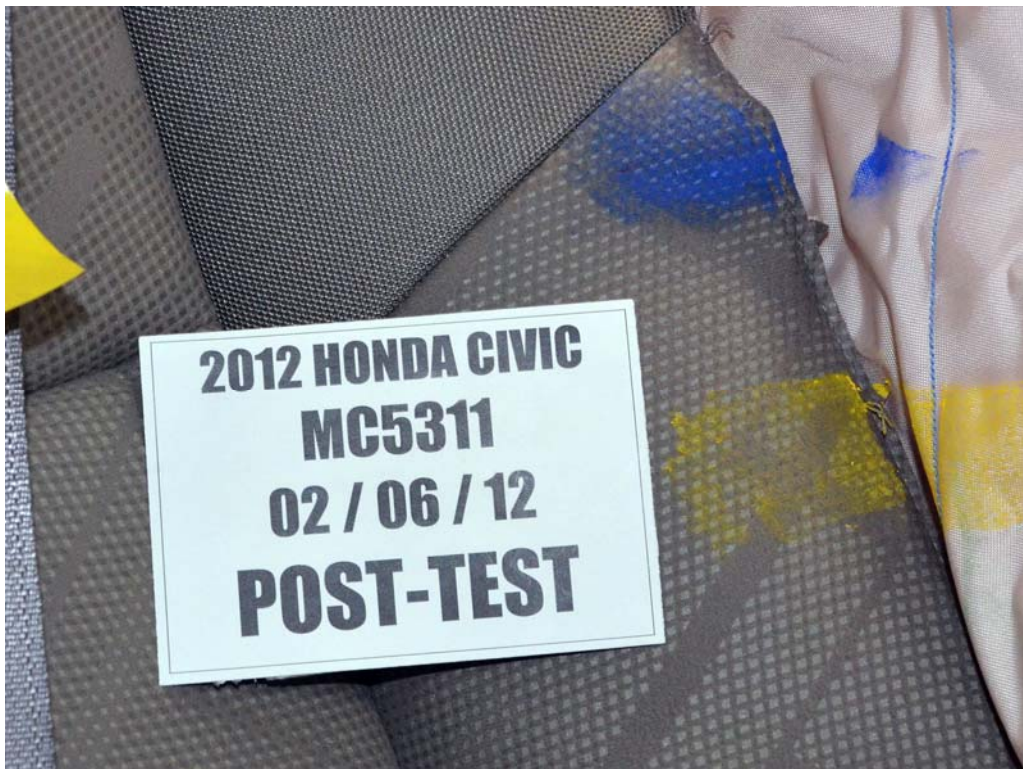
FIGURE 50. Post-Test Driver Dummy Close-Up Torso Contact with Vehicle Interior View

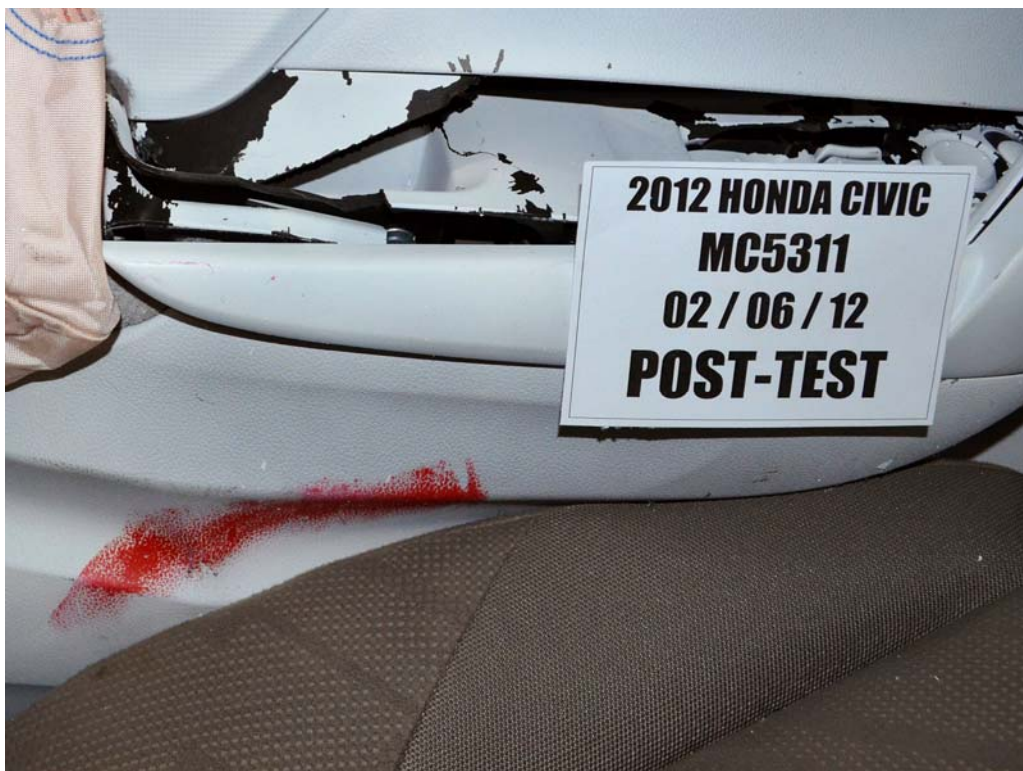
FIGURE 52. Post-Test Driver Dummy Close-Up Pelvis Contact with Vehicle Interior View

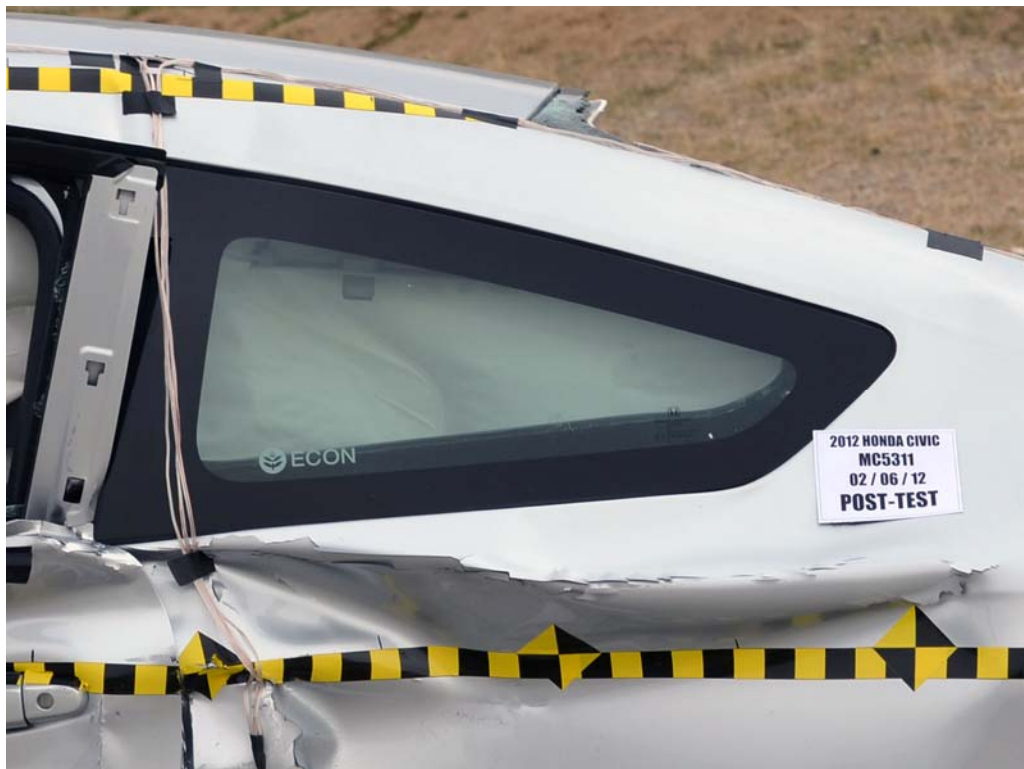
FIGURE 56. Post-Test Left Side View of Rear Passenger Dummy  
Shoulder and Door Top View

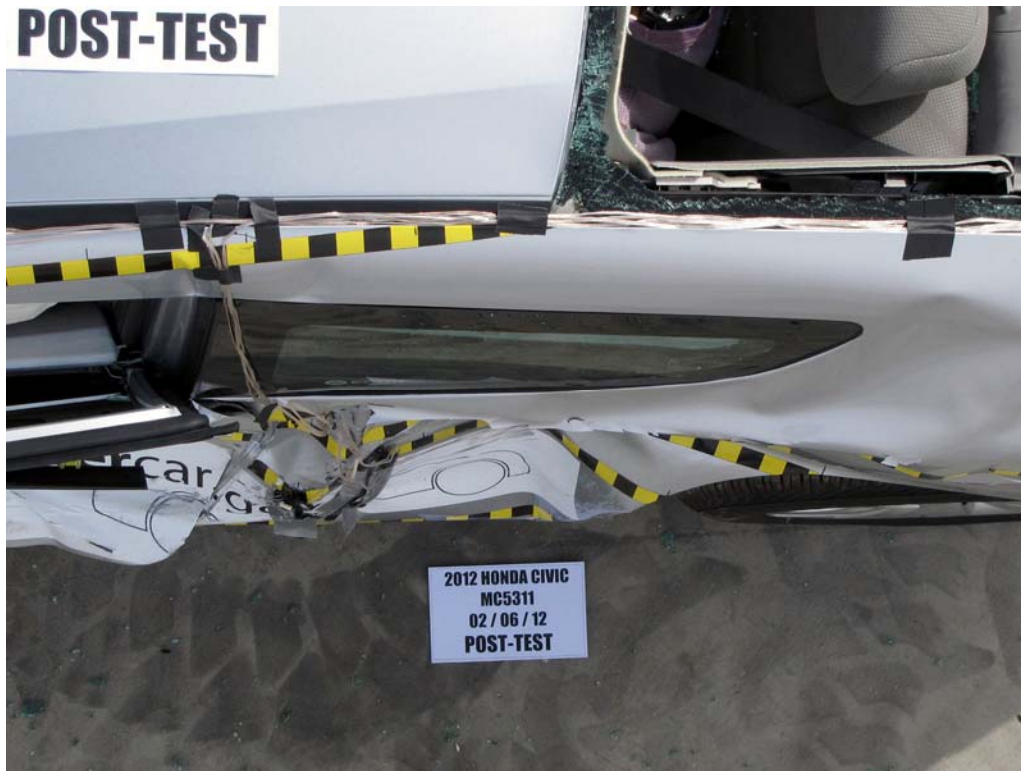
FIGURE 69. Post-Test Rear Passenger Dummy and Door Clearance View

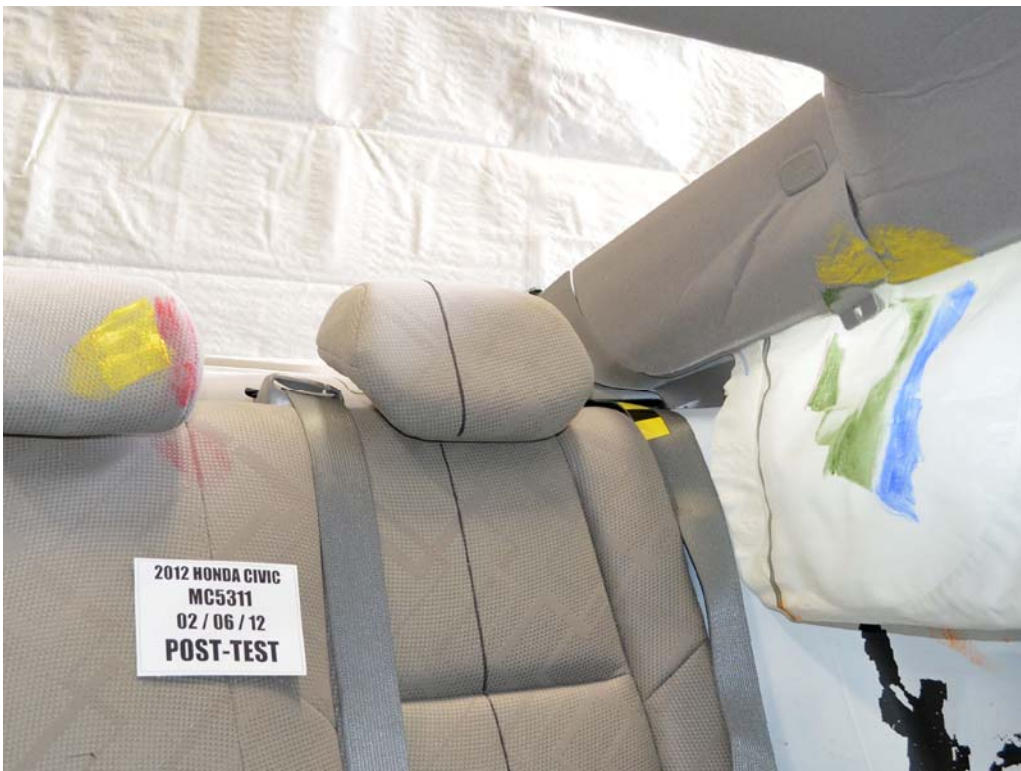
FIGURE 74. Post-Test Rear Passenger Dummy Close-Up  
Head Contact with Vehicle Interior View

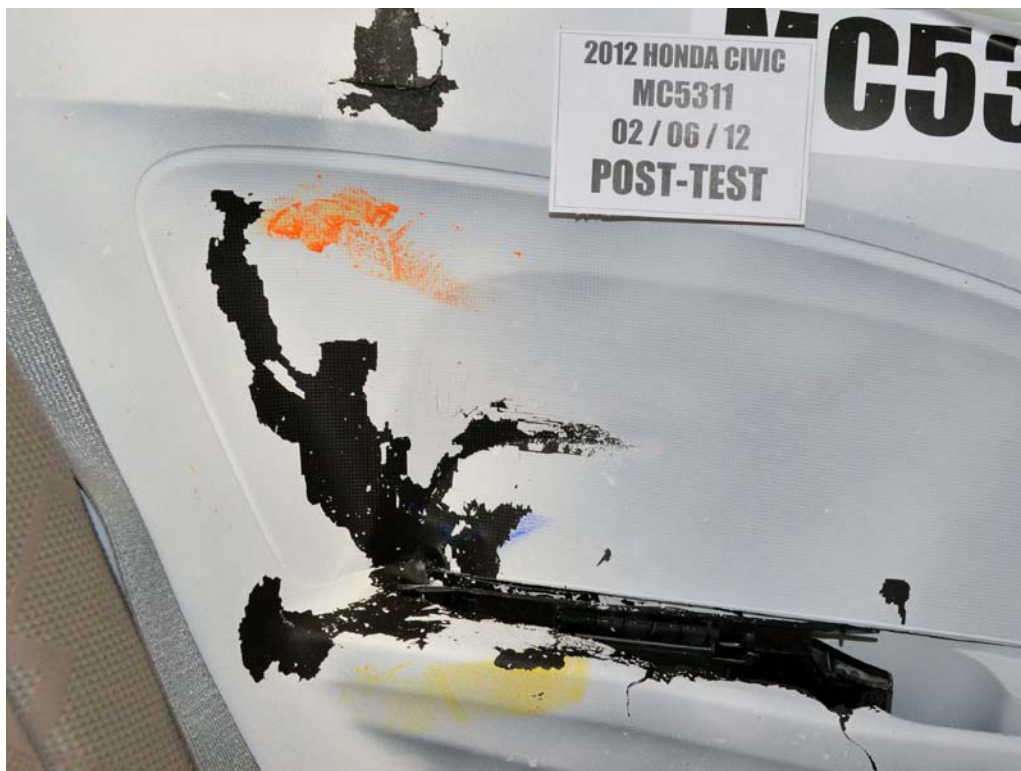
FIGURE 76. Post-Test Rear Passenger Dummy Close-Up  
Torso Contact with Vehicle Interior View

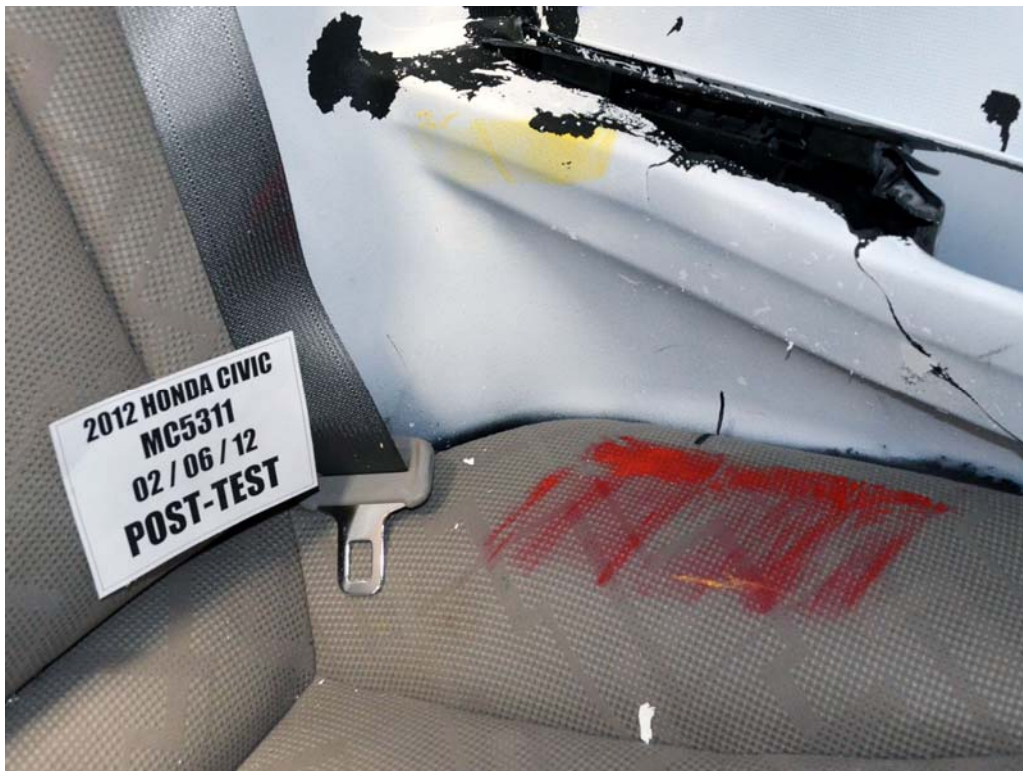
FIGURE 78. Post-Test Rear Passenger Dummy Close-Up  
Pelvis Contact with Vehicle Interior View

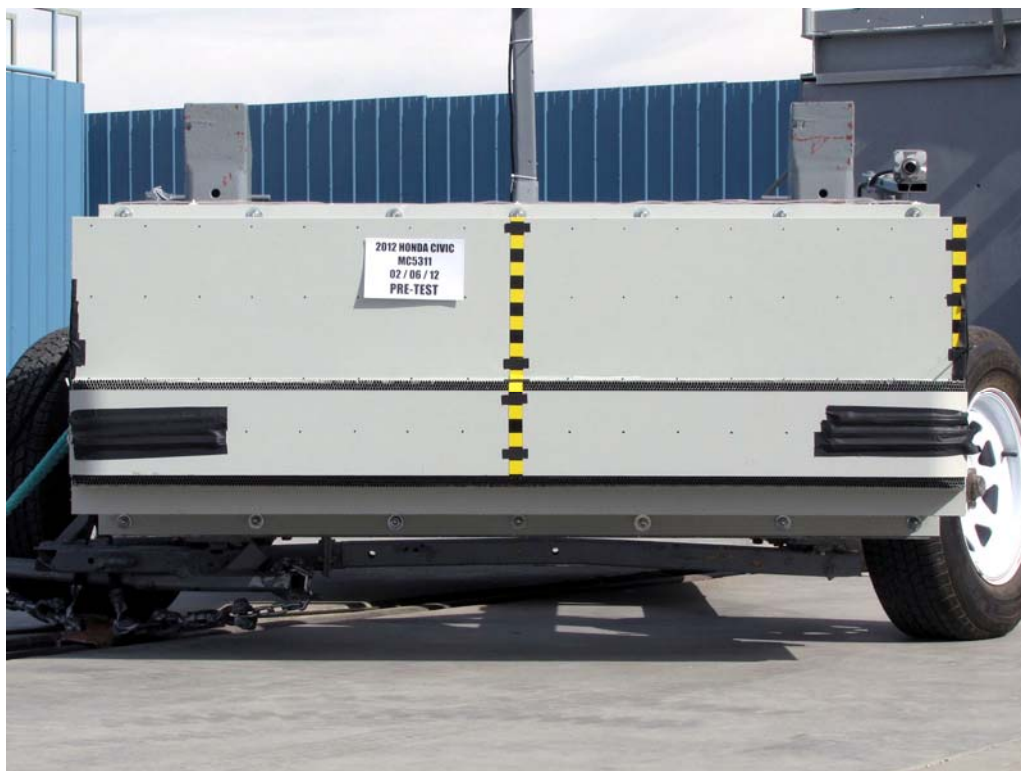
FIGURE 82. Pre-Test Front View of MDB Impactor Face
