**REPORT NUMBER: SPNCAP-KAR-12-049**

**NEW CAR ASSESSMENT PROGRAM (NCAP)  
SIDE IMPACT POLE TEST**

**HONDA OF CANADA MFG.  
2012 HONDA CIVIC LX 2-DOOR COUPE**

**FINAL REPORT**

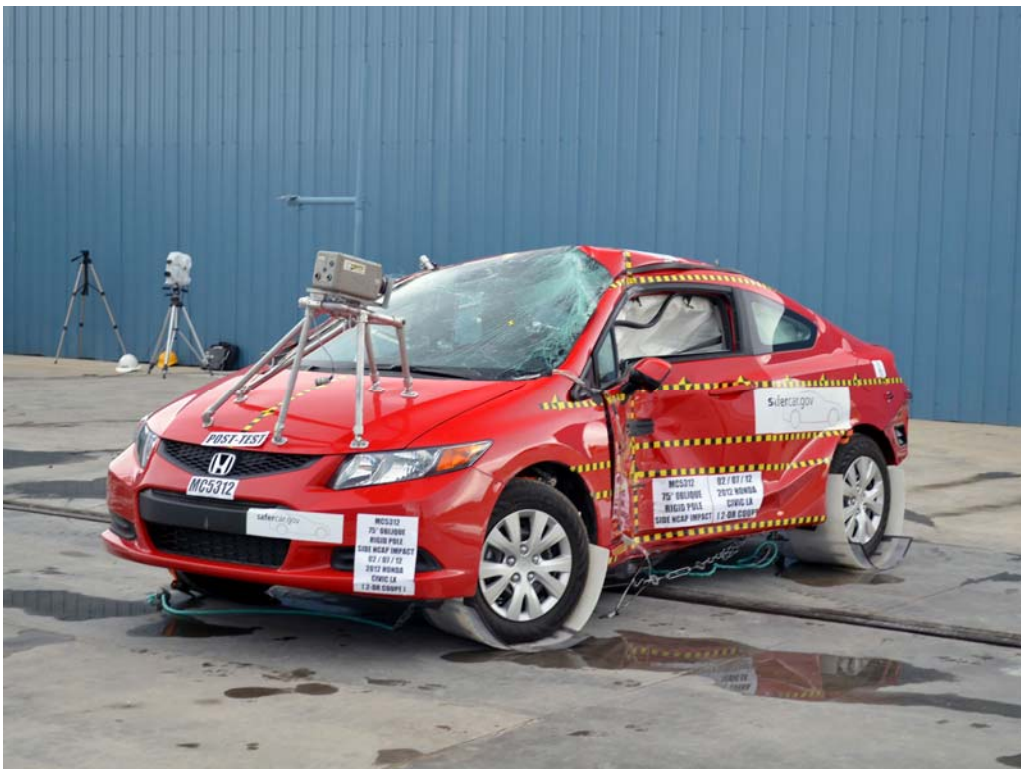
FIGURE 6. Post-Test Left Front  $\frac{3}{4}$  View of Test Vehicle

The door on the struck side of the vehicle remained closed and latched. There was no separation at the hinges or latches. The door on the non-struck side remained closed and latched. There were no ATD values that exceeded limits.

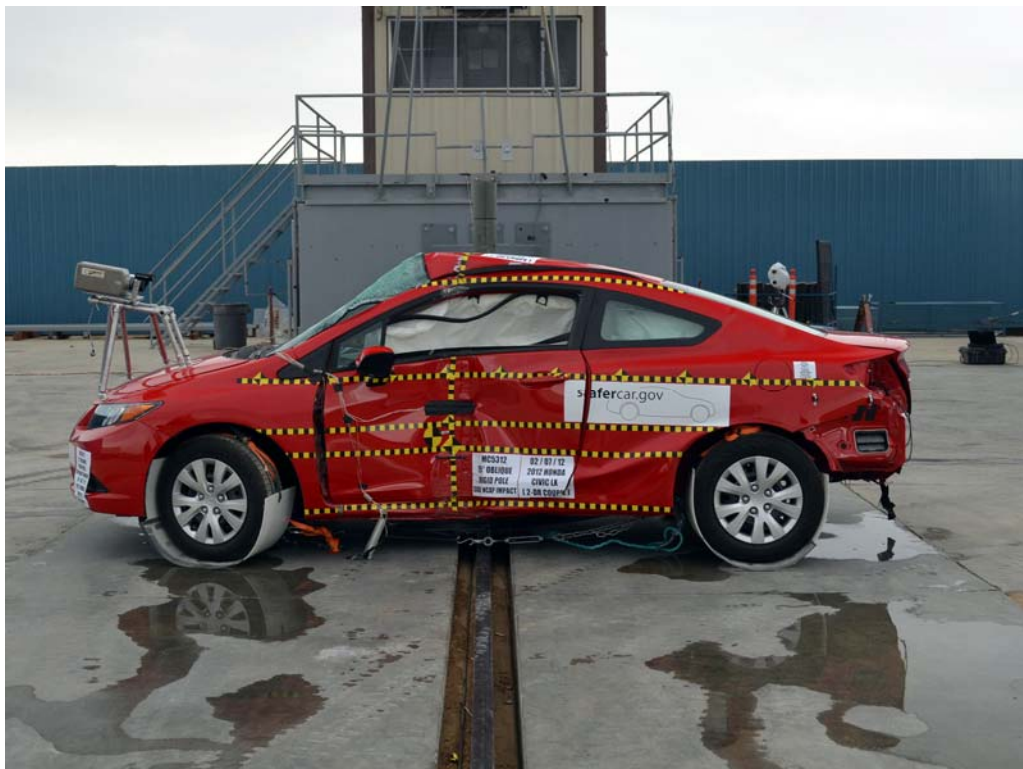
FIGURE 8. Post-Test Left Side View of Test Vehicle

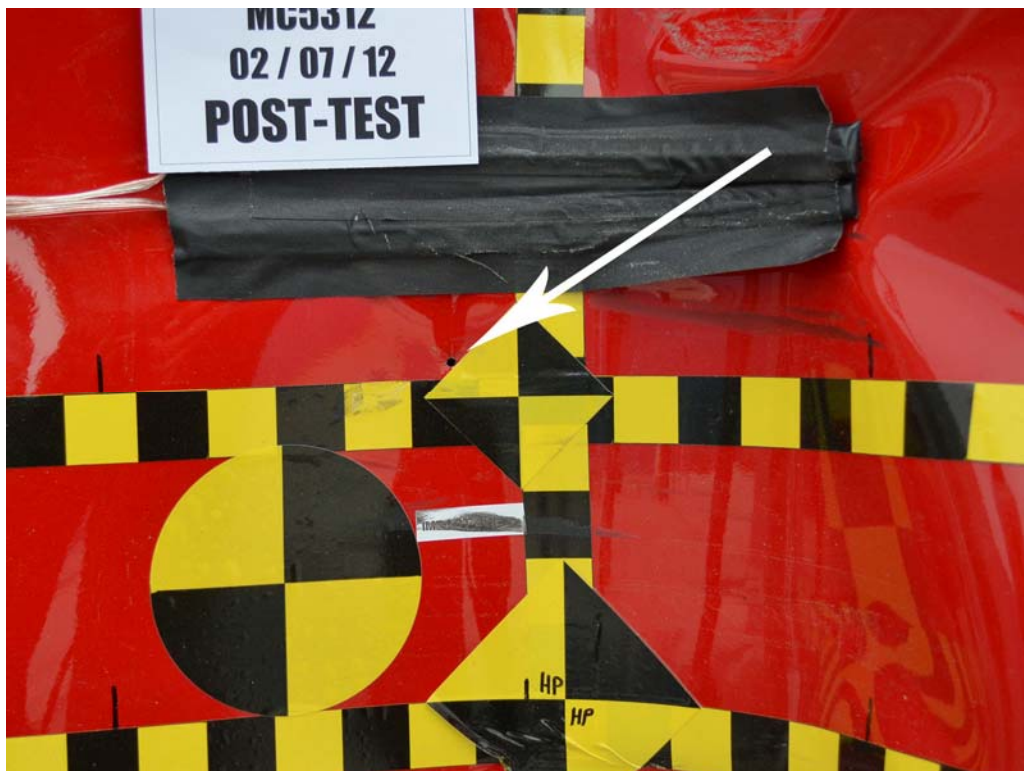
FIGURE 20. Post-Test Close-Up View of Impact Point Target Showing Impact Location

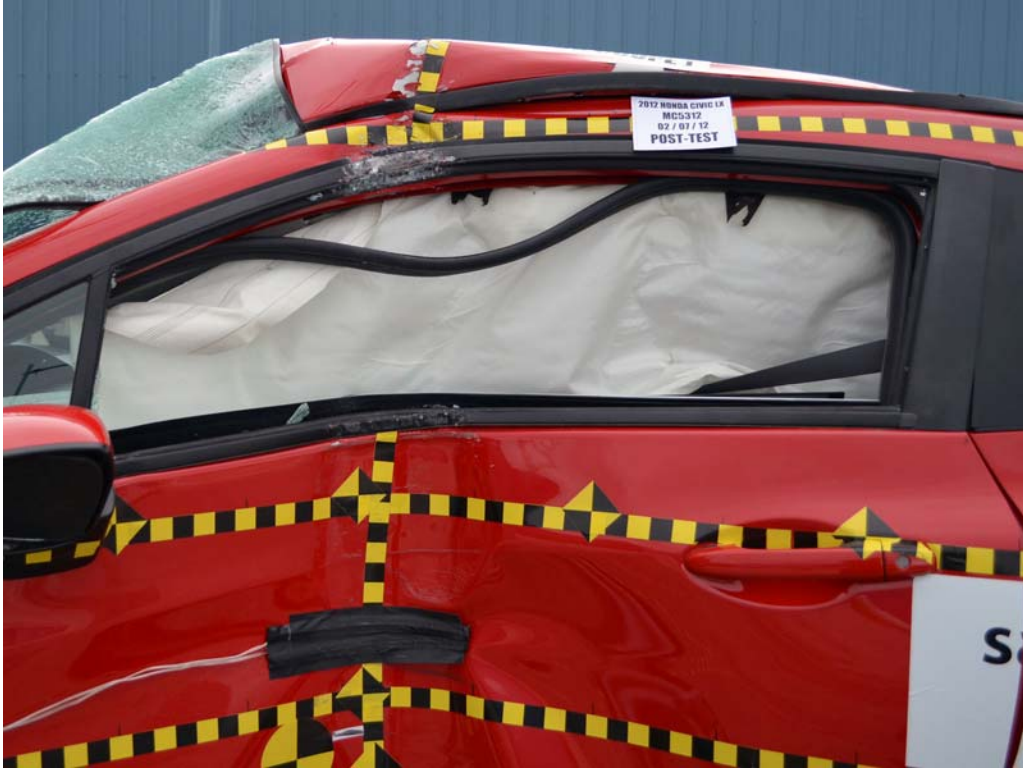
FIGURE 25. Post-Test Left Side View of Dummy Shoulder and Door Top View

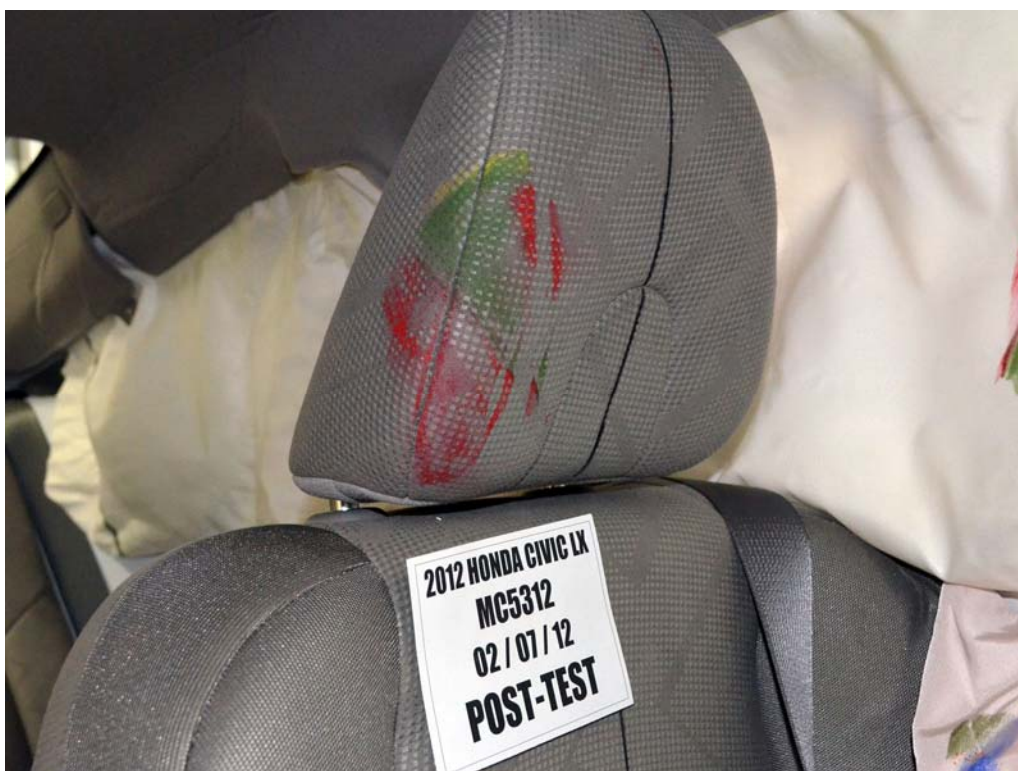
FIGURE 46. Post-Test Dummy Close-Up Head Contact with Vehicle Interior View

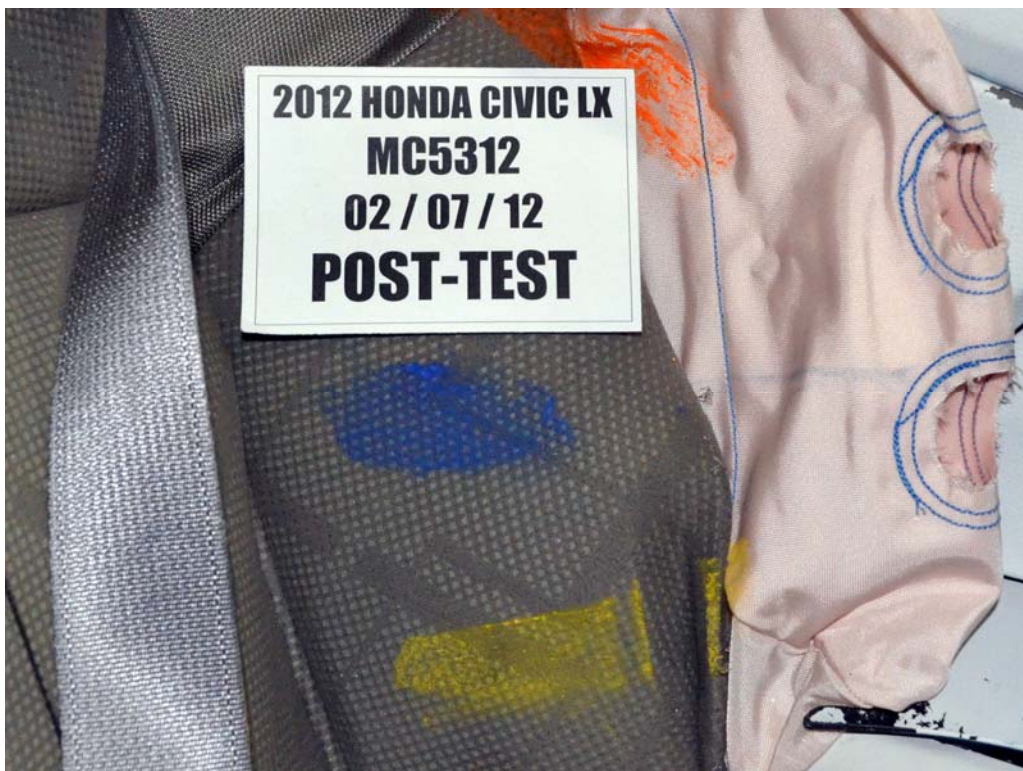
FIGURE 48. Post-Test Dummy Close-Up Torso Contact with Vehicle Interior View

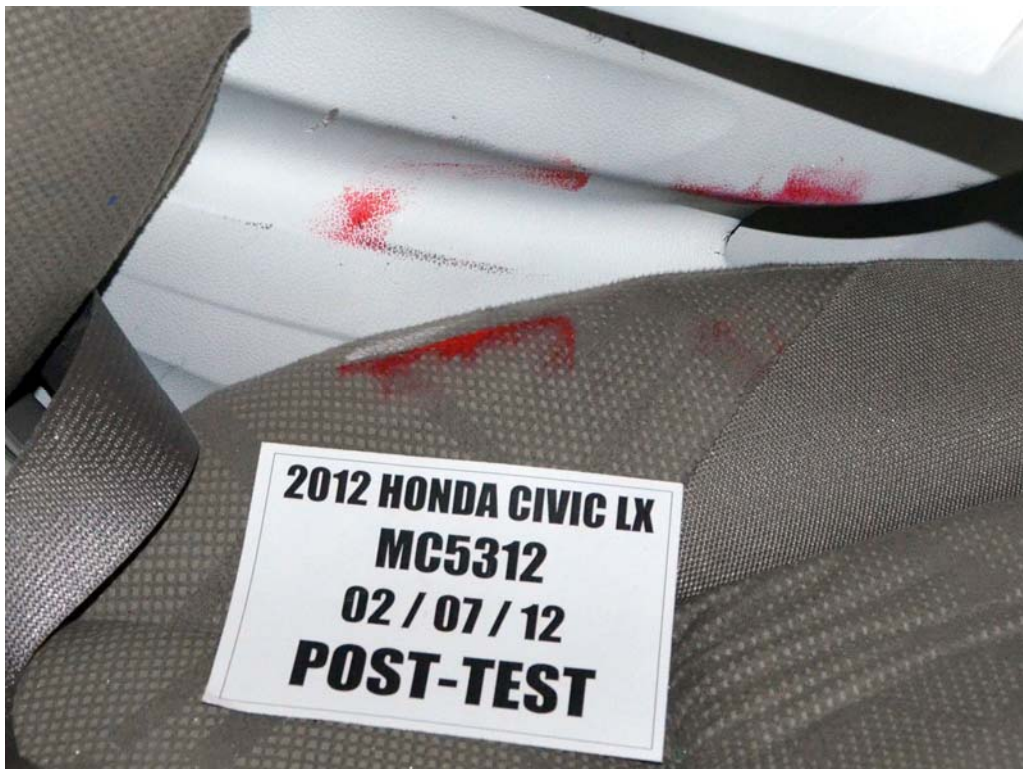
FIGURE 50. Post-Test Dummy Close-Up Pelvis Contact with Vehicle Interior View

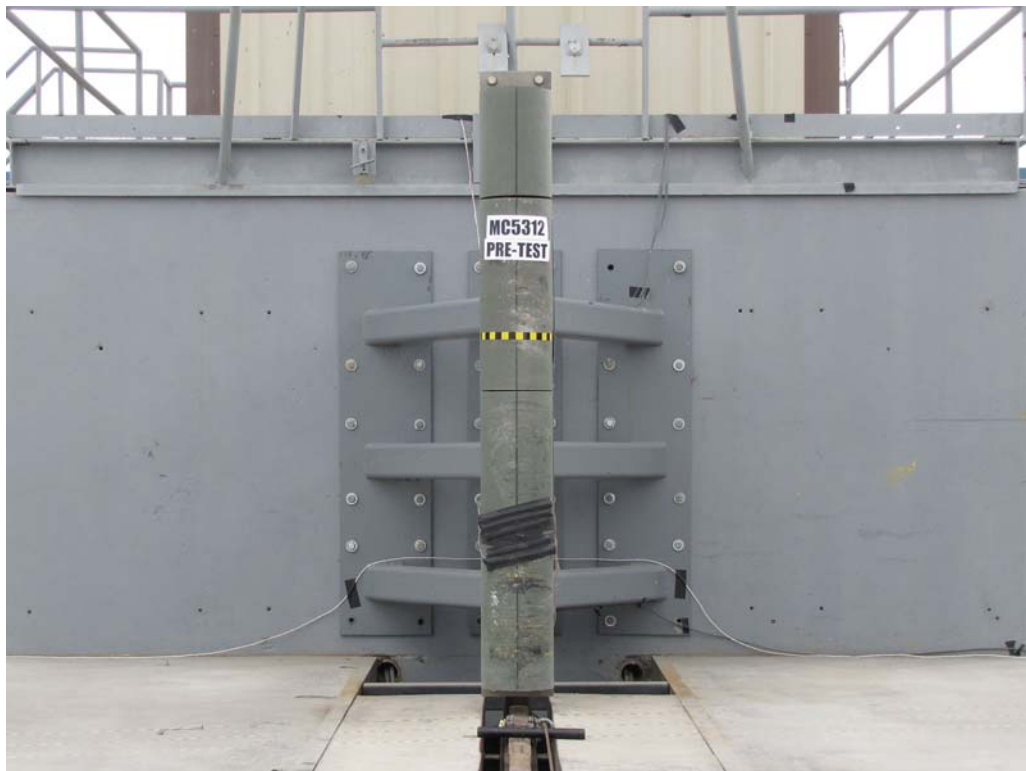
FIGURE 56. Pre-Test Pole Barrier Front View

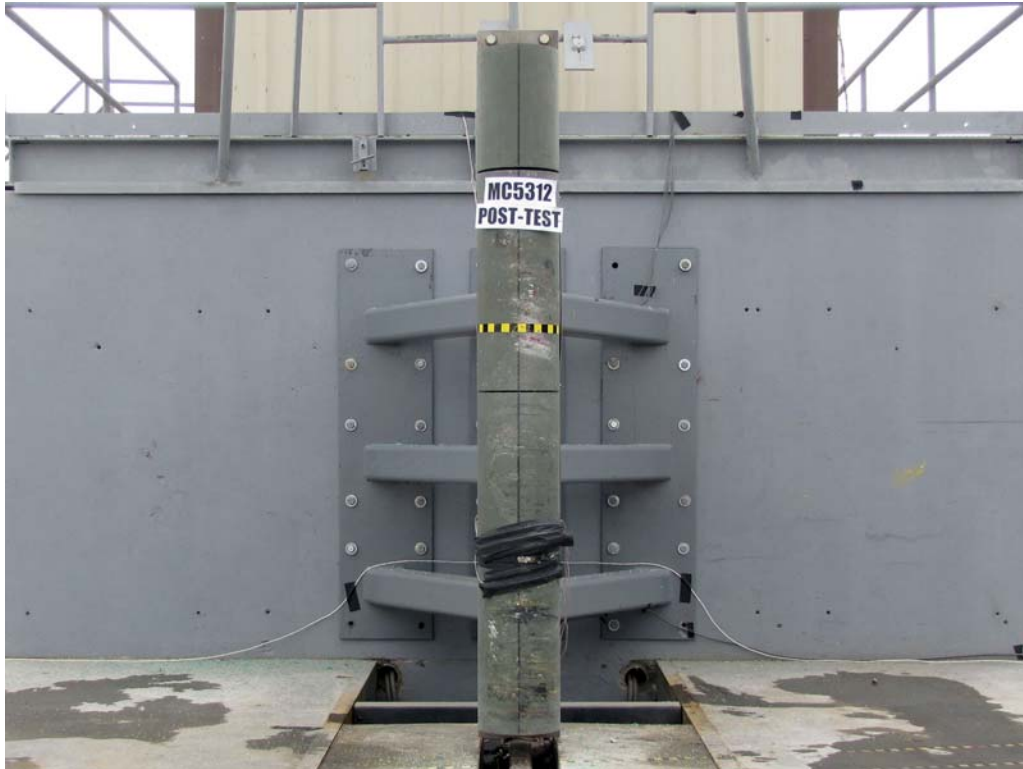
FIGURE 57. Post-Test Pole Barrier Front View

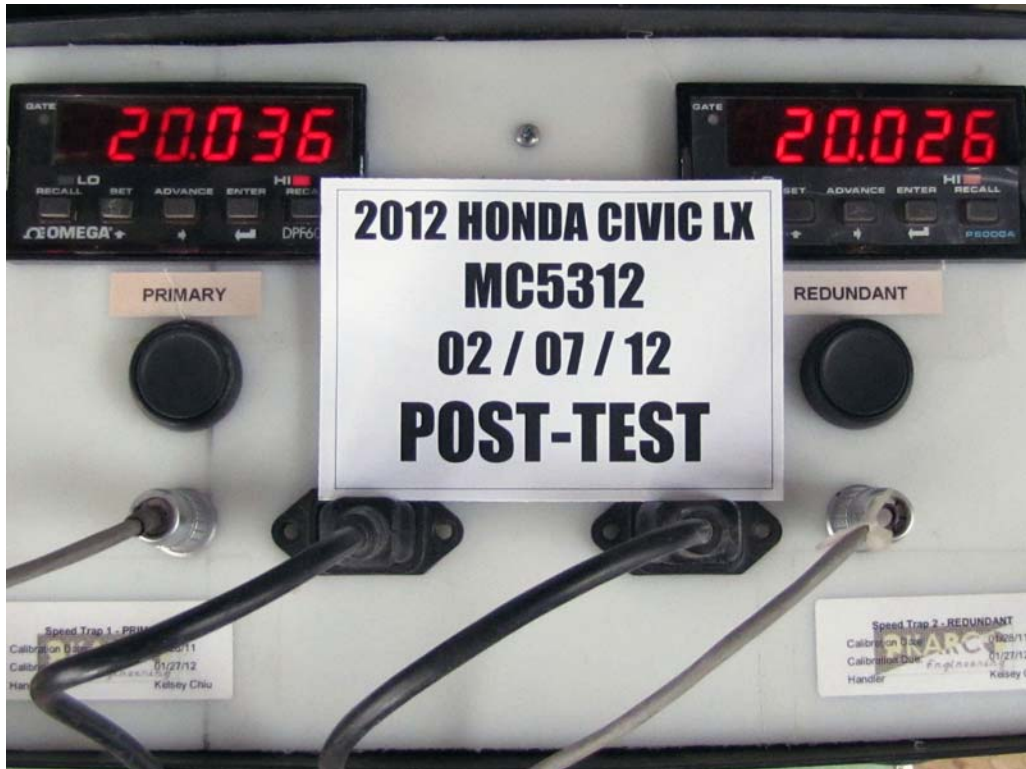
FIGURE 61. Post-Test Primary and Redundant Speed Trap Read-Out

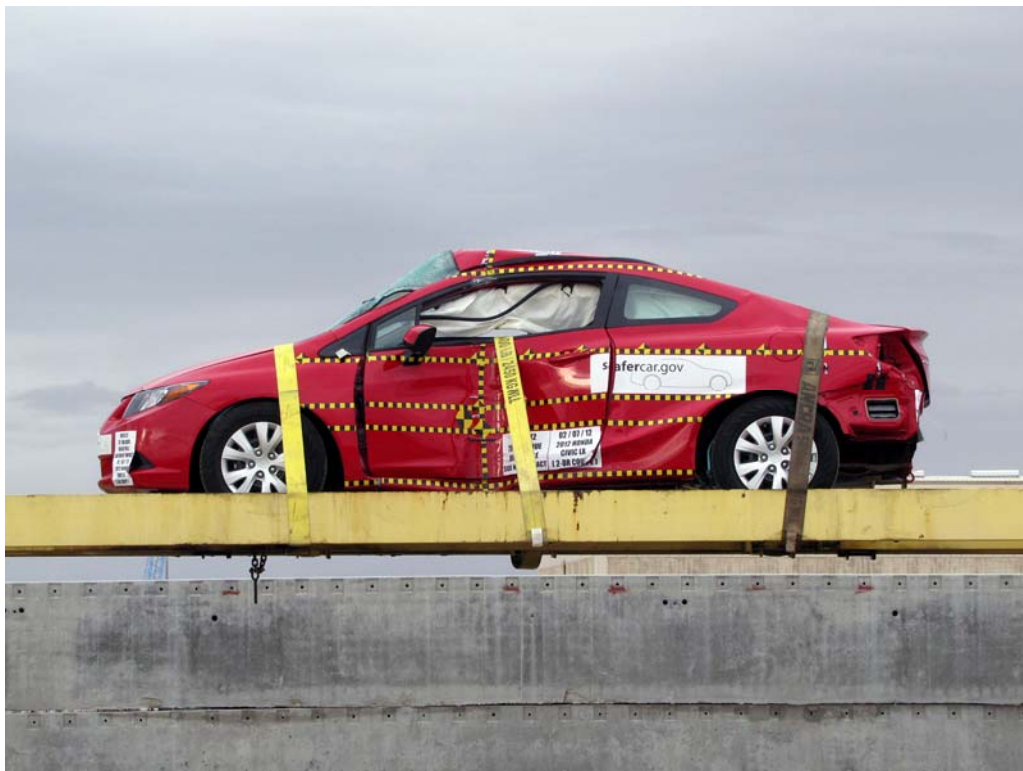
FIGURE 62. FMVSS No. 301-305 Rollover 0 Degrees
