REPORT NUMBER: SPNCAP-KAR-12-050

**NEW CAR ASSESSMENT PROGRAM (NCAP)
SIDE IMPACT POLE TEST**

**FORD MOTOR CO.
2012 FORD SUPERDUTY F-250 CREW CAB 4-DOOR TRUCK**

**PREPARED BY:
KARCO ENGINEERING, LLC.
9270 HOLLY ROAD
ADELANTO, CA 92301**

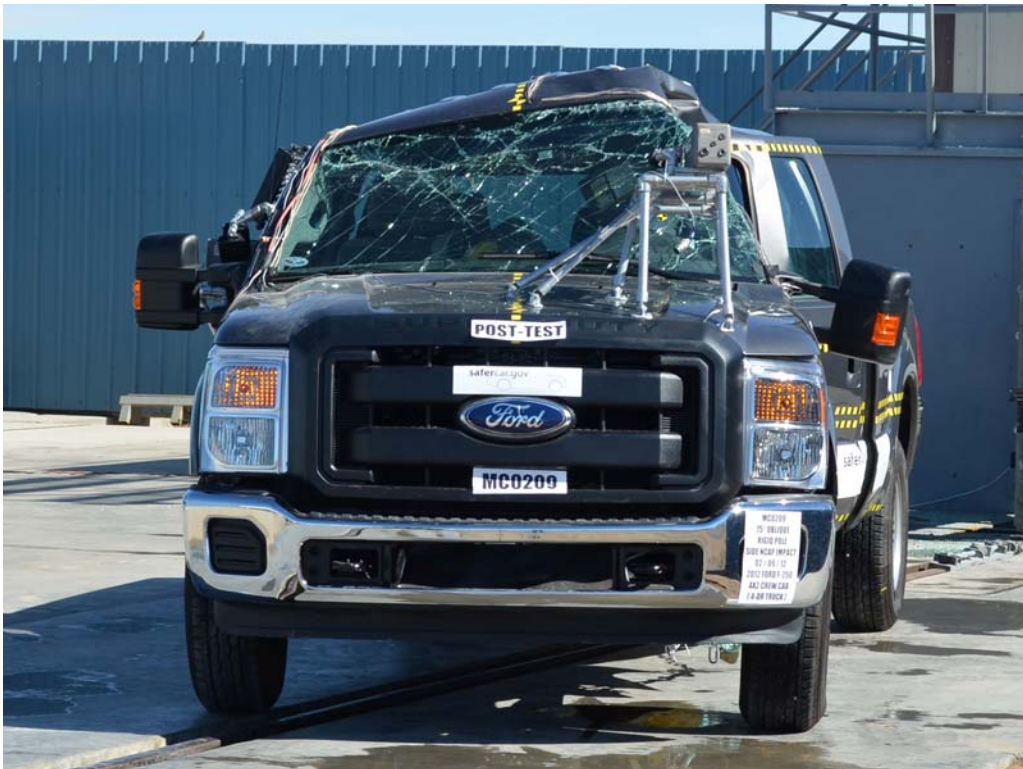
FIGURE 4. Post-Test Frontal View of Test Vehicle

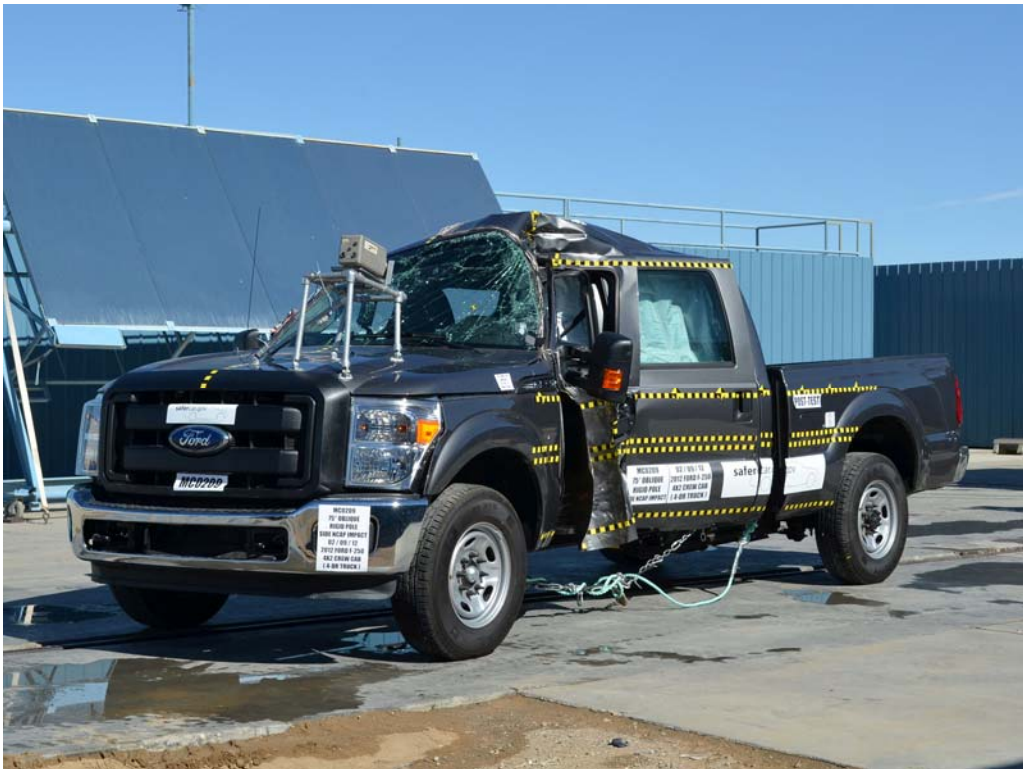
FIGURE 6. Post-Test Left Front $\frac{3}{4}$ View of Test Vehicle

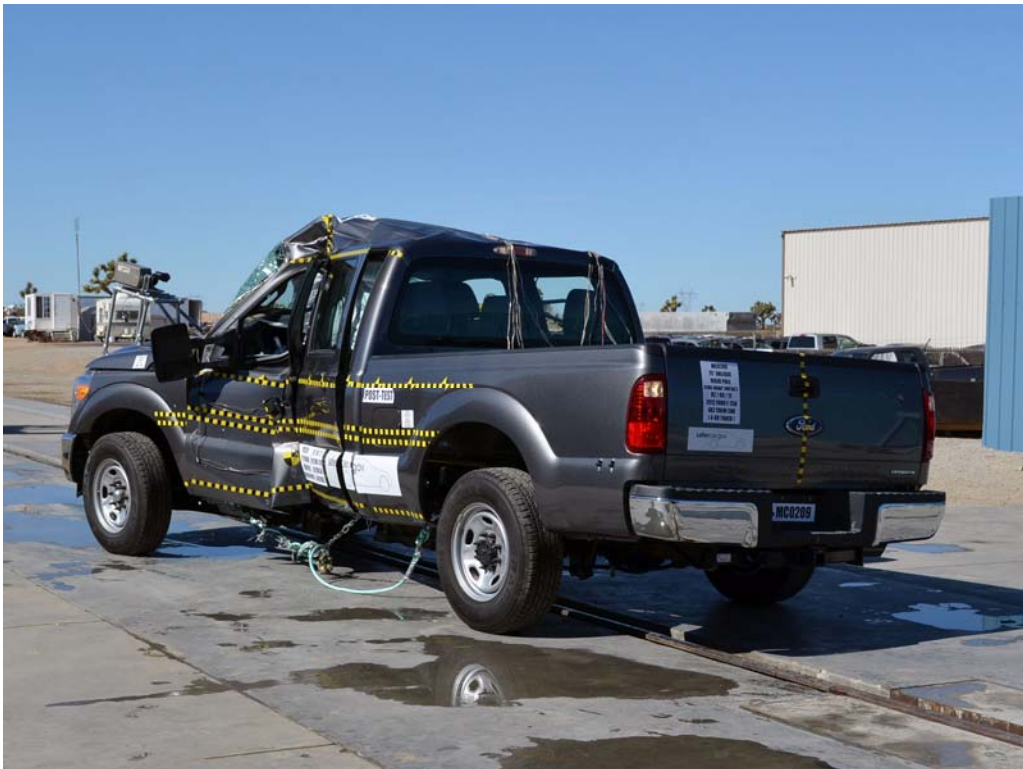
FIGURE 10. Post-Test Left Rear ¾ View of Test Vehicle

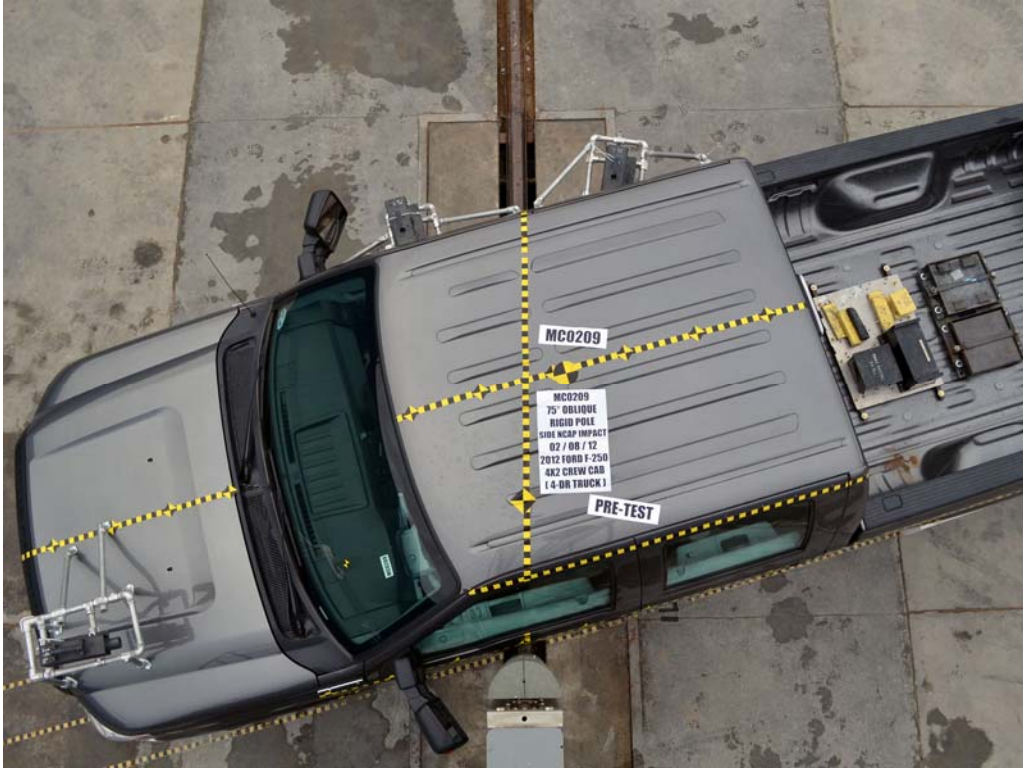
FIGURE 15. Pre-Test Overhead View of Test Vehicle and Pole

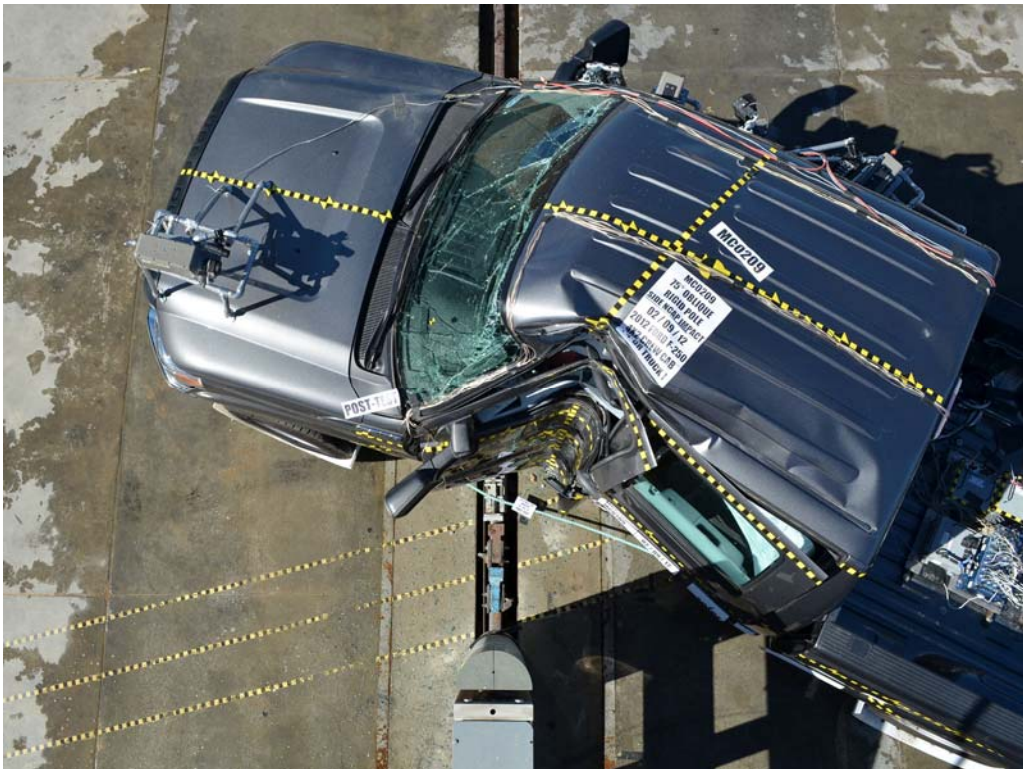
FIGURE 16. Post-Test Overhead View of Test Vehicle and Pole

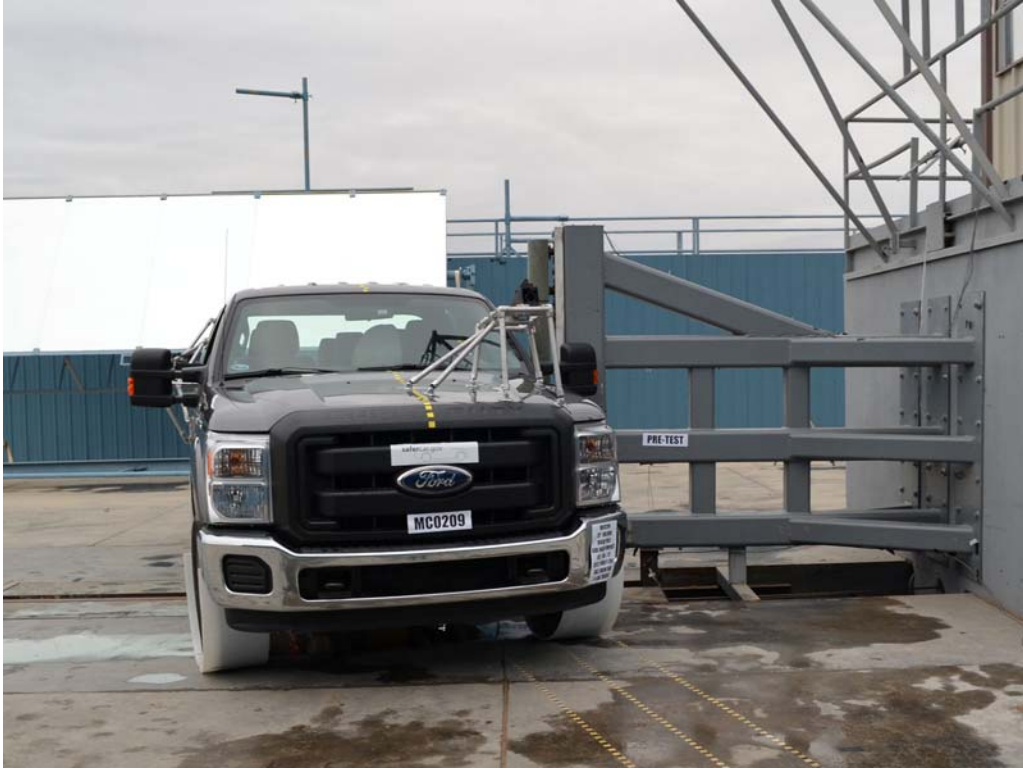
FIGURE 17. Pre-Test Left Side View of Pole
Positioned Against Side of Vehicle at Impact Point

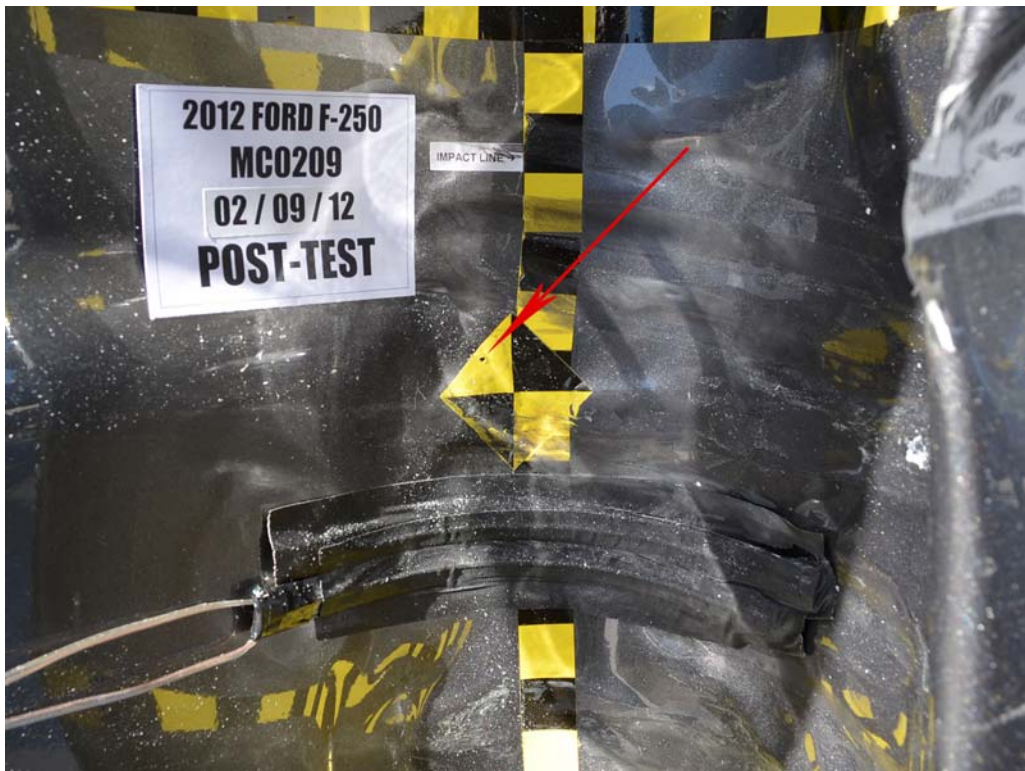
FIGURE 20. Post-Test Close-Up View of Impact Point Target Showing Impact Location

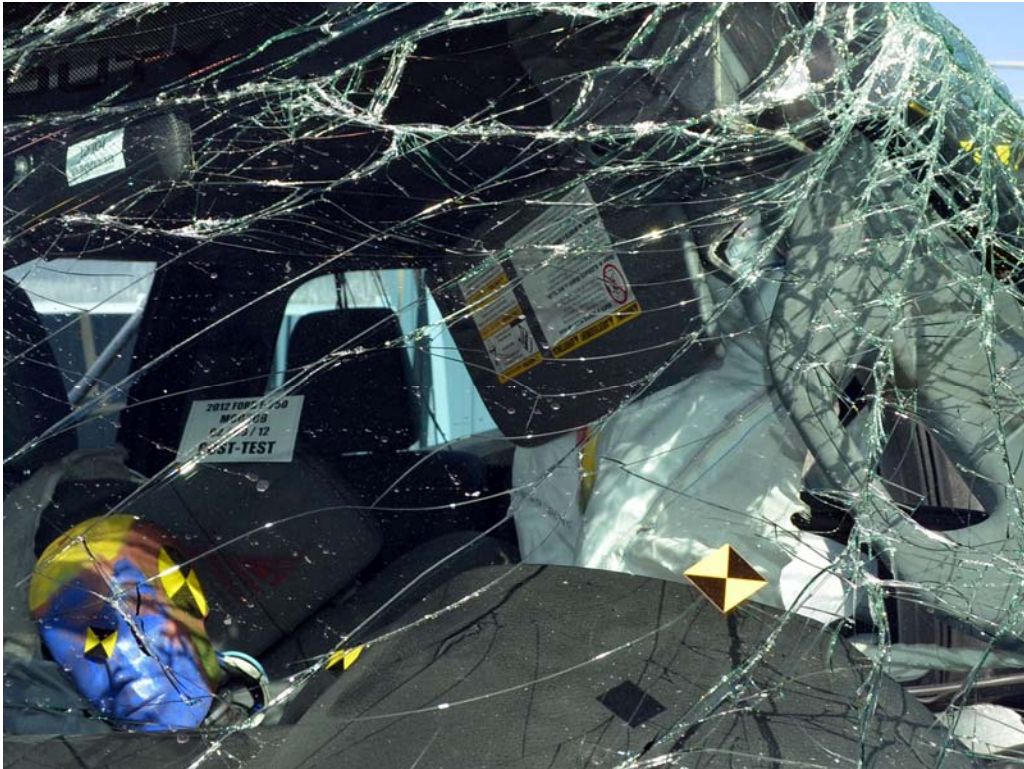
FIGURE 22. Post-Test Front Close-Up View of Dummy

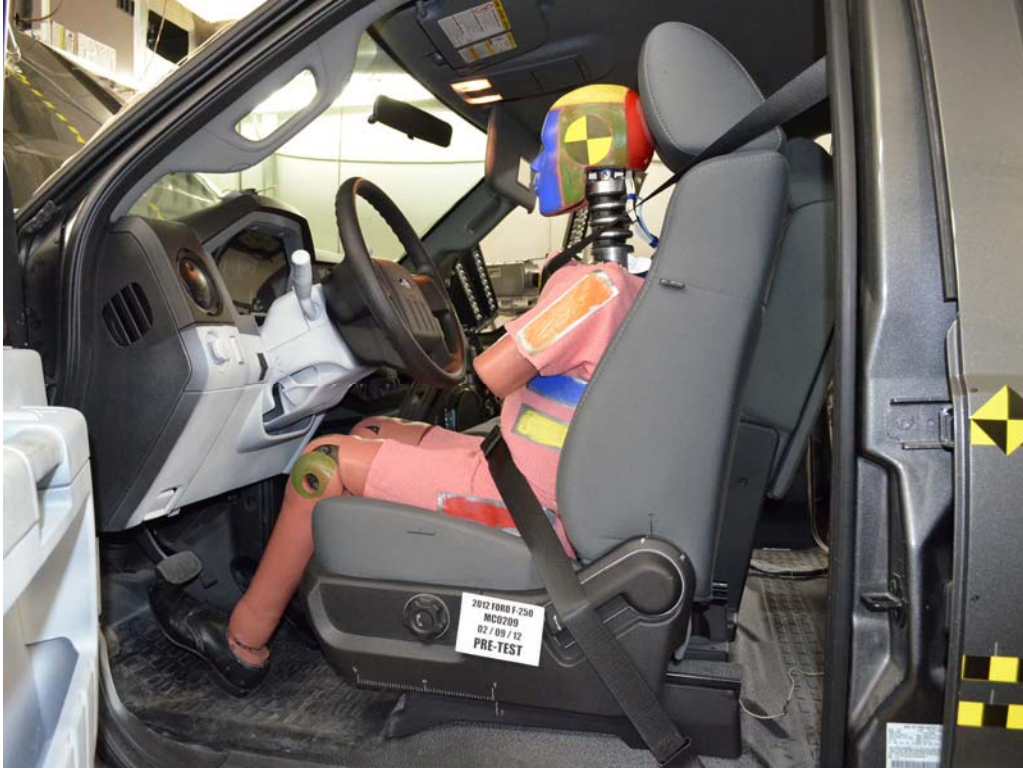
FIGURE 23. Pre-Test Left Side View of Dummy Showing Belt, Chalking, and Contact Switches

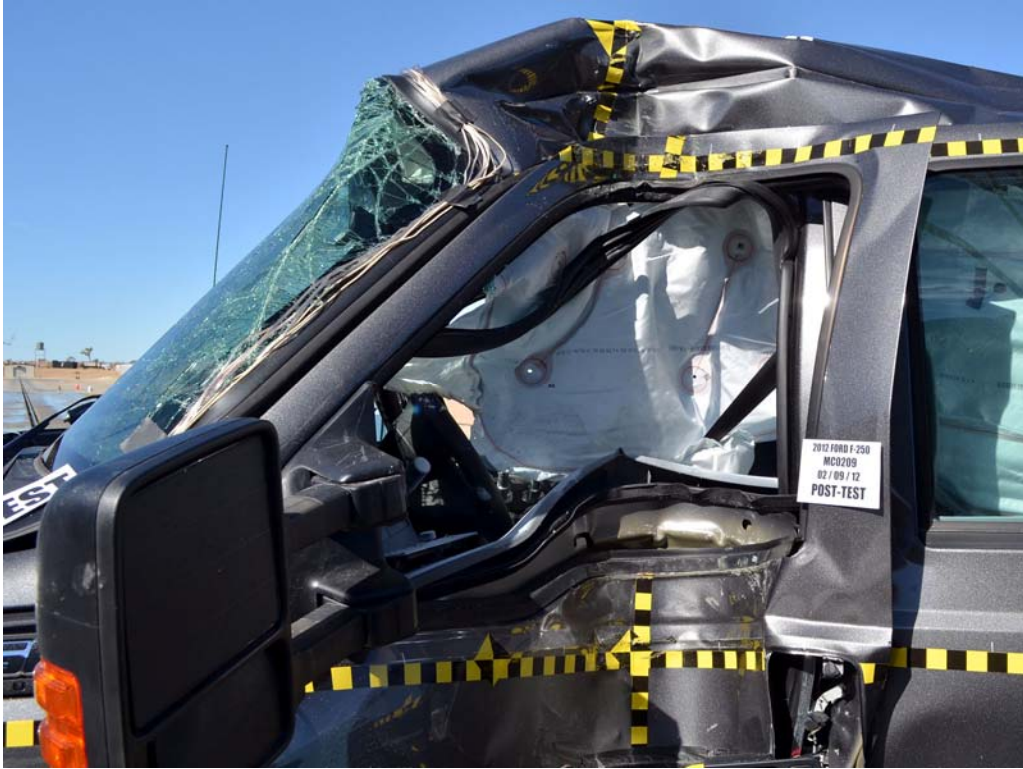
FIGURE 25. Post-Test Left Side View of Dummy Shoulder and Door Top View

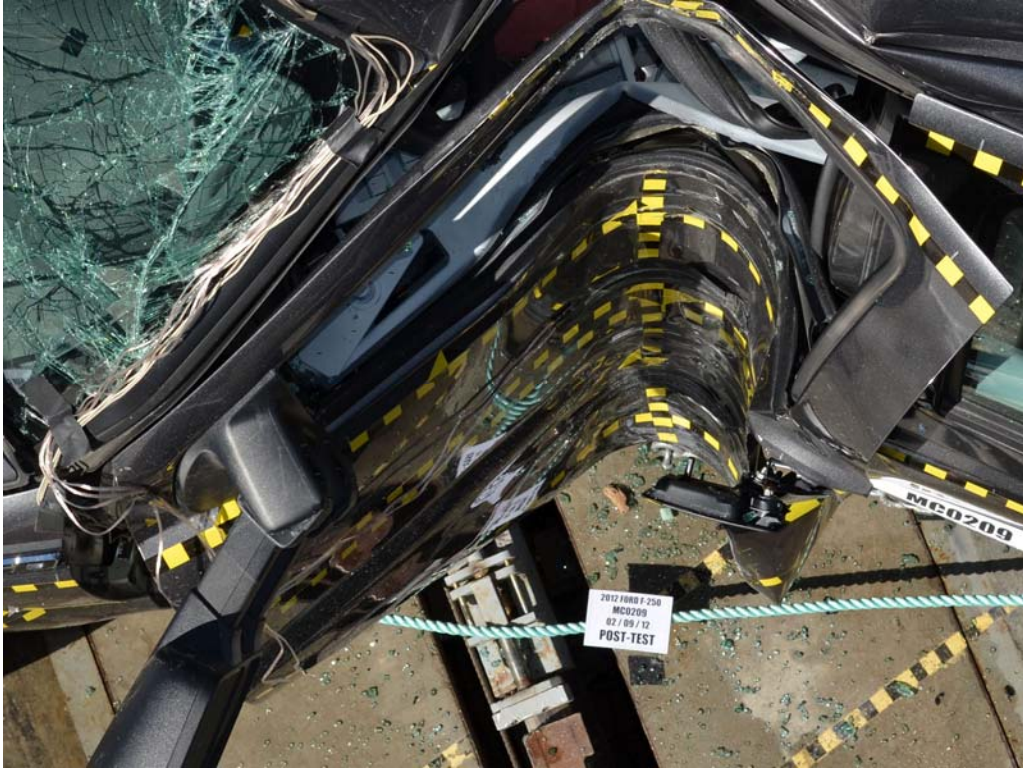
FIGURE 41. Post-Test Driver Dummy and Door Clearance

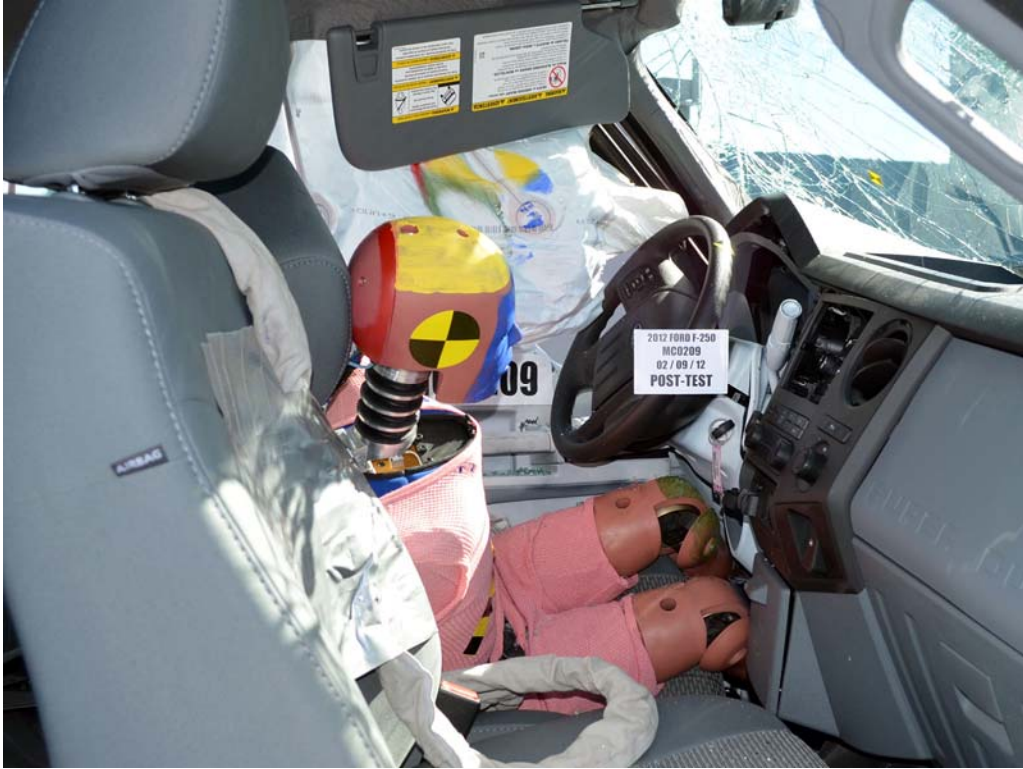
FIGURE 43. Post-Test Right Side View of Dummy and Front Seat Occupant Compartment

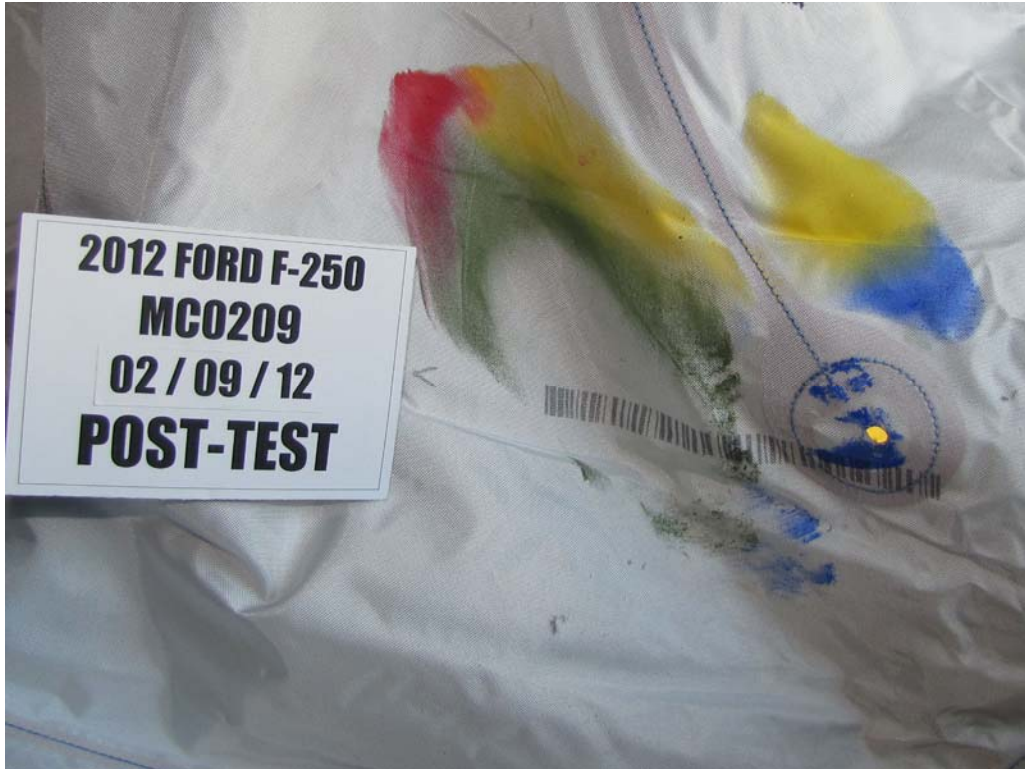
FIGURE 47. Post-Test Dummy Close-Up Head Contact with Side Airbag View

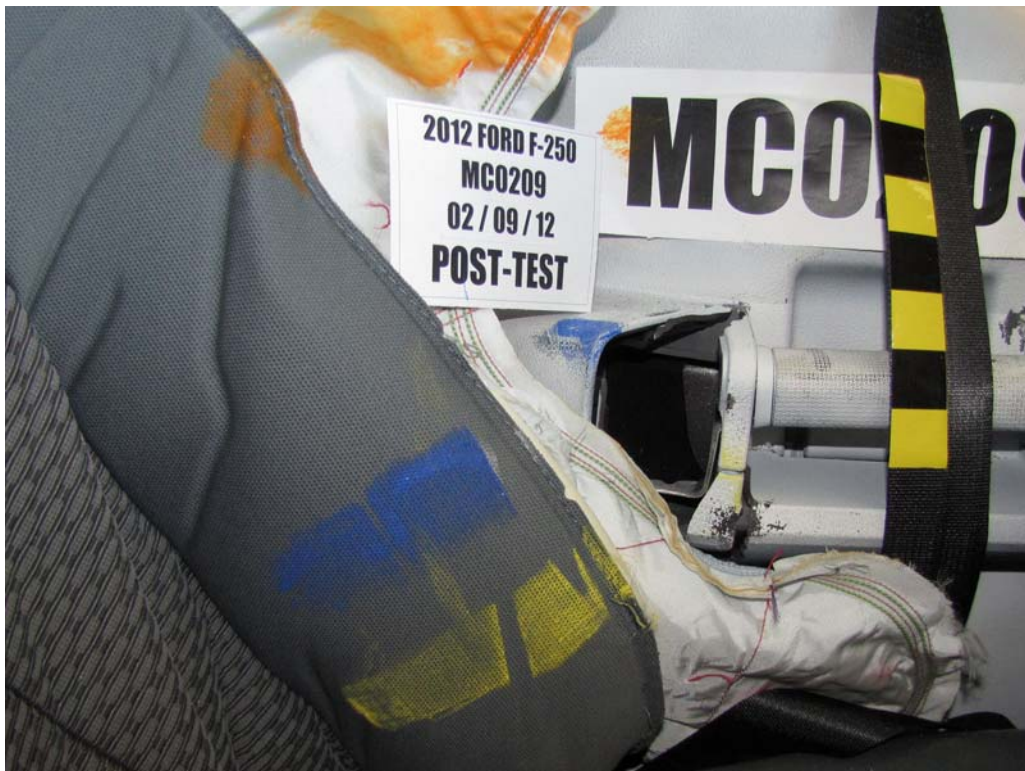
FIGURE 48. Post-Test Dummy Close-Up Torso Contact with Vehicle Interior View

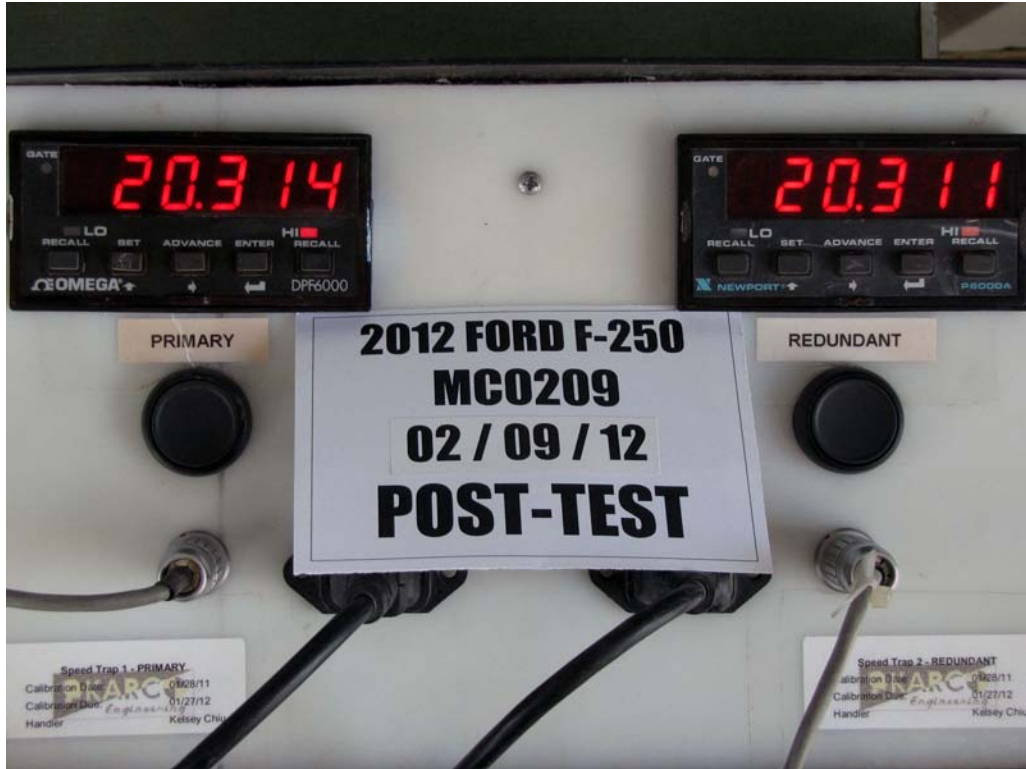
FIGURE 61. Post-Test Primary and Redundant Speed Trap Read-Out

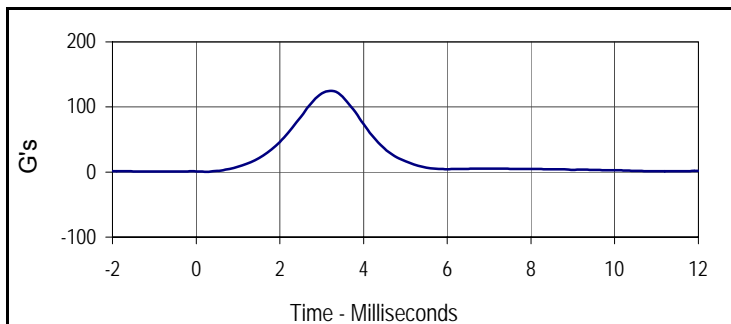
Curve Description			
Head Resultant			
Plot No.	Type	SAE Class	Units
001	RES	1000	G's
Max	Time	Min	Time
124.9	3.2	0.3	0.2

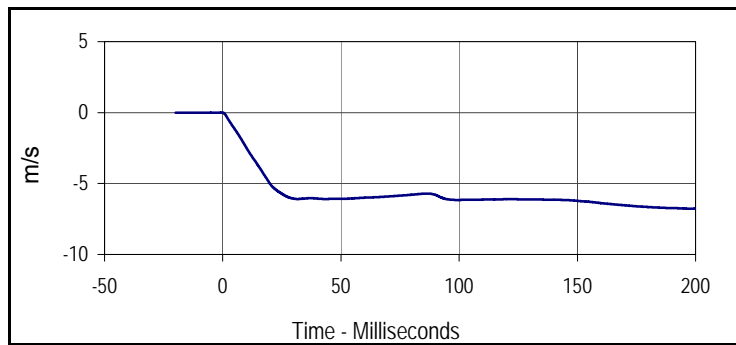
Curve Description			
Pendulum Velocity			
Plot No.	Type	SAE Class	Units
001	FIL	180	m/s
Max	Time	Min	Time
0.0	-0.6	-6.8	200.0

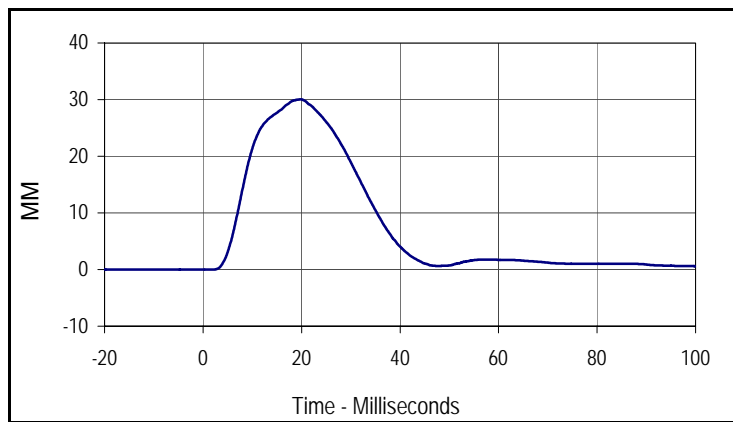
Curve Description			
Shoulder Deflection			
Plot No.	Type	SAE Class	Units
001	FIL	600	MM
Max	Time	Min	Time
30.0	19.8	0.0	-5.1

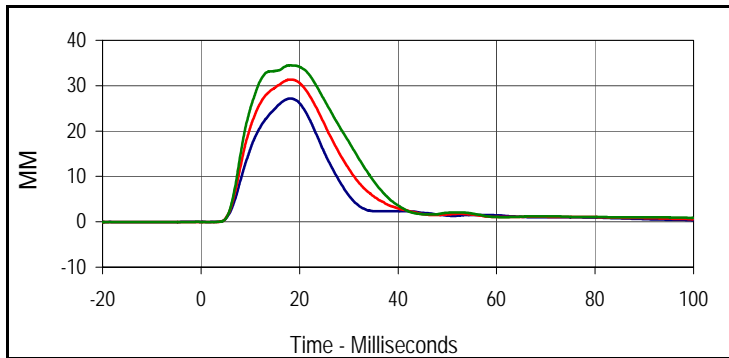
Curve Description			
Upper Thorax Deflection			
Plot No.	Type	SAE Class	Units
001	FIL	600	MM
Max	Time	Min	Time
27.2	18.2	0.0	-6.3
Middle Thorax Deflection			
Max	Time	Min	Time
31.4	18.2	-0.1	-16.9
Lower Thorax Deflection			
Max	Time	Min	Time
34.5	18.1	0.0	-11.3

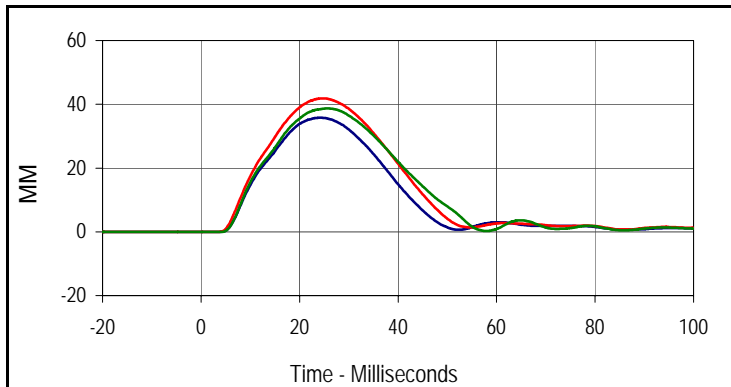
Curve Description			
Upper Thorax Deflection			
Plot No.	Type	SAE Class	Units
001	FIL	600	MM
Max	Time	Min	Time
35.8	24.1	0.0	-7.2
Middle Thorax Deflection			
Max	Time	Min	Time
41.9	24.7	0.0	-8.2
Lower Thorax Deflection			
Max	Time	Min	Time
38.7	25.6	0.0	-6.1

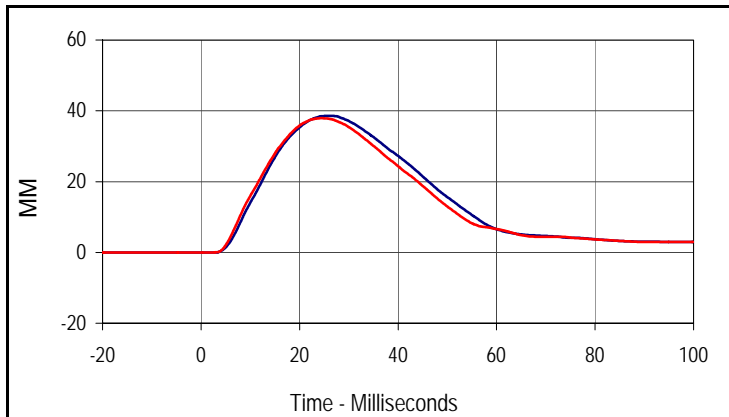
Curve Description			
Upper Abdominal Rib Deflection			
Plot No.	Type	SAE Class	Units
001	FIL	600	MM
Max	Time	Min	Time
38.6	26.1	0.0	-5.8
Curve Description			
Lower Abdominal Rib Deflection			
Plot No.	Type	SAE Class	Units
002	FIL	600	MM
Max	Time	Min	Time
37.9	24.5	0.0	-9.8

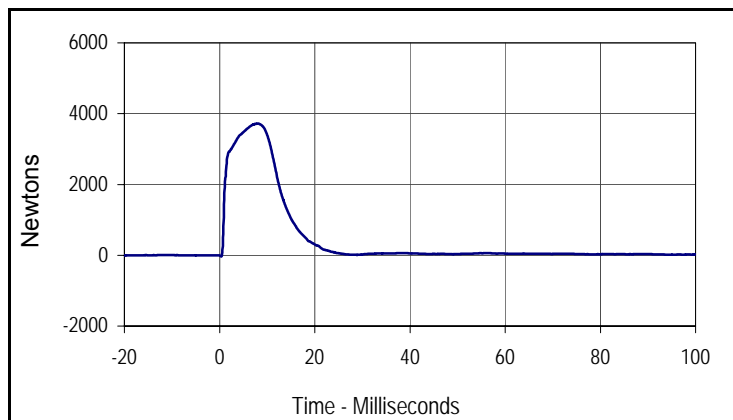
Curve Description			
Pelvis Acetabulum Force			
Plot No.	Type	SAE Class	Units
001	FIL	600	Newtons
Max	Time	Min	Time
3721.4	8.0	-31.3	0.4

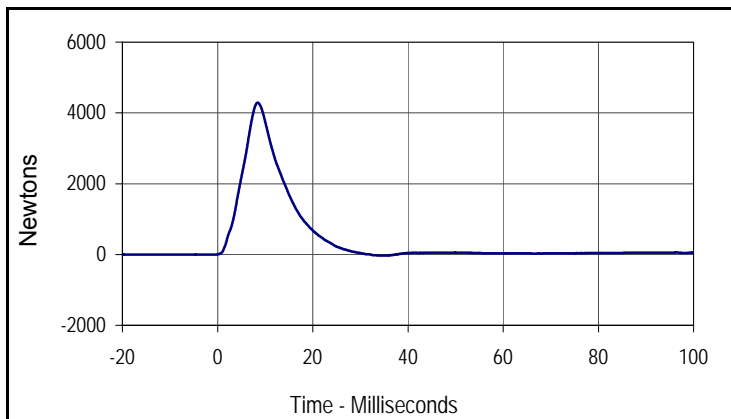
Curve Description			
Pelvis Iliac Force			
Plot No.	Type	SAE Class	Units
001	FIL	600	Newtons
Max	Time	Min	Time
4288.2	8.4	-32.7	35.1

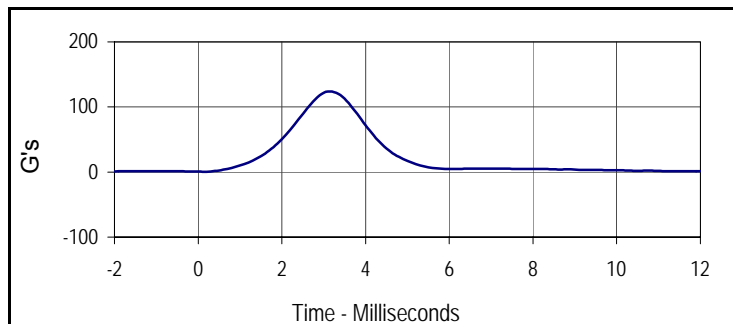
Curve Description			
Head Resultant			
Plot No.	Type	SAE Class	Units
001	RES	1000	G's
Max	Time	Min	Time
123.9	3.2	0.3	0.1

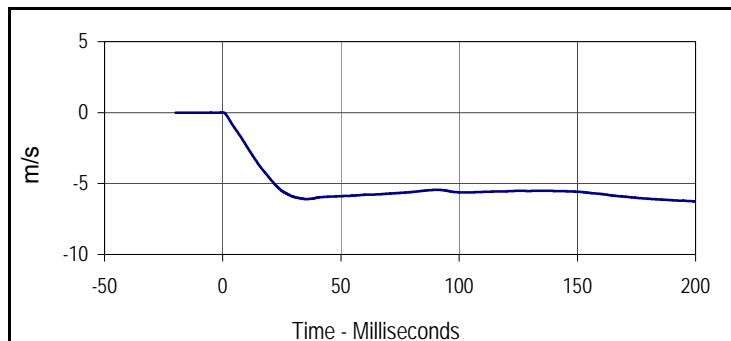
Curve Description			
Pendulum Velocity			
Plot No.	Type	SAE Class	Units
001	FIL	180	m/s
Max	Time	Min	Time
0.0	-0.2	-6.3	200.0

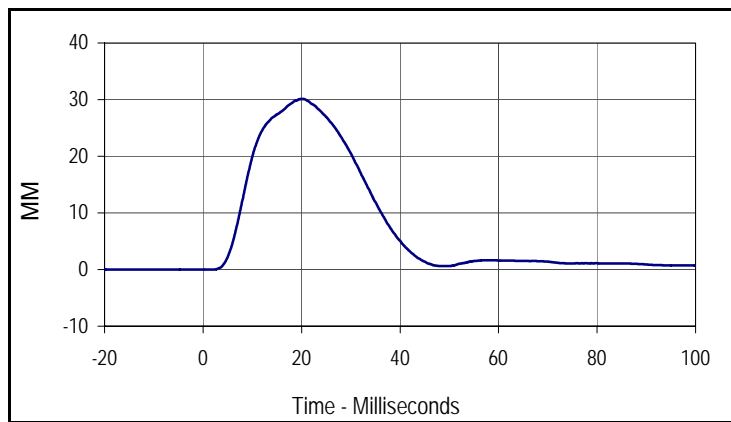
Curve Description			
Shoulder Deflection			
Plot No.	Type	SAE Class	Units
001	FIL	600	MM
Max	Time	Min	Time
30.1	20.1	0.0	-17.6

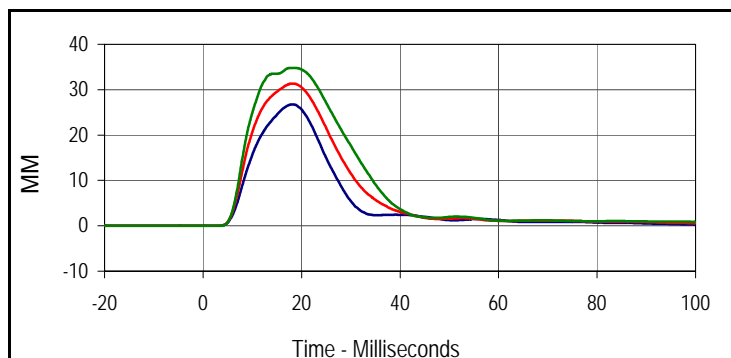
Curve Description			
Upper Thorax Deflection			
Plot No.	Type	SAE Class	Units
001	FIL	600	MM
Max	Time	Min	Time
26.7	18.1	0.0	-5.7
Middle Thorax Deflection			
Max	Time	Min	Time
31.3	18.2	0.0	-6.0
Lower Thorax Deflection			
Max	Time	Min	Time
34.8	17.9	0.0	-6.1

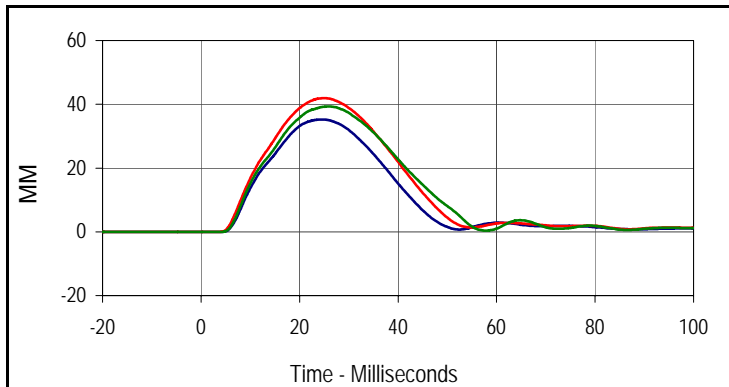
Curve Description			
Upper Thorax Deflection			
Plot No.	Type	SAE Class	Units
001	FIL	600	MM
Max	Time	Min	Time
35.2	24.7	0.0	-3.5
Middle Thorax Deflection			
Max	Time	Min	Time
41.9	25.2	0.0	1.3
Lower Thorax Deflection			
Max	Time	Min	Time
39.4	25.9	0.0	3.5

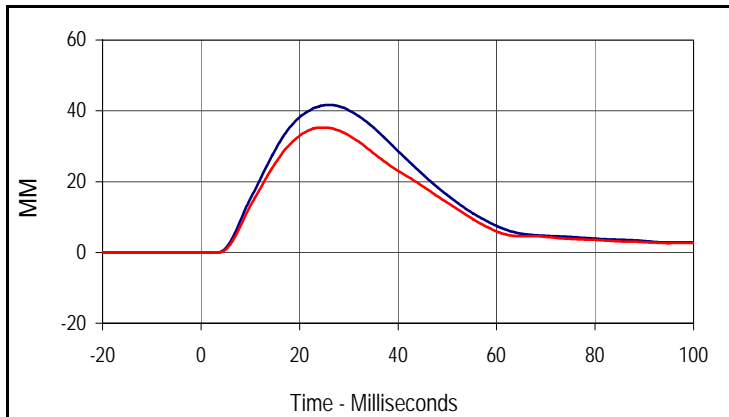
Curve Description			
Upper Abdominal Rib Deflection			
Plot No.	Type	SAE Class	Units
001	FIL	600	MM
Max	Time	Min	Time
41.7	25.9	0.0	-17.7
Curve Description			
Lower Abdominal Rib Deflection			
Plot No.	Type	SAE Class	Units
002	FIL	600	MM
Max	Time	Min	Time
35.2	24.4	0.0	-17.7

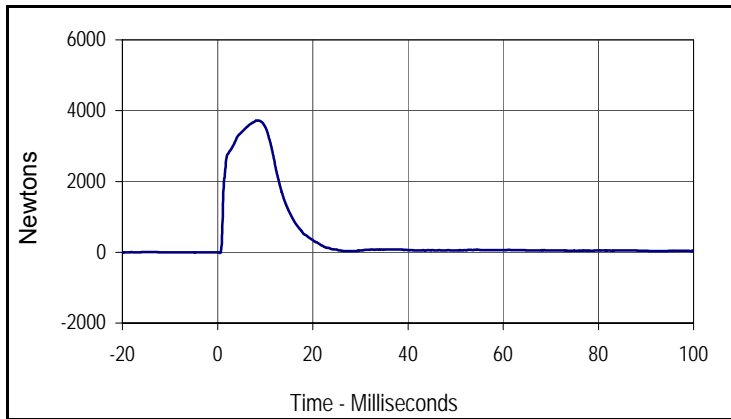
Curve Description			
Pelvis Acetabulum Force			
Plot No.	Type	SAE Class	Units
001	FIL	600	Newtons
Max	Time	Min	Time
3720.7	8.4	-23.7	0.6

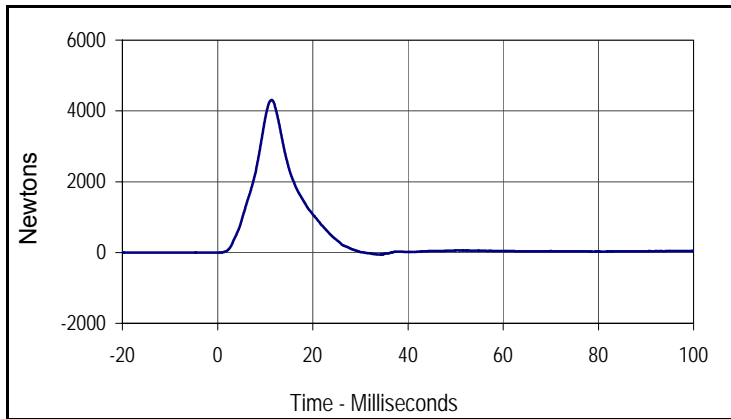
Curve Description			
Pelvis Iliac Force			
Plot No.	Type	SAE Class	Units
001	FIL	600	Newtons
Max	Time	Min	Time
4307.9	11.3	-58.5	34.4
