**REPORT NUMBER: SINCAP-MGA-2012-059**

**NEW CAR ASSESSMENT PROGRAM (NCAP)  
Moving Deformable Barrier Side Impact Test**

**HONDA MOTOR CO., LTD  
2012 Honda Civic IMA 4-Dr Sedan  
NHTSA No.: MC5301**

**FINAL REPORT**

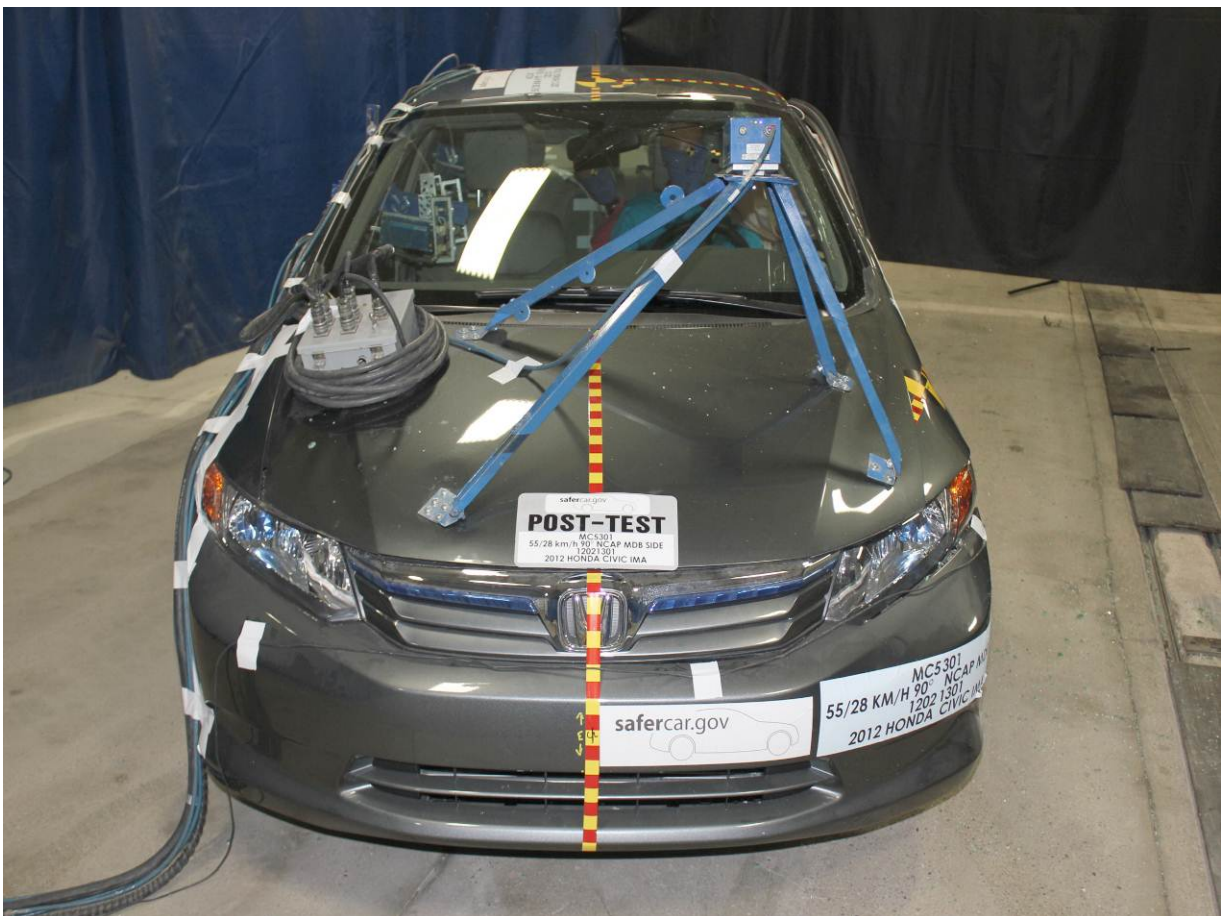
Post-Test Frontal View of Test Vehicle

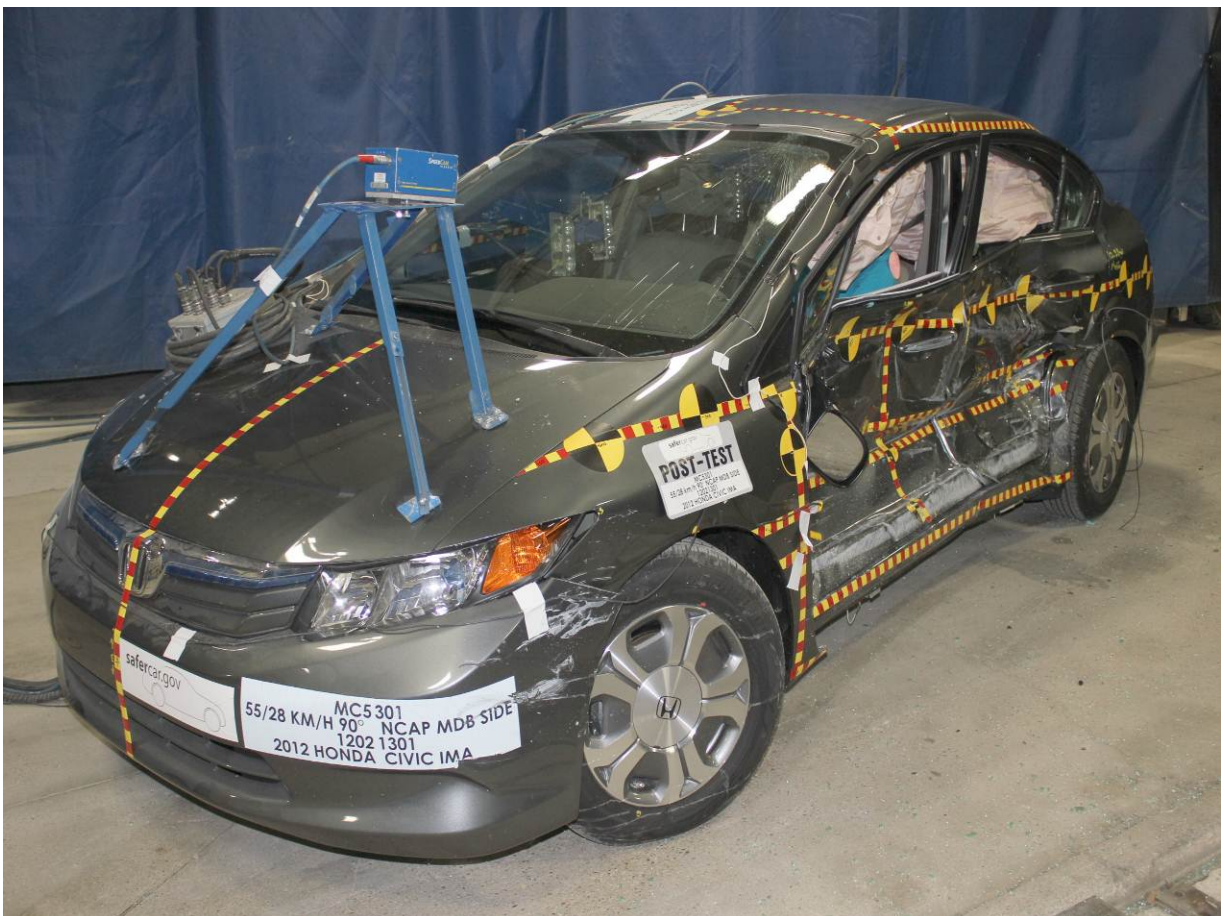
Post-Test Left Front Three-Quarter View of Test Vehicle

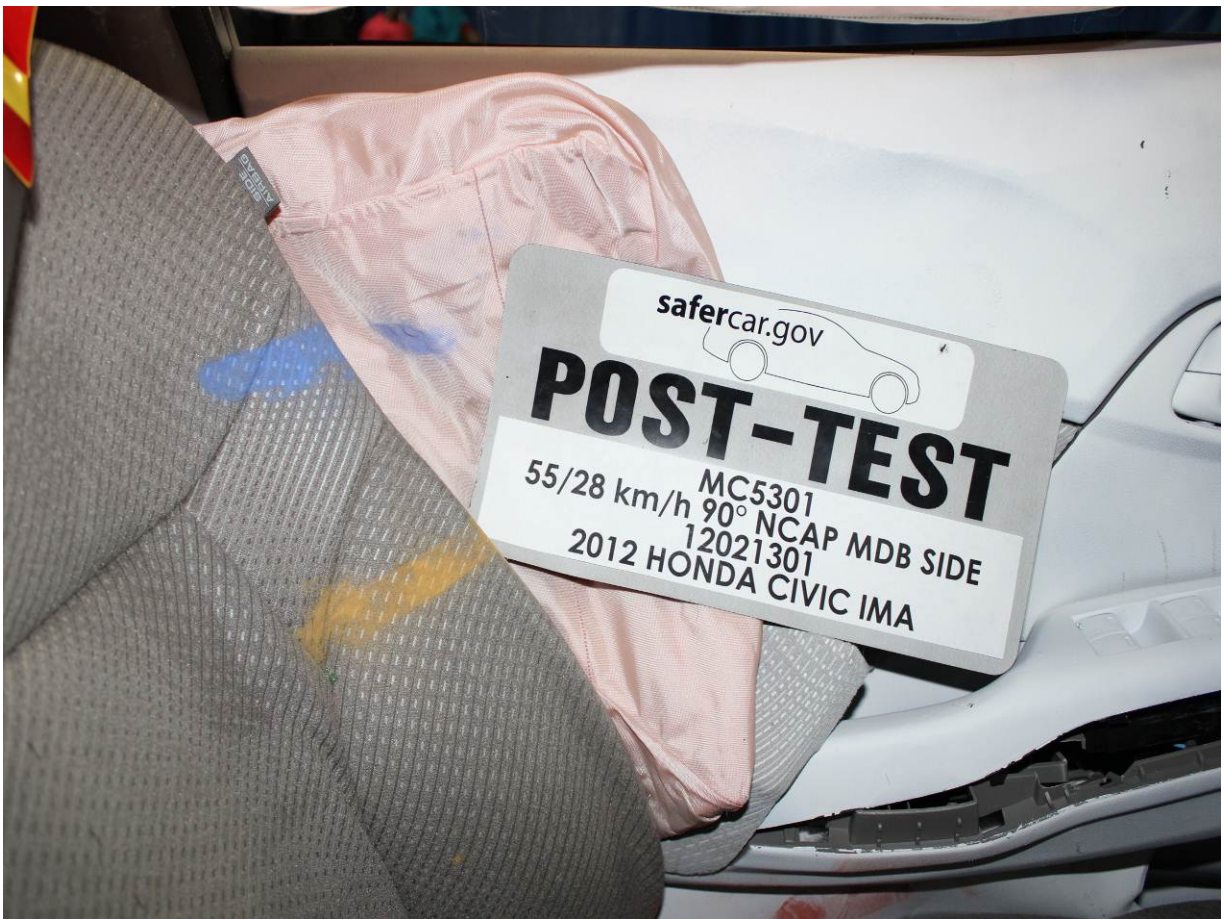
Post-Test Driver Dummy Close-up Head Contact with Side Airbag View

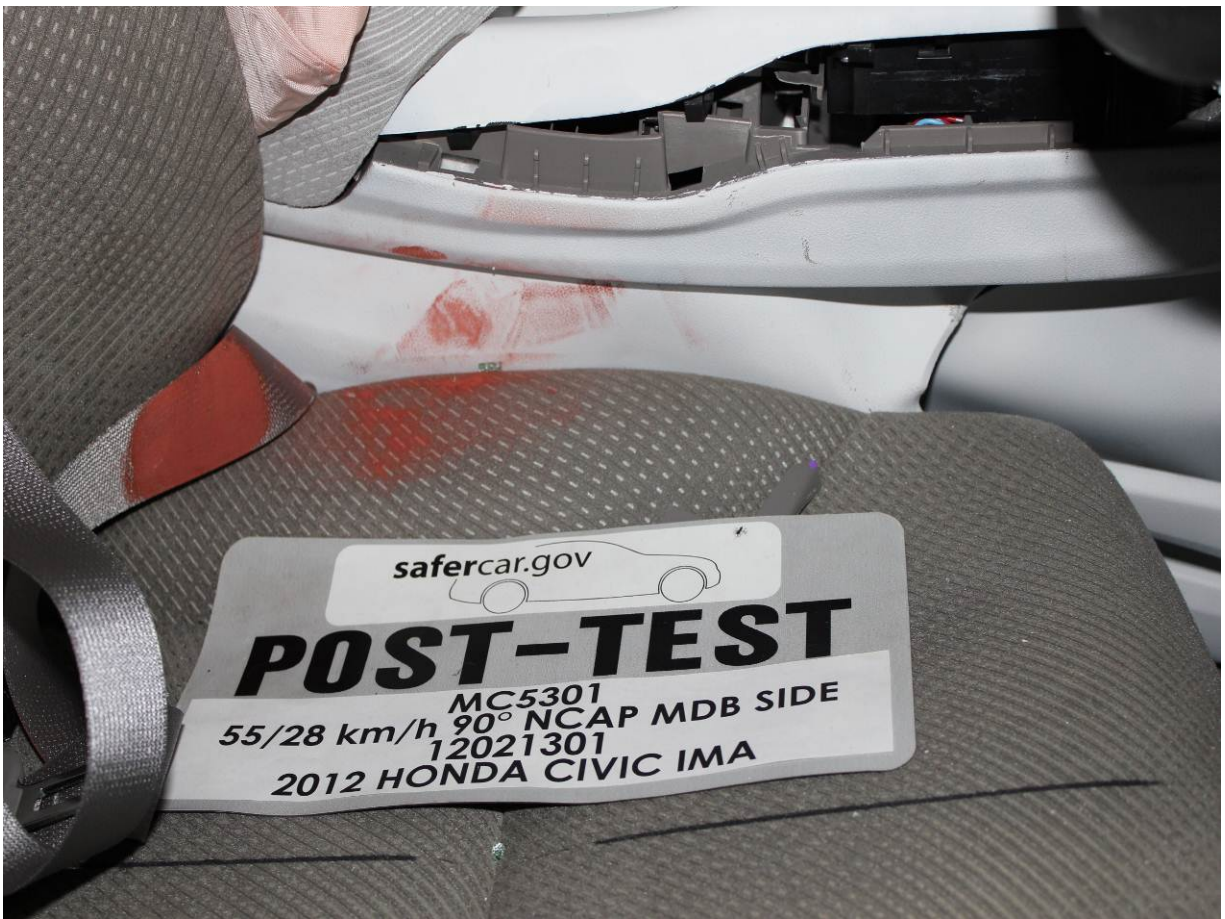
Post-Test Driver Dummy Close-up Torso Contact with Side Airbag View
