**REPORT NUMBER: SINCAP-MGA-2012-061**

**NEW CAR ASSESSMENT PROGRAM (NCAP)  
Moving Deformable Barrier Side Impact Test**

**FUJI HEAVY INDUSTRIES LTD.  
2012 Subaru Impreza 4-Dr Sedan  
NHTSA No.: MC5504**

**FINAL REPORT**

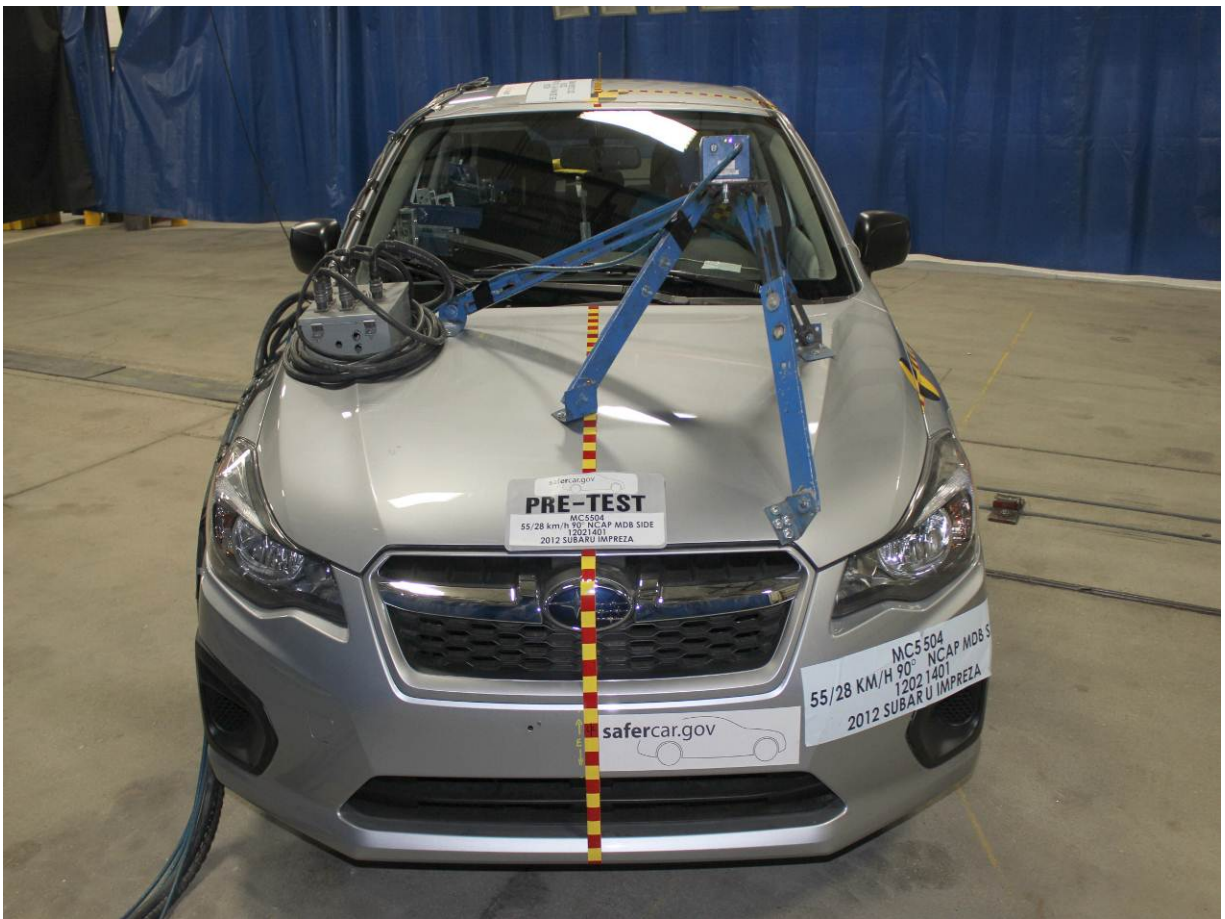
Pre-Test Frontal View of Test Vehicle

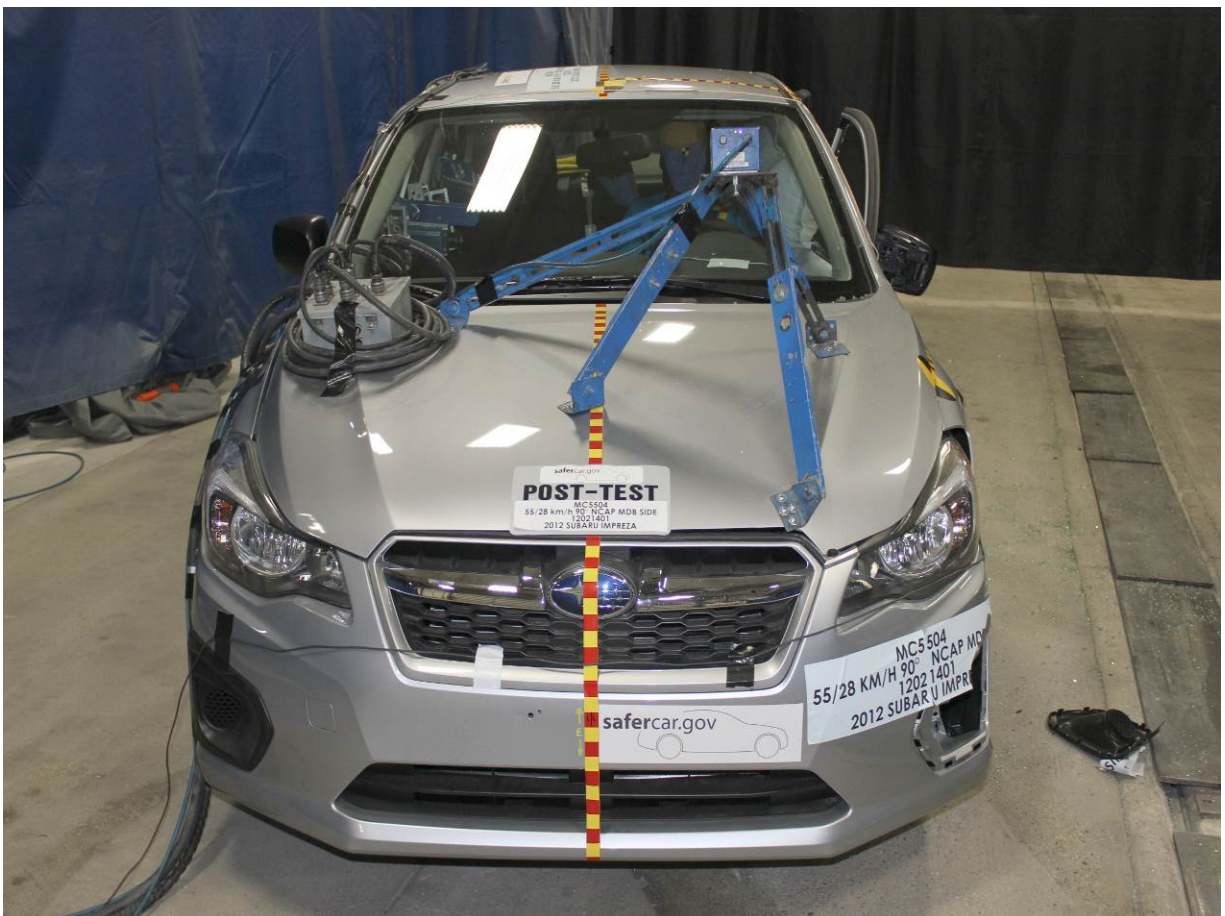
Post-Test Frontal View of Test Vehicle

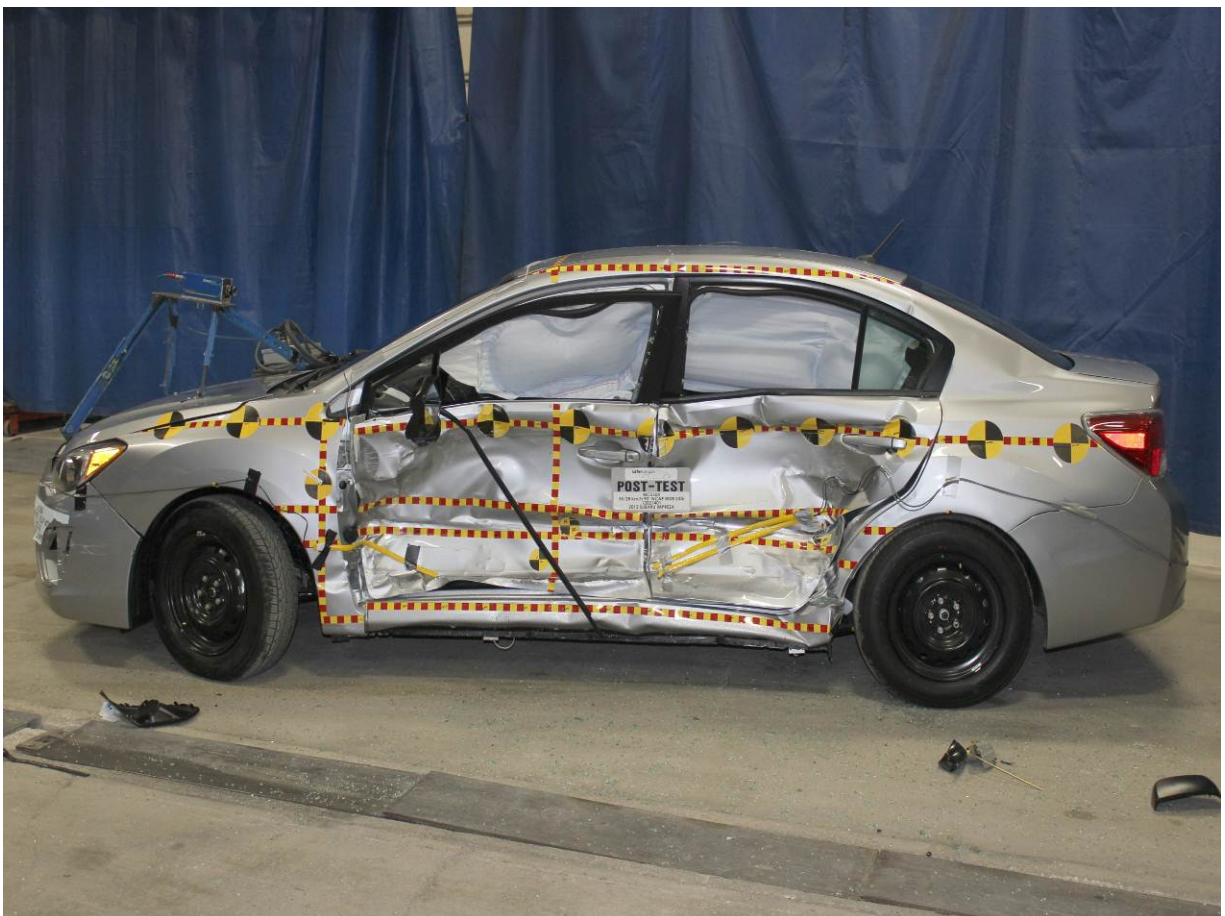
Post-Test Left Side View of Test Vehicle

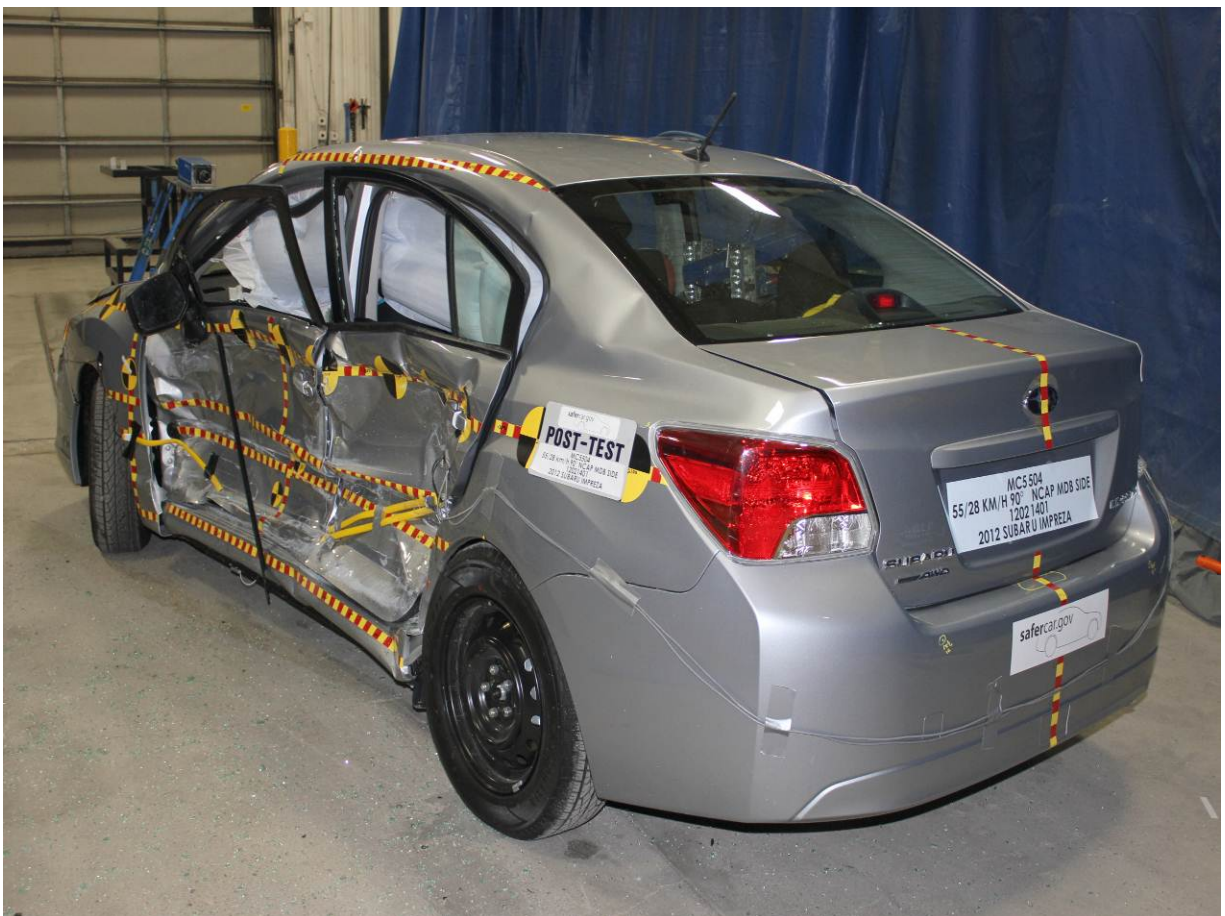
Post-Test Left Three-Quarter Rear View of Test Vehicle

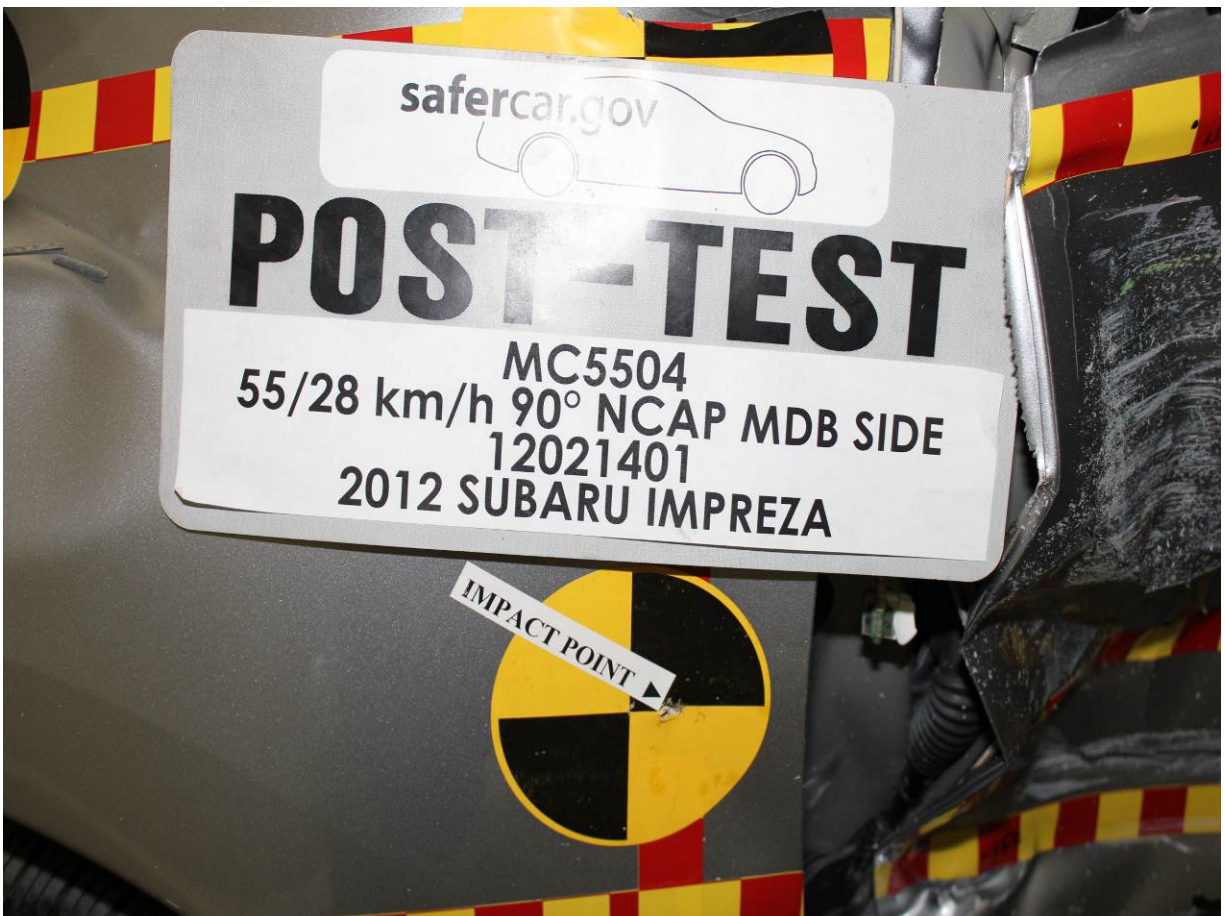
Post-Test Close-Up View of Impact Point Target

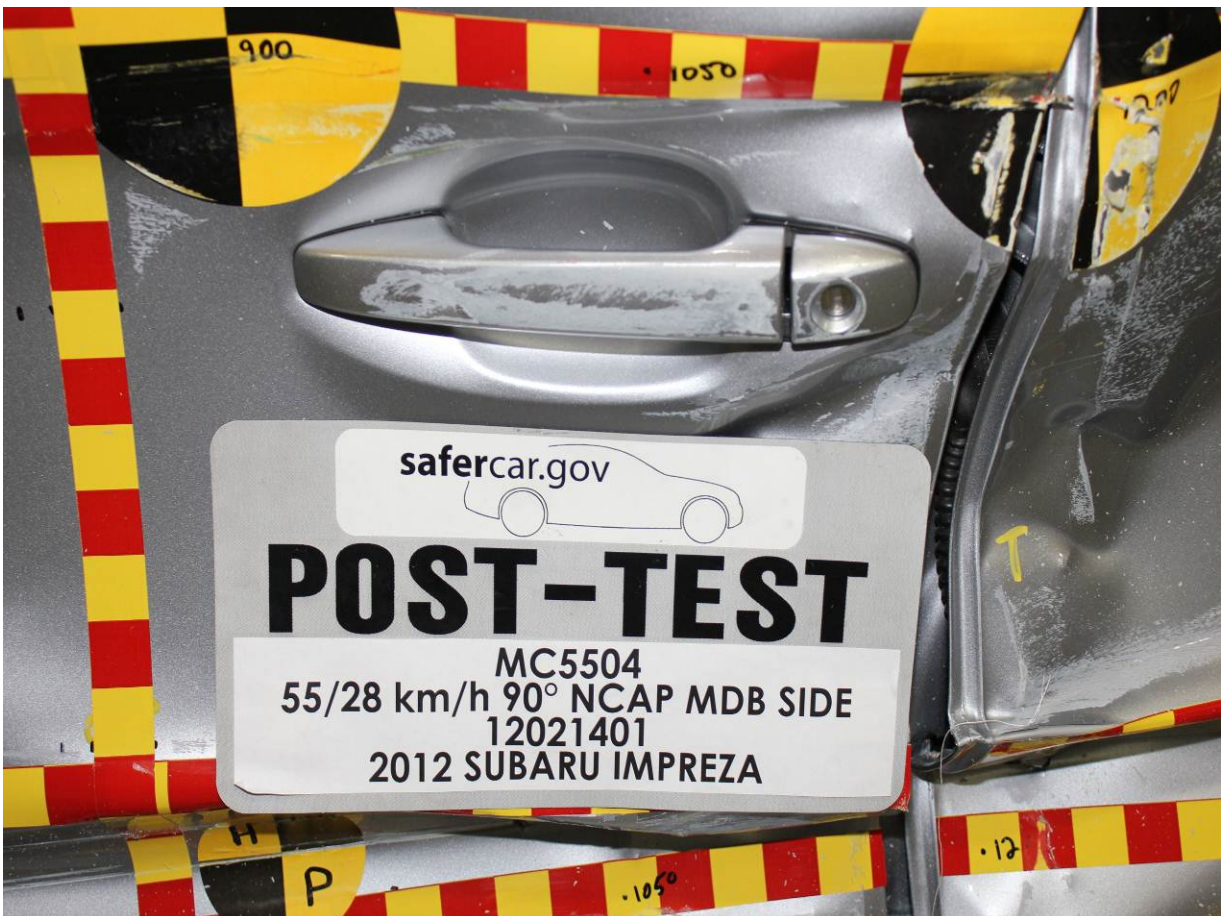
Post-Test Left Front Door Latch Close-Up

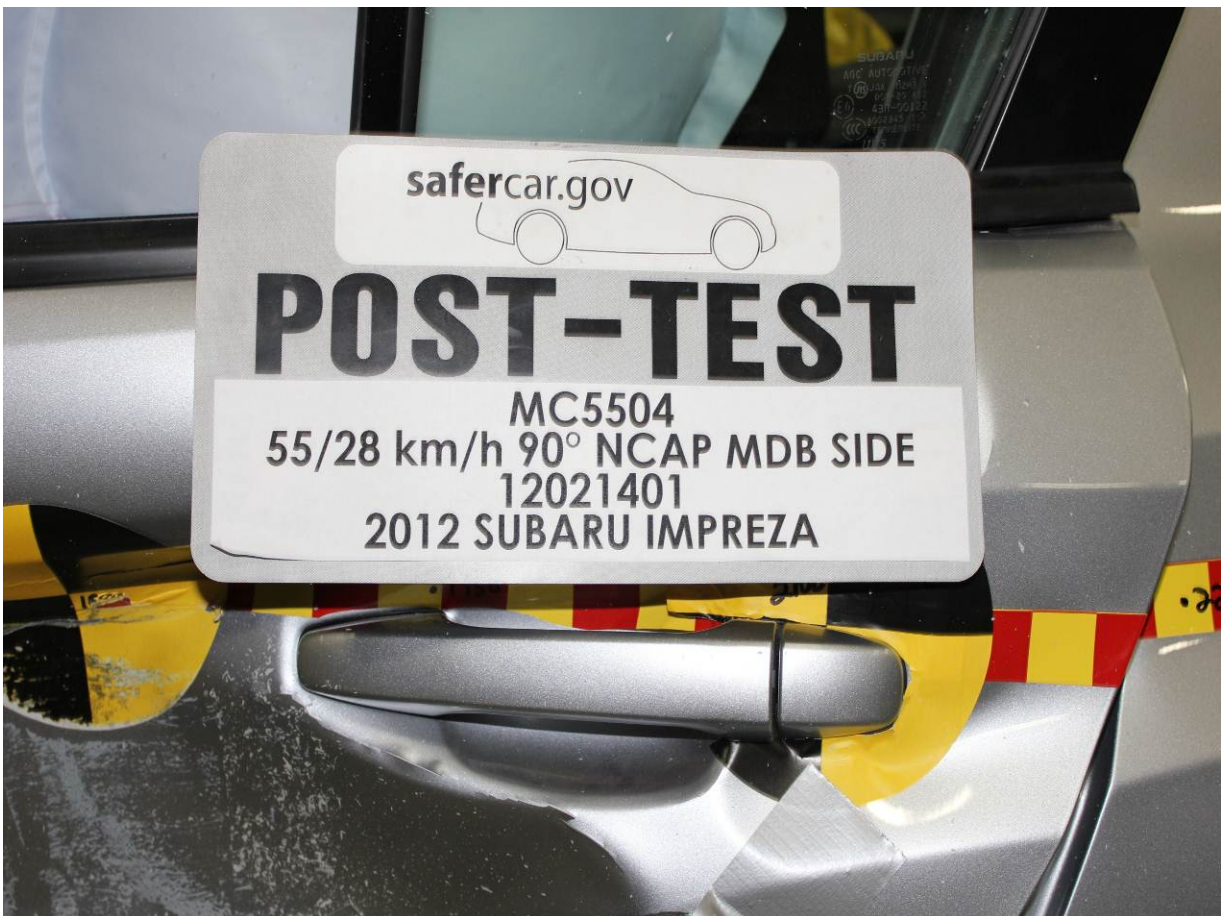
Post-Test Left Rear Door Latch Close-Up

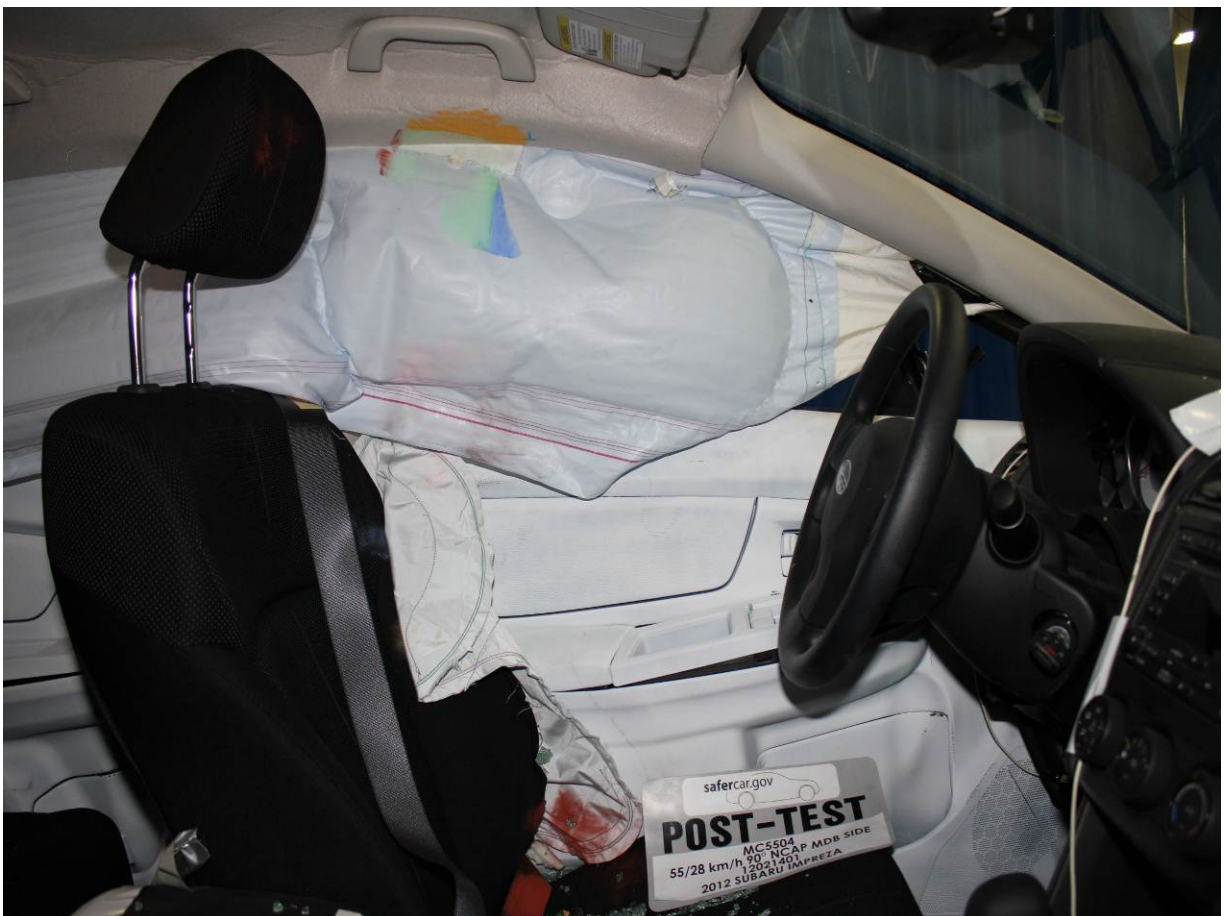
Post-Test Driver Inner Door Panel View

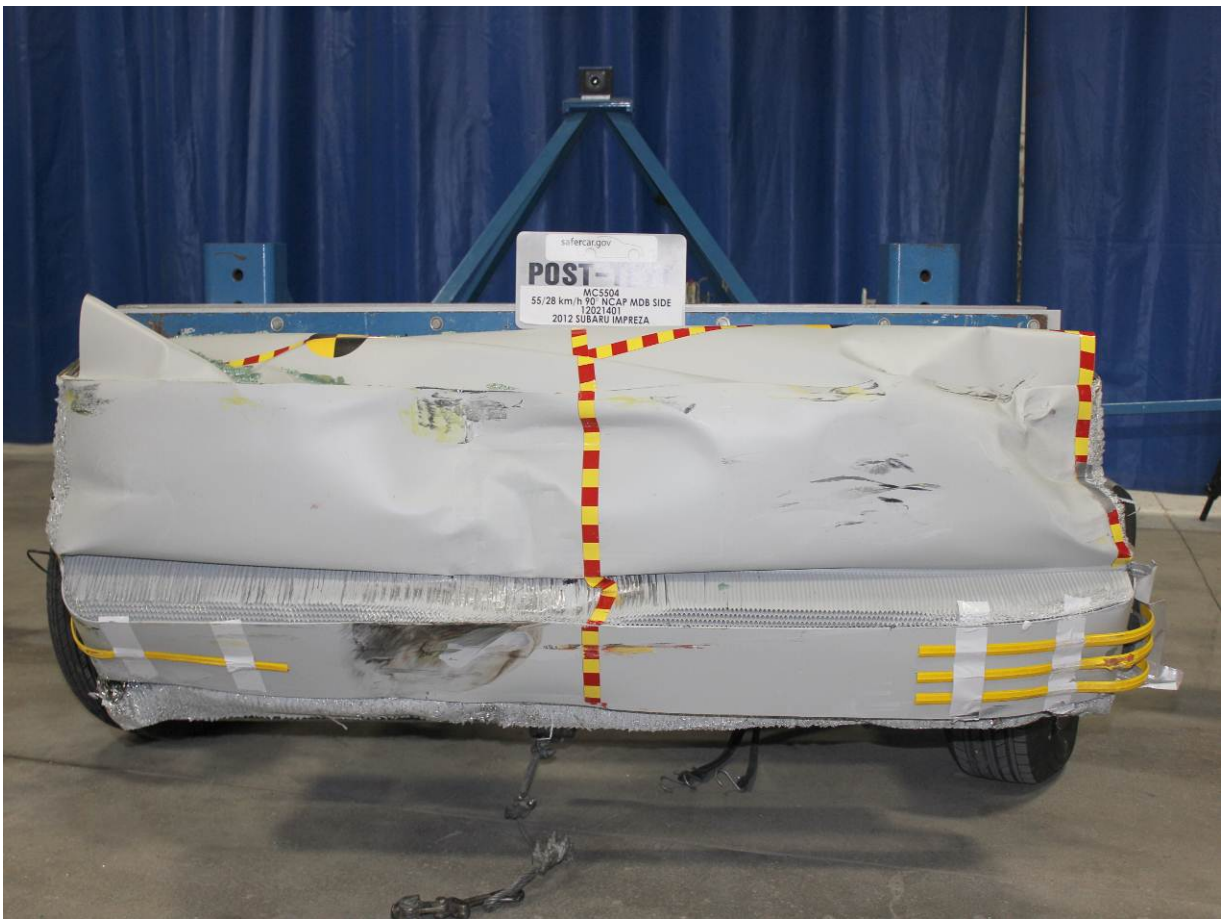
Post-Test Front View of MDB Impactor Face
