**REPORT NUMBER: SPNCAP-MGA-2012-060**

**NEW CAR ASSESSMENT PROGRAM (NCAP)  
Side Impact Pole Test**

**HONDA MOTOR CO., LTD  
2012 Honda Civic IMA 4-Dr Sedan  
NHTSA No.: MC5302**

**FINAL REPORT**

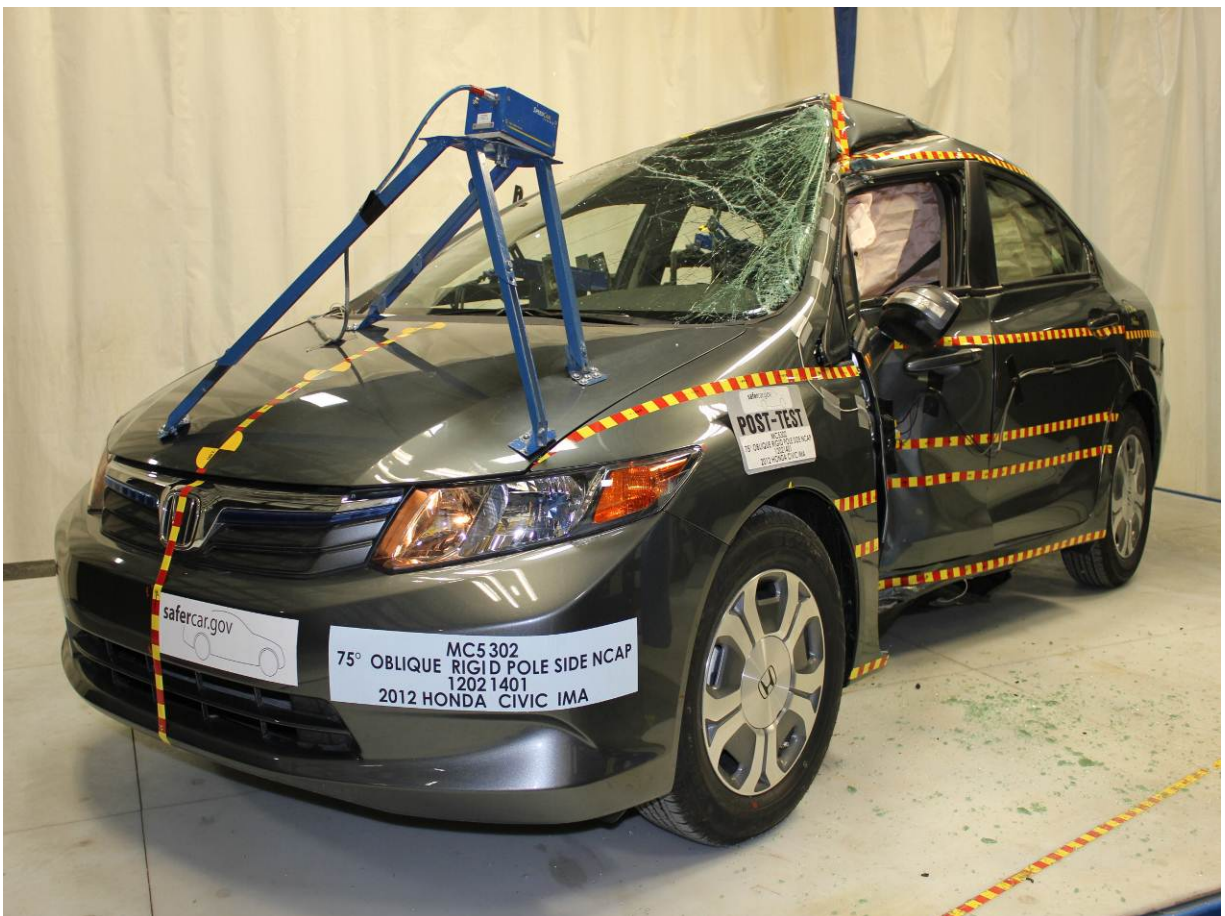
Post-Test Left Front ¾ View of Test Vehicle

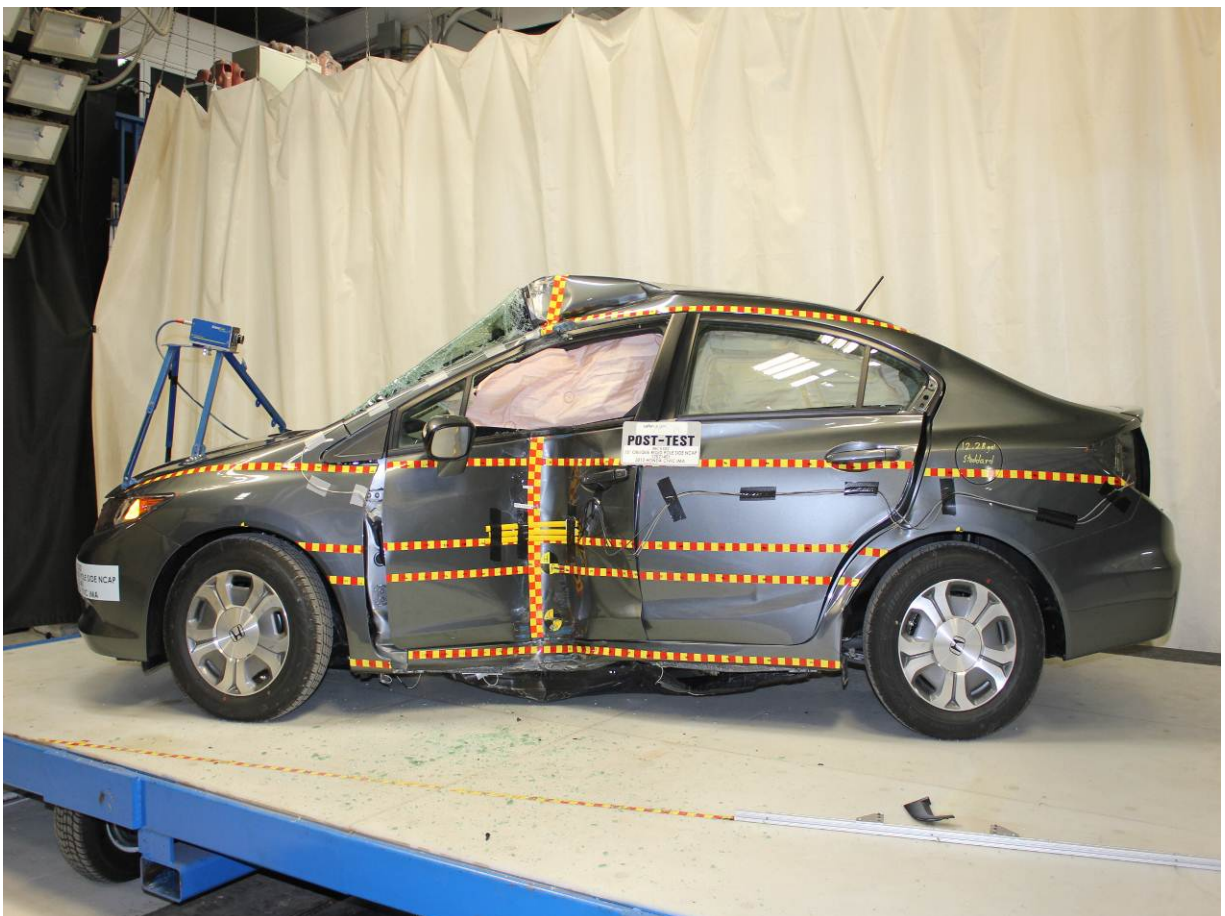
Post-Test Left Side View of Test Vehicle

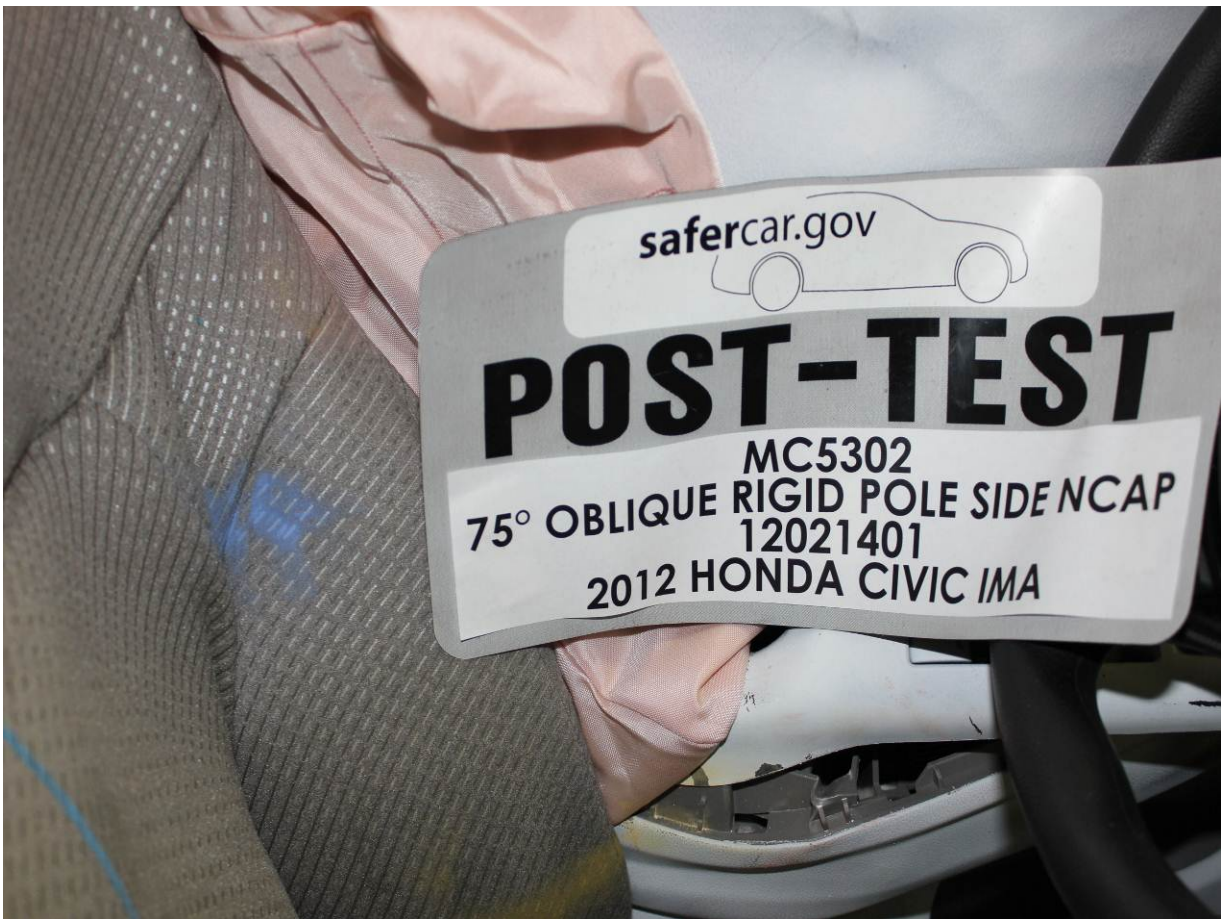
Post-Test Dummy Close-Up Head Contact with Side Air Bag View
