**REPORT NUMBER: NCAP305I-MGA-2012-003**

**NEW CAR ASSESSMENT PROGRAM (NCAP)  
FMVSS No. 305 Indicant Test**

**HONDA MOTOR CO., LTD  
2012 HONDA CIVIC IMA 4-DR HYBRID SEDAN  
NHTSA NUMBER: MC5302**

**FINAL REPORT**

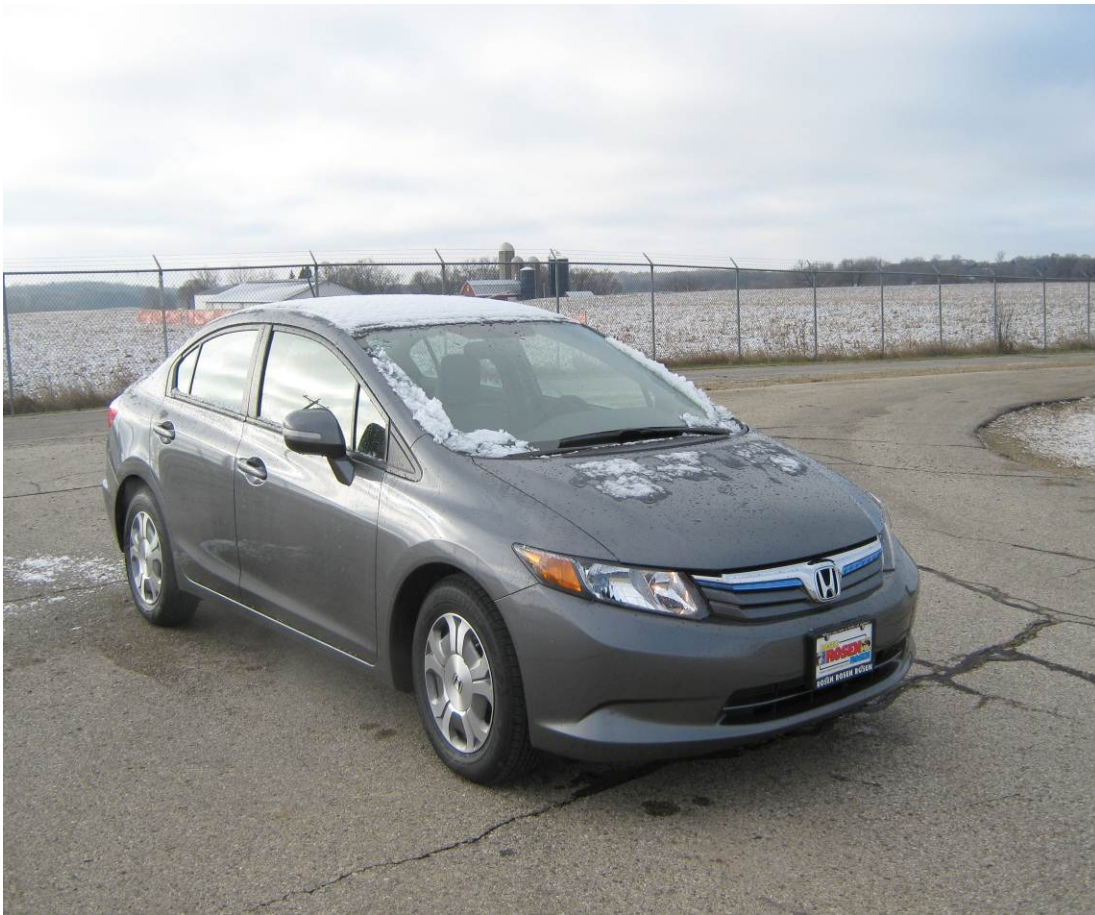
| | <u>Page No.</u> |
|---|---|
| Photo No. 1. As Delivered Right Front $\frac{3}{4}$ View of Test Vehicle | A-1 |

As Delivered Right Front ¾ View of Test Vehicle

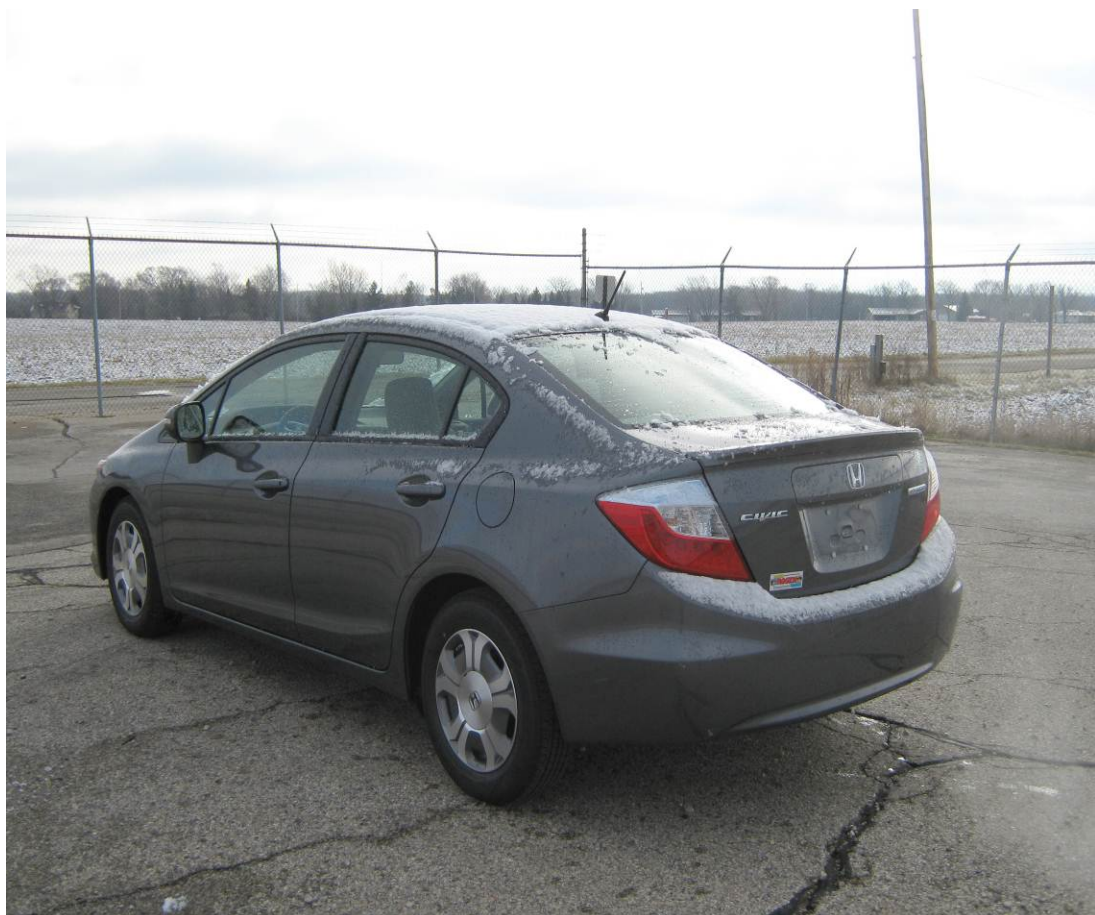
| | <u>Page No.</u> |
|---|---|
| Photo No. 2. As Delivered Left Rear $\frac{3}{4}$ View of Test Vehicle | A-1 |

As Delivered Left Rear ¾ View of Test Vehicle

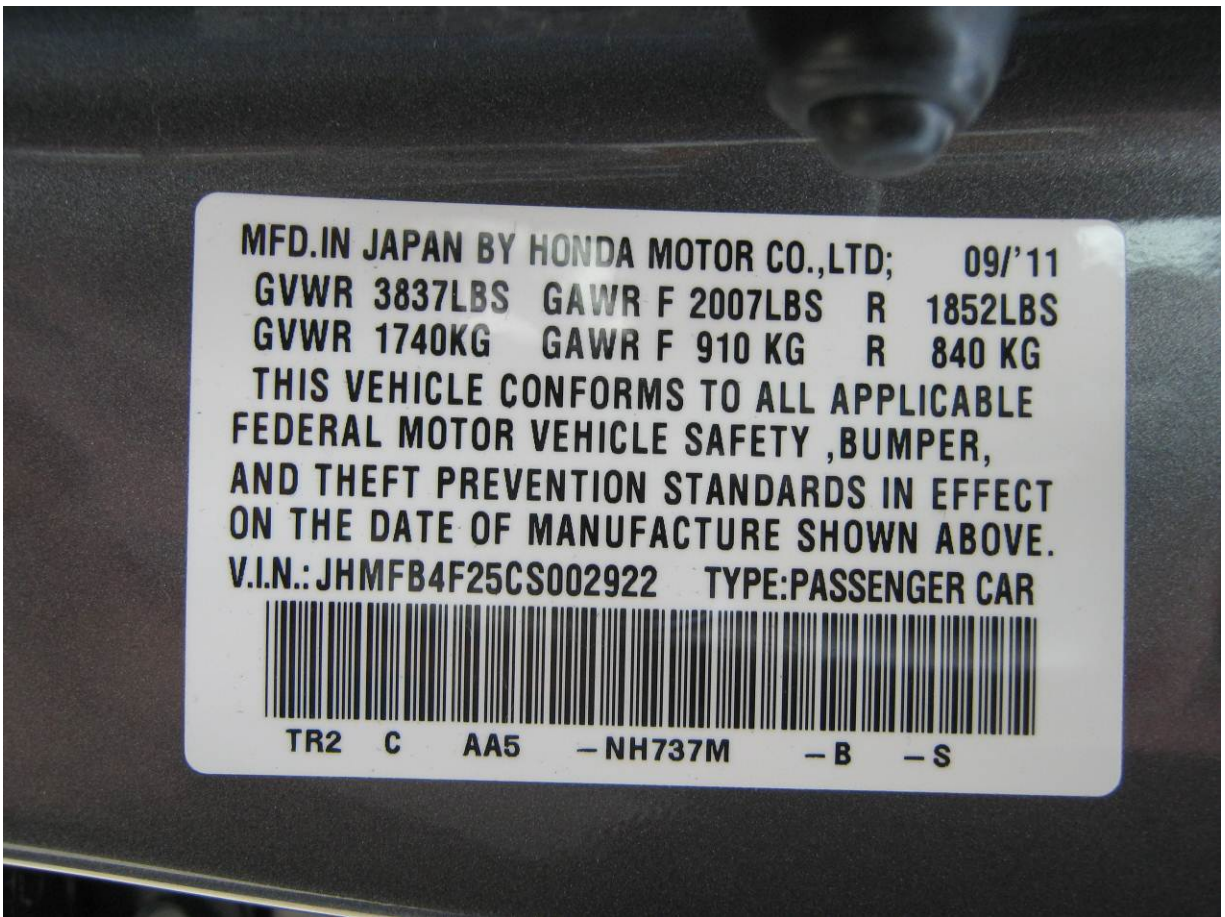
| | <u>Page No.</u> |
|---|---|
| Photo No. 3. Vehicle's Certification Label | A-2 |

Vehicle's Certification Label

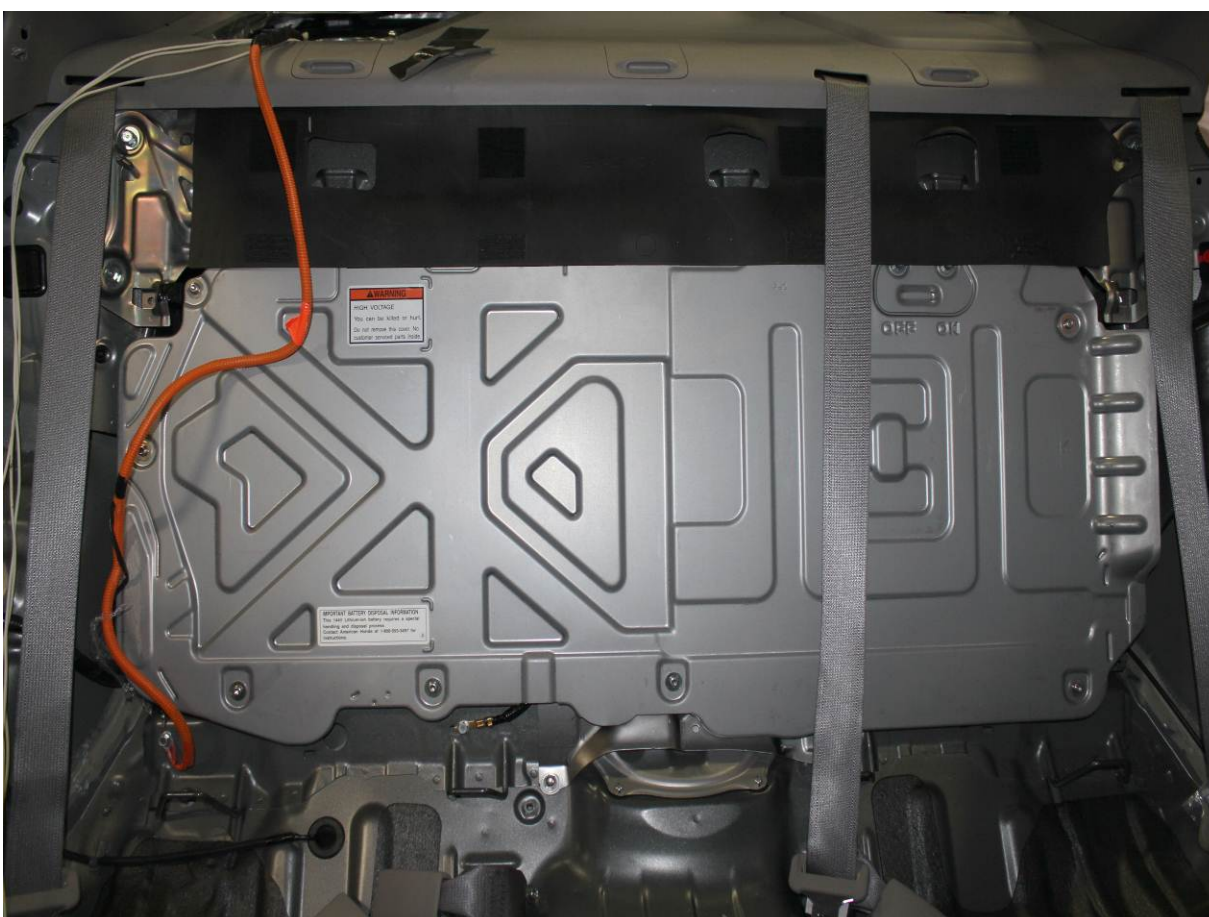
| | <u>Page No.</u> |
|---|---|
| Photo No. 6. Post-Test View of Electric Energy Storage/Conversion System | A-3 |

| | Yes, Pass | No, Fail |
|---|---|---|
| All Components of Electrical Energy Storage/Conversion Device remained attached to the vehicle with at least one mounting location. | X | |

Post-Test View of Electric Energy Storage/Conversion System

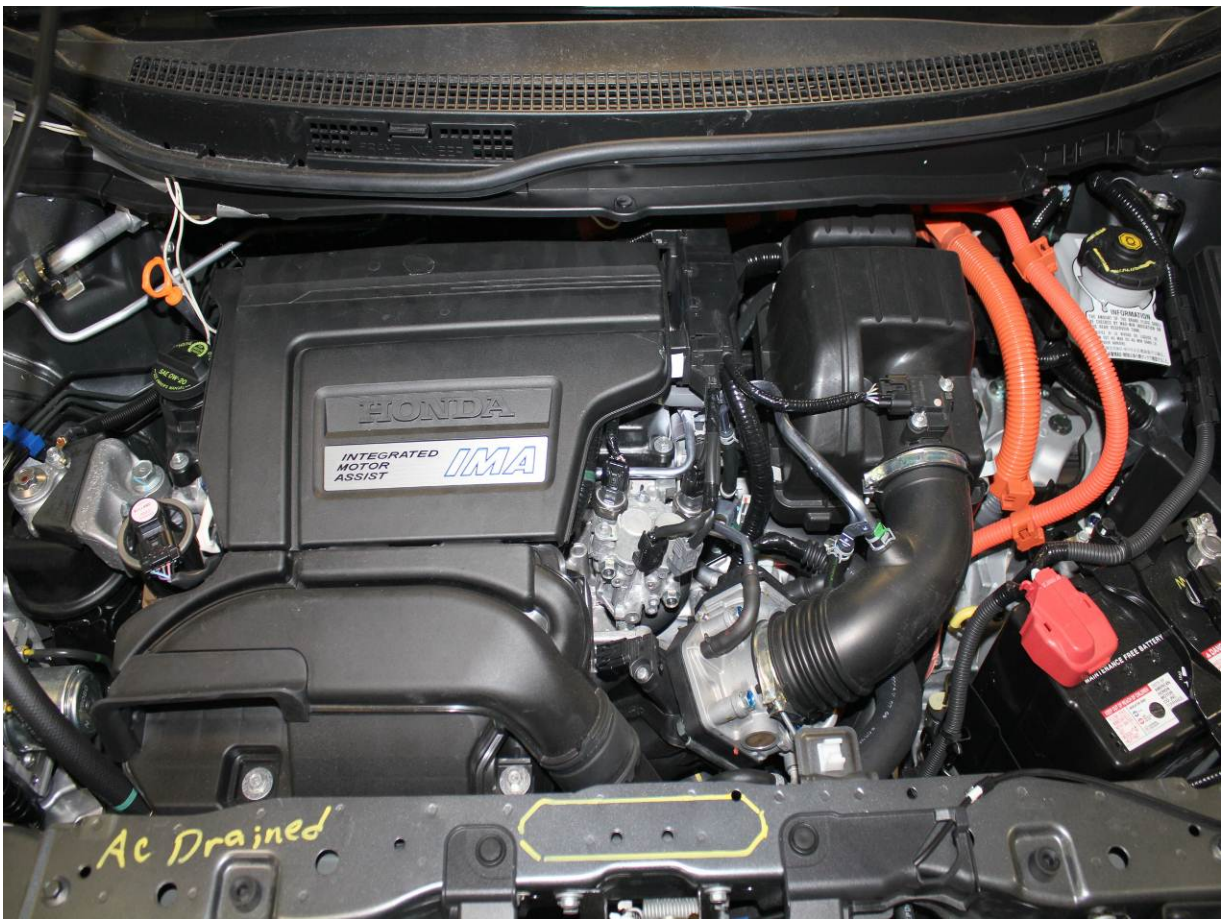
| | <u>Page No.</u> |
|---|---|
| Photo No. 9. Pre-Test View of Electric Propulsion Drive | A-5 |

Pre-Test View of Electric Propulsion Drive

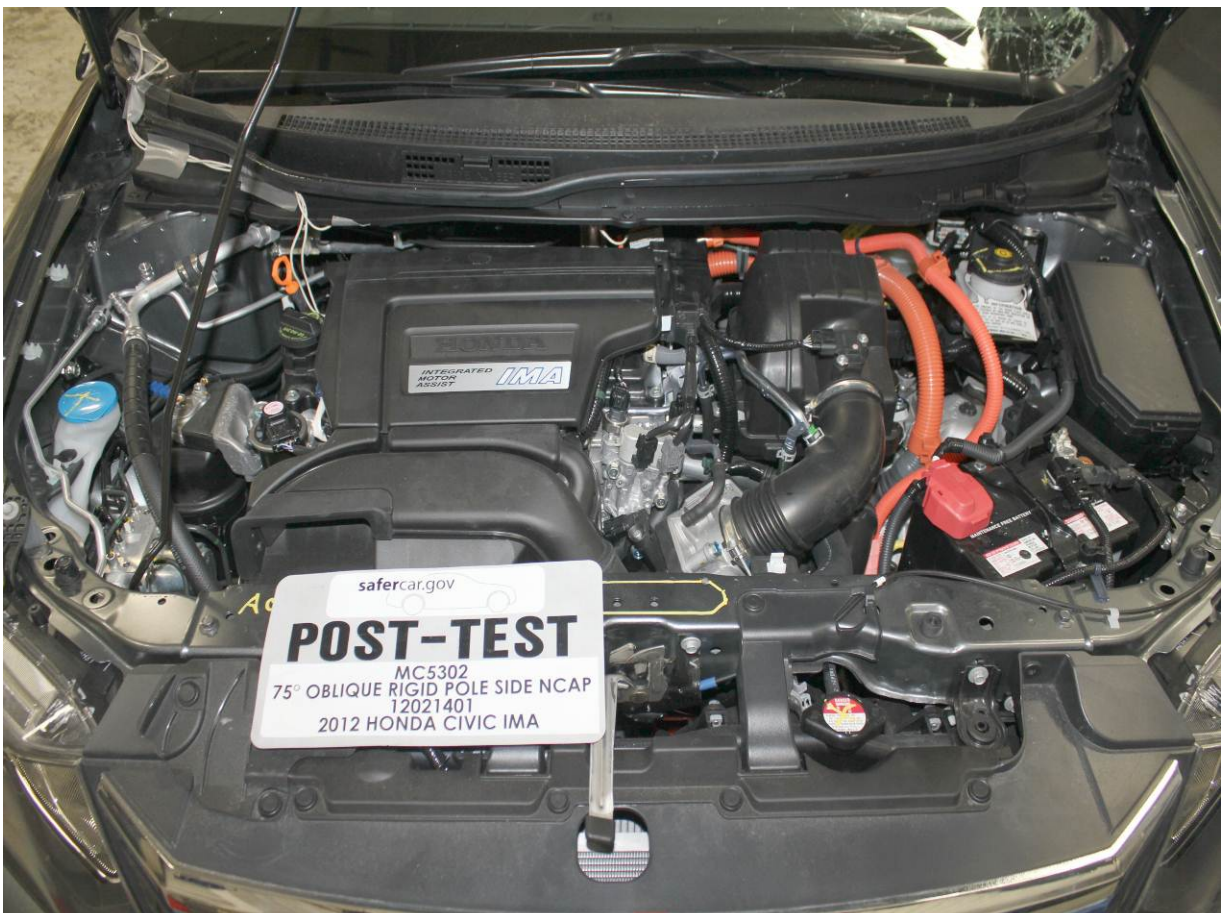
| | <u>Page No.</u> |
|---|---|
| Photo No. 10. Post-Test View of Electric Propulsion Drive | A-5 |

Post-Test View of Electric Propulsion Drive

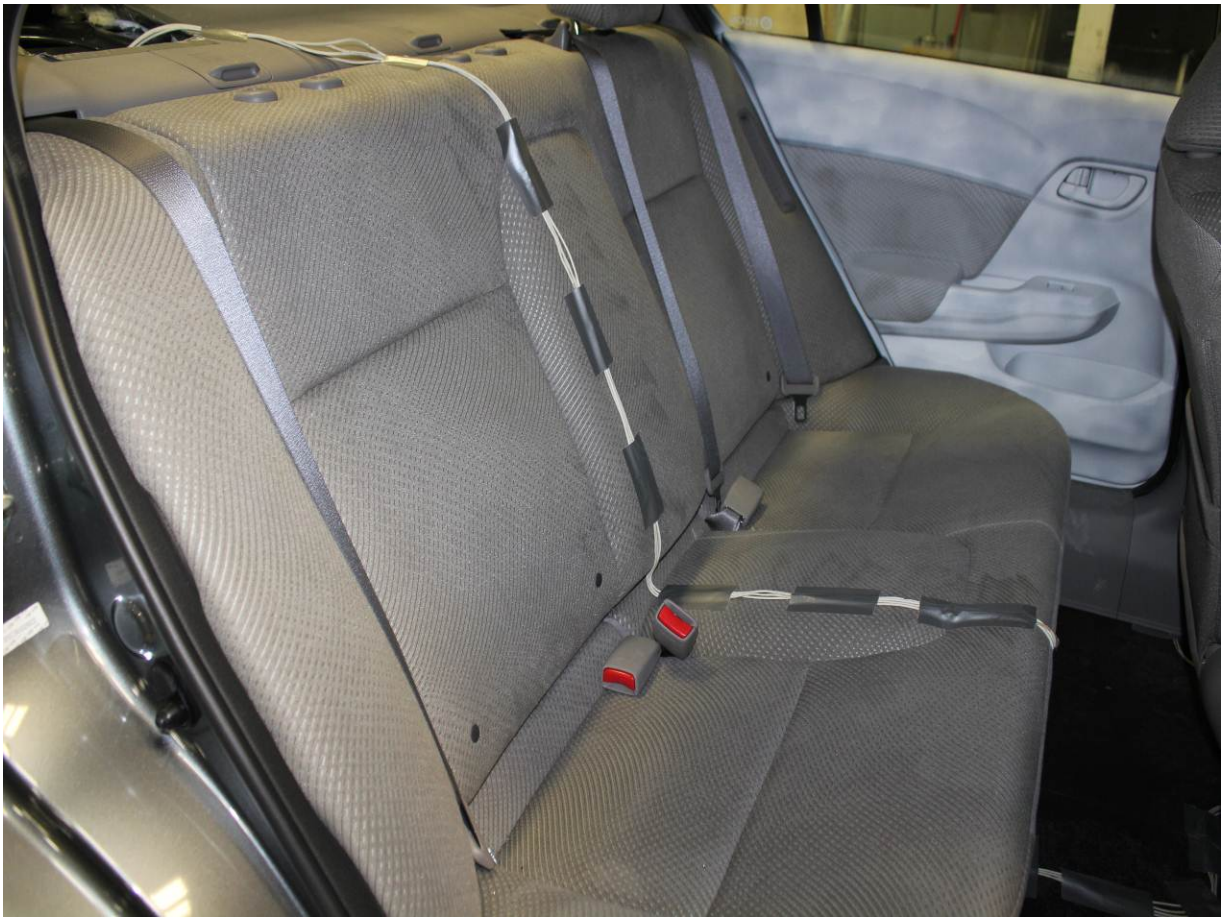
| | <u>Page No.</u> |
|---|---|
| Photo No. 11. Pre-Test View of Vehicle's Passenger Compartment Adjacent to Electric Energy Storage/Conversion System | A-6 |

Pre-Test View of Vehicle's Passenger Compartment Adjacent to Electric Energy Storage/Conversion System

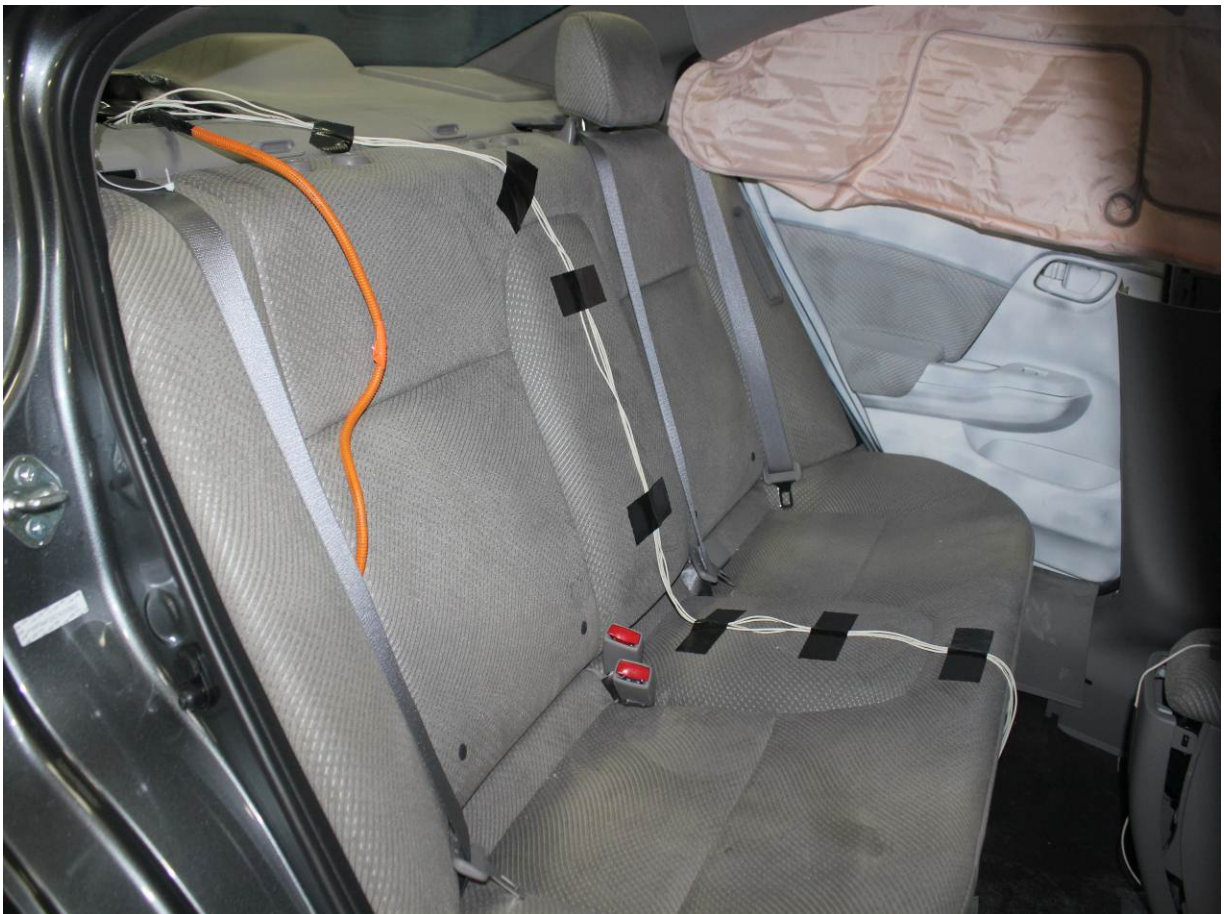
| | <u>Page No.</u> |
|---|---|
| Photo No. 12. Post-Test View of Vehicle's Passenger Compartment Adjacent to Electric Energy Storage/Conversion System | A-6 |

| No Intrusion |

| | Yes, Fail | No, Pass |
|---|---|---|
| Is Electric Energy Storage/Conversion Device electrolyte spillage visible in the passenger compartment? | | X |

Post-Test View of Vehicle's Passenger Compartment Adjacent to Electric Energy Storage/Conversion System

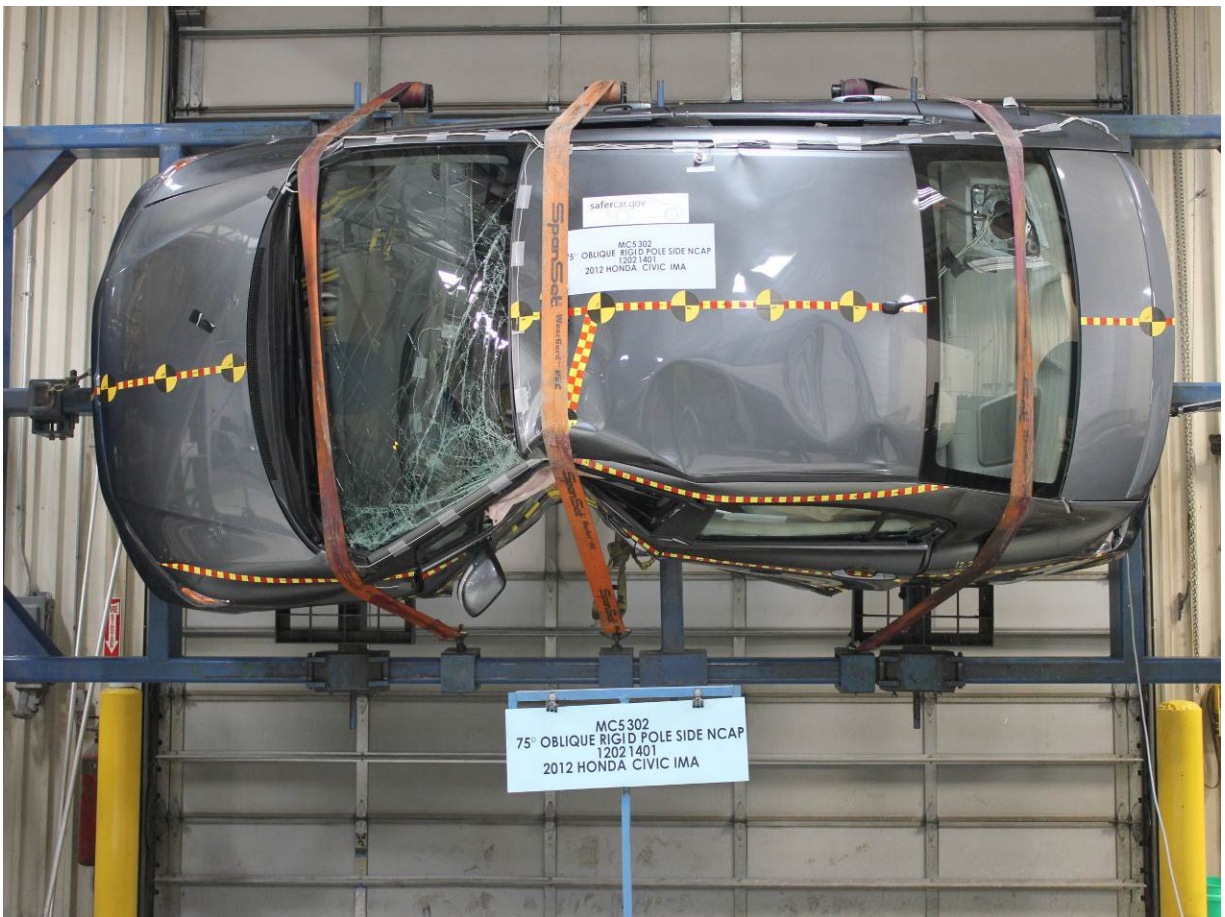
| | <u>Page No.</u> |
|---|---|
| Photo No. 13. Vehicle at 90 Degrees on Static Rollover Device | A-7 |

| Rollover Stage | Electric Energy Storage/Conversion<br>Device Electrolyte Spillage (L) | Spillage Location |
|---|---|---|
| 0° to 90° | 0 | Not Applicable |

Vehicle at 90 Degrees on Static Rollover Device

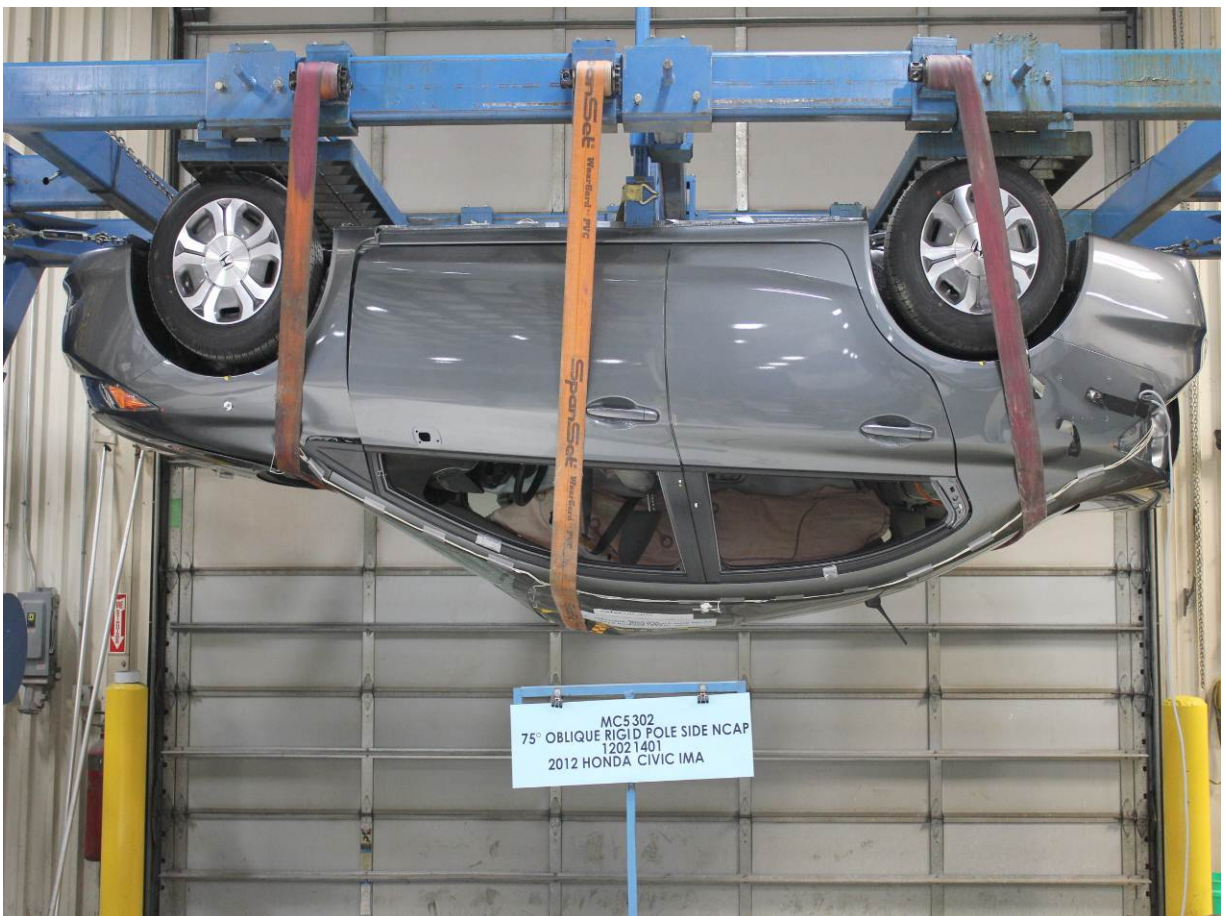
| | <u>Page No.</u> |
|---|---|
| Photo No. 14. Vehicle at 180 Degrees on Static Rollover Device | A-7 |

| Rollover Stage | Electric Energy Storage/Conversion<br>Device Electrolyte Spillage (L) | Spillage Location |
|---|---|---|
| 90° to 180° | 0 | Not Applicable |

Vehicle at 180 Degrees on Static Rollover Device

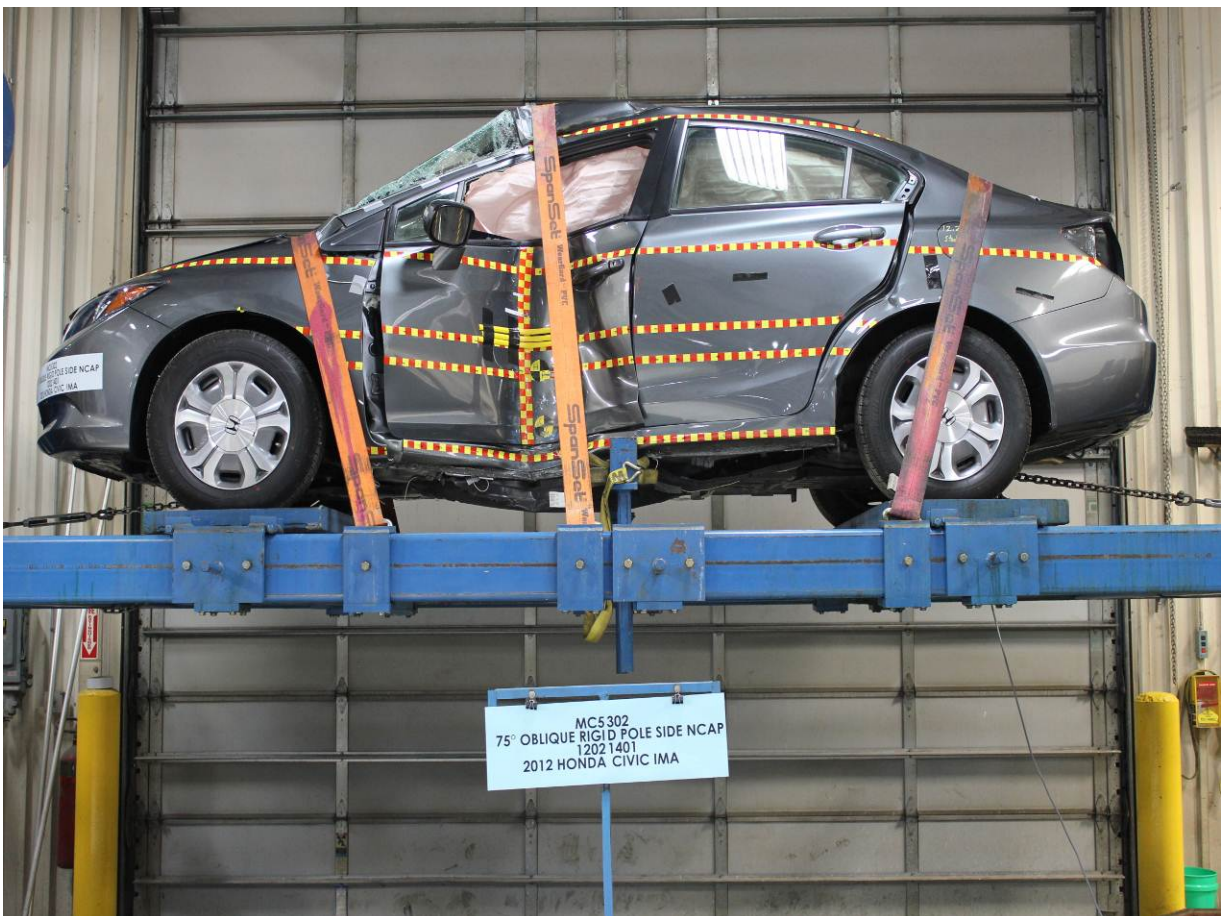
| | <u>Page No.</u> |
|---|---|
| Photo No. 16. Vehicle at 360 Degrees on Static Rollover Device | A-8 |

| Rollover Stage | Electric Energy Storage/Conversion<br>Device Electrolyte Spillage (L) | Spillage Location |
|---|---|---|
| 270° to 360° | 0 | Not Applicable |

Vehicle at 360 Degrees on Static Rollover Device

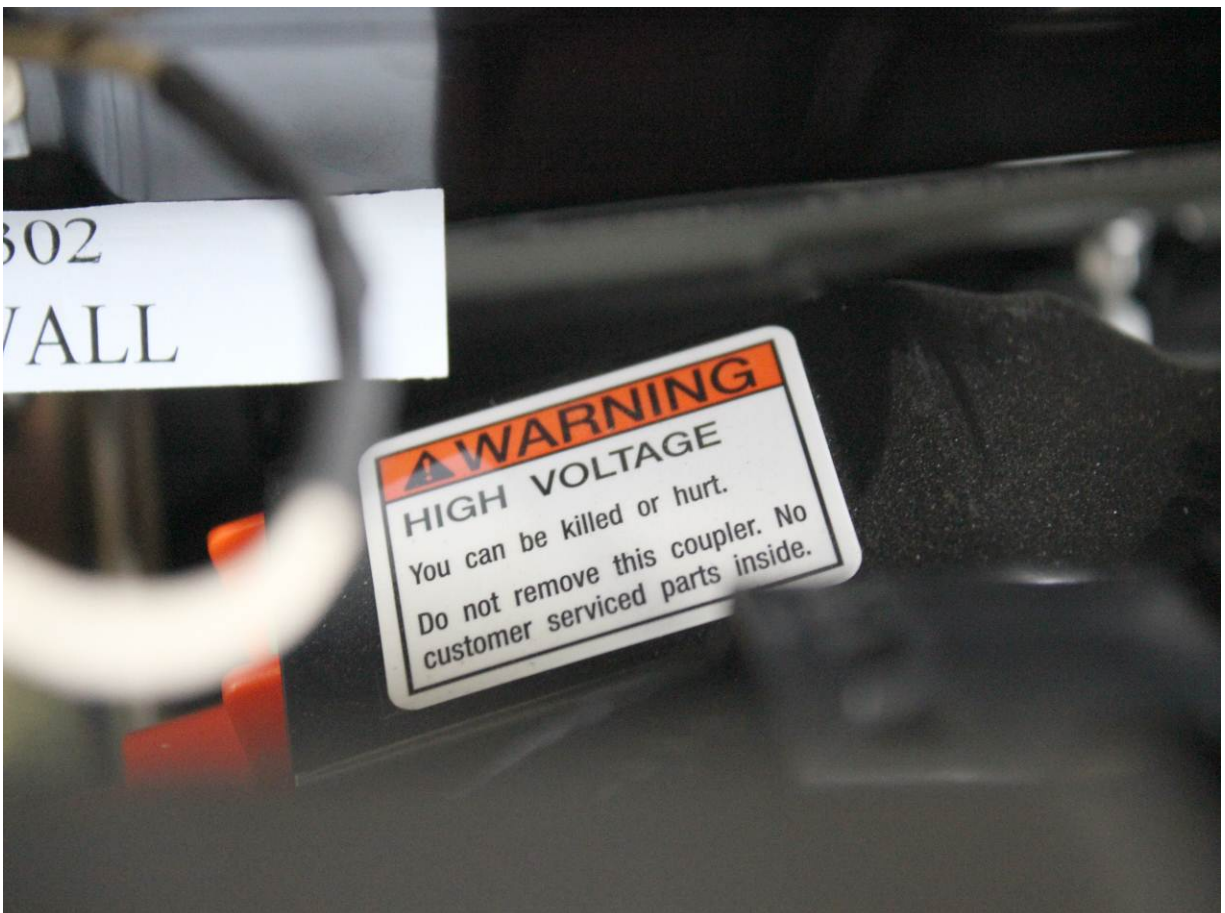
| | <u>Page No.</u> |
|---|---|
| Photo No. 18. High Voltage Warning Label | A-9 |

High Voltage Warning Label

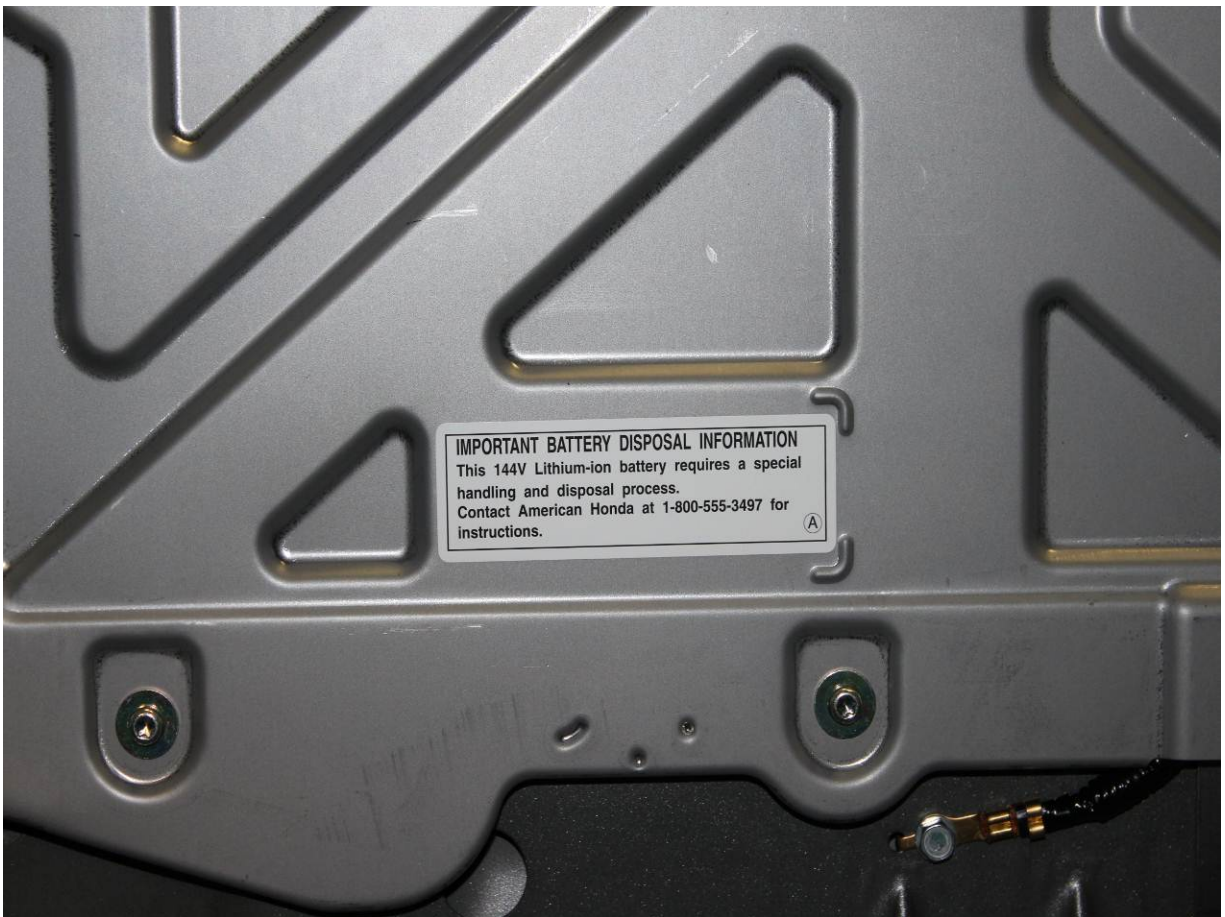
High Voltage Warning Label

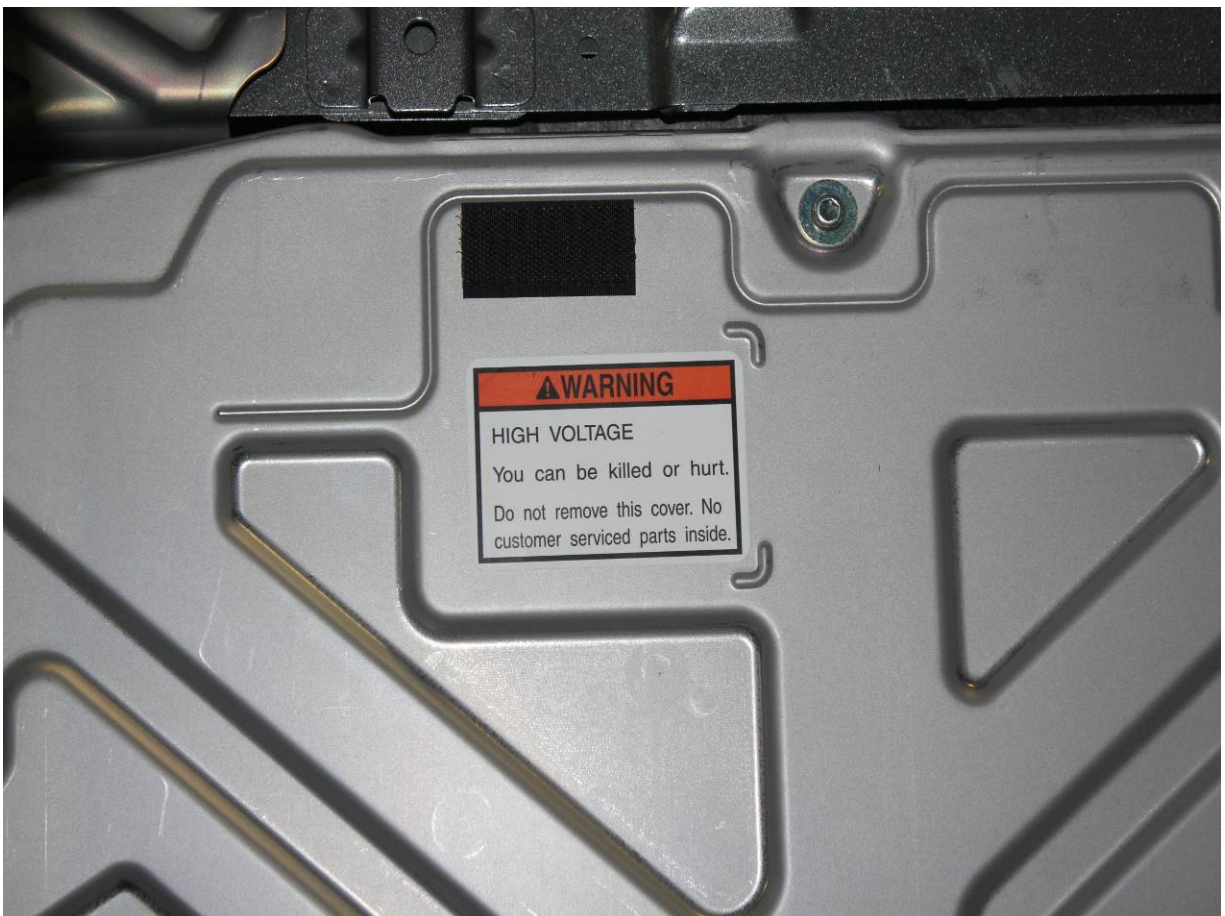
High Voltage Warning Label

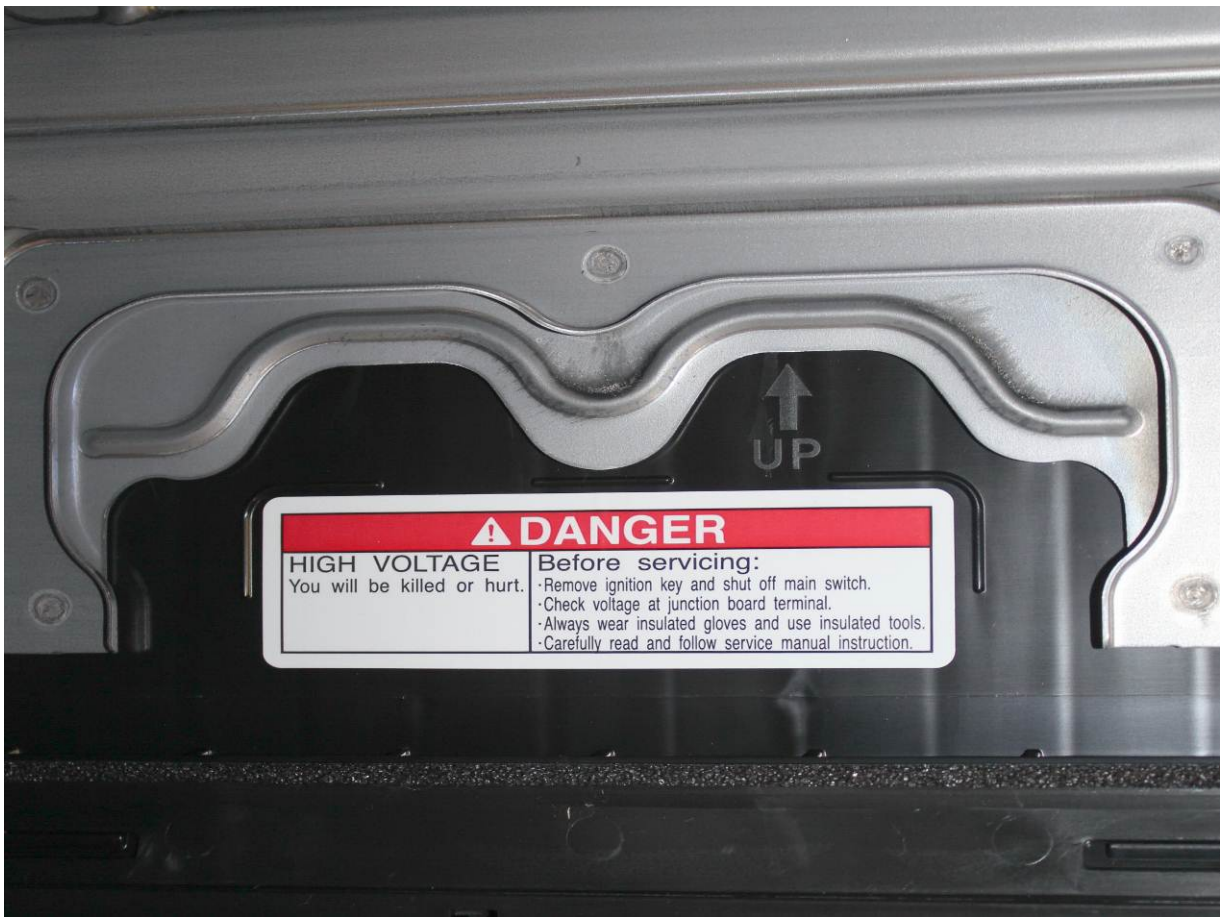
High Voltage Warning Label
