REPORT NUMBER: TWG-CAL-12-01

NEW CAR ASSESSMENT PROGRAM (NCAP)
SIDE AIRBAG OUT-OF-POSITION INJURY TESTING

AUTO ALLIANCE INTERNATIONAL, INC.
2012 MAZDA 6
4-DOOR SEDAN

NHTSA NUMBER: MC5401-TWG2
CALSPAN TEST NUMBER: CT2012-01

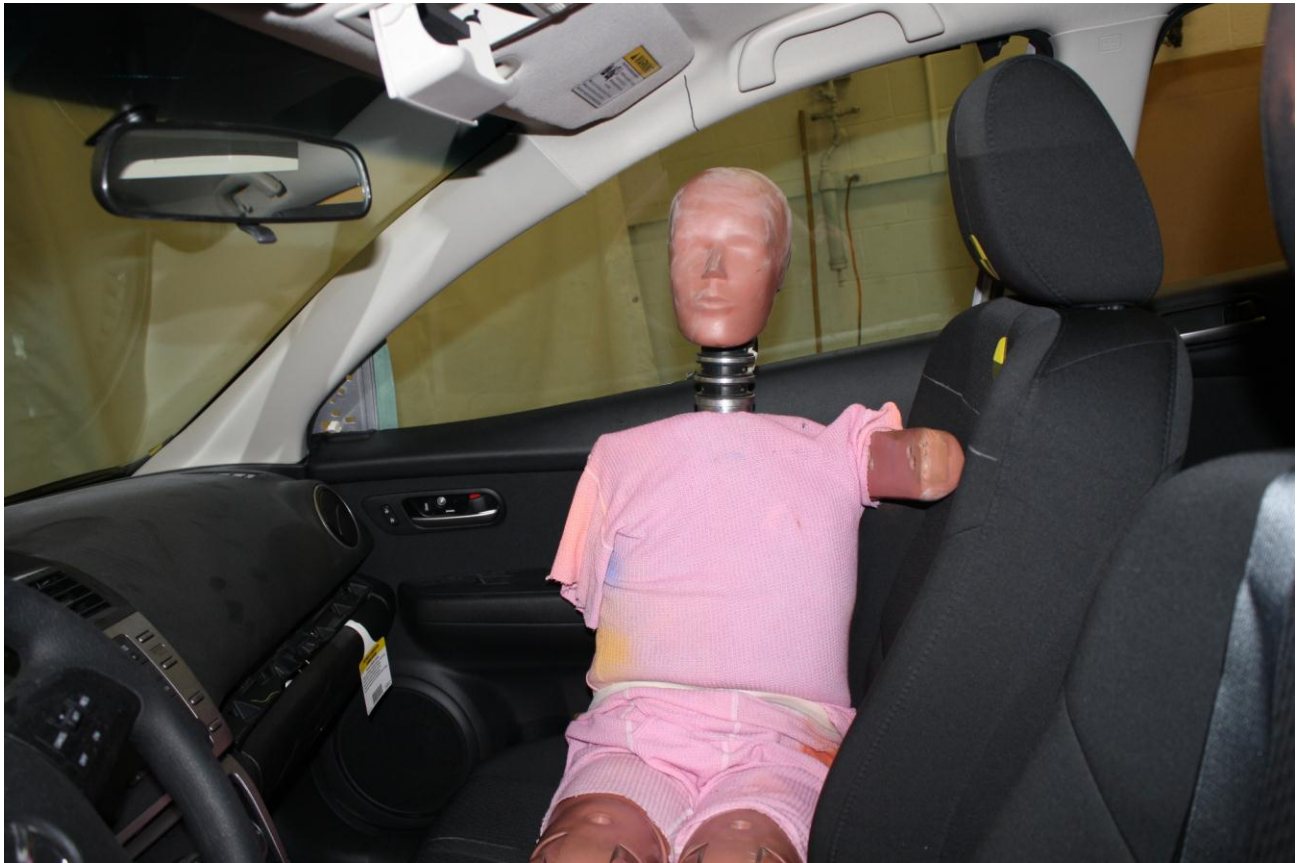
Figure A-5: Pre-Test 5th female SID-IIs Dummy Left Side View

The 5th female ATD was placed with its left arm outstretched against the back of the right front (passenger) seat facing inboard cross car with its legs extended. After consultation with the program sponsor, the seat track was adjusted to locate the head c.g. under the expected deployment location of a head curtain chamber to maximize the airbag to head interaction. The location was determined by observing test data from the previous left side impact test on this vehicle. While keeping the head in neutral orientation, the ATD's pelvis was moved outboard until the dummy's back contacted the door trim panel armrest. The center of gravity of the head was centered in the deployment trajectory of the airbag. The dummy was then moved to maintain the vertical plane through the centerline of the ATD's shoulder bolts parallel to the vehicle centerline. The ATD's arm was bent straight across the back seat cushion. This orientation complies with section 3.3.5.3 of the TWG Recommended Procedures for Evaluating Occupant Injury Risk from Deploying Side Airbags as defined by Lund, et al and the Technical Working Group First Revision dated July, 2003.

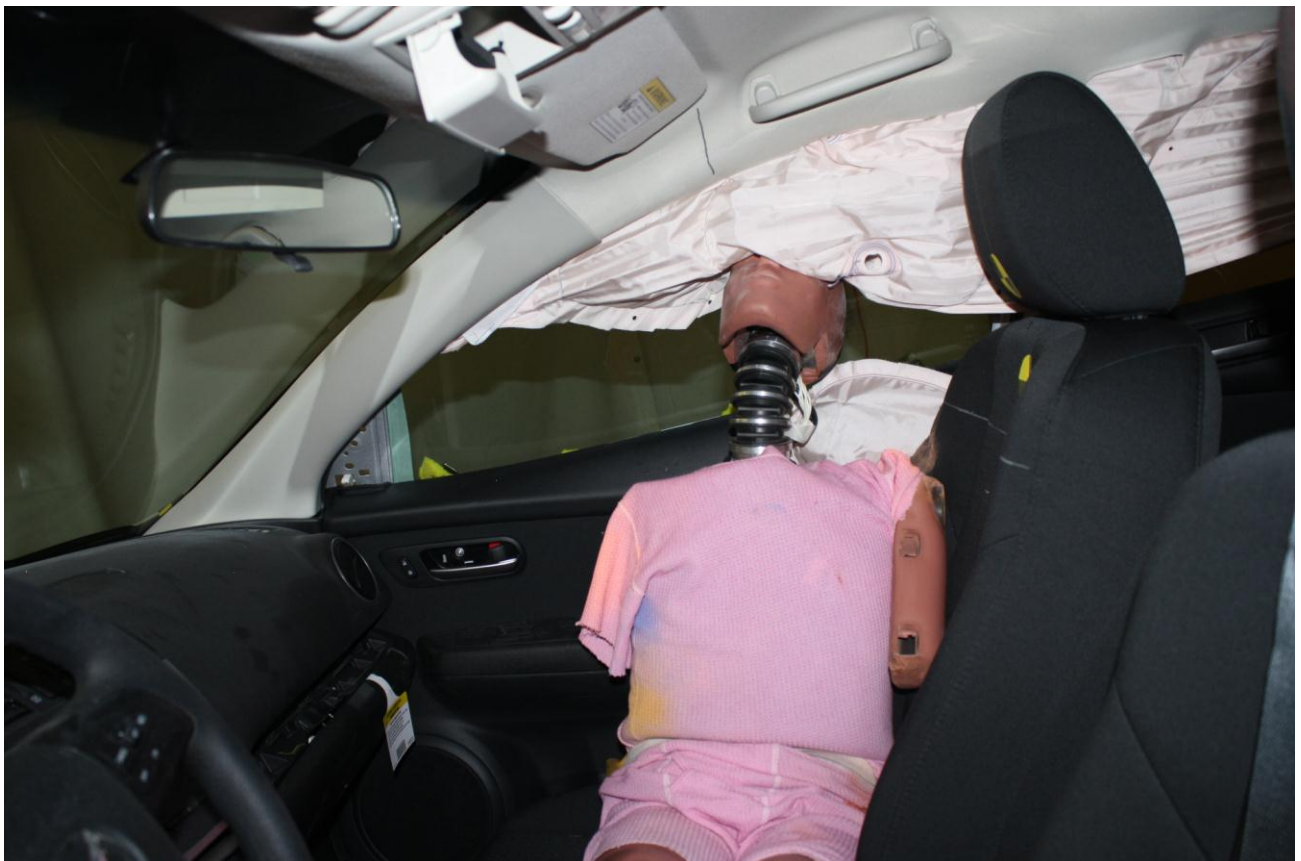
Figure A-6: Post-Test 5th female SID-IIs Dummy Left Side View

Head Contact:	Curtain Airbag
Upper Torso Contact:	Torso Airbag and Passenger side door
Lower Torso Contact:	Seat Back
Left Knee Contact:	None
Right Knee Contact:	None

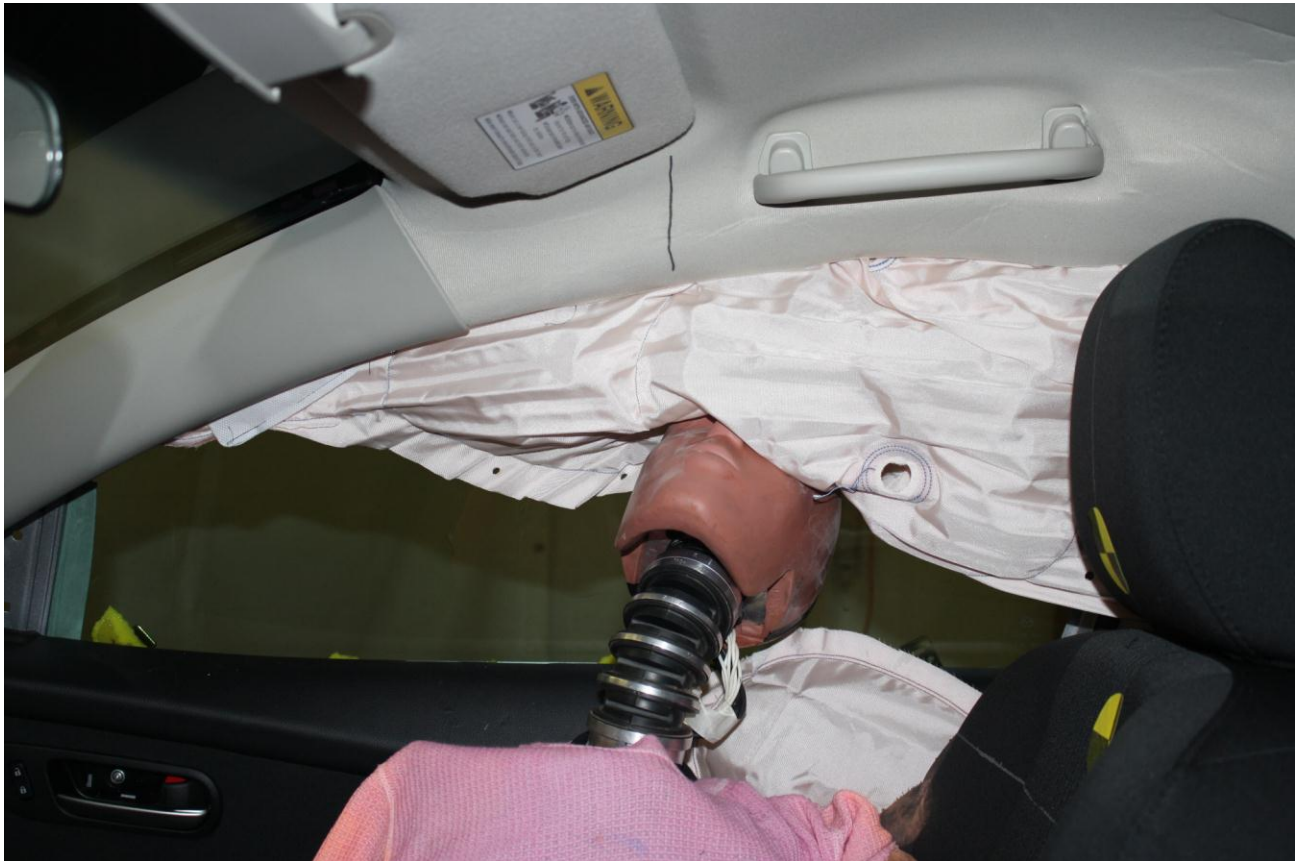
Figure A-17: Post-Test Curtain Airbag Left Side View

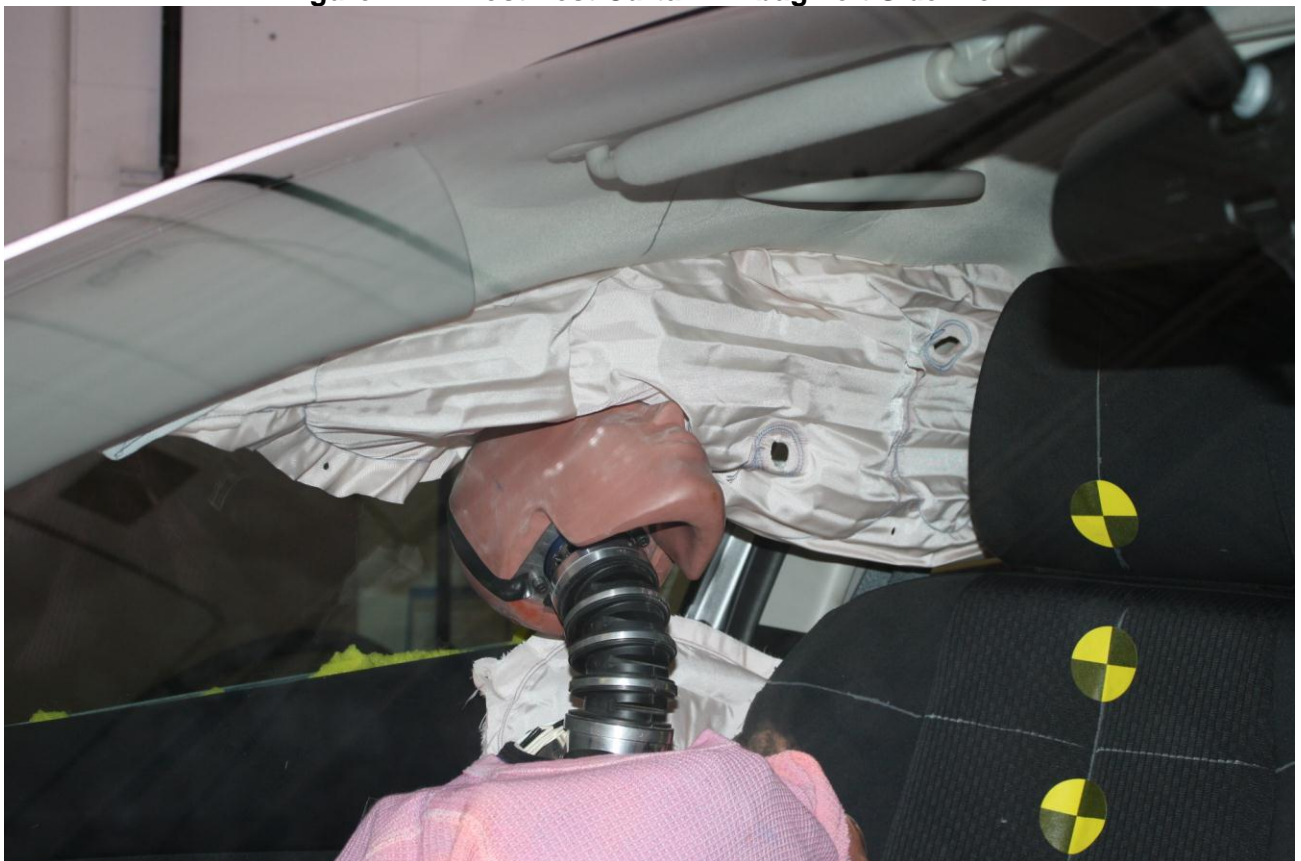
Figure A-18: Post-Test Curtain Airbag Left ¾ Front View

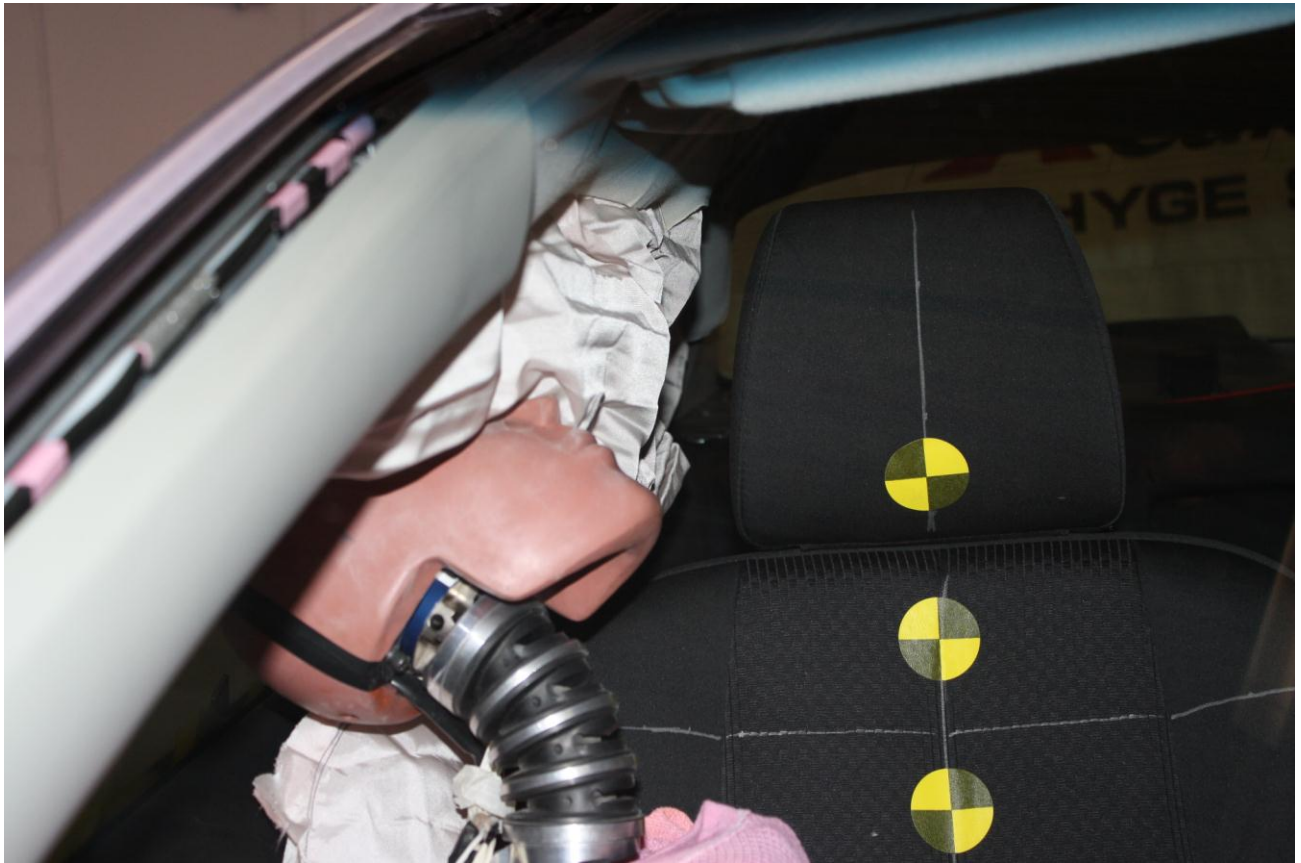
Figure A-19: Post-Test Curtain Airbag Front View

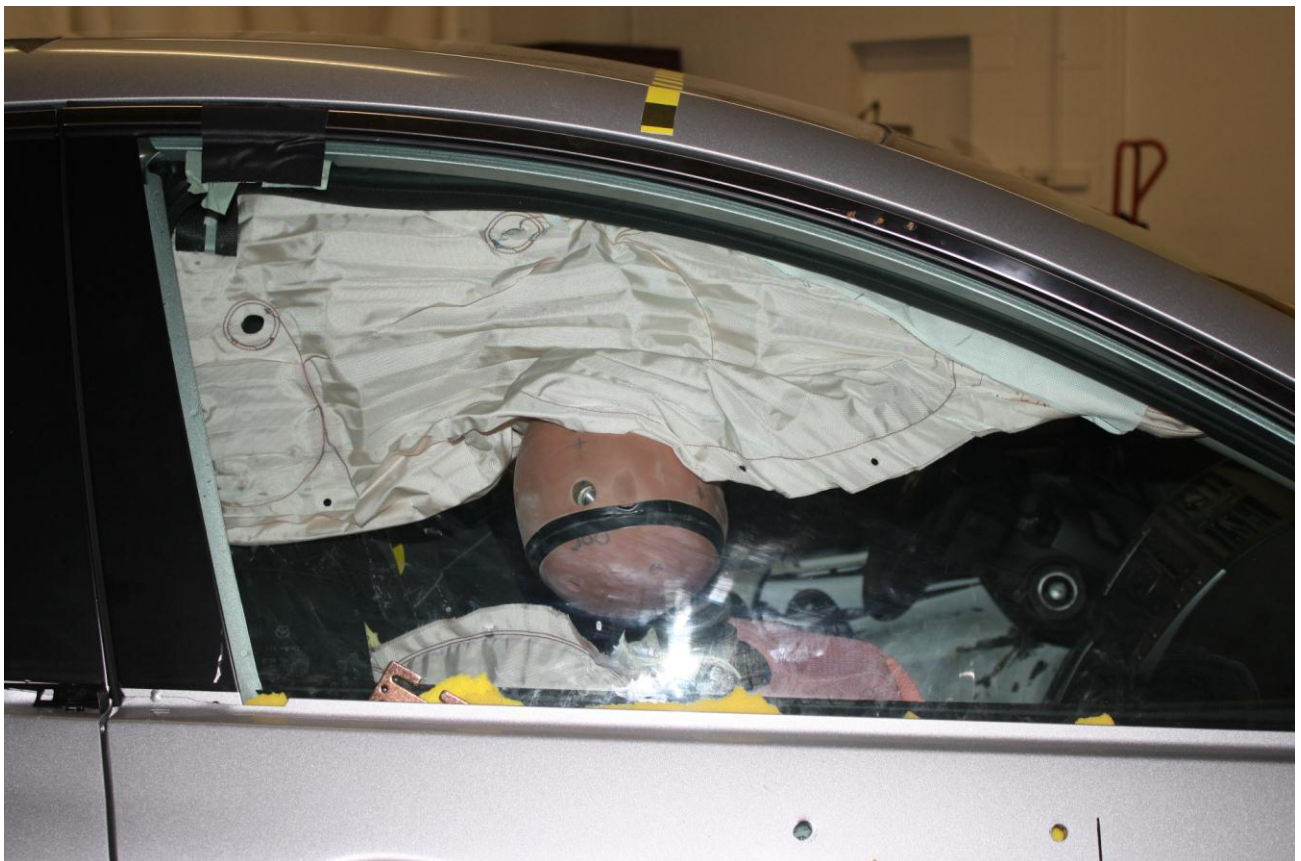
Figure A-20: Post-Test Curtain Airbag Right Side View

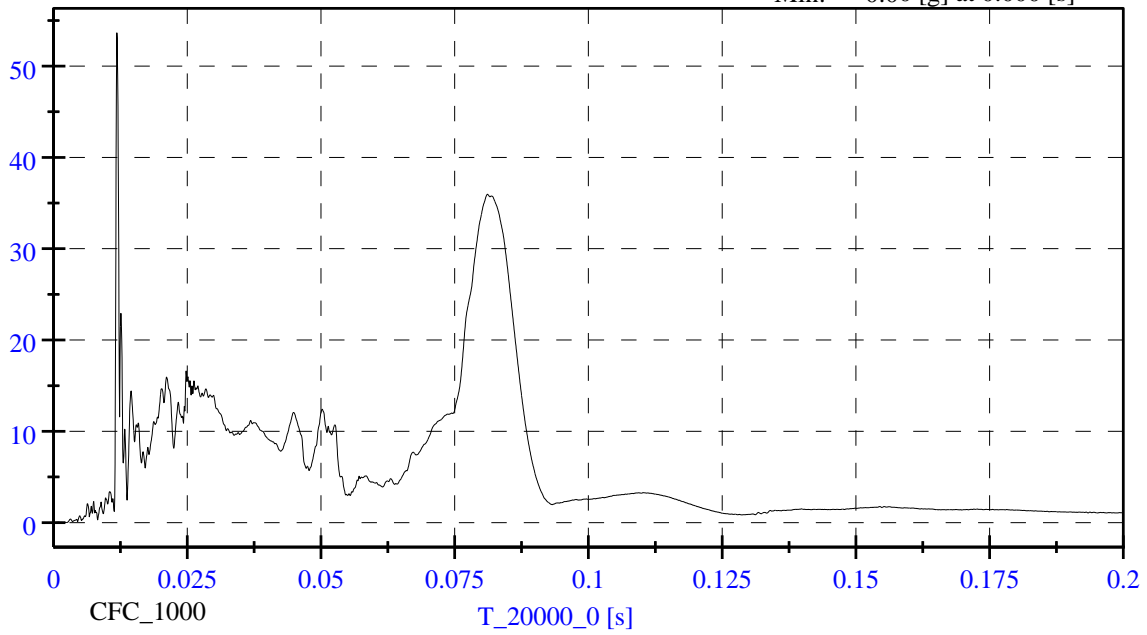
V1P2 Headform Resultant [g, CFC_1000]

Max: 53.64 [g] at 0.012 [s]

Min: 0.00 [g] at 0.000 [s]

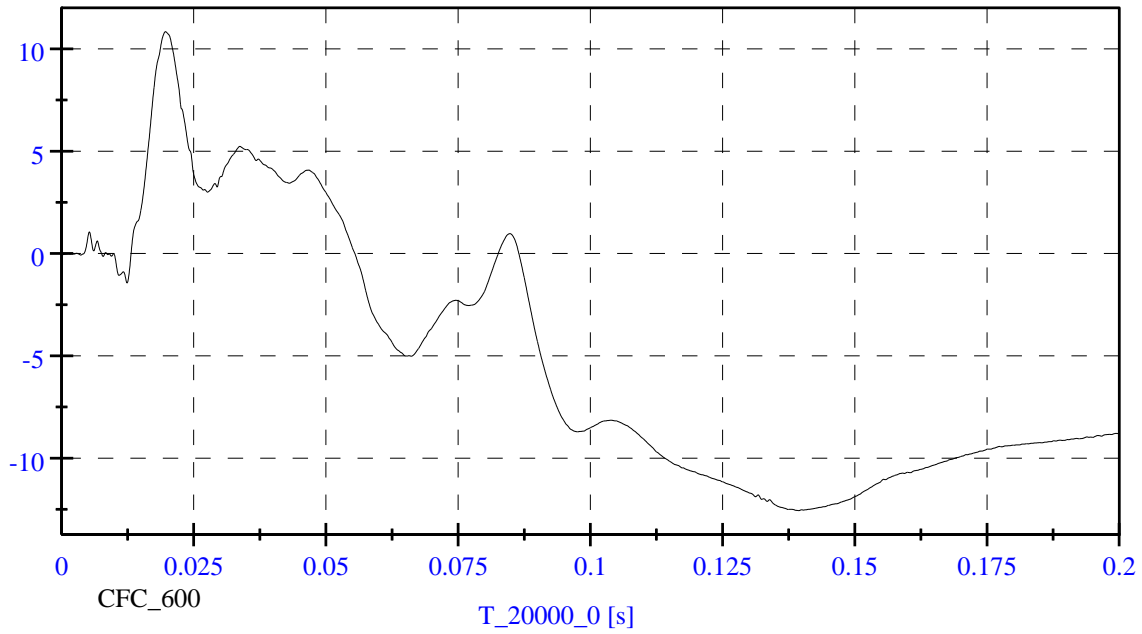
V1P2 Upper Neck Mocy [N-m, CFC_600]

Max: 10.84 [N-m] at 0.020 [s]

Min: -12.56 [N-m] at 0.139 [s]

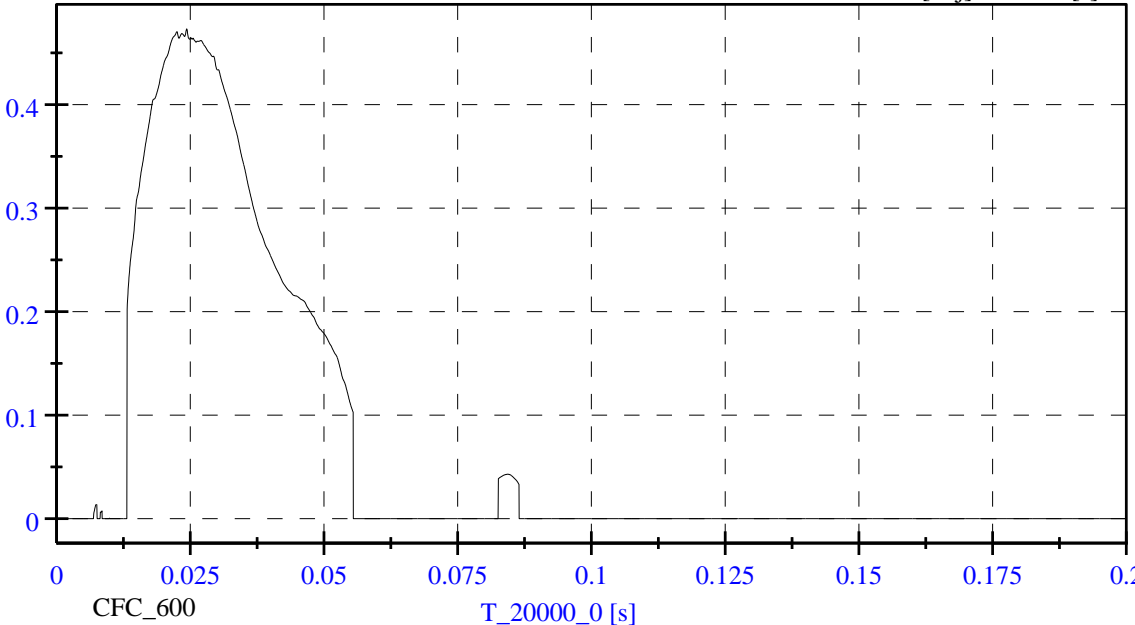
V1P2 Upper Neck Ncf [N-m, CFC_600]

Max: 0.47 [Nij] at 0.024 [s]
Min: 0.00 [Nij] at 0.000 [s]

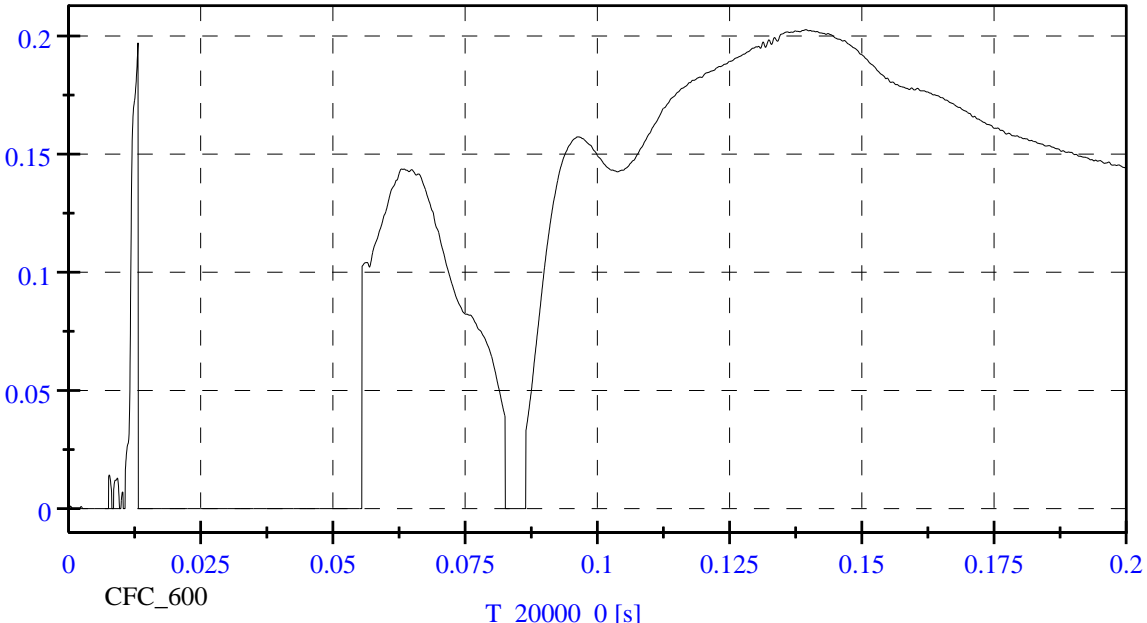
V1P2 Upper Neck Nce [N-m, CFC_600]

Max: 0.20 [Nij] at 0.139 [s]
Min: 0.00 [Nij] at 0.000 [s]

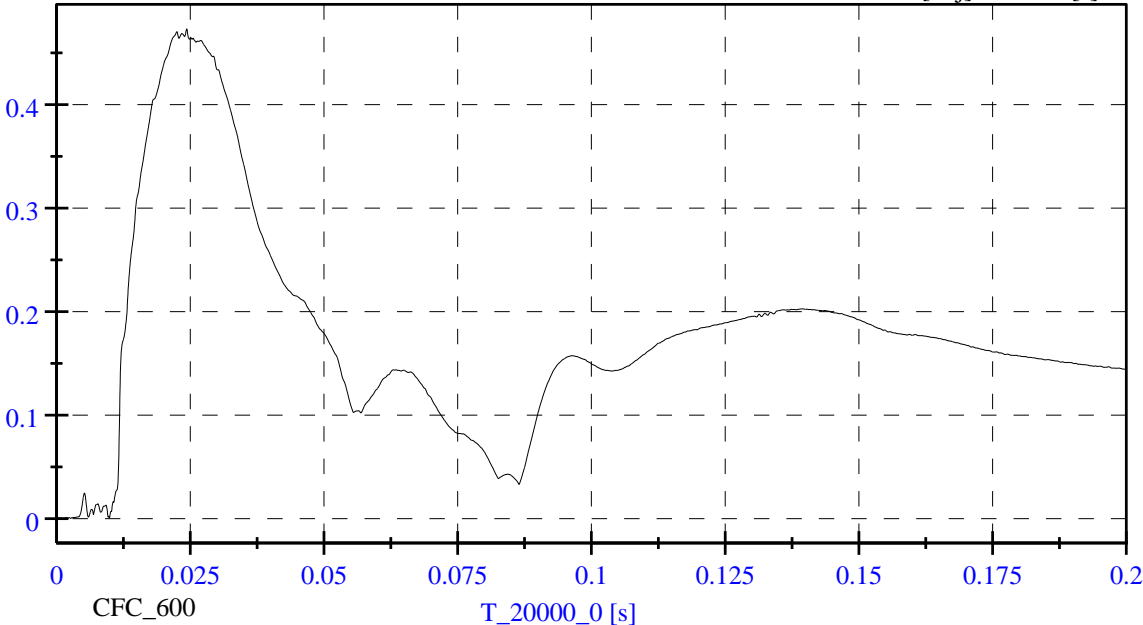
V1P2 Upper Neck Nij [Nij, CFC_600]

Max: 0.47 [Nij] at 0.024 [s]
Min: 0.00 [Nij] at 0.000 [s]

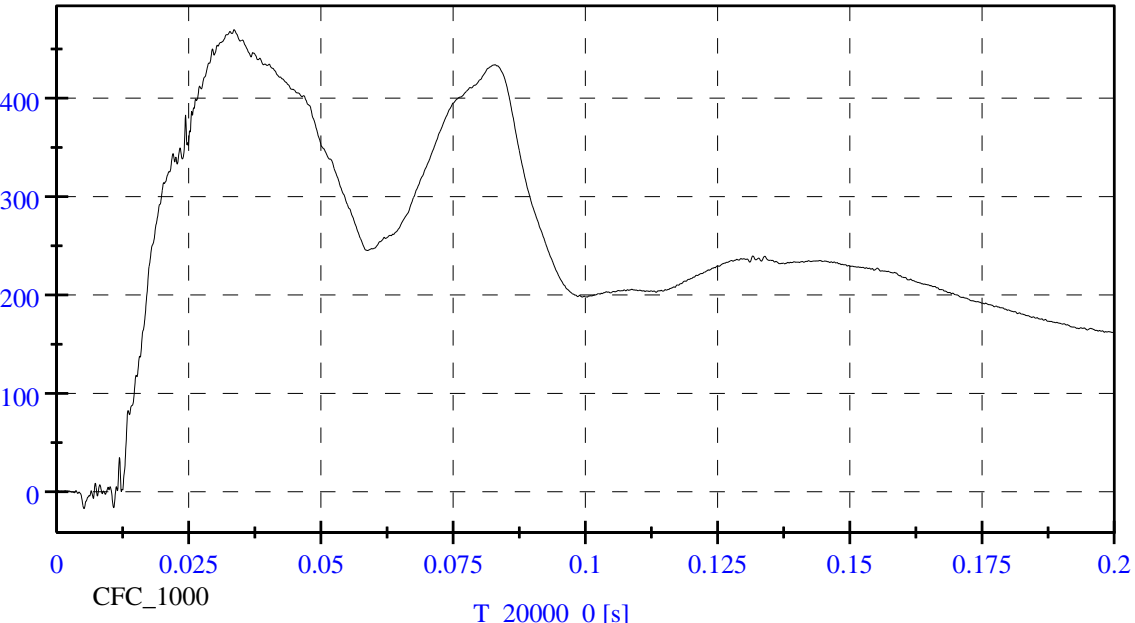
V1P2 Upper Neck Fx [N, CFC_1000]

Max: 469.63 [N] at 0.034 [s]
Min: -17.09 [N] at 0.005 [s]

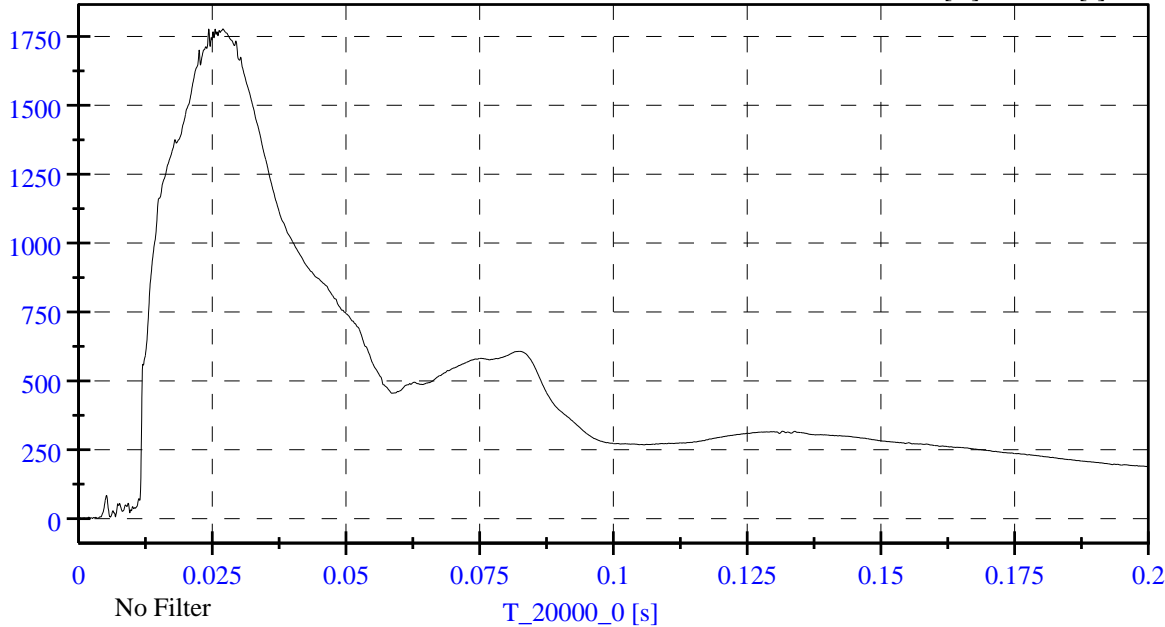
Input: V1P2 NEKU Fx F (32), V1P2 NEKU Fy F (33)...

Max: 1777.34 [N] at 0.027 [s]

Min: 0.00 [N] at 0.000 [s]

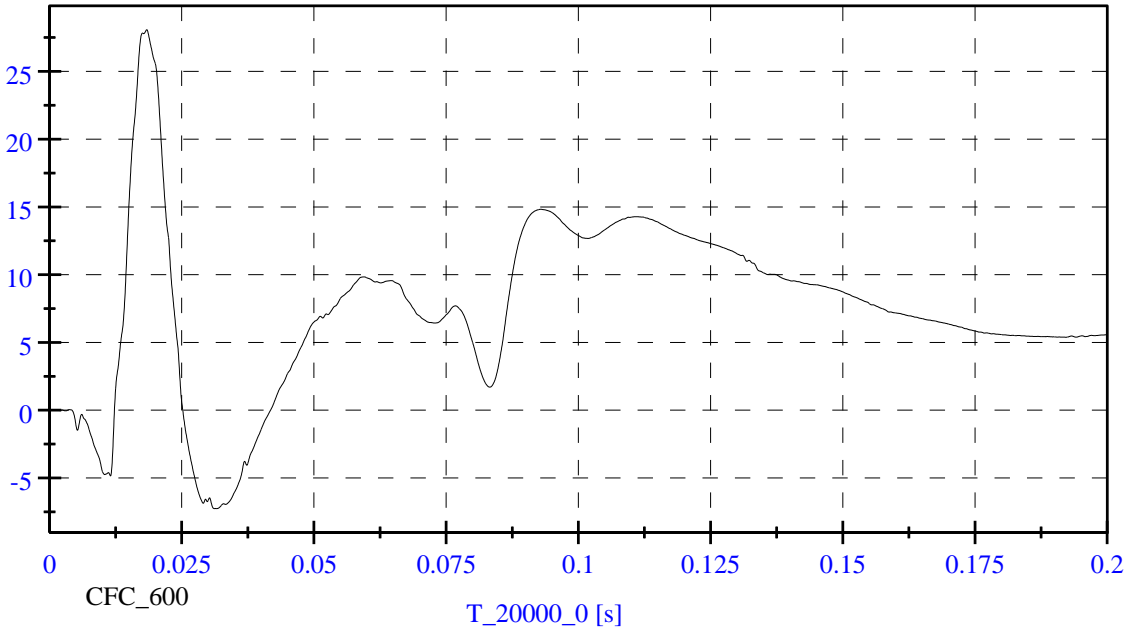
V1P2 Upper Neck Mx [N-m , CFC_600]

Max: 28.08 [N-m] at 0.018 [s]

Min: -7.26 [N-m] at 0.031 [s]

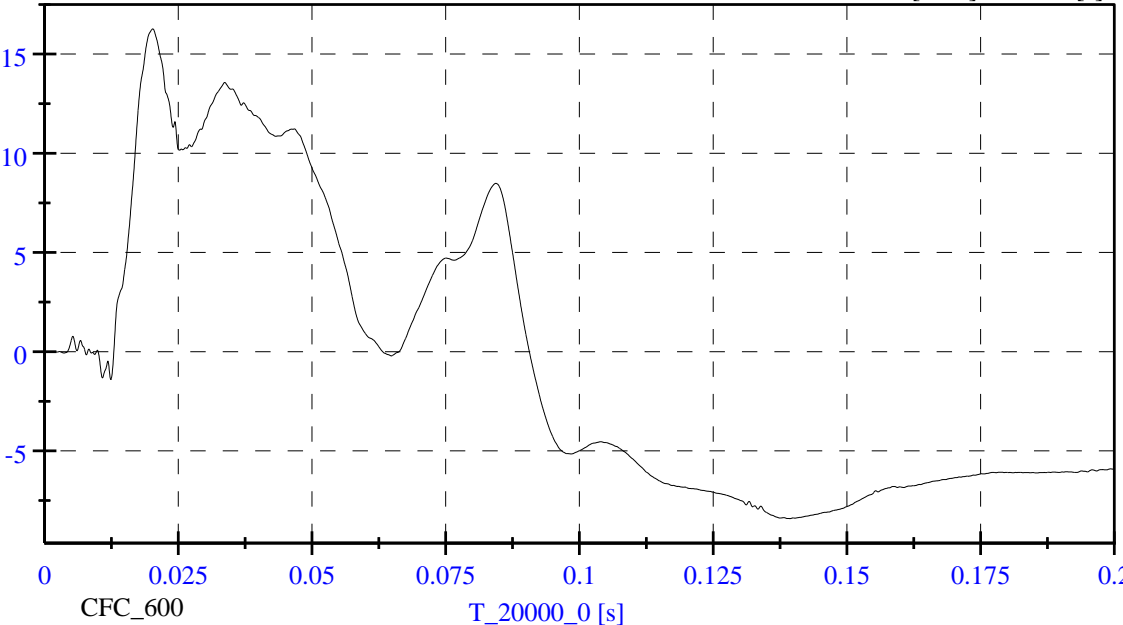
V1P2 Upper Neck My [N-m , CFC_600]

Max: 16.27 [N-m] at 0.020 [s]
Min: -8.41 [N-m] at 0.139 [s]

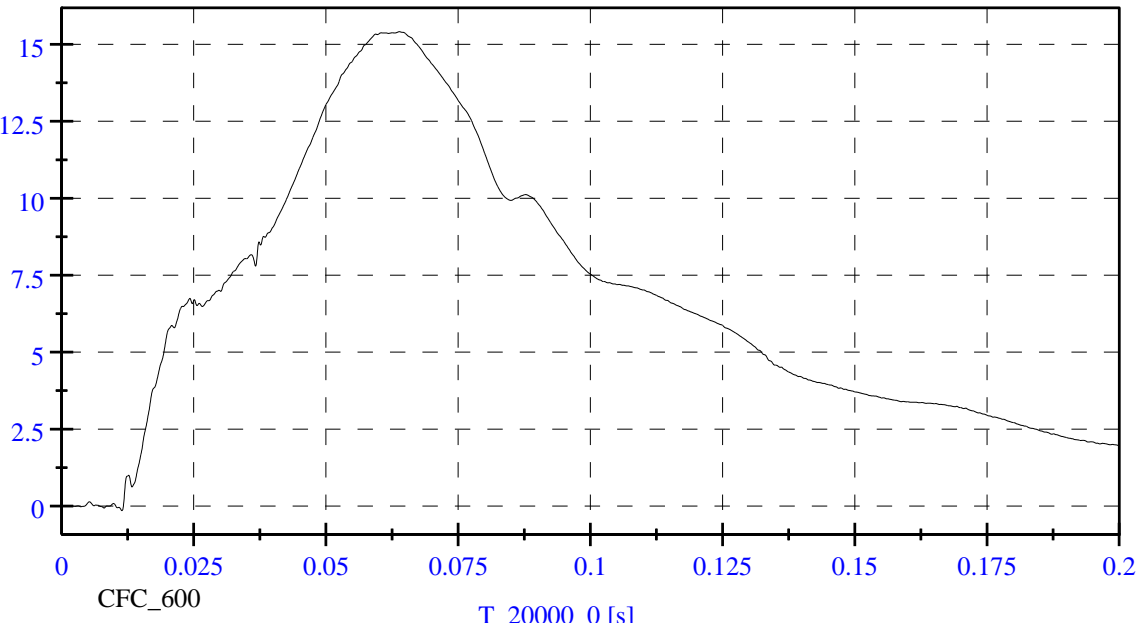
V1P2 Upper Neck Mz [N-m , CFC_600]

Max: 15.41 [N-m] at 0.064 [s]
Min: -0.15 [N-m] at 0.011 [s]

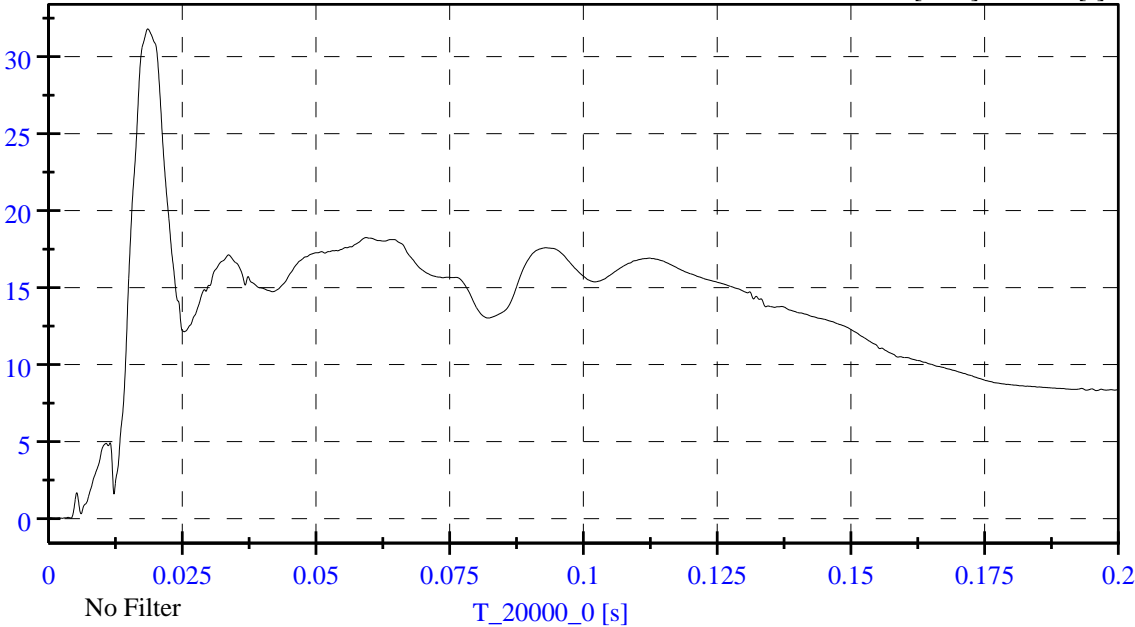
Input: V1P2 NEKU Mx F (35), V1P2 NEKU My F (36)...

Max: 31.80 [N-m] at 0.019 [s]

Min: 0.00 [N-m] at 0.000 [s]

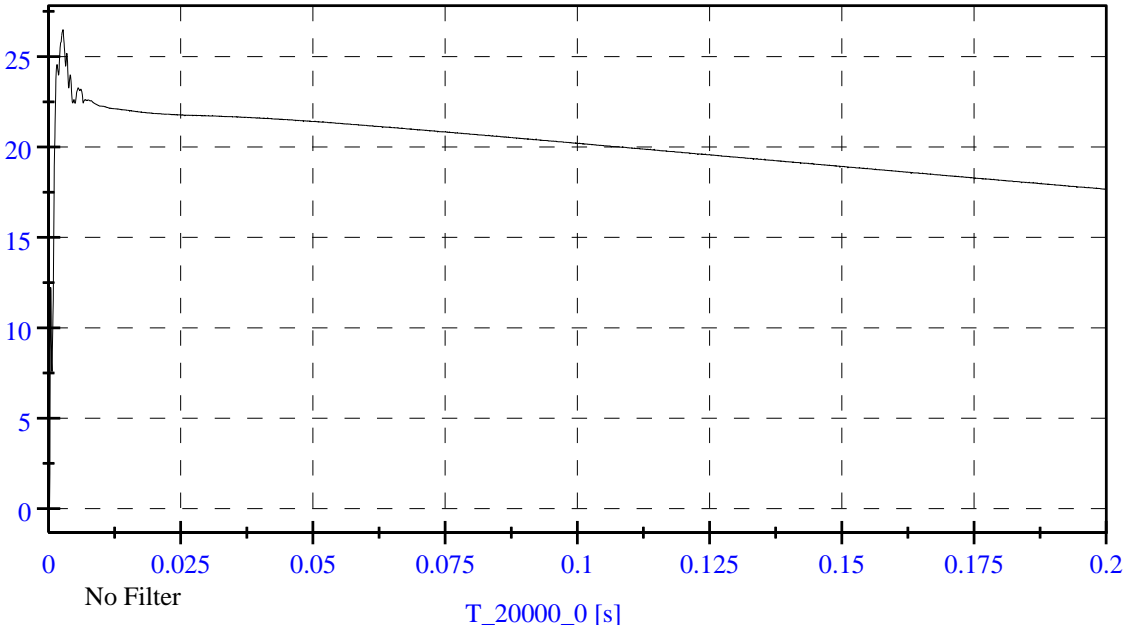
Curtain Volts

Max: 26.49 [V] at 0.003 [s]

Min: 0.00 [V] at 0.000 [s]
