**REPORT NUMBER: SPNCAP-MGA-2012-062**

**NEW CAR ASSESSMENT PROGRAM (NCAP)  
Side Impact Pole Test**

**FUJI HEAVY INDUSTRIES LTD.  
2012 Subaru Impreza 4-Dr Sedan  
NHTSA No.: MC5505**

**MGA RESEARCH CORPORATION  
5000 Warren Road  
Burlington, WI 53105**

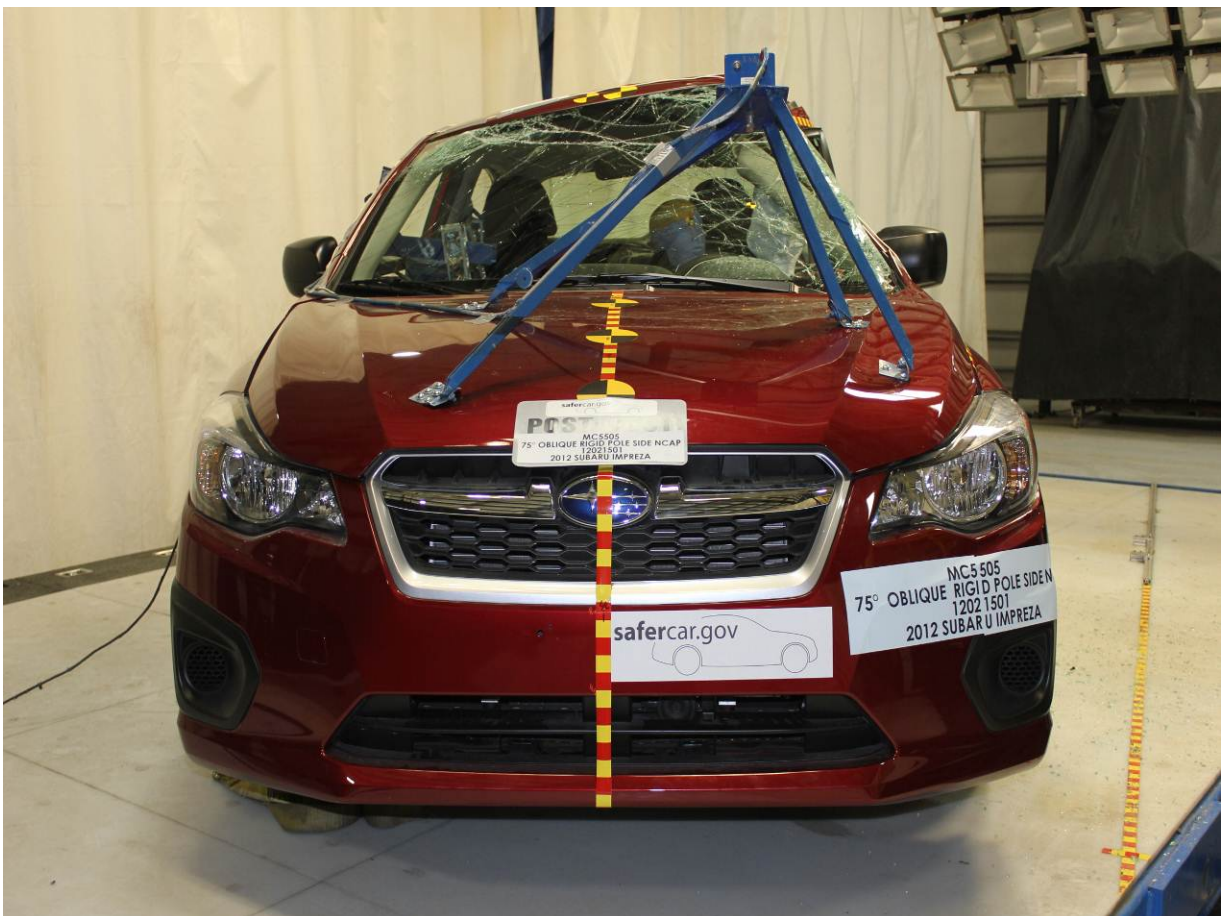
Post-Test Frontal View of Test Vehicle

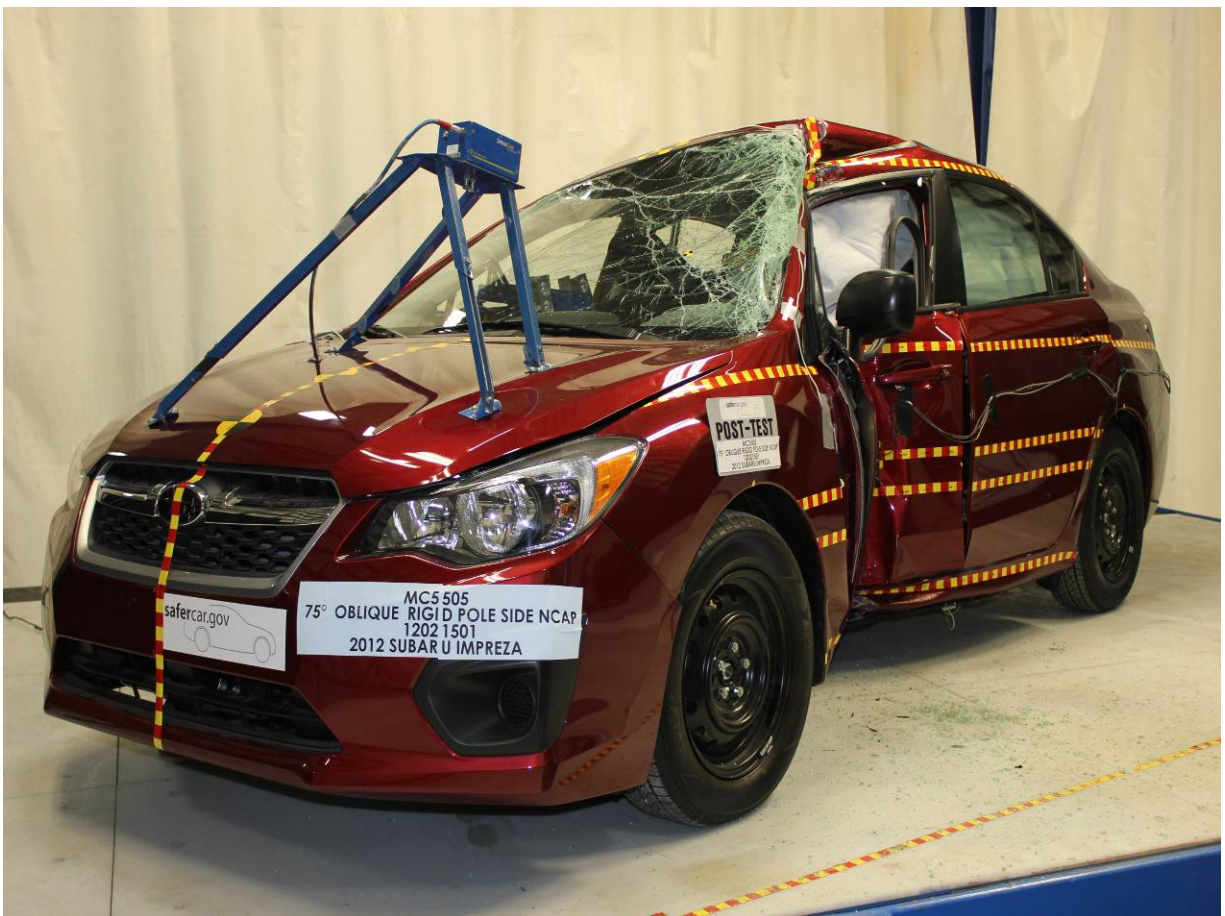
Post-Test Left Front  $\frac{3}{4}$  View of Test Vehicle

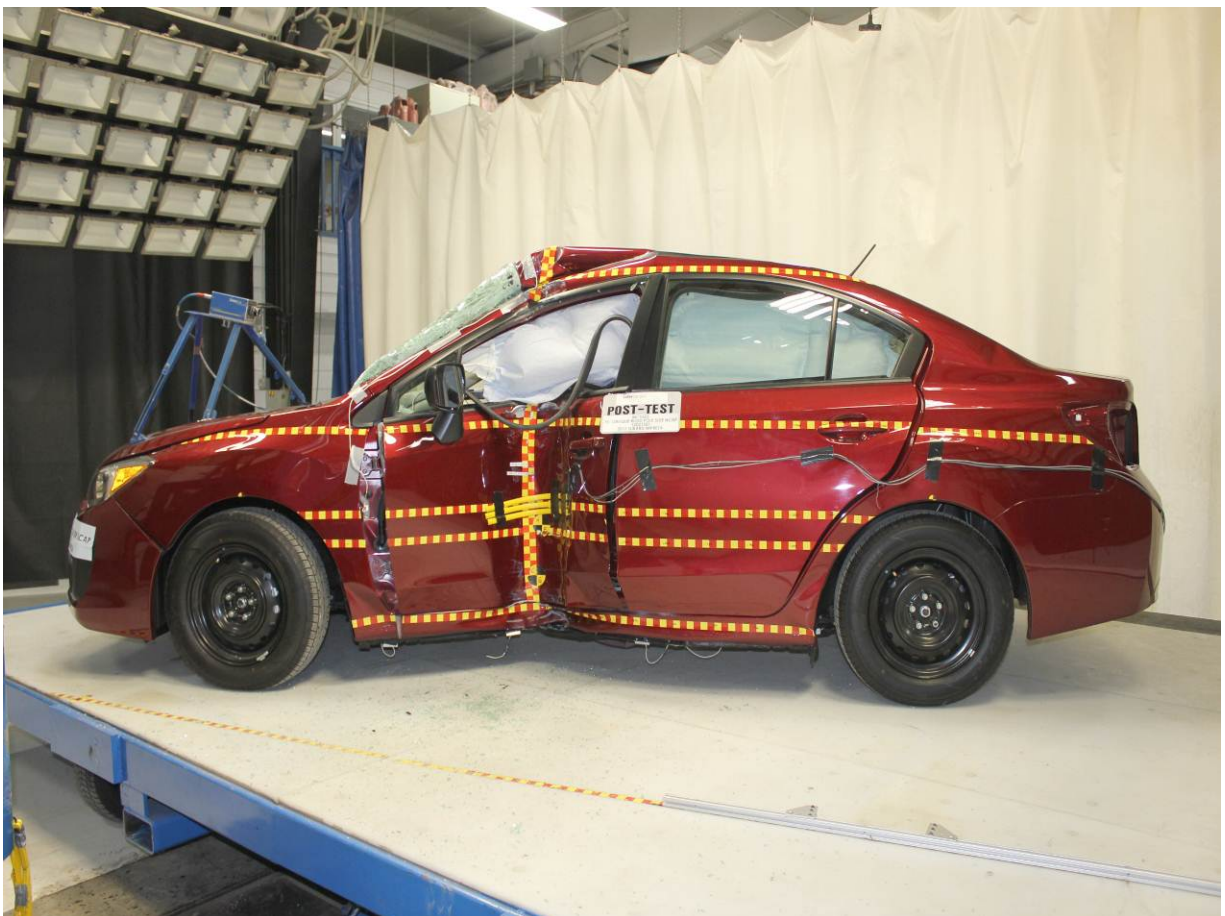
Post-Test Left Side View of Test Vehicle

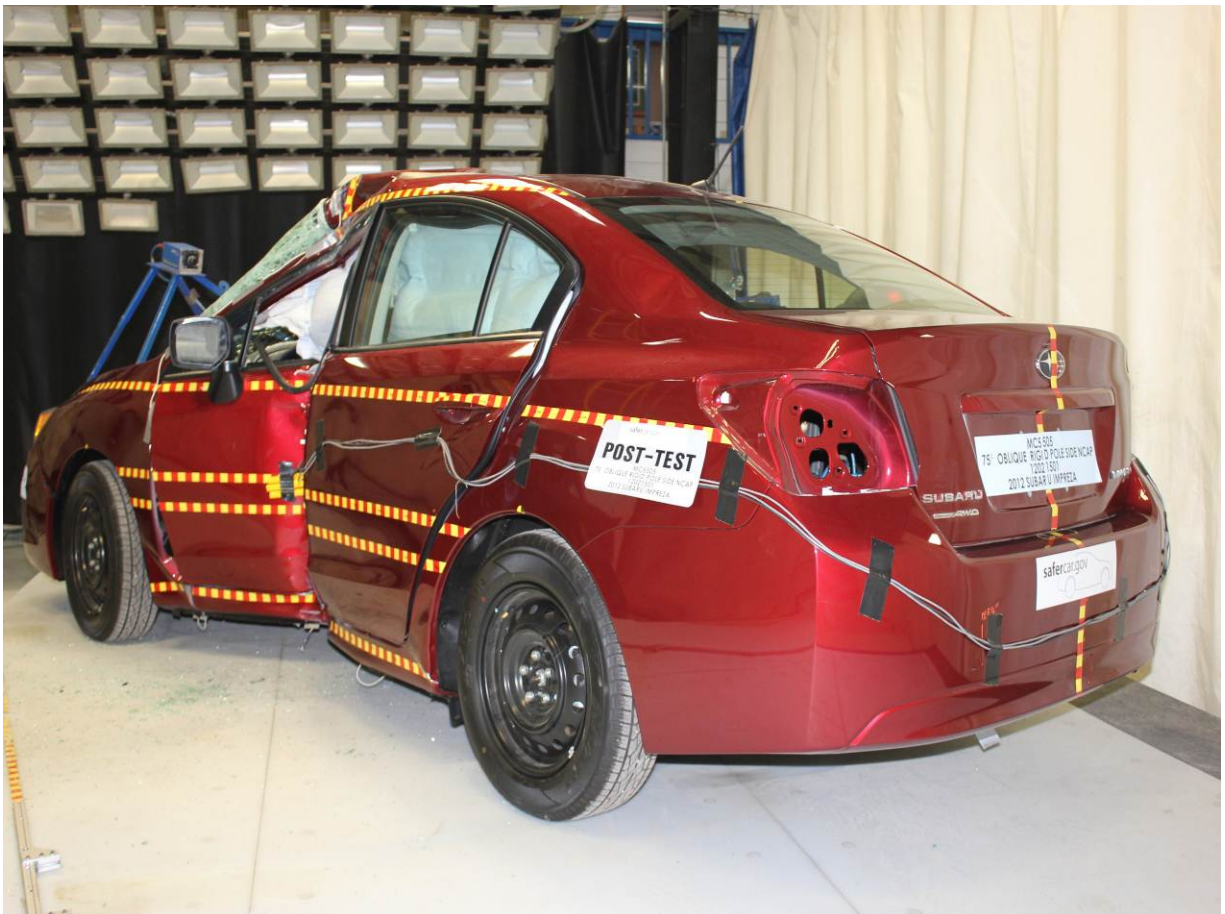
Post-Test Left Rear  $\frac{3}{4}$  View of Test Vehicle

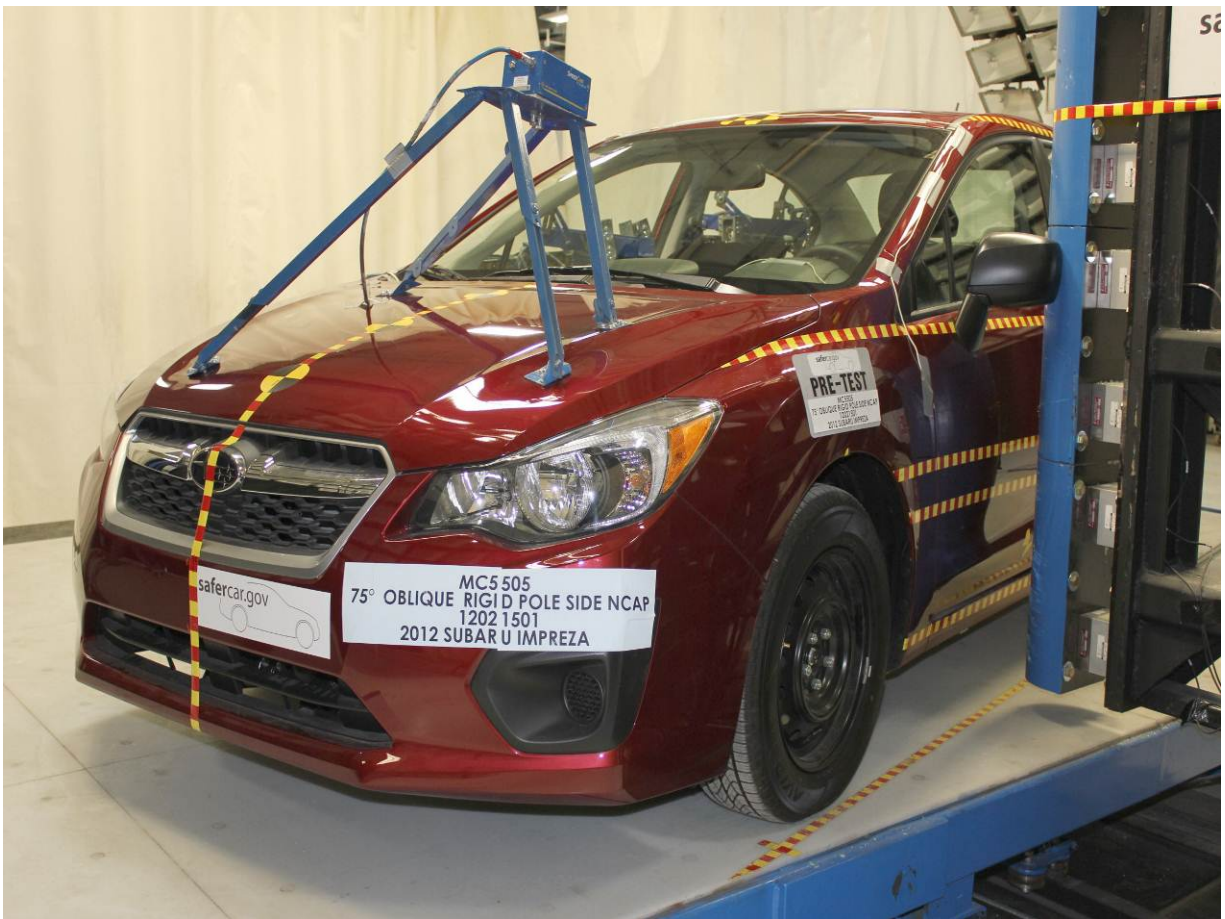
Pre-Test Left Side View of Pole Positioned Against Side of Vehicle

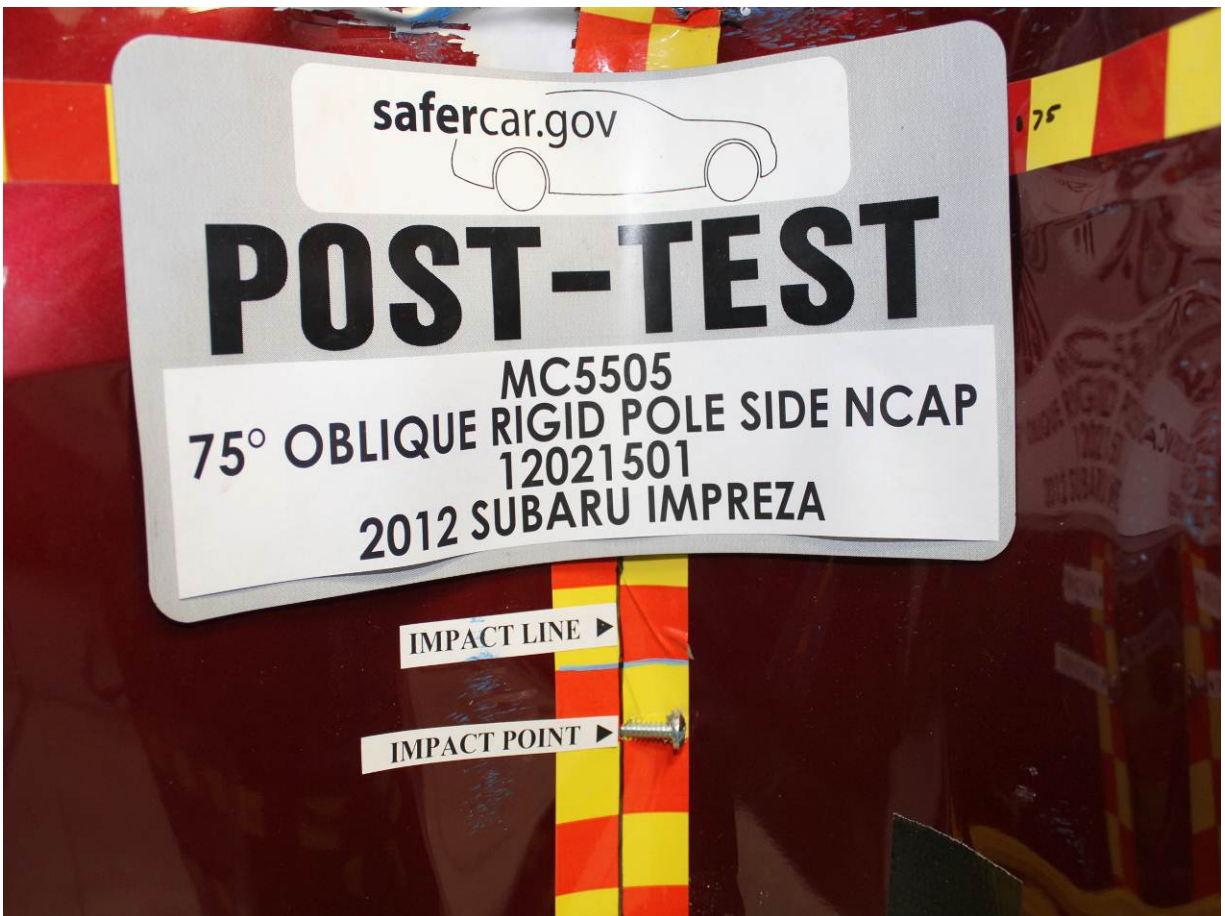
Post-Test Close-Up View of Impact Point Target Showing Impact Location

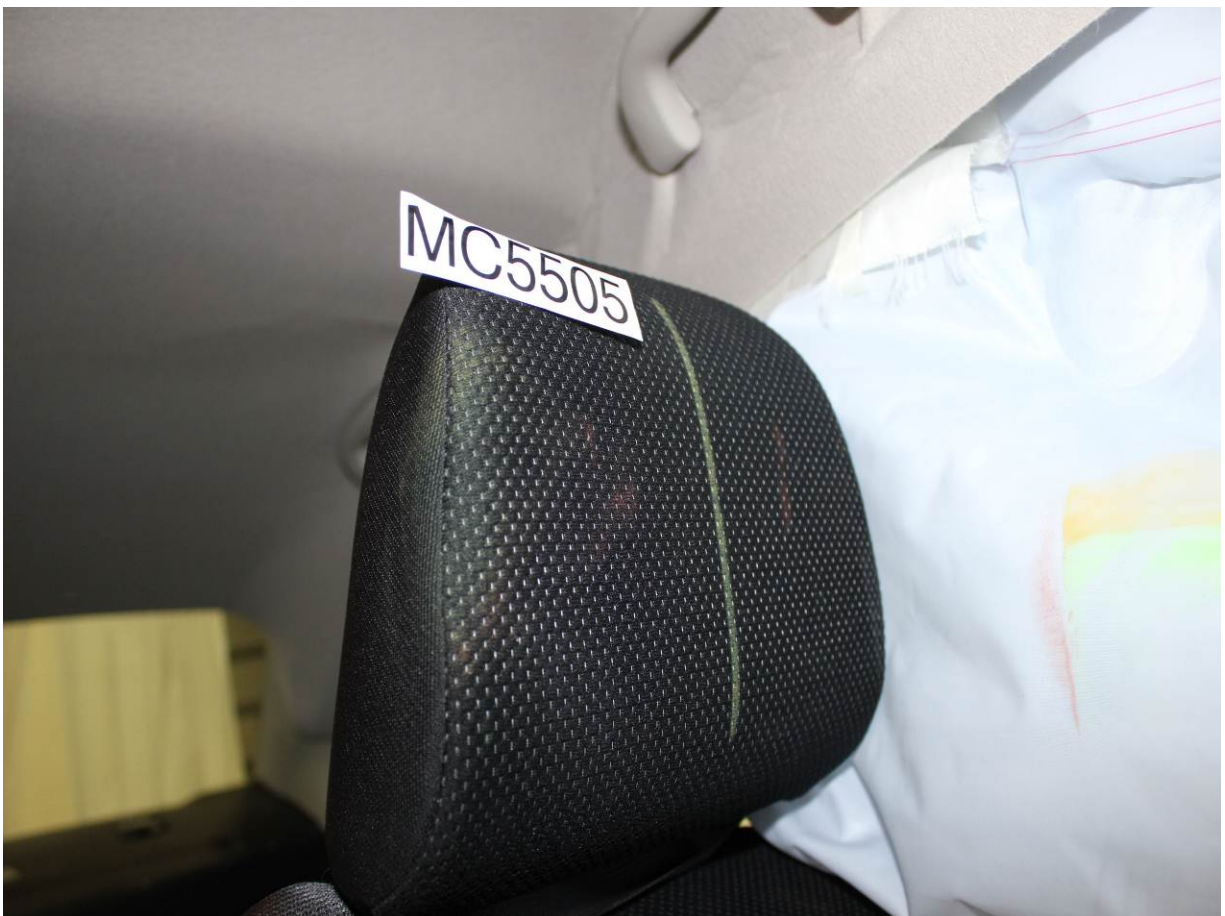
Post-Test Dummy Close-Up Head Contact with Vehicle Interior View

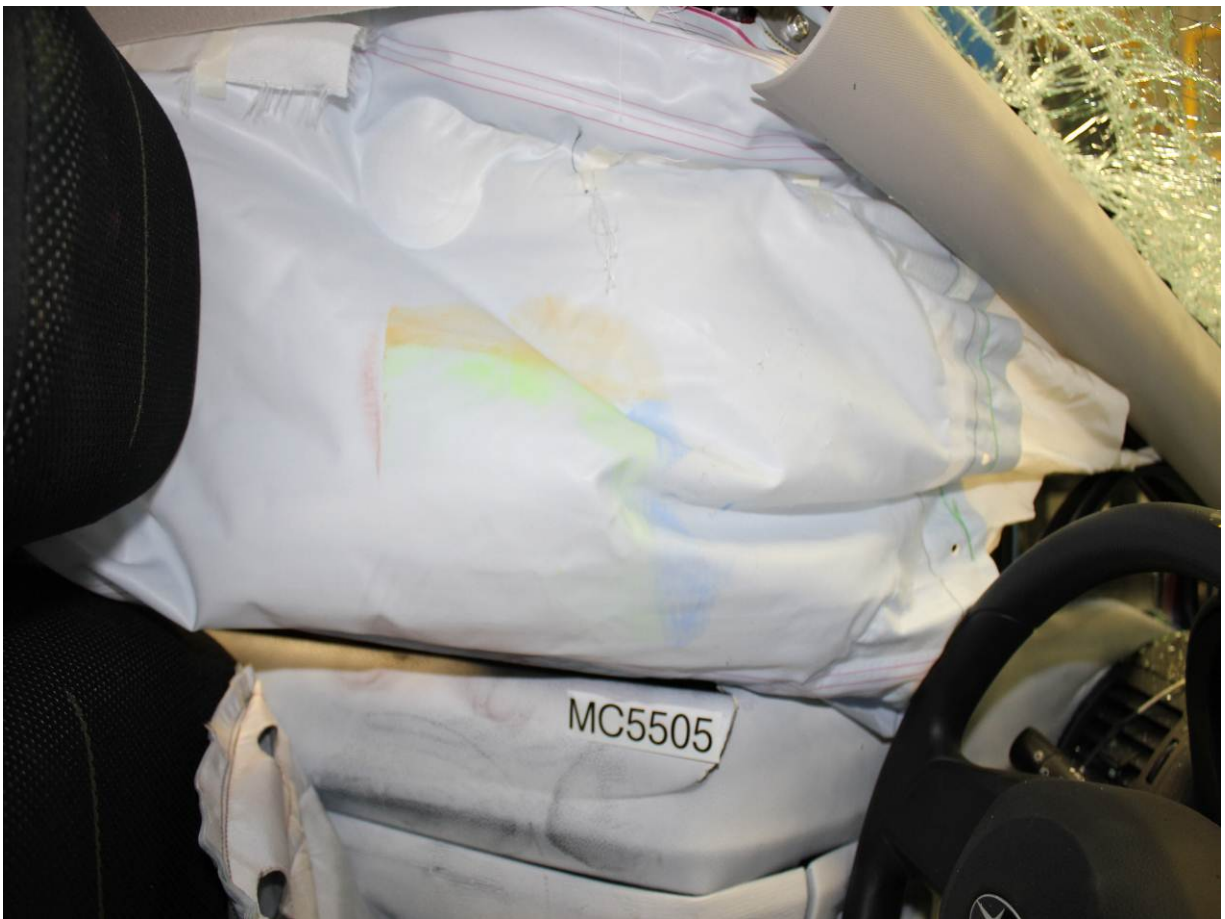
Post-Test Dummy Close-Up Head Contact with Side Air Bag View

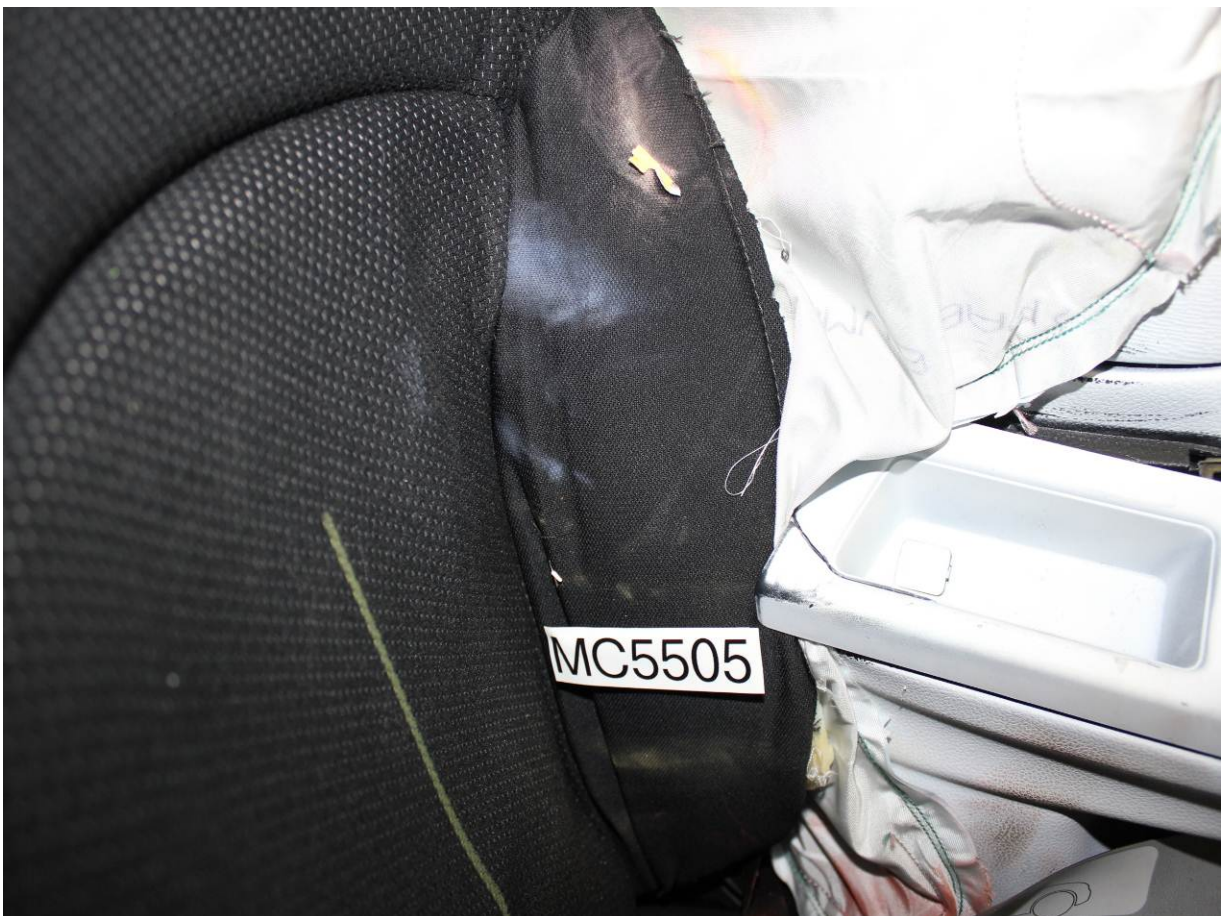
Post-Test Dummy Close-Up Torso Contact with Vehicle Interior View

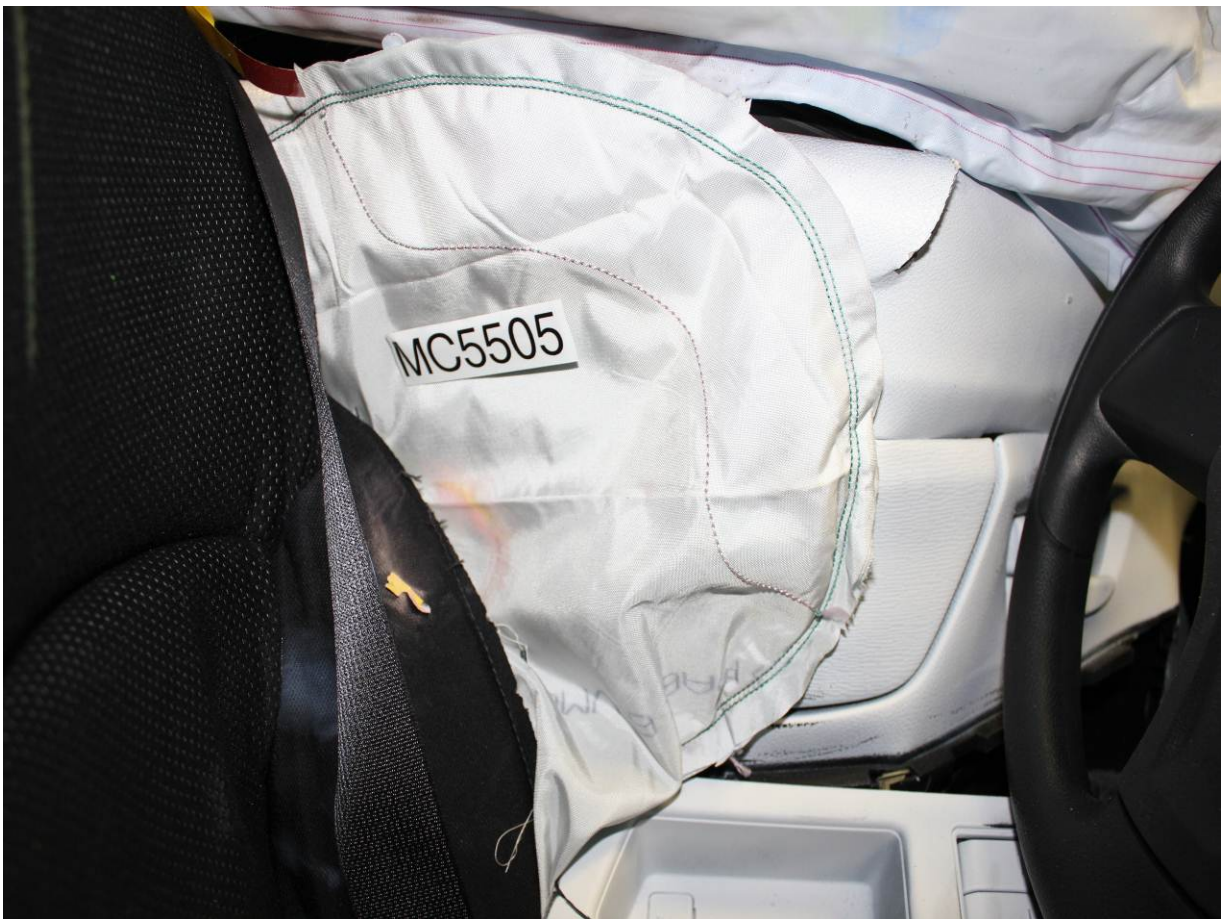
Post-Test Dummy Close-Up Torso Contact with Side Air Bag View

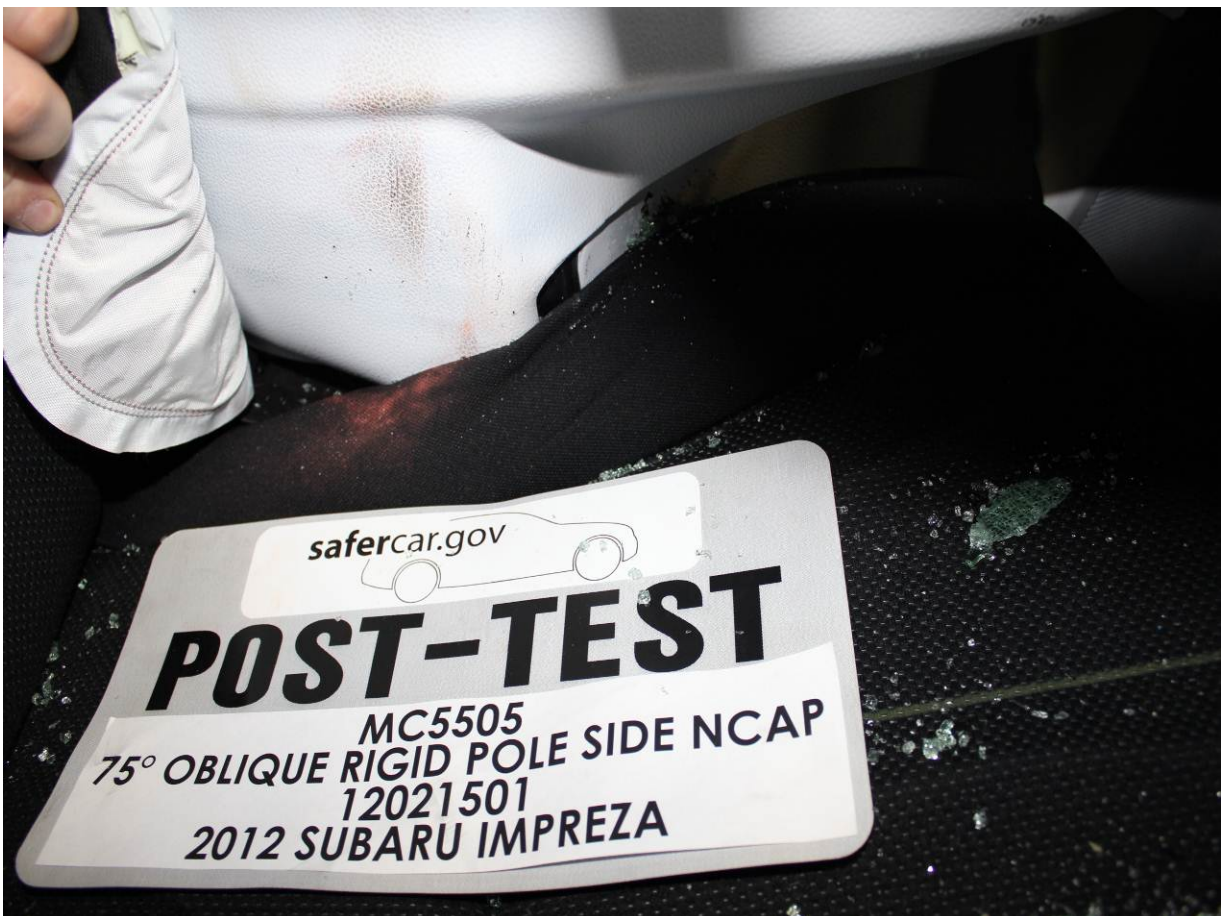
Post-Test Dummy Close-Up Pelvis Contact with Vehicle Interior View

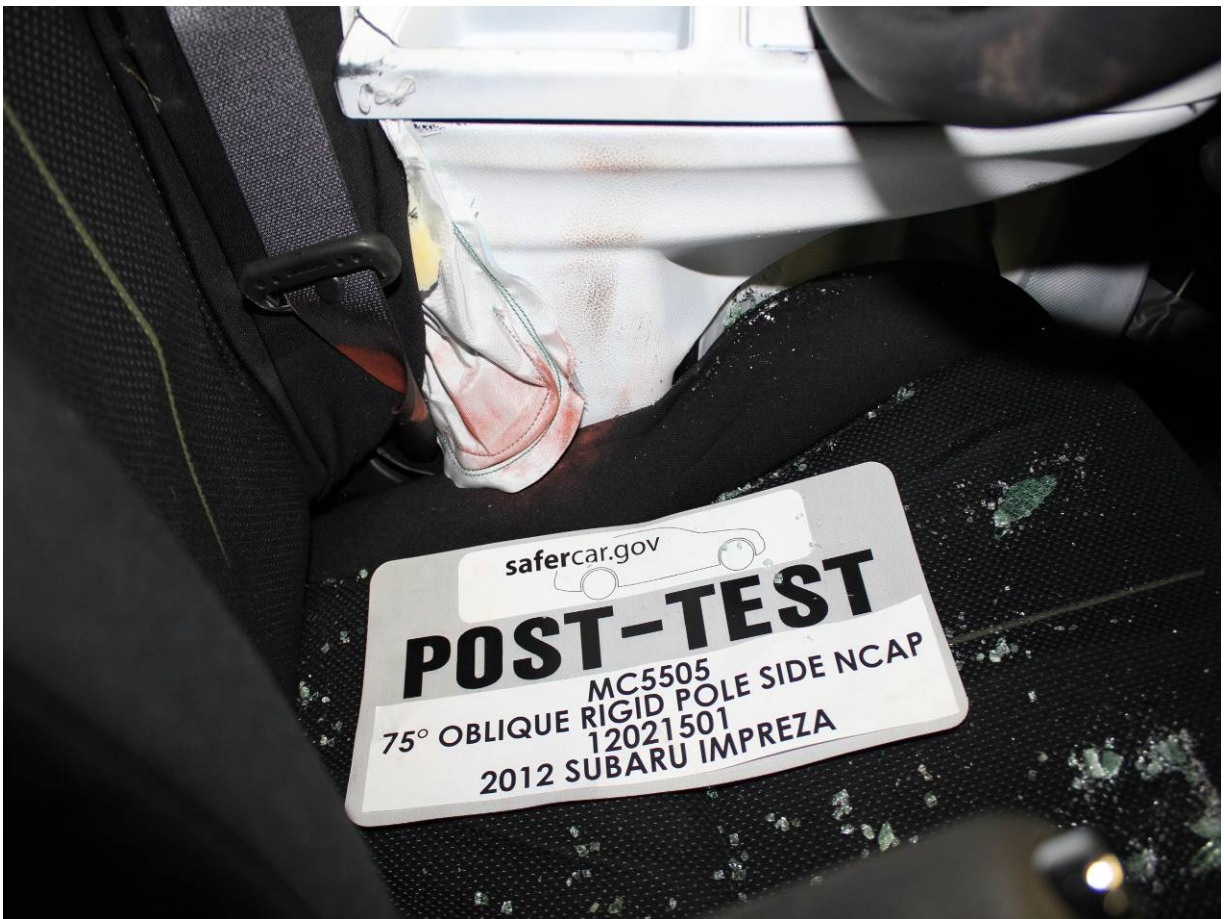
Post-Test Dummy Close-Up Pelvis Contact with Side Air Bag View
