**REPORT NUMBER: SPNCAP-MCW-12-09**

**NEW CAR ASSESSMENT PROGRAM (SPNCAP)  
SIDE IMPACT POLE TEST**

**HONDA OF AMERICA MFG. INC.  
2012 HONDA CR-V 5-DOOR SUV**

**FINAL REPORT**

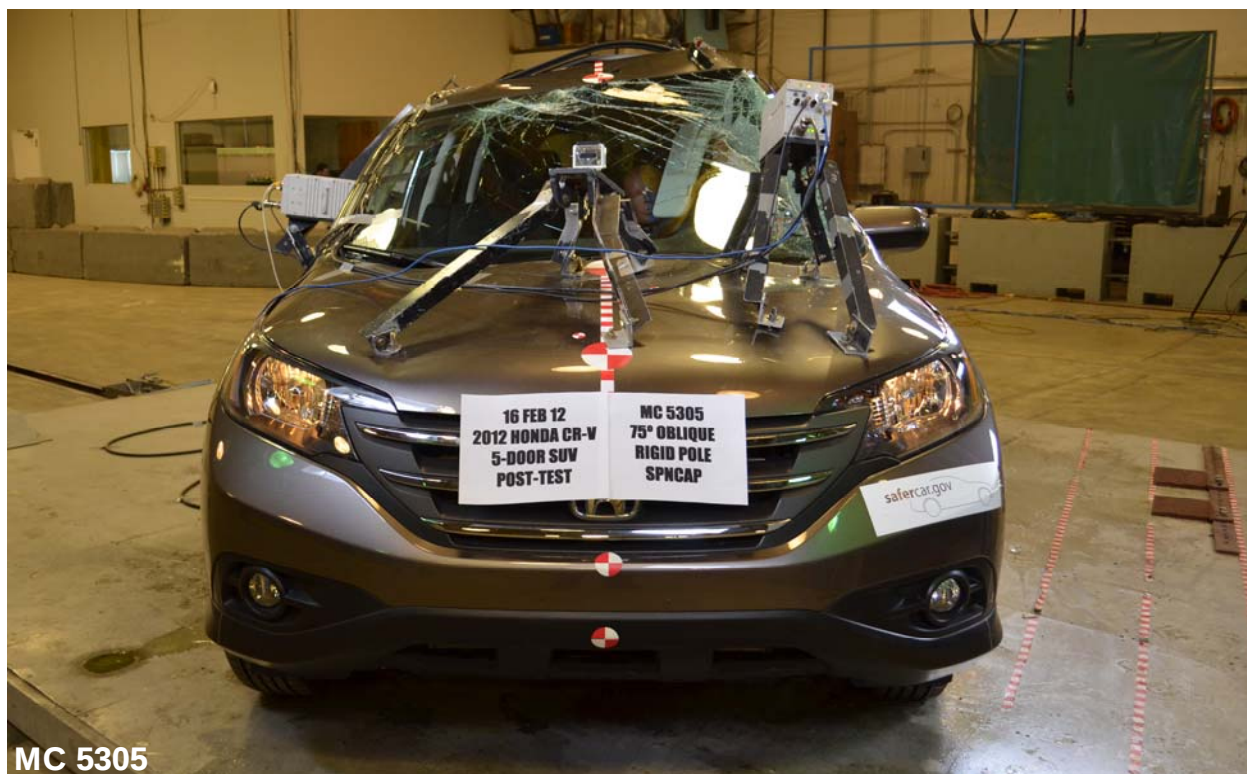
Figure 004: Post-Test Frontal View of Test Vehicle

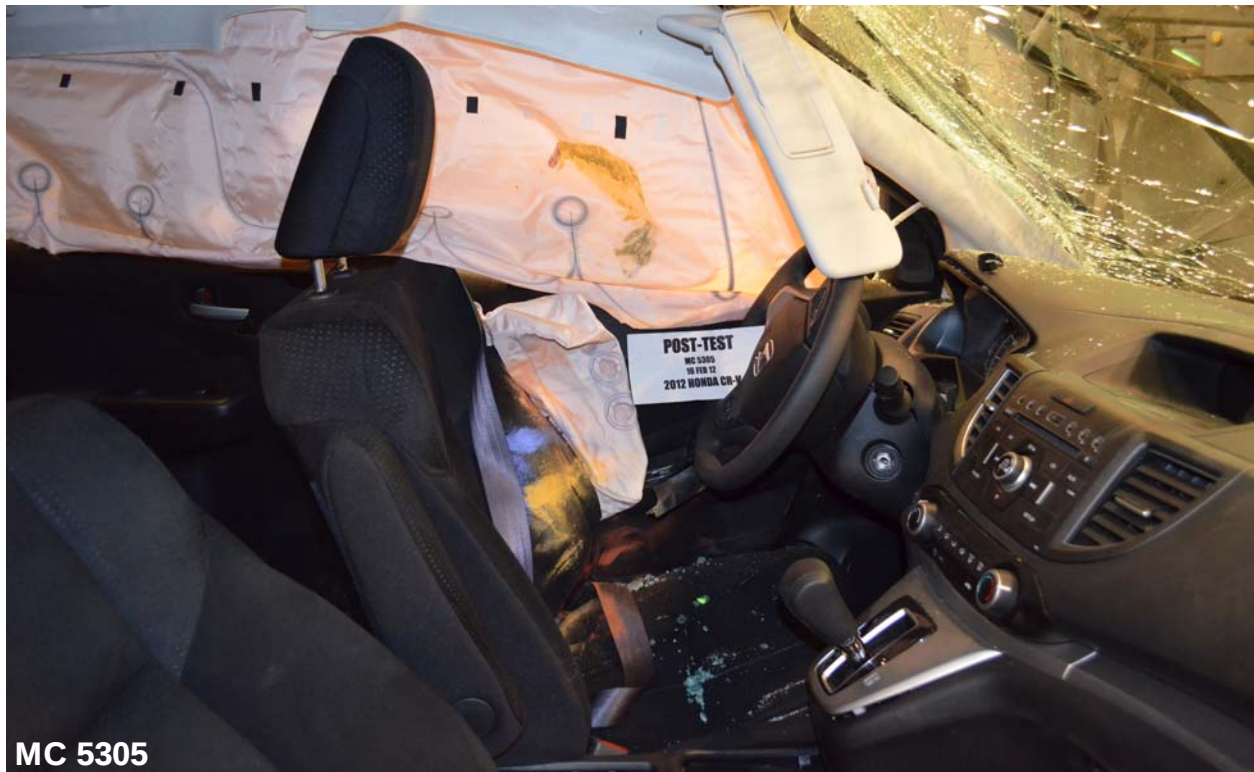
Figure 045: Post-Test Inner Door Panel View Showing Dummy Contact Locations

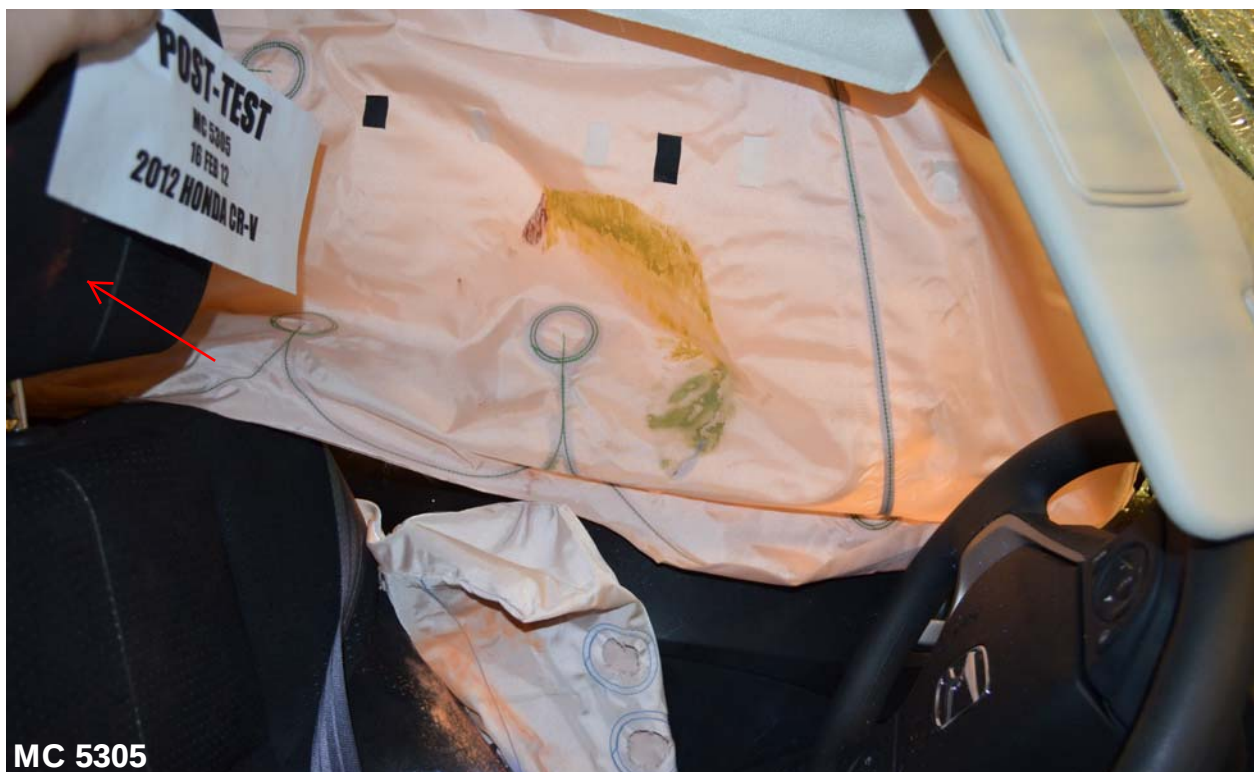
Figure 046 Post-Test Dummy Close-Up Head Contact with Vehicle Interior View

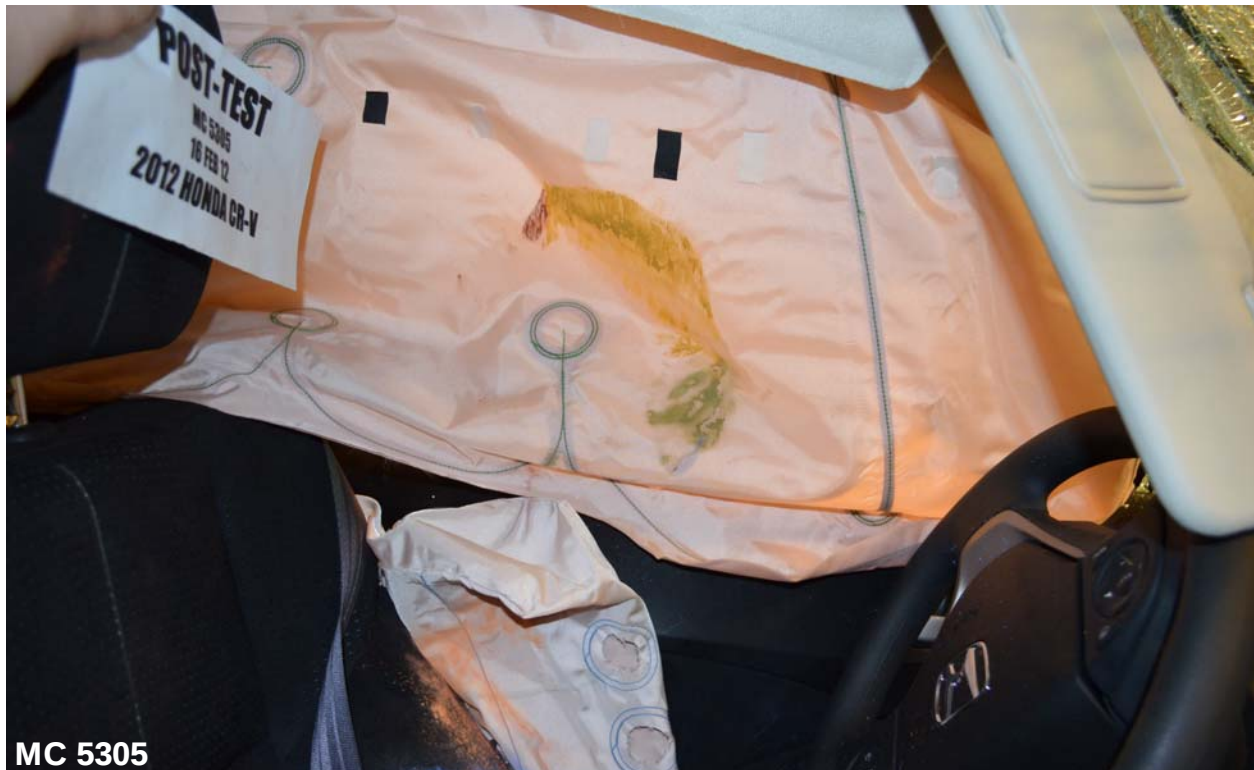
Figure 047: Post-Test Dummy Close-Up Head Contact with Side Air bag View

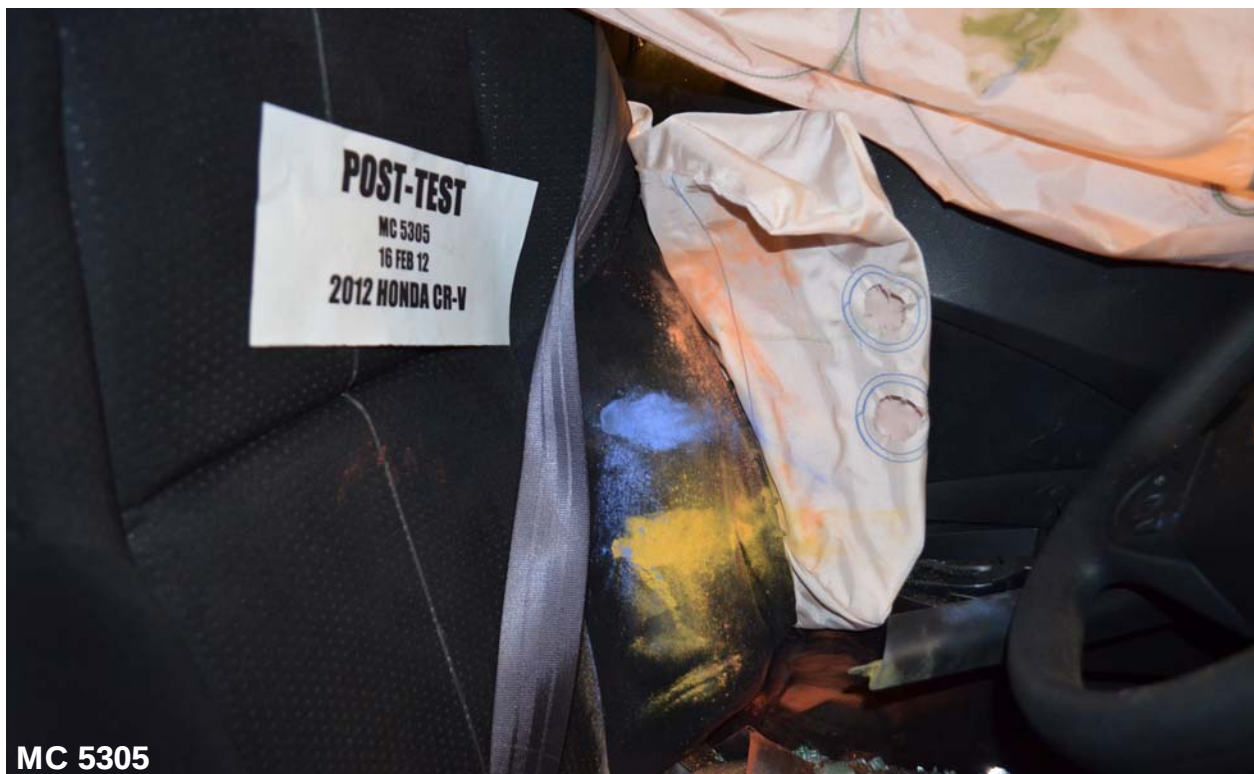
Figure 048: Post-Test Dummy Close-Up Torso Contact with Vehicle Interior View

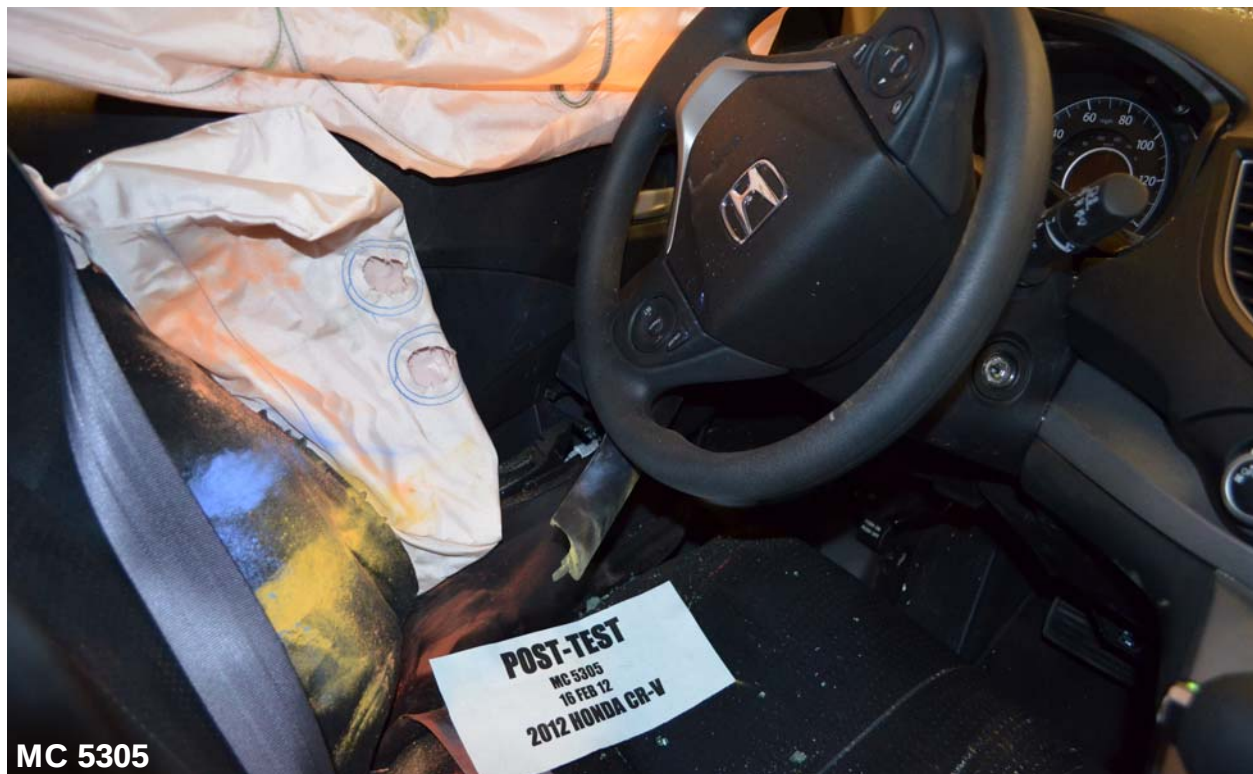
Figure 049: Post-Test Dummy Close-Up Torso Contact with Side Air bag View

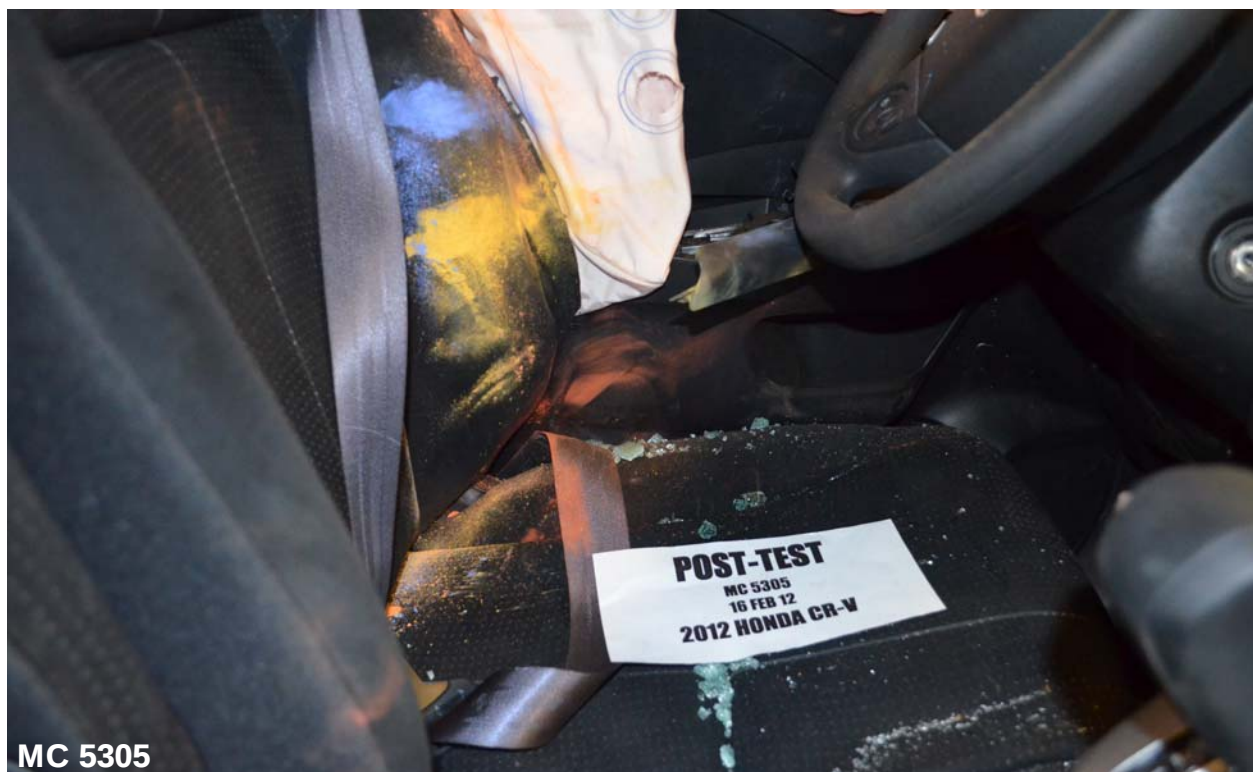
Figure 050: Post-Test Dummy Close-Up Pelvis Contact with Vehicle Interior View

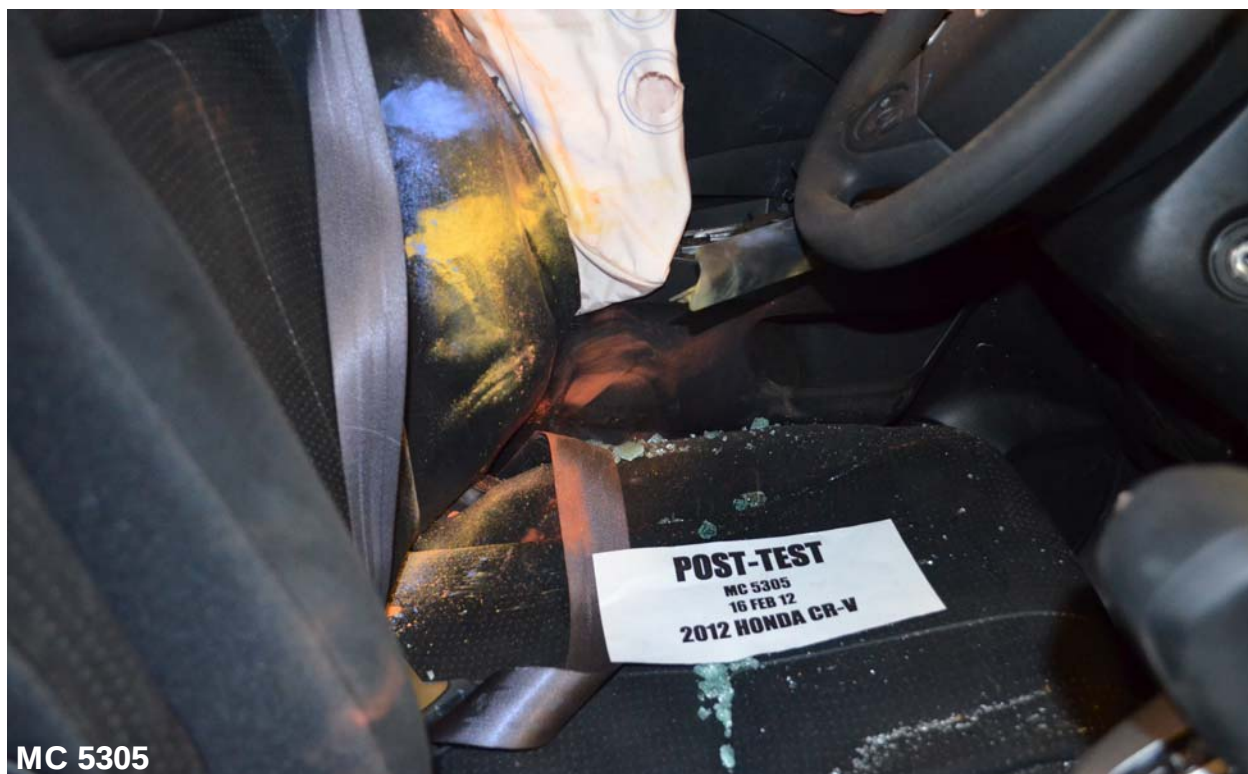
Figure 051: Post-Test Dummy Close-Up Pelvis Contact with Side Air bag View
