REPORT NUMBER: TWG-CAL-12-02

**NEW CAR ASSESSMENT PROGRAM (NCAP)**  
SIDE AIRBAG OUT-OF-POSITION INJURY TESTING

TOYOTA MOTOR MANUFACTURING, INDIANA, INC.  
2012 TOYOTA SIENNA  
MINIVAN

NHTSA NUMBER: QC5100-TWG2  
CALSPAN TEST NUMBER: CT2012-02

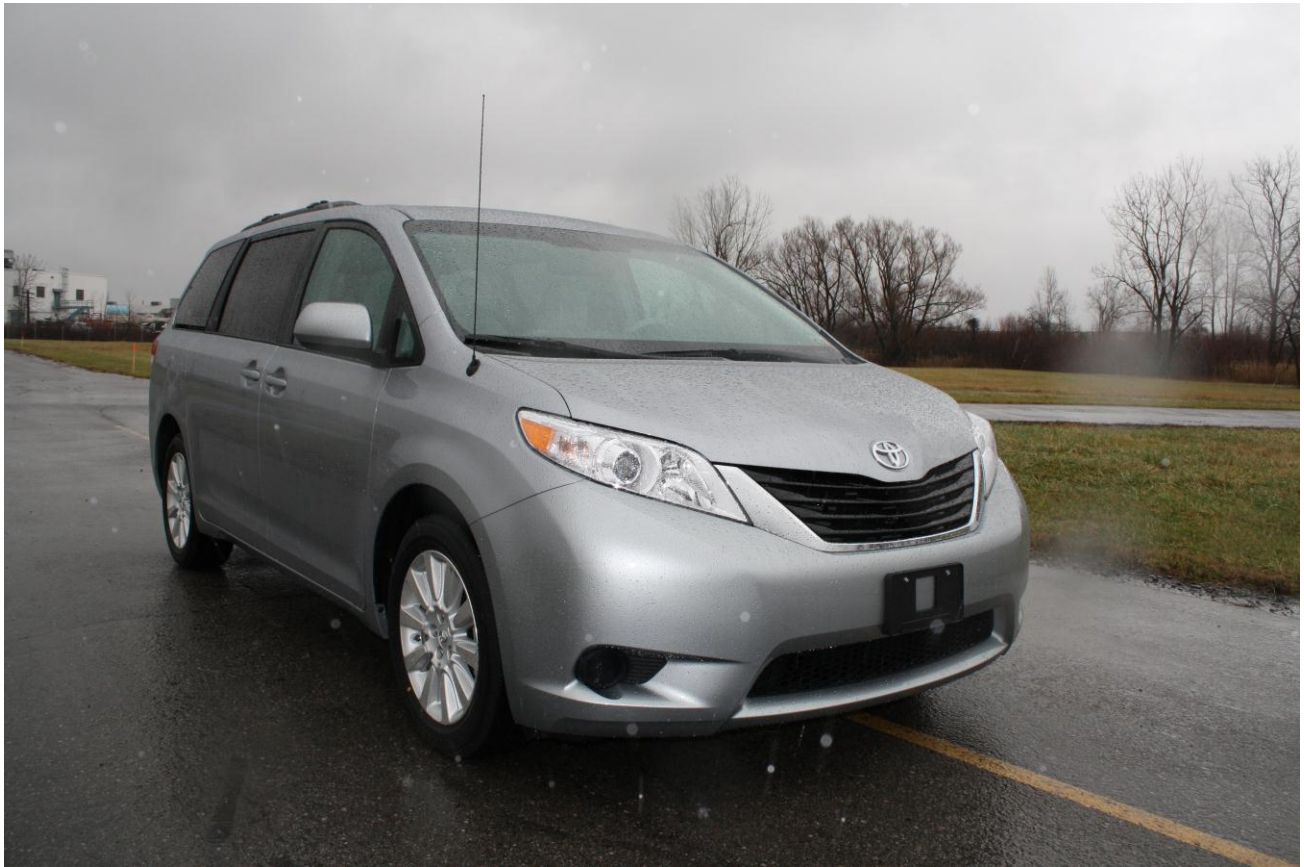
Figure A-1: Right ¾ Front View of Vehicle, As Received

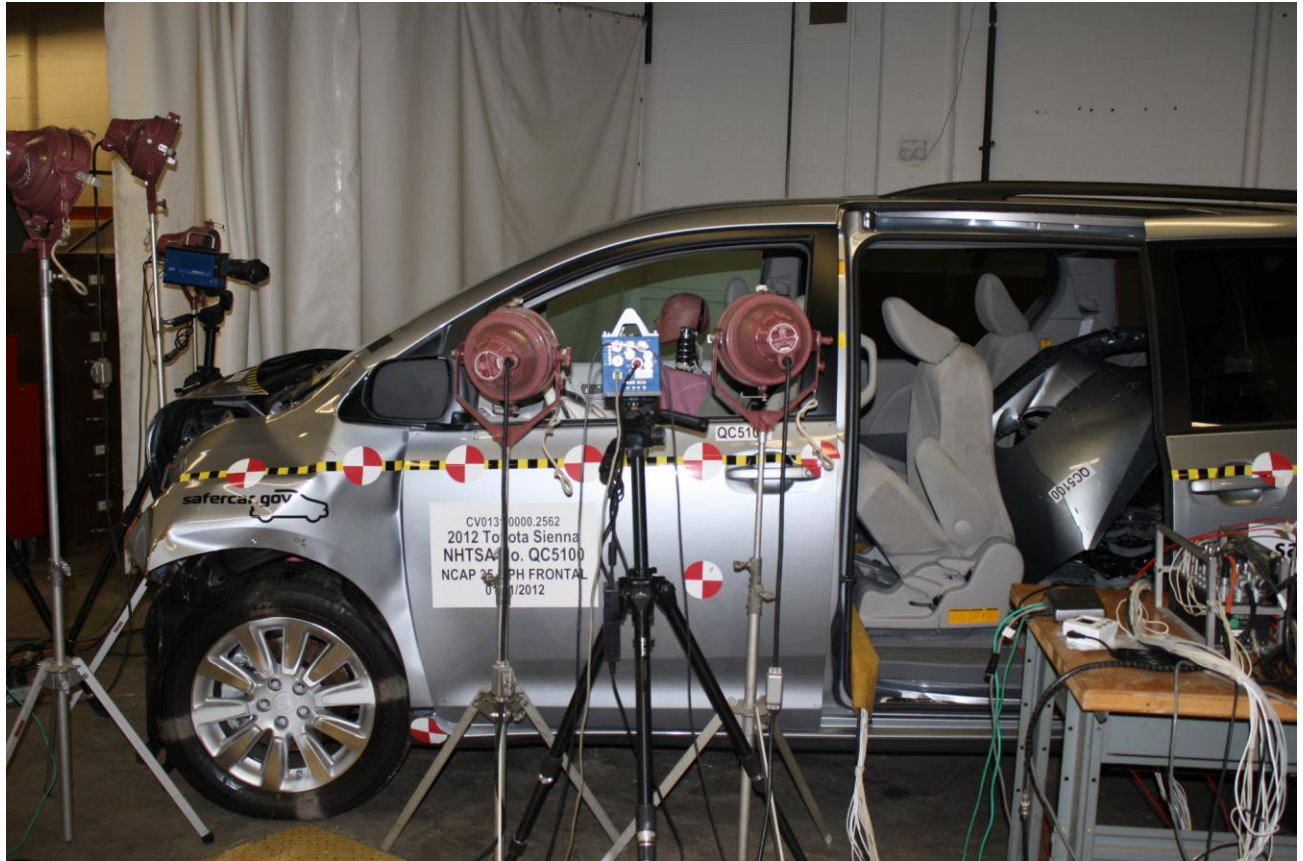
**Figure A-3: Pre-Test Vehicle Left Side View**

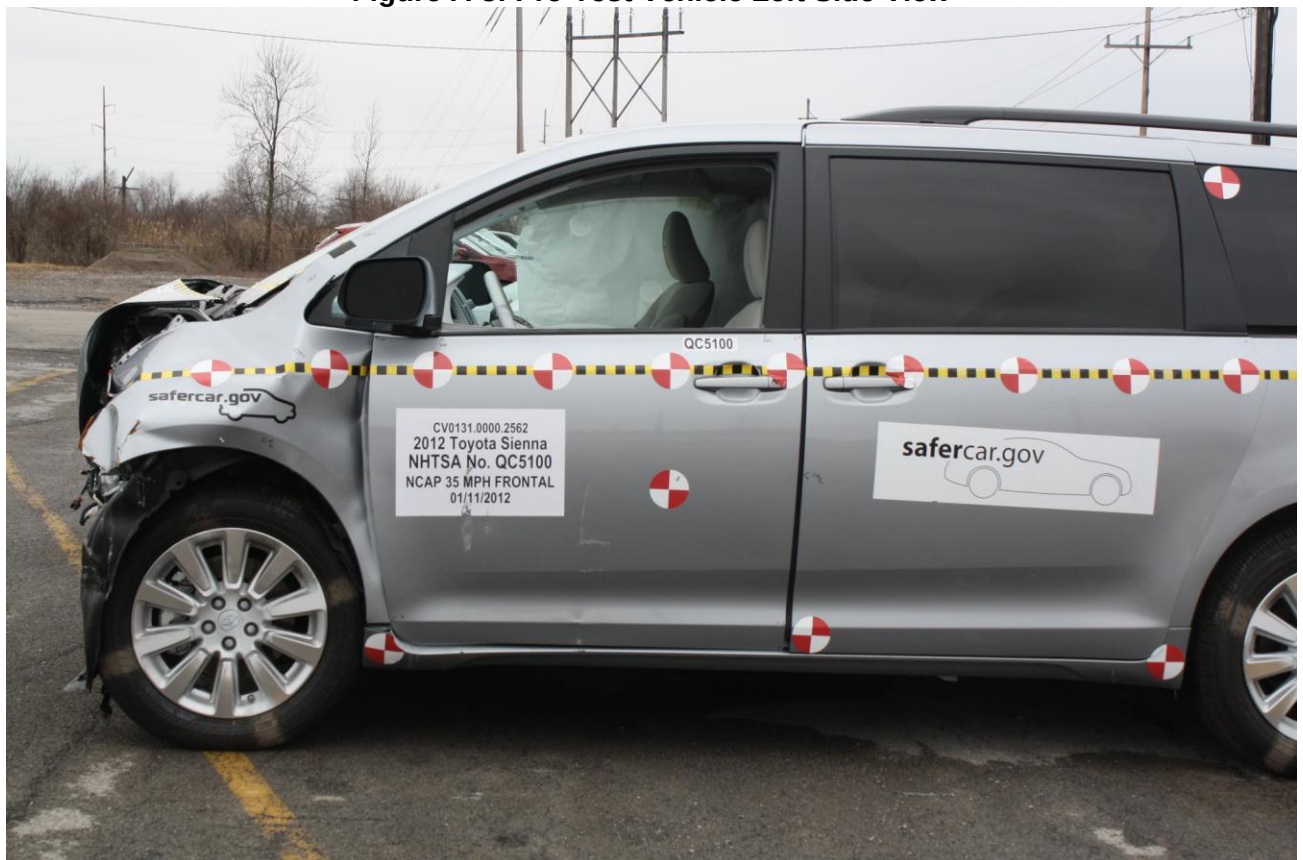
**Figure A-4: Post-Test Vehicle Left Side View**

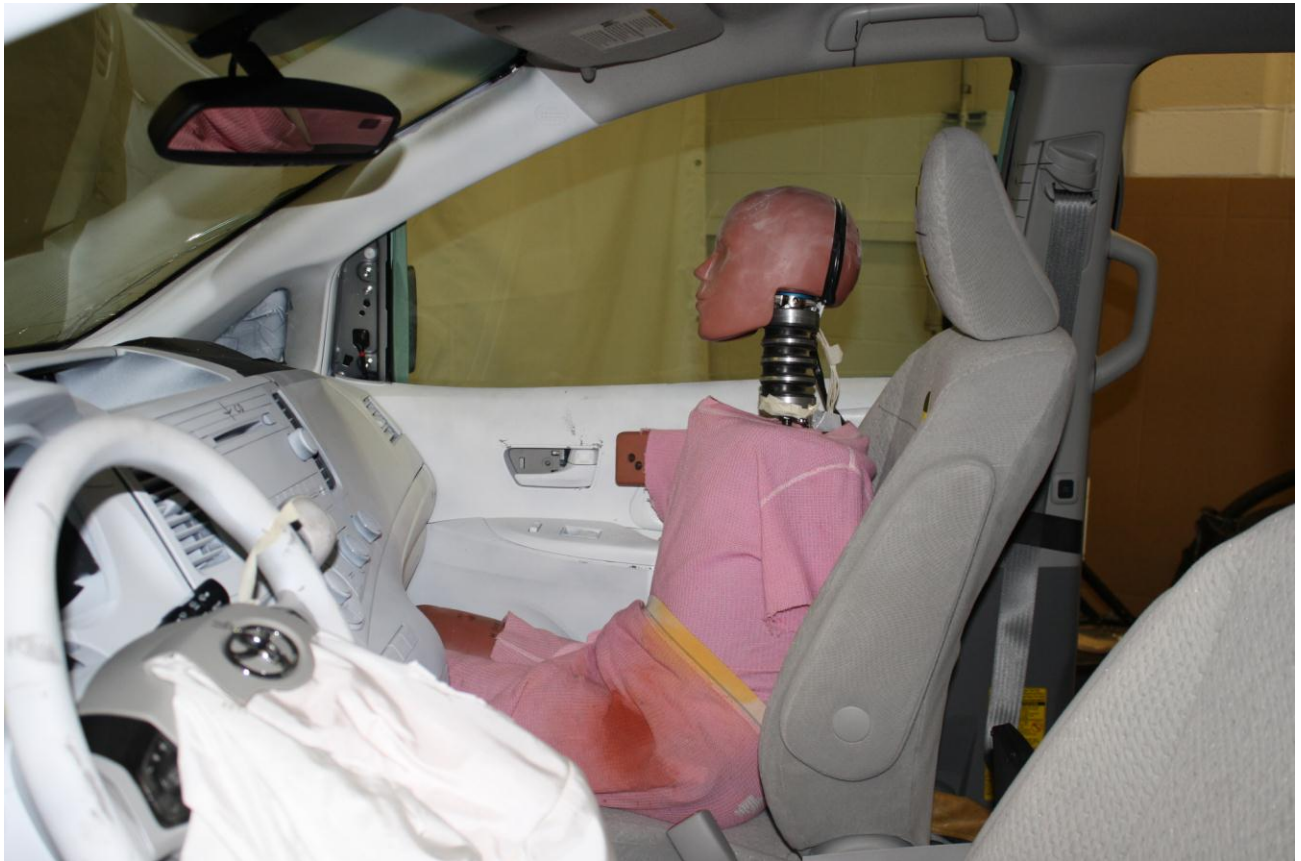
**Figure A-5: Pre-Test 5th female SID-IIs Dummy Left Side View**

The 5<sup>th</sup> female ATD was placed facing forward with its midsagittal plane parallel to the vehicle centerline but shifted outboard (to the right) until the outer pelvis contacted the right side seat cushion bolster. The upper torso was then tipped outboard to move the head outboard into the expected path of the deploying head curtain air bag. The seat track was then adjusted to locate the head c.g. under the expected deployment location of a head curtain chamber to maximize the airbag to head interaction. The overriding placement decision is to place the ATD in the expected worst case location. The placement decisions were made after consultation with the program monitor. The location was determined by observing test data from a previous left side impact test on the previous model year vehicle. This orientation complies with section 3.3.5.2 of the TWG Recommended Procedures for Evaluating Occupant Injury Risk from Deploying Side Airbags as defined by Lund, et al and the Technical Working Group First Revision dated July, 2003.

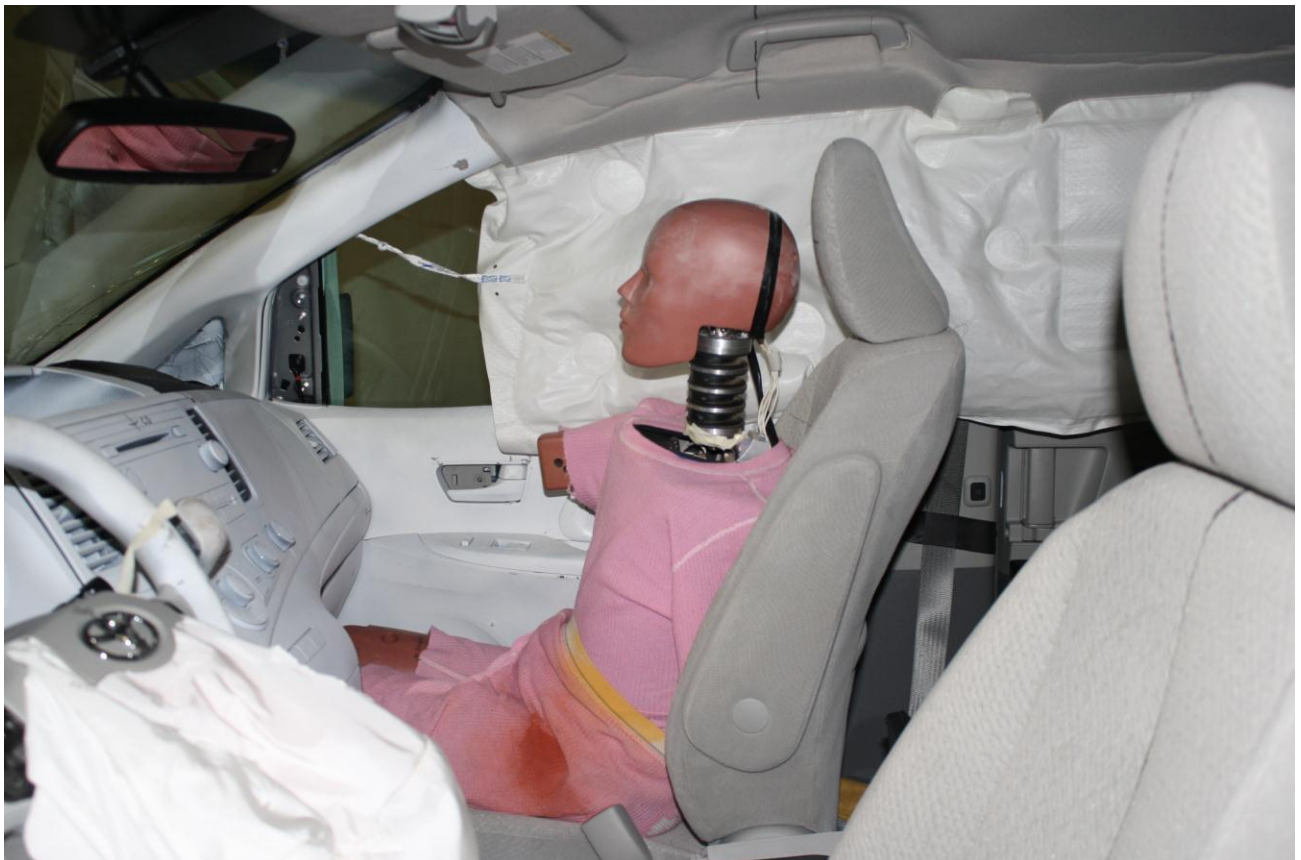
**Figure A-6: Post-Test 5th female SID-IIs Dummy Left Side View**

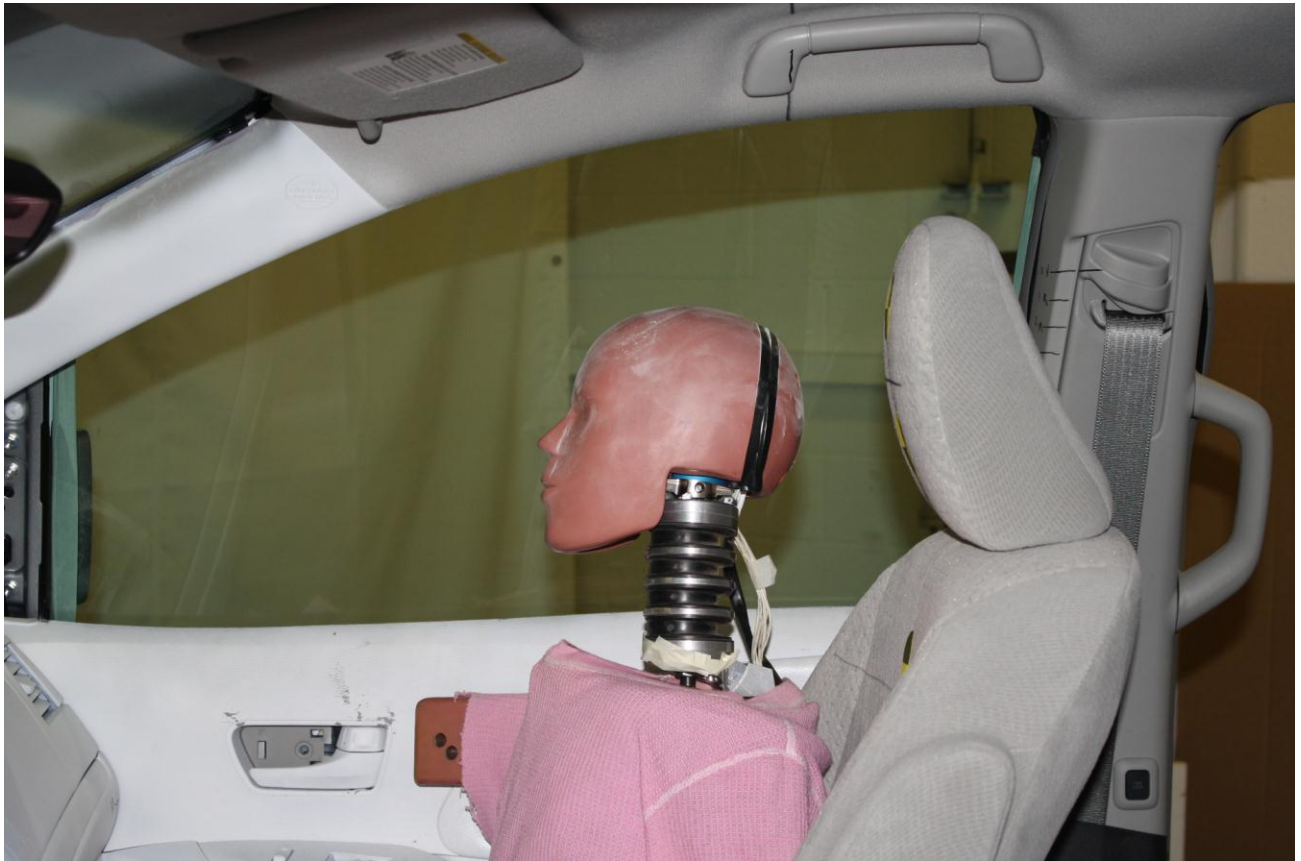
**Figure A-7: Pre-Test 5th female SID-II's Dummy Left Side Close-up View**

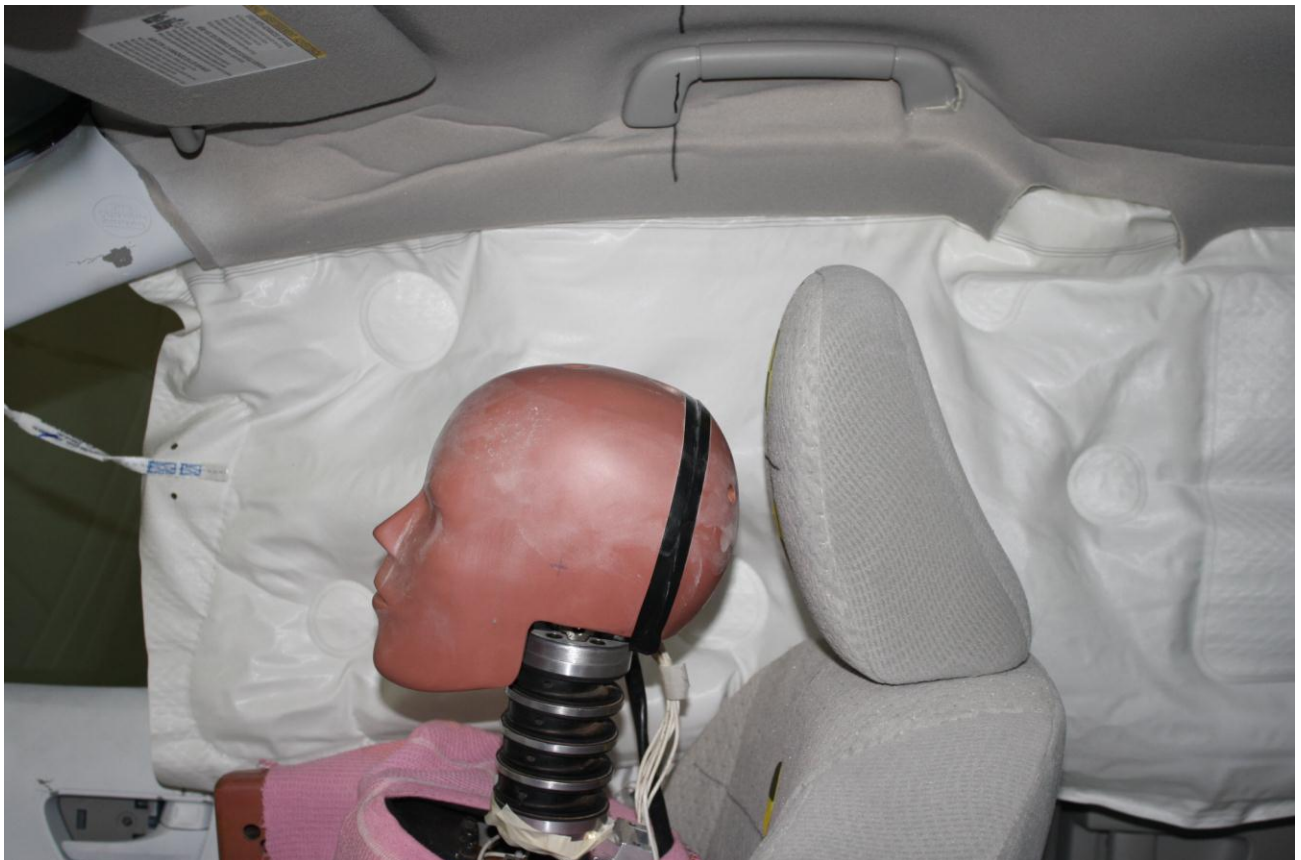
**Figure A-8: Post-Test 5th female SID-II's Dummy Left Side Close-up View**

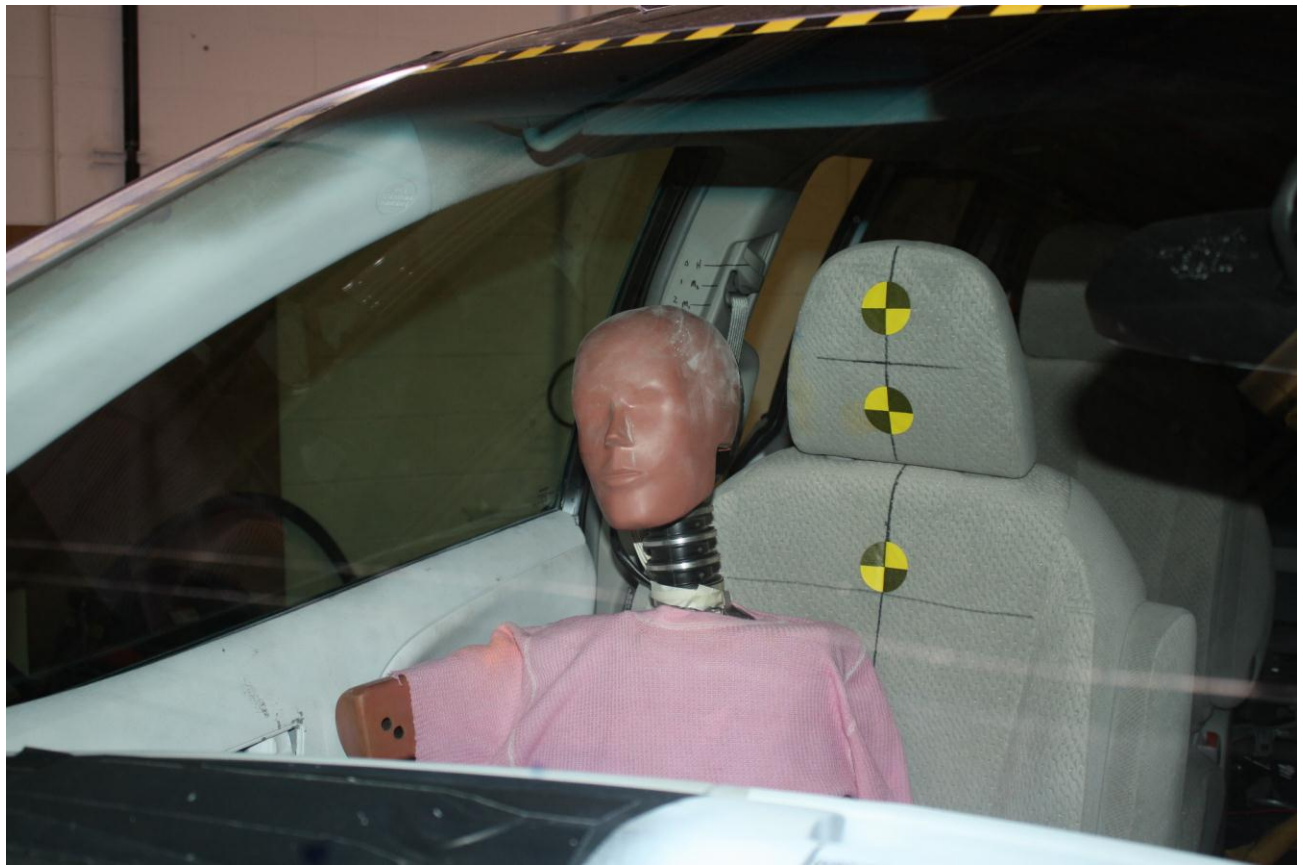
**Figure A-9: Pre-Test 5th female SID-IIIs Dummy Left  $\frac{3}{4}$  Front View**

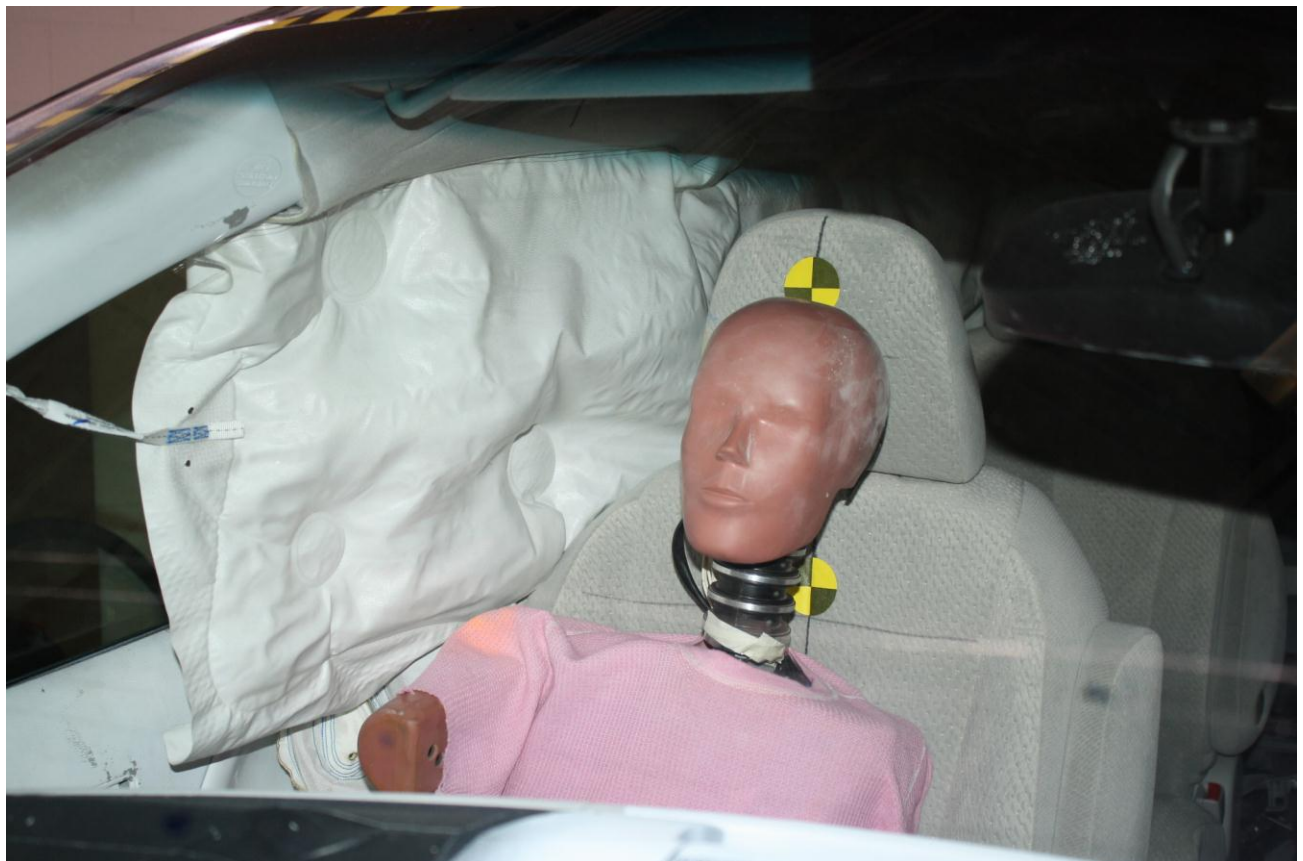
**Figure A-10: Post-Test 5th female SID-IIIs Dummy Left  $\frac{3}{4}$  Front View**

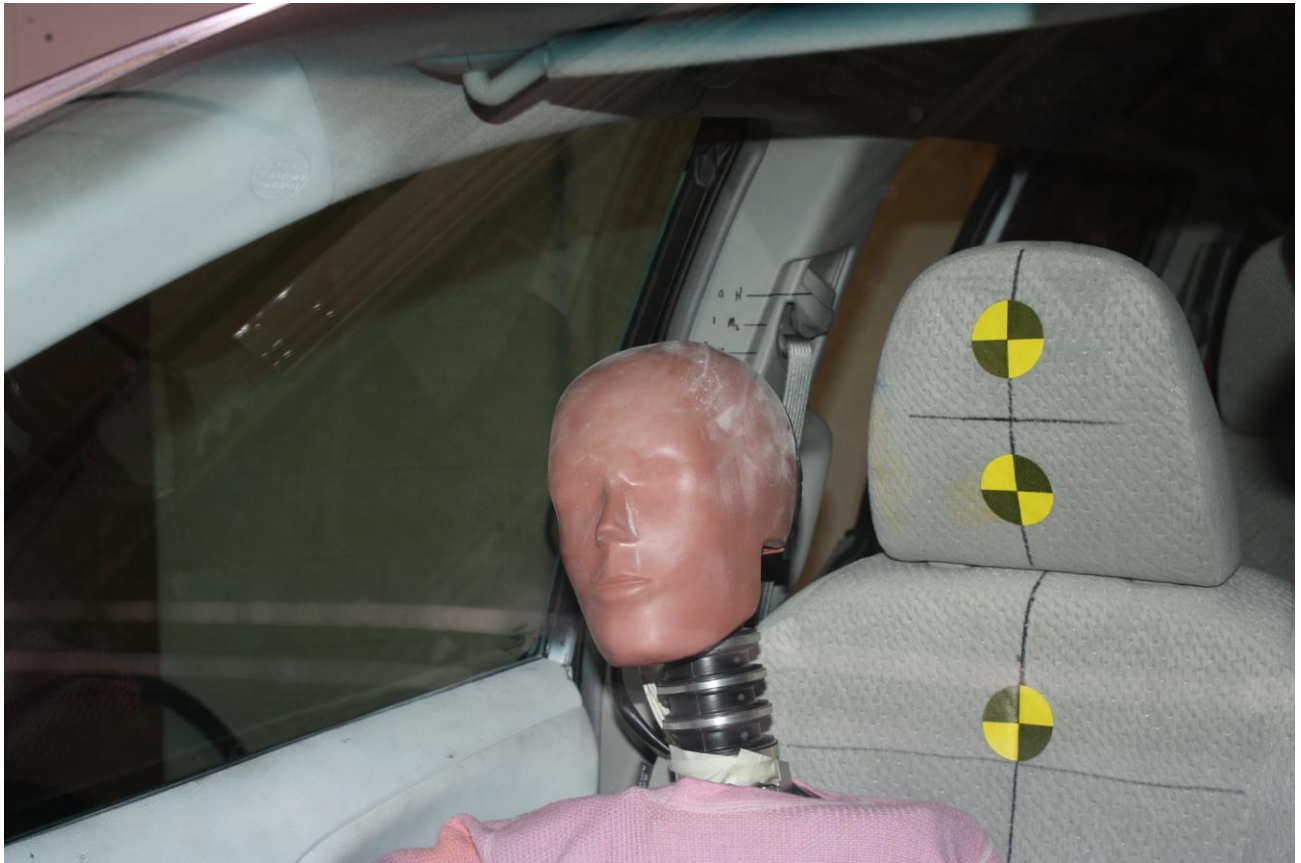
**Figure A-11: Pre-Test 5th female SID-III Dummy Left  $\frac{3}{4}$  Front Close-up View**

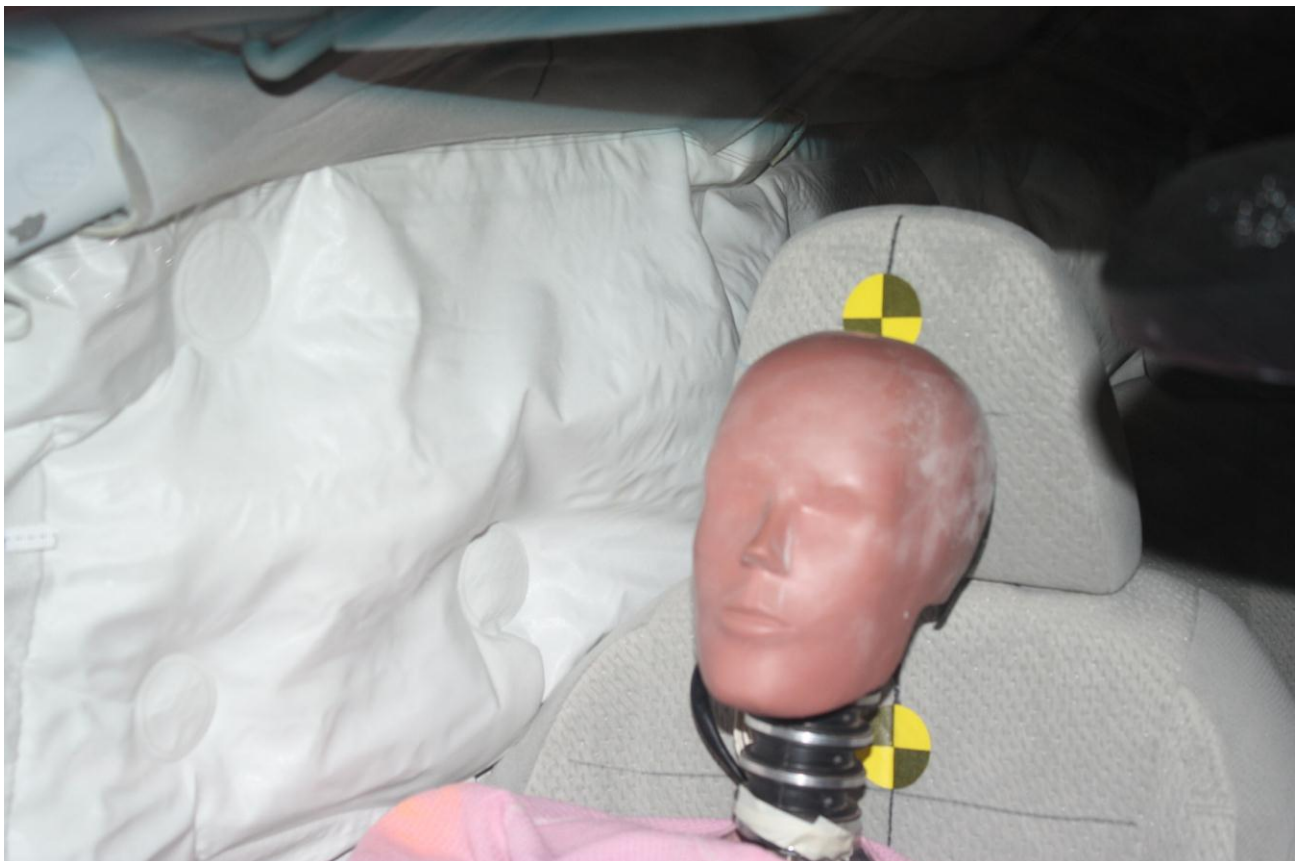
**Figure A-12: Post-Test 5th female SID-III Dummy Left  $\frac{3}{4}$  Front Close-up View**

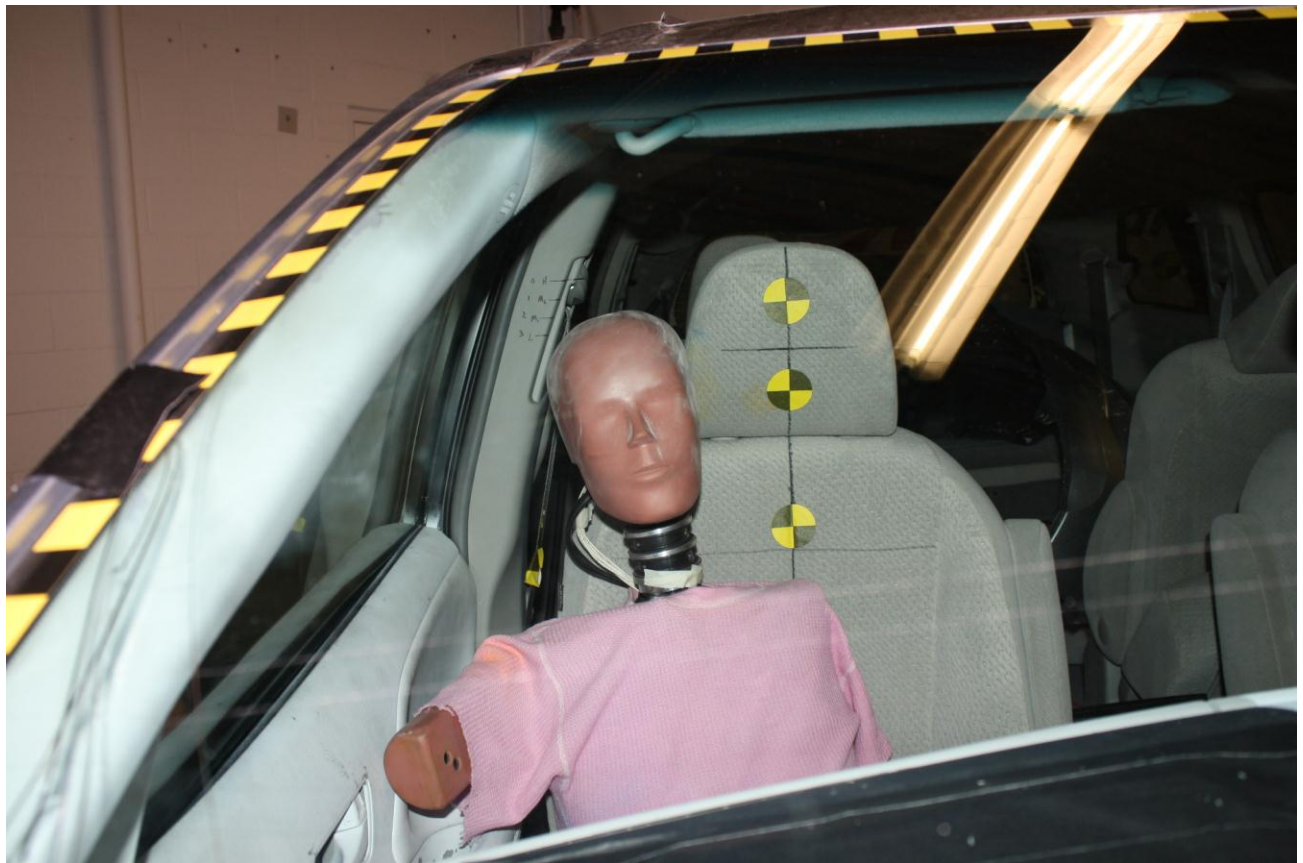
**Figure A-13: Pre-Test 5th female SID-II's Dummy Front View**

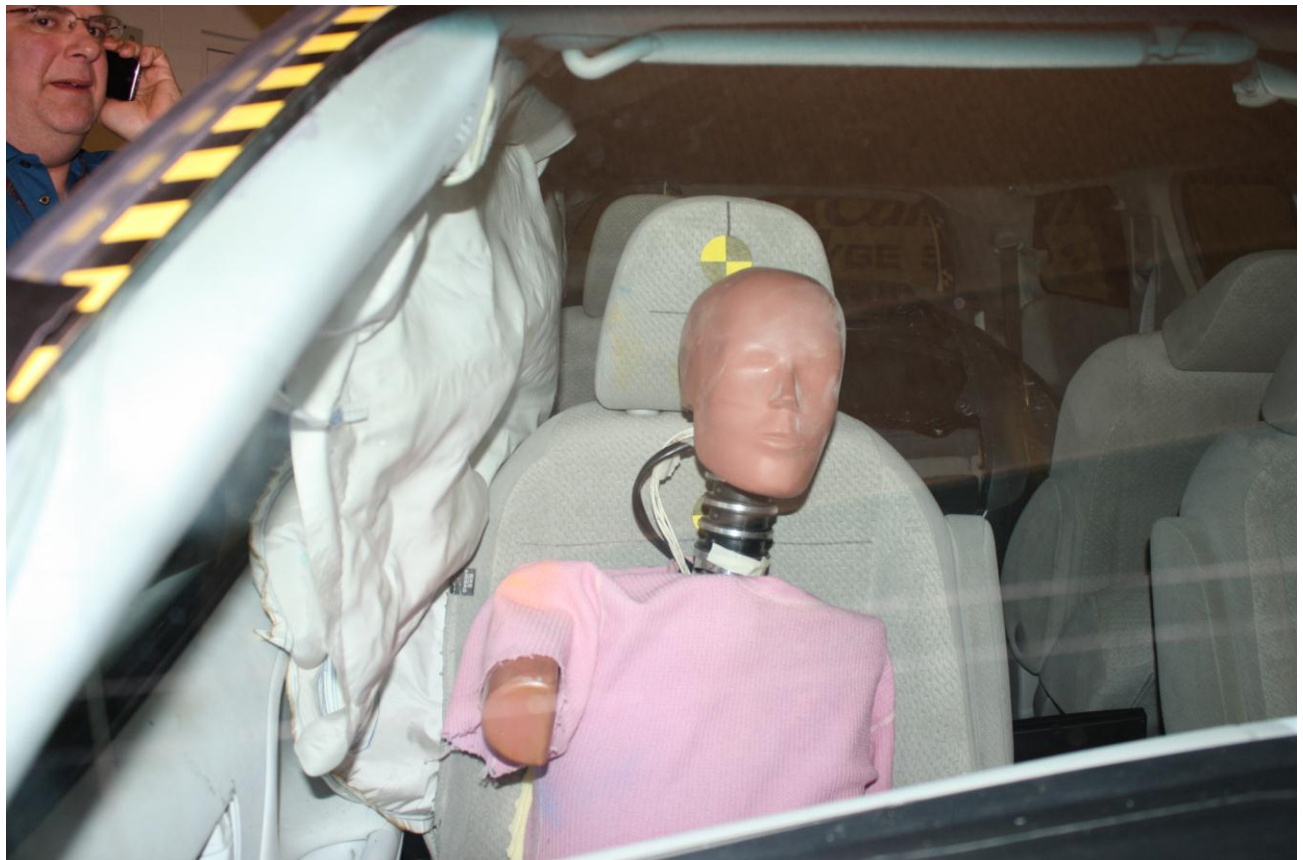
**Figure A-14: Post-Test 5th female SID-II's Dummy Front View**

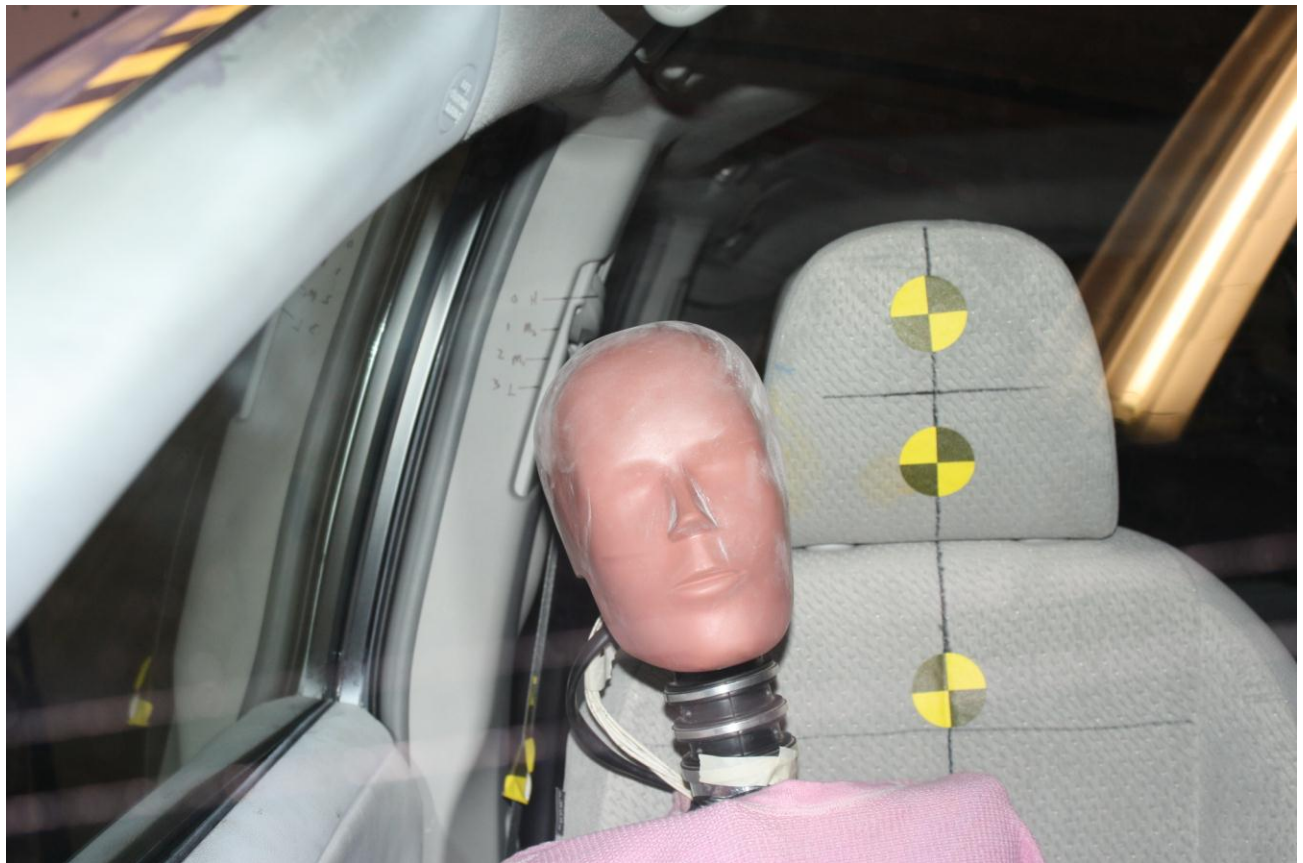
**Figure A-15: Pre-Test 5th female SID-IIs Dummy Front Close-up View**

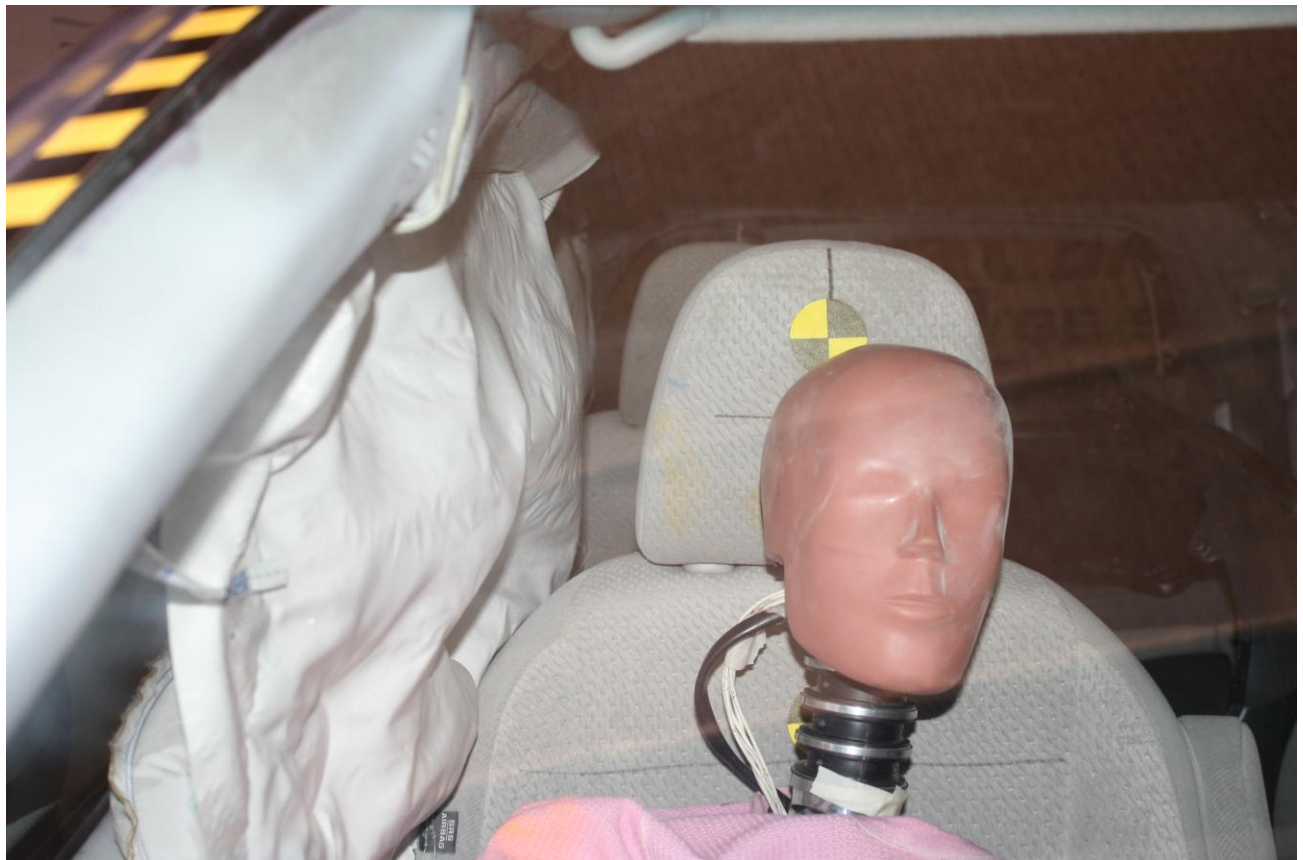
**Figure A-16: Pre-Test 5th female SID-IIs Dummy Right Side View**

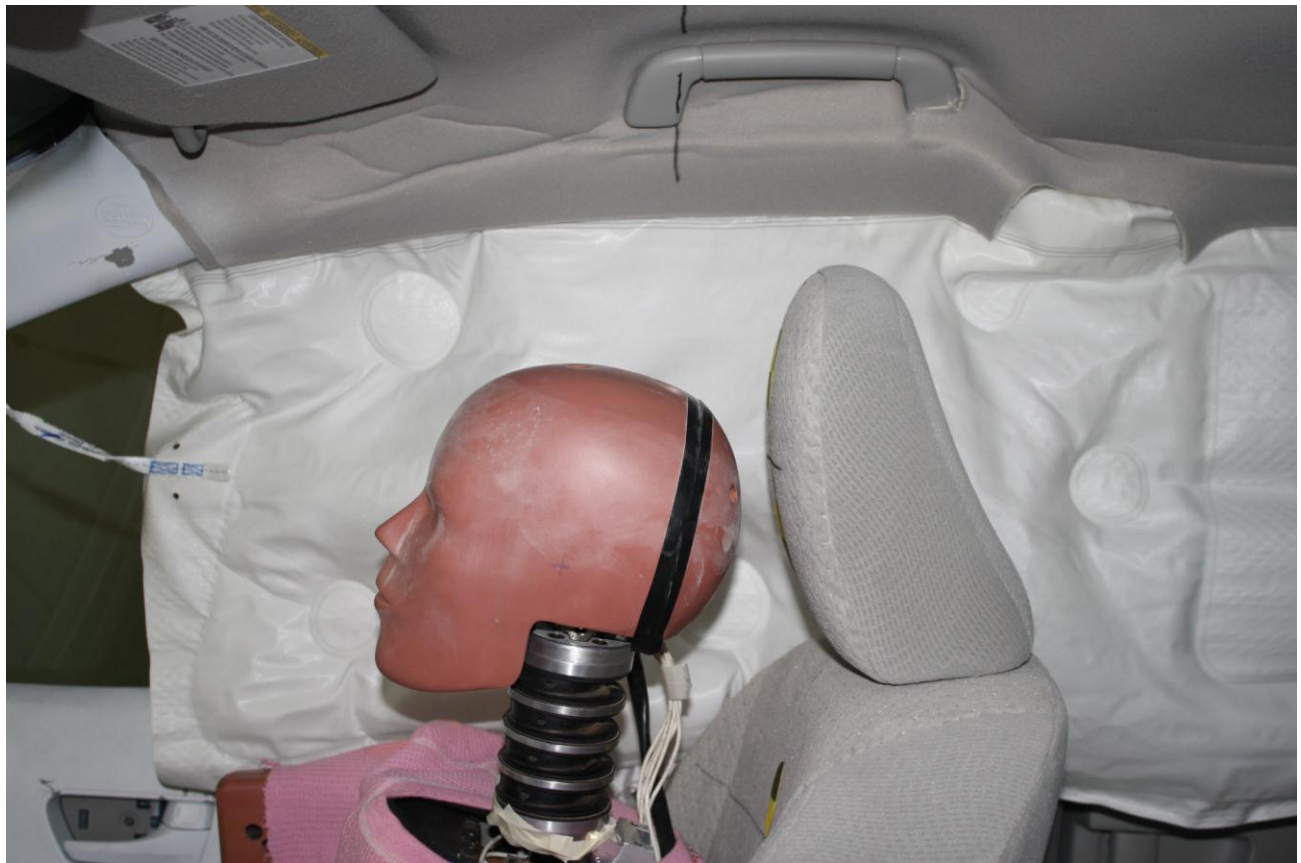
**Figure A-17: Post-Test Curtain Airbag Left Side View**

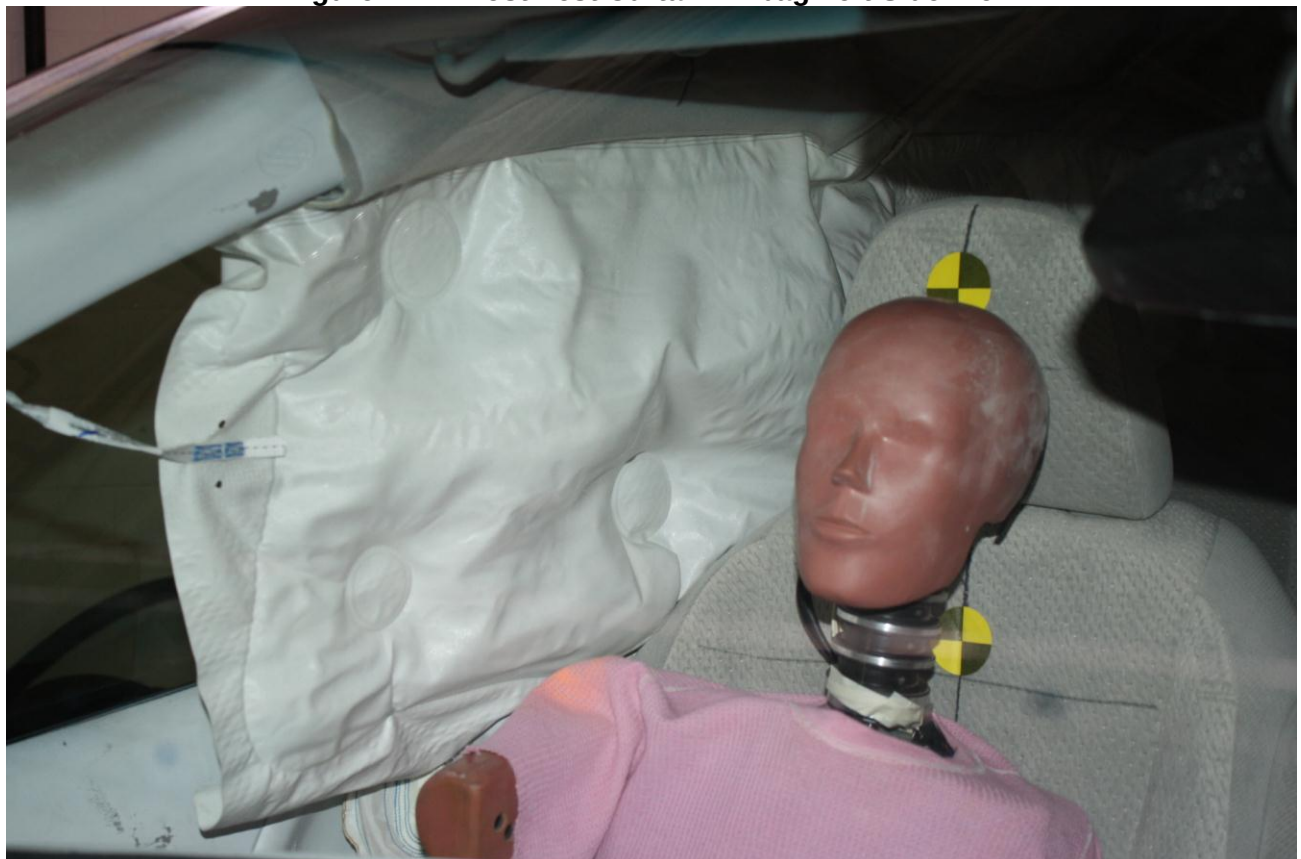
**Figure A-18: Post-Test Curtain Airbag Left  $\frac{3}{4}$  Front View**

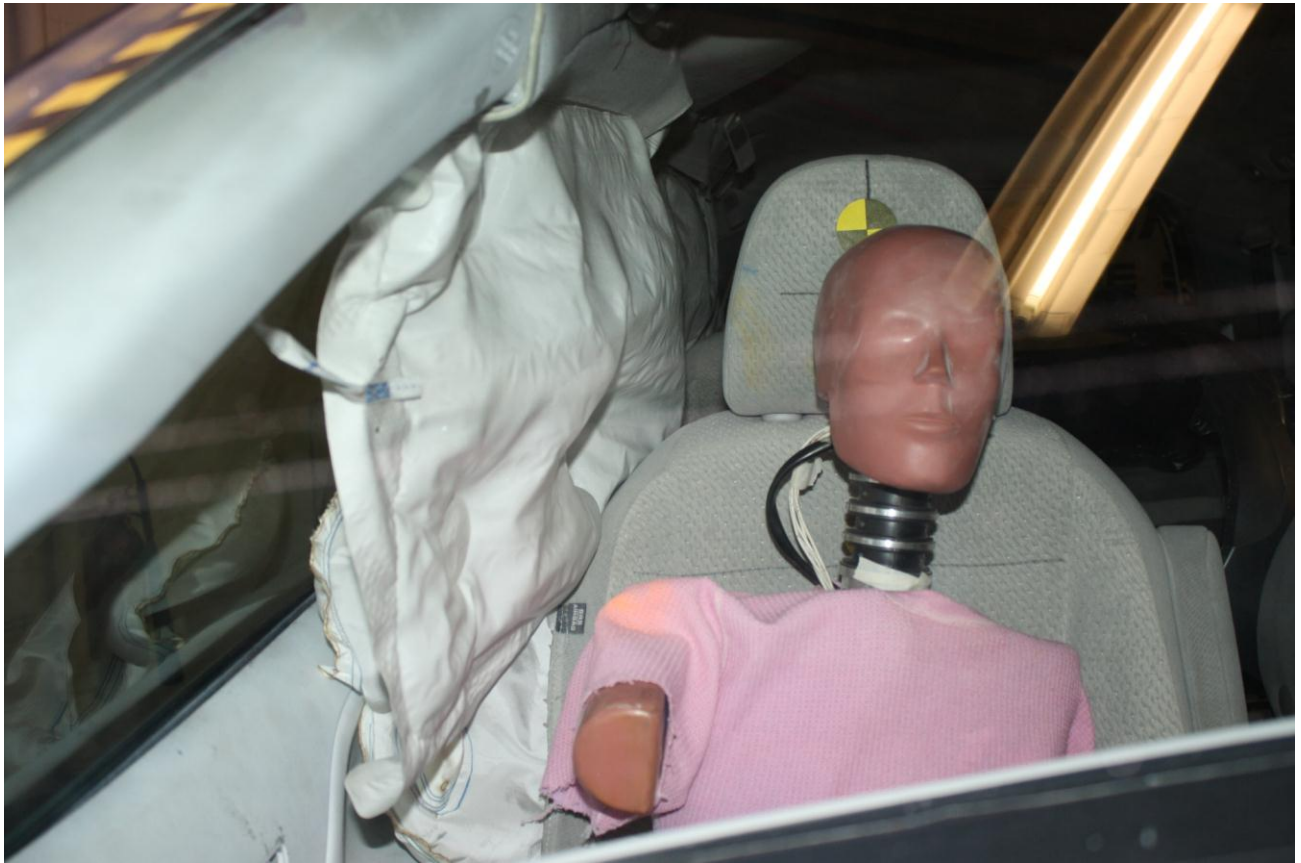
**Figure A-19: Post-Test Curtain Airbag Front View**

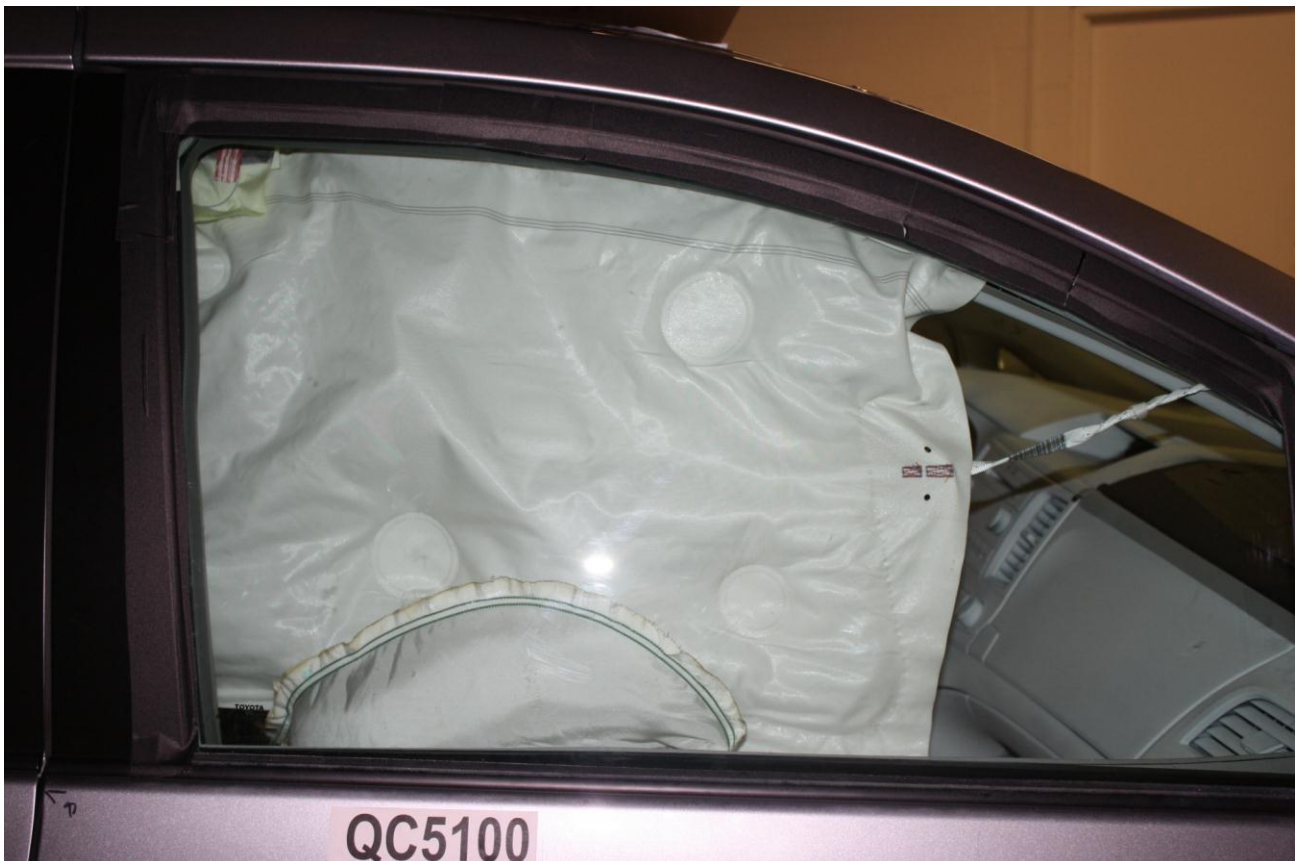
**Figure A-20: Post-Test Curtain Airbag Right Side View**
