REPORT NUMBER: NCAP-KAR-12-052

**NEW CAR ASSESSMENT PROGRAM (NCAP)
FRONTAL BARRIER IMPACT TEST**

**TOYOTA MOTOR CORPORATION
2012 SCION IQ 3-DOOR HATCHBACK**

FINAL REPORT

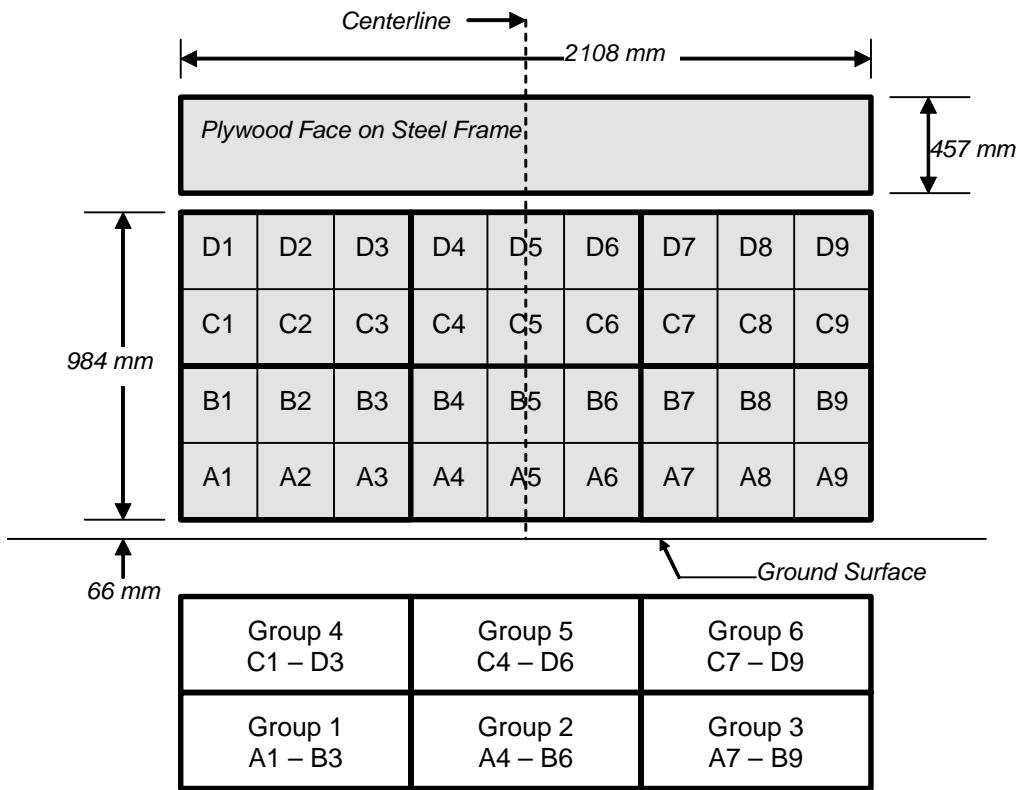
**36 Load Cell Rigid Barrier (NHTSA Standard)
Load Cell Locations on Fixed Barrier**

6 Groups of 6 Load Cells Each

A load cell barrier consisting of 36 load cells was impacted by a 2012 Scion iQ 3-door hatchback at a velocity of 56.42 km/h. The test was performed at KARCO Engineering, LLC. on February 22, 2012. Pre- and post-test photographs of the vehicle and dummies can be found in Appendix A of this report.

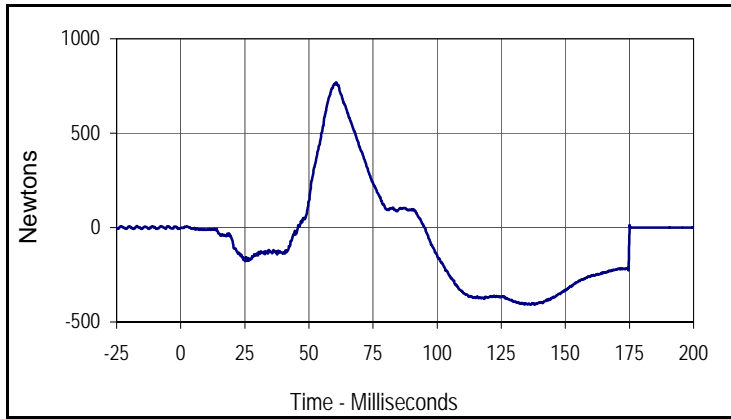
Curve Description			
Driver Upper Neck Force X			
Plot No.	Type	SAE Class	Units
010	FIL	1000	Newtons
Max	Time	Min	Time
769.4	60.6	-408.7	136.5

* Channel failed at 175.0 msec.

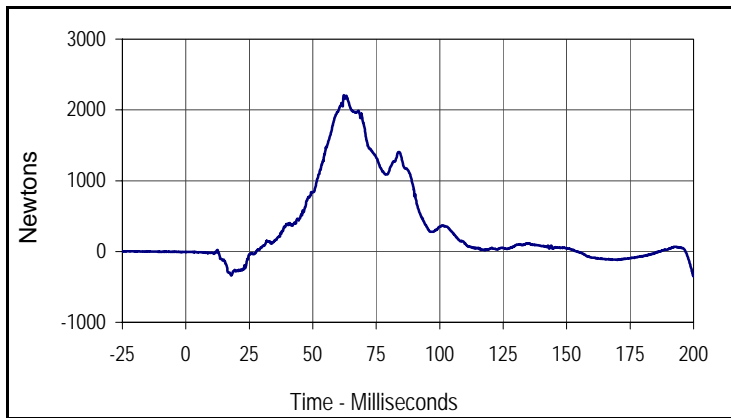
Curve Description			
Driver Upper Neck Force Z			
Plot No.	Type	SAE Class	Units
011	FIL	1000	Newtons
Max	Time	Min	Time
2207.7	62.2	-354.8	200.0

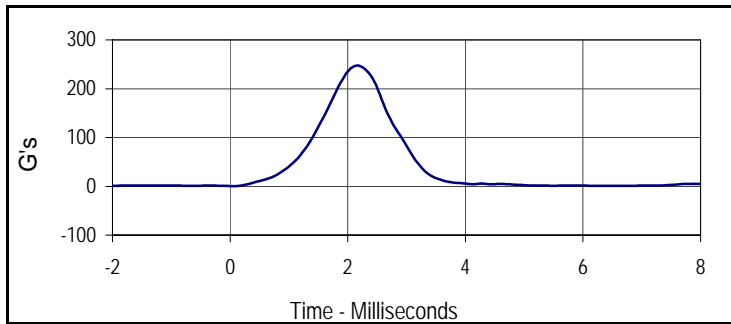
Curve Description			
Head Resultant			
Plot No.	Type	SAE Class	Units
001	RES	1000	G's
Max	Time	Min	Time
246.6	2.2	0.2	0.1

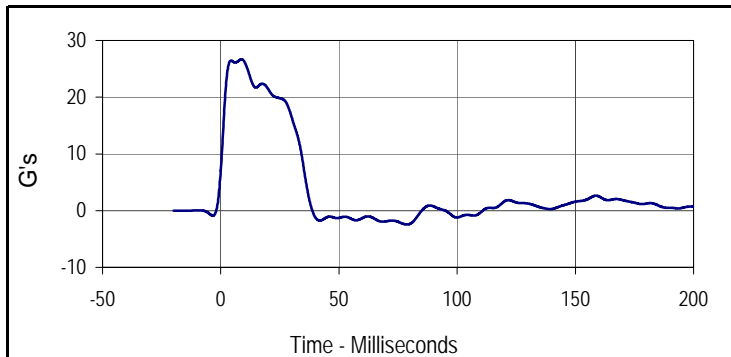
Curve Description			
Pendulum Deceleration			
Plot No.	Type	SAE Class	Units
001	FIL	60	G's
Max	Time	Min	Time
26.7	8.8	-2.5	78.8

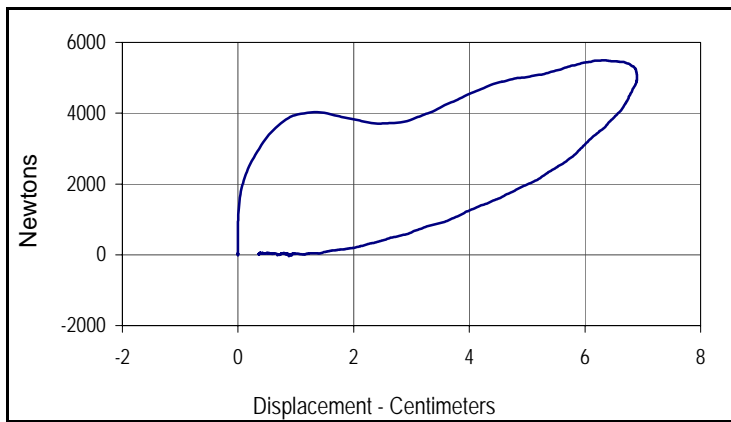
Curve Description			
Probe Force vs. Chest Deflection			
Plot No.	Type	SAE Class	Hysteresis
001	FIL	180	69.9
Peak Probe Force		Peak Chest Deflection	
5495		6.90

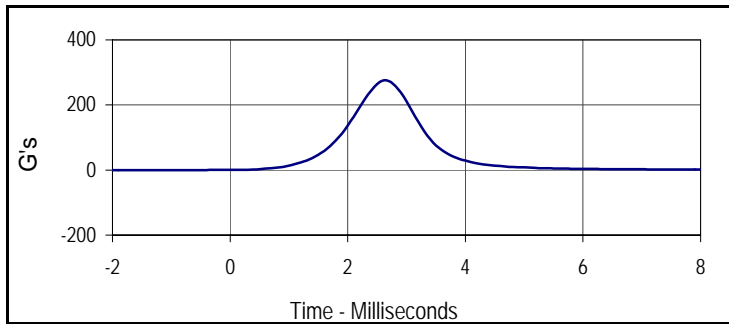
Curve Description			
Head Resultant			
Plot No.	Type	SAE Class	Units
001	RES	1000	G's
Max	Time	Min	Time
275.1	2.6	0.0	-2.0

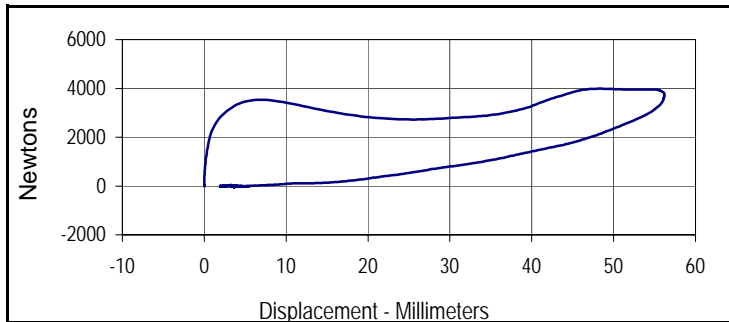
Curve Description			
Probe Force vs. Chest Deflection			
Plot No.	Type	SAE Class	Hysteresis
001	FIL	180	70.3
Peak Probe Force		Peak Chest Deflection	
3988.6		56.2

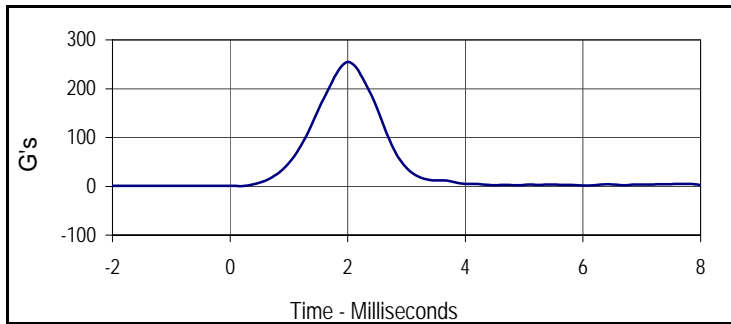
Curve Description			
Head Resultant			
Plot No.	Type	SAE Class	Units
001	RES	1000	G's
Max	Time	Min	Time
254.6	2.0	0.4	0.2

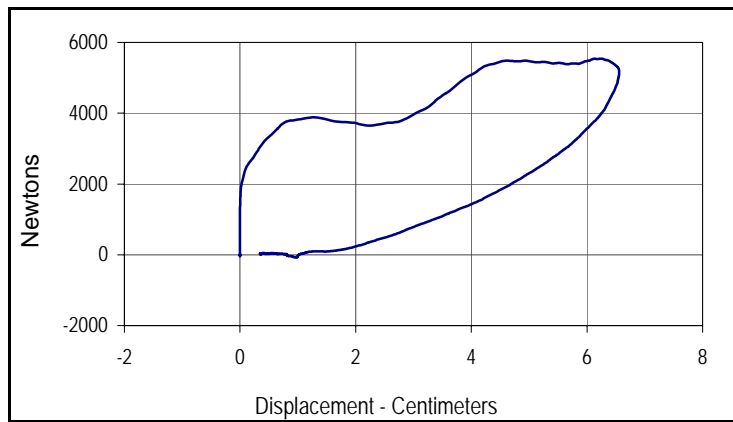
Curve Description			
Probe Force vs. Chest Deflection			
Plot No.	Type	SAE Class	Hysteresis
001	FIL	180	70.0
Peak Probe Force		Peak Chest Deflection	
5540		6.56

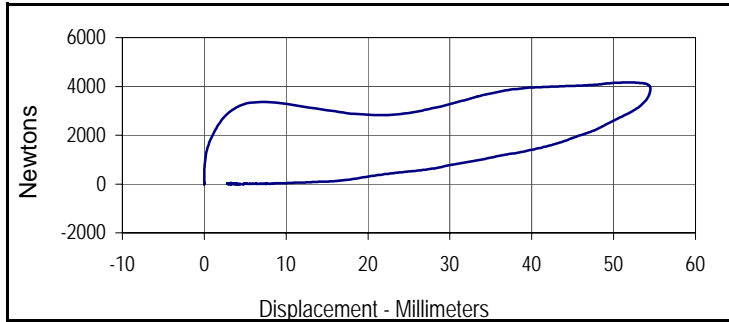
Curve Description			
Probe Force vs. Chest Deflection			
Plot No.	Type	SAE Class	Hysteresis
001	FIL	180	72.9
Peak Probe Force		Peak Chest Deflection	
4164.8		54.5
