**REPORT NUMBER: SPNCAP-MGA-2012-065**

**NEW CAR ASSESSMENT PROGRAM (NCAP)  
Side Impact Pole Test**

**MITSUBISHI MOTORS CORPORATION, JAPAN  
2012 Mitsubishi Lancer ES 4-Dr Sedan  
NHTSA No.: MC5605**

**MGA RESEARCH CORPORATION  
5000 Warren Road  
Burlington, WI 53105**

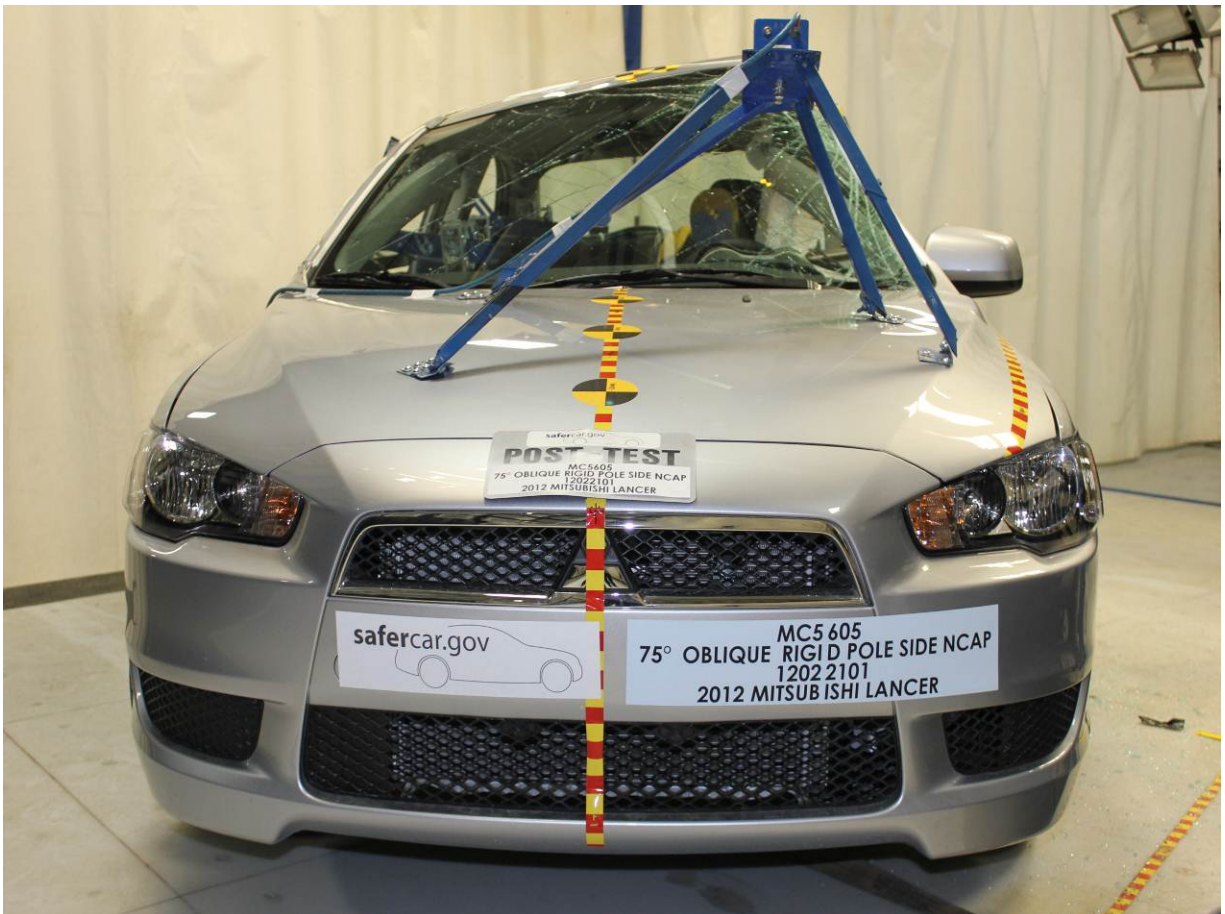
Post-Test Frontal View of Test Vehicle

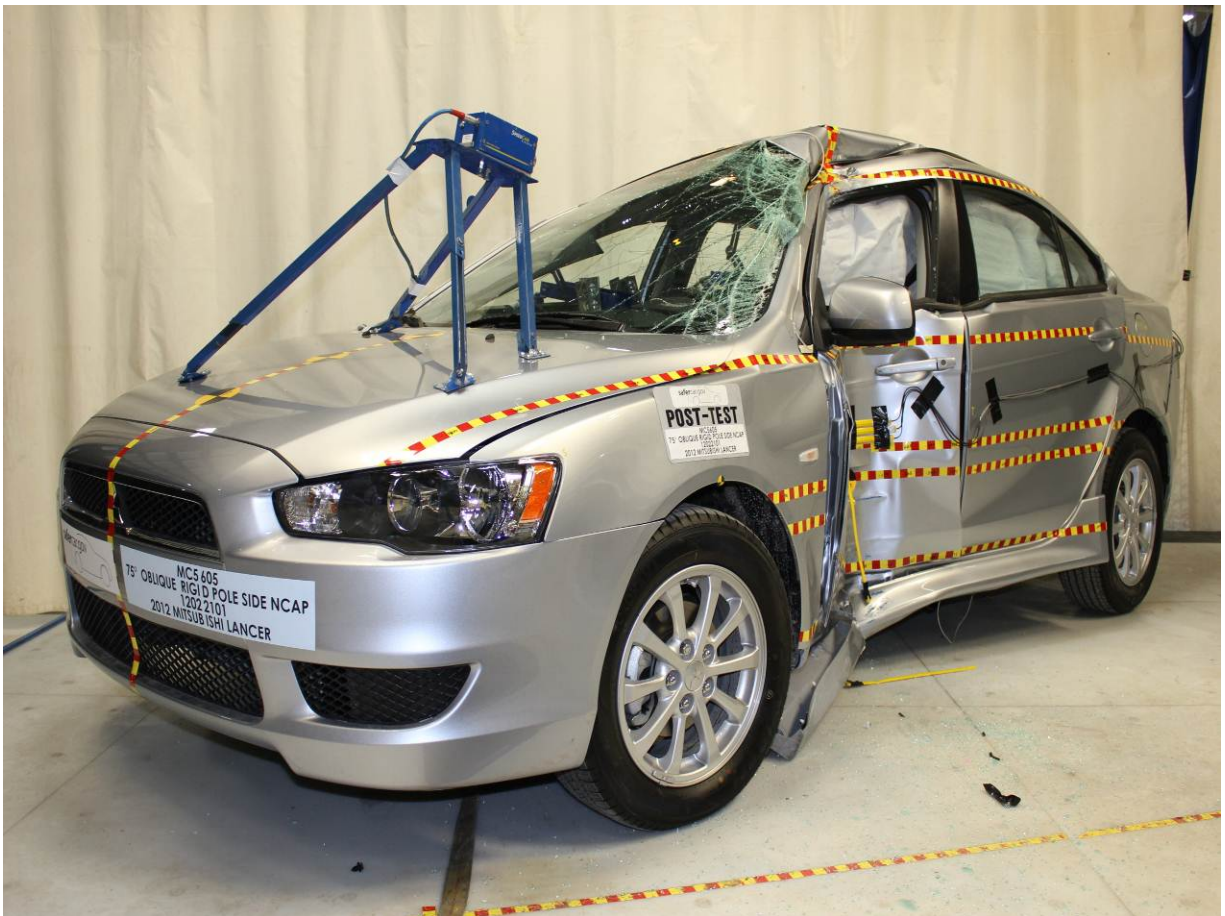
Post-Test Left Front ¾ View of Test Vehicle

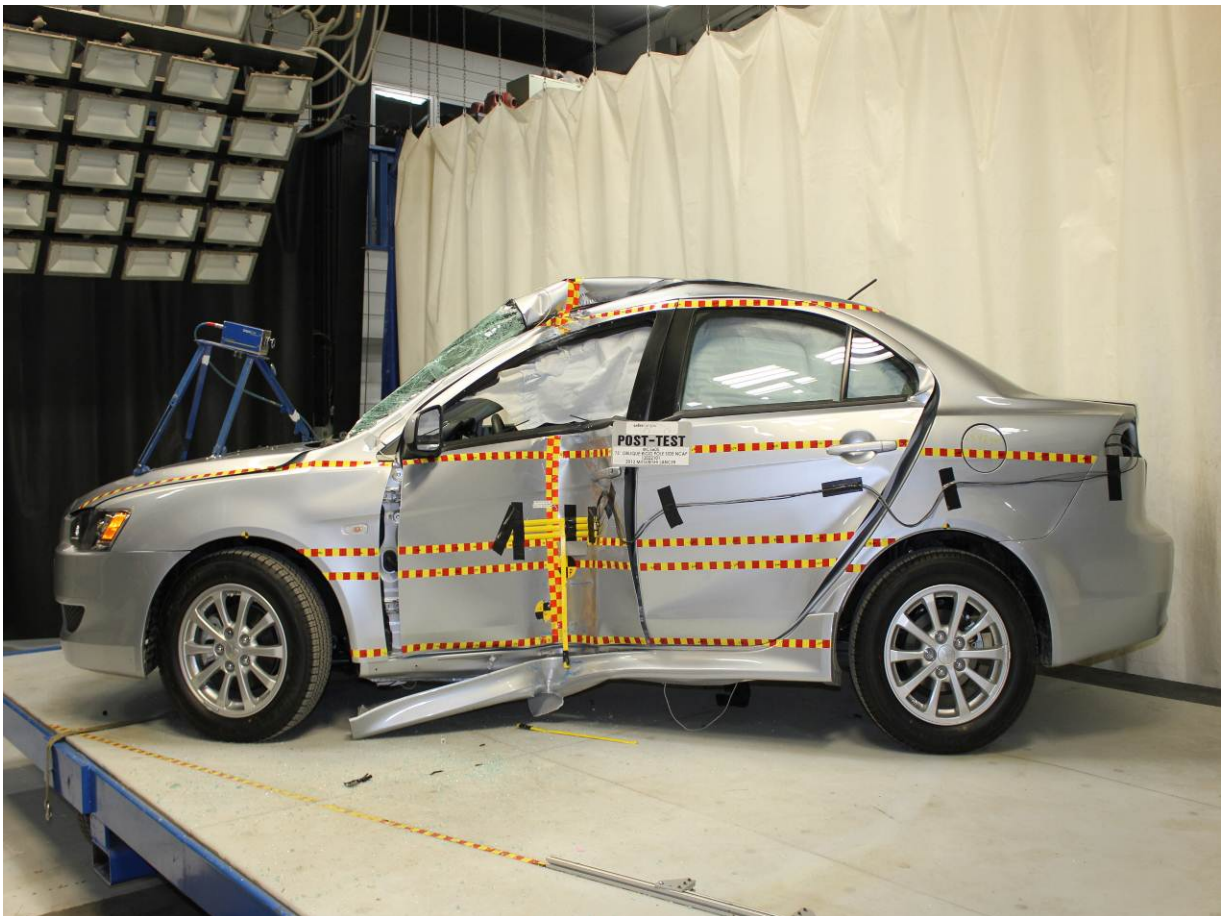
Post-Test Left Side View of Test Vehicle

Critical Areas of Performance	Observations and Conclusions
Pillar Performance	No Separation
Sill Separation	None
Windshield Damage	Cracked
Side Window Damage	Left Front Window Broke
Other Notable Effects	* The trunk opened upon impact

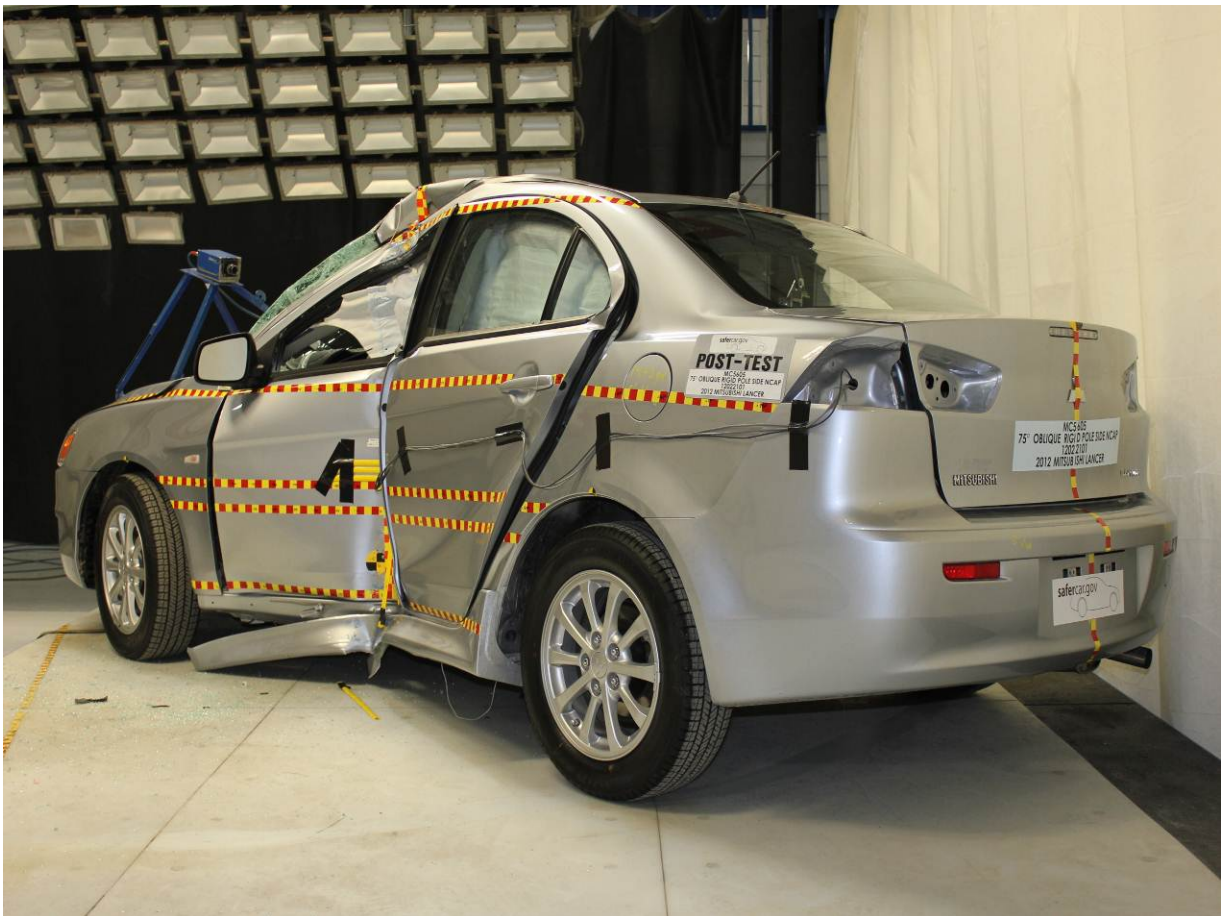
Post-Test Left Rear  $\frac{3}{4}$  View of Test Vehicle

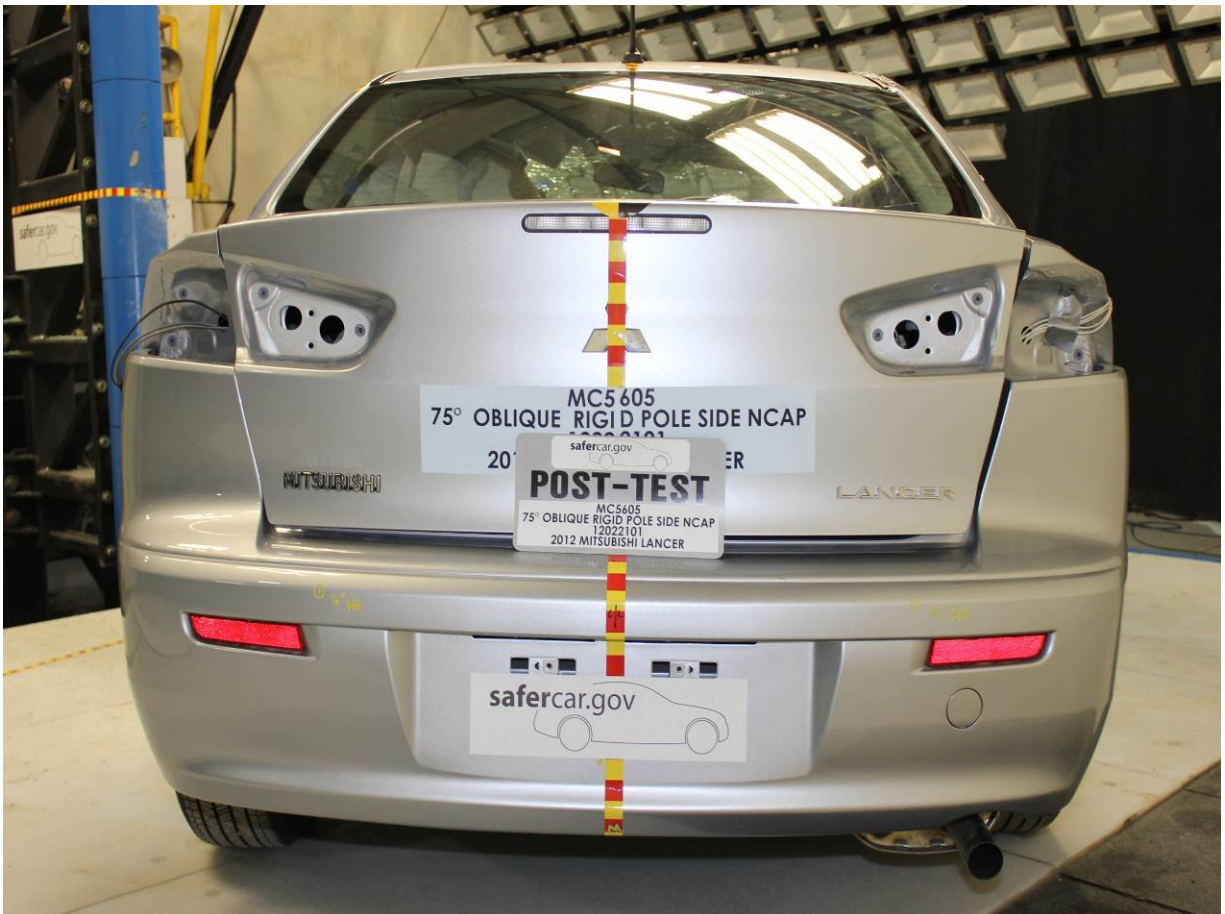
Post-Test Rear View of Test Vehicle

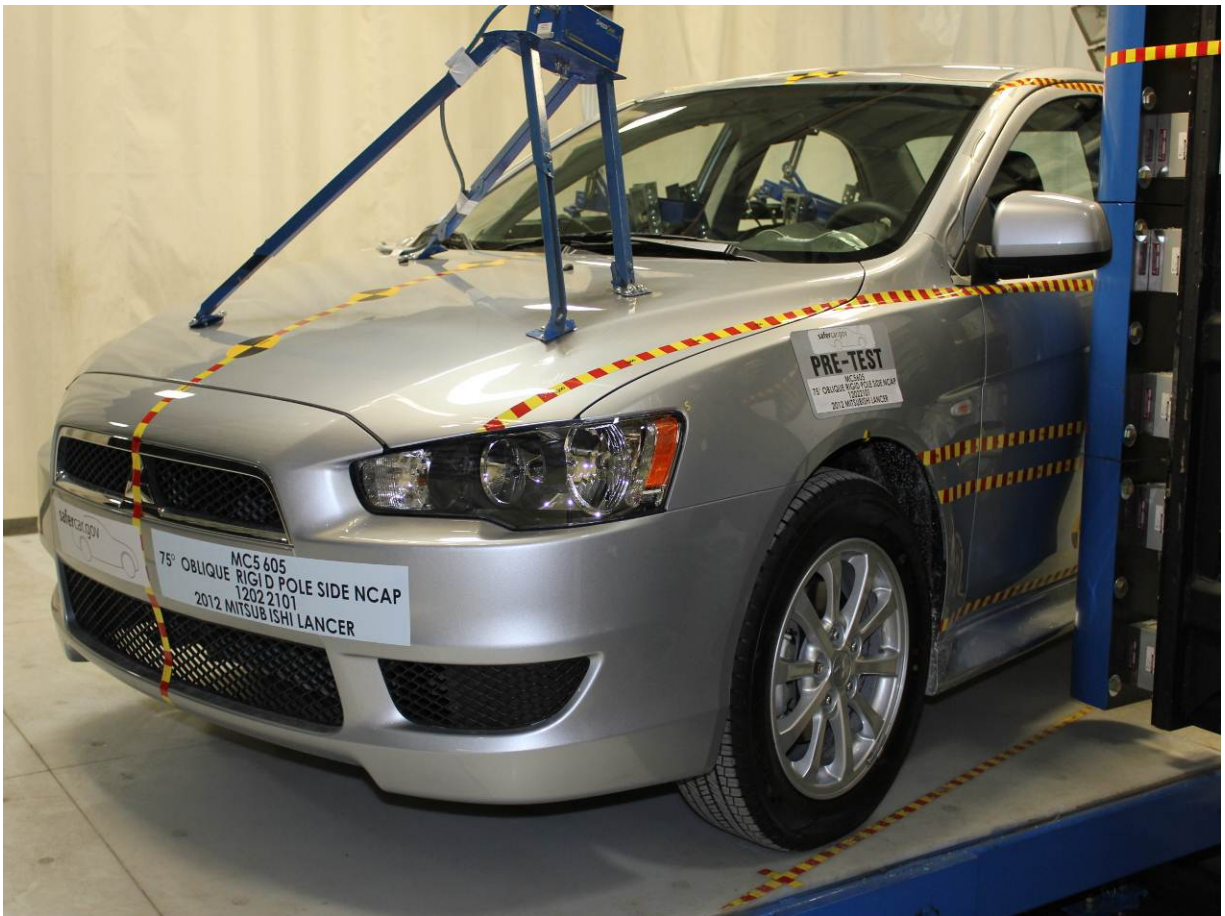
Pre-Test Left Side View of Pole Positioned Against Side of Vehicle

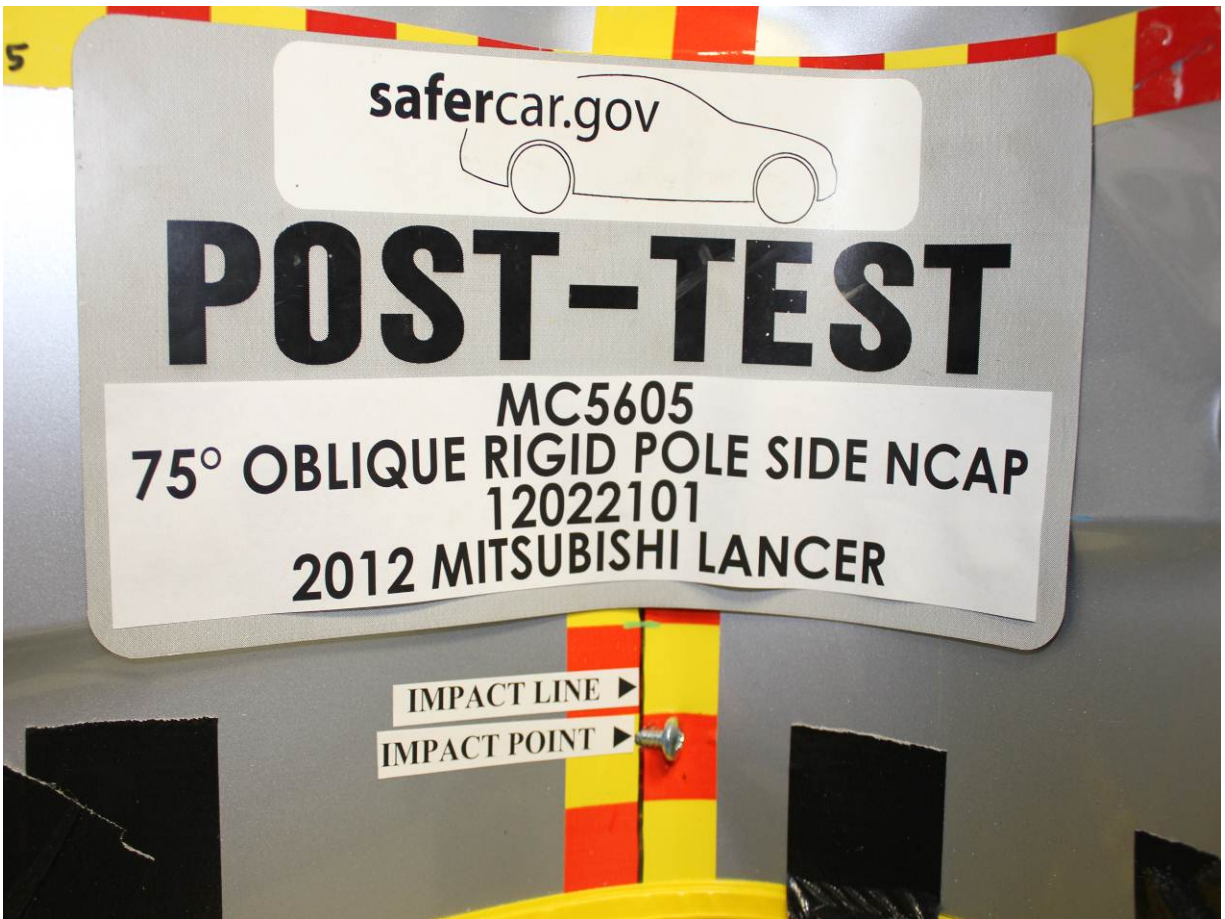
Post-Test Close-Up View of Impact Point Target Showing Impact Location

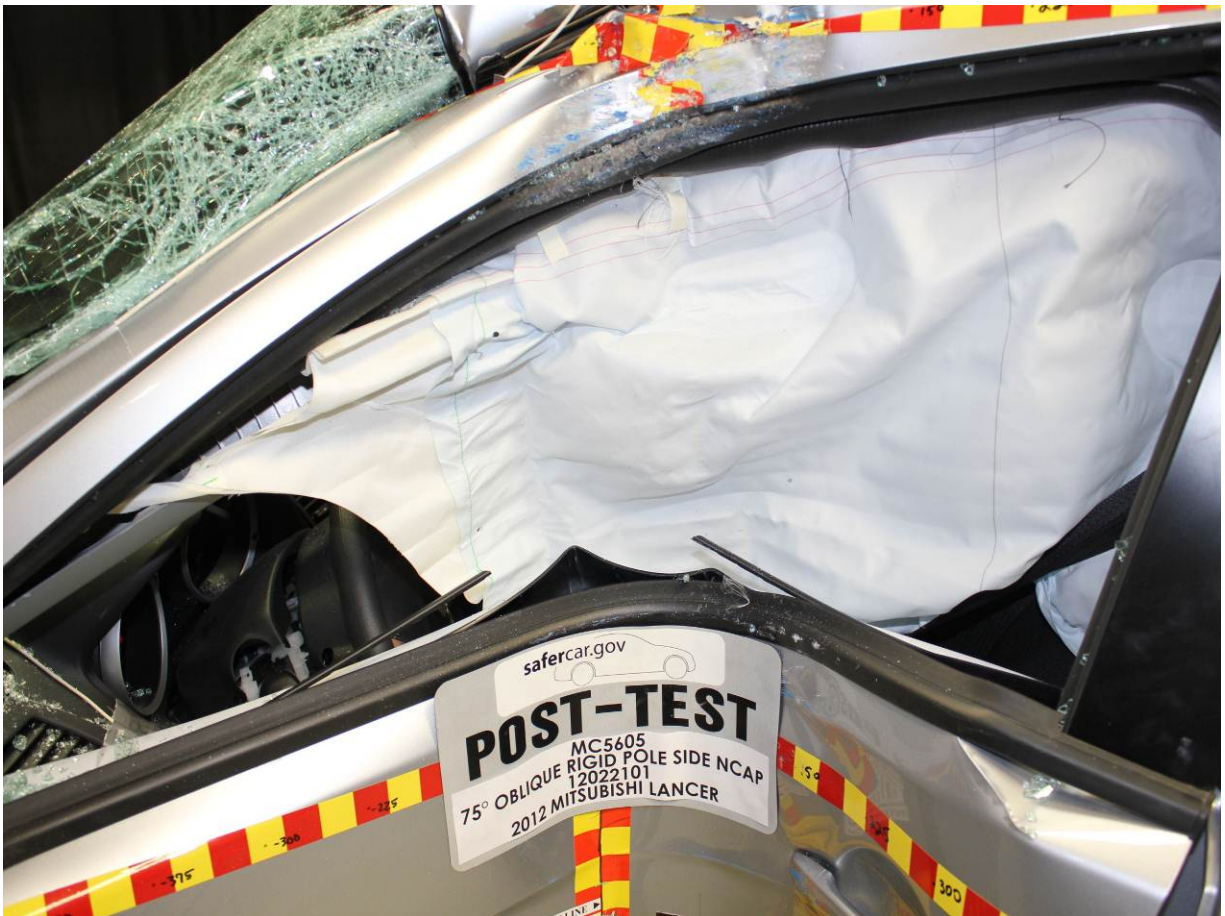
Post-Test Left Side View of Dummy Shoulder and Door Top View

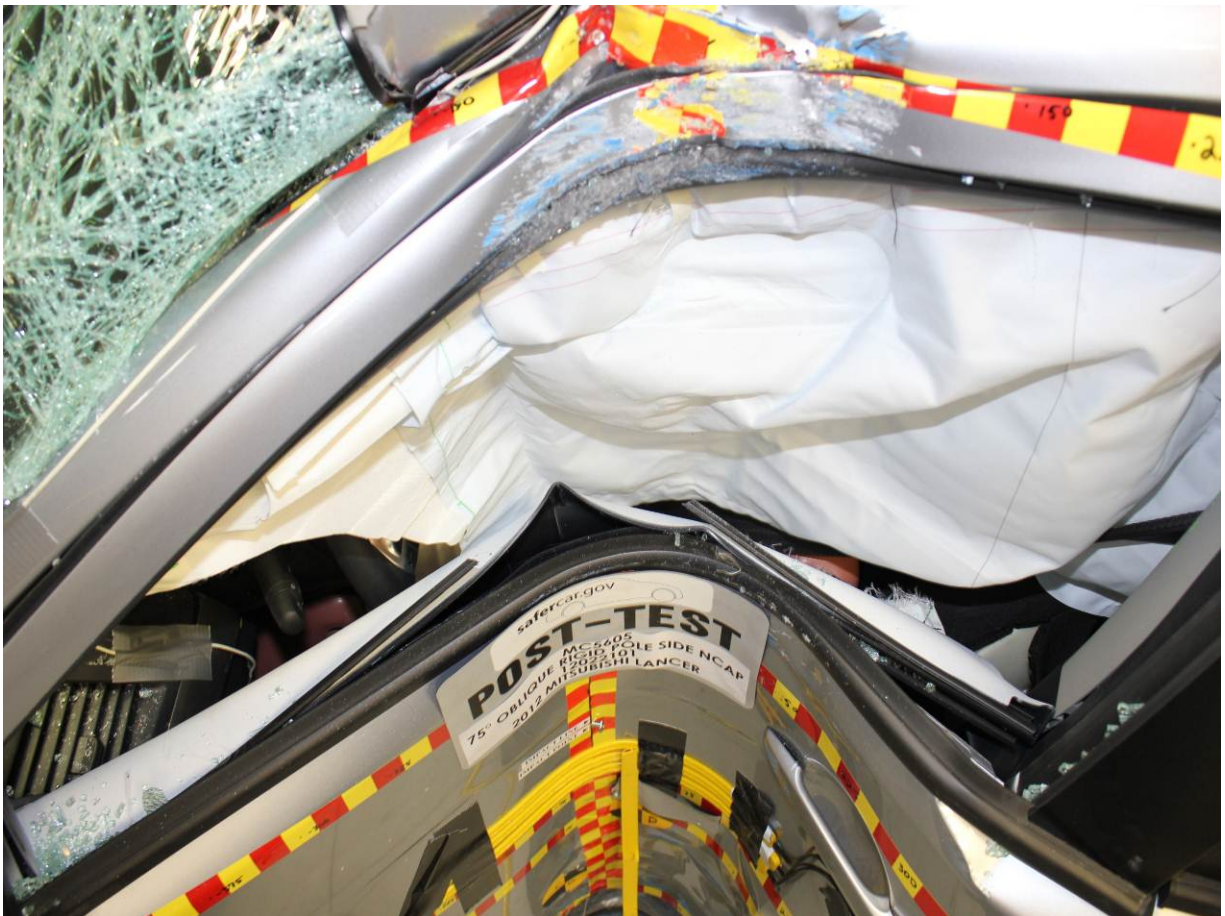
Post-Test Dummy and Door Clearance View

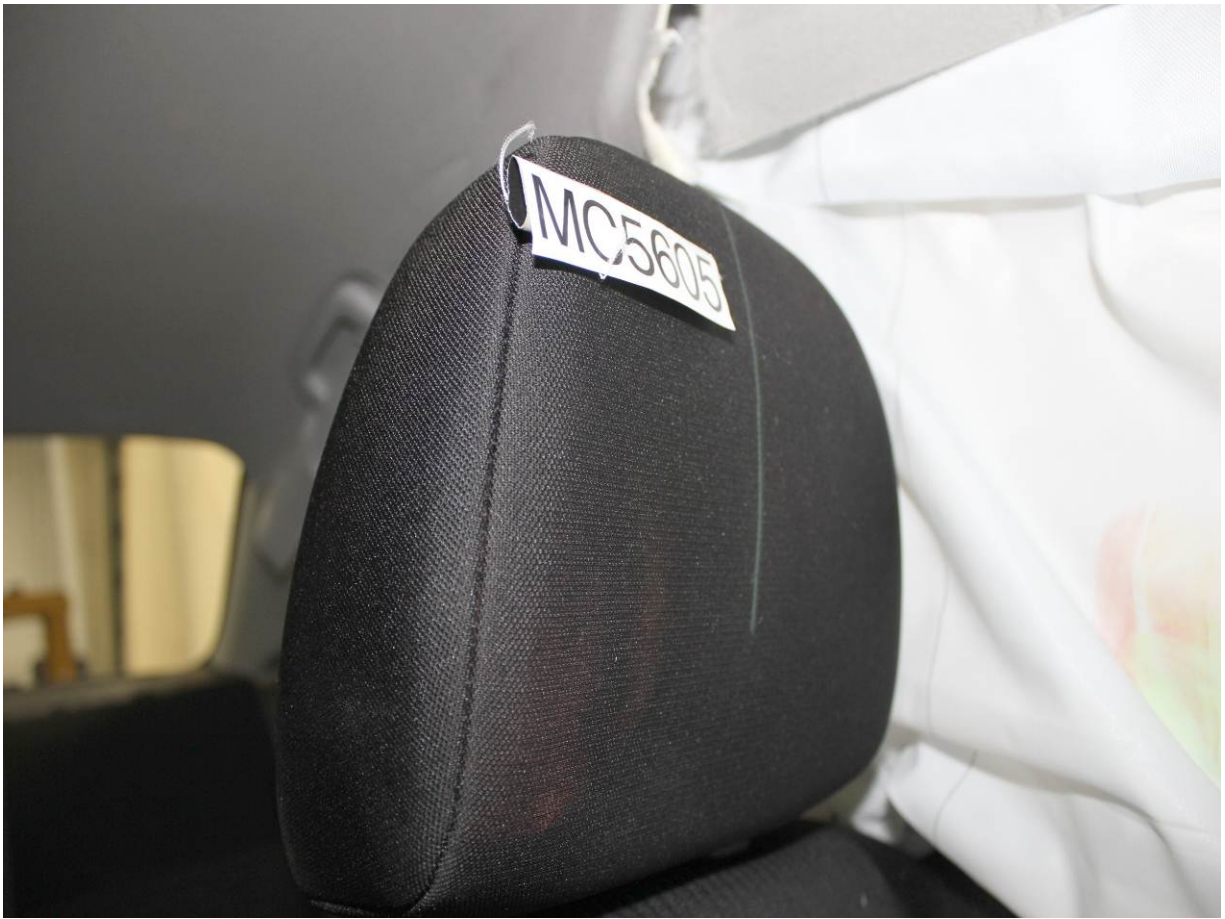
Post-Test Dummy Close-Up Head Contact with Vehicle Interior View

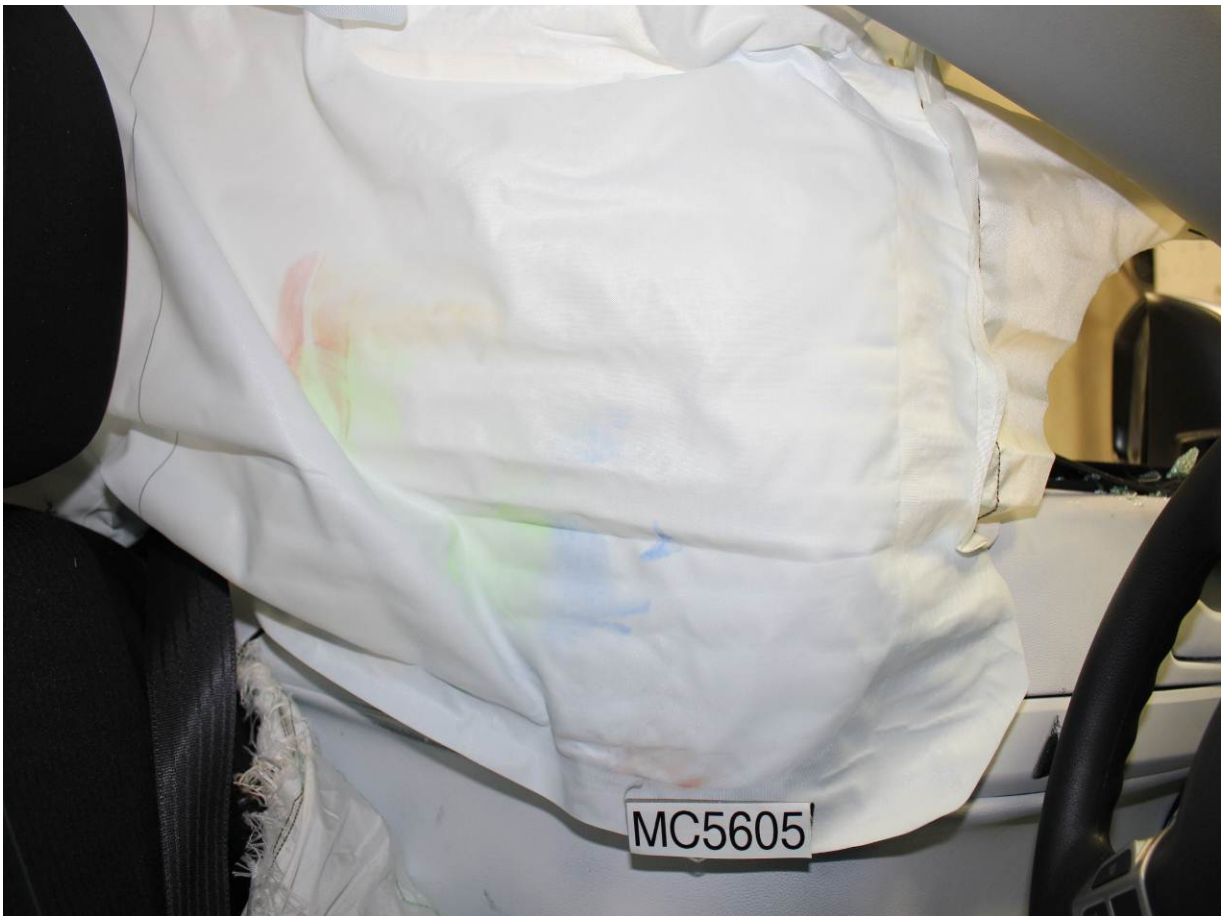
Post-Test Dummy Close-Up Head Contact with Side Air Bag View

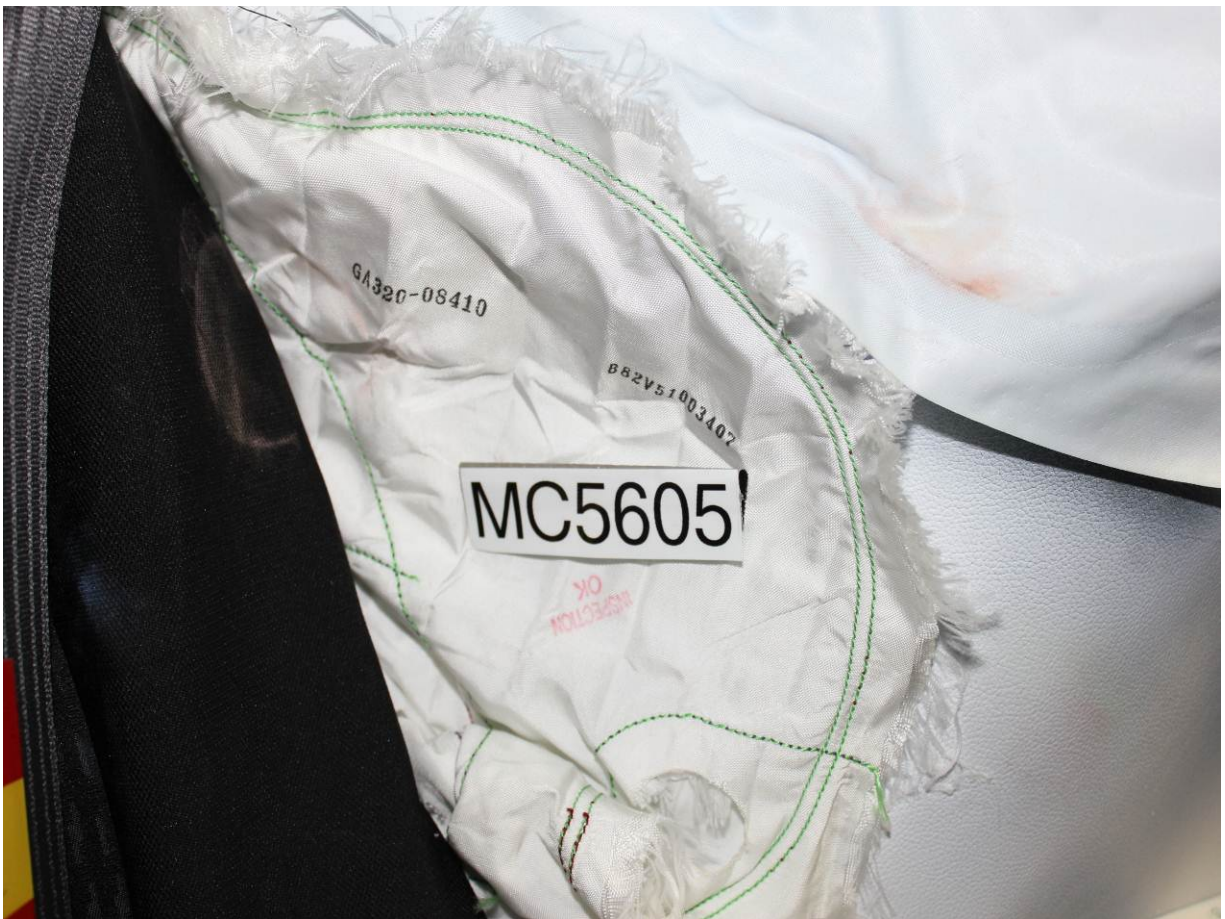
Post-Test Dummy Close-Up Torso Contact with Side Air Bag View

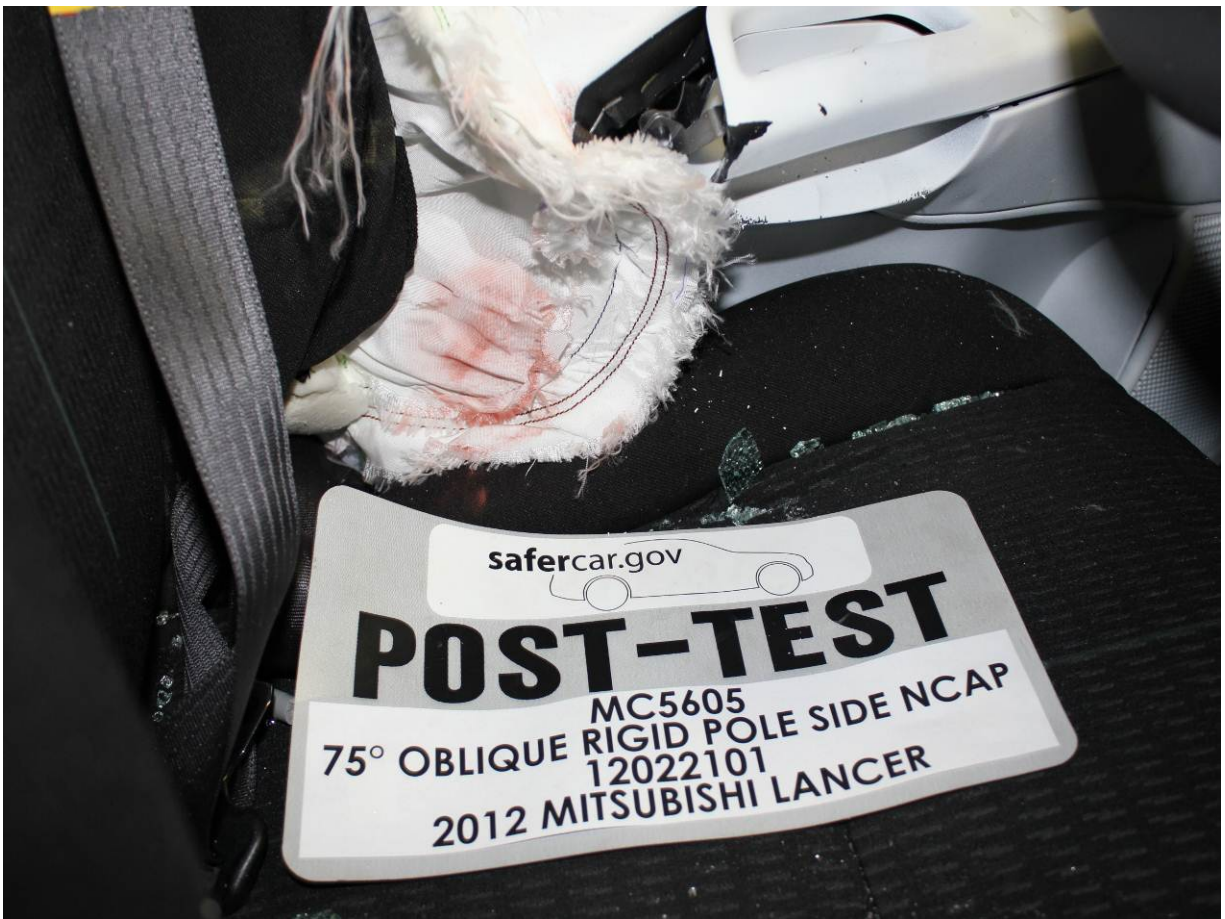
Post-Test Dummy Close-Up Pelvis Contact with Side Air Bag View
