**REPORT NUMBER: SINCAP-MGA-2012-066**

**NEW CAR ASSESSMENT PROGRAM (NCAP)  
Moving Deformable Barrier Side Impact Test**

**MITSUBISHI MOTORS CORPORATION, JAPAN  
2012 Mitsubishi Lancer ES 4-Dr Sedan  
NHTSA No.: MC5604**

**MGA RESEARCH CORPORATION  
5000 Warren Road  
Burlington, WI 53105**

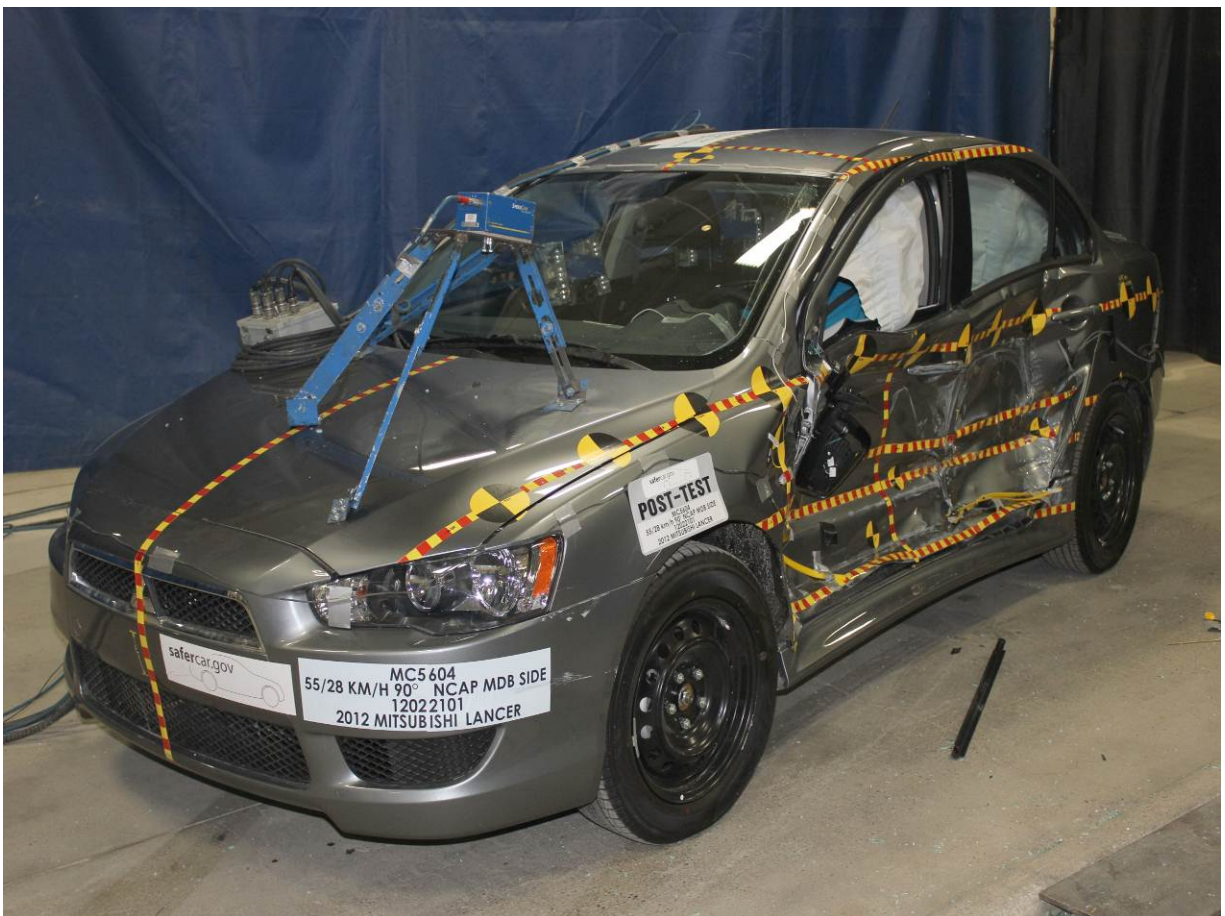
Post-Test Left Front Three-Quarter View of Test Vehicle

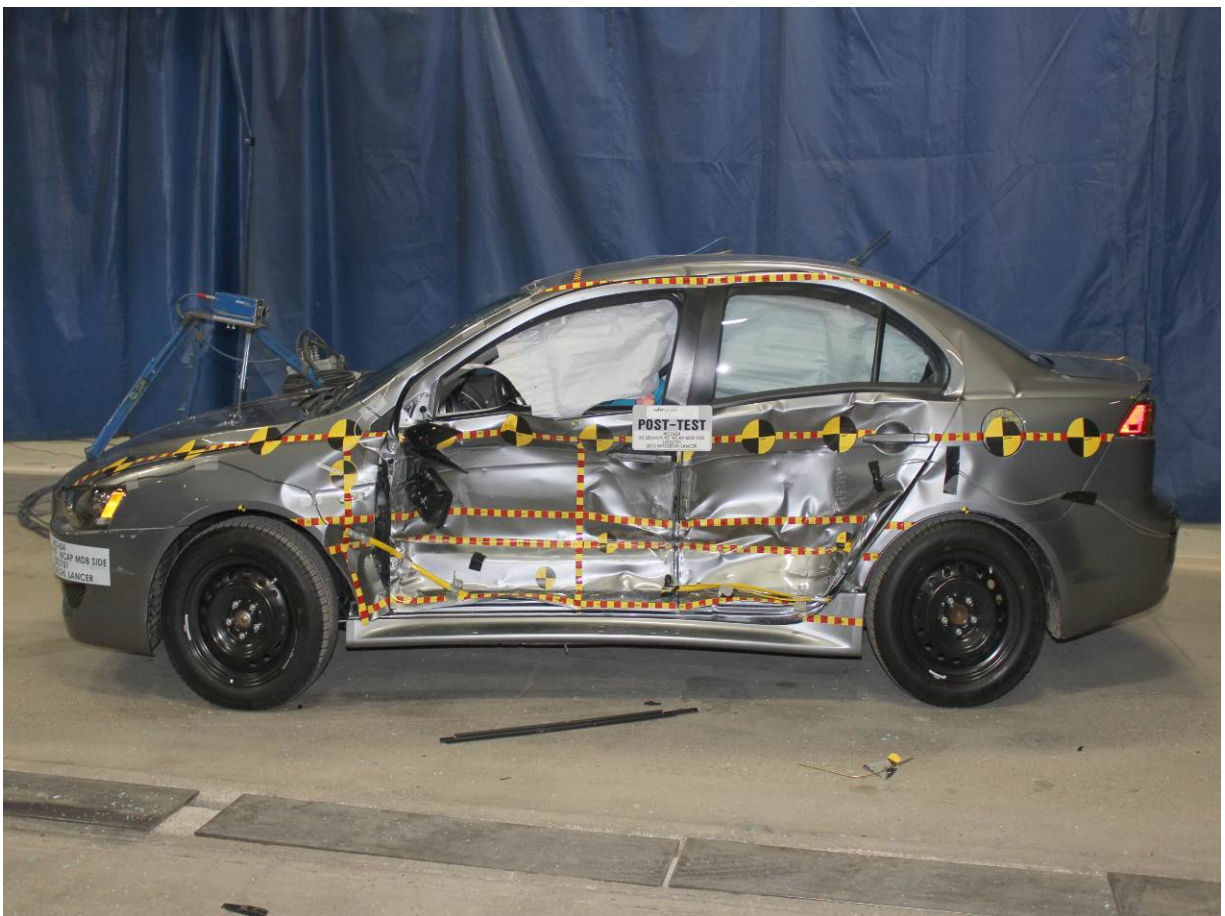
Post-Test Left Side View of Test Vehicle

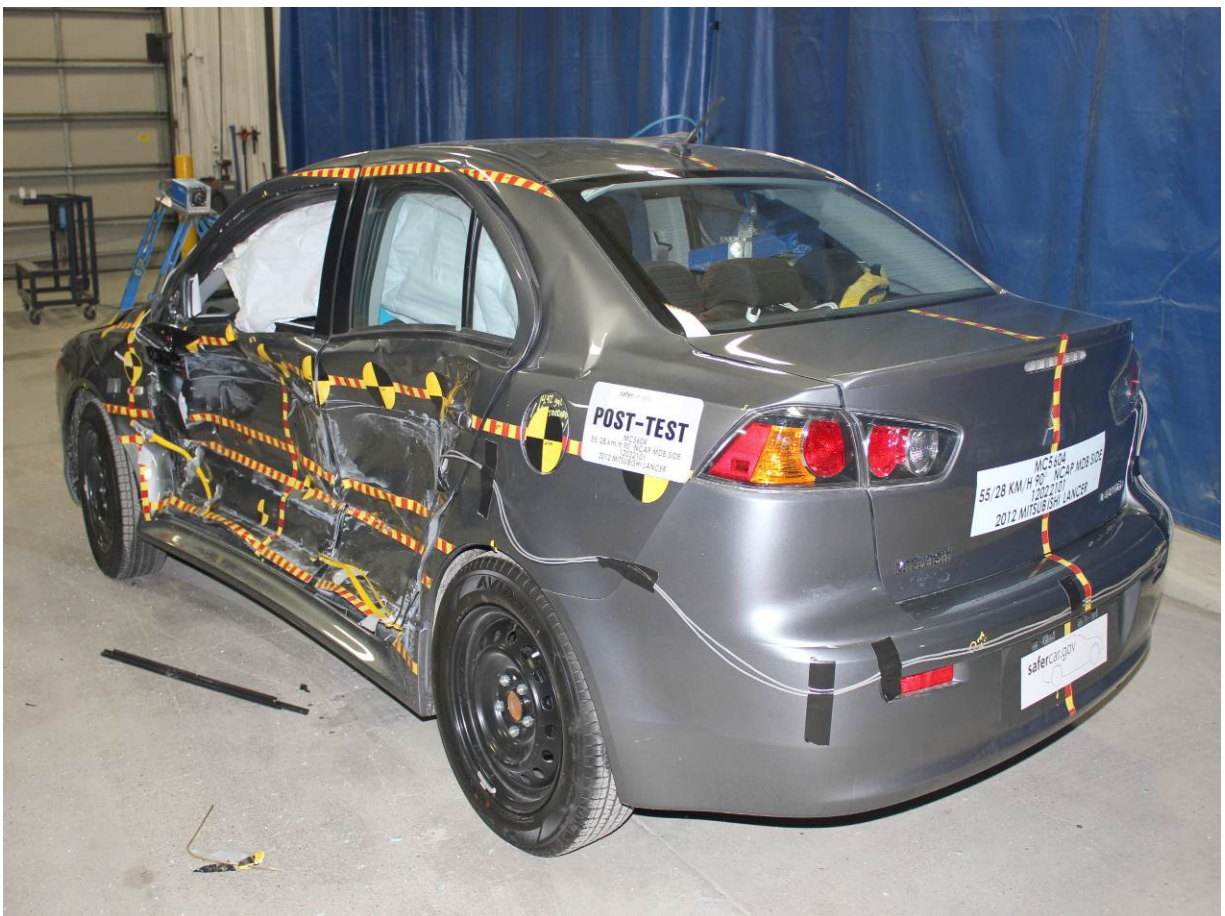
Post-Test Left Three-Quarter Rear View of Test Vehicle

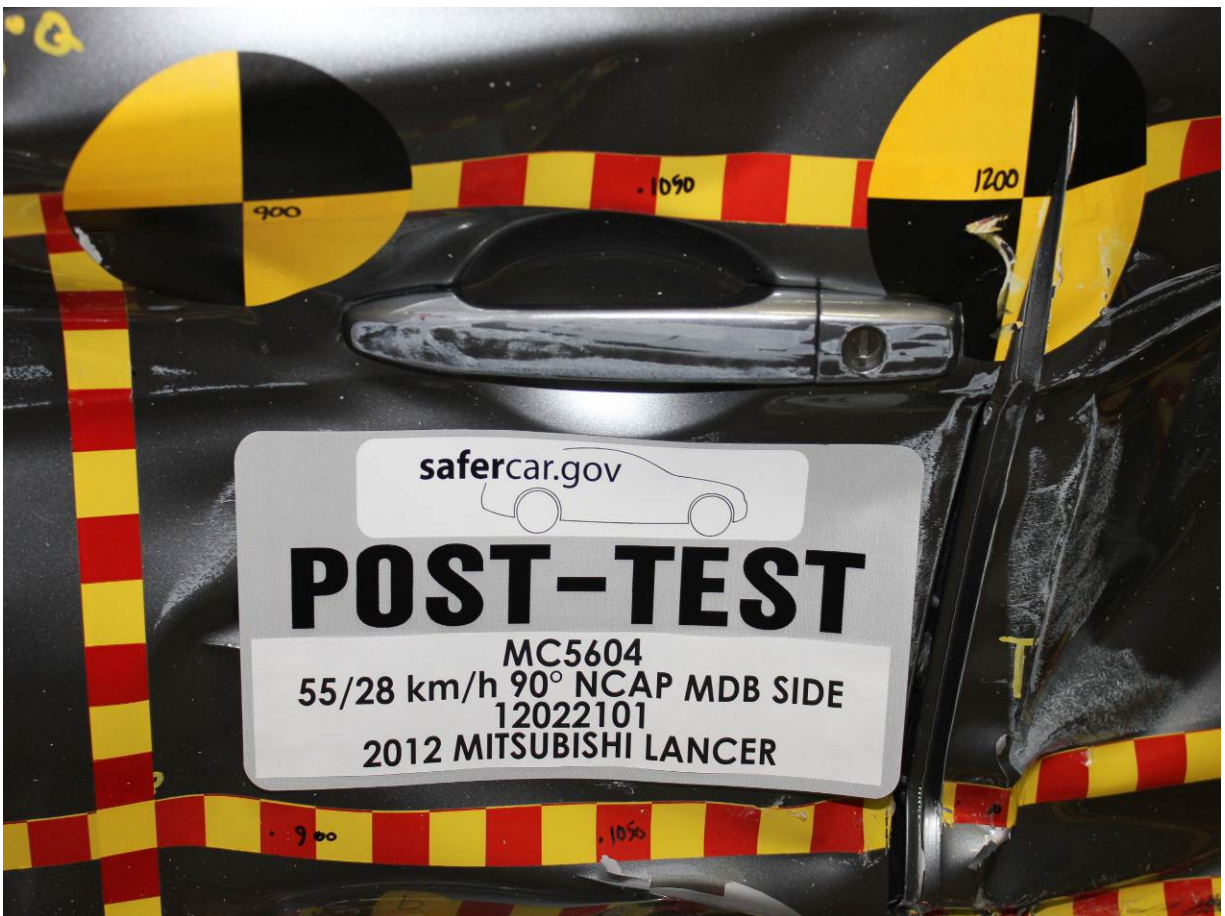
Post-Test Left Front Door Latch Close-Up

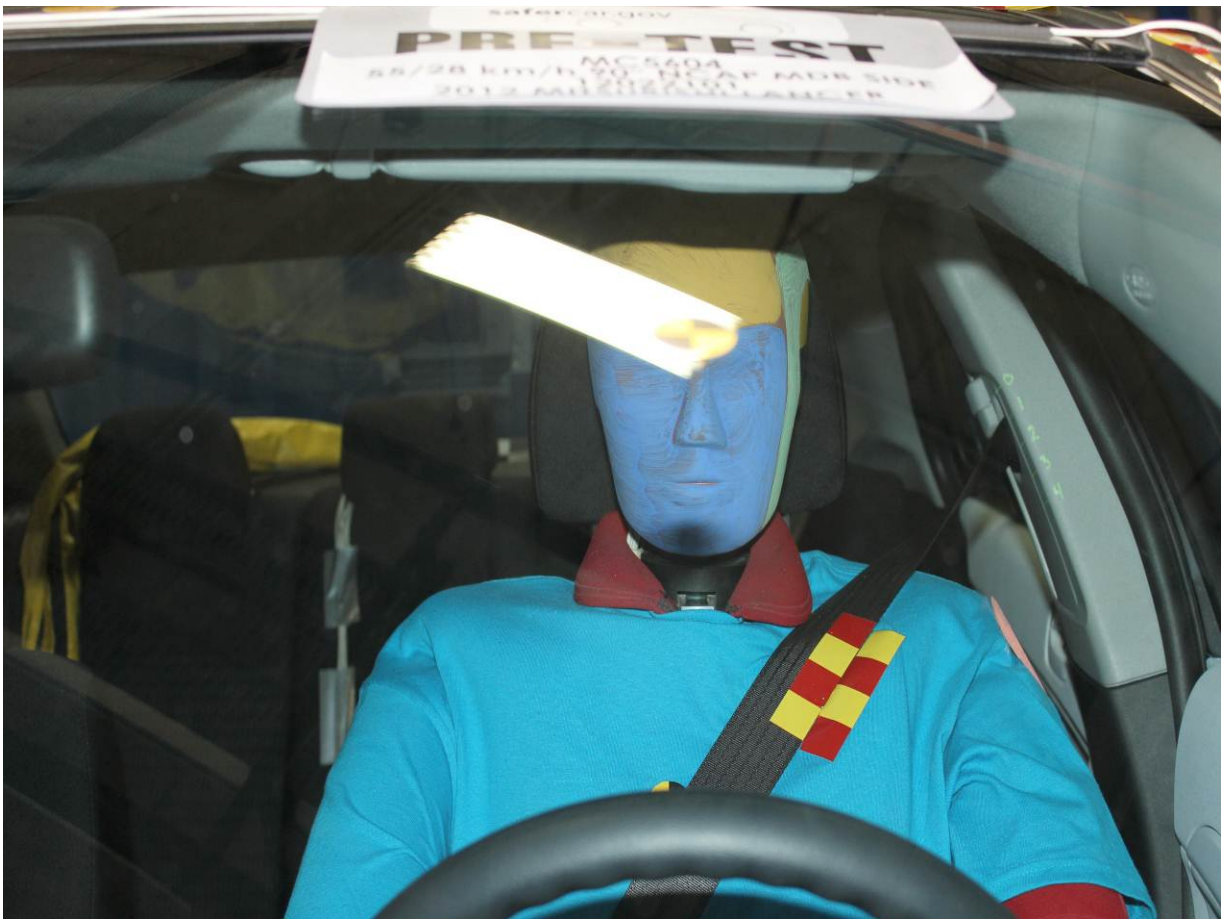
Pre-Test Front Close-Up View of Driver Dummy
