**REPORT NUMBER: SPNCAP-KAR-12-054**

**NEW CAR ASSESSMENT PROGRAM (NCAP)  
SIDE IMPACT POLE TEST**

**TOYOTA MOTOR CORPORATION  
2012 SCION IQ 3-DOOR HATCHBACK**

**FINAL REPORT**

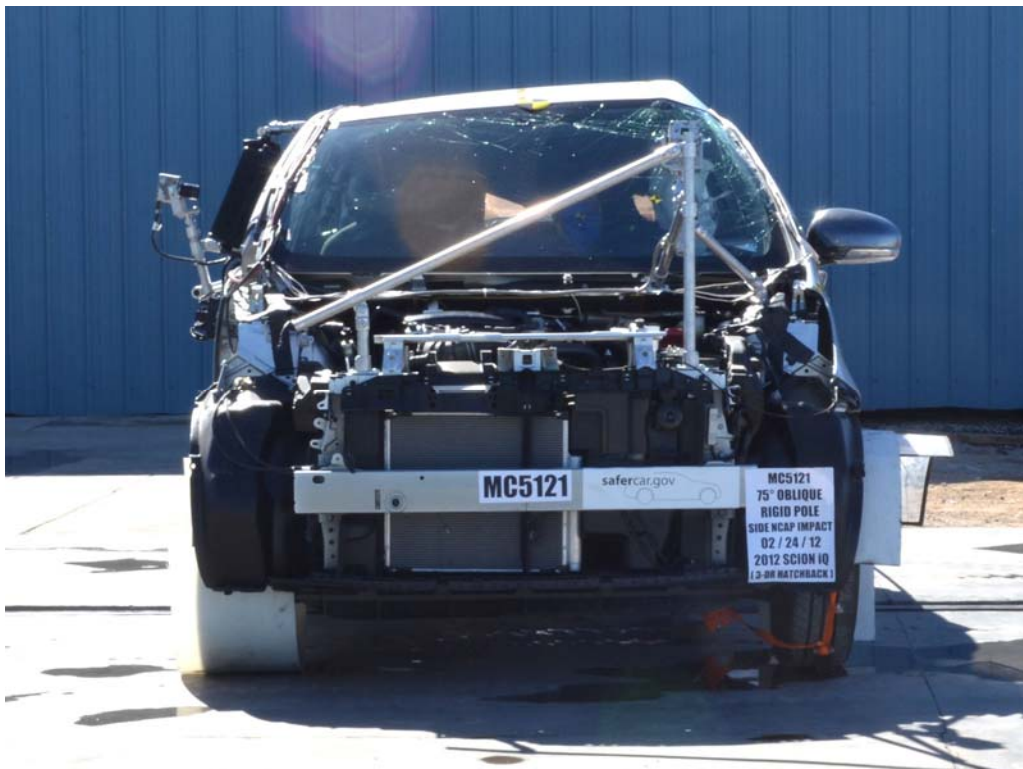
FIGURE 4. Post-Test Frontal View of Test Vehicle

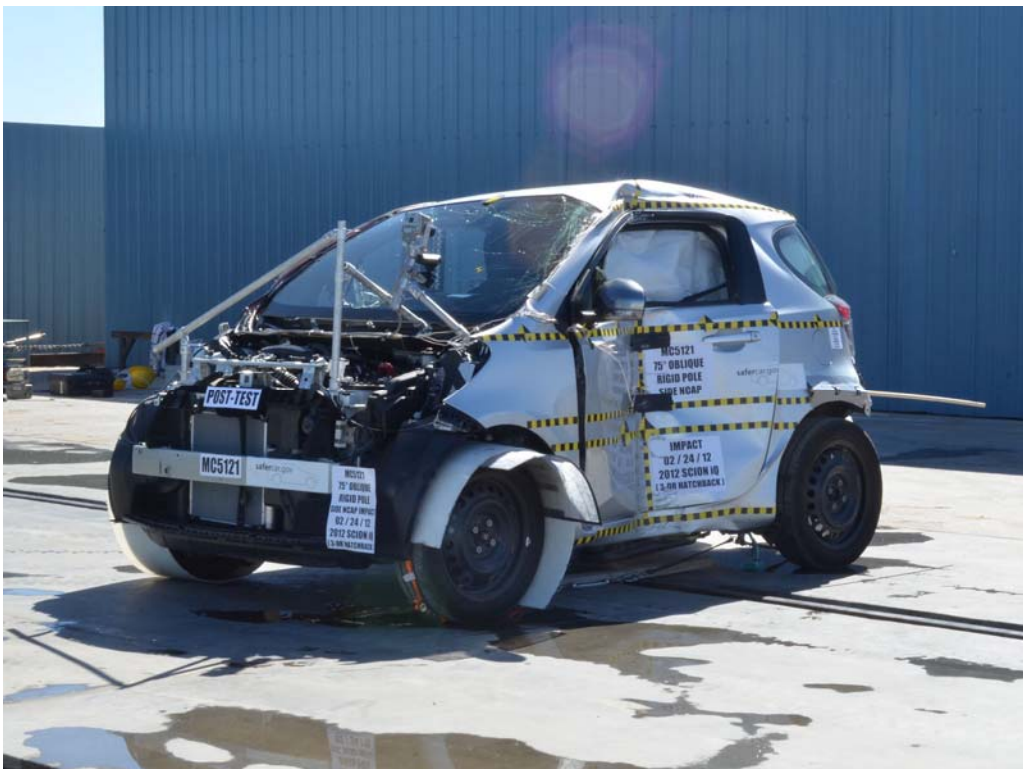
FIGURE 6. Post-Test Left Front  $\frac{3}{4}$  View of Test Vehicle

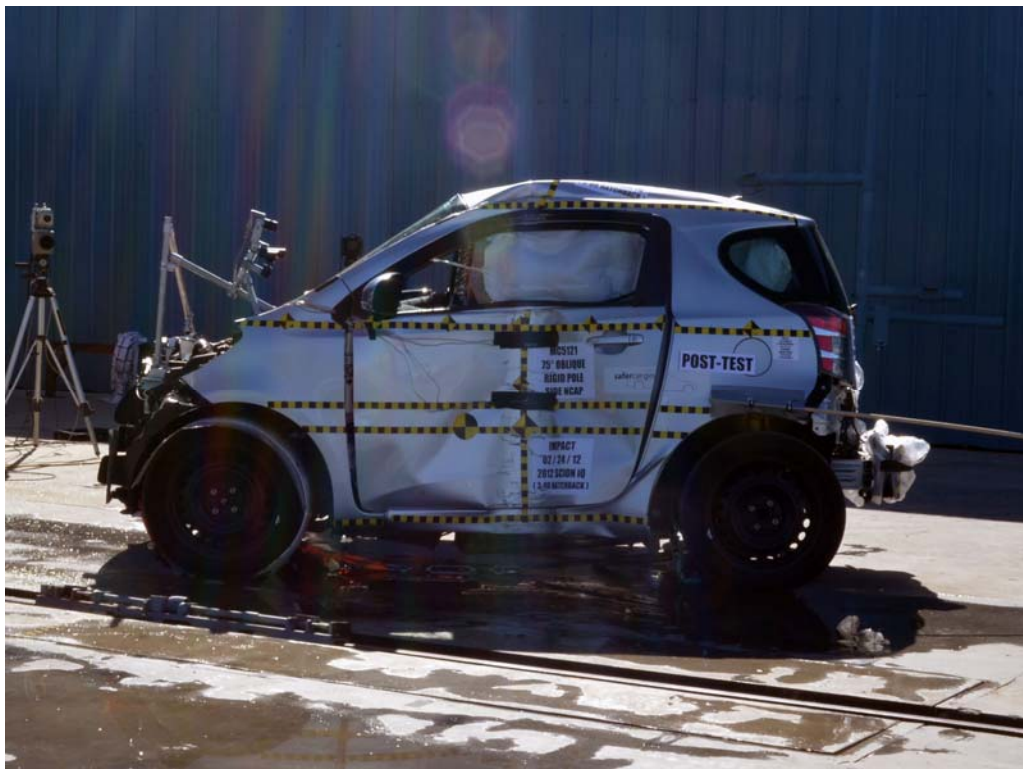
FIGURE 8. Post-Test Left Side View of Test Vehicle

The door on the struck side of the vehicle remained closed and latched. There was no separation at the hinge or latch. The door on the non-struck side remained closed and latched.

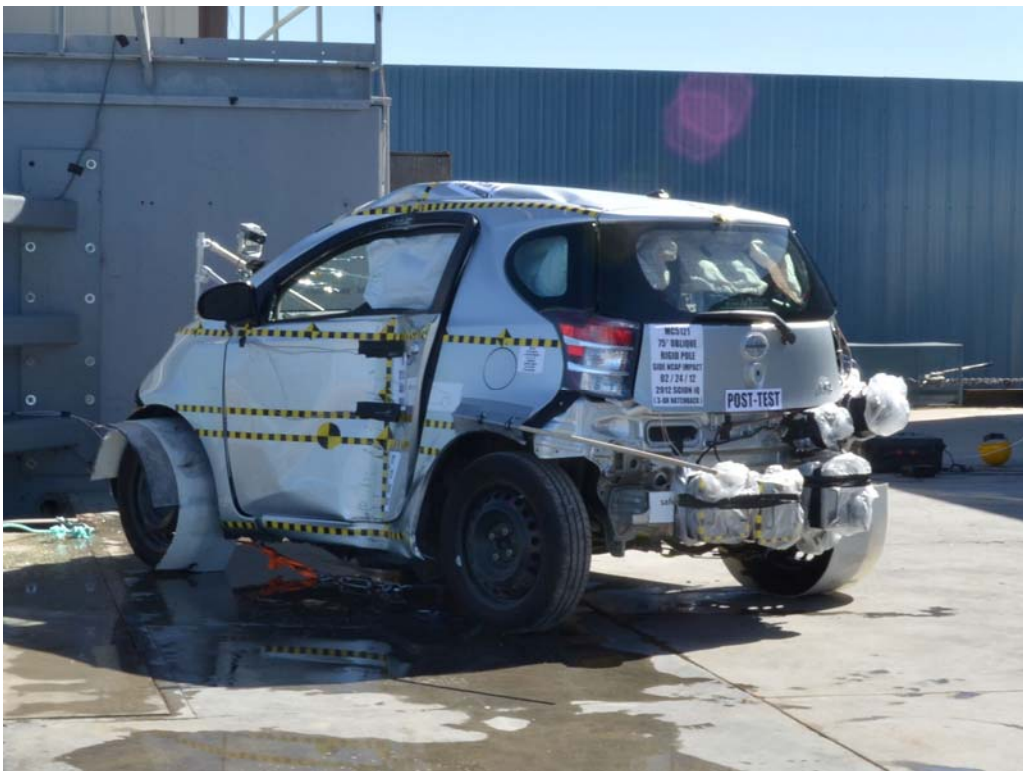
FIGURE 10. Post-Test Left Rear  $\frac{3}{4}$  View of Test Vehicle

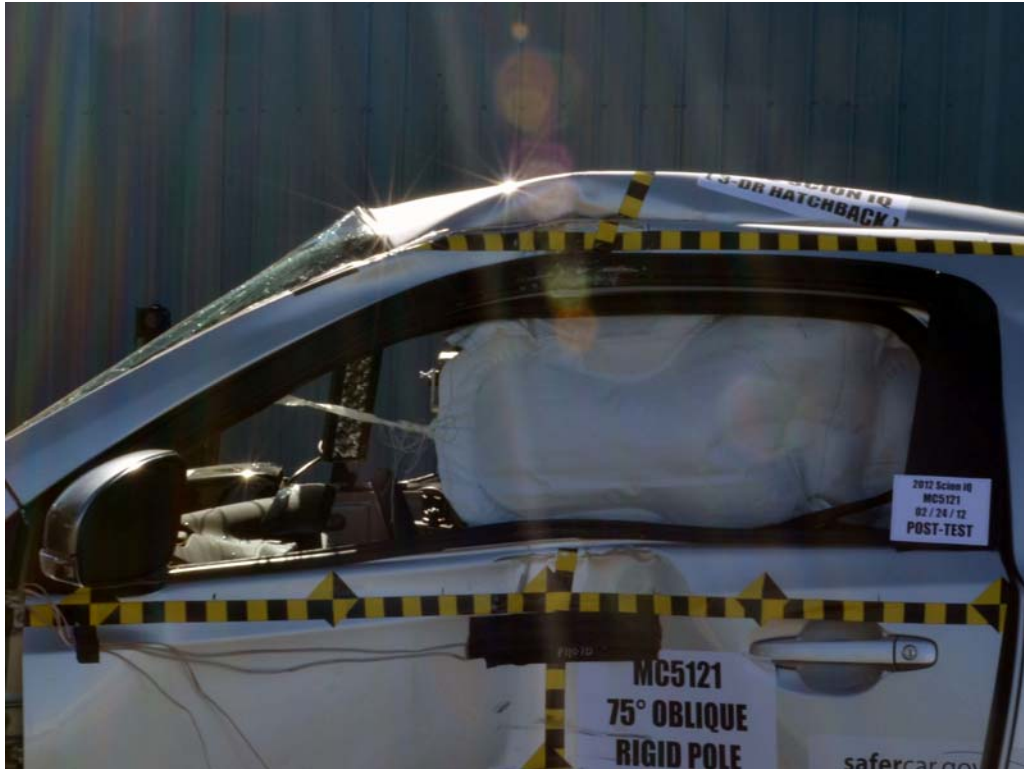
FIGURE 25. Post-Test Left Side View of Dummy Shoulder and Door Top View

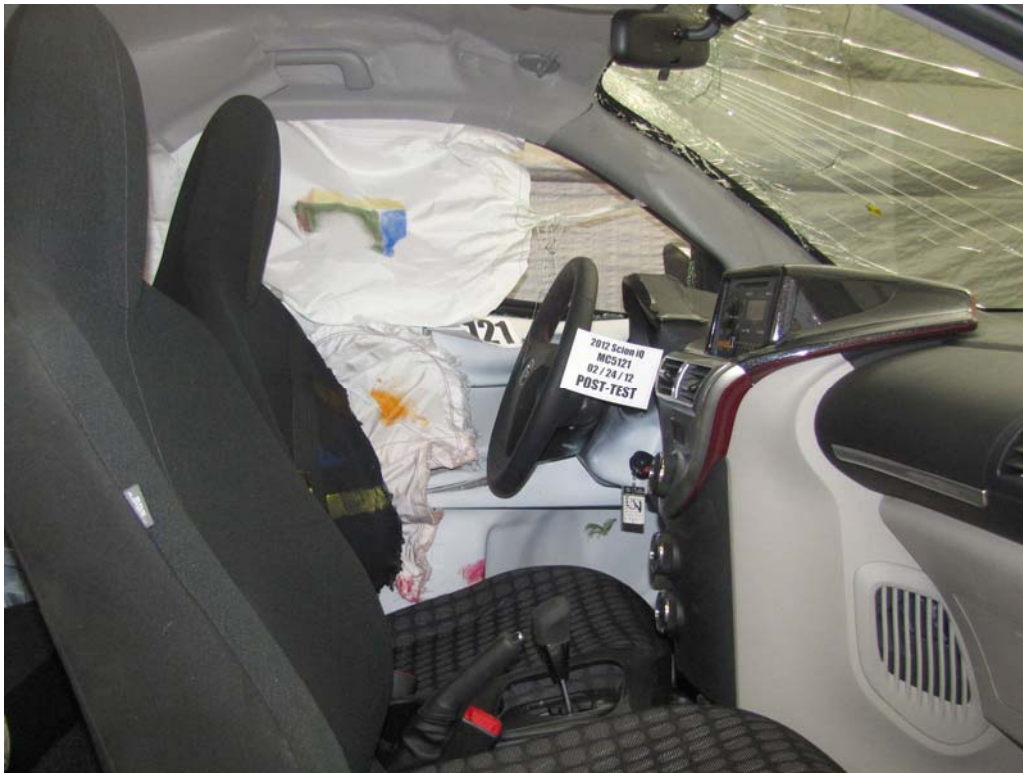
FIGURE 45. Post-Test Inner Driver Door Panel View  
Showing Dummy Contact Locations

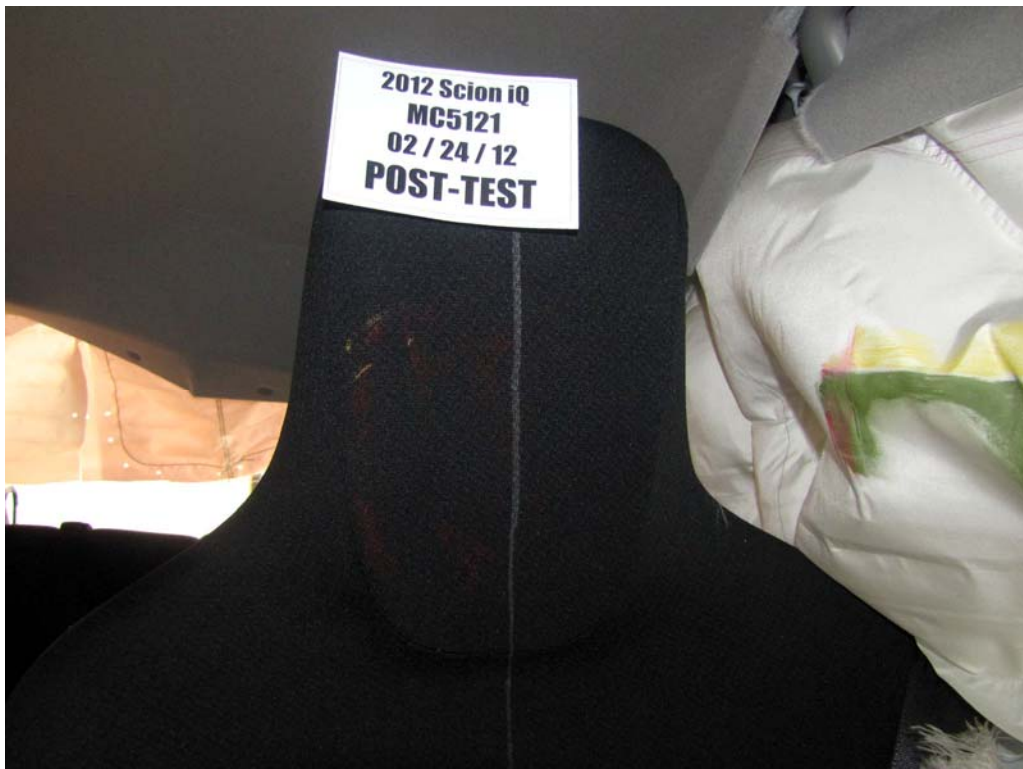
FIGURE 46. Post-Test Dummy Close-Up Head Contact with Vehicle Interior View

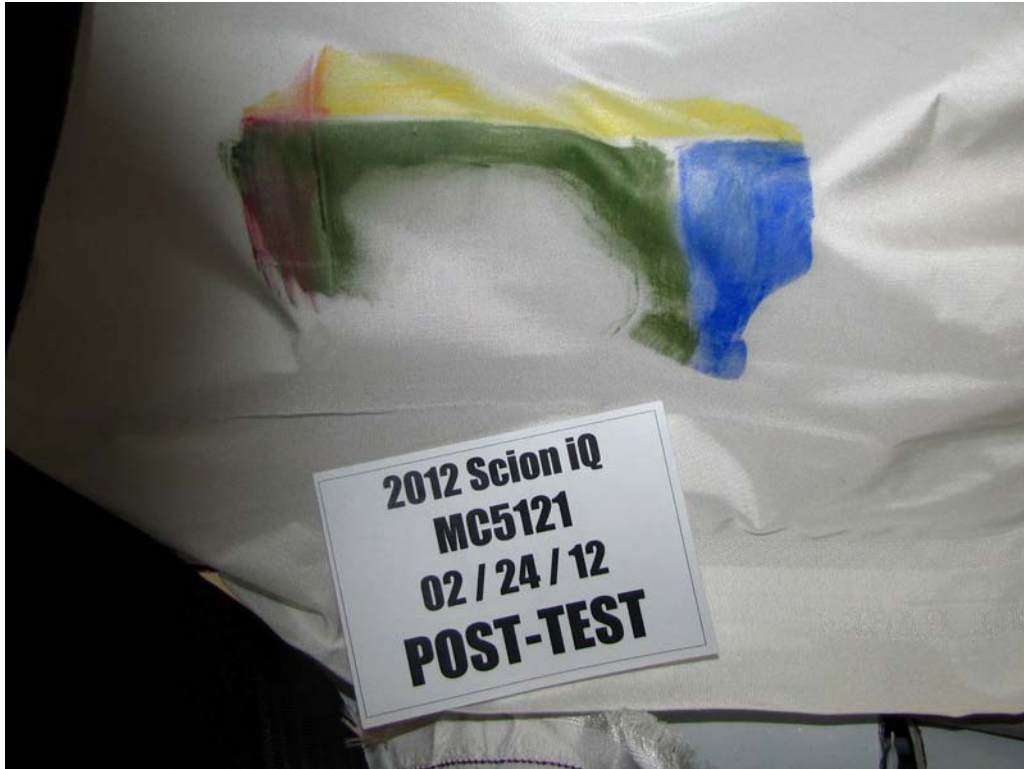
FIGURE 47. Post-Test Dummy Close-Up Head Contact with Side Airbag View

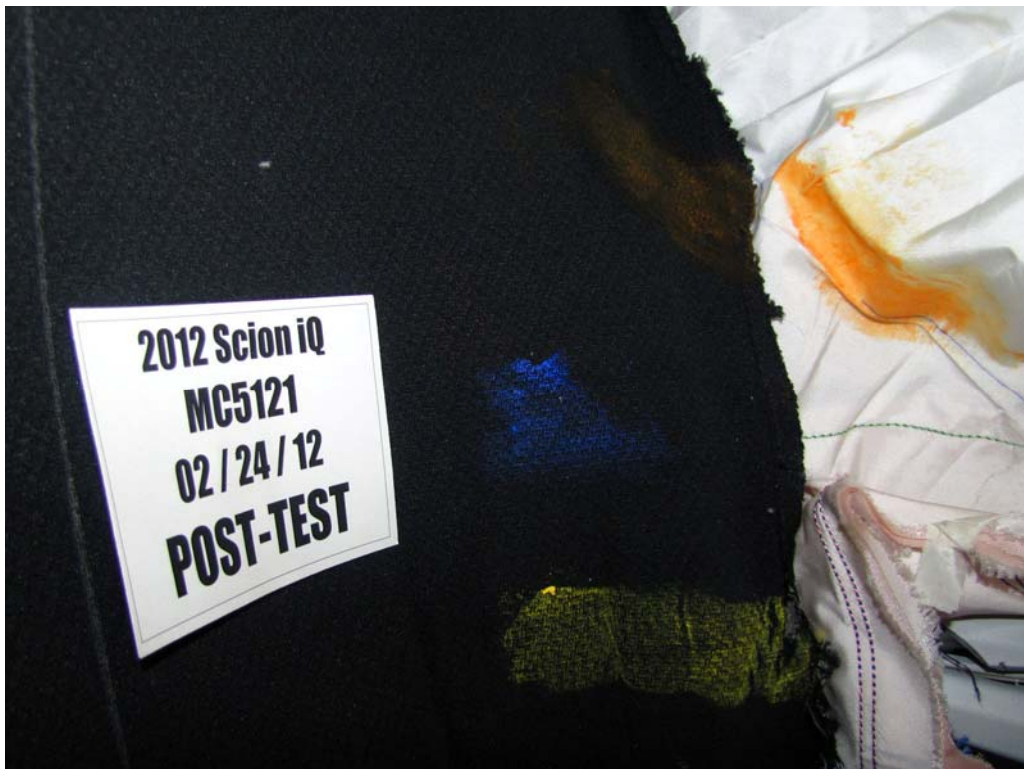
FIGURE 48. Post-Test Dummy Close-Up Torso Contact with Vehicle Interior View

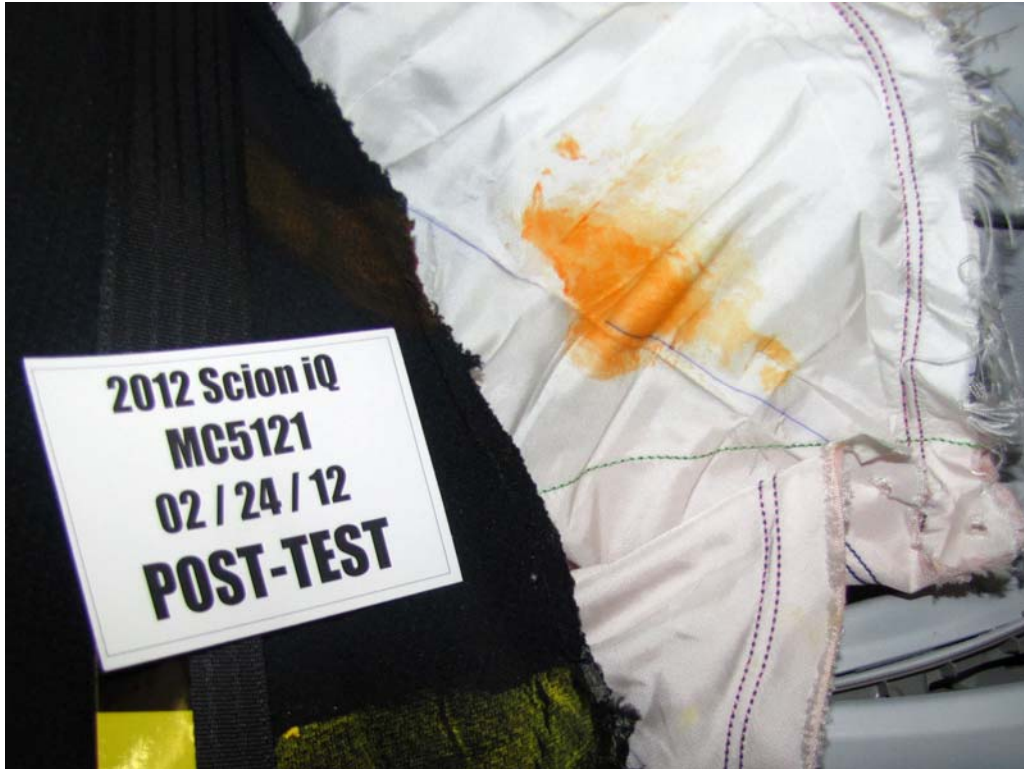
FIGURE 49. Post-Test Dummy Close-Up Torso Contact with Side Airbag View

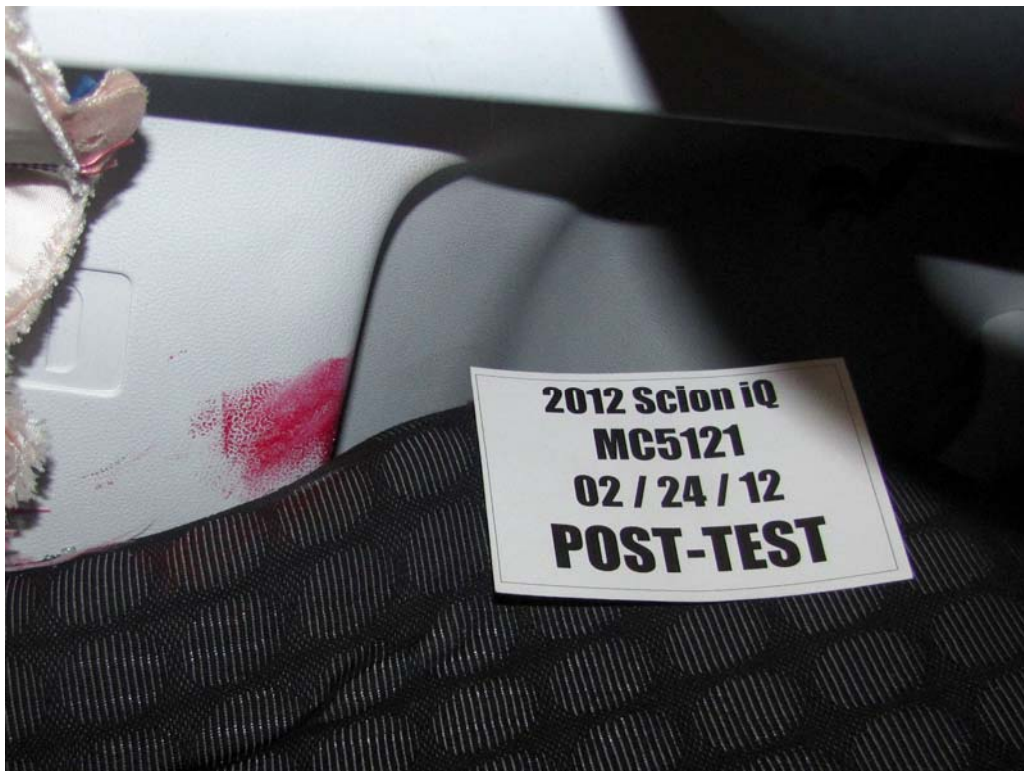
FIGURE 50. Post-Test Dummy Close-Up Pelvis Contact with Vehicle Interior View

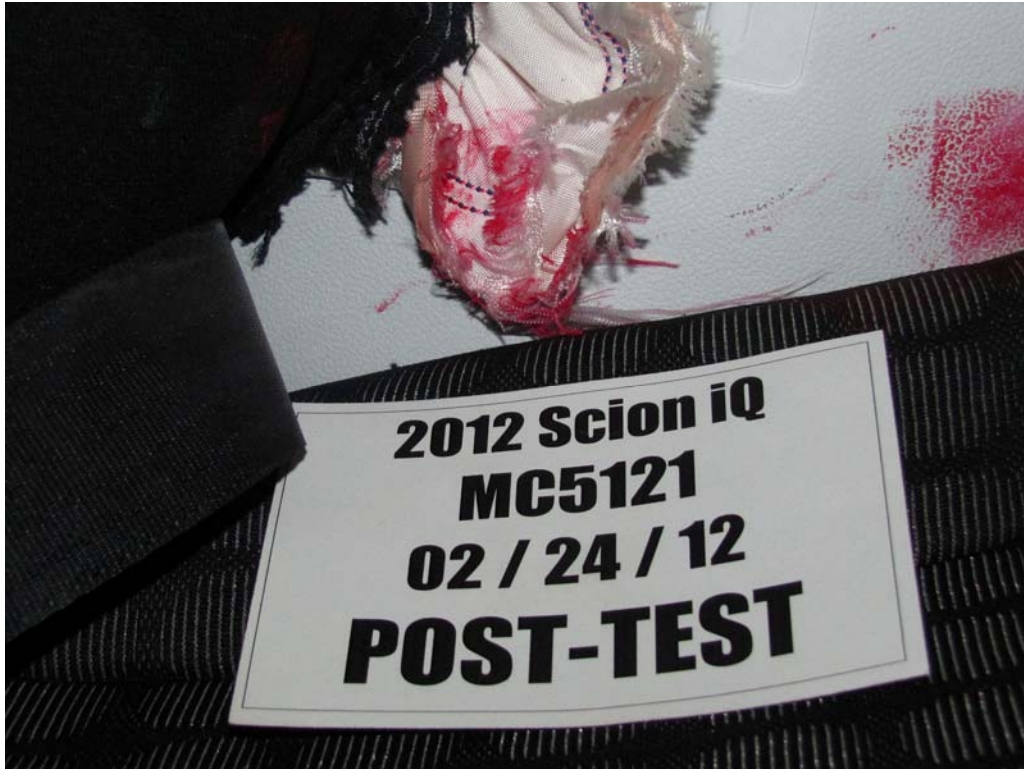
FIGURE 51. Post-Test Dummy Close-Up Pelvis Contact with Side Airbag View

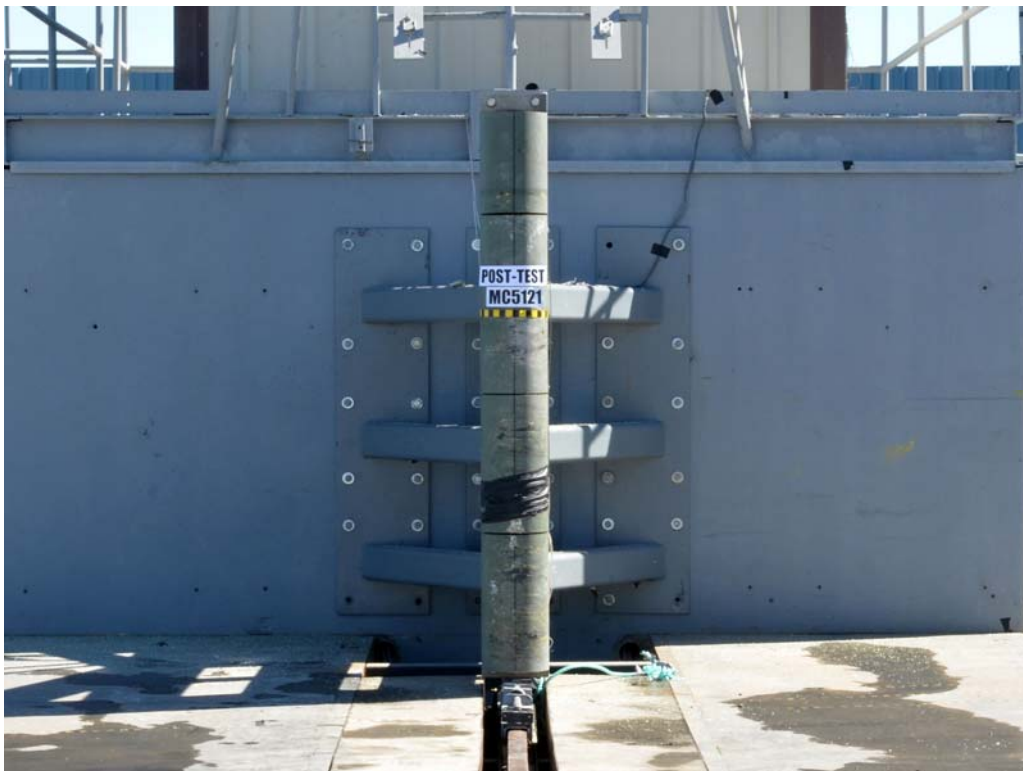
FIGURE 57. Post-Test Pole Barrier Front View

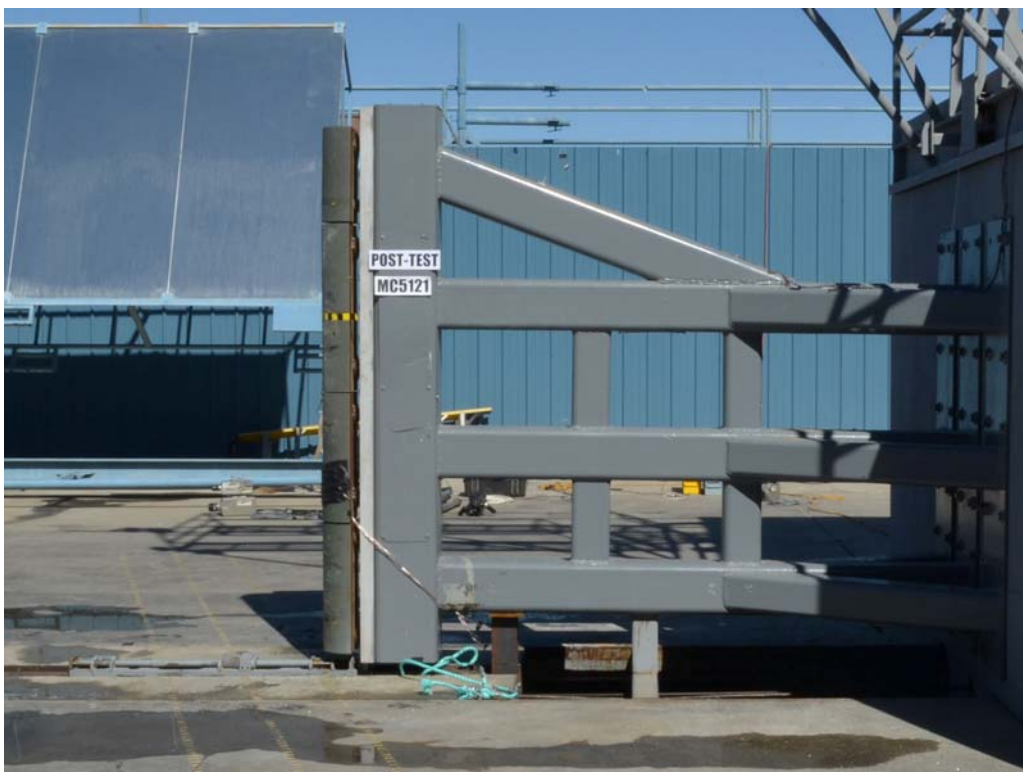
FIGURE 59. Post-Test Pole Barrier Side View

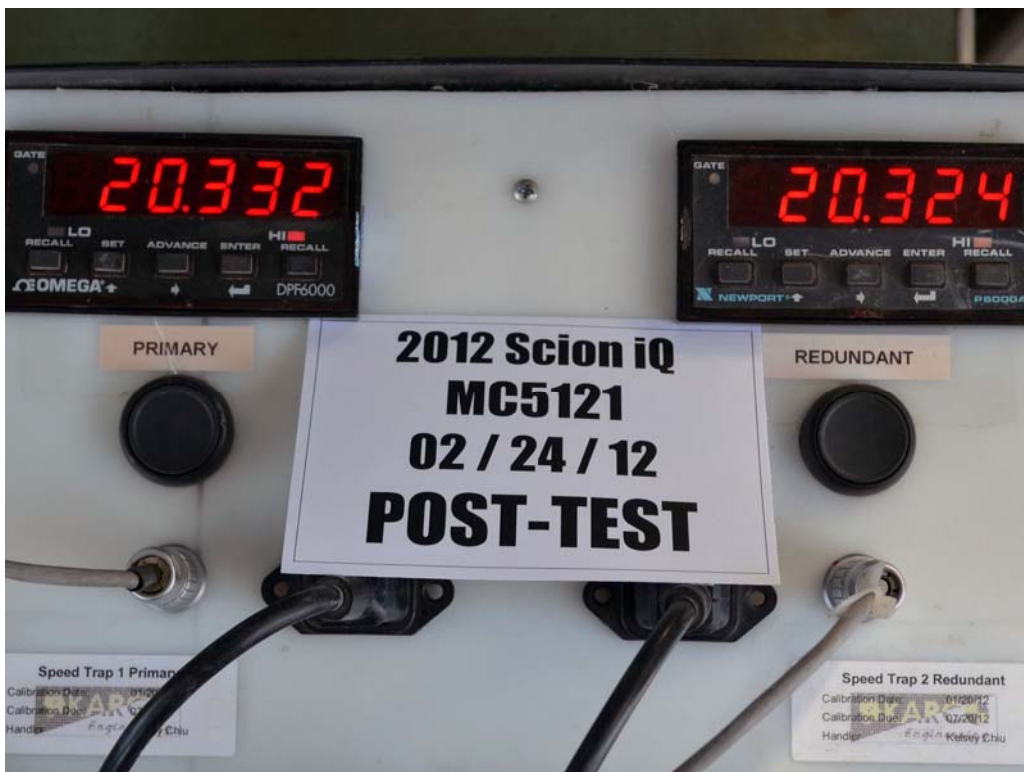
FIGURE 61. Post-Test Primary and Redundant Speed Trap Read-Out

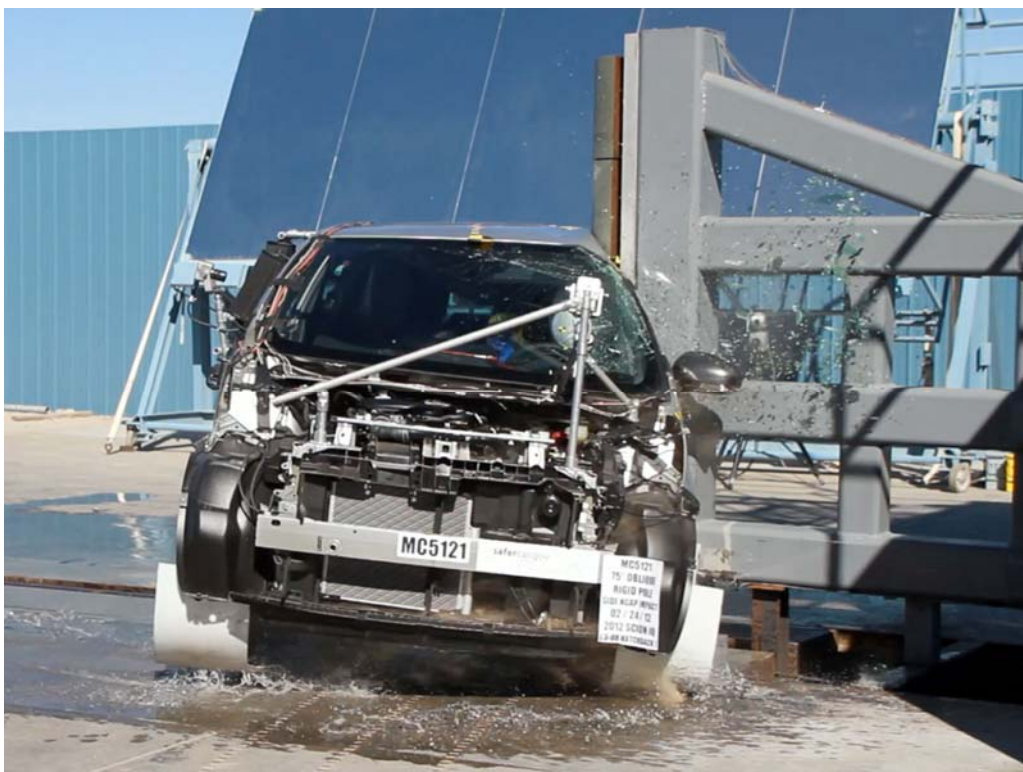
FIGURE 67. Impact Event

A rigid pole side impact test was conducted on a 2012 Scion iQ 3-door hatchback. The subject vehicle was towed into the rigid pole at an angle of 76.3° and a velocity of 32.7 km/h. The test was conducted by KARCO Engineering, LLC. in Adelanto, California on February 24, 2012. Pre- and post-test photographs of the test vehicle and side impact dummy (SID-IIs) are included in Appendix A of this report.
