REPORT NUMBER: SPNCAP-MGA-2012-069

**NEW CAR ASSESSMENT PROGRAM (NCAP)
Side Impact Pole Test**

**MITSUBISHI MOTORS CORPORATION, JAPAN
2012 Mitsubishi Outlander Sport ES SUV
NHTSA No.: MC5602**

FINAL REPORT

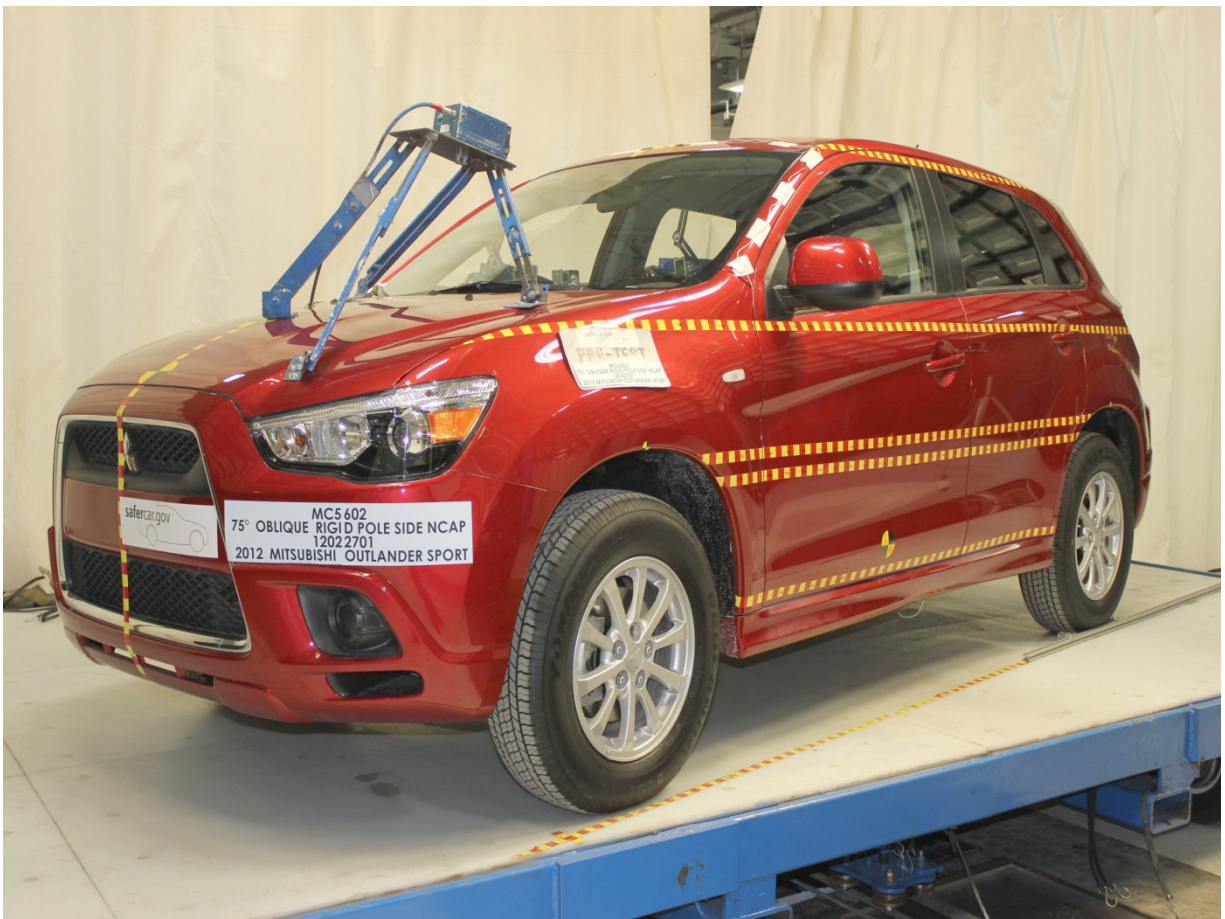
Post-Test Frontal View of Test Vehicle

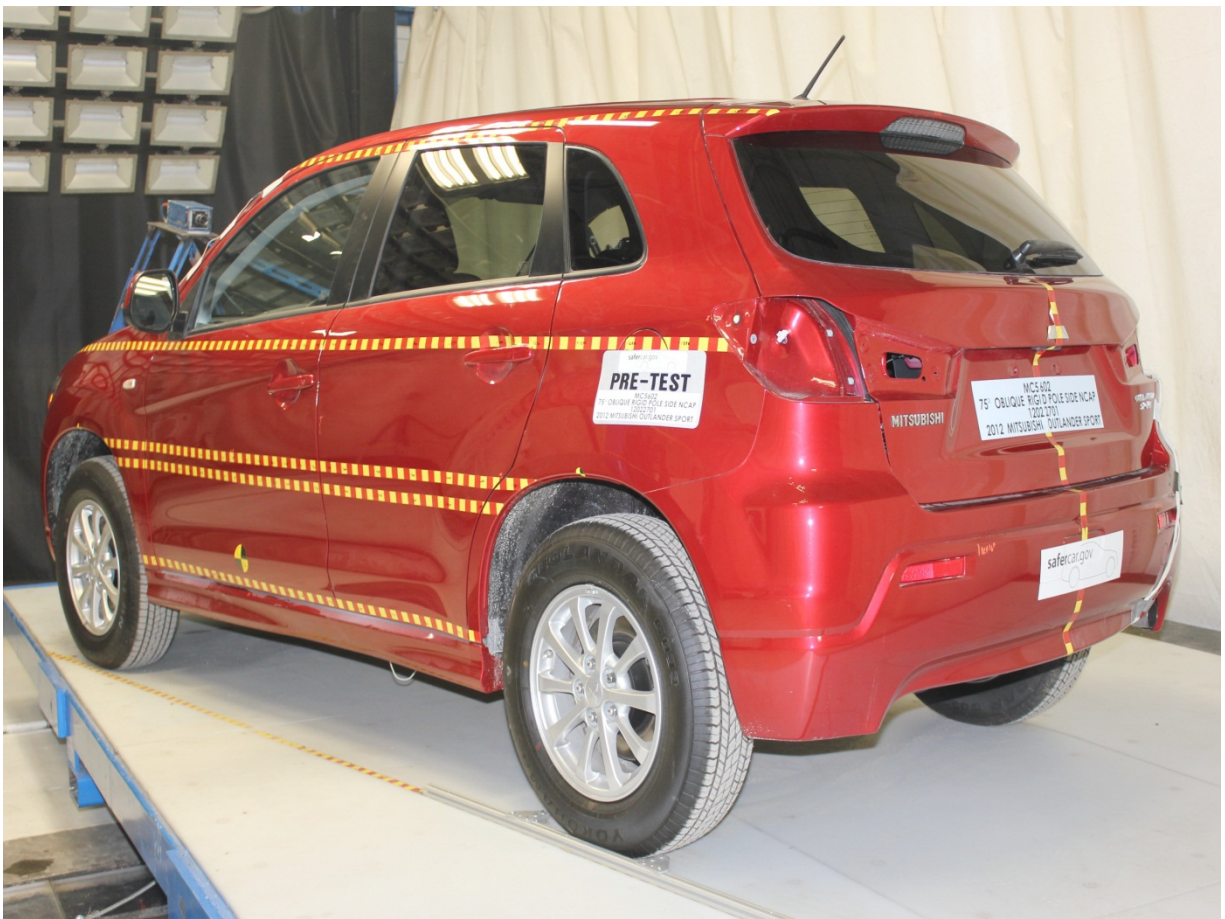
Post-Test Left Side View of Test Vehicle

Critical Areas of Performance	Observations and Conclusions
Pillar Performance	No Separation
Sill Separation	None
Windshield Damage	Cracked
Side Window Damage	Left Front Window Broke
Other Notable Effects	None

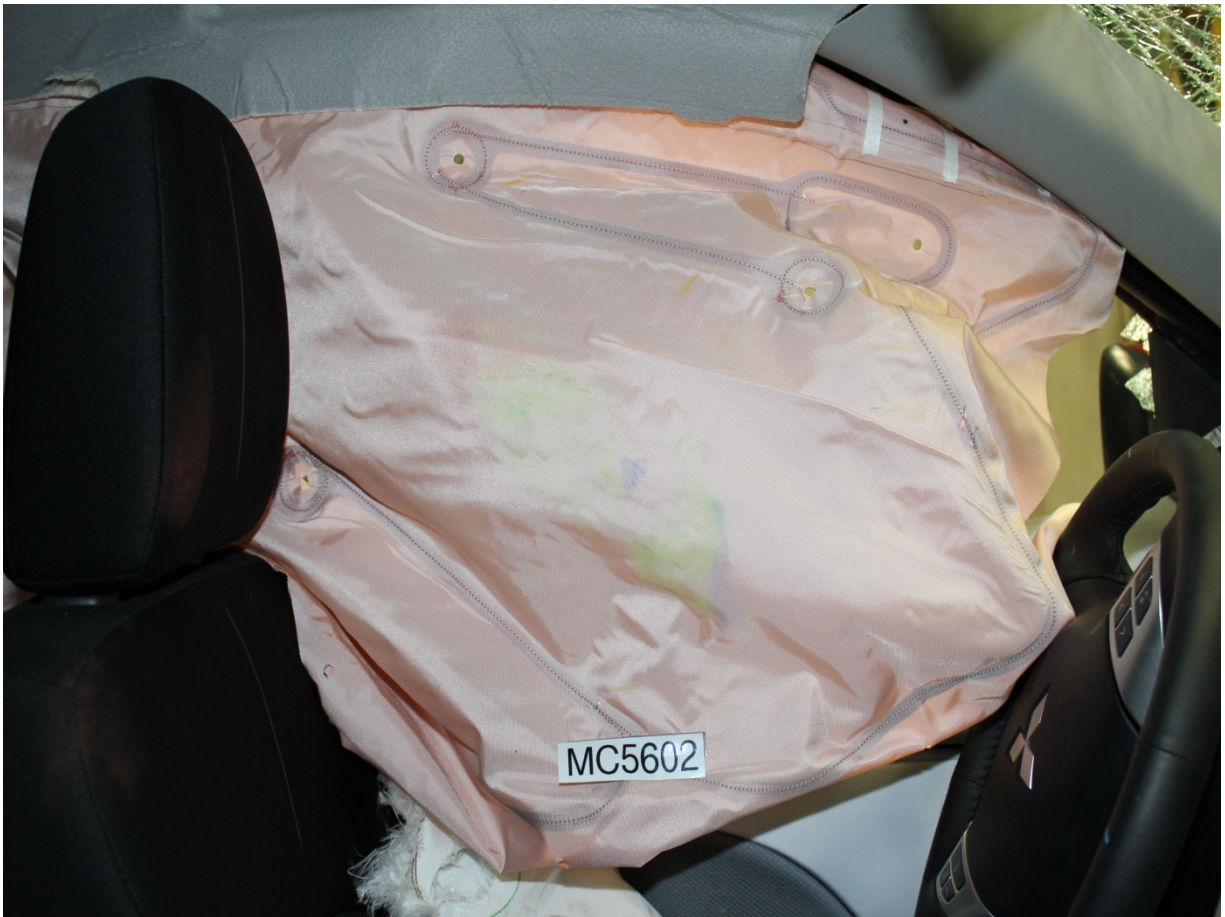
Post-Test Dummy Close-Up Head Contact with Vehicle Interior View

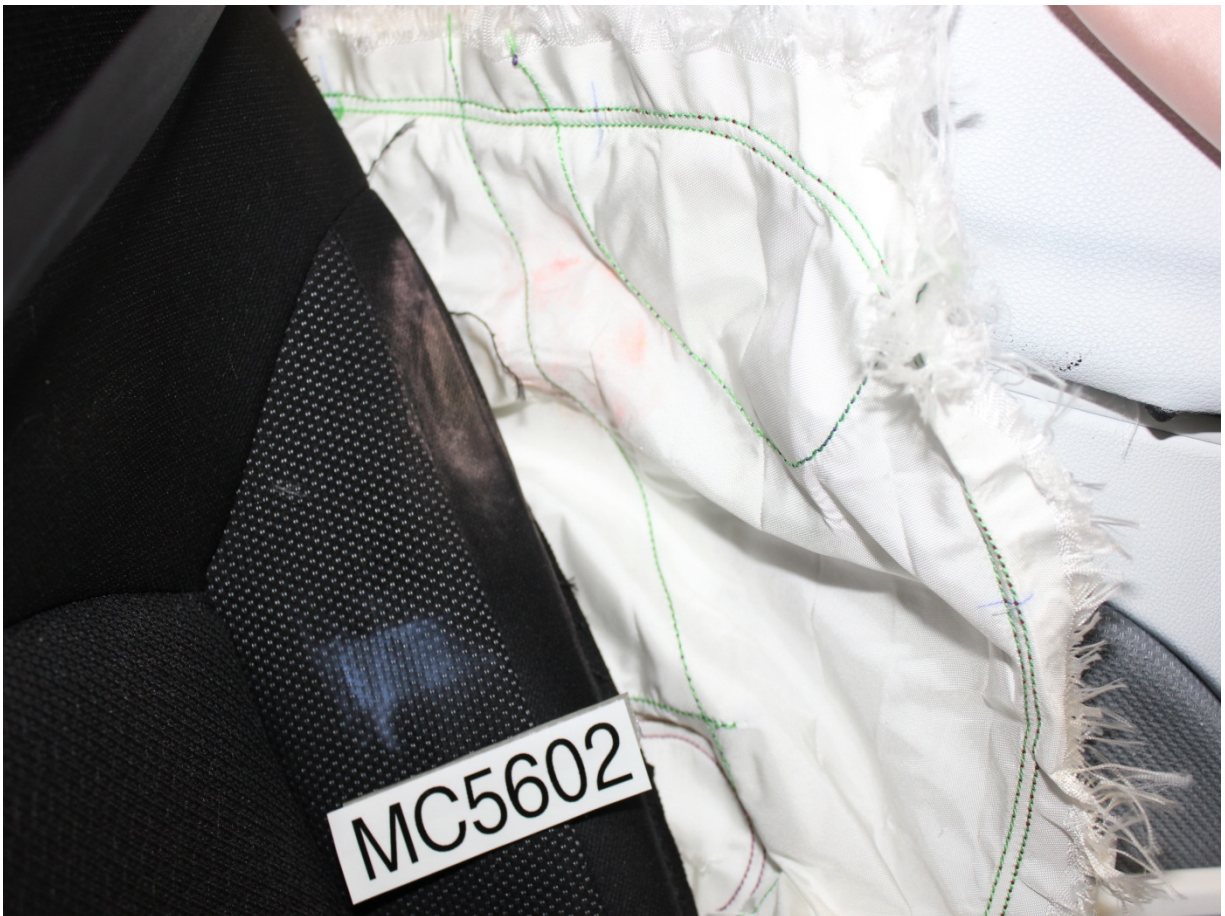
Post-Test Dummy Close-Up Head Contact with Side Air Bag View

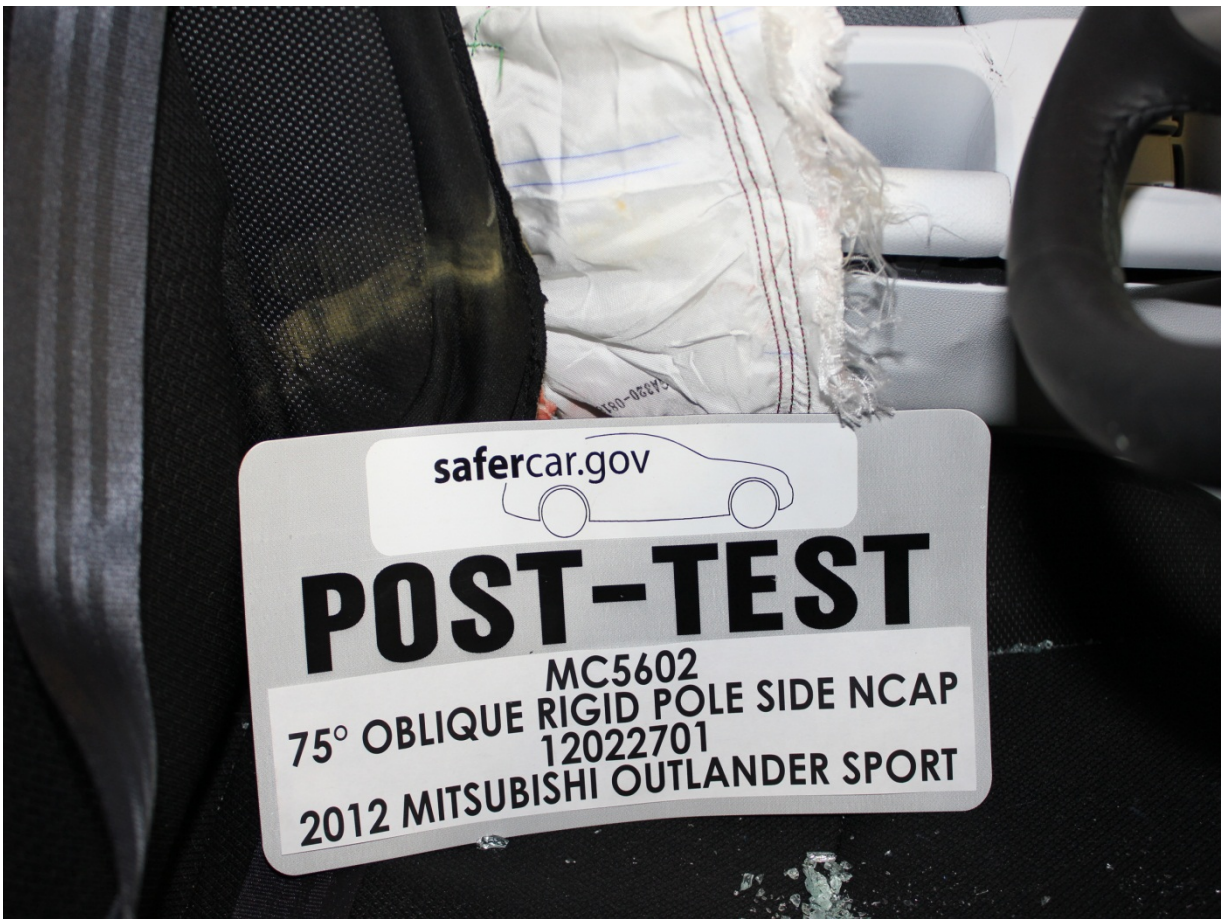
Post-Test Dummy Close-Up Torso Contact with Vehicle Interior View

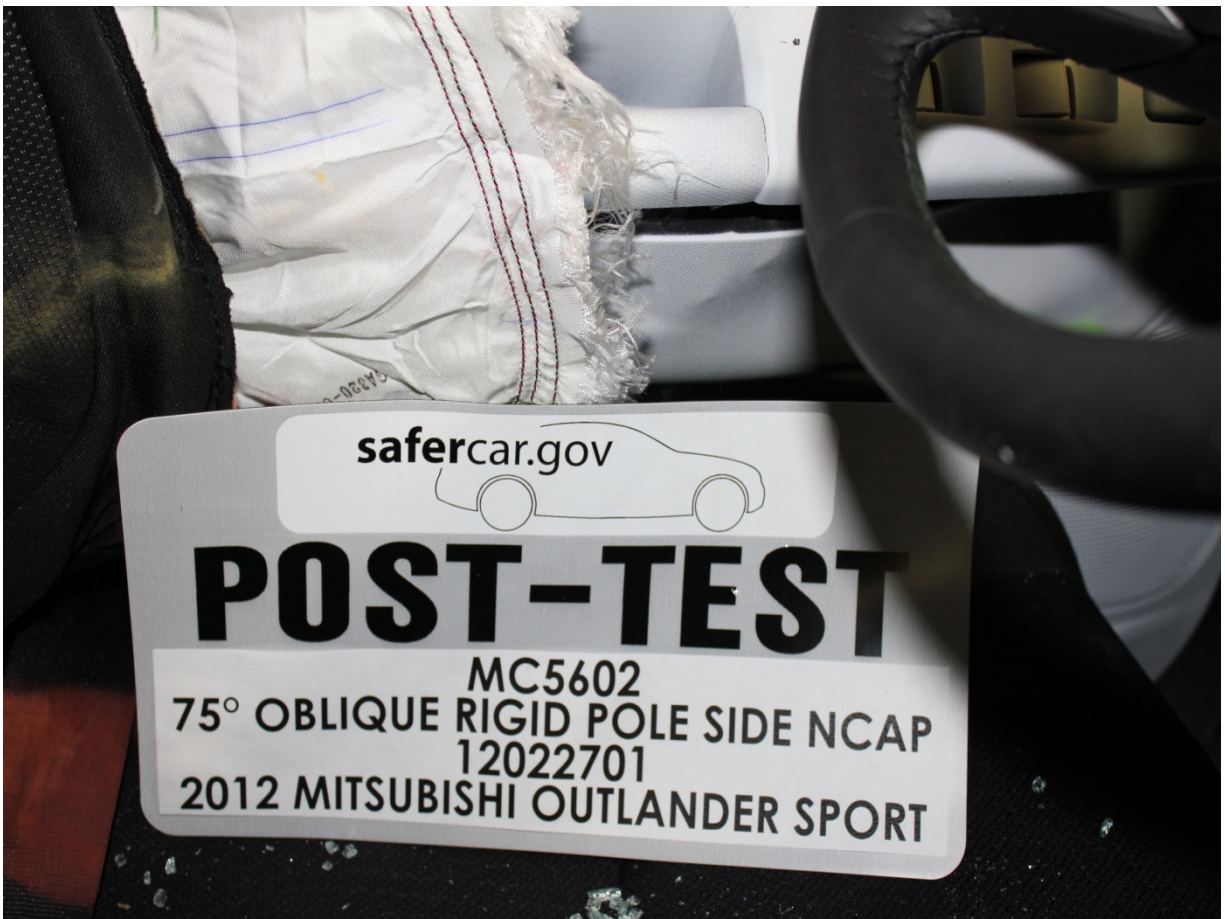
Post-Test Dummy Close-Up Torso Contact with Side Air Bag View

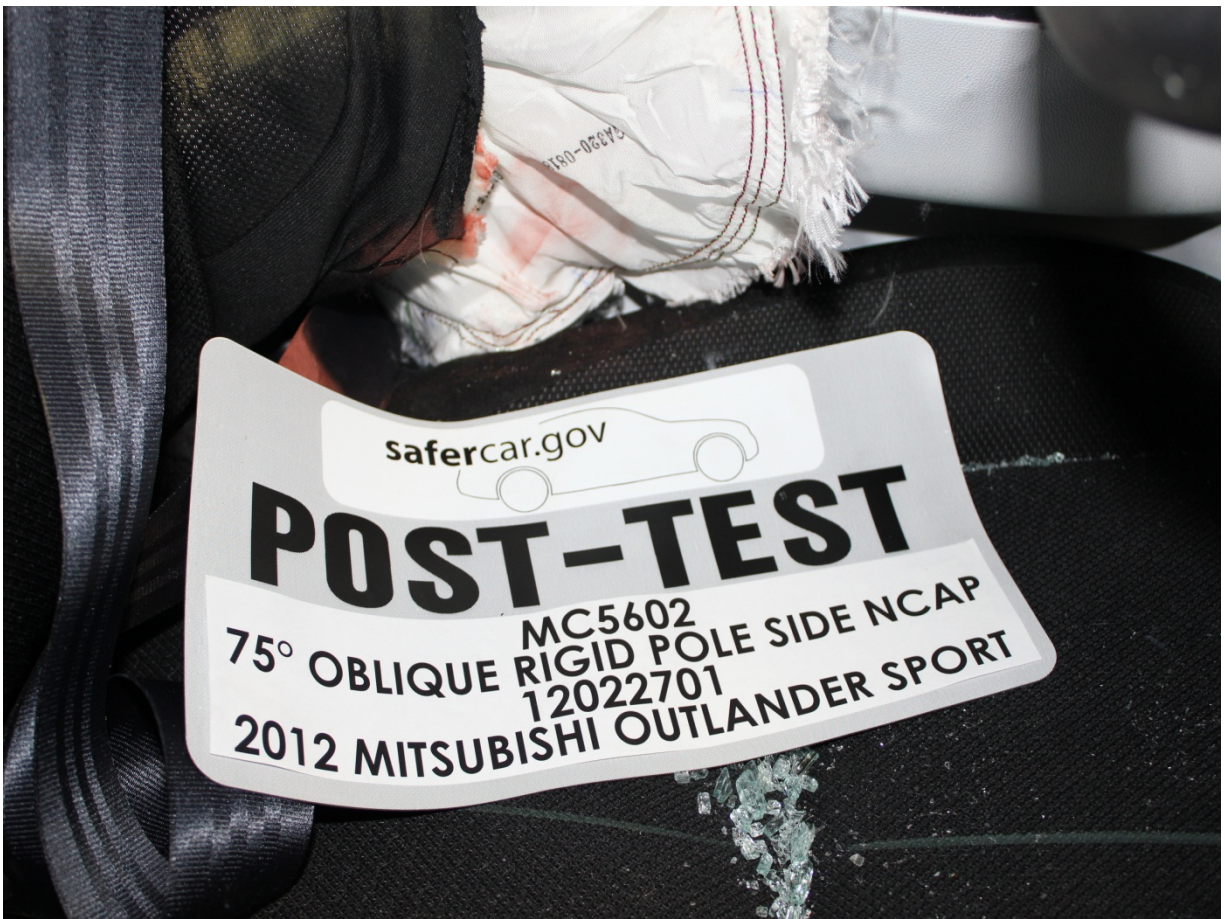
Post-Test Dummy Close-Up Pelvis Contact with Vehicle Interior View
