**REPORT NUMBER: NCAP-MGA-2012-071**

**NEW CAR ASSESSMENT PROGRAM (NCAP)  
Frontal Barrier Impact Test**

**GENERAL MOTORS OF CANADA LTD.  
2012 Buick Regal Premium II Group with eAssist 4-Dr Sedan  
NHTSA No.: MC0118**

**FINAL REPORT**

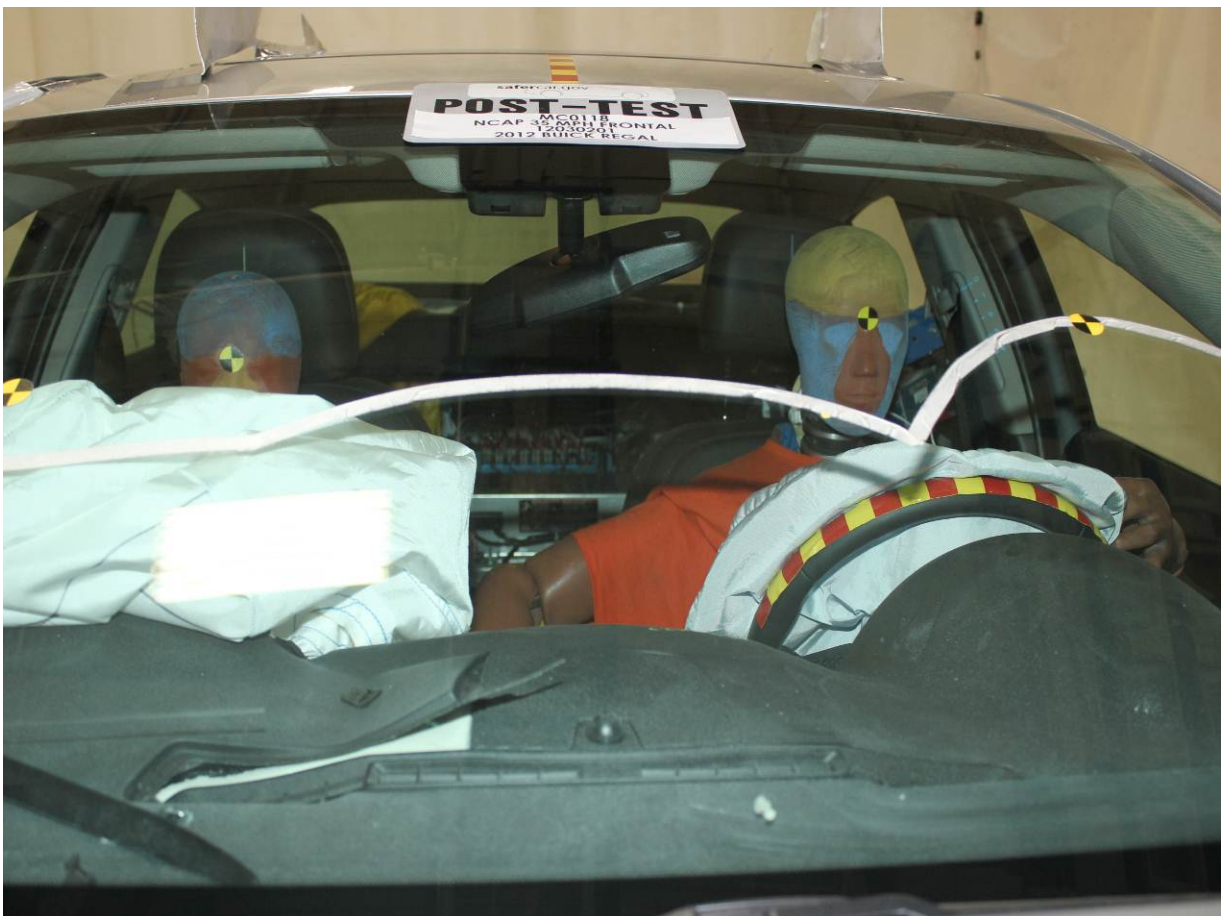
Post-Test Windshield View

There was 100 percent windshield retention and no intrusion into the protected zone of the windshield during the event. There was no Stoddard Solvent leakage after the event or during any phase of the static rollover.

| Critical Areas of Performance | Observations and Conclusions |
|---|---|
| Windshield Damage | Cracked |

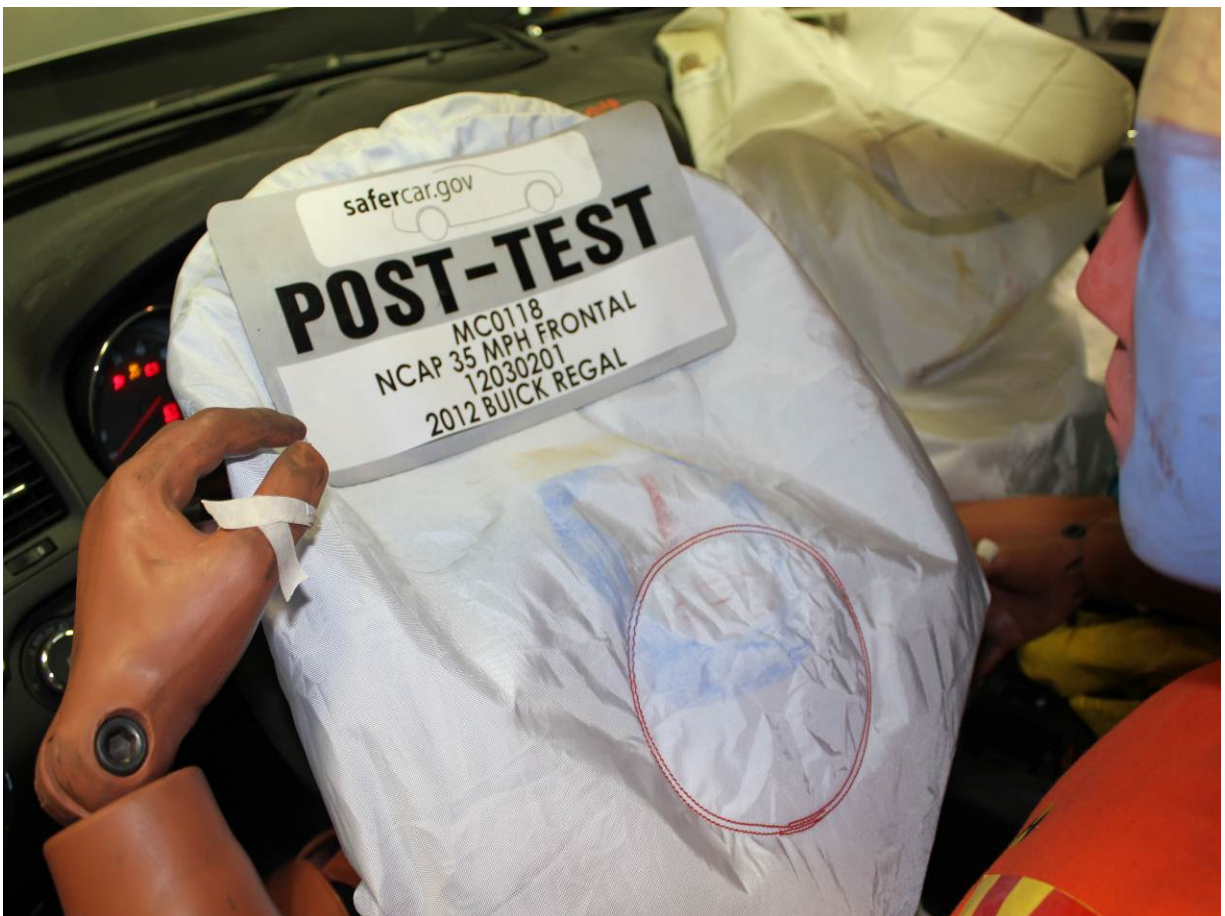
Post-Test Driver Dummy Contact with Airbag

The driver's visible contact points were as follows: The driver's head and chest contacted the airbag. The driver's head also contacted the headrest. The driver's knees contacted the knee bolster. The passenger's visible contact points were as follows: The passenger's head and chest contacted the airbag. The passenger's head also contacted the headrest. The passenger's knees contacted the glovebox.

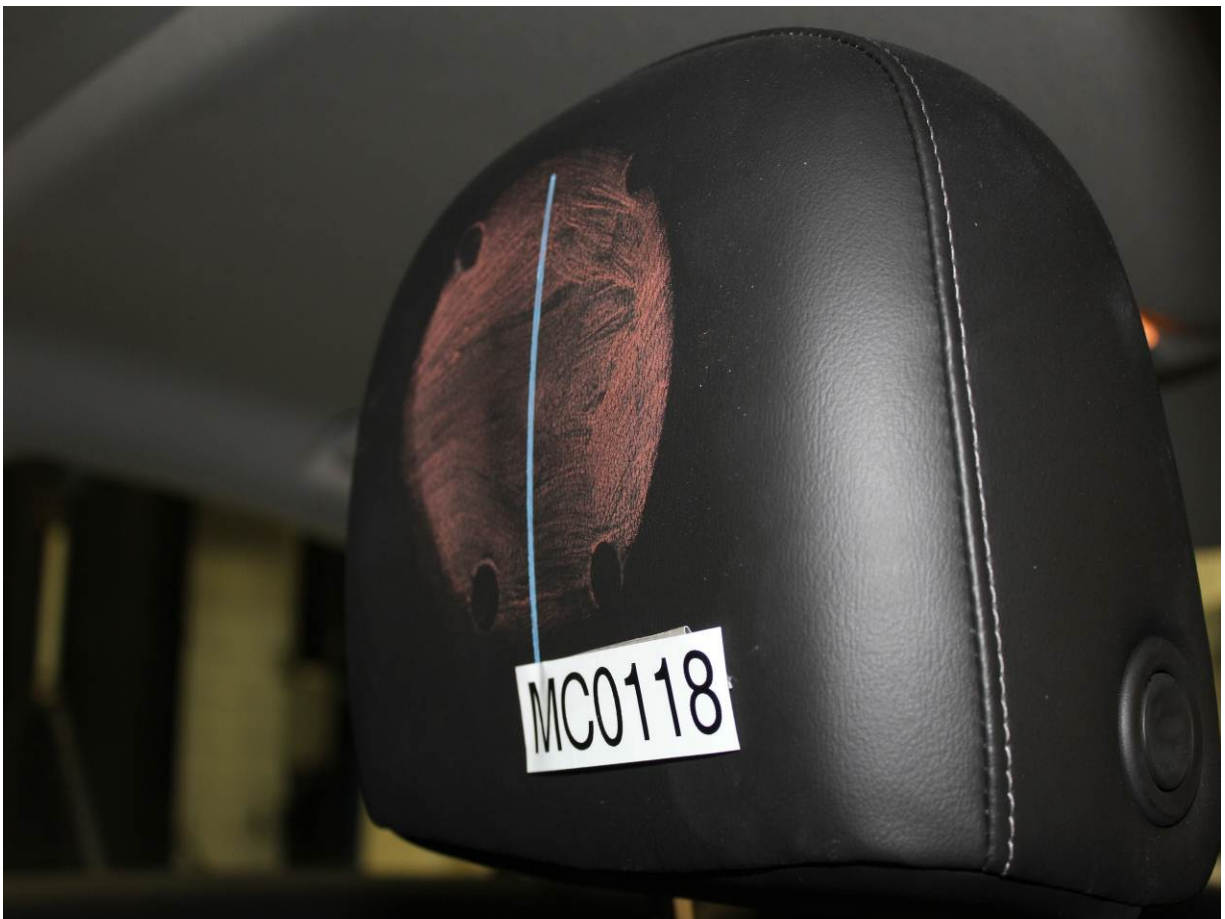
Post-Test Driver Dummy Contact with Headrest

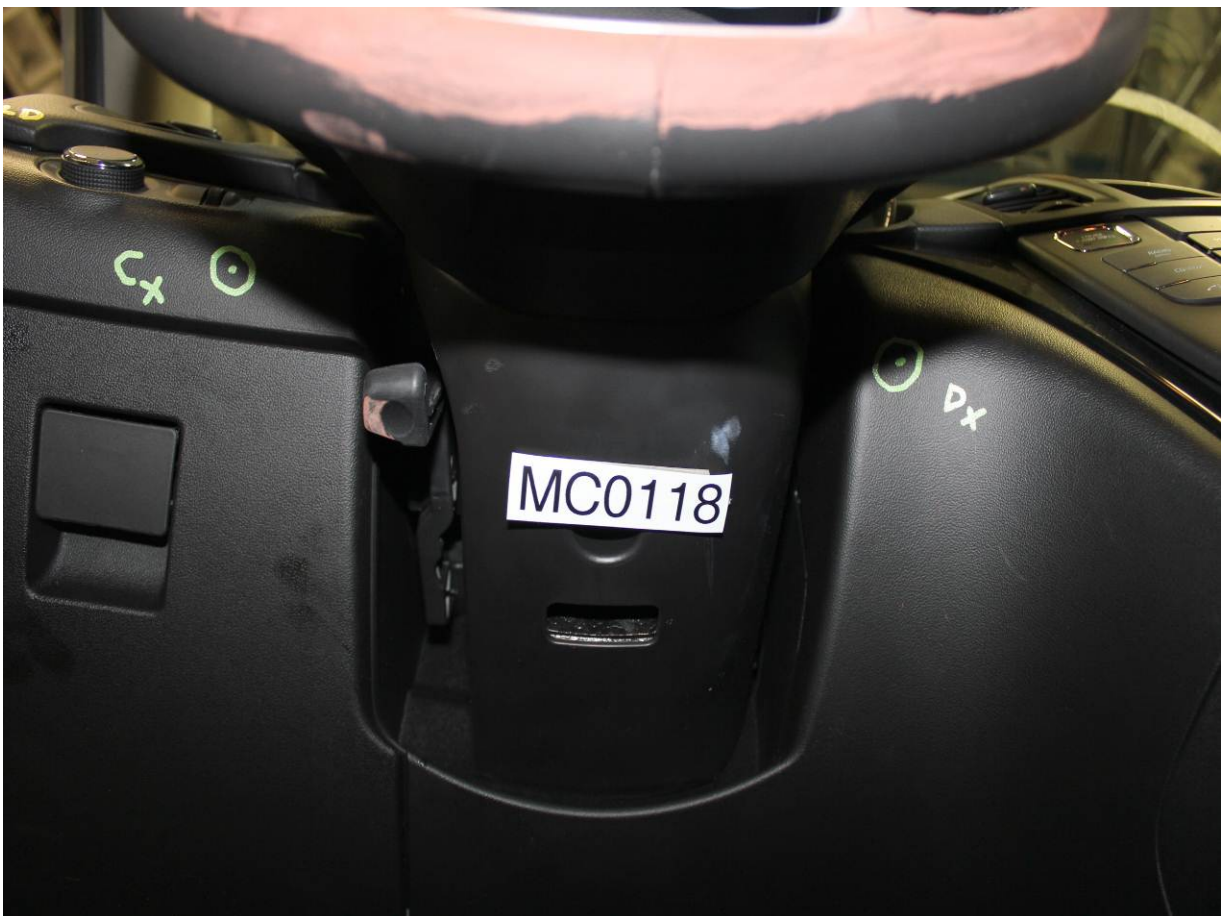
Post-Test Driver Dummy Contact with Knee Bolster

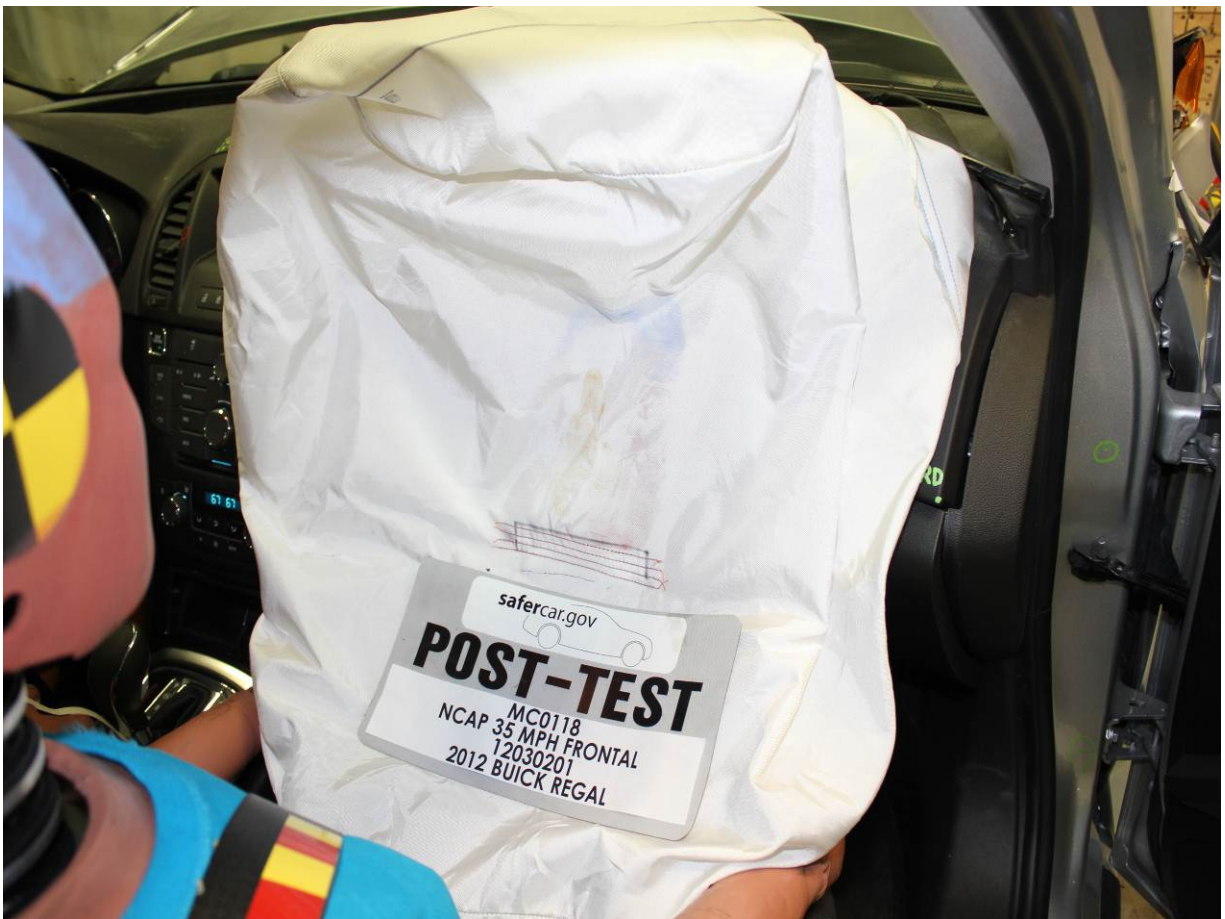
Post-Test Passenger Dummy Contact with Airbag

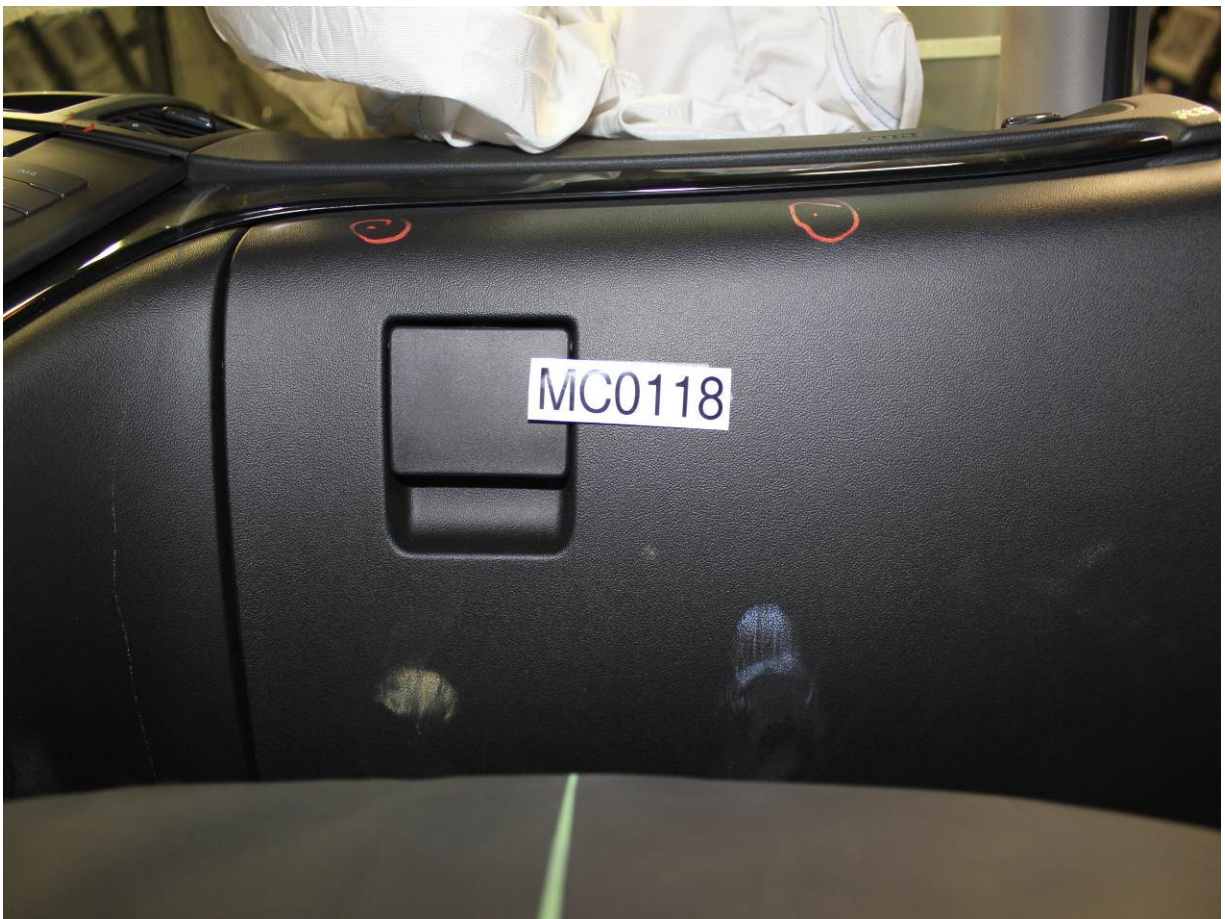
Post-Test Passenger Dummy Contact with Knee Bolster

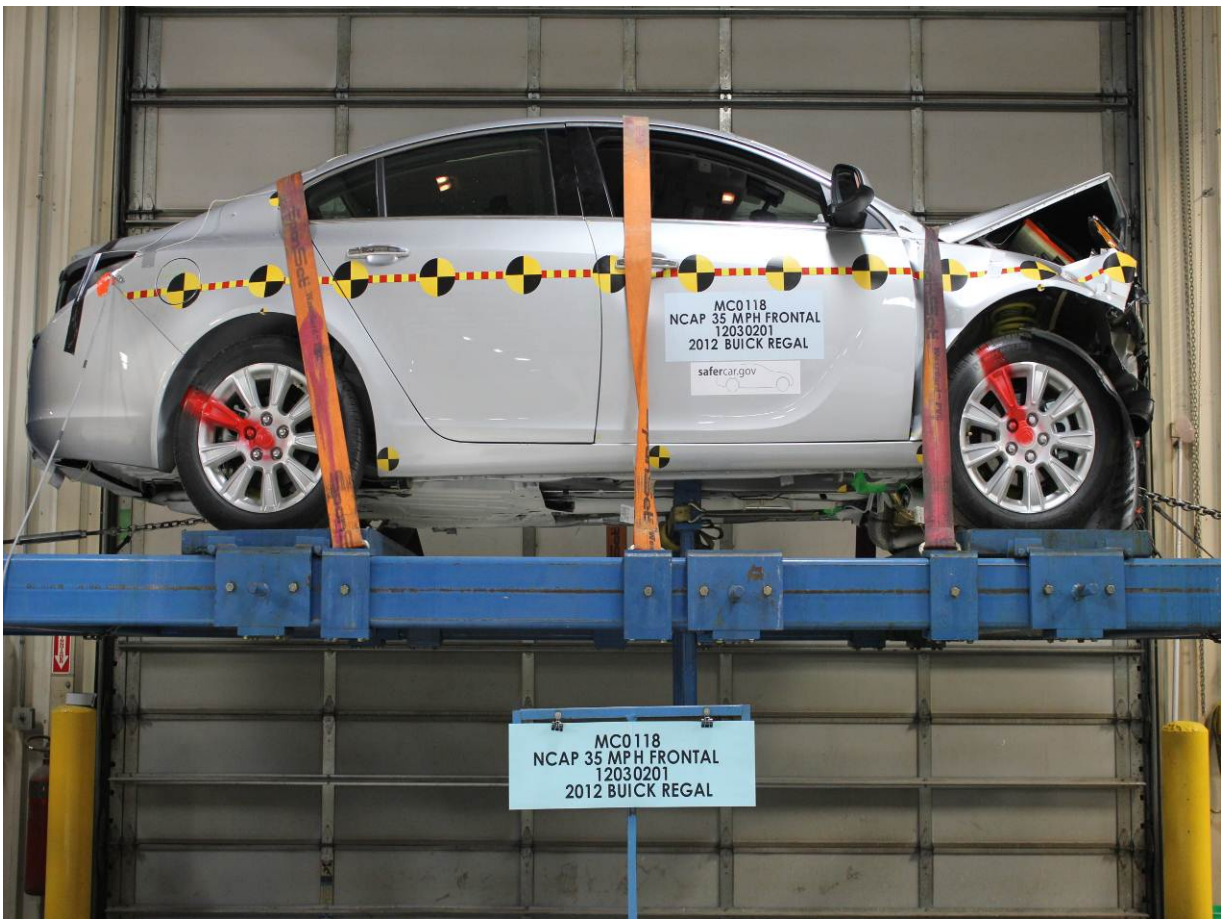
Vehicle at 0 Degrees on Static Rollover Device

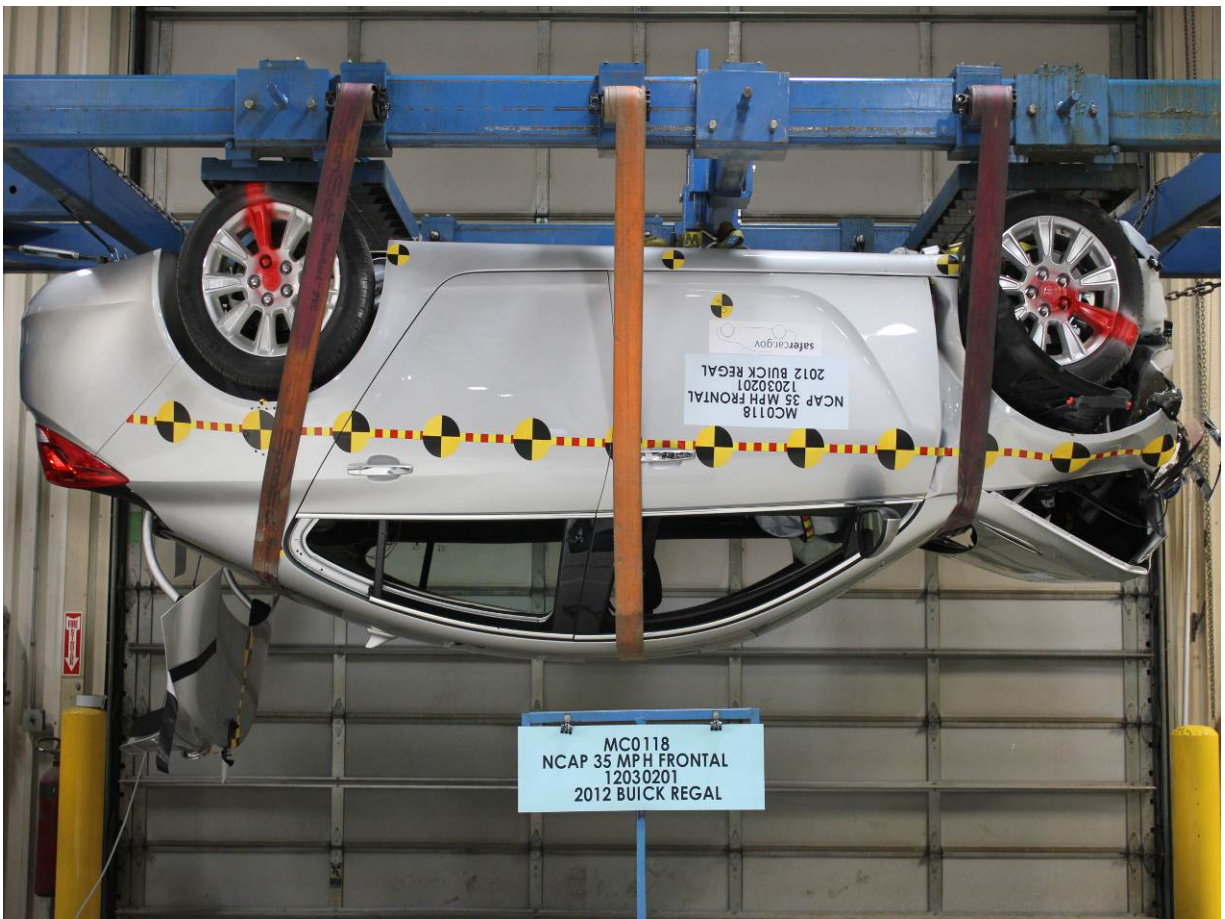
Vehicle at 180 Degrees on Static Rollover Device

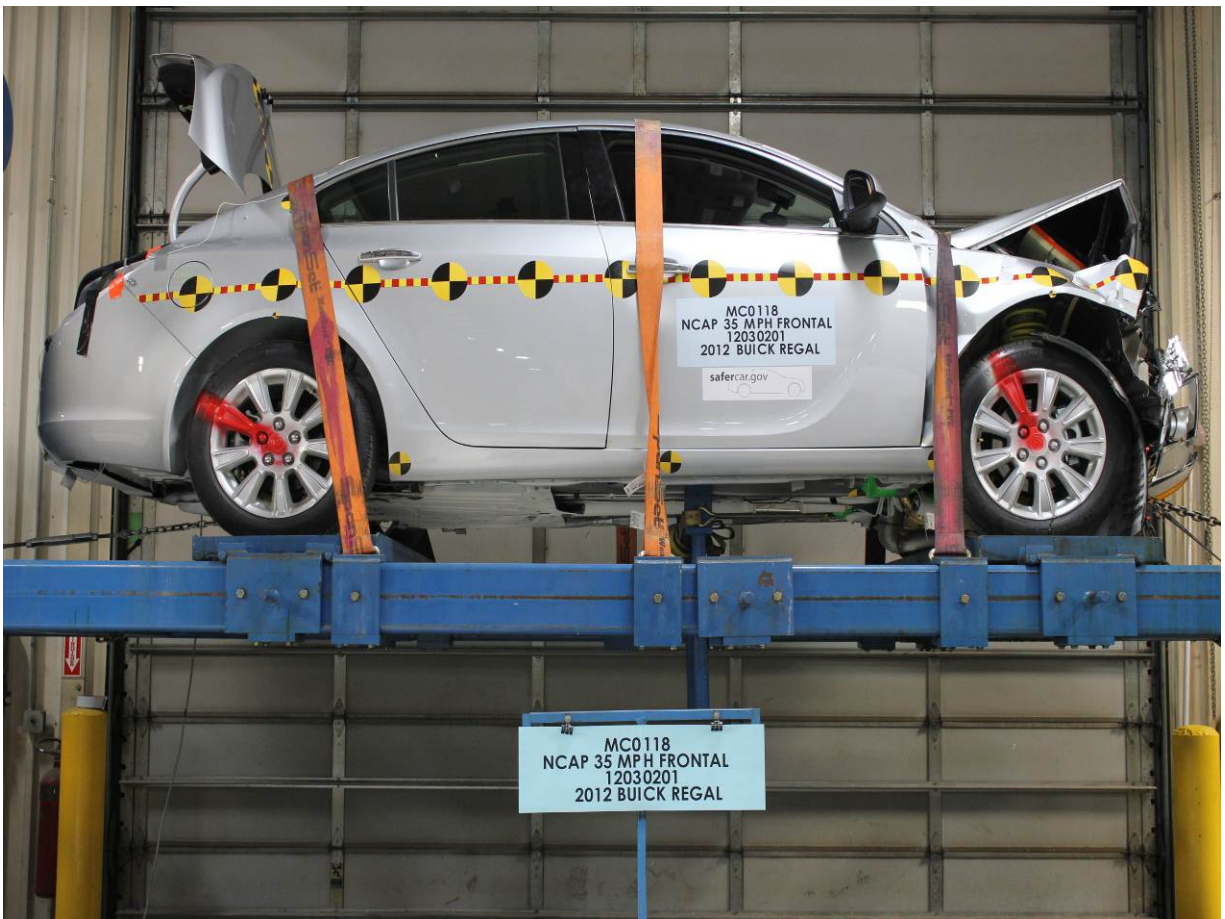
Vehicle at 360 Degrees on Static Rollover Device
