**REPORT NUMBER: SPNCAP-MGA-2012-072**

**NEW CAR ASSESSMENT PROGRAM (NCAP)  
Side Impact Pole Test**

**GENERAL MOTORS OF CANADA LTD.  
2012 Buick Regal with eAssist 4-Dr Sedan  
NHTSA No.: MC0120**

**FINAL REPORT**

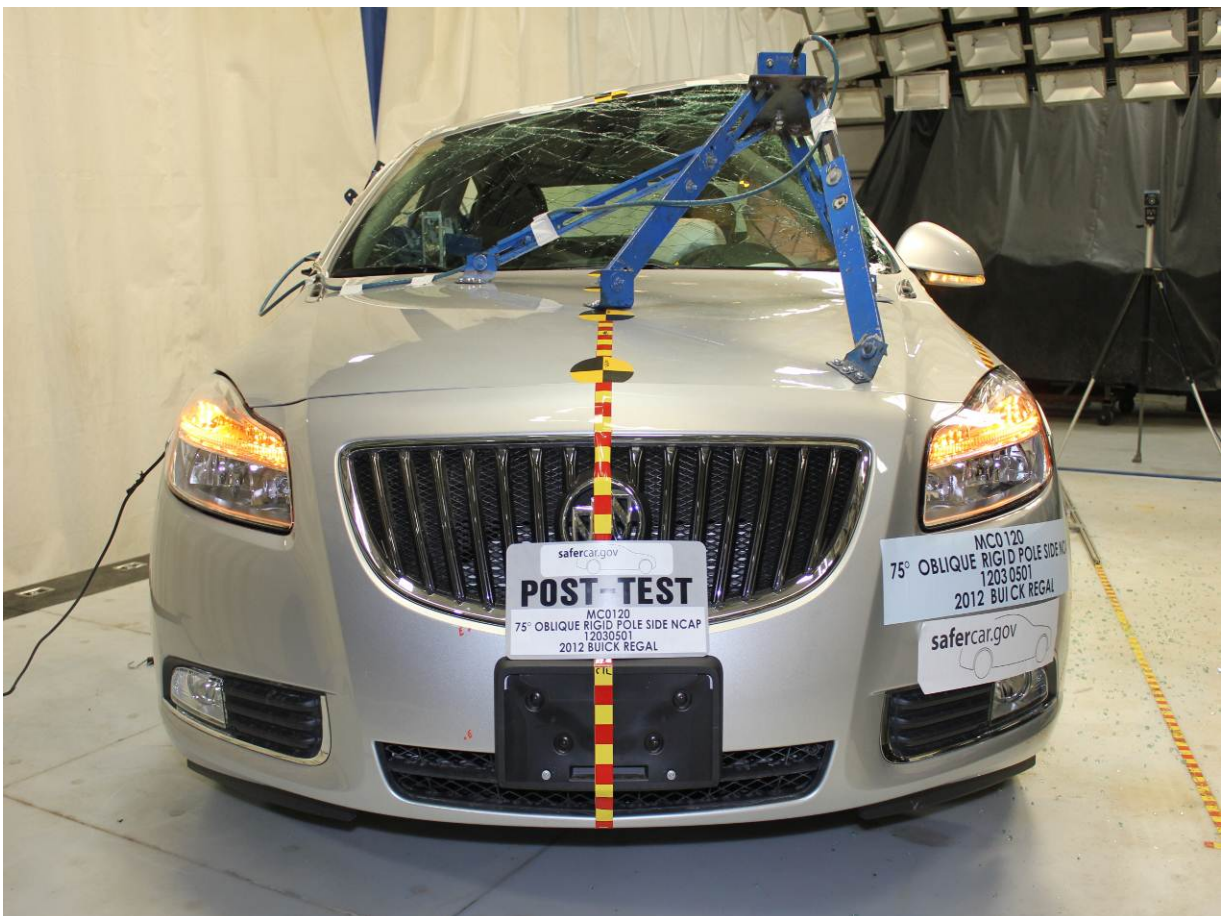
Post-Test Frontal View of Test Vehicle

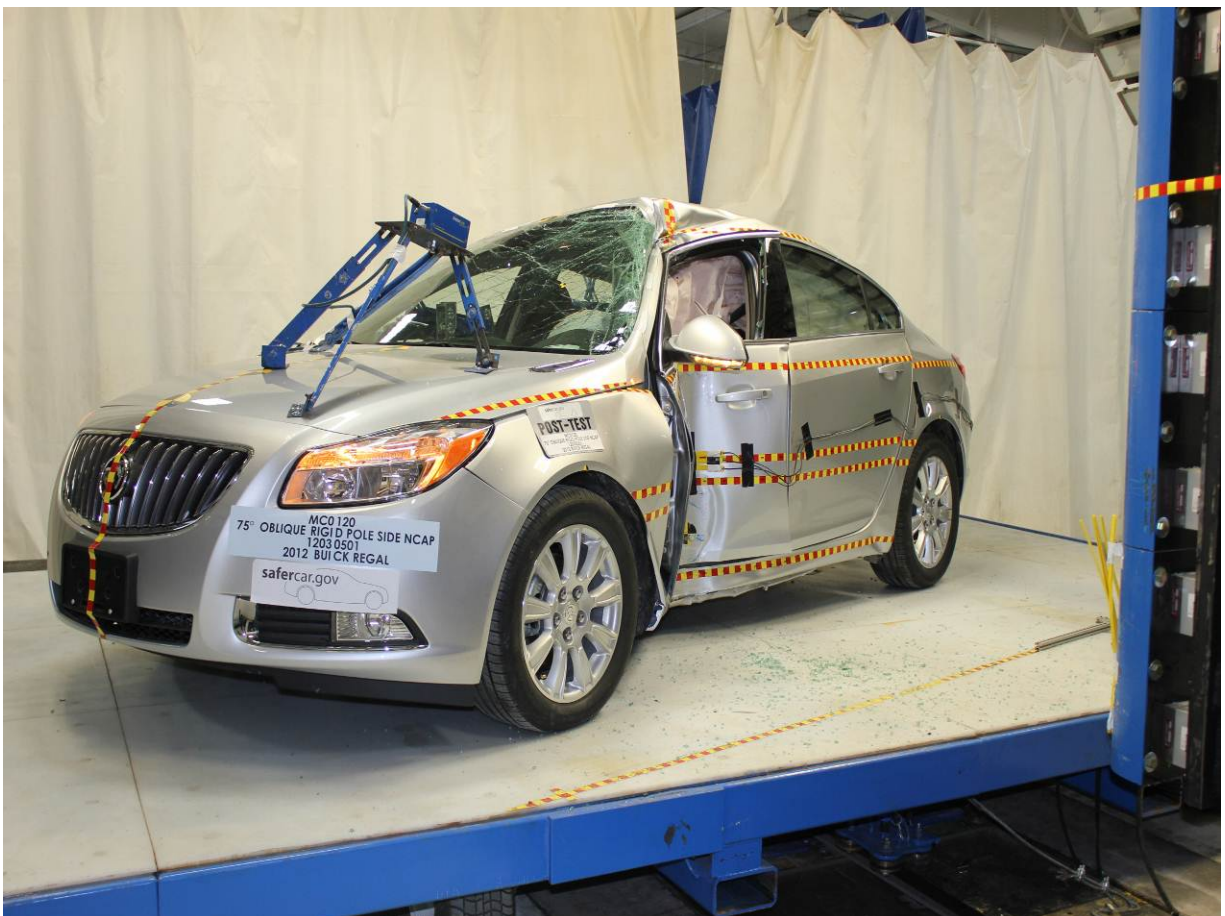
Post-Test Left Front  $\frac{3}{4}$  View of Test Vehicle

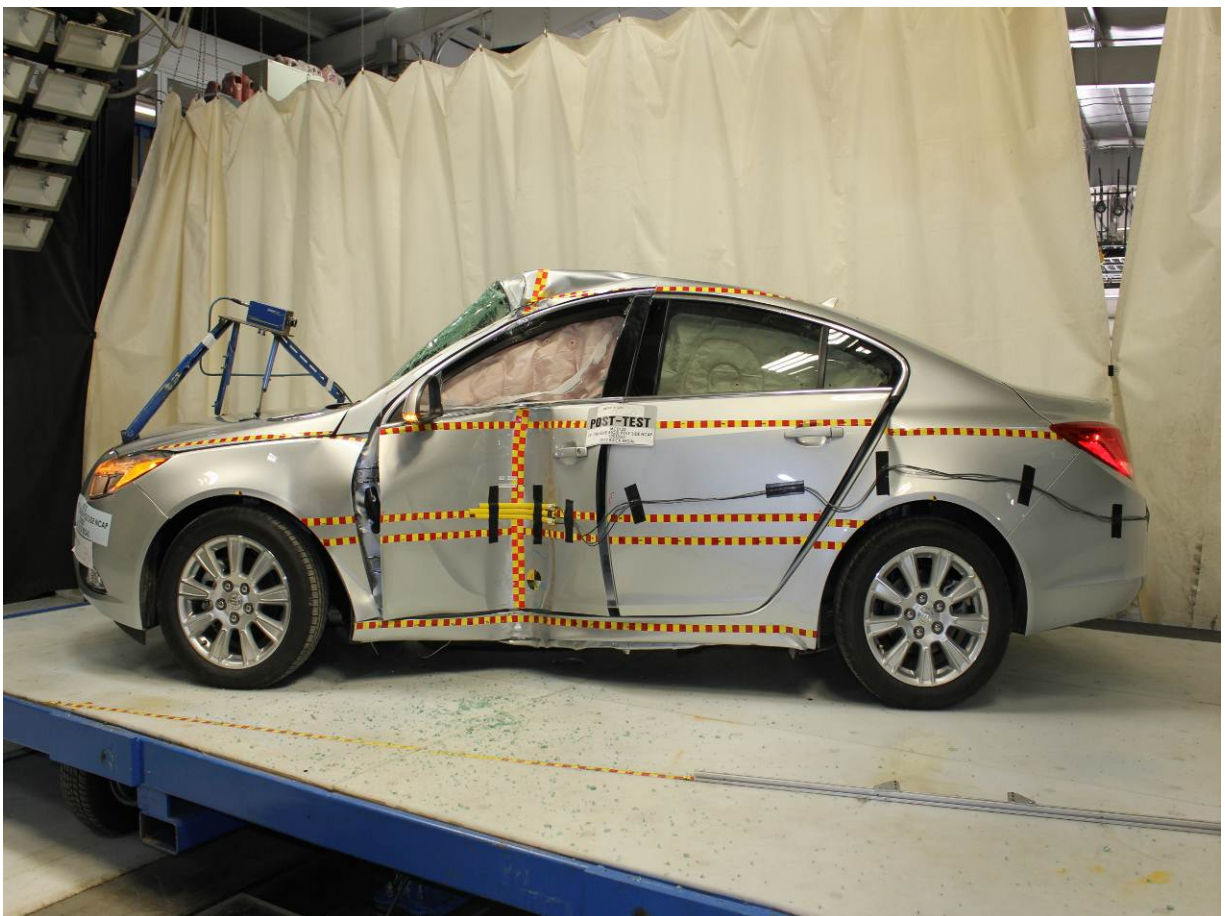
Post-Test Left Side View of Test Vehicle

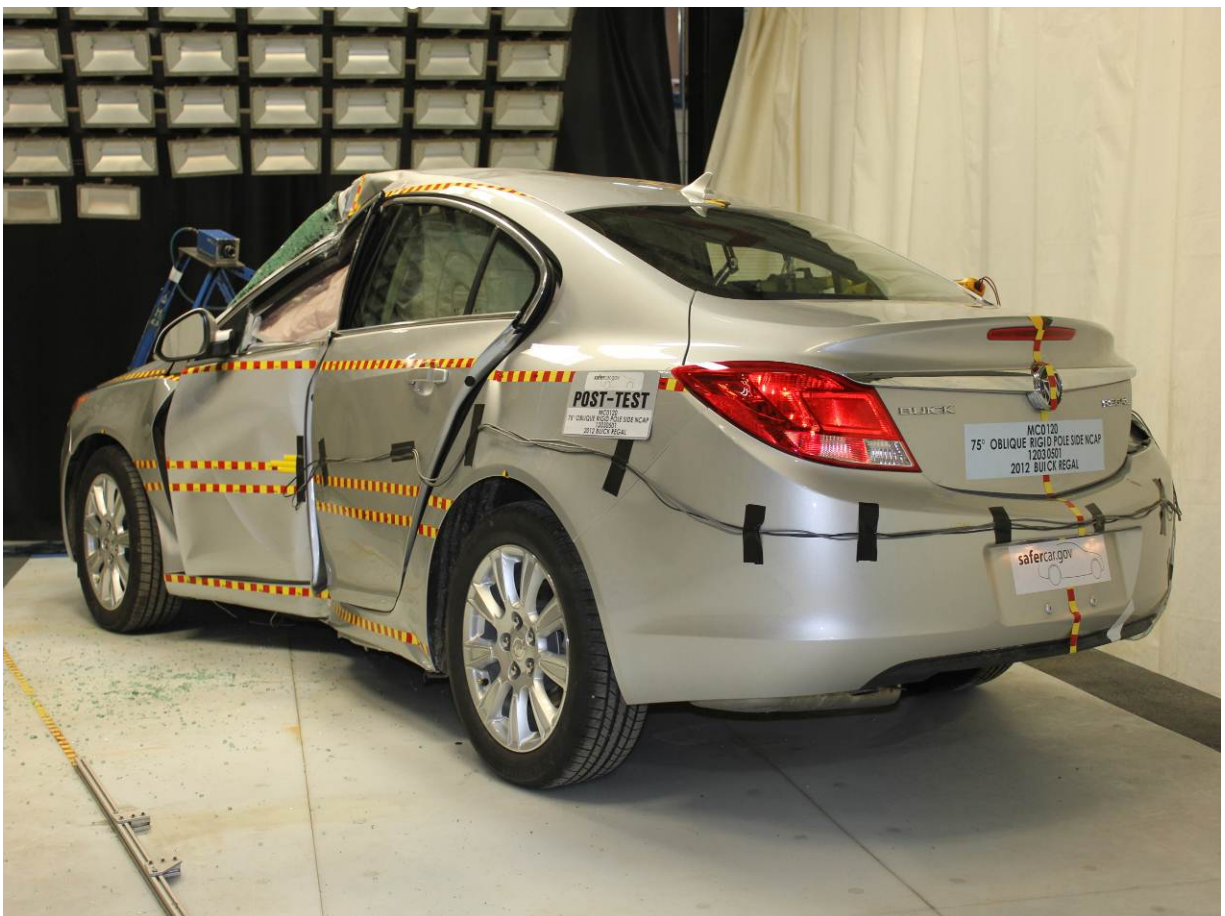
Post-Test Left Rear  $\frac{3}{4}$  View of Test Vehicle

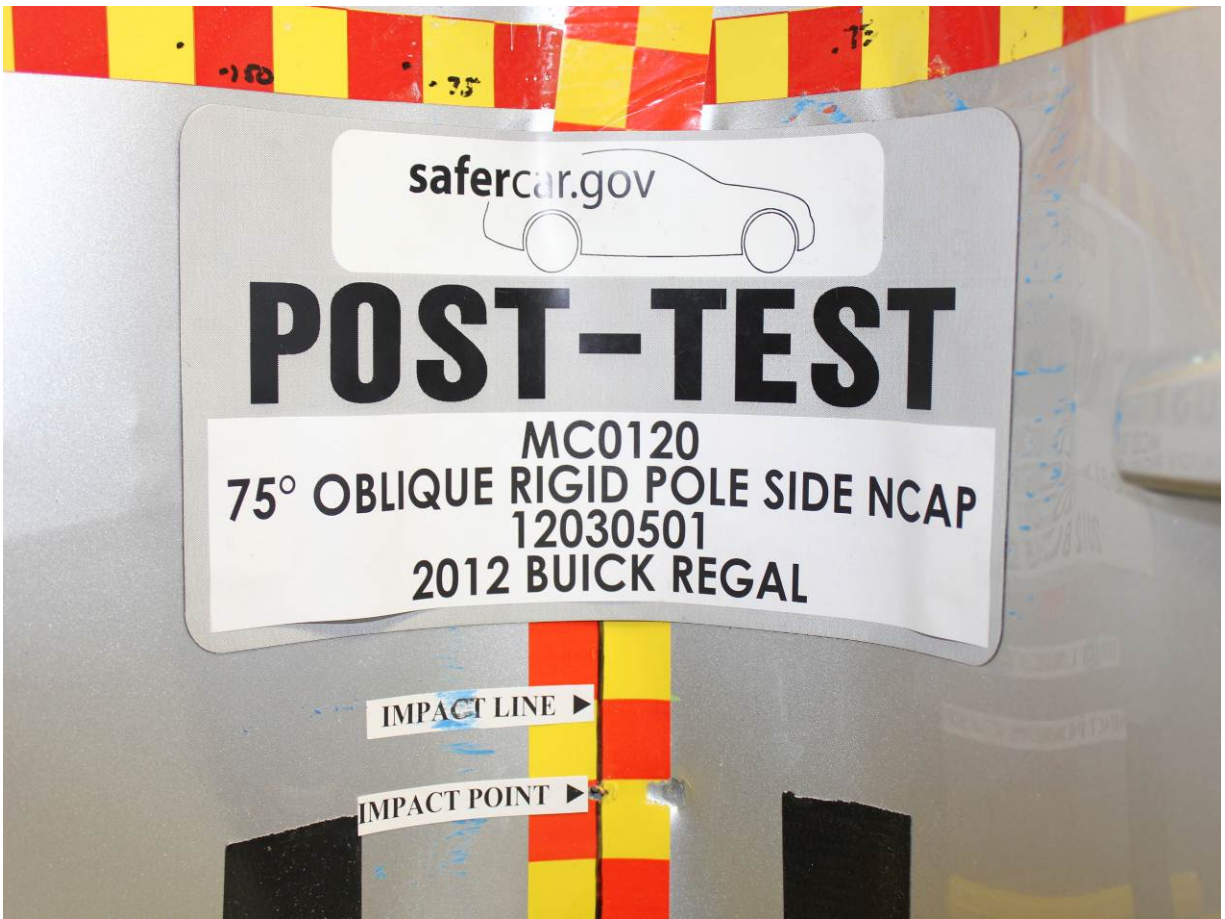
Post-Test Close-Up View of Impact Point Target Showing Impact Location

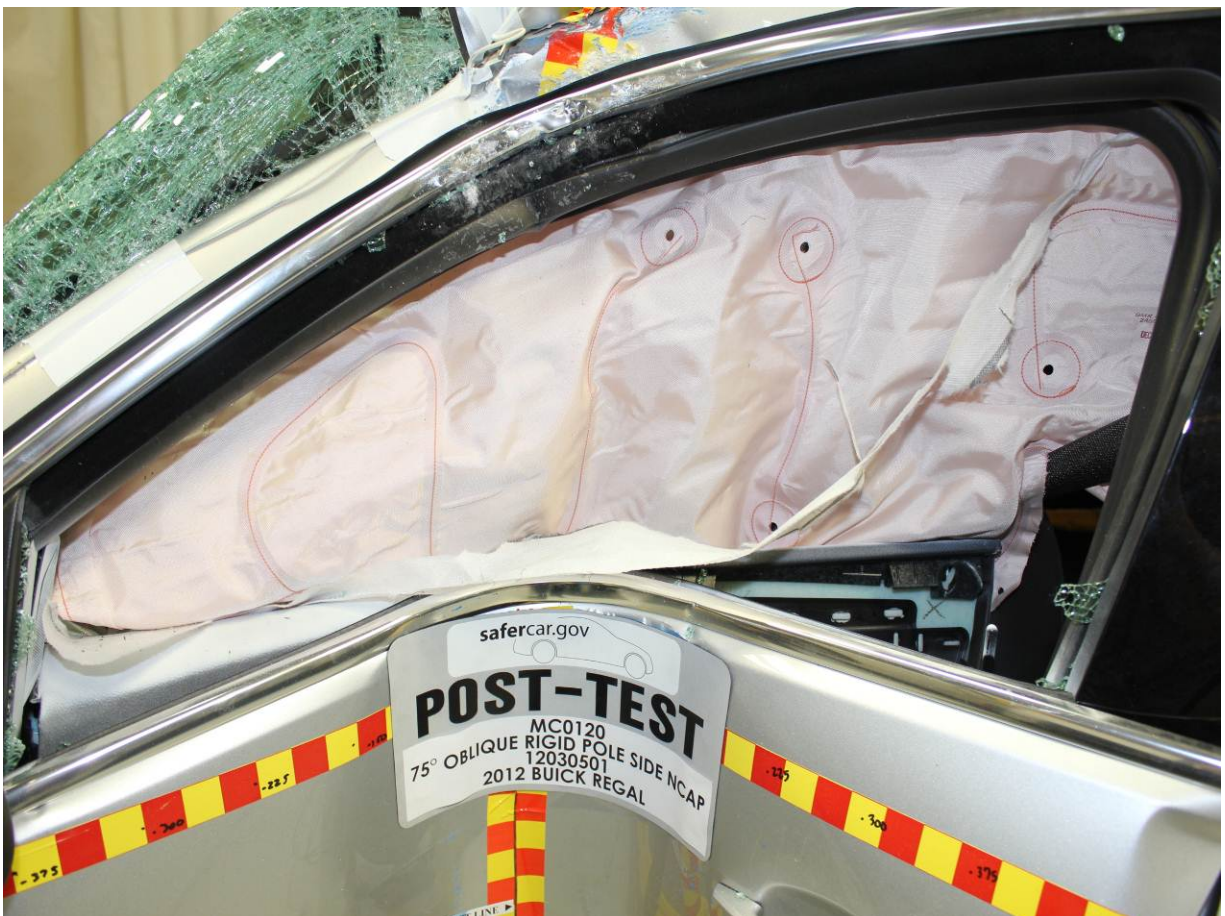
Post-Test Left Side View of Dummy Shoulder and Door Top View

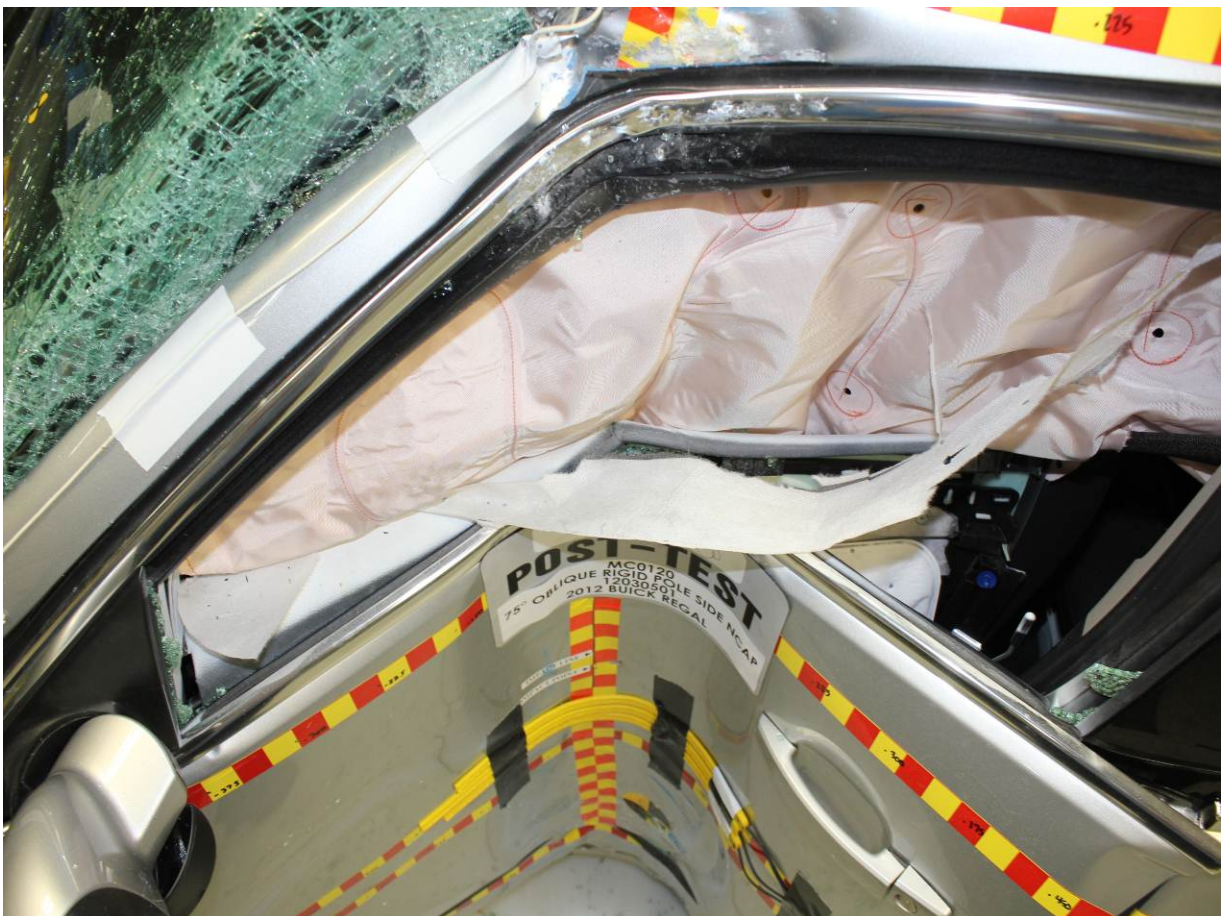
Post-Test Dummy and Door Clearance View

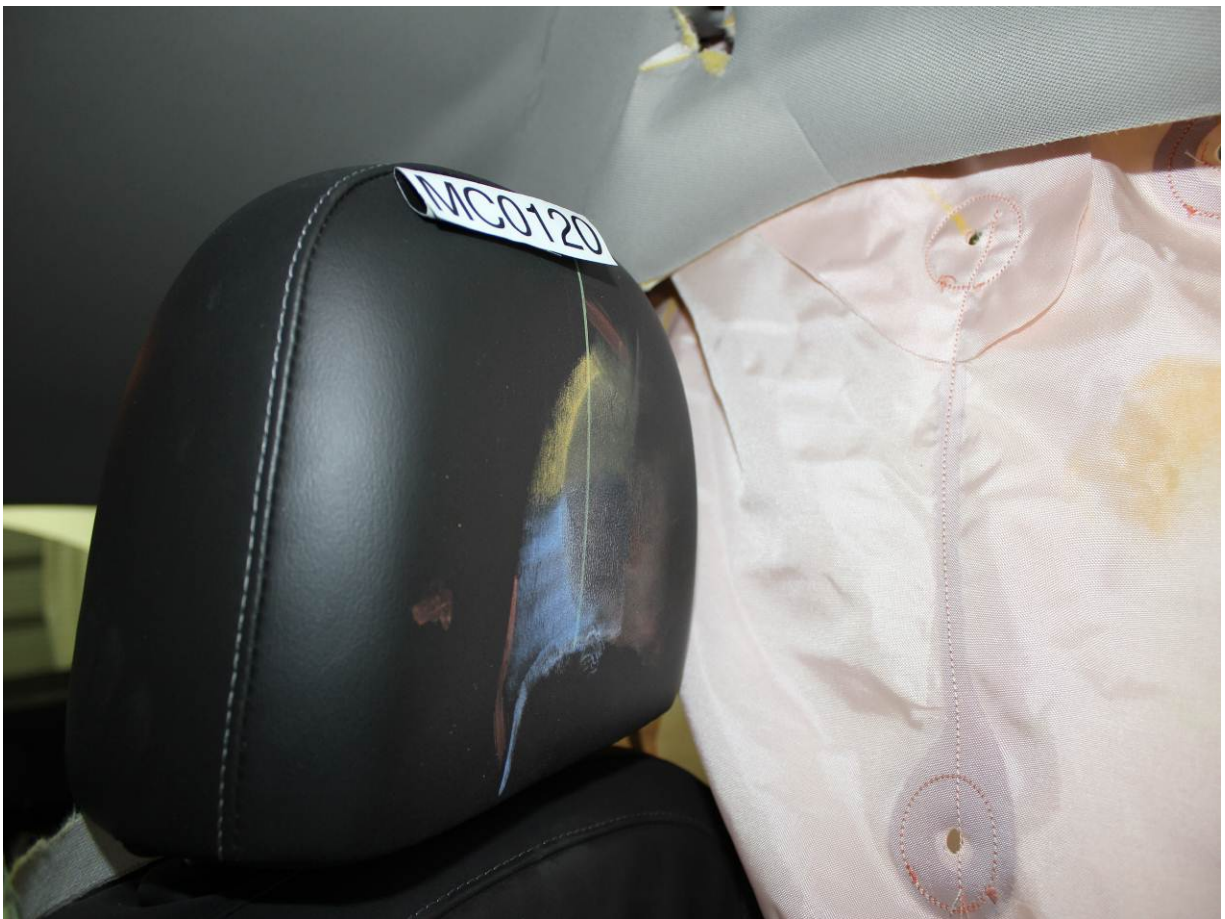
Post-Test Dummy Close-Up Head Contact with Vehicle Interior View

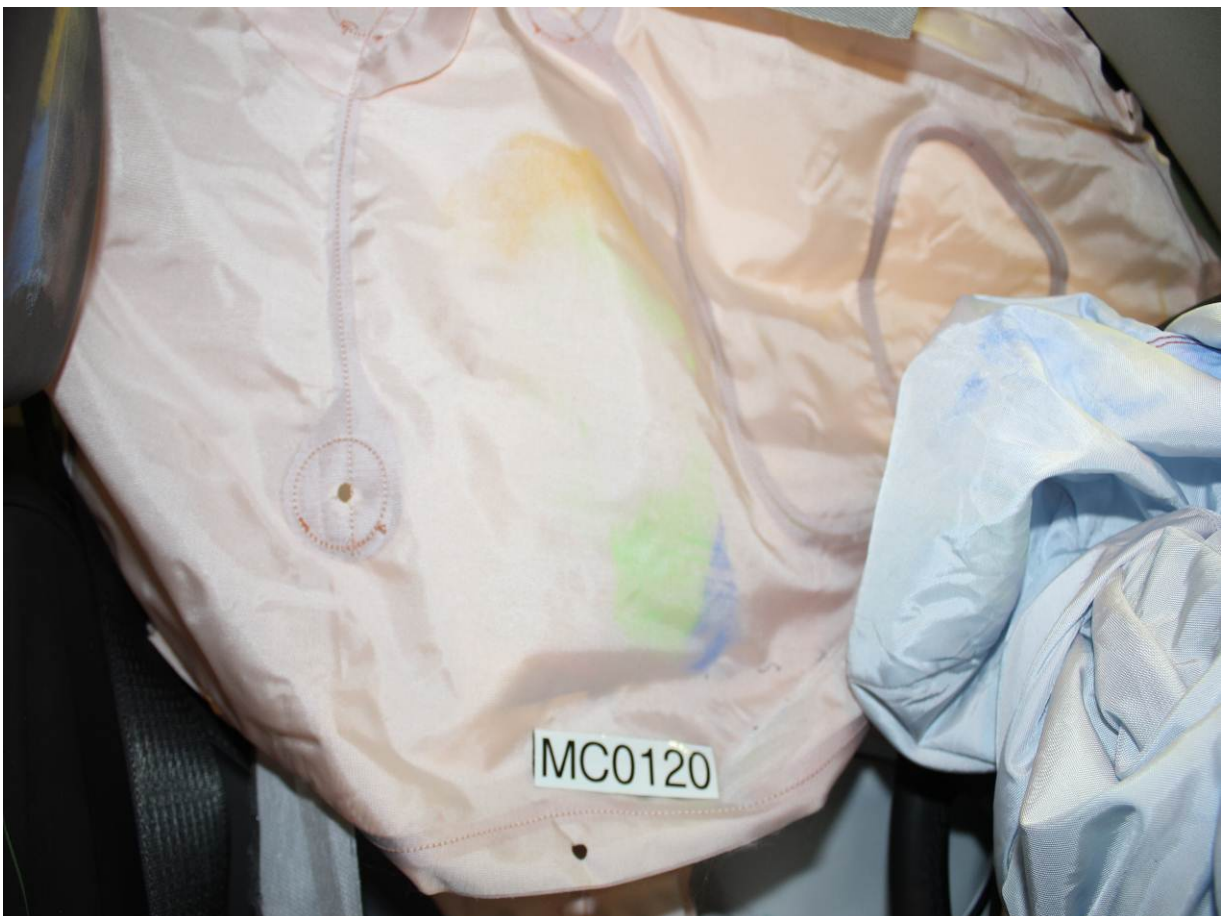
Post-Test Dummy Close-Up Head Contact with Side Air Bag View

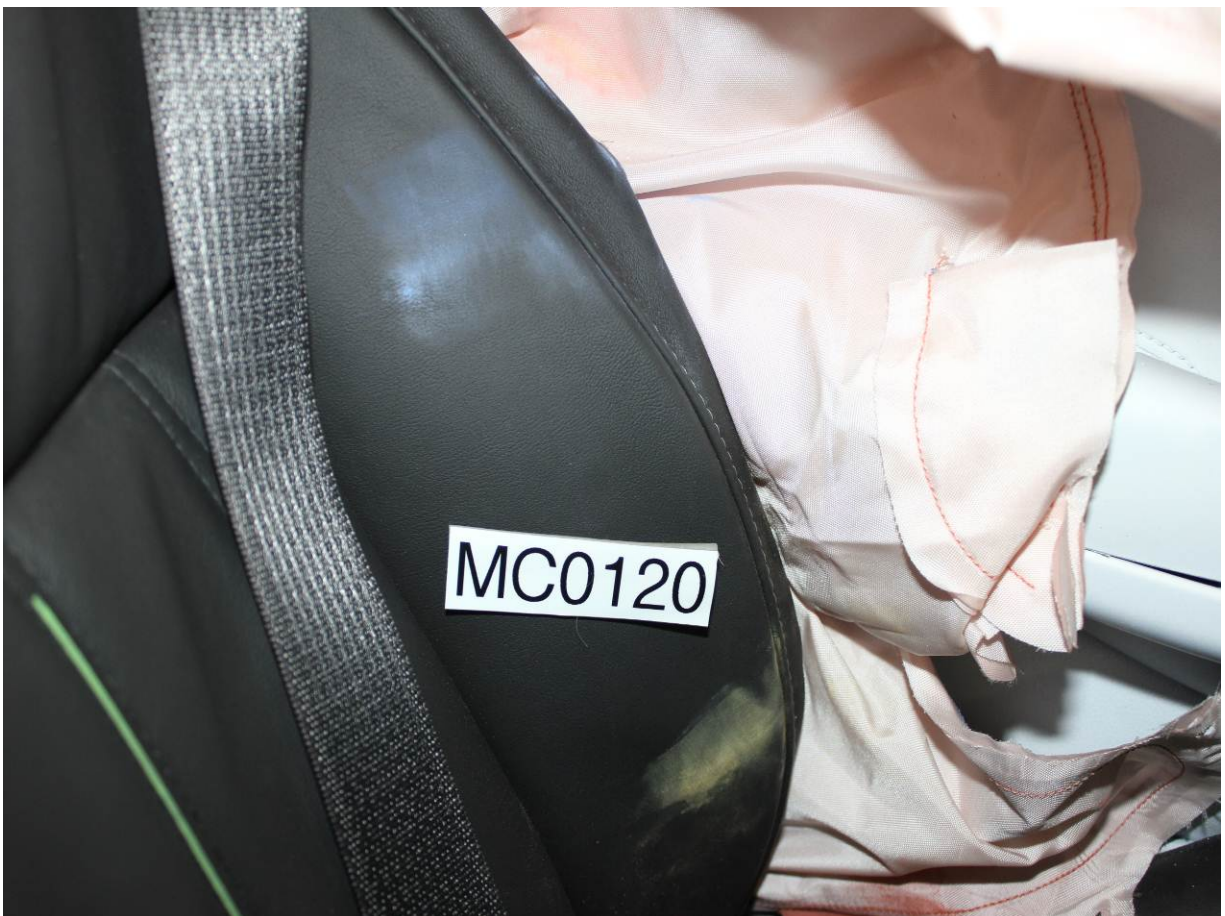
Post-Test Dummy Close-Up Torso Contact with Vehicle Interior View

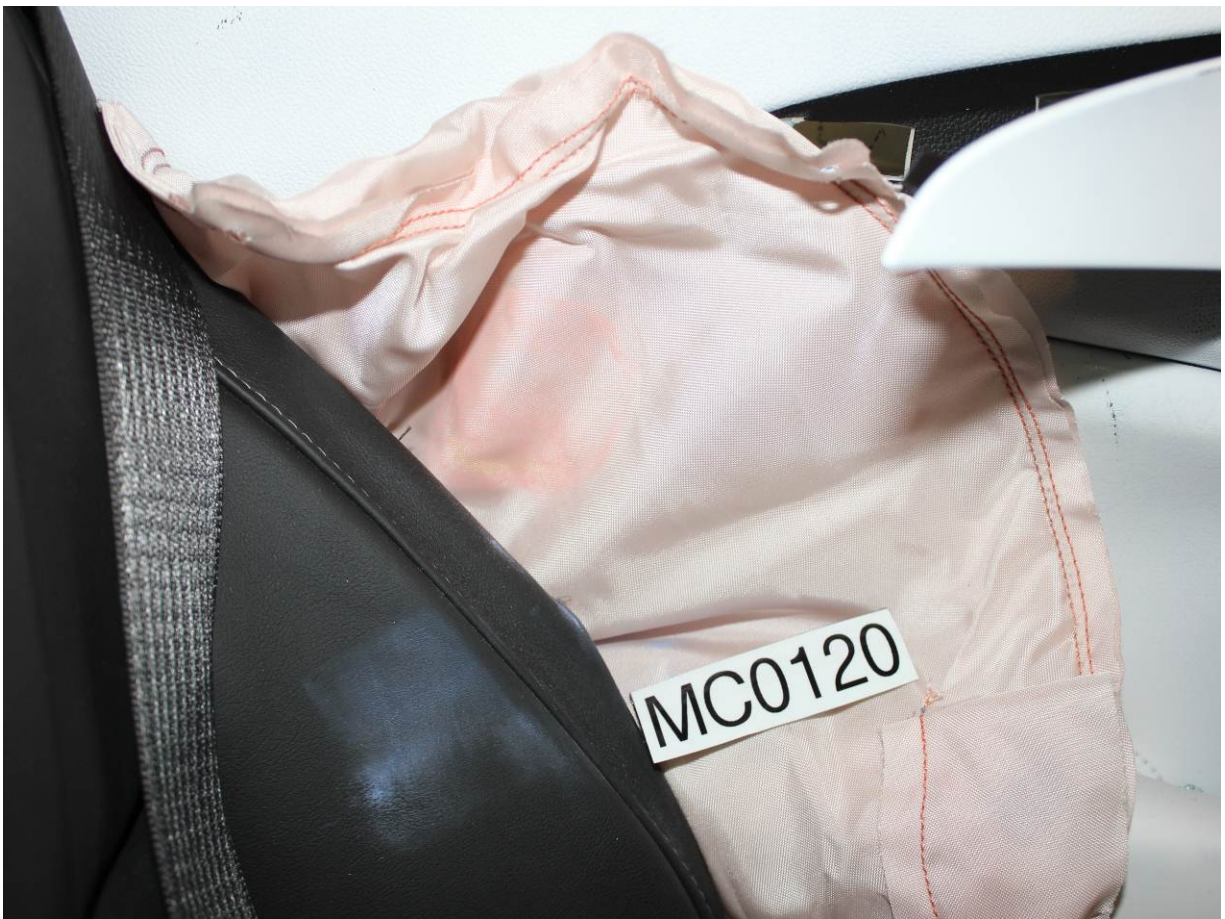
Post-Test Dummy Close-Up Torso Contact with Side Air Bag View

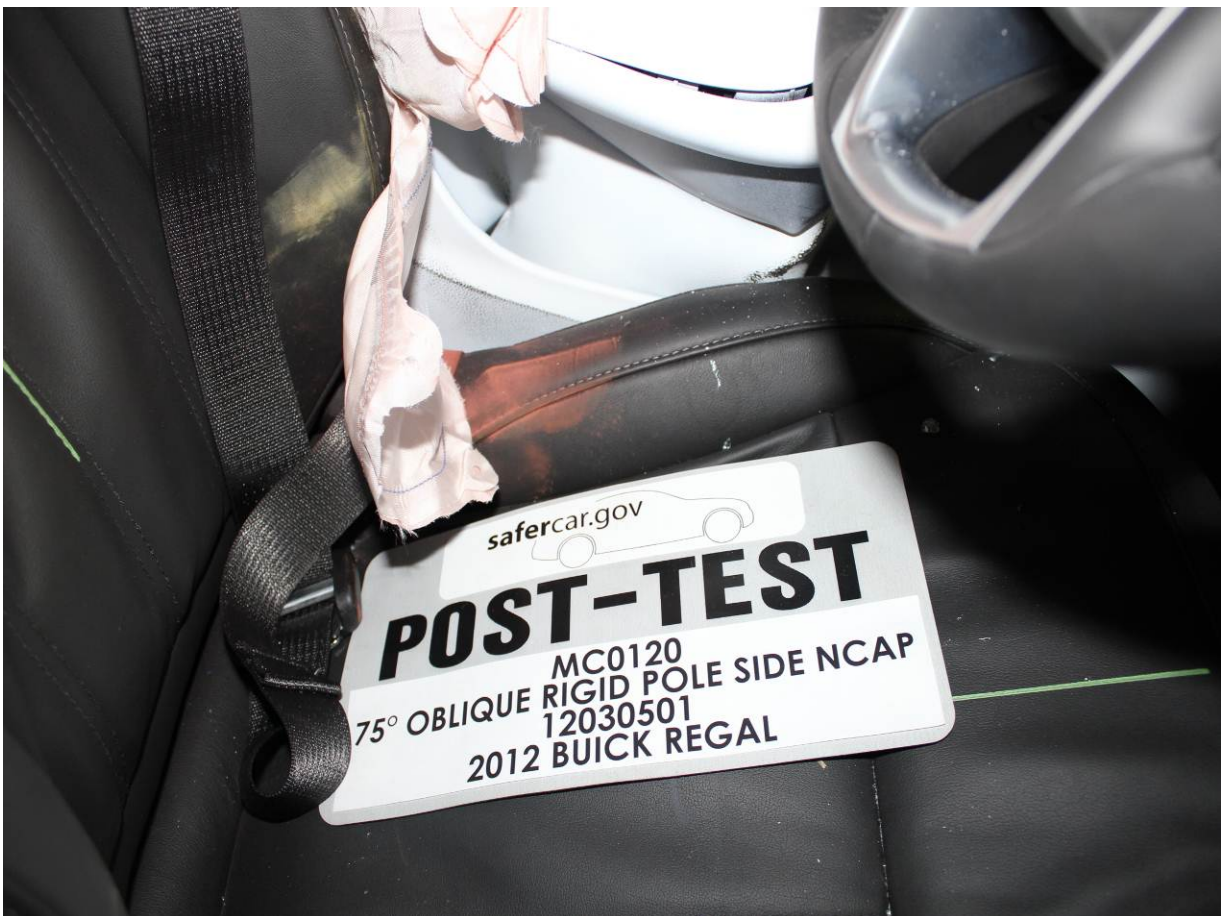
Post-Test Dummy Close-Up Pelvis Contact with Vehicle Interior View

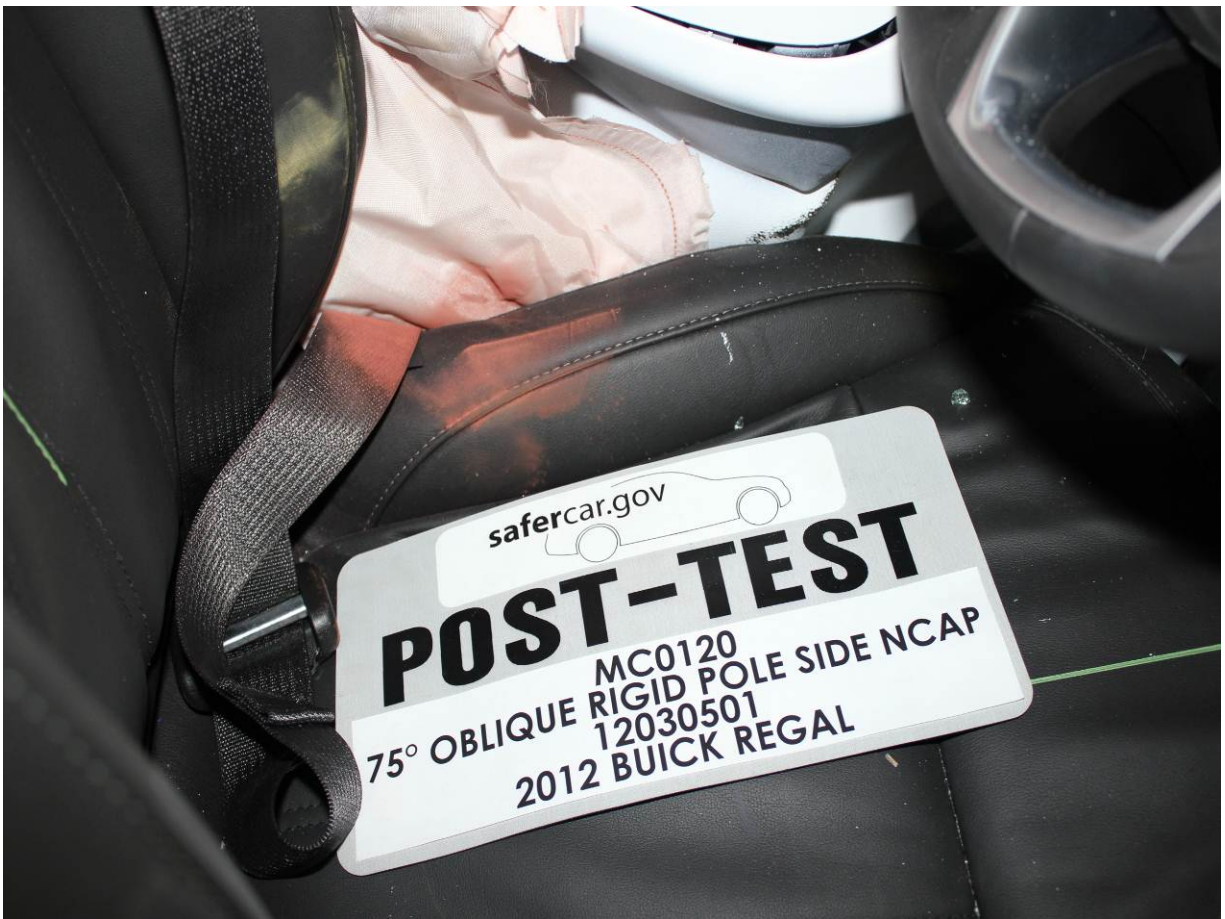
Post-Test Dummy Close-Up Pelvis Contact with Side Air Bag View
