**REPORT NUMBER: SINCAP-MCW-12-10**

**NEW CAR ASSESSMENT PROGRAM (SINCAP)  
MOVING DEFORMABLE BARRIER SIDE IMPACT TEST**

**HONDA MOTOR CO., LTD.  
2012 HONDA CR-V 5-DOOR SUV  
NHTSA NUMBER: MC 5304**

**PREPARED BY:  
MEDICAL COLLEGE OF WISCONSIN  
5000 WEST NATIONAL AVENUE  
RESEARCH 151  
MILWAUKEE, WISCONSIN 53295**

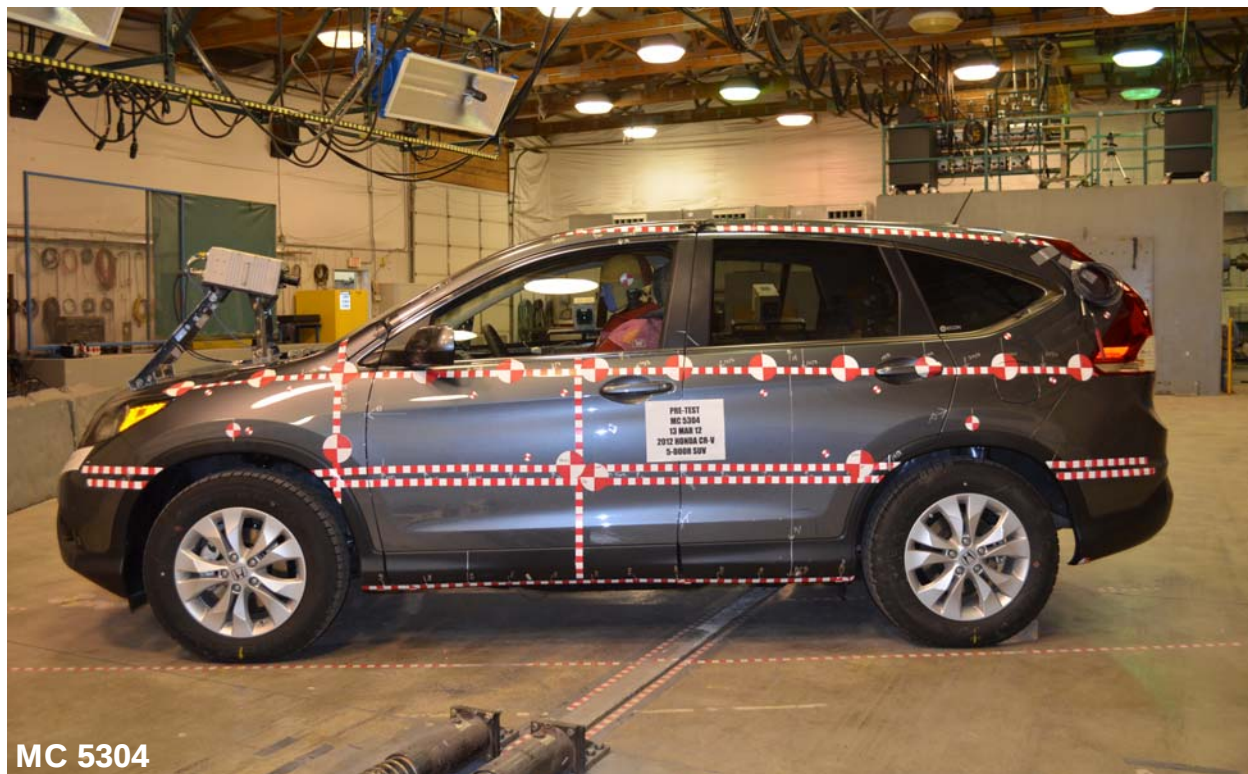
Figure A-6: Post-Test Left Front 3-4 View of Test Vehicle

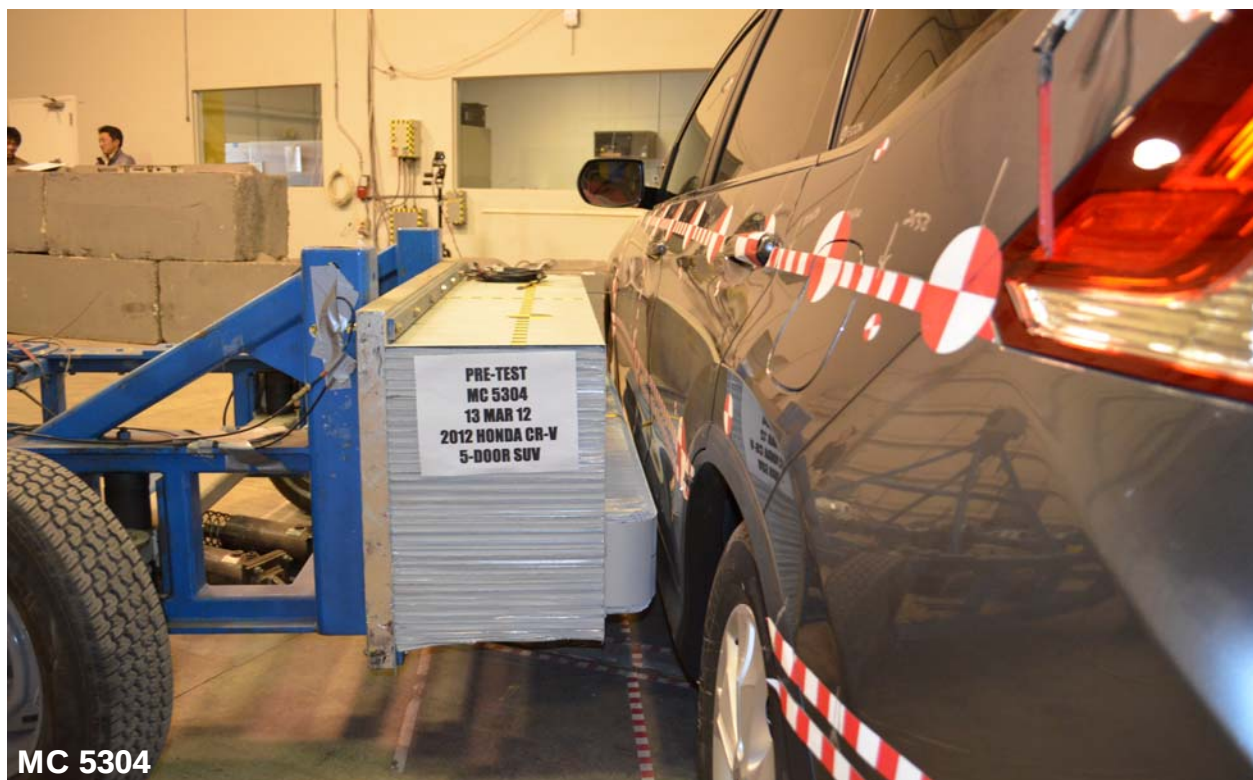
Figure A-17: Pre-Test Left Side View of MDB Positioned Against Side of Test Vehicle

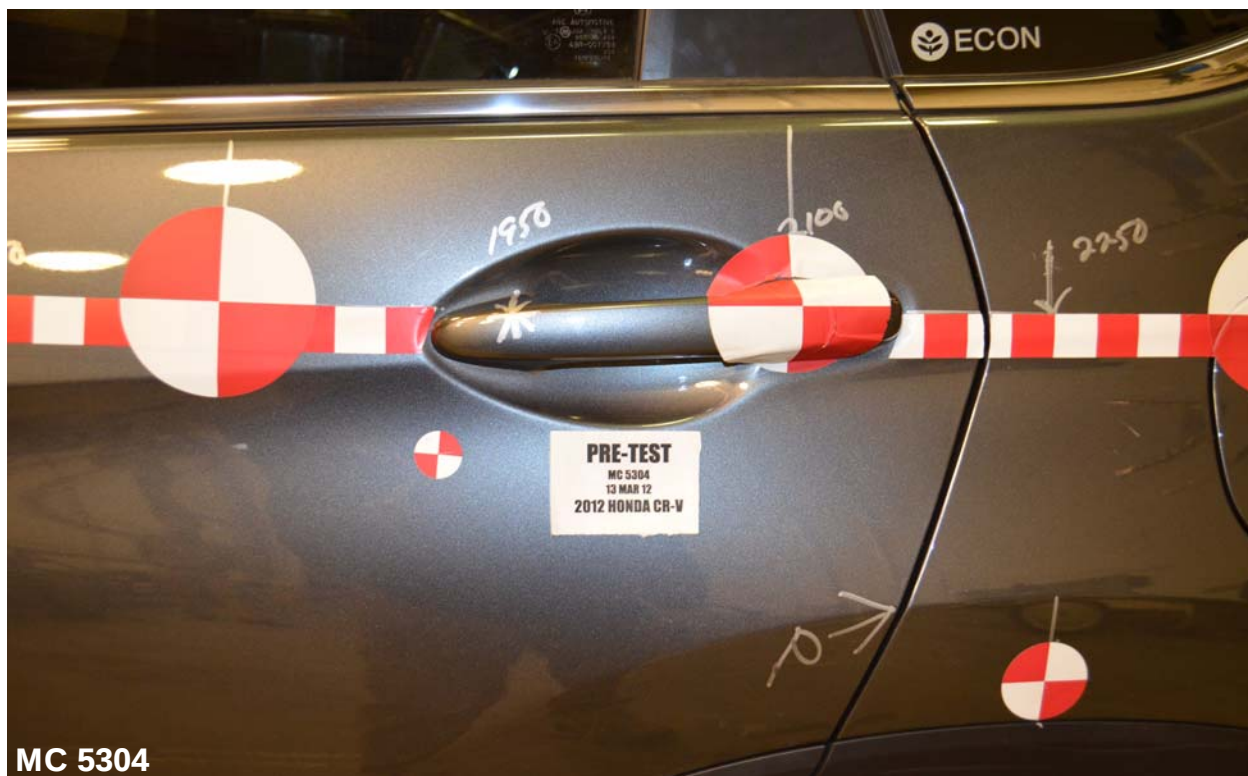
Figure A-22: Post-Test Left Front Door Latch Close-Up

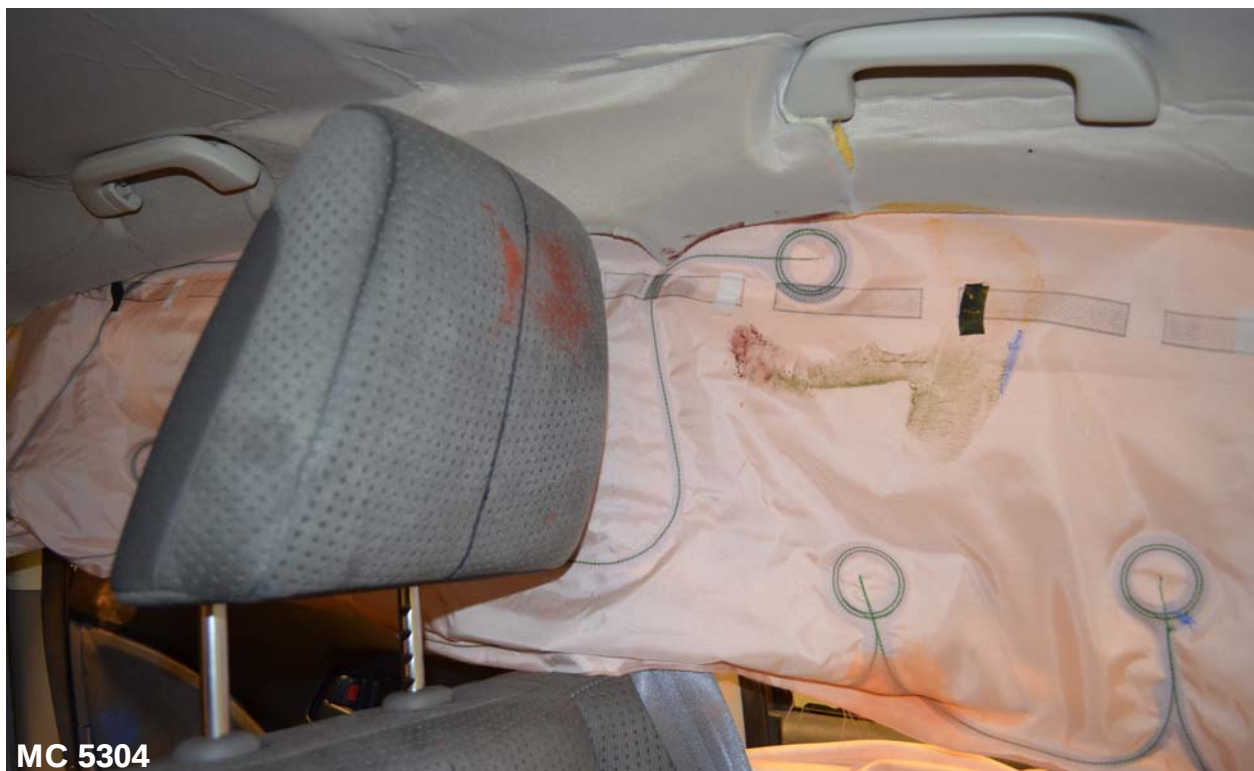
Figure A-47: Post-Test Driver Inner Door Panel View Showing Driver Dummy Contact Locations

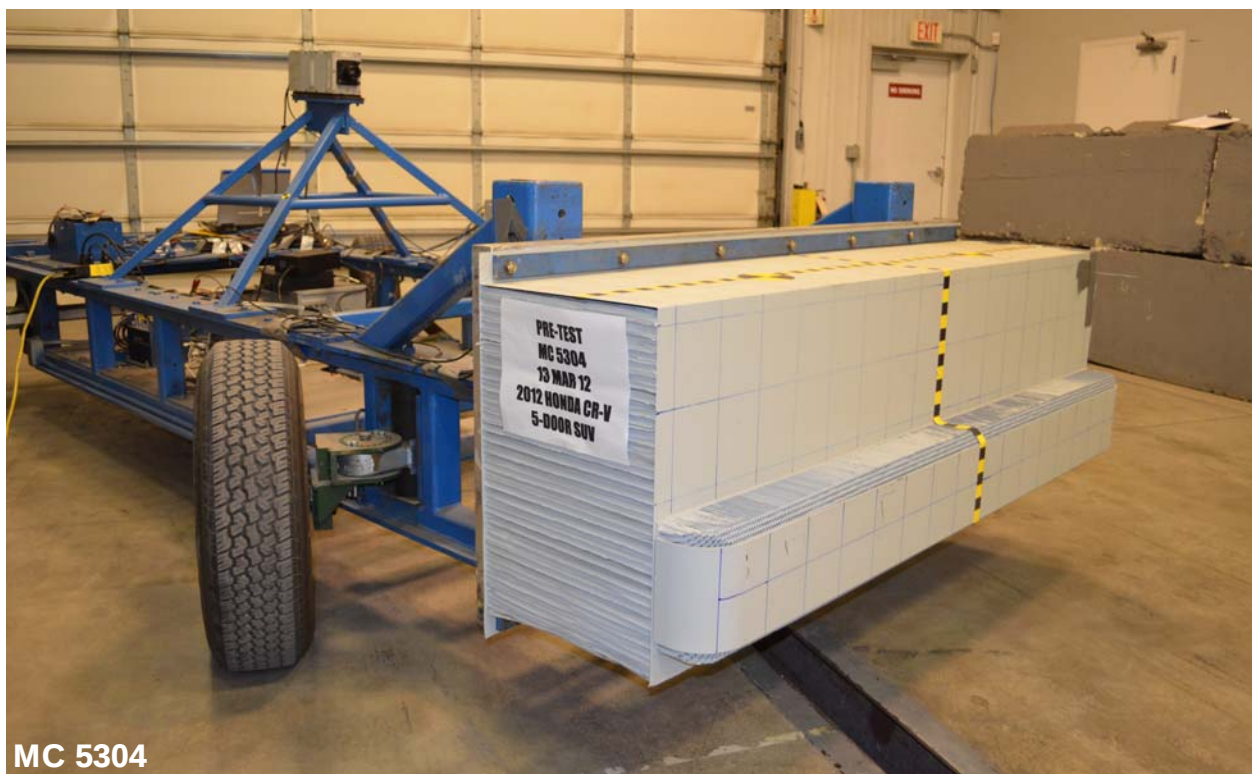
Figure A-87: Post-Test Left Side View of MDB Impactor Face
