**REPORT NUMBER: NCAP-MGA-2012-074**

**NEW CAR ASSESSMENT PROGRAM (NCAP)  
Frontal Barrier Impact Test**

**KIA MOTORS CORPORATION  
2012 KIA Rio LX 4-Dr Sedan  
NHTSA No.: MC0521**

**MGA RESEARCH CORPORATION  
5000 Warren Road  
Burlington, WI 53105**

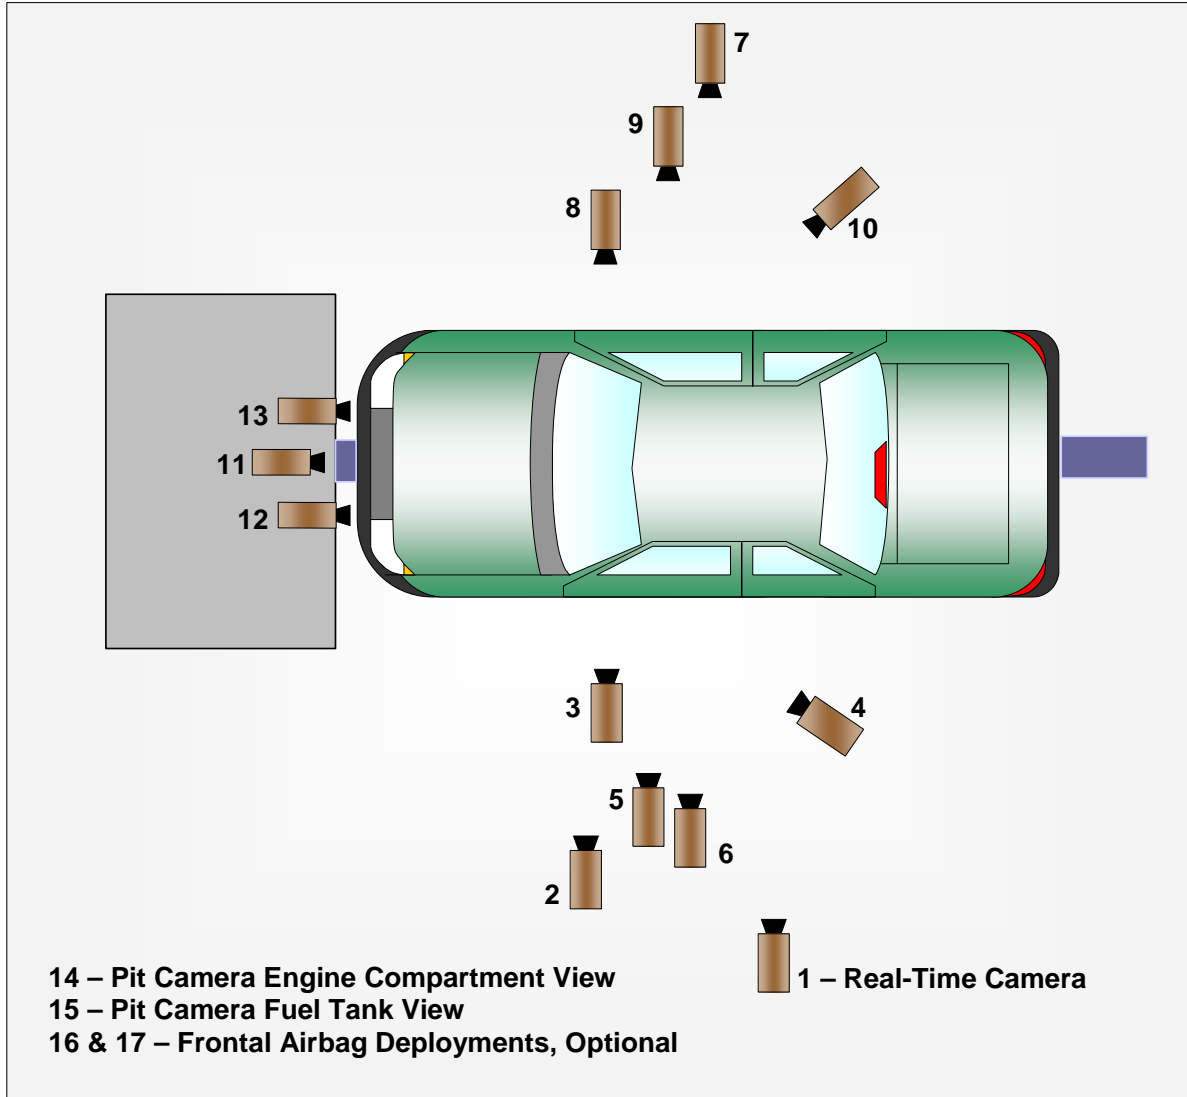
**CAMERA POSITIONS FOR FRONTAL IMPACTS**

Two real-time cameras and fourteen (14) high-speed cameras were used to document the frontal barrier impact event. Camera locations and other pertinent camera information can be found in this report.

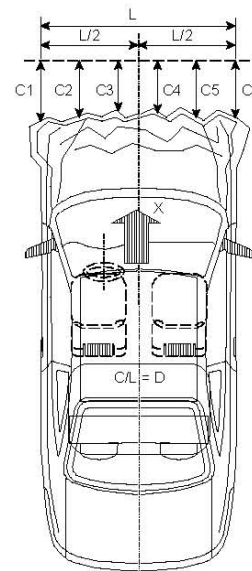
Accelerometer Locations: As per measurements on Page 15  
Cal. Procedure/Interval: MGA procedure / 6 month  
Integration Algorithm: Trapezoidal Linearity: > 99%  
Impact Velocity (km/h): 56.1  
Velocity Change (km/h): 61.9  
Time of Separation (msec): 82.1

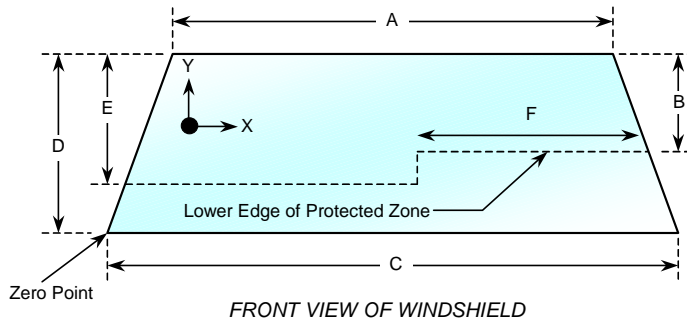
**WINDSHIELD PERIPHERY MEASUREMENTS**

Measurement	Pre-Test (mm)	Post-Test (mm)	% of Retention
Left Side	2058	2058	100
Right Side	2058	2058	100
Total	4116	4116	100

Item	Units	Value
A	mm	1164
B	mm	498
C	mm	1448
D	mm	752
E	mm	510
F	mm	506

**AREA OF PROTECTED ZONE FAILURES - NONE**

There was 100 percent windshield retention and no intrusion into the protected zone of the windshield during the event. There was no Stoddard Solvent leakage after the event or during any phase of the static rollover.

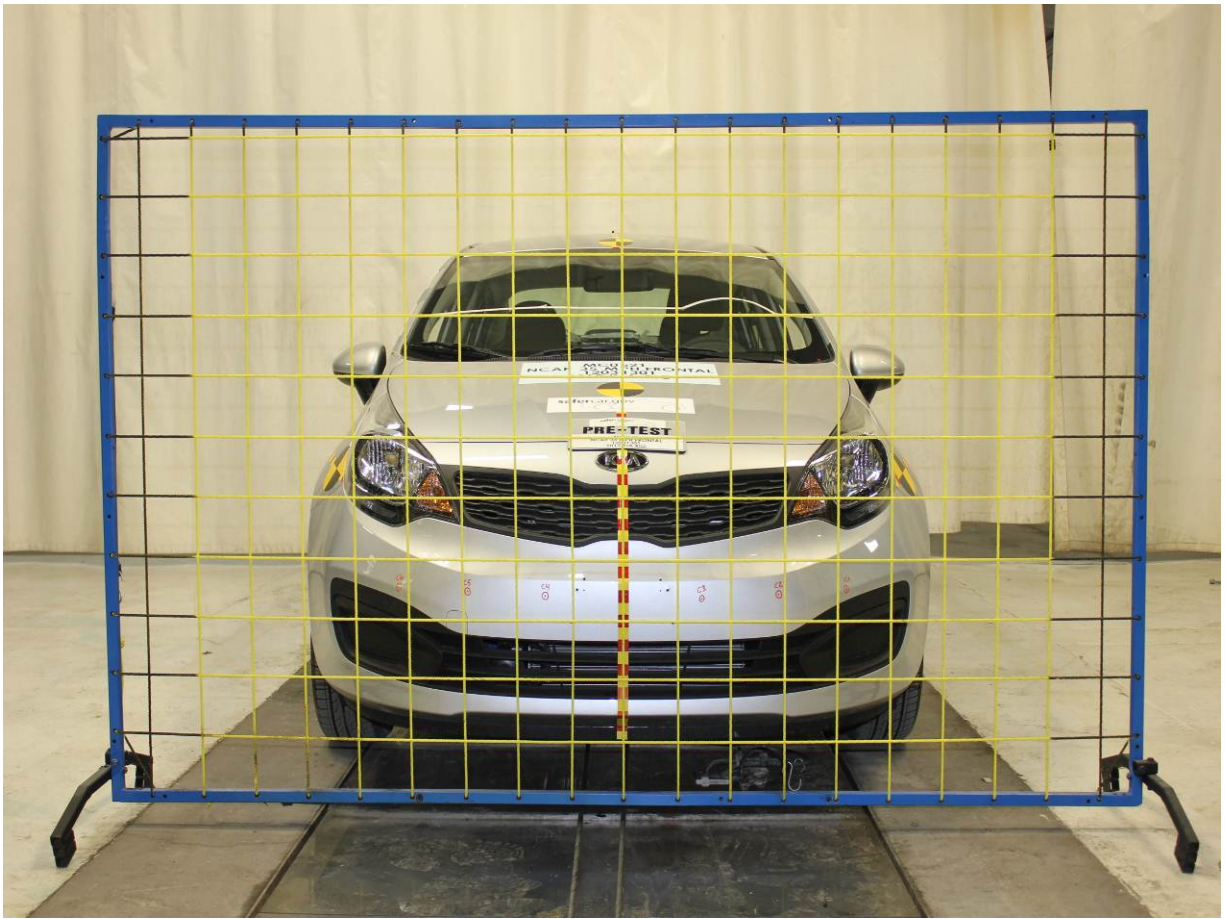
Load Cell Location

A load cell barrier was impacted by a 2012 KIA Rio LX 4-Dr Sedan at a velocity of 56.1 kph. The test was performed at MGA Research Corporation on March 13, 2012. Pre-test and post-test photographs of the vehicle and dummies can be found in Appendix A.

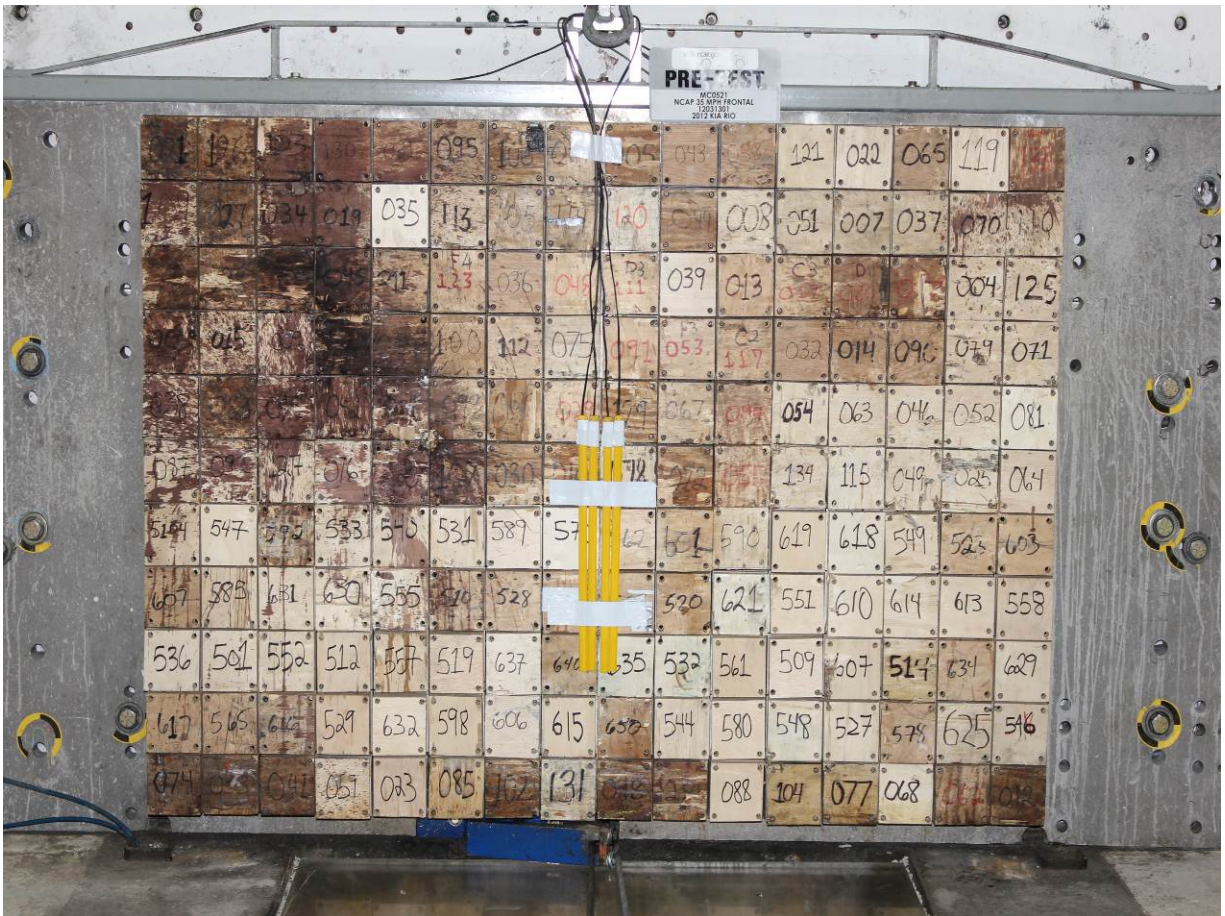
Load Cell Wall

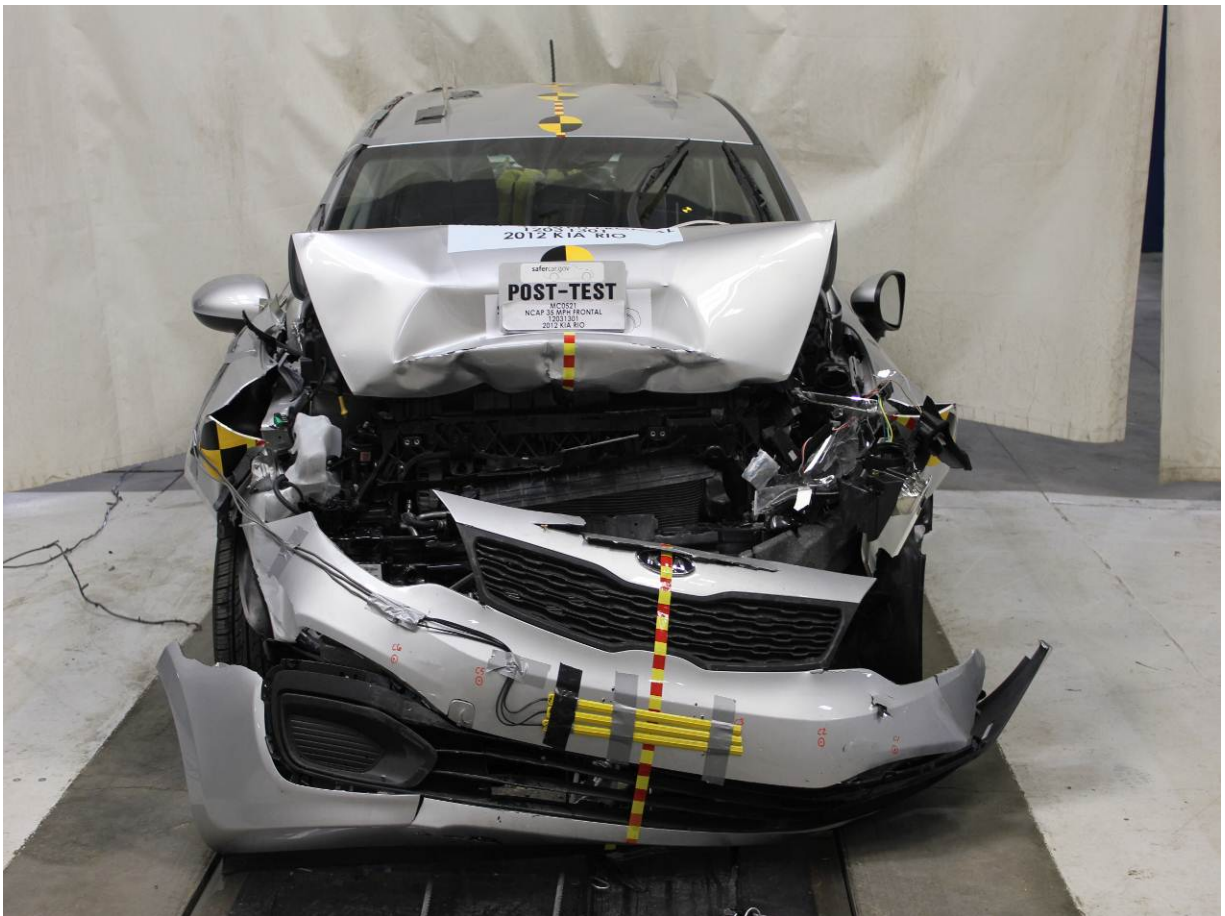
Post-Test Front View of Test Vehicle

The maximum static crush of the vehicle was 507 mm and both the driver and passenger side doors remained closed during the impact event and were operable after the impact.

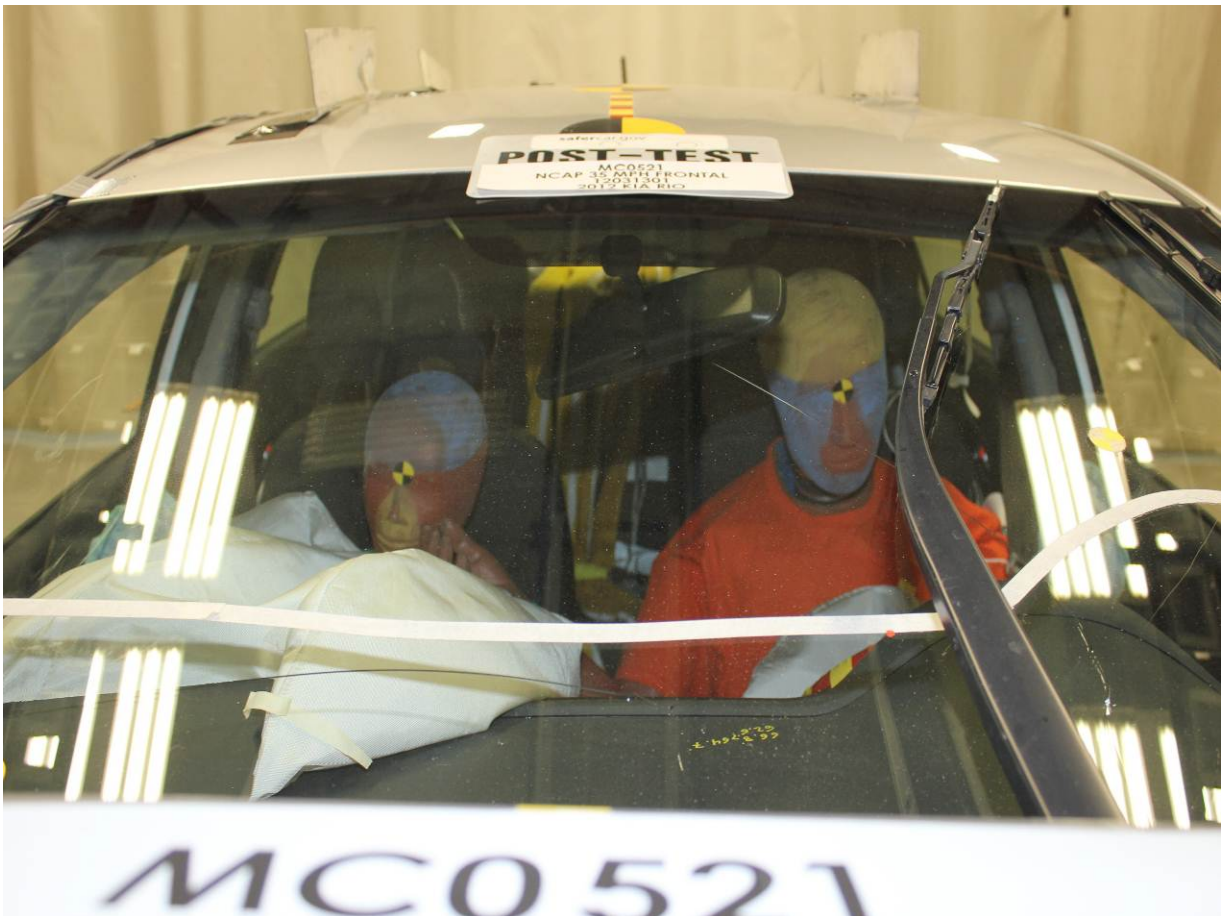
Post-Test Windshield View

Critical Areas of Performance	Observations and Conclusions
Windshield Damage	Cracked
Window Damage	None
Other Notable Effects	None

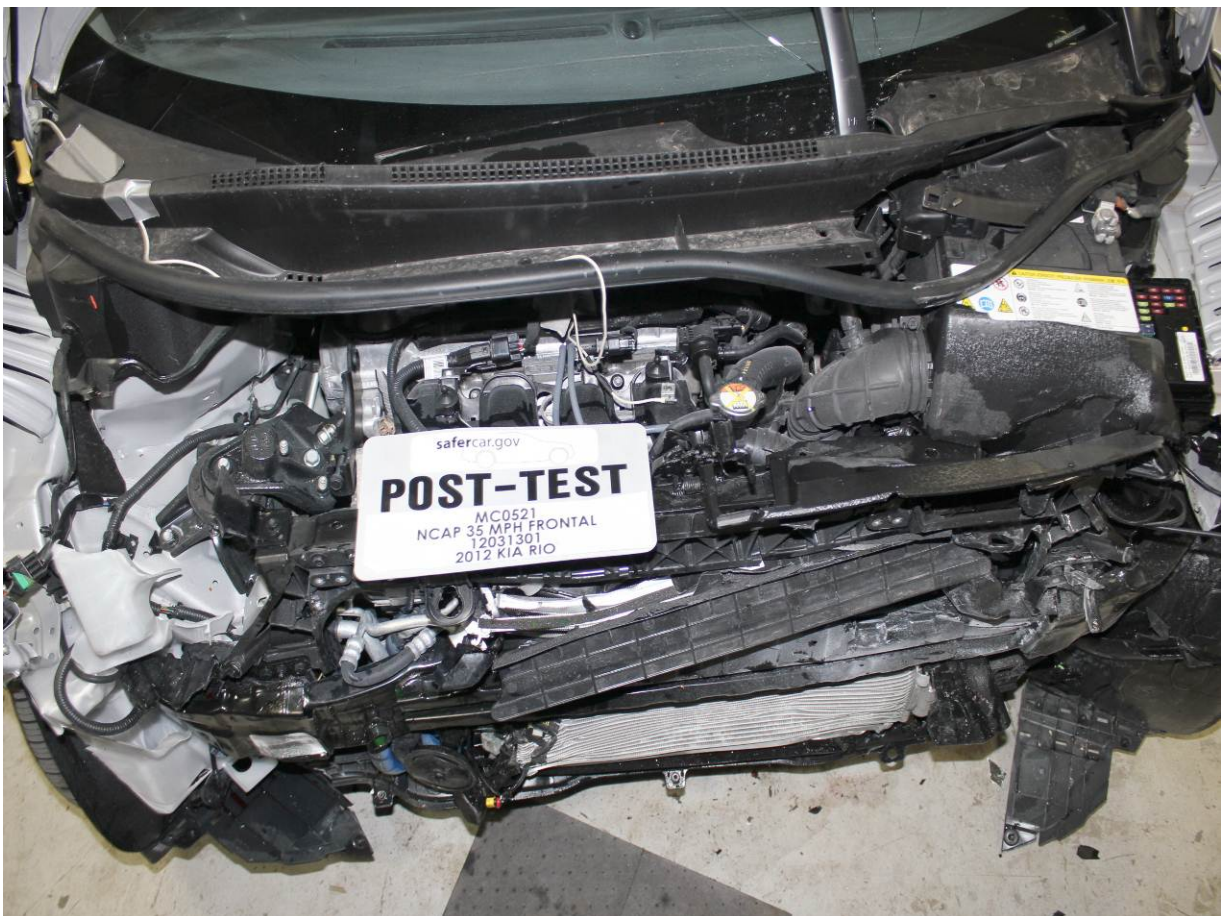
Post-Test Engine Compartment View

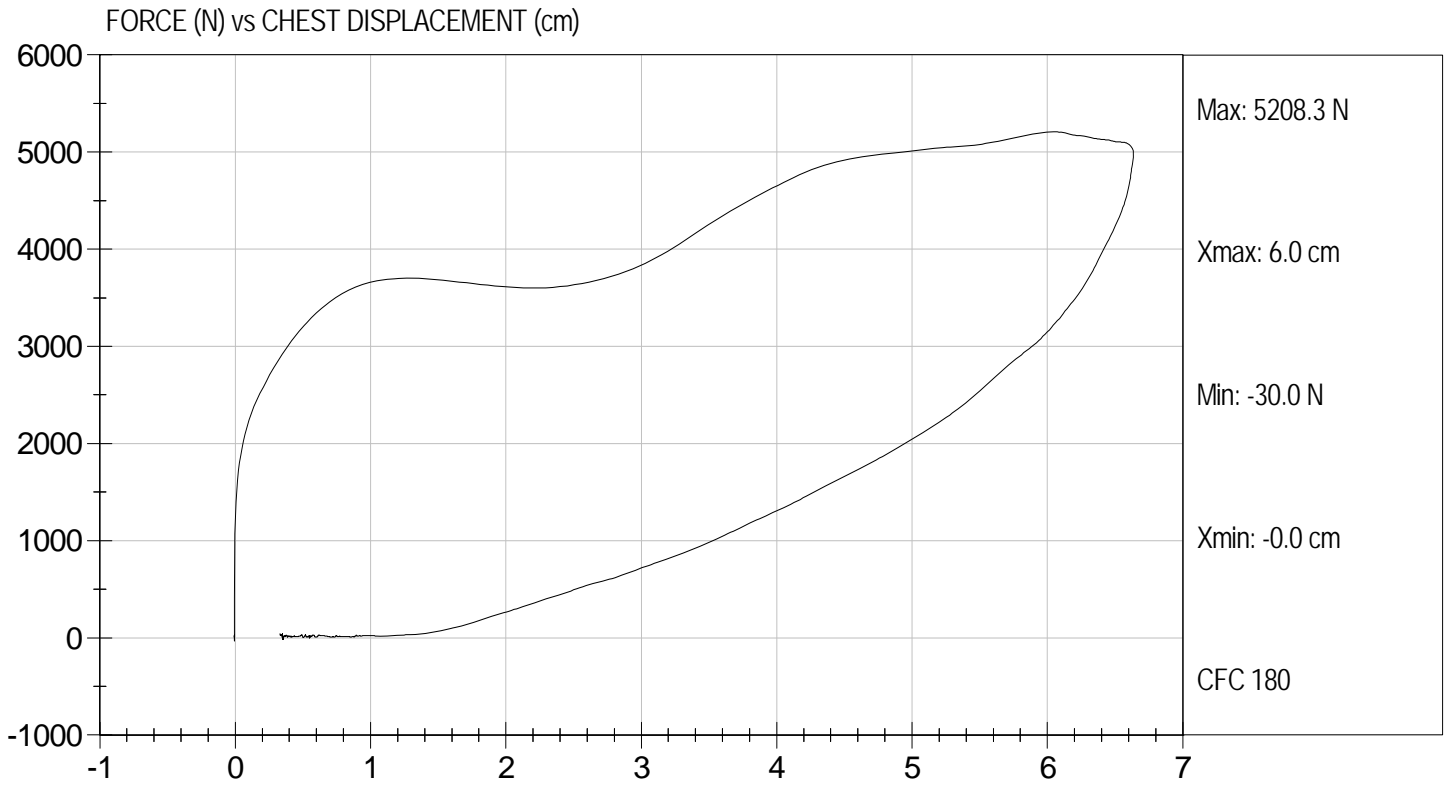
Test Desc: Thorax Impact  
Component ID: D12804

Test Date: 3/5/12  
Velocity: 22.22 ft/s, 6.77 m/s

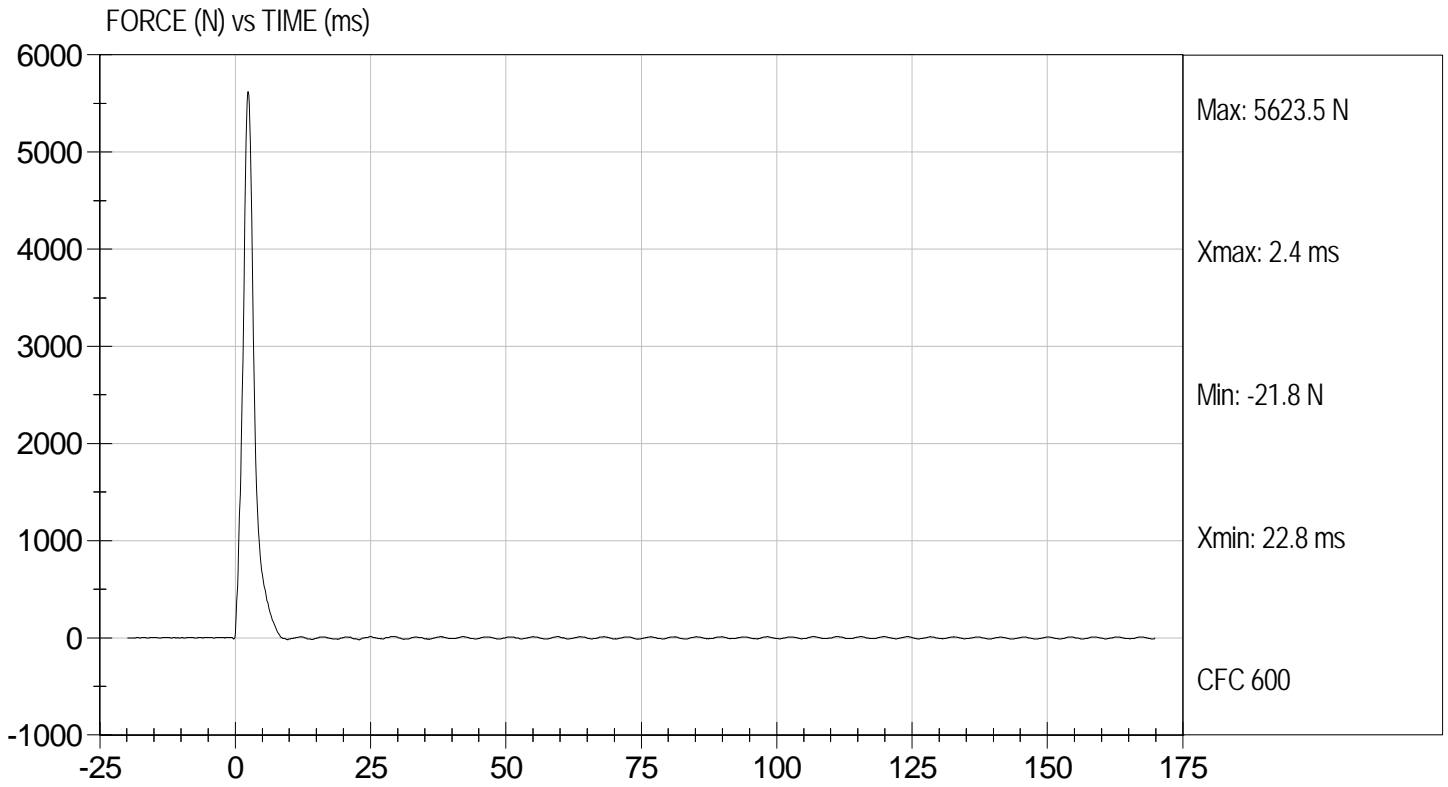
Test Desc: Right Knee  
Component ID: D12805

Test Date: 3/5/12  
Velocity: 6.97 ft/s, 2.12 m/s

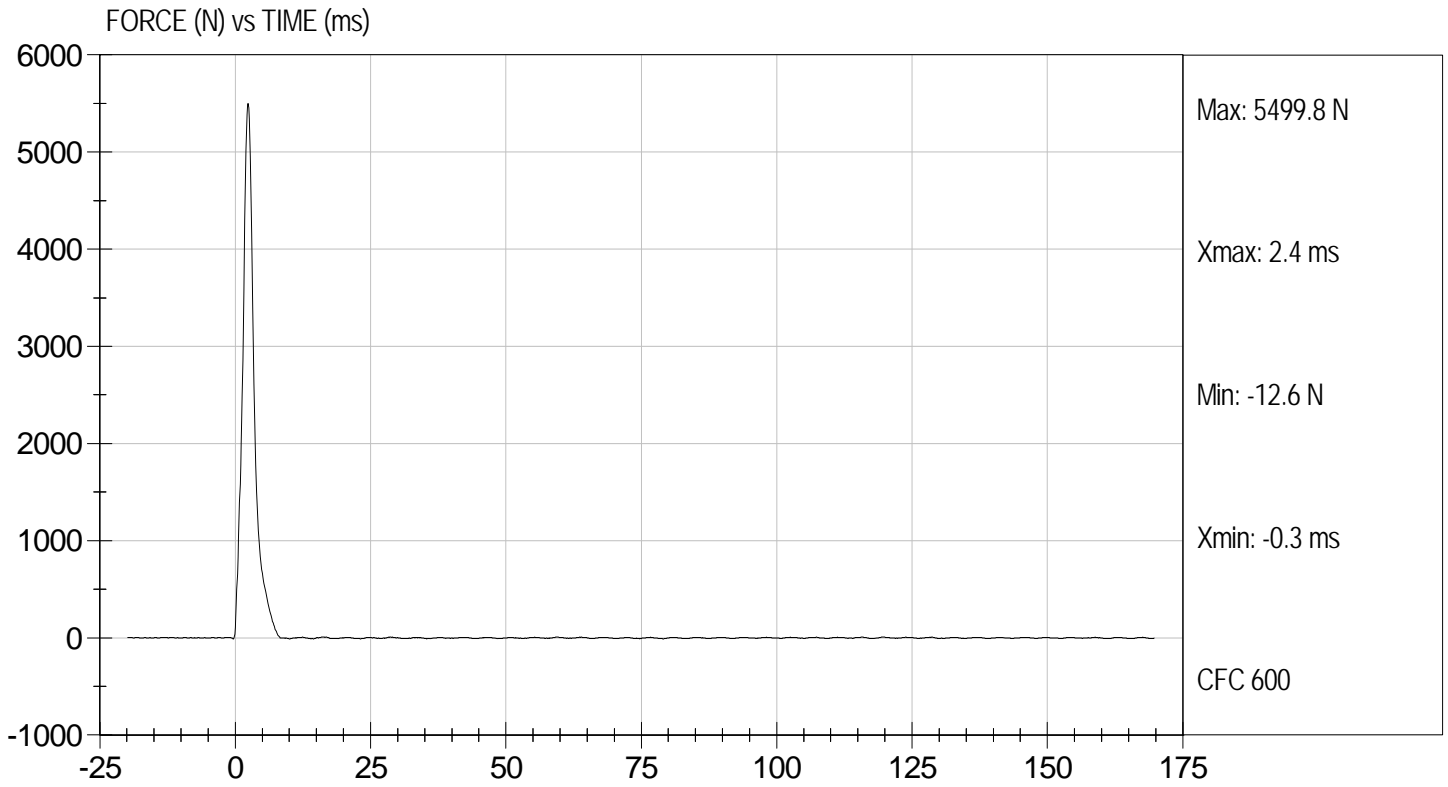
Test Desc: Left Knee  
Component ID: D12806

Test Date: 3/5/12  
Velocity: 6.97 ft/s, 2.12 m/s

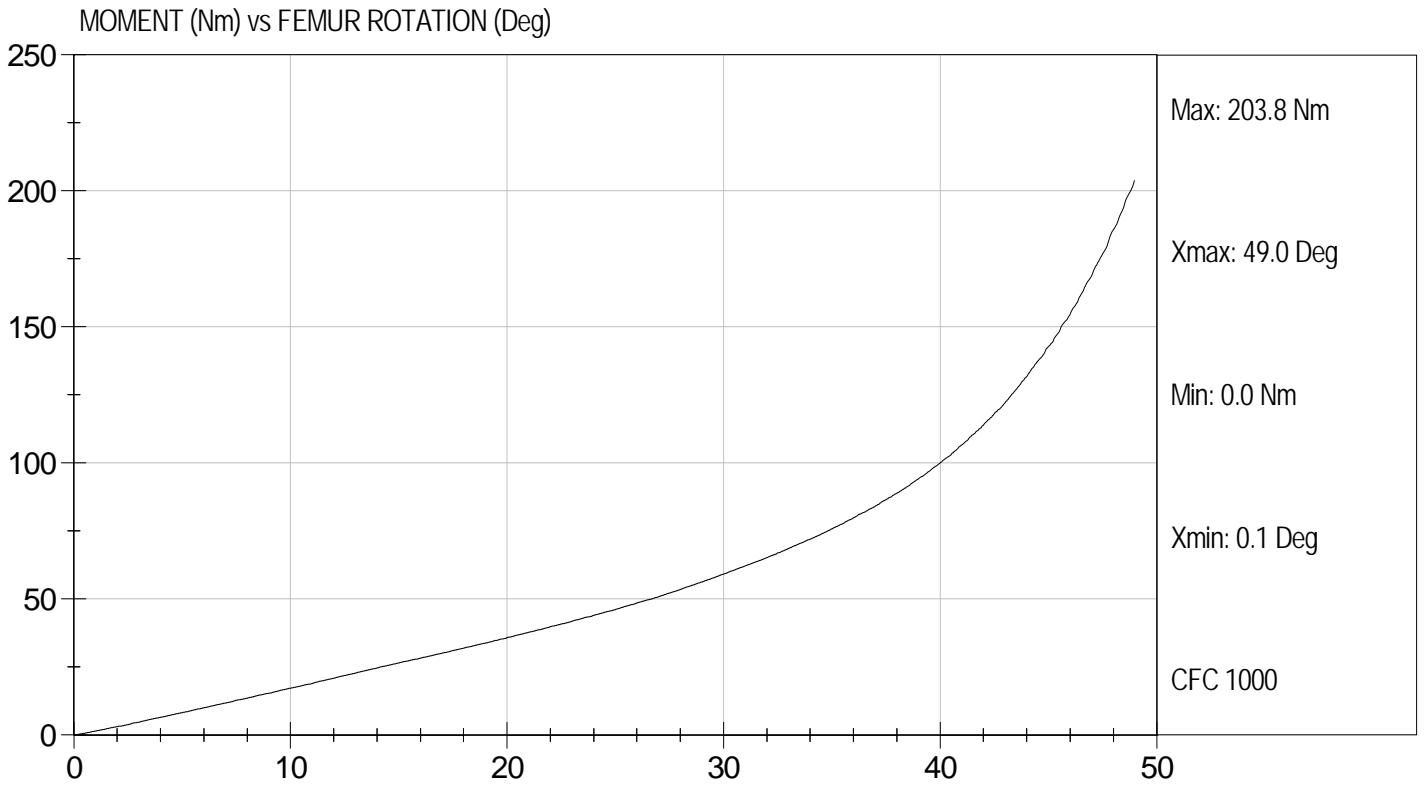
Test Desc: Hip Femur Flexion  
Component ID: D12809

Test Date: 3/2/12  
Velocity: 0 ft/s, 0.00 m/s

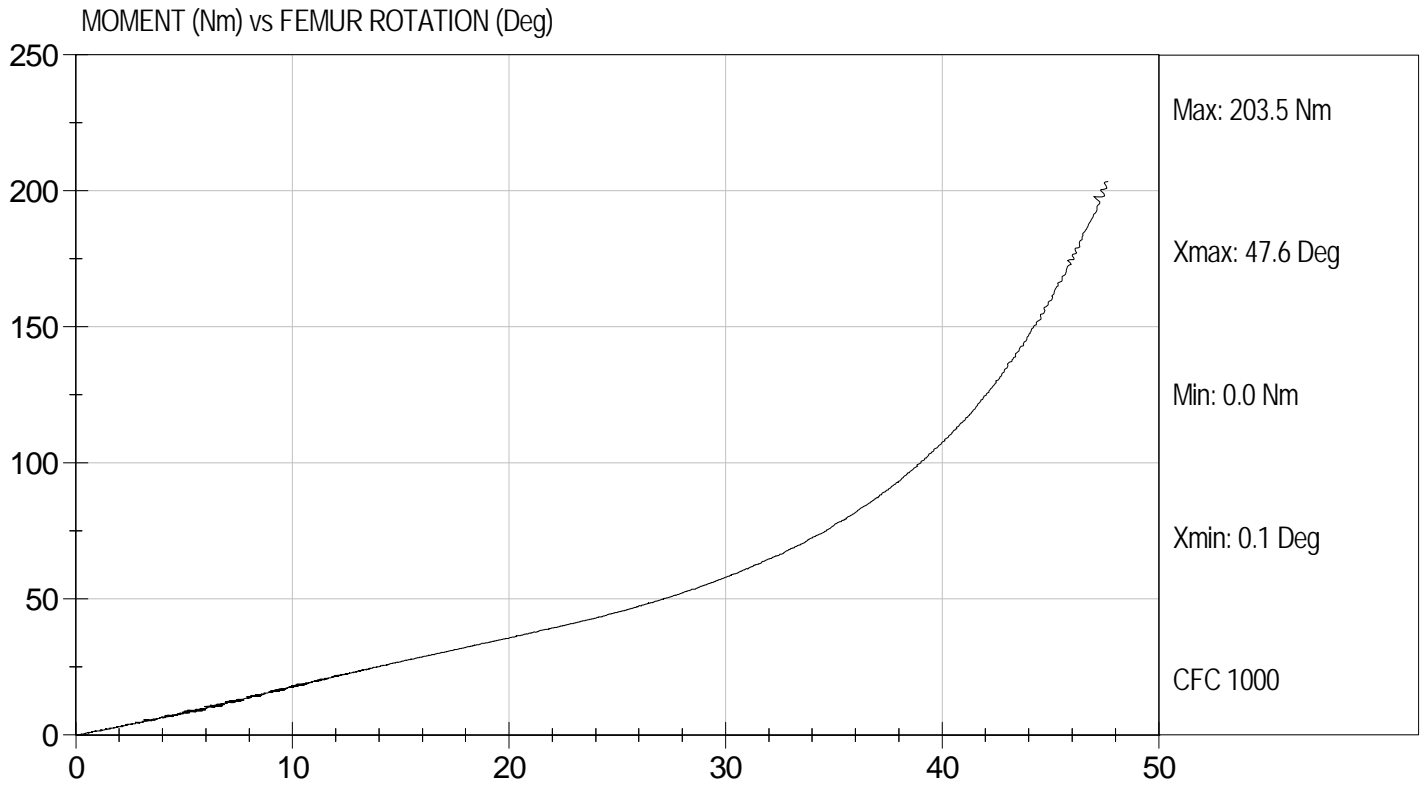
Test Desc: Hip Femur Flexion  
Component ID: D12800

Test Date: 3/2/12  
Velocity: 0 ft/s, 0.00 m/s

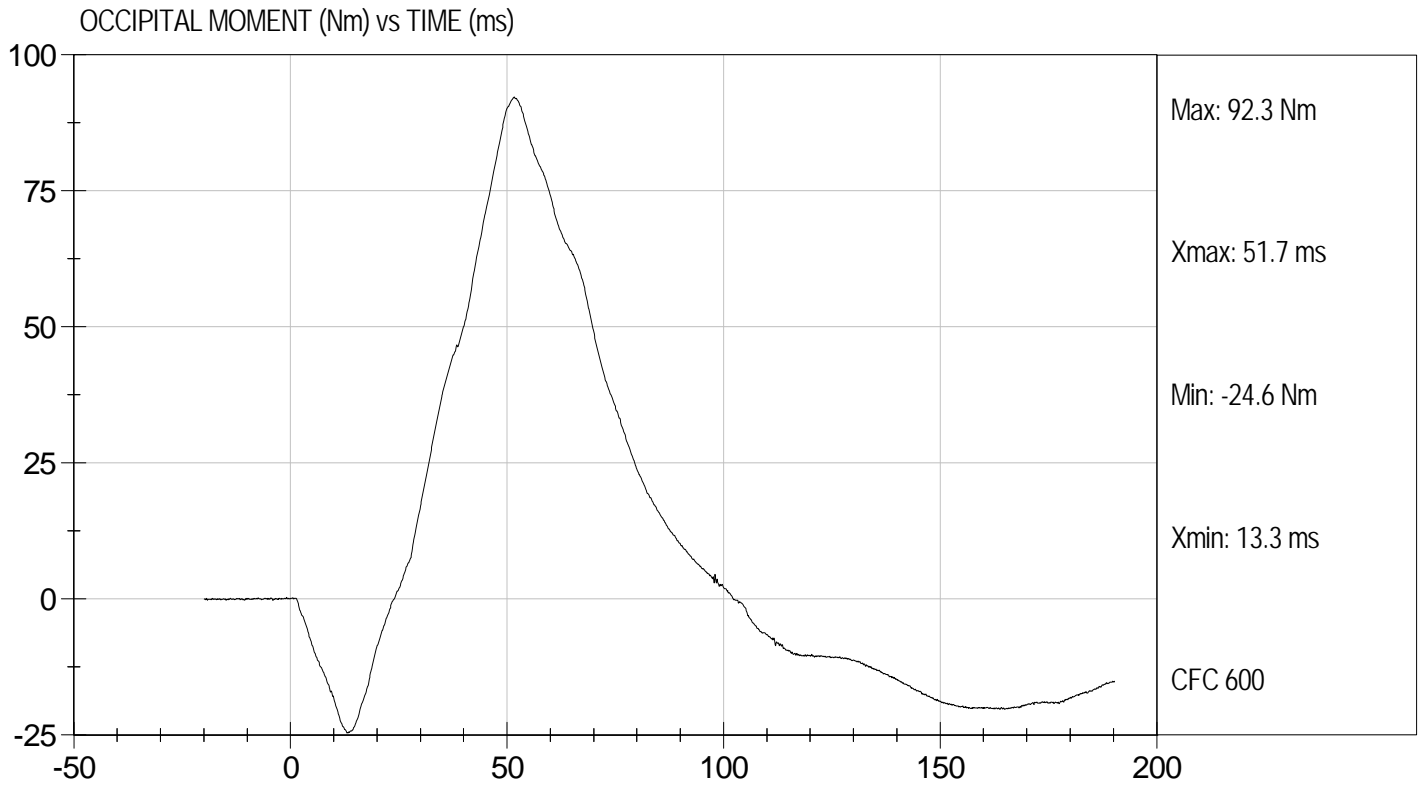
Test Desc: Neck Flexion  
Component ID: D121012

Test Date: 3/14/12  
Velocity: 22.7 ft/s, 6.92 m/s

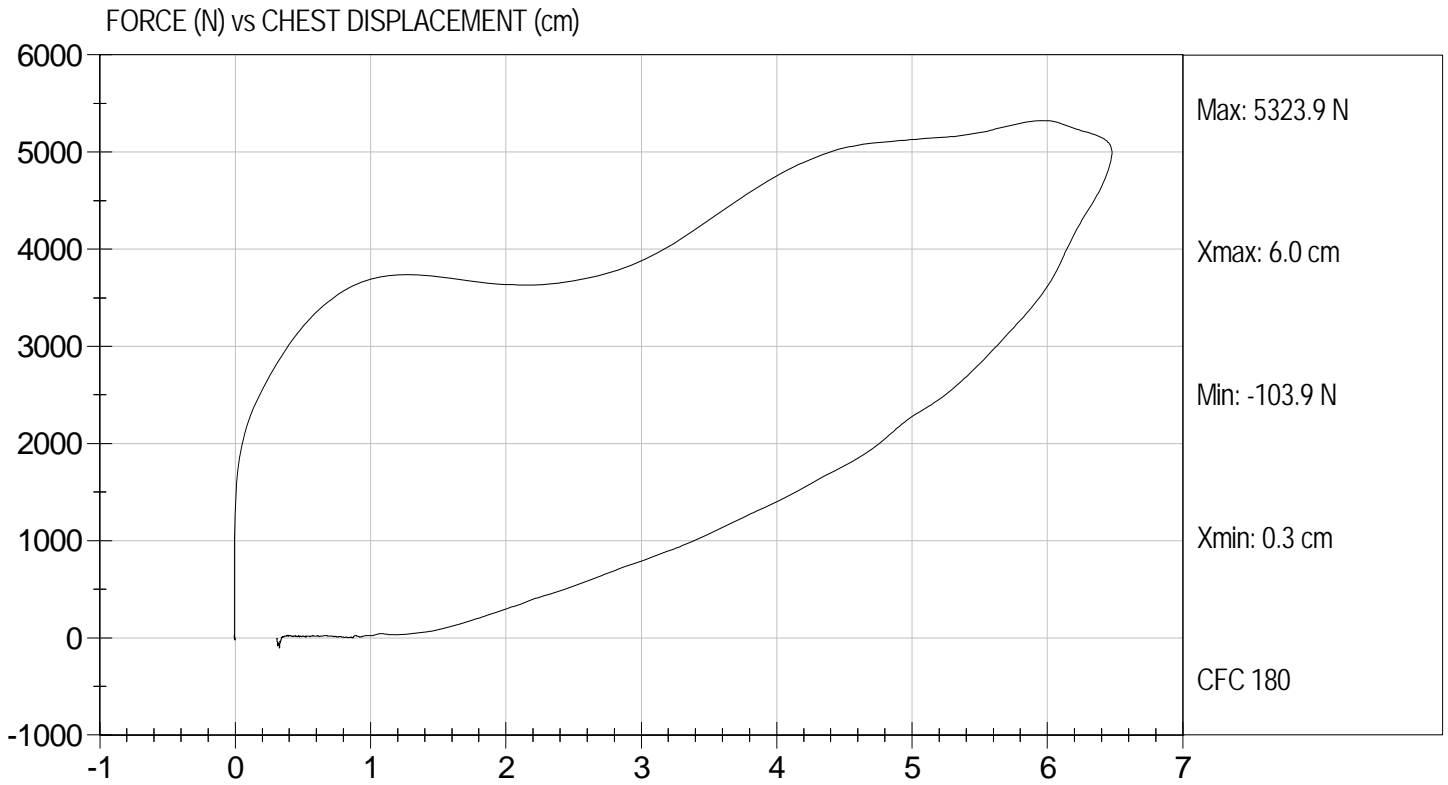
Test Desc: Thorax Impact  
Component ID: D121014

Test Date: 3/14/12  
Velocity: 22.22 ft/s, 6.77 m/s

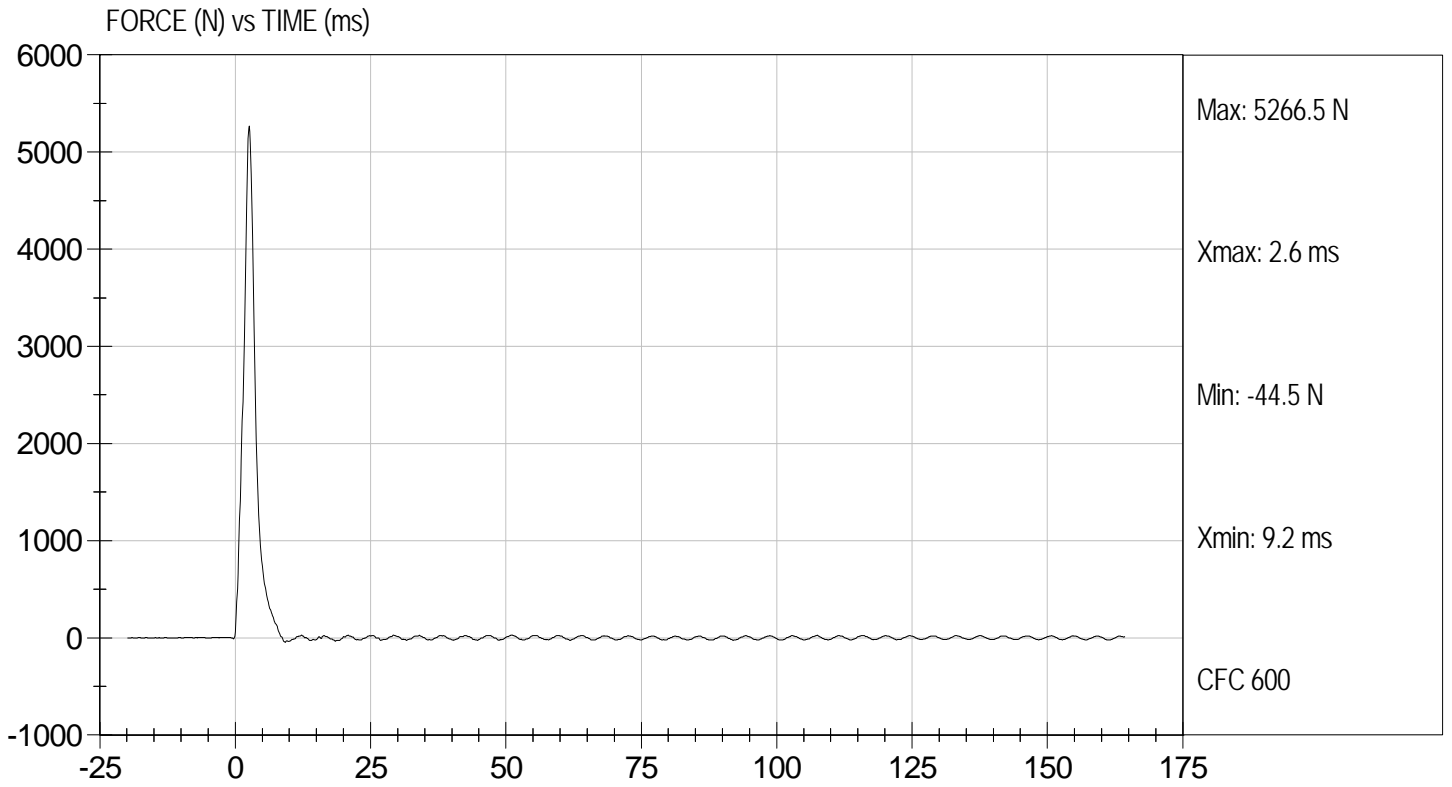
Test Desc: Right Knee  
Component ID: D121015

Test Date: 3/13/12  
Velocity: 6.94 ft/s, 2.12 m/s

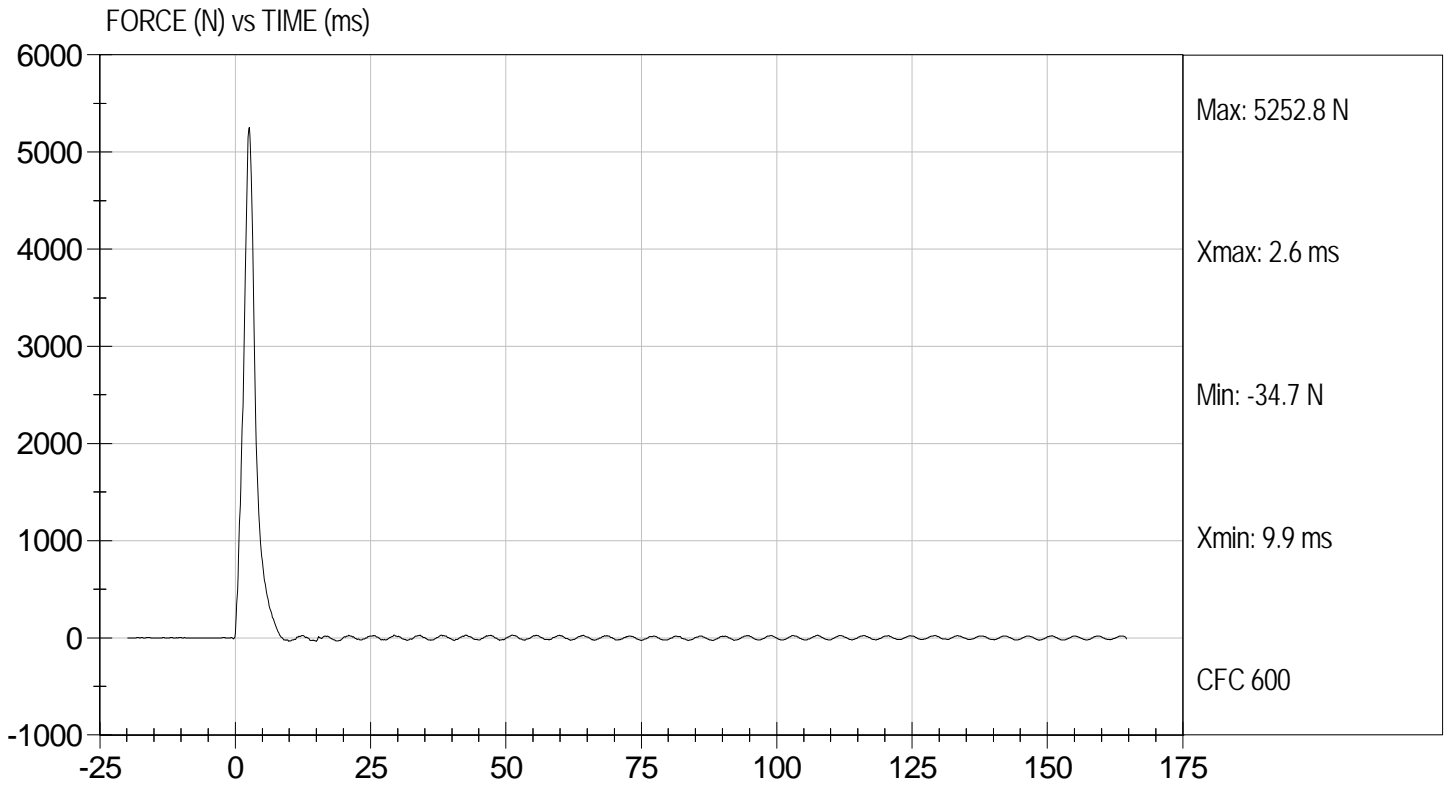
Test Desc: Left Knee  
Component ID: D121016

Test Date: 3/13/12  
Velocity: 6.97 ft/s, 2.12 m/s

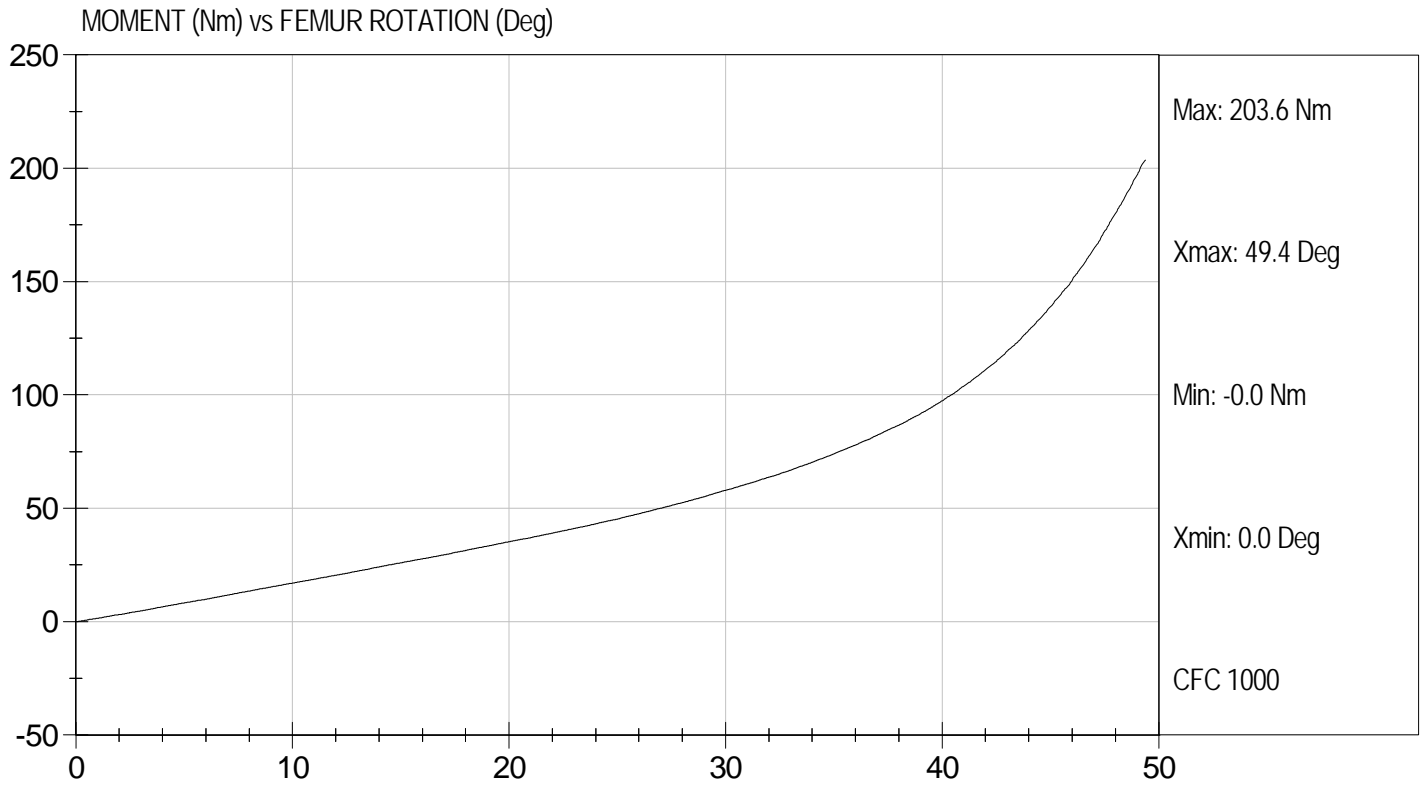
Test Desc: Hip Femur Flexion  
Component ID: D121019

Test Date: 3/13/12  
Velocity: 0 ft/s, 0.00 m/s

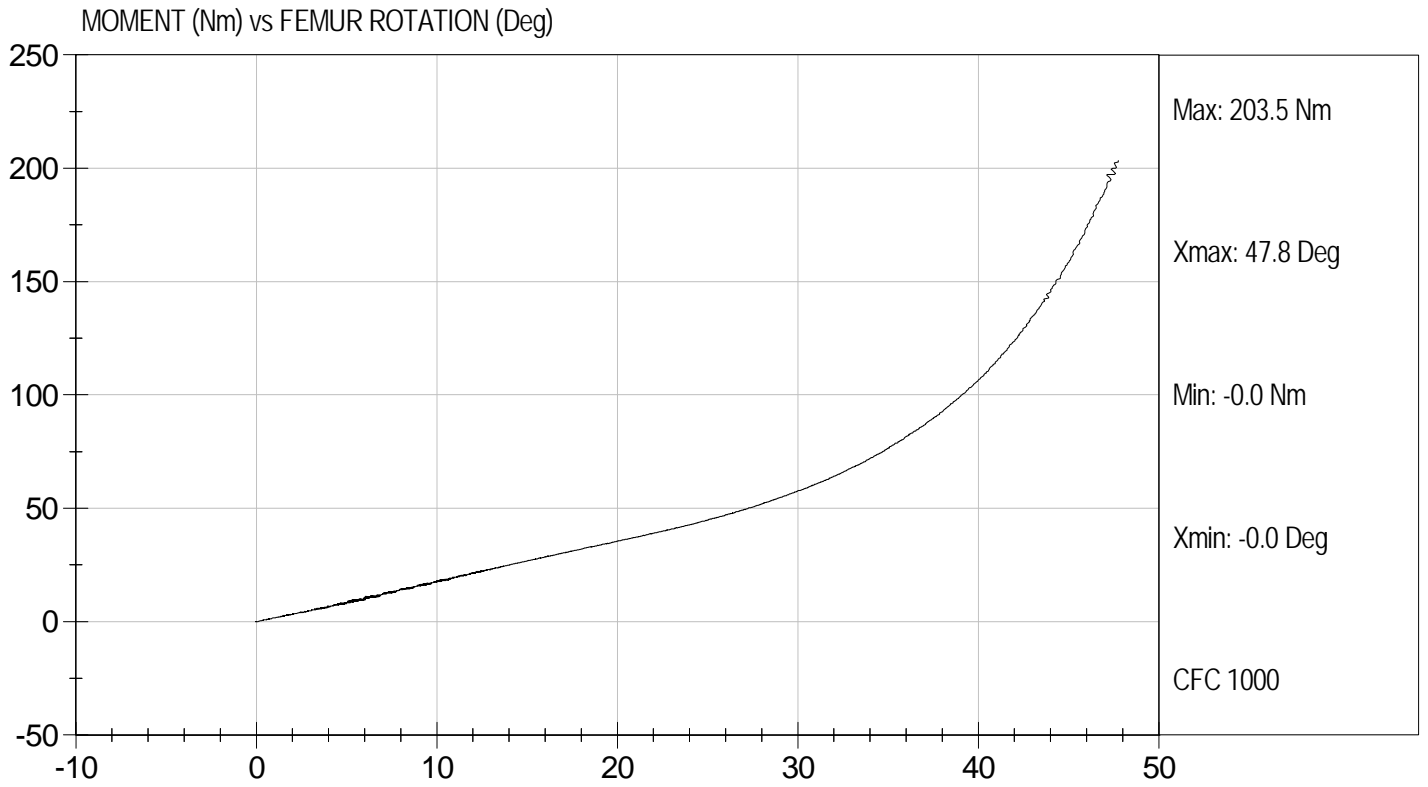
Test Desc: Hip Femur Flexion  
Component ID: D121010

Test Date: 3/13/12  
Velocity: 0 ft/s, 0.00 m/s
