REPORT NUMBER: SINCAP-MGA-2012-075

**NEW CAR ASSESSMENT PROGRAM (NCAP)
Moving Deformable Barrier Side Impact Test**

**KIA MOTORS CORPORATION
2012 KIA Rio LX 4-Dr Sedan
NHTSA No.: MC0522**

**MGA RESEARCH CORPORATION
5000 Warren Road
Burlington, WI 53105**

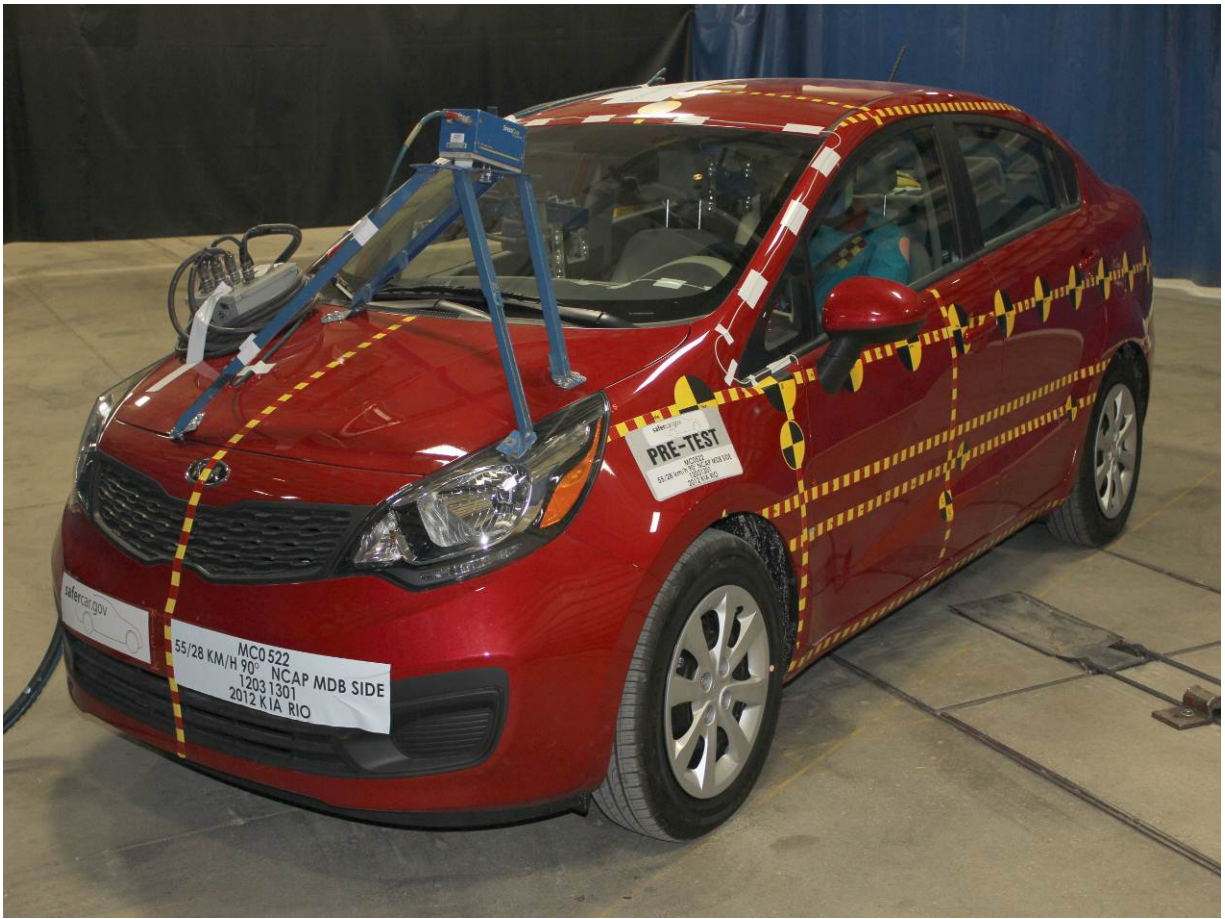
Post-Test Frontal View of Test Vehicle

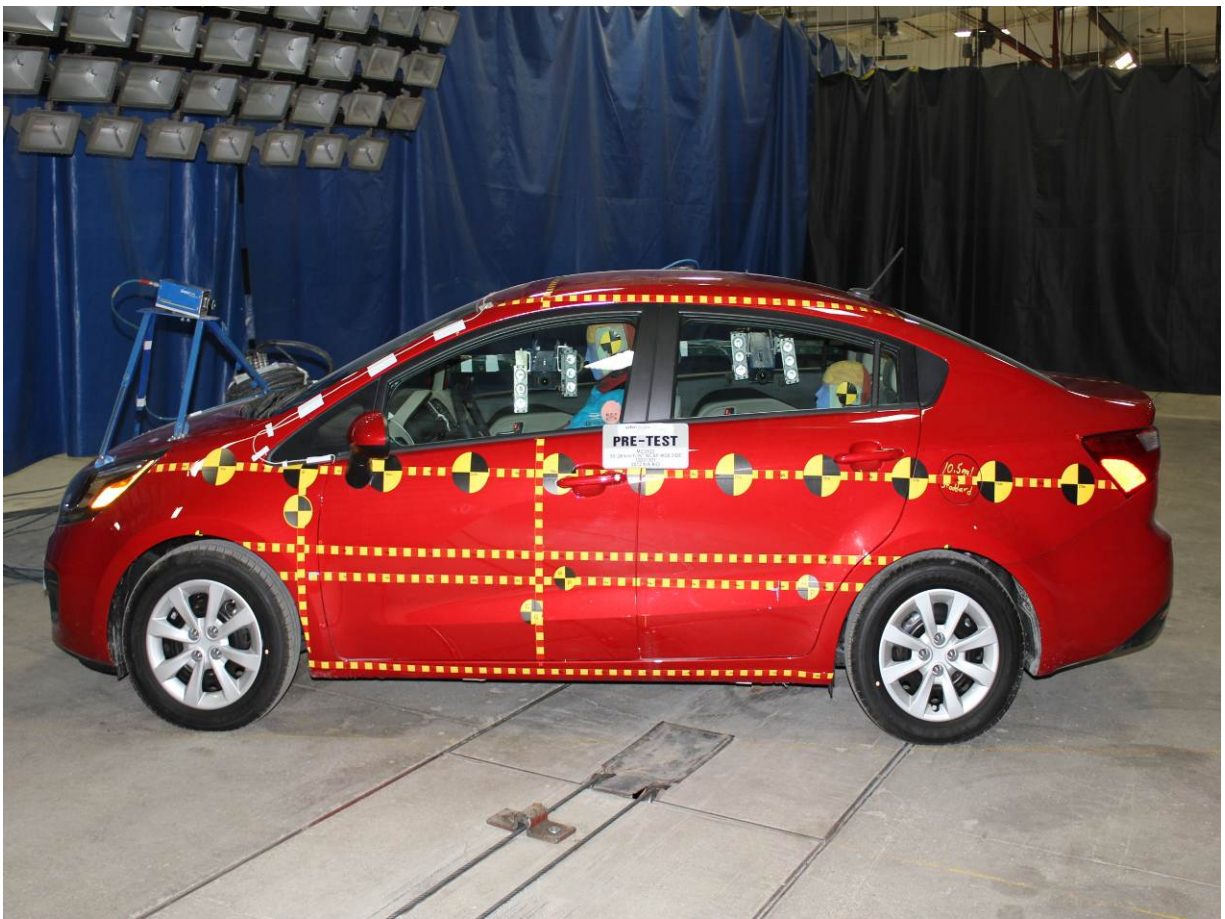
Post-Test Left Front Three-Quarter View of Test Vehicle

Critical Areas of Performance	Observations and Conclusions
Pillar Performance	No Separation
Sill Separation	None
Windshield Damage	None
Side Window Damage	Left Front Window Broke
Other Notable Effects	None

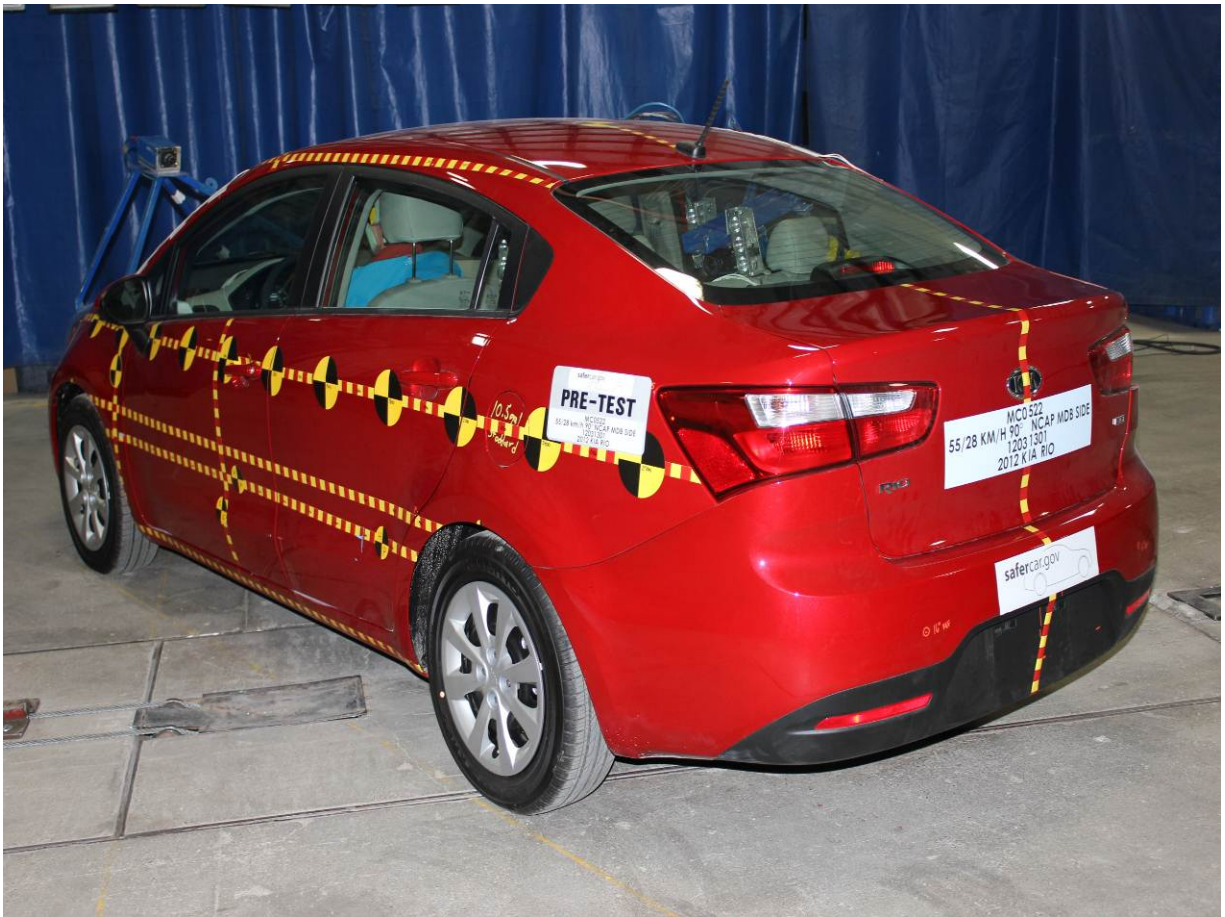
Post-Test Left Side View of Test Vehicle

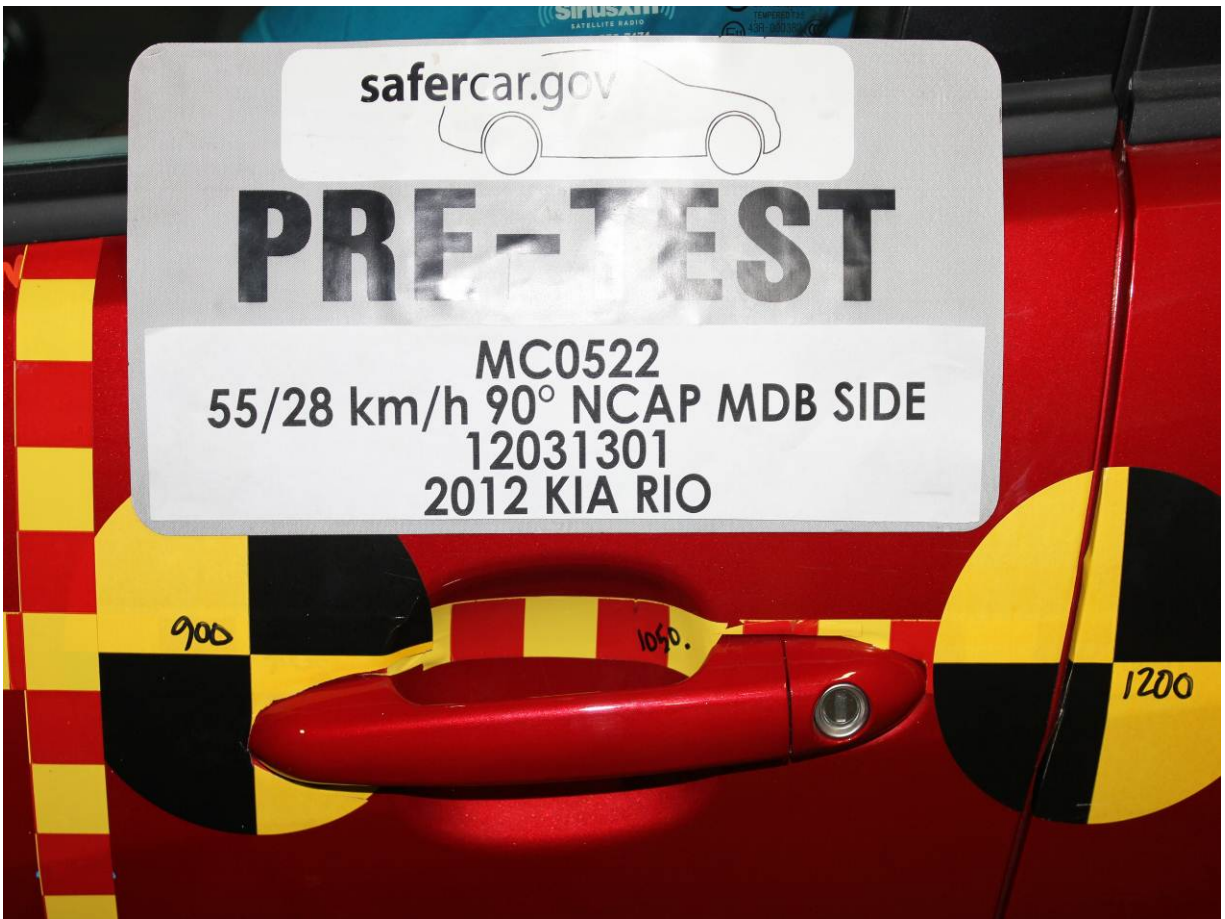
Post-Test Close-Up View of Impact Point Target

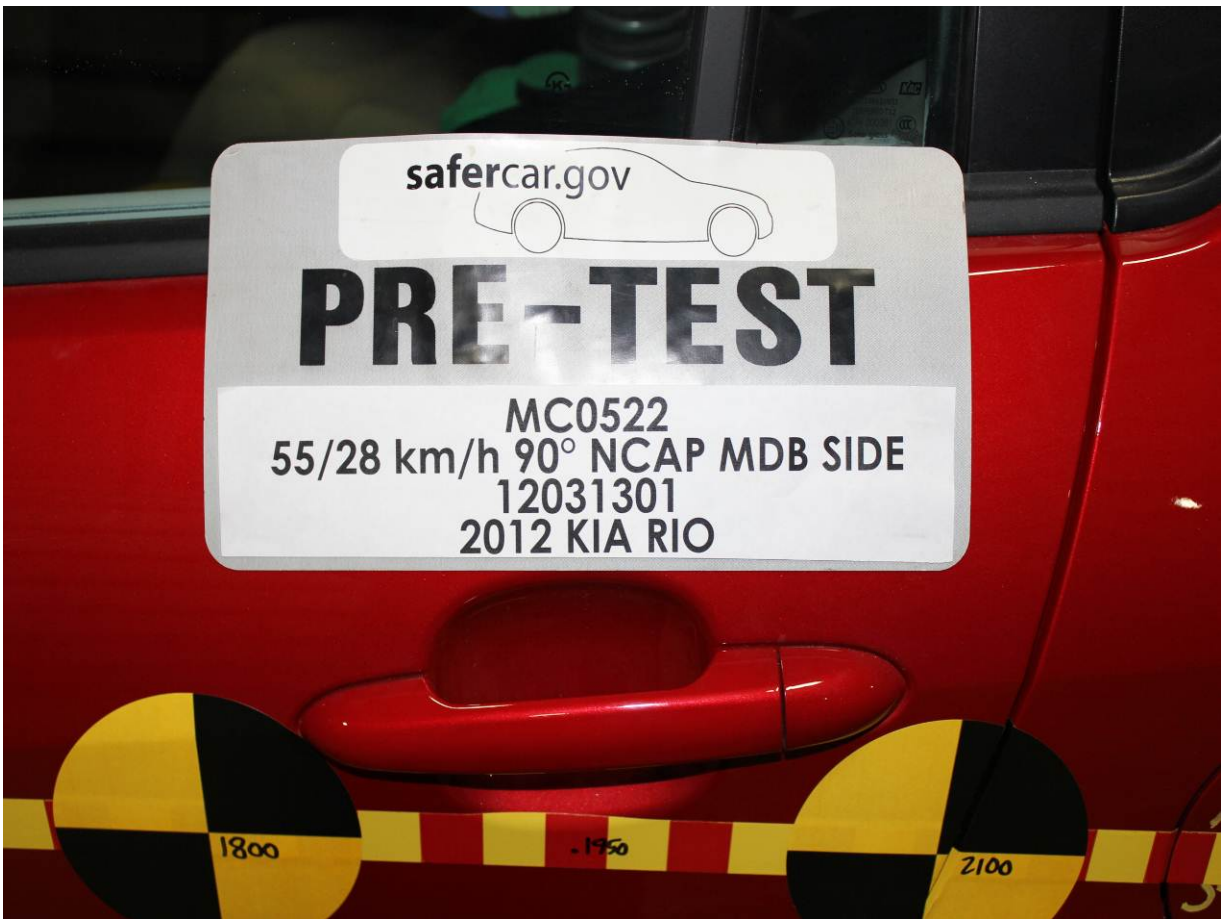
Post-Test Left Front Door Latch Close-Up

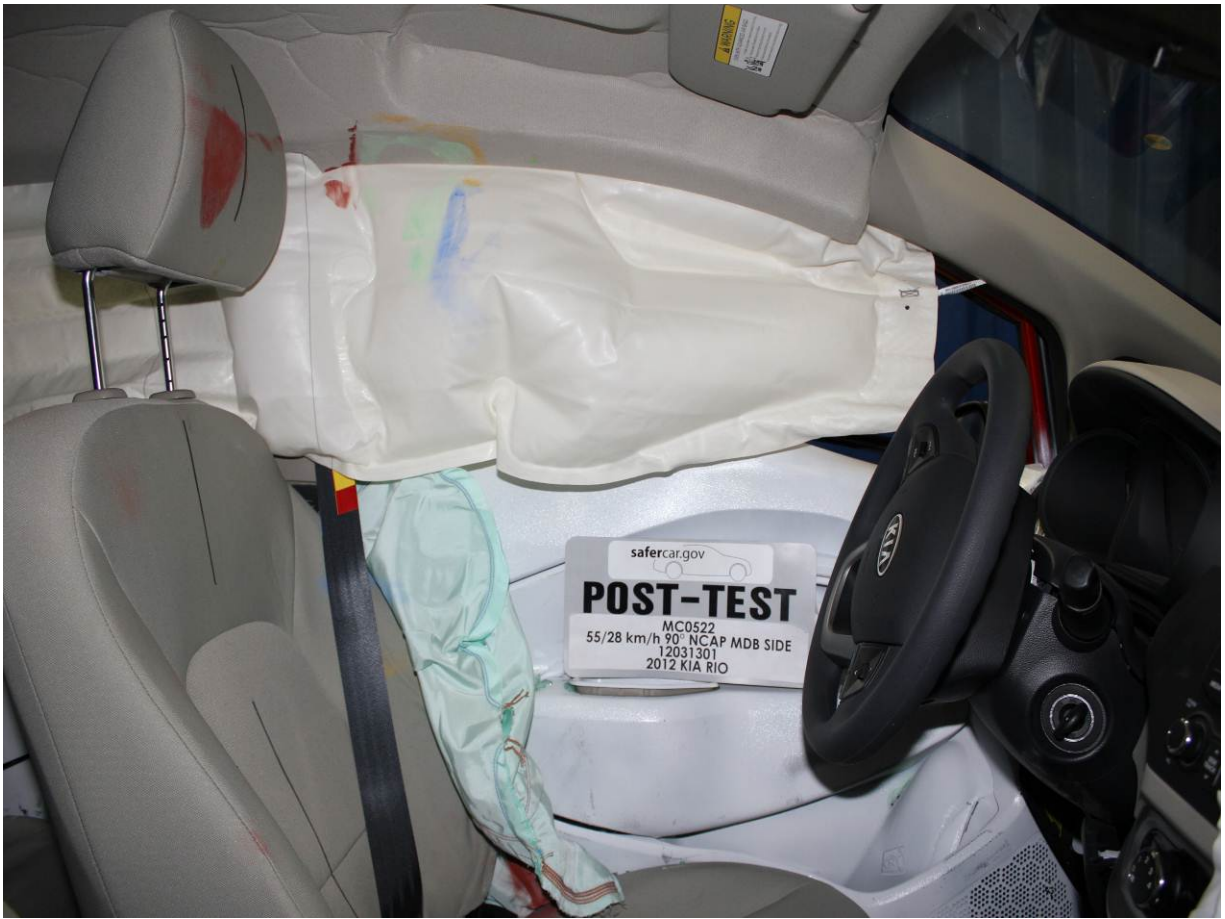
Post-Test Driver Inner Door Panel View

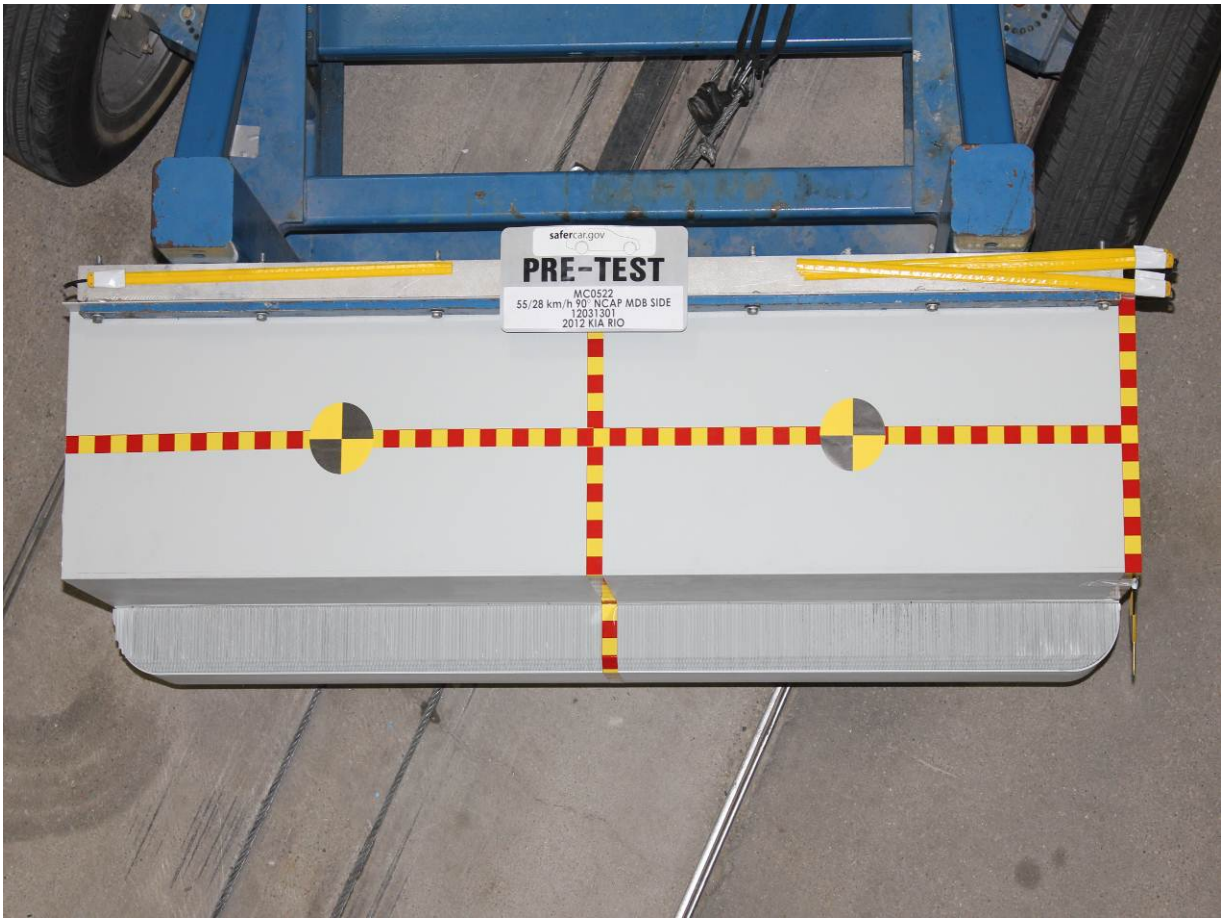
Post-Test Front View of MDB Impactor Face

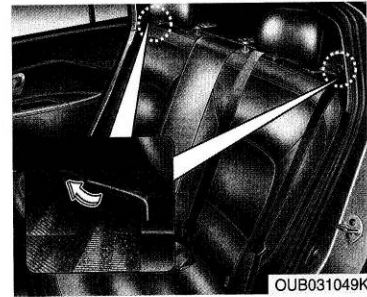
To fold down the rear seatback:

• 4 door

1. Make sure the rear seat belt webbing is in the guide to prevent the seat belt from being damaged.
2. Set the front seatback to the upright position and if necessary, slide the front seat forward.
3. Lower the rear headrests to the lowest position.

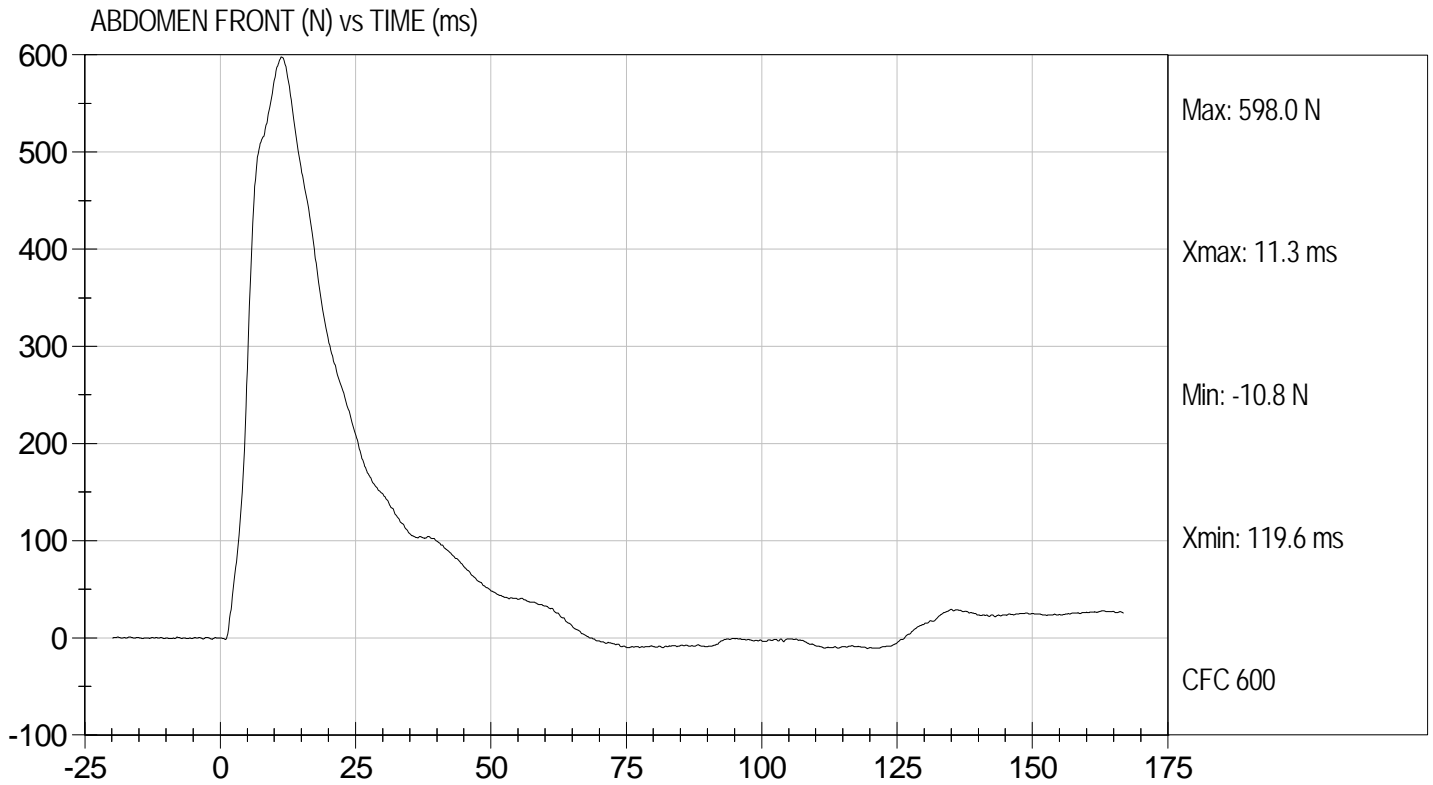
Test Desc: Abdomen Impact
Component ID: D12857

Test Date: 3/6/12
Velocity: 13.02 ft/s, 3.97 m/s

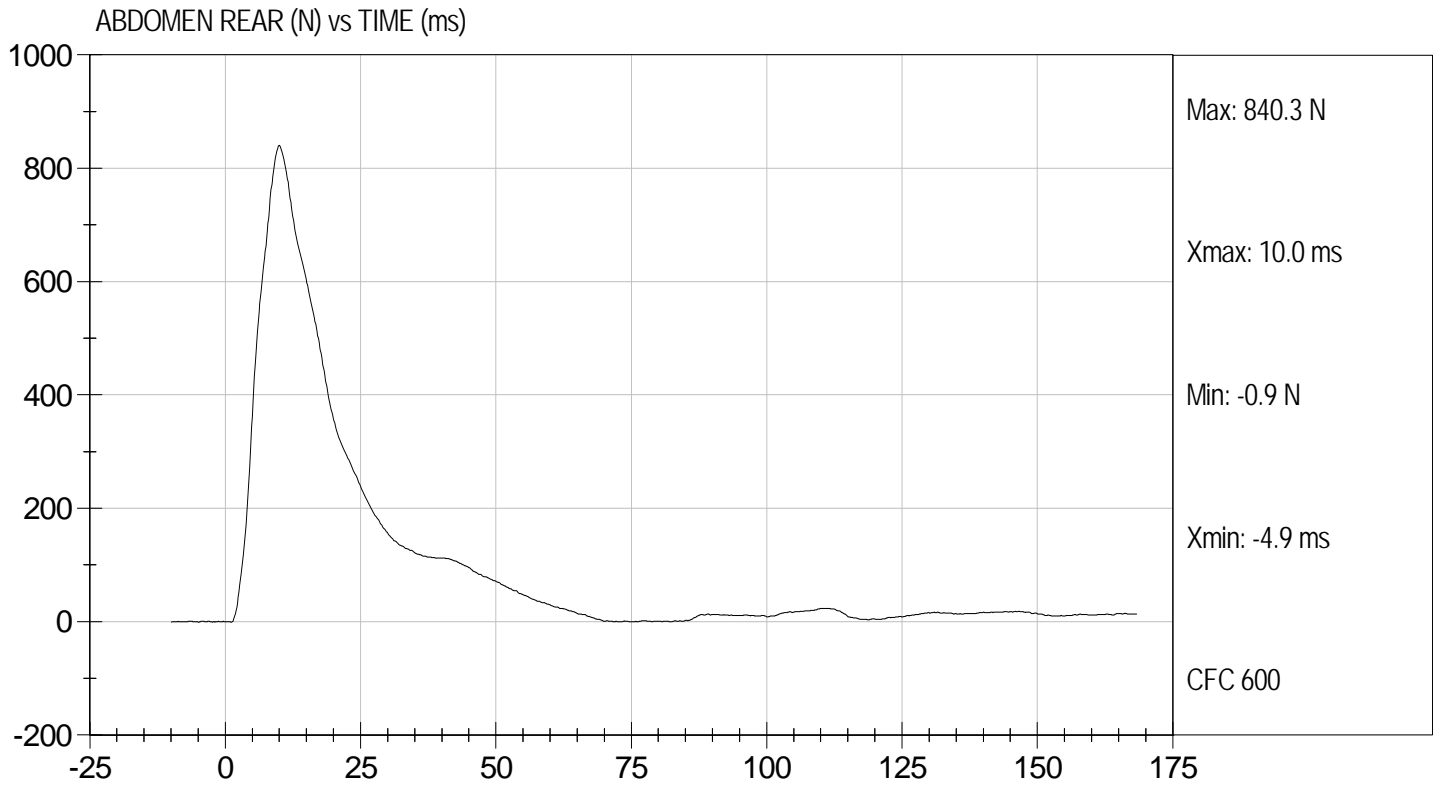
Test Desc: Abdomen Impact
Component ID: D12987

Test Date: 3/13/12
Velocity: 13.12 ft/s, 4.00 m/s

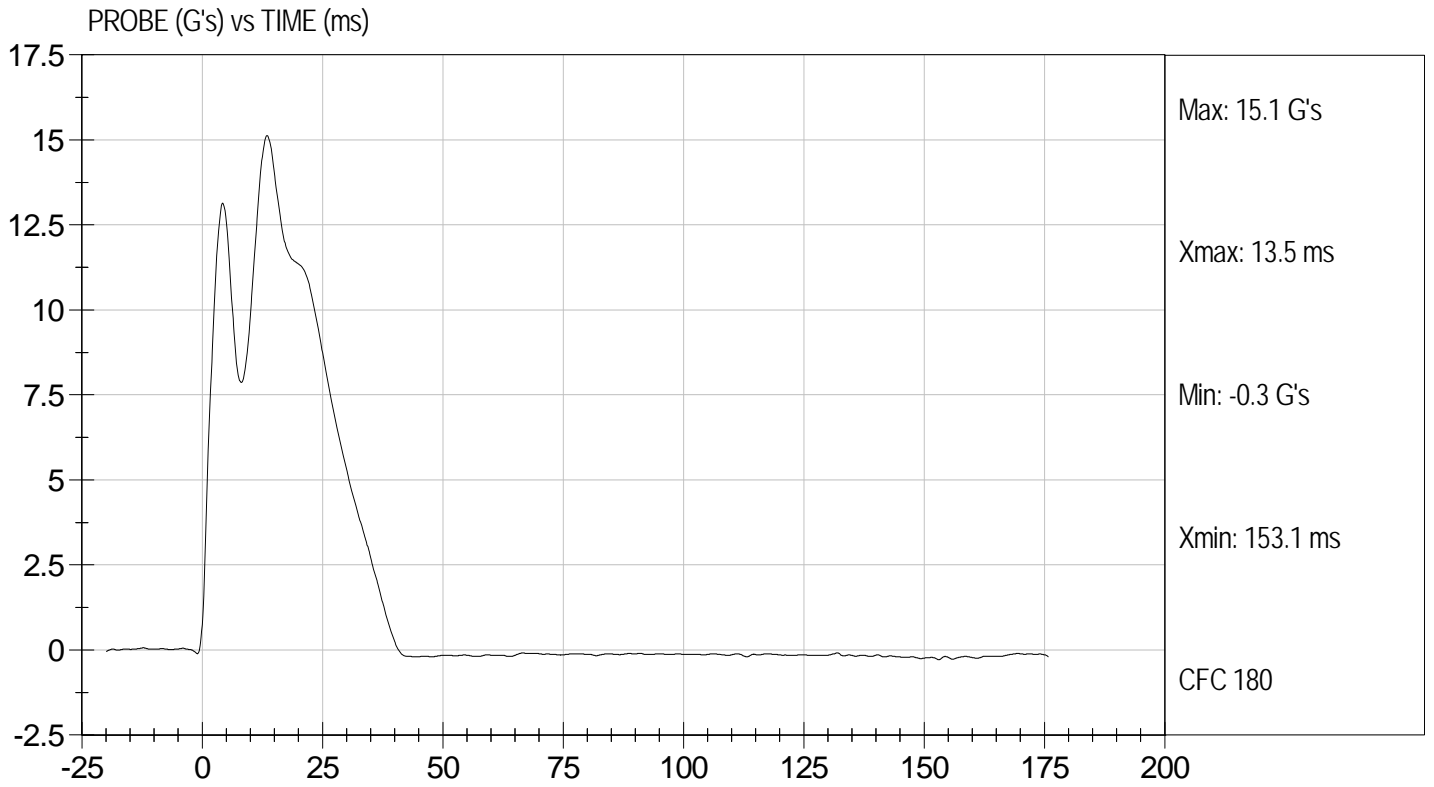
Test Desc: Shoulder Impact
Component ID: D12863

Test Date: 3/6/12
Velocity: 14.37 ft/s, 4.38 m/s

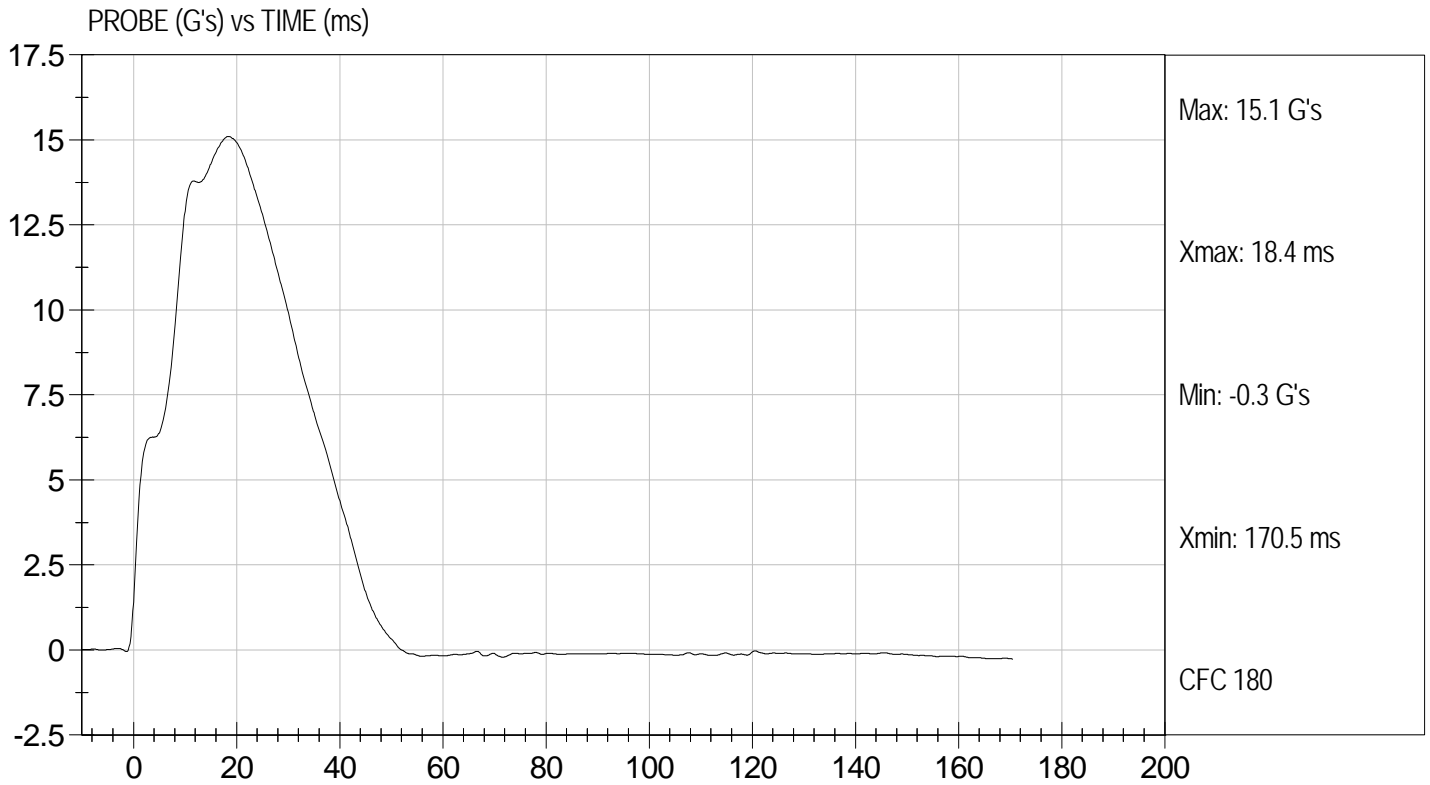
Test Desc: Thorax Without Arm
Component ID: D12865

Test Date: 3/6/12
Velocity: 14.25 ft/s, 4.34 m/s

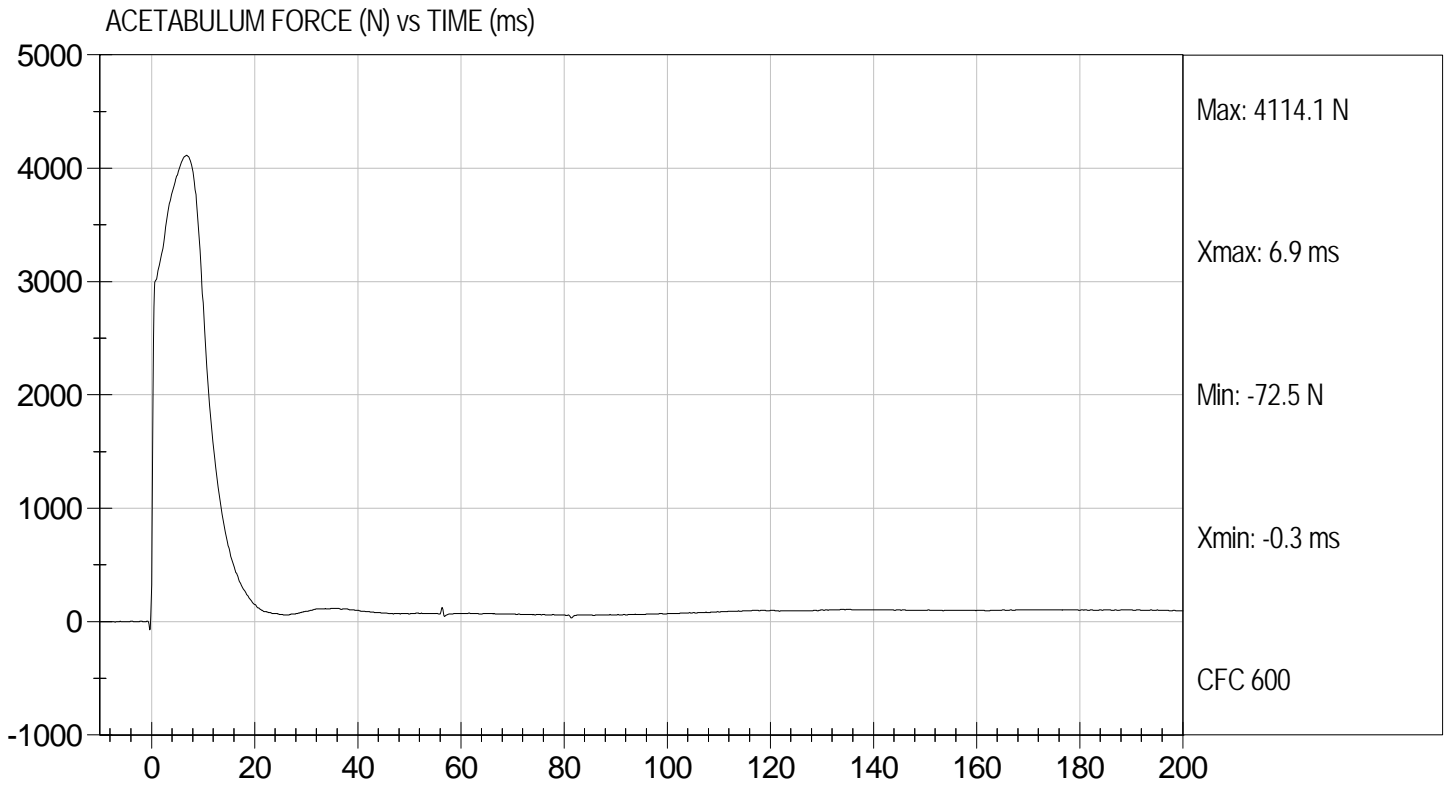
Test Desc: Pelvis Impact
Component ID: D12867

Test Date: 3/6/12
Velocity: 22.10 ft/s, 6.74 m/s

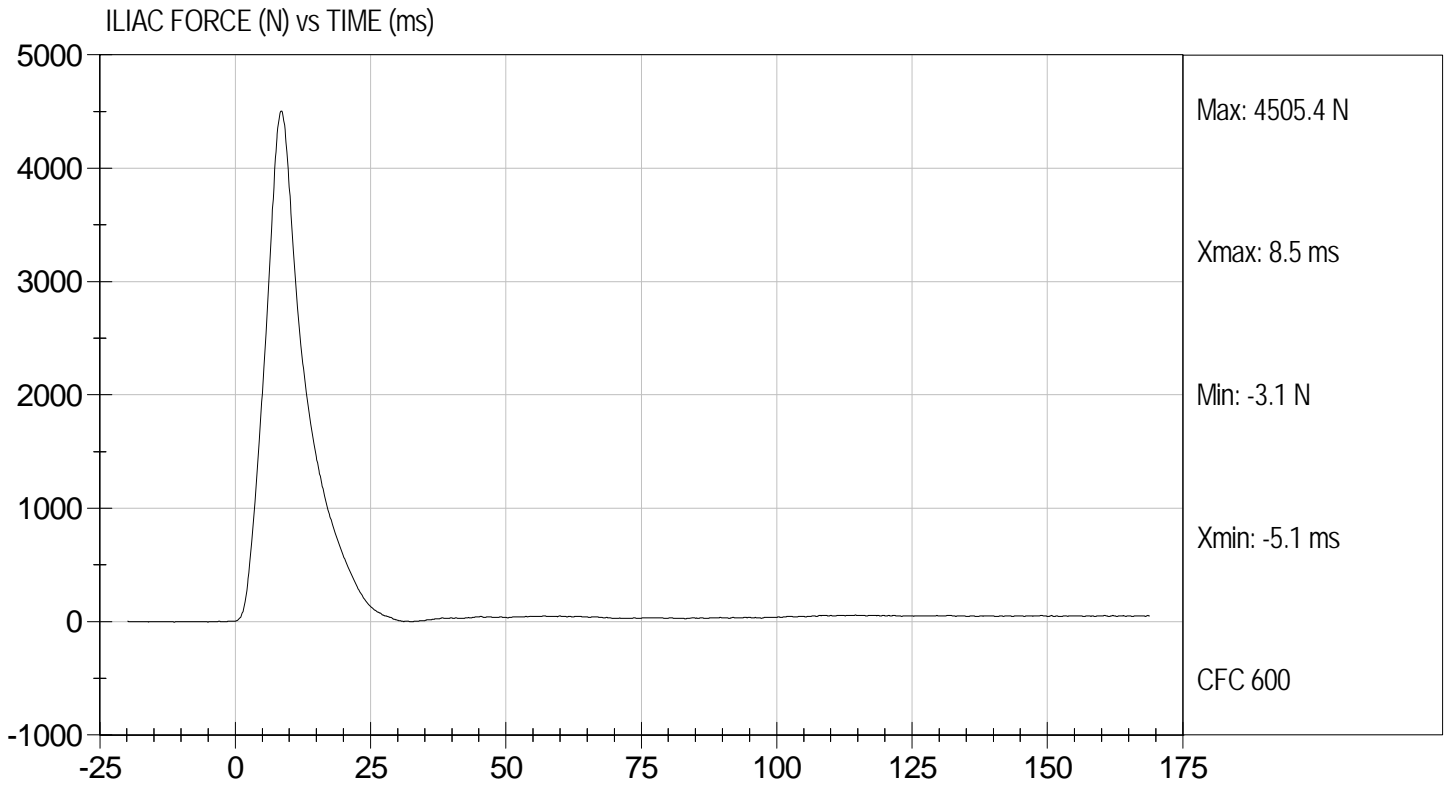
Test Desc: Iliac Impact
Component ID: D12868

Test Date: 3/6/12
Velocity: 14.25 ft/s, 4.34 m/s

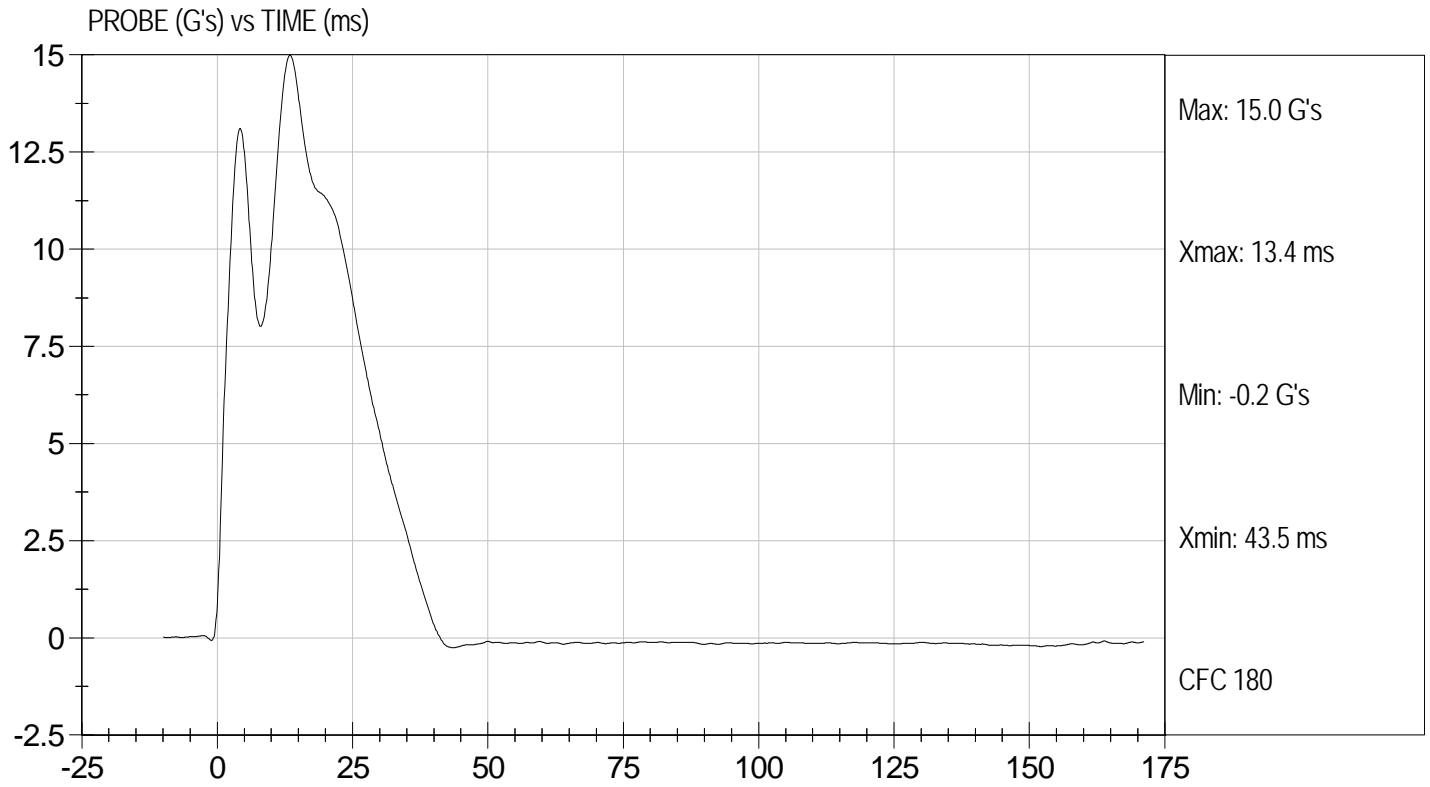
Test Desc: Shoulder Impact
Component ID: D12993

Test Date: 3/13/12
Velocity: 14.24 ft/s, 4.34 m/s

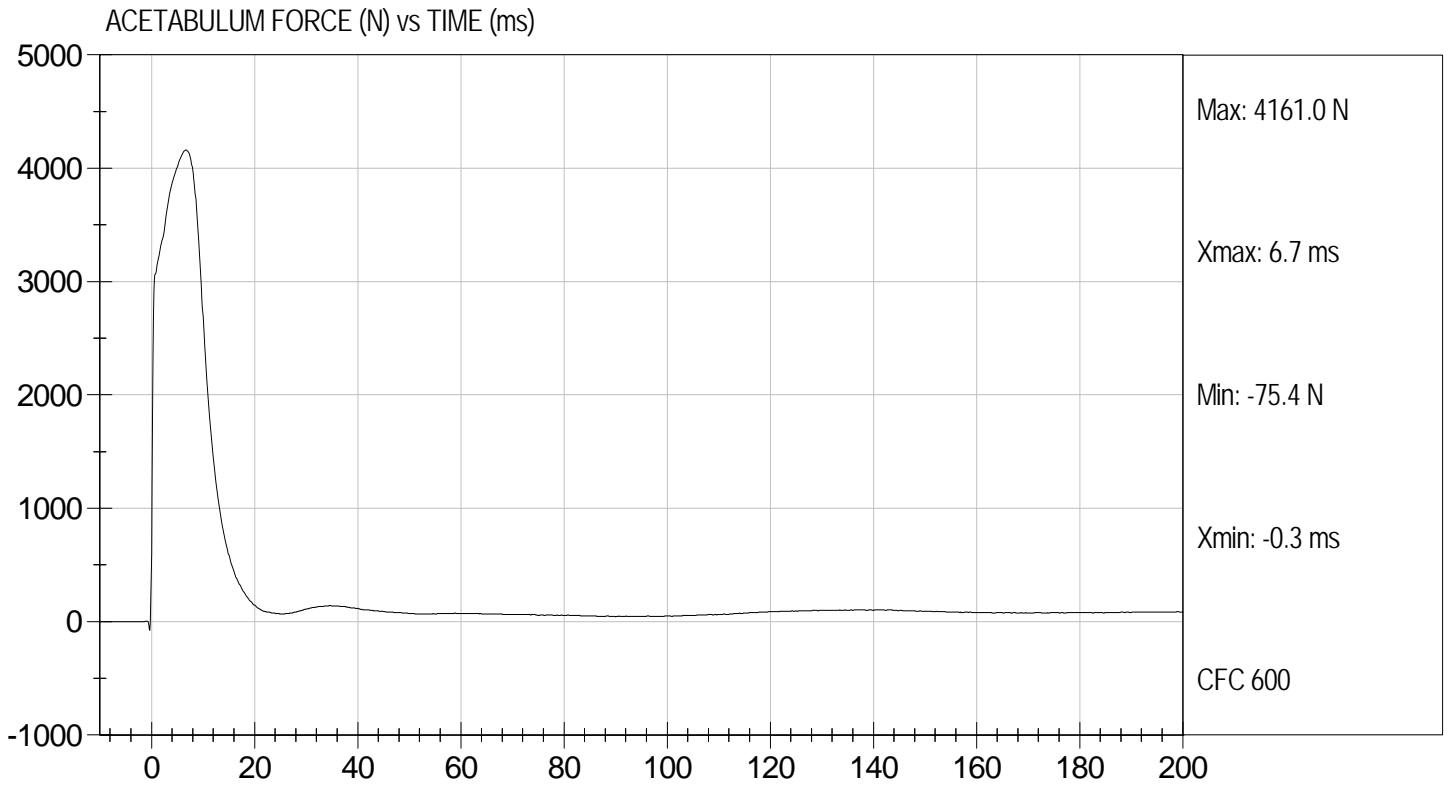
Test Desc: Pelvis Impact
Component ID: D12997

Test Date: 3/13/12
Velocity: 21.9 ft/s, 6.68 m/s

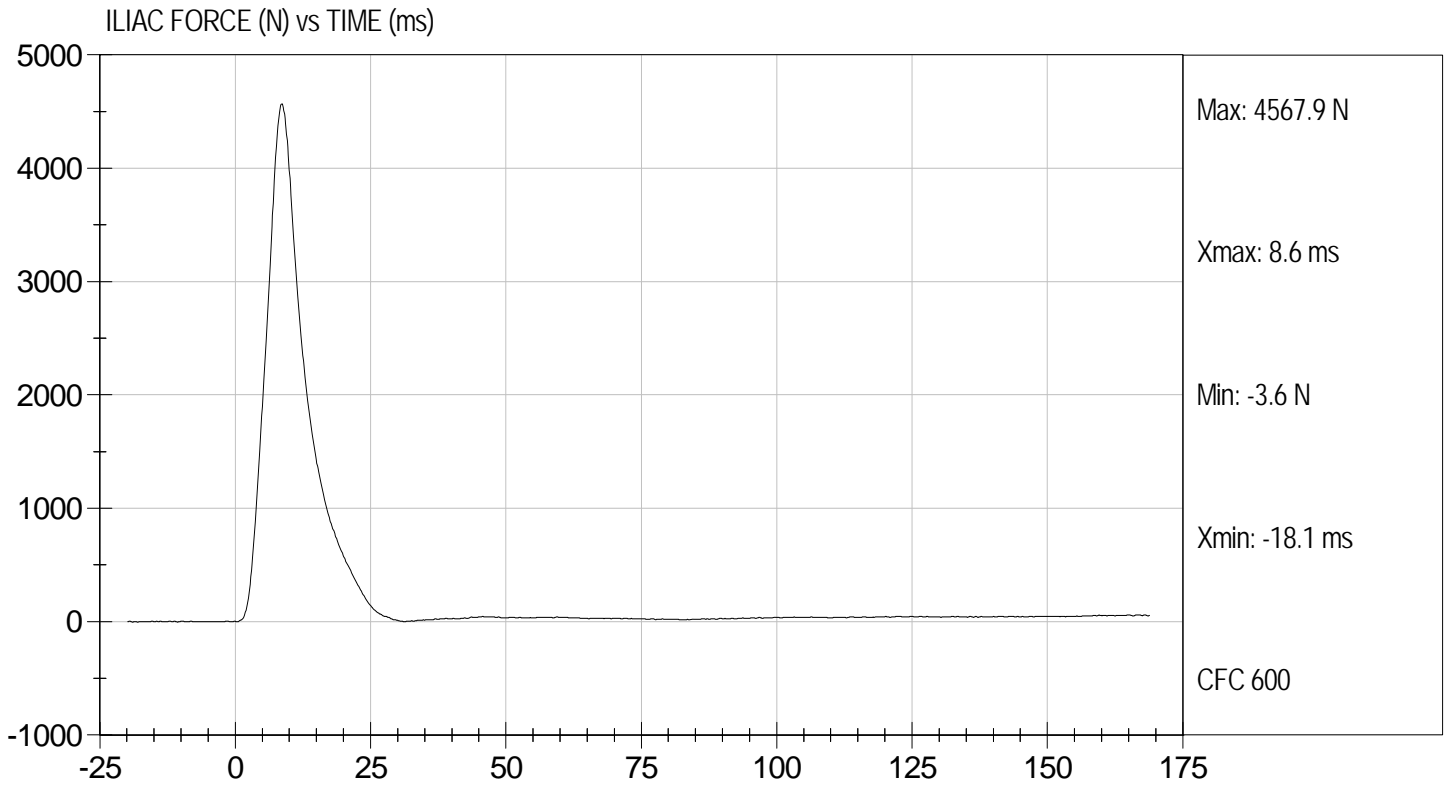
Test Desc: Iliac Impact
Component ID: D12998

Test Date: 3/13/12
Velocity: 14.36 ft/s, 4.38 m/s
