**REPORT NUMBER: SPNCAP-MGA-2012-076**

**NEW CAR ASSESSMENT PROGRAM (NCAP)  
Side Impact Pole Test**

**KIA MOTORS CORPORATION  
2012 KIA Rio LX 4-Dr Sedan  
NHTSA No.: MC0523**

**FINAL REPORT**

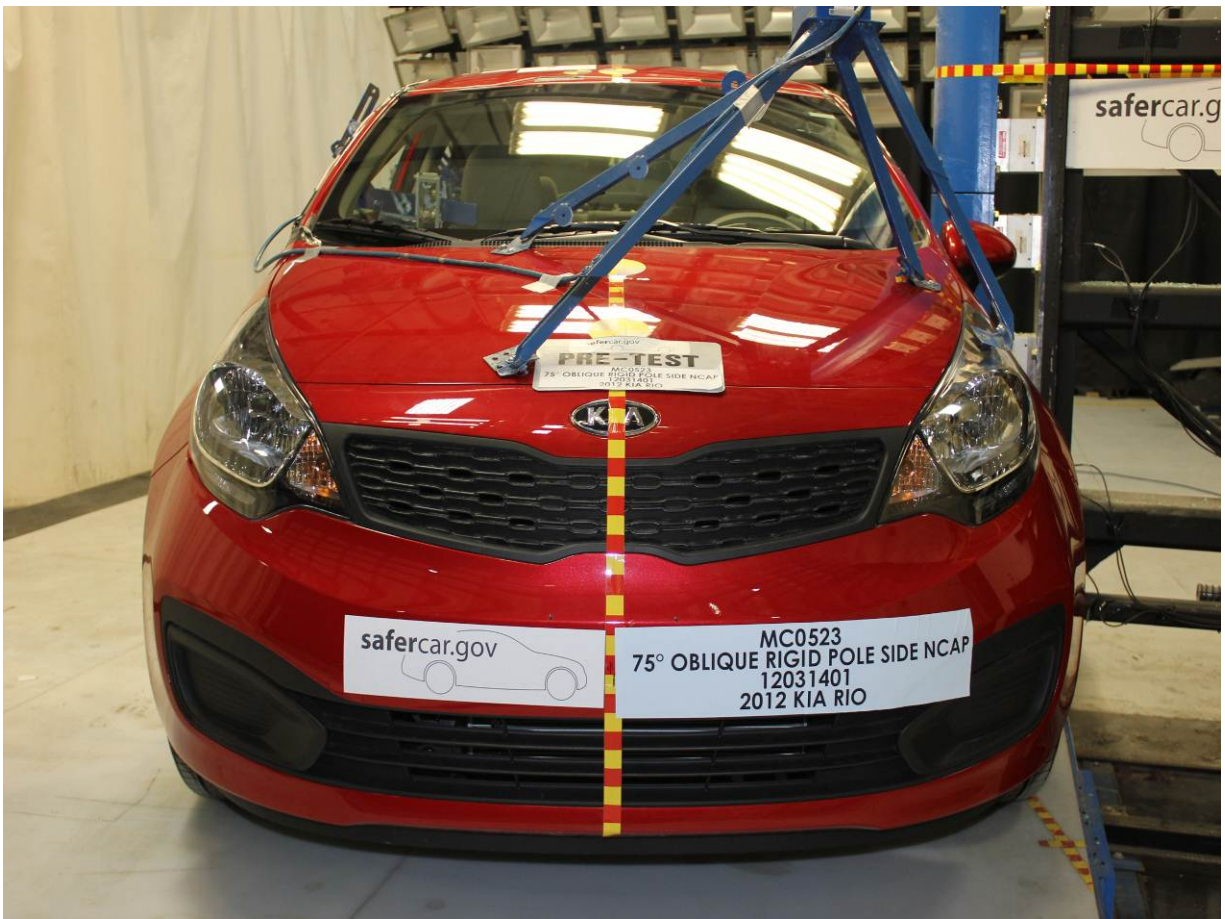
Pre-Test Frontal View of Test Vehicle

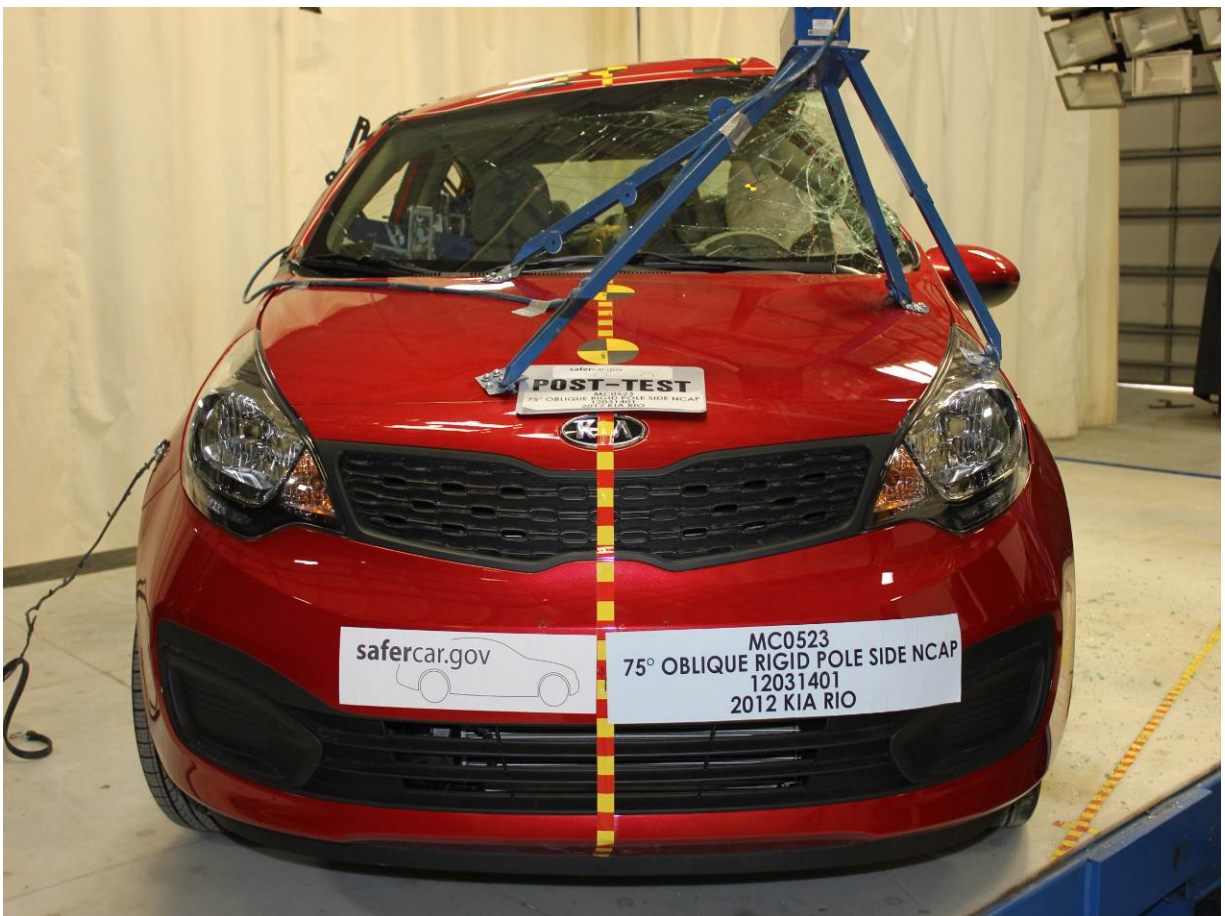
Post-Test Frontal View of Test Vehicle

The windshield retention was 100% on the right side and 64.5% on the left side for a total retention of 82%.

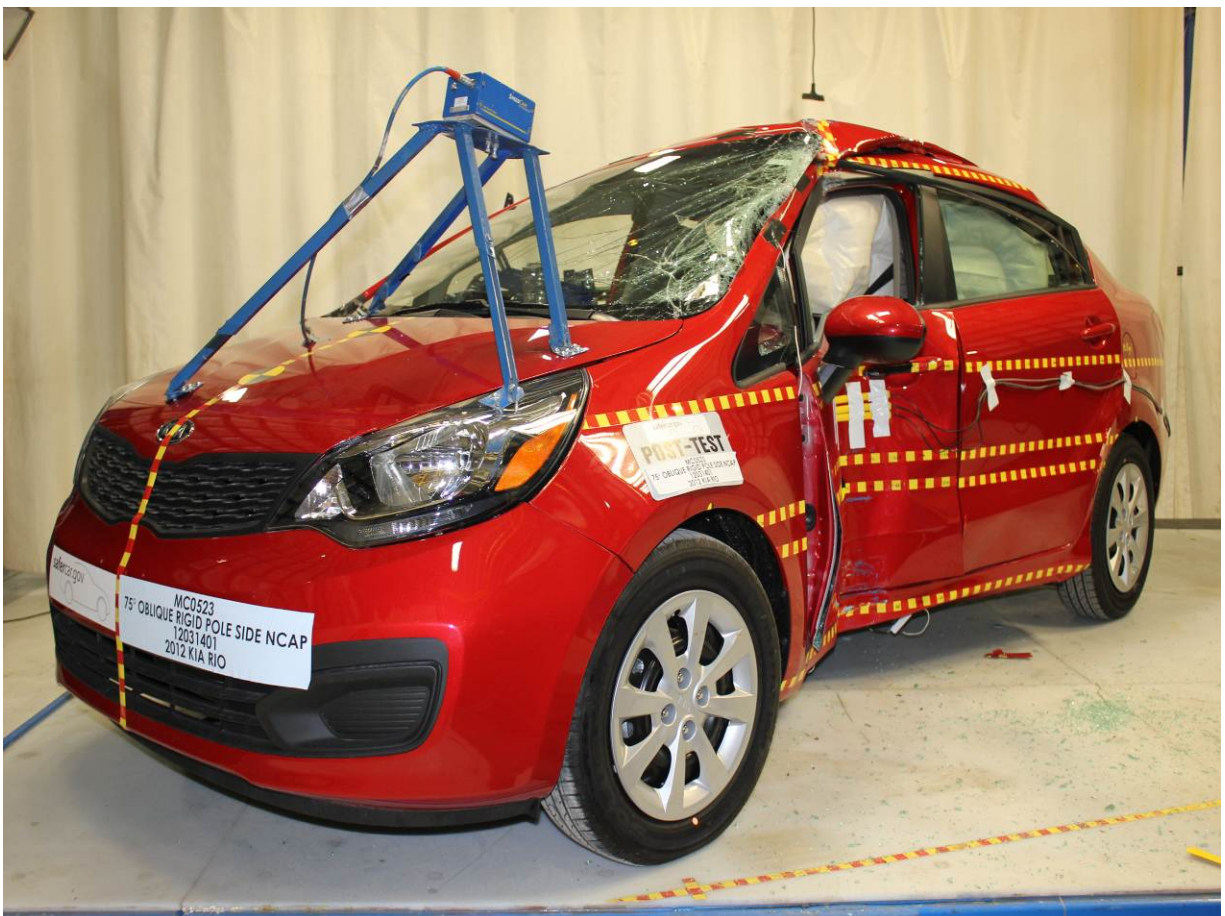
Post-Test Left Front  $\frac{3}{4}$  View of Test Vehicle

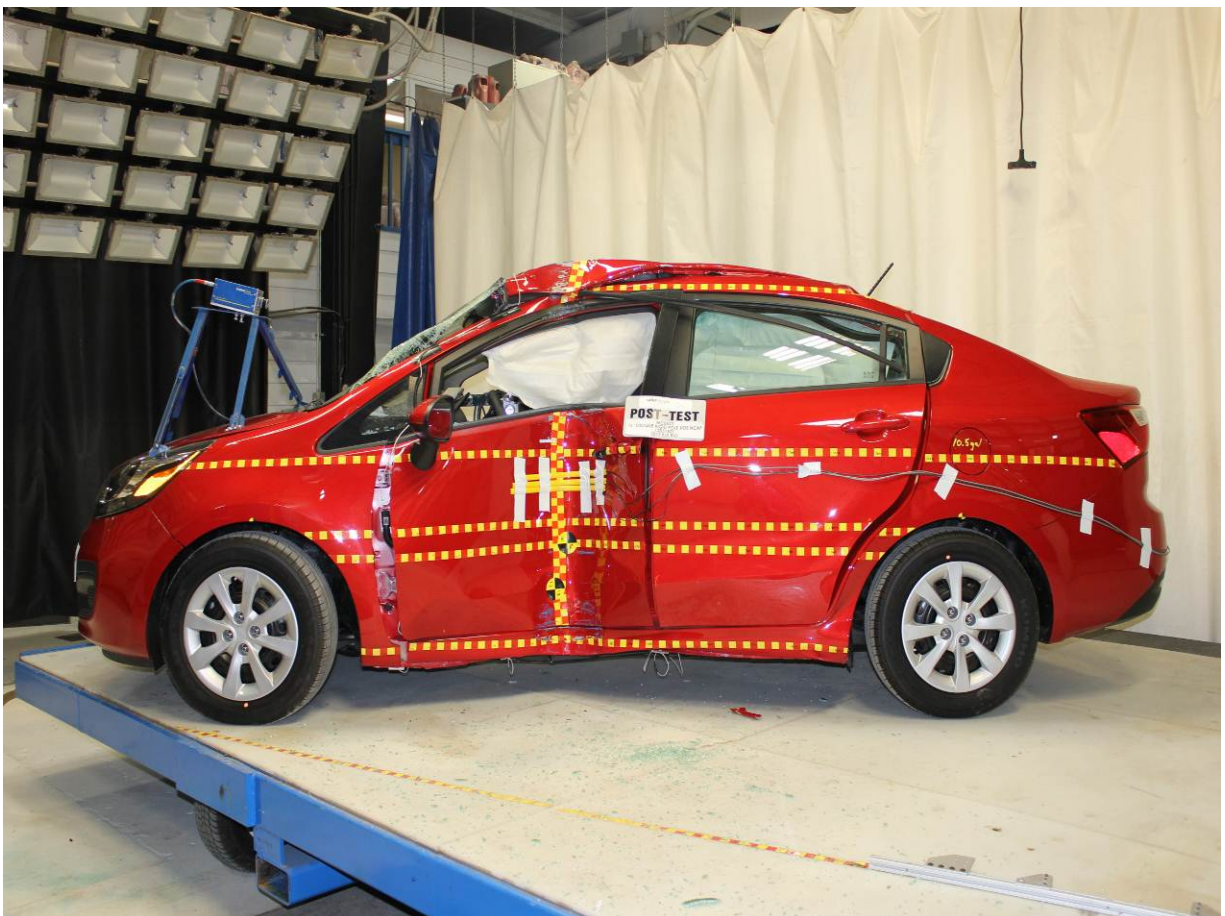
Post-Test Left Side View of Test Vehicle

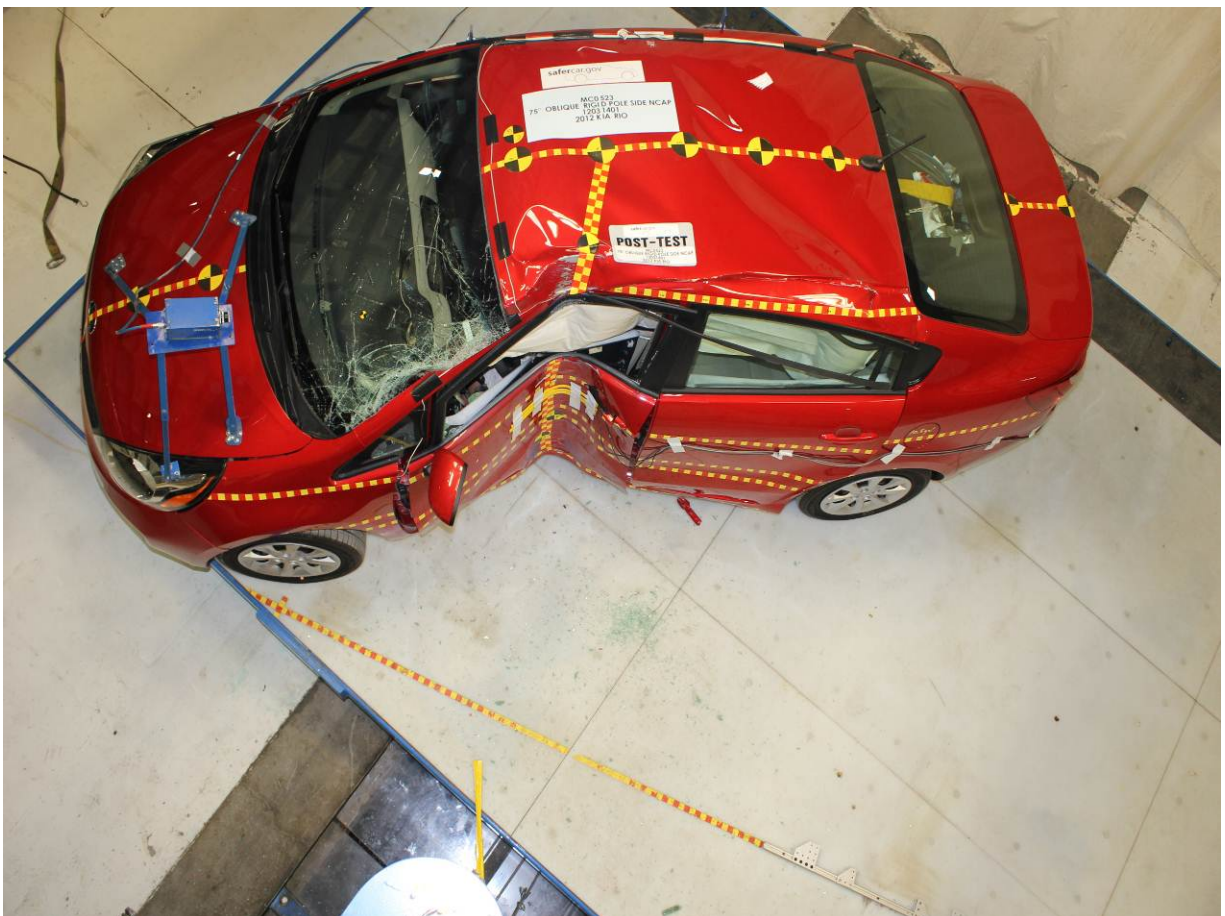
Post-Test Overhead View of Test Area

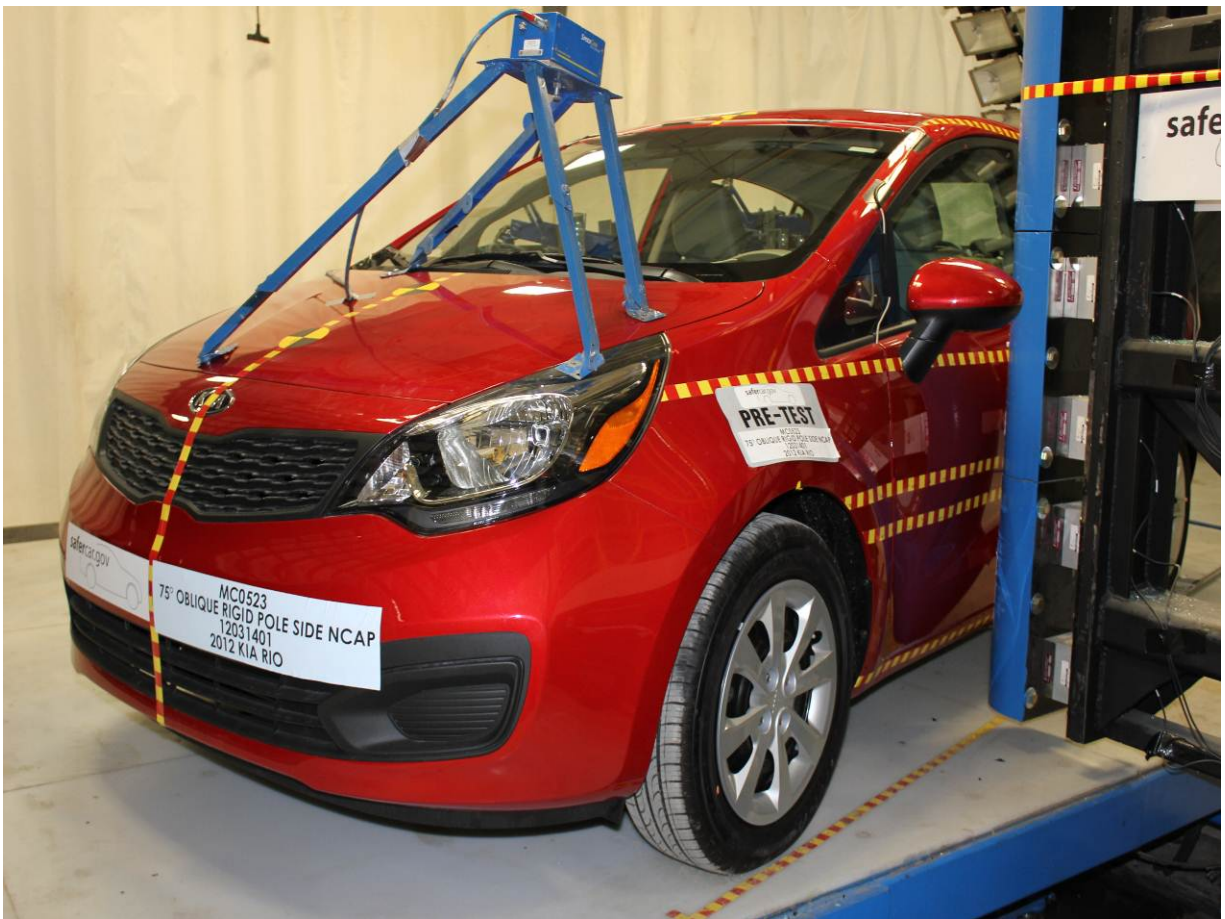
Pre-Test Left Side View of Pole Positioned Against Side of Vehicle

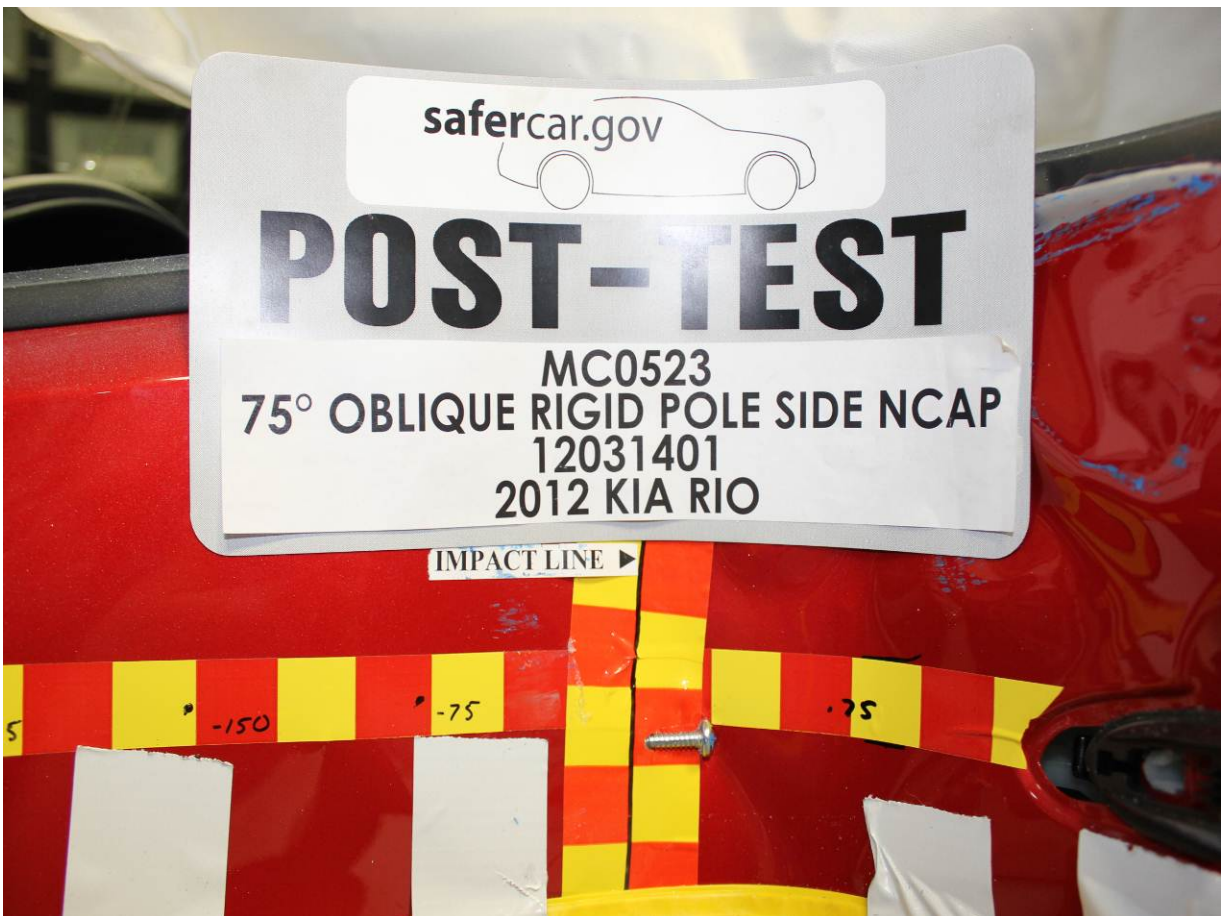
Post-Test Close-Up View of Impact Point Target Showing Impact Location

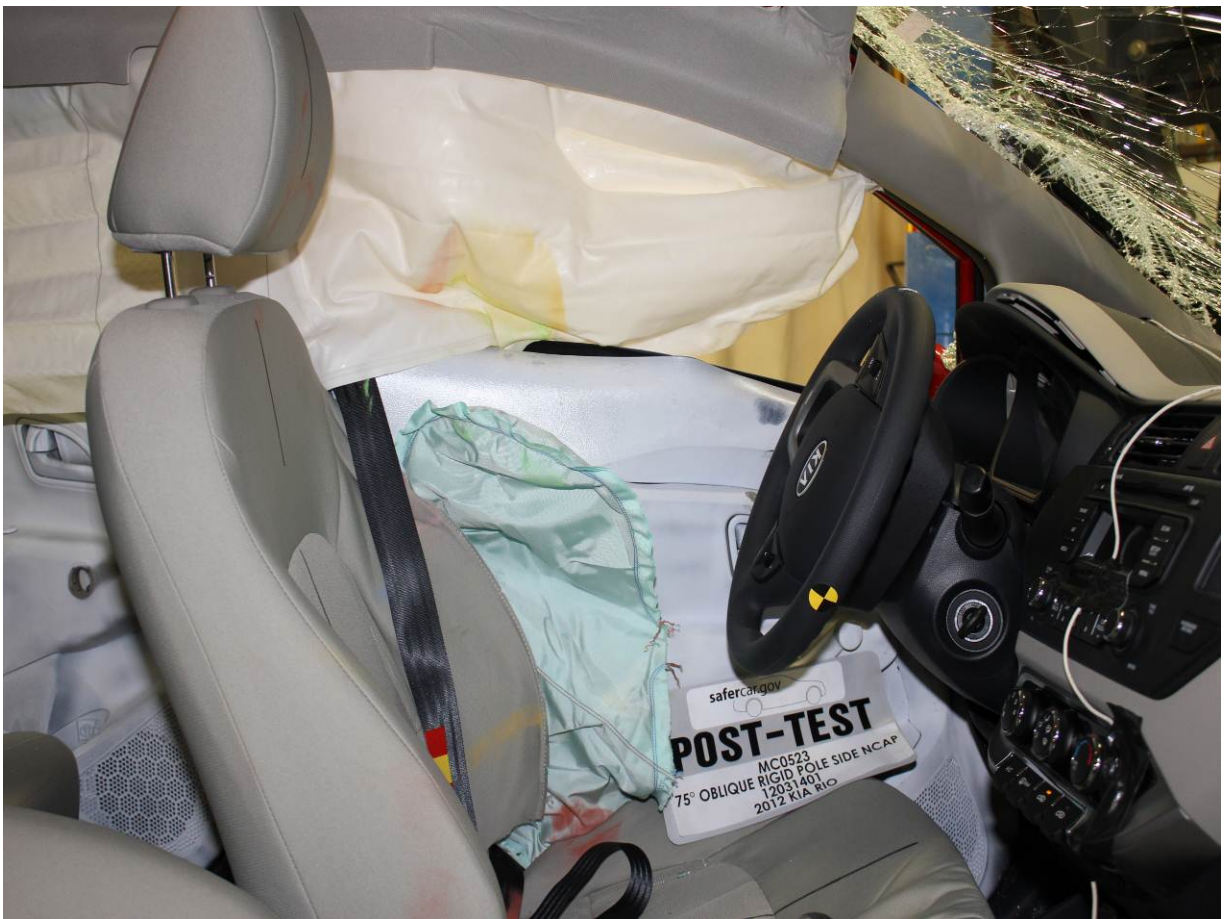
Post-Test Inner Door Panel View Showing Dummy Contact Location

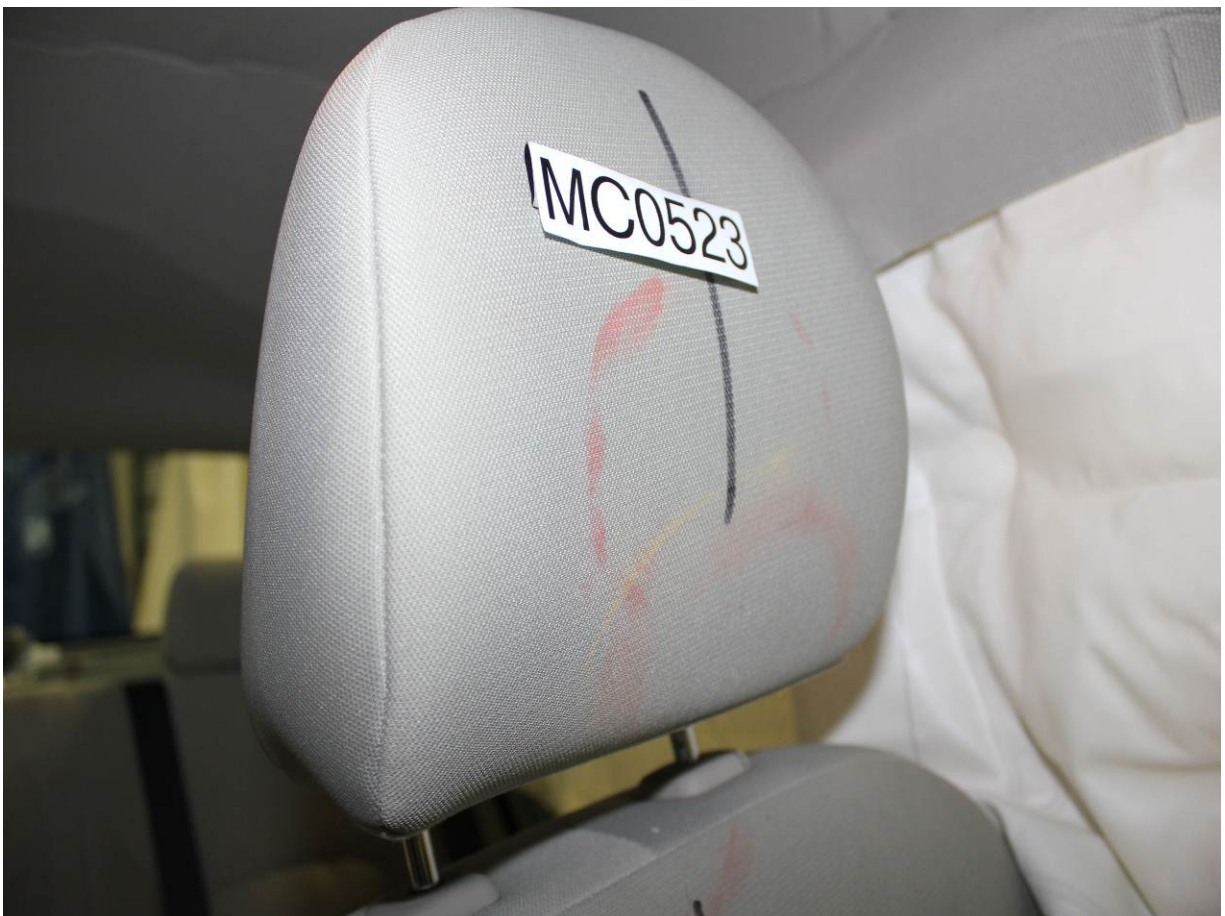
Post-Test Dummy Close-Up Head Contact with Vehicle Interior View

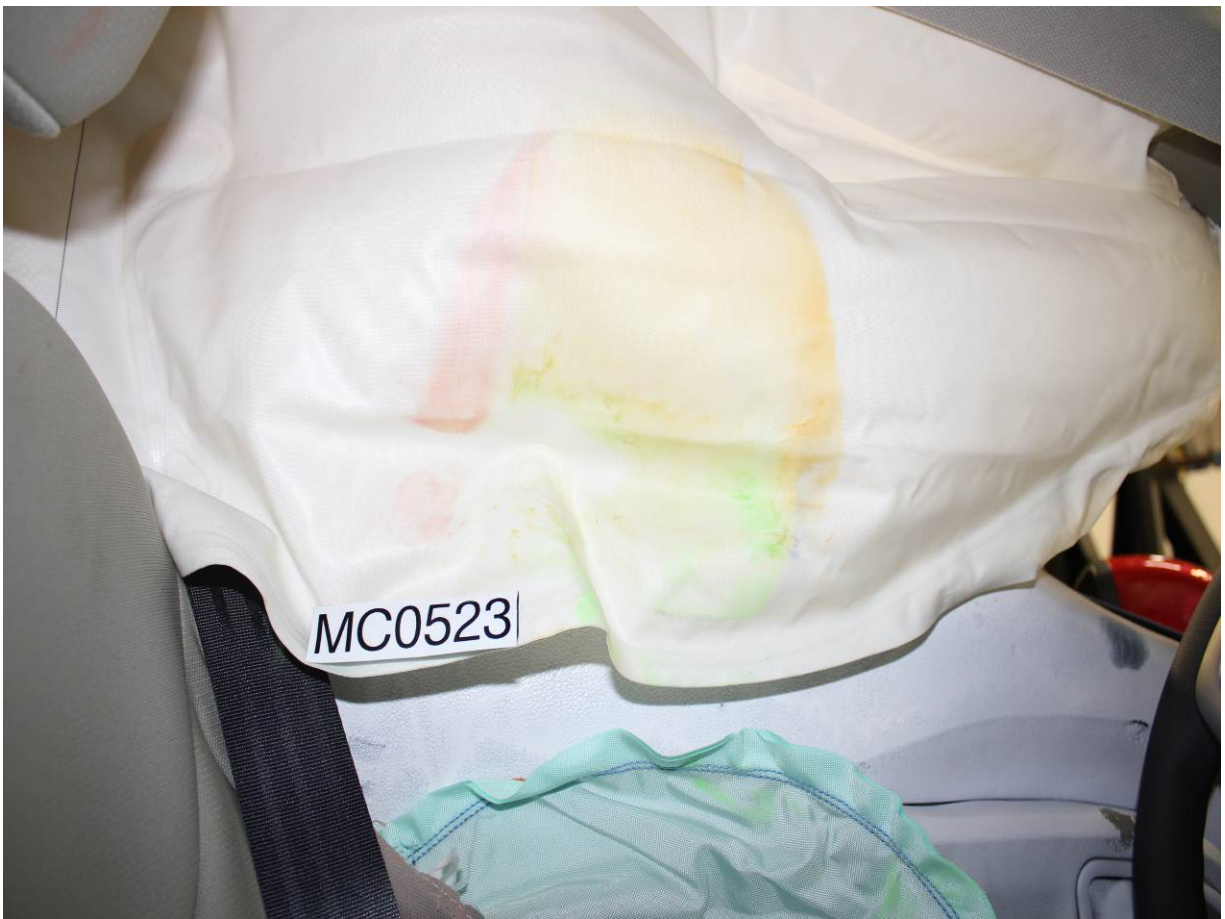
Post-Test Dummy Close-Up Head Contact with Side Air Bag View

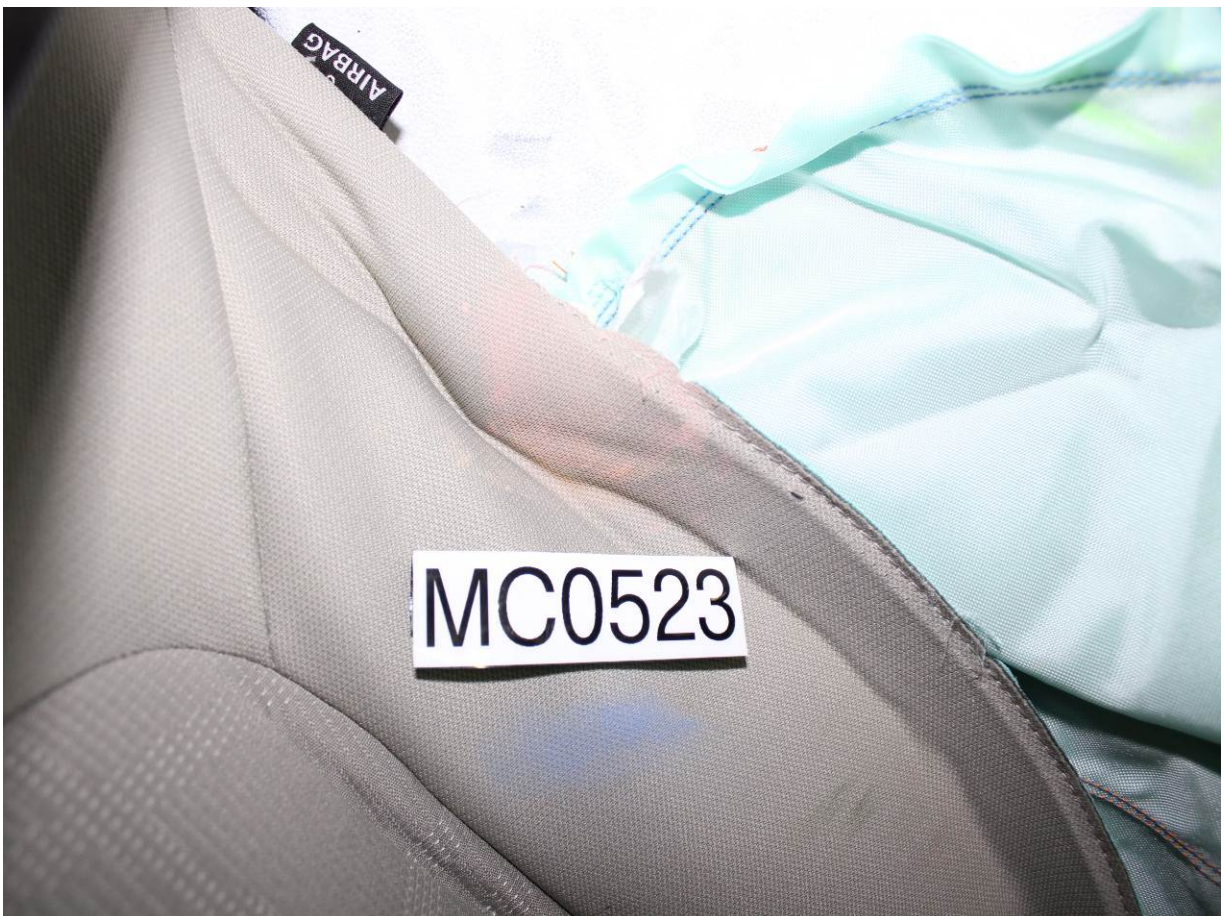
Post-Test Dummy Close-Up Torso Contact with Vehicle Interior View

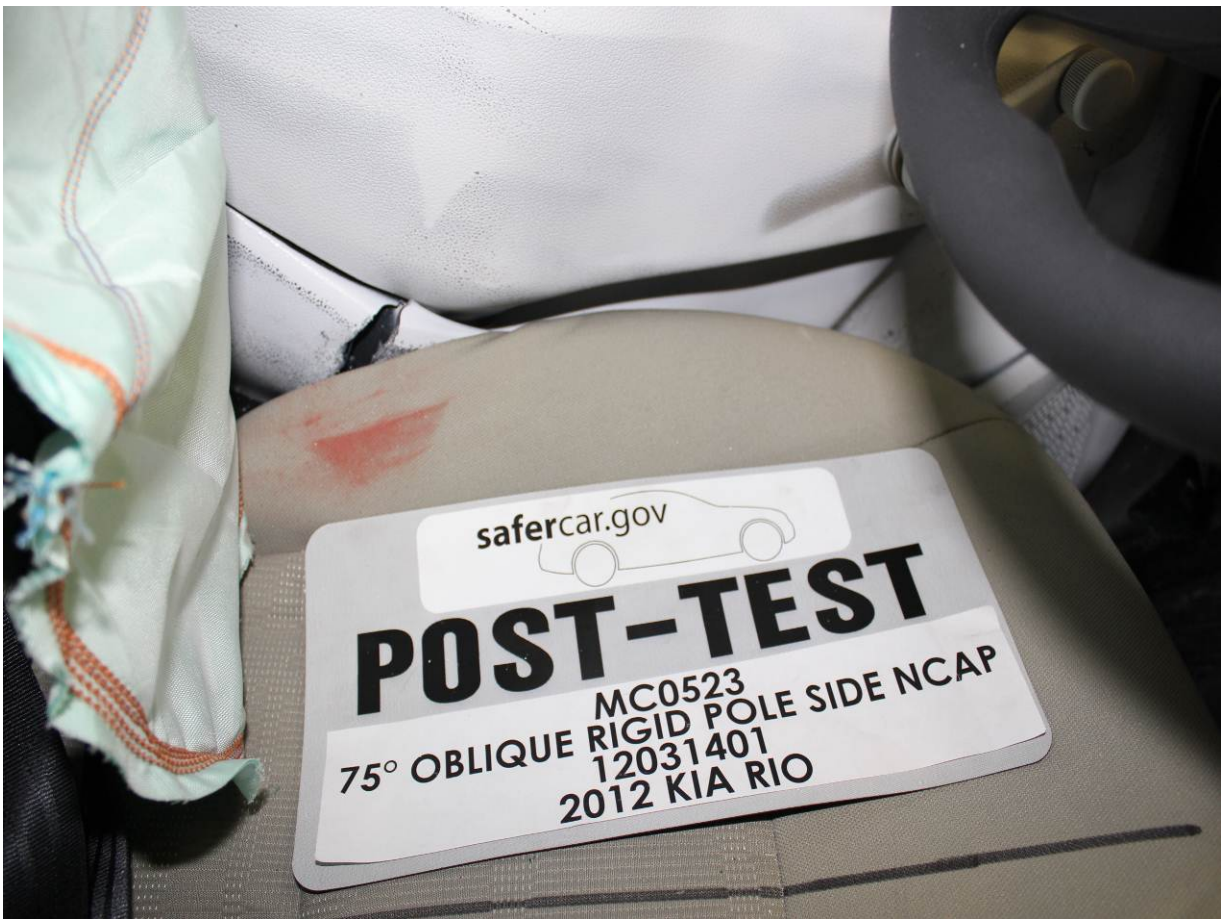
Post-Test Dummy Close-Up Pelvis Contact with Vehicle Interior View

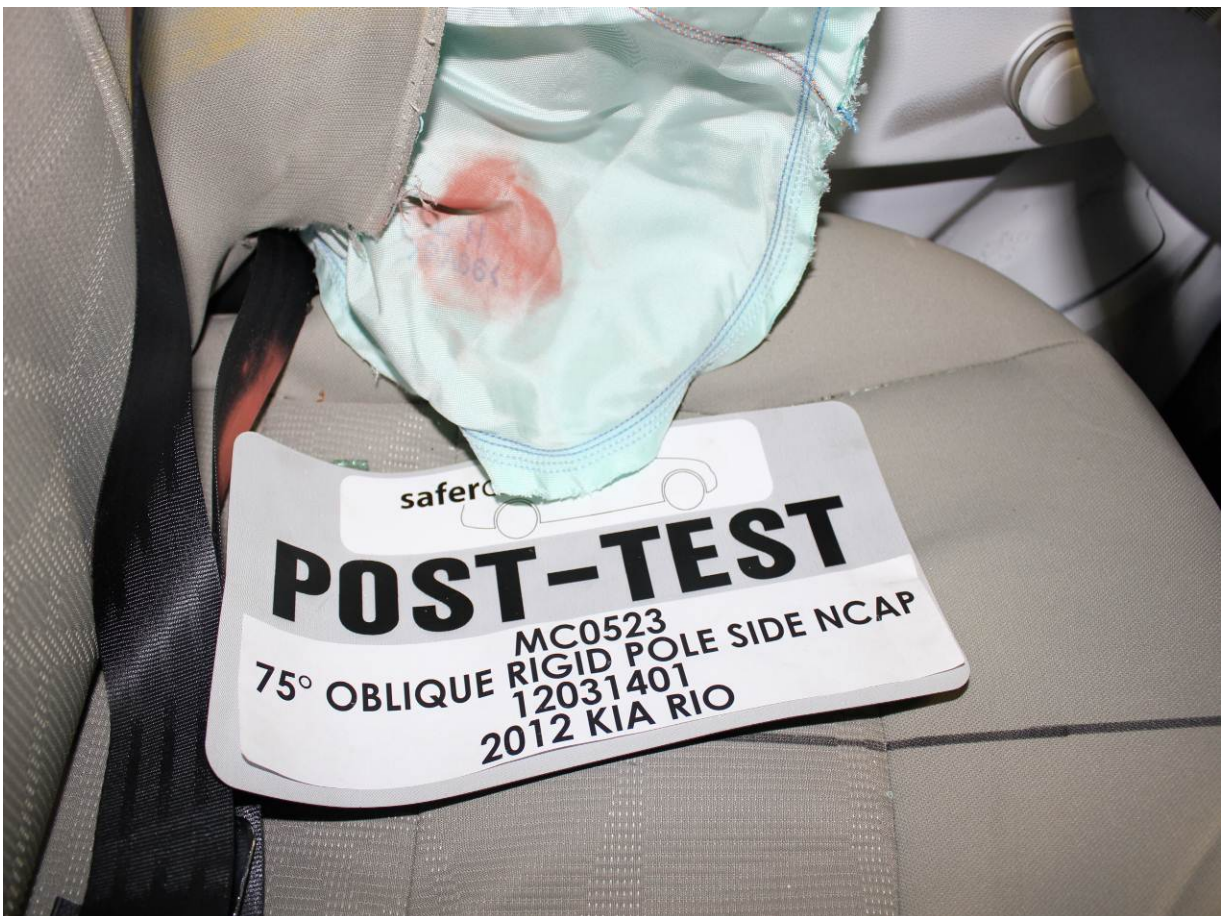
Post-Test Dummy Close-Up Pelvis Contact with Side Air Bag View

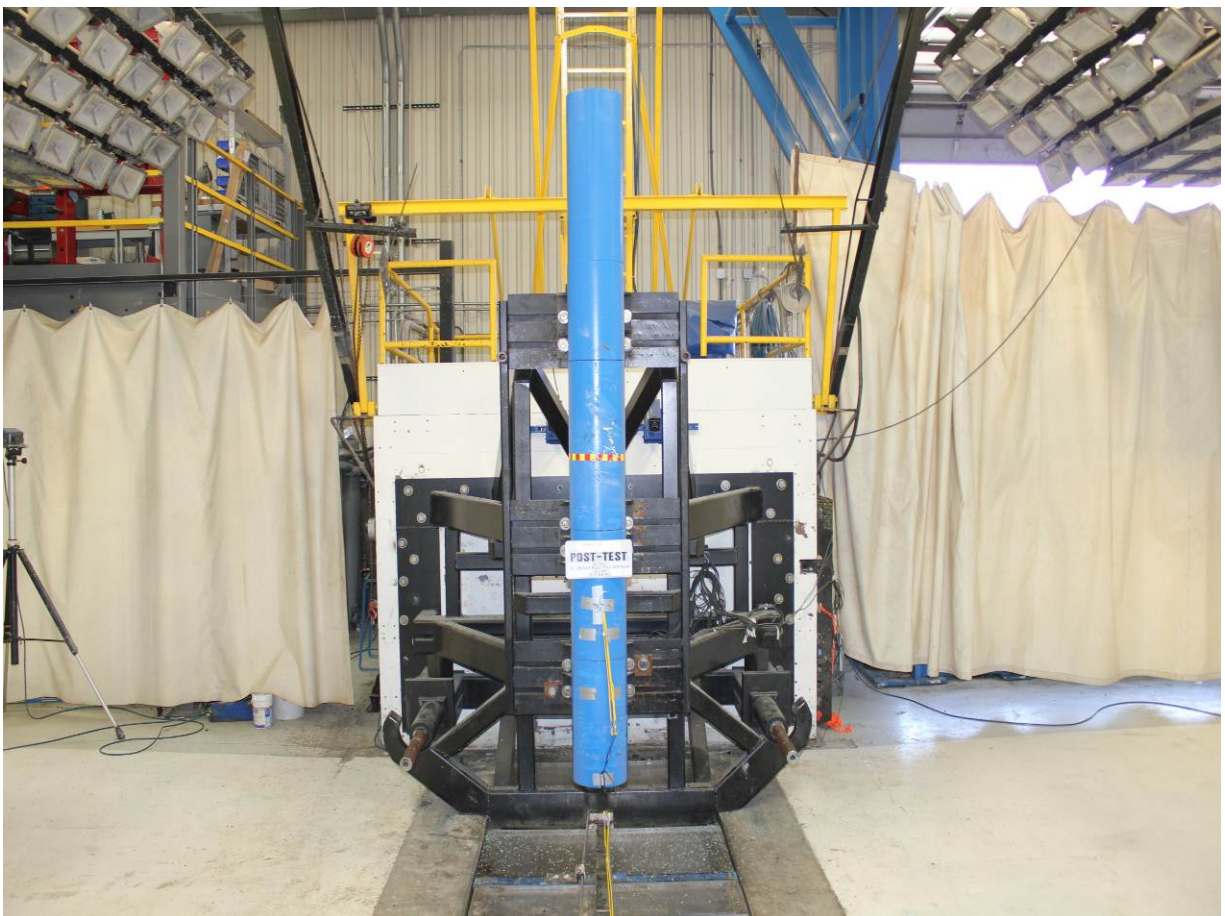
Post-Test Pole Barrier Front View
