**REPORT NUMBER: TWG-MGA-2012-013**

**SIDE AIRBAG OUT-OF-POSITION INJURY  
TECHNICAL WORKING GROUP**

**MITSUBISHI MOTORS CORPORATION, JAPAN  
2012 MITSUBISHI OUTLANDER SPORT SE AWD SUV  
NHTSA No.: MC5600TWG2**

**FINAL REPORT**

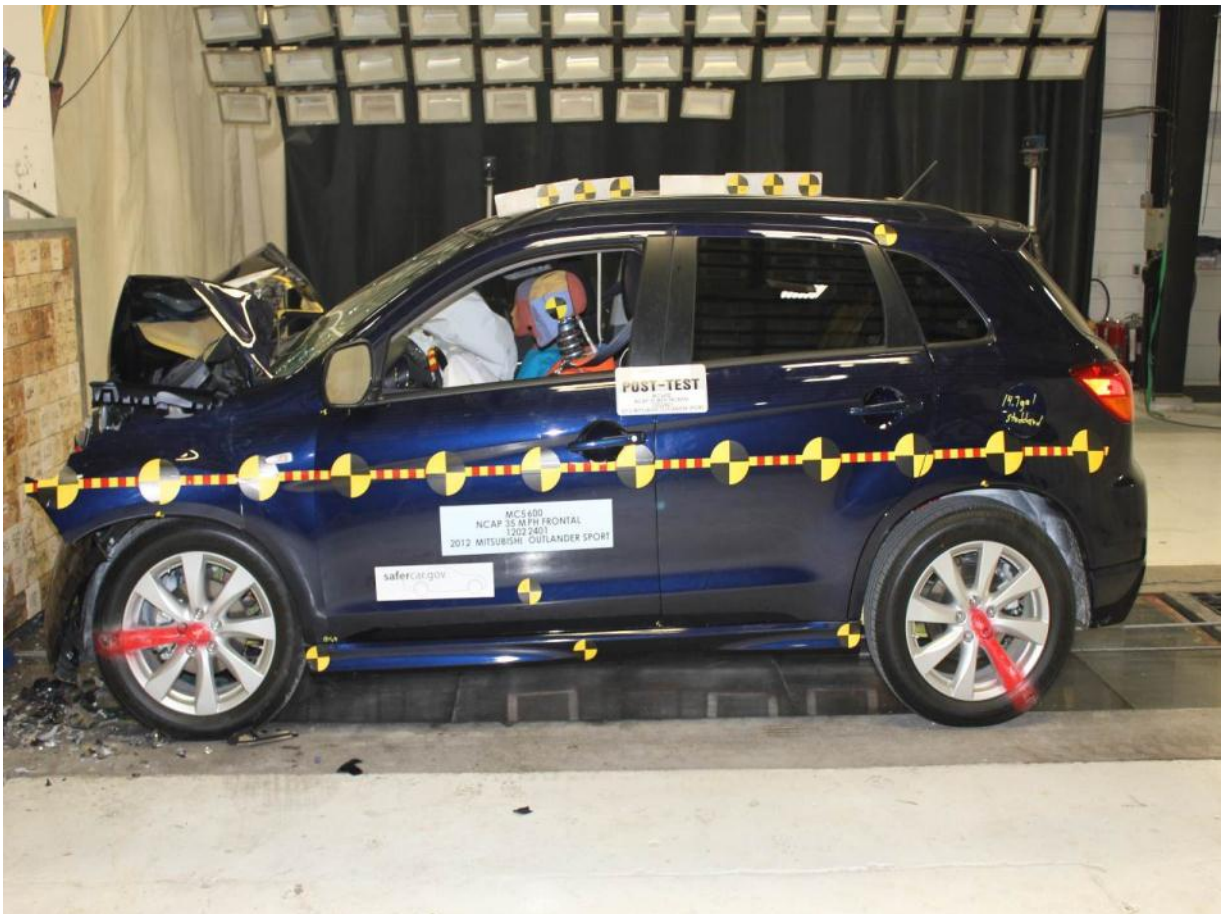
Post-Test Vehicle Left Side View

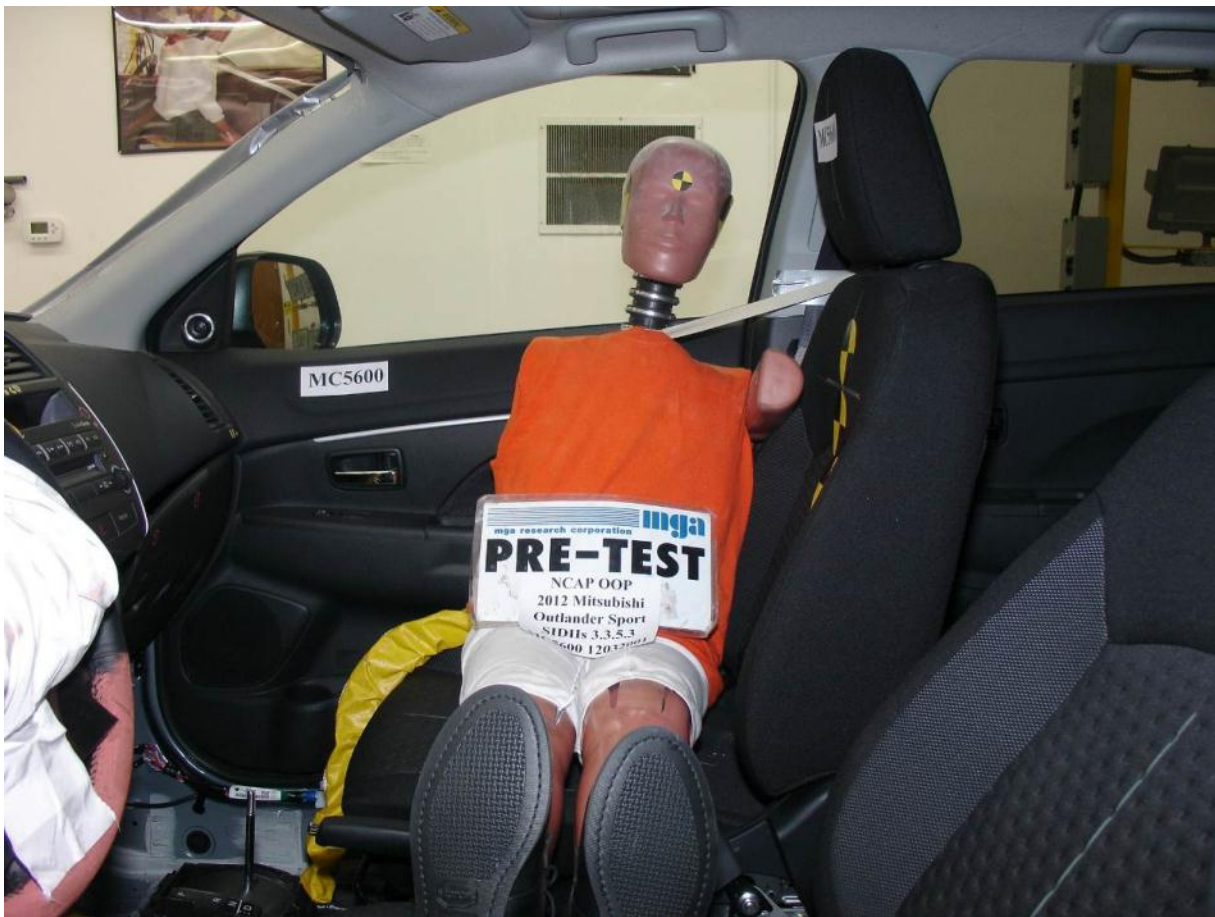
Pre-Test SID-IIs Dummy Left Side View

The SID-IIs dummy was placed in the right front passenger seat facing toward the center of the vehicle with its arm against the seatback. The arm was rotated horizontally in the forward direction with respect to the dummy. The seat track was adjusted to the full rearward position. The dummy's pelvis was slid outboard until the dummy's back contacted the door trim panel or armrest and the CG of the head was centered in the deployment trajectory of the airbag. The vertical plane through the centerline of the dummy's rib-stiffener and shoulder bolt was parallel to the centerline of the vehicle. Masking tape was wrapped around the dummy's neck bracket to hold the dummy in place.

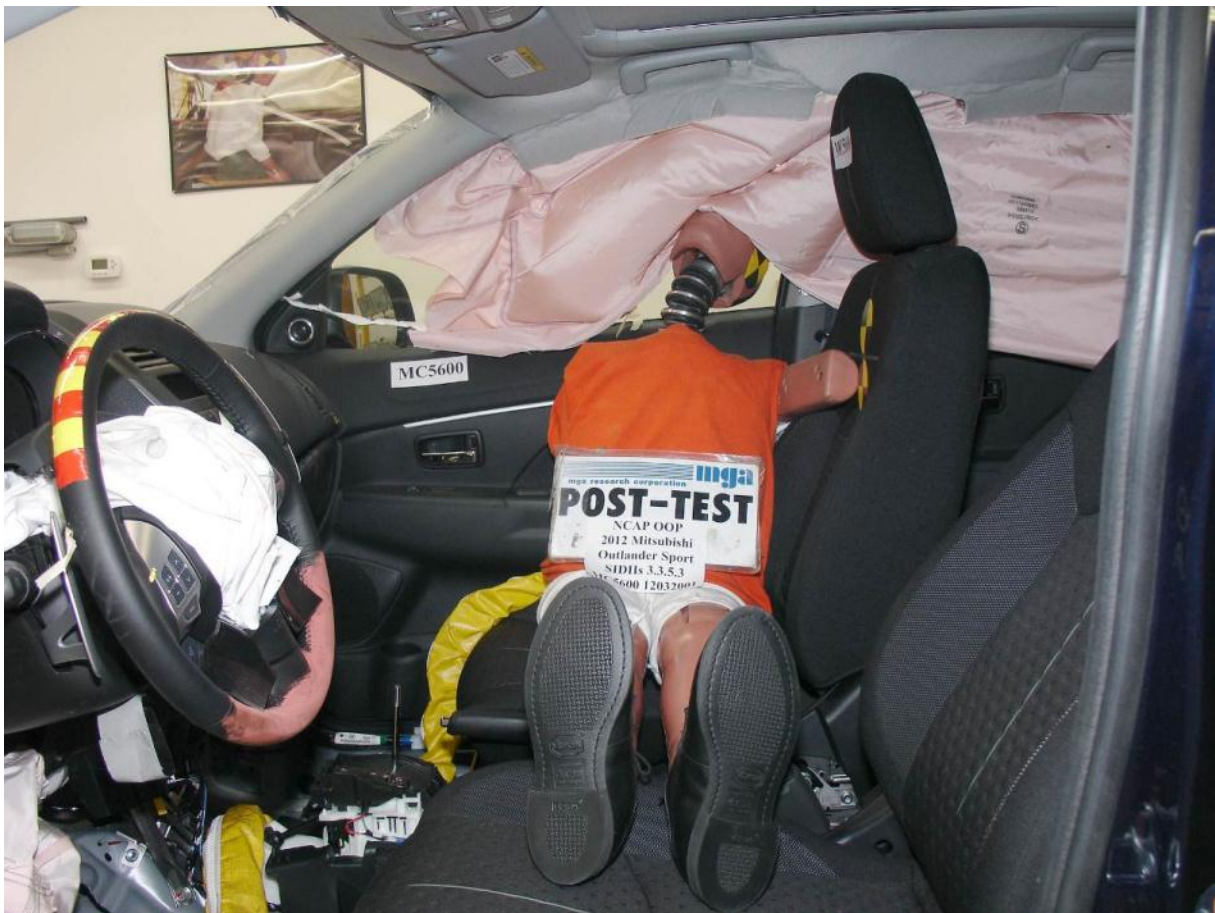
Post-Test SID-IIs Dummy Left Side View

- Curtain airbag to top of head
- Torso bag to left torso, and left pelvis

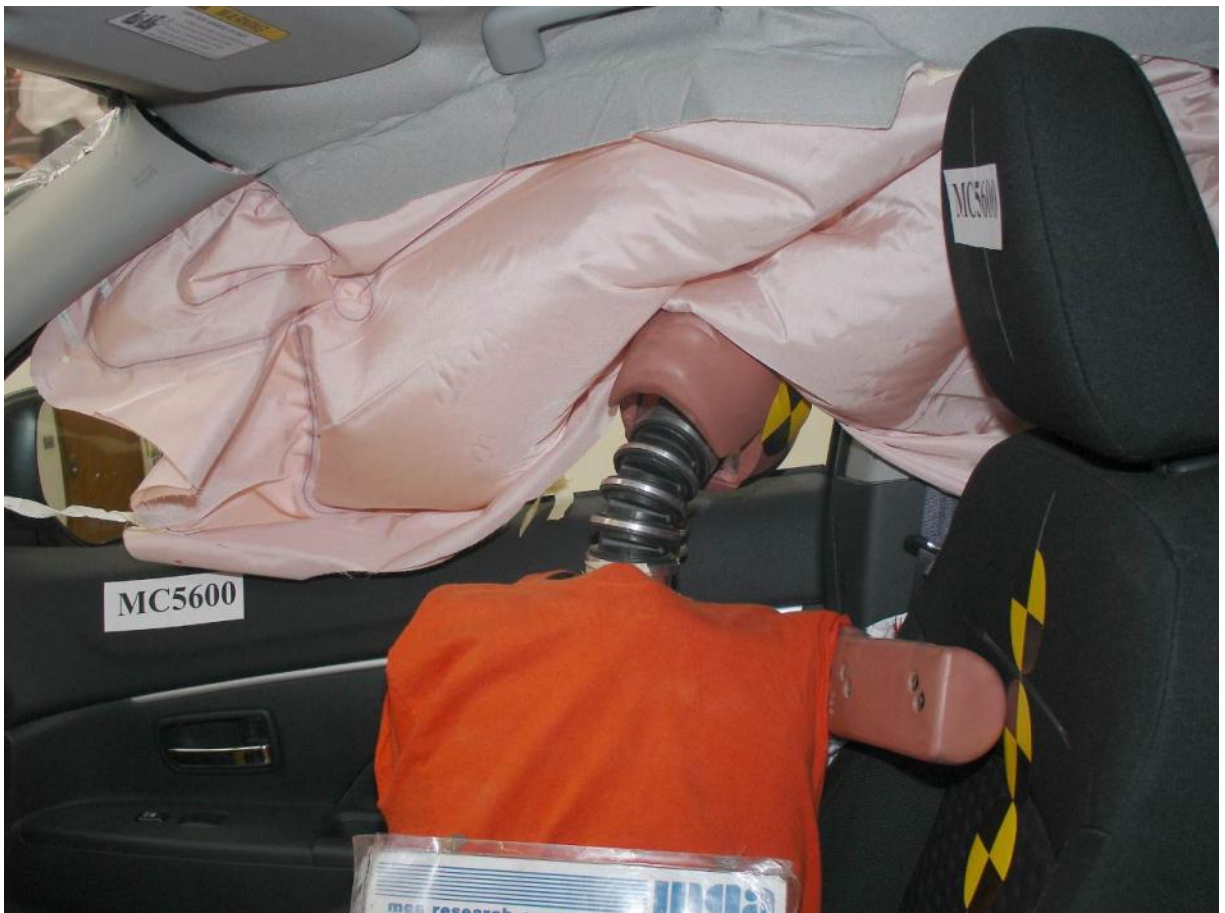
Post-Test SID-IIs Dummy Left Side Closeup View

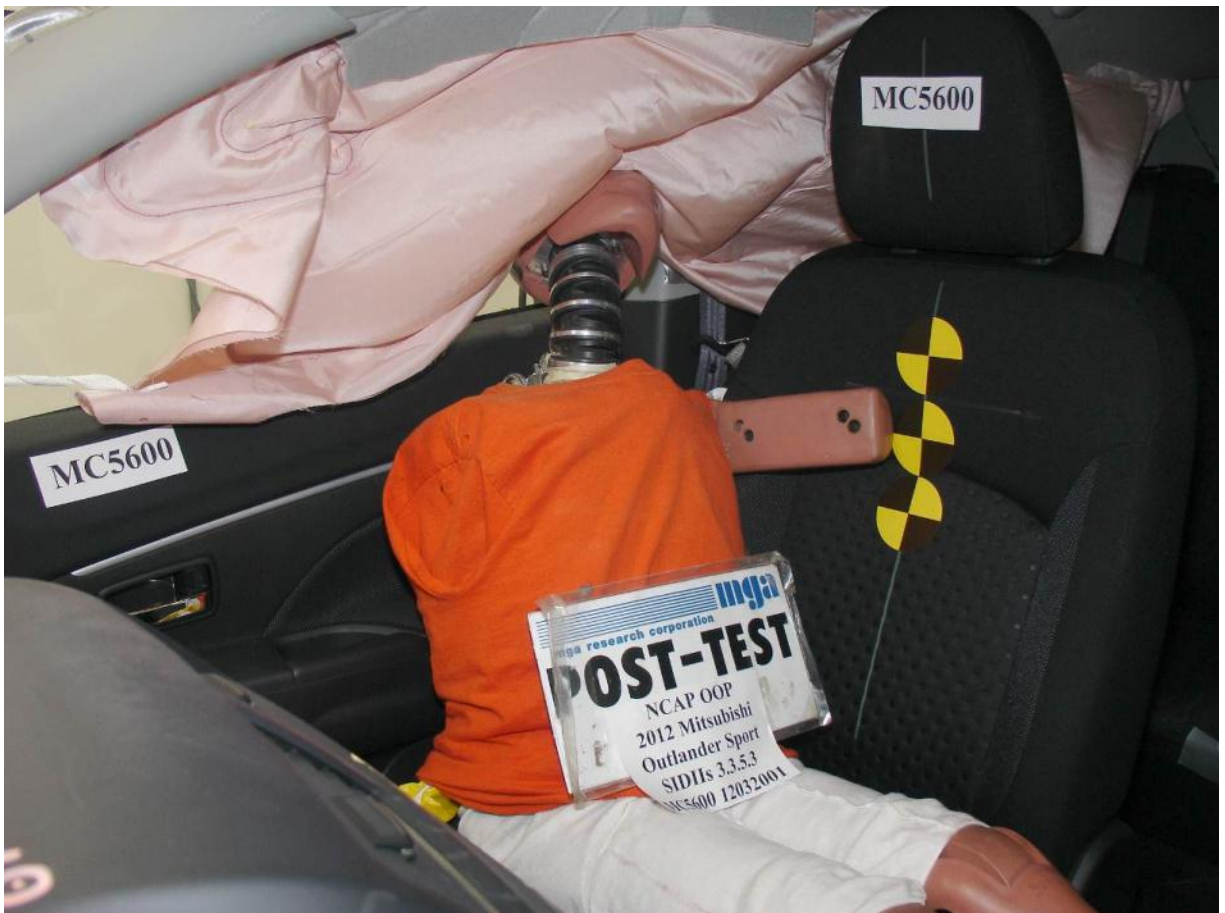
Post-Test SID-11s Dummy Left 3/4 Front View

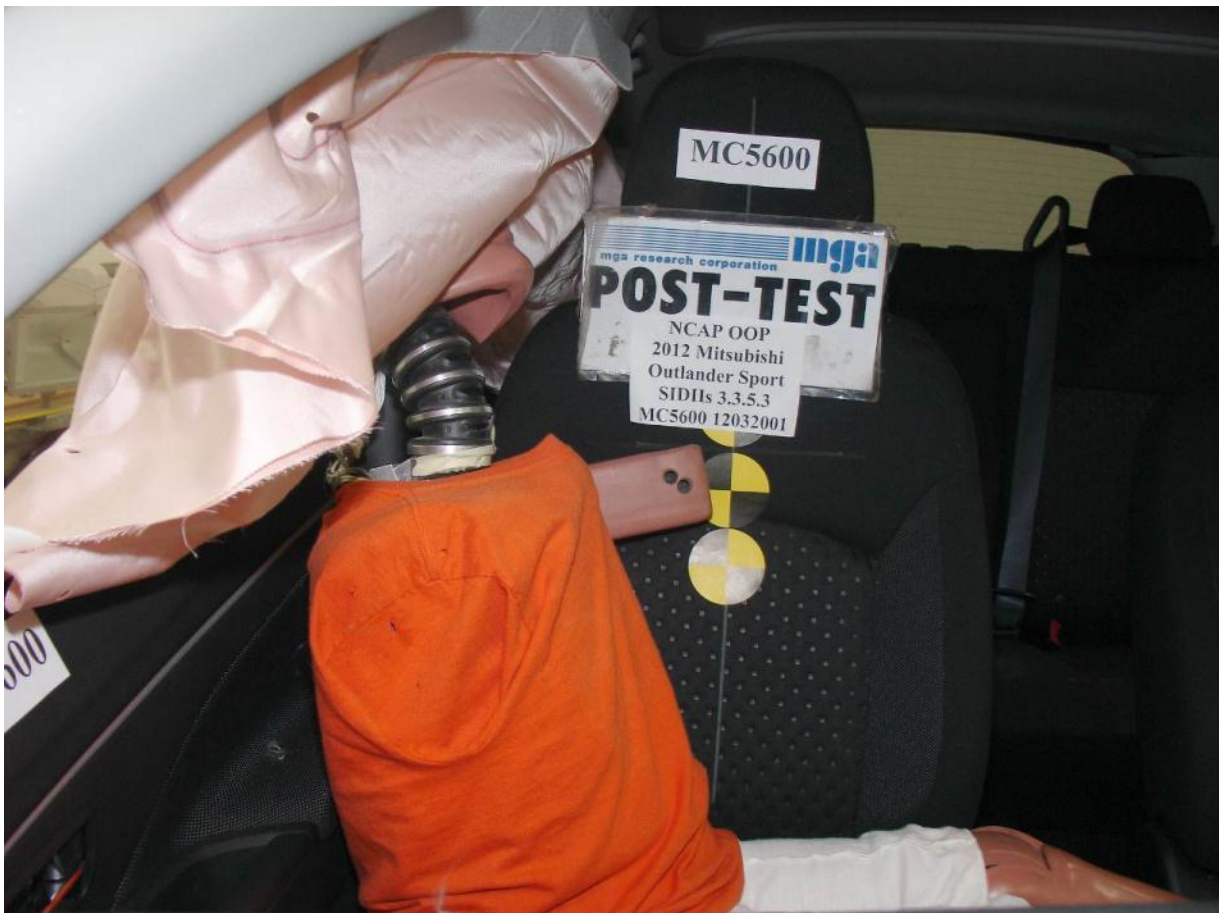
Post-Test SID-IIs Dummy Front View

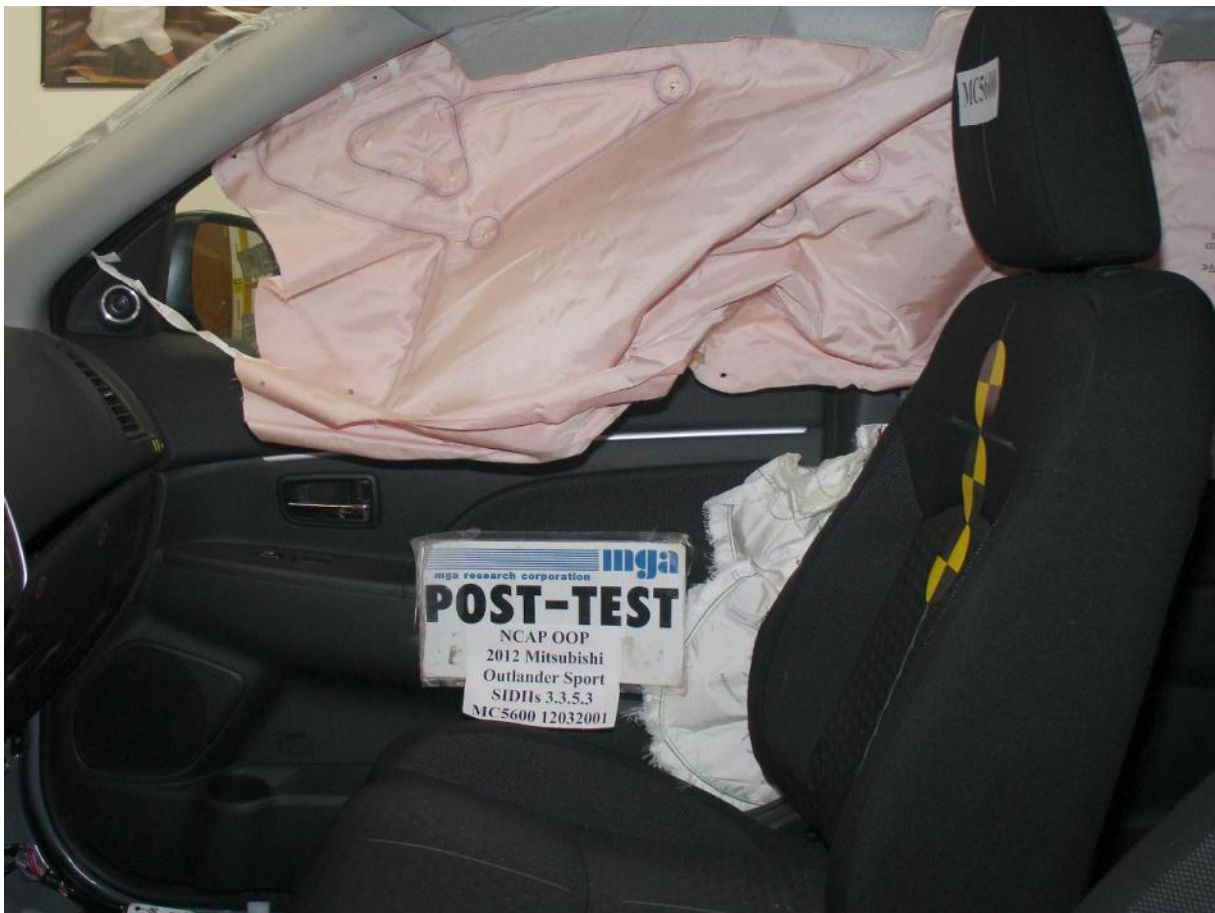
Post-Test Curtain Airbag Left Side View

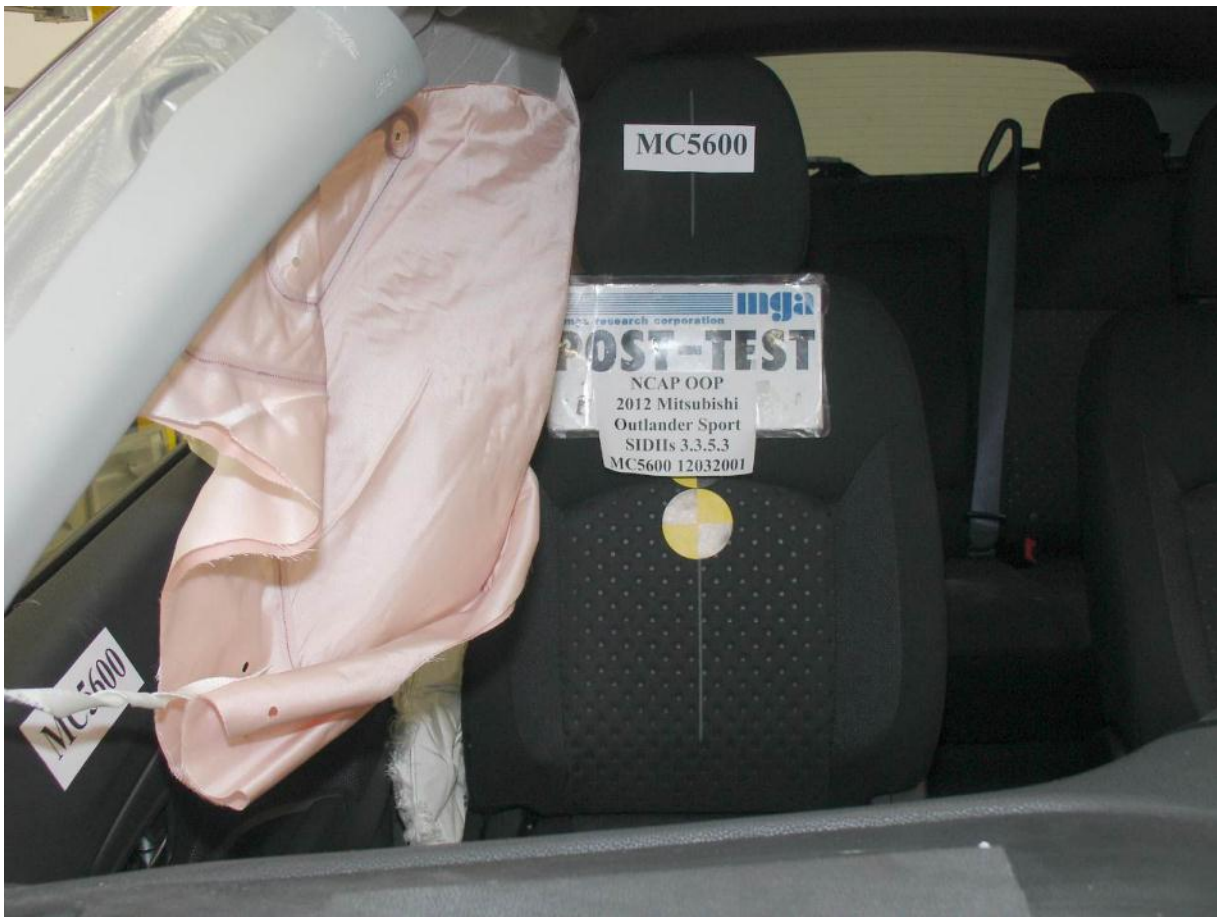
Post-Test Curtain Airbag Front View

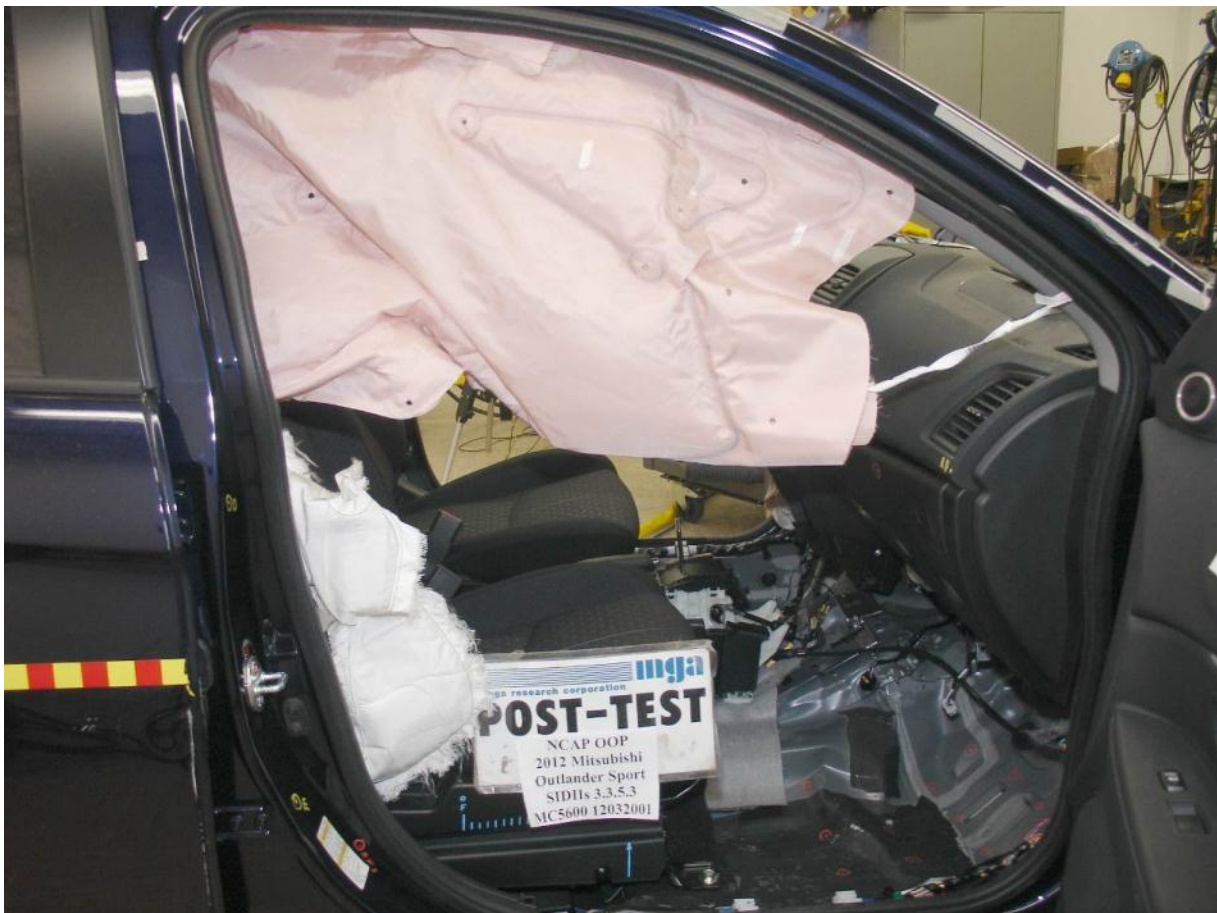
Post-Test Curtain Airbag Right Side View (Door Open)
