**REPORT NUMBER: SPNCAP-MGA-2012-078**

**NEW CAR ASSESSMENT PROGRAM (NCAP)  
Side Impact Pole Test**

**GENERAL MOTORS LLC  
2013 Chevrolet Malibu ECO 1SA 4-Dr Sedan  
NHTSA No.: MD0102**

**FINAL REPORT**

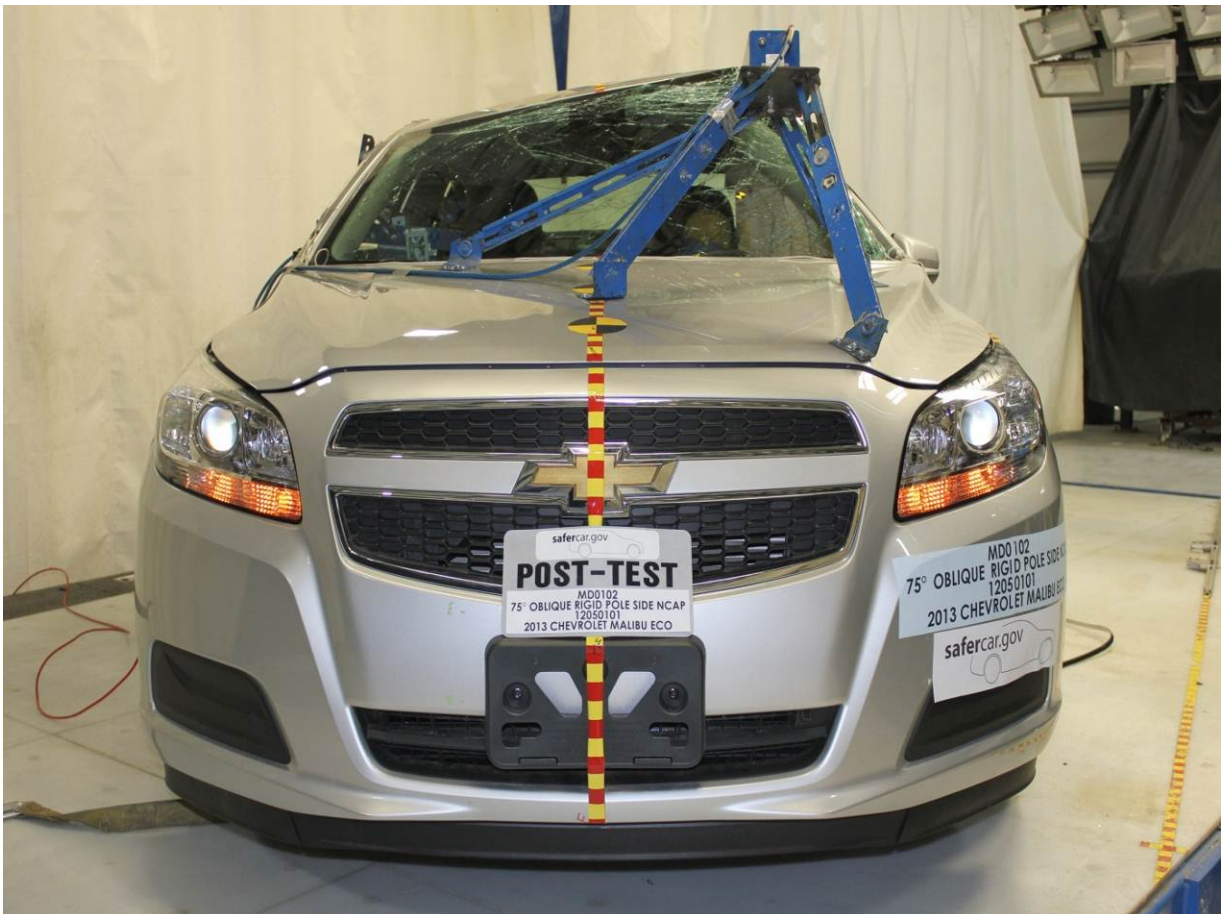
Post-Test Frontal View of Test Vehicle

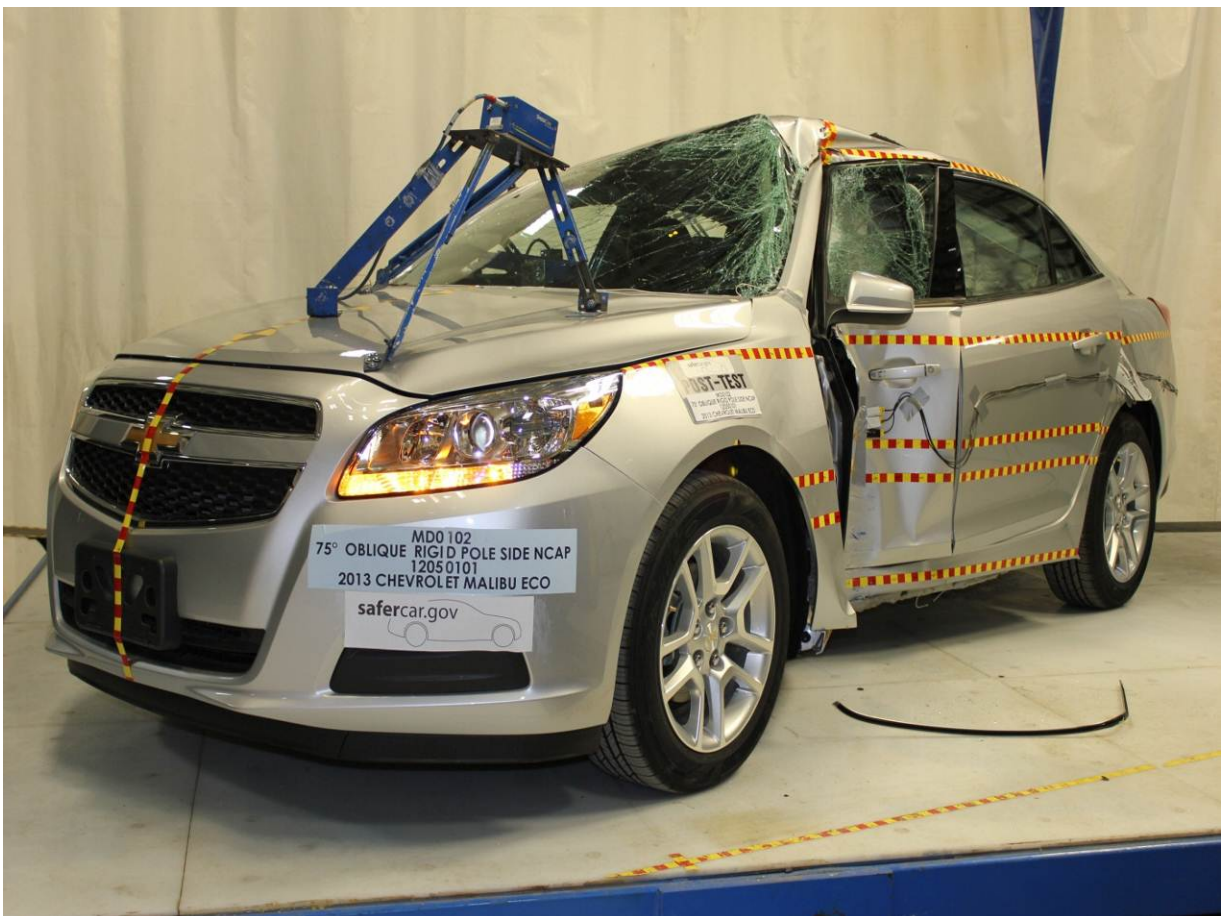
Post-Test Left Front  $\frac{3}{4}$  View of Test Vehicle

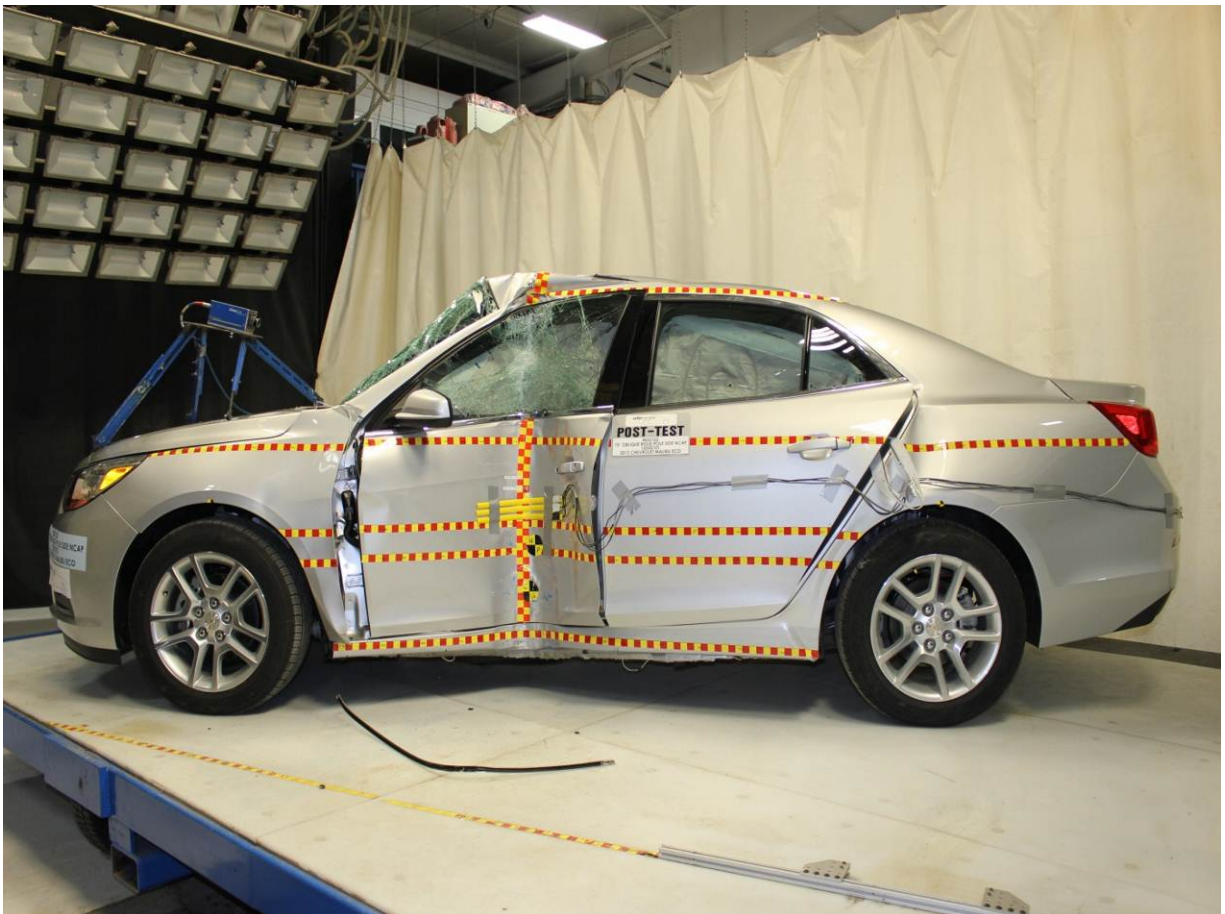
Post-Test Left Side View of Test Vehicle

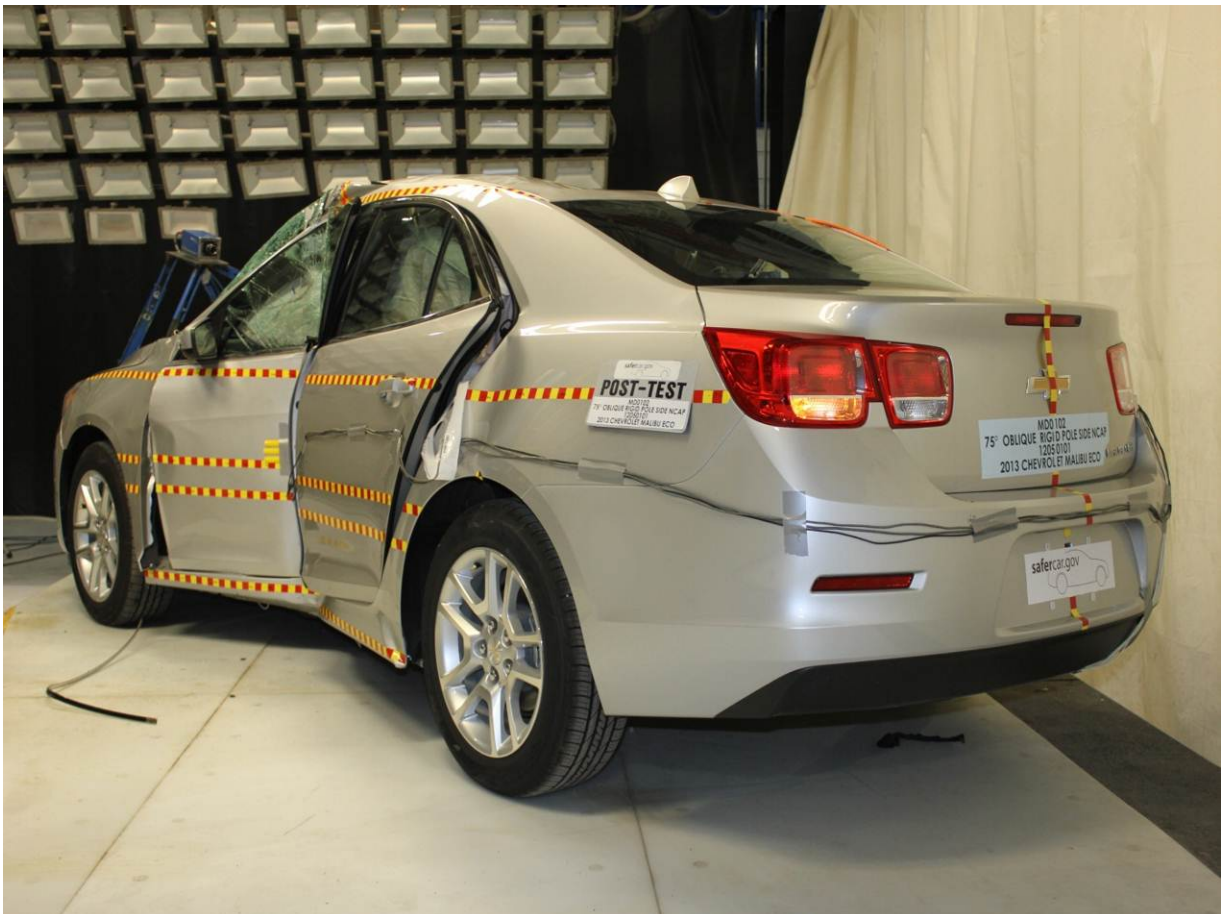
Post-Test Left Rear  $\frac{3}{4}$  View of Test Vehicle

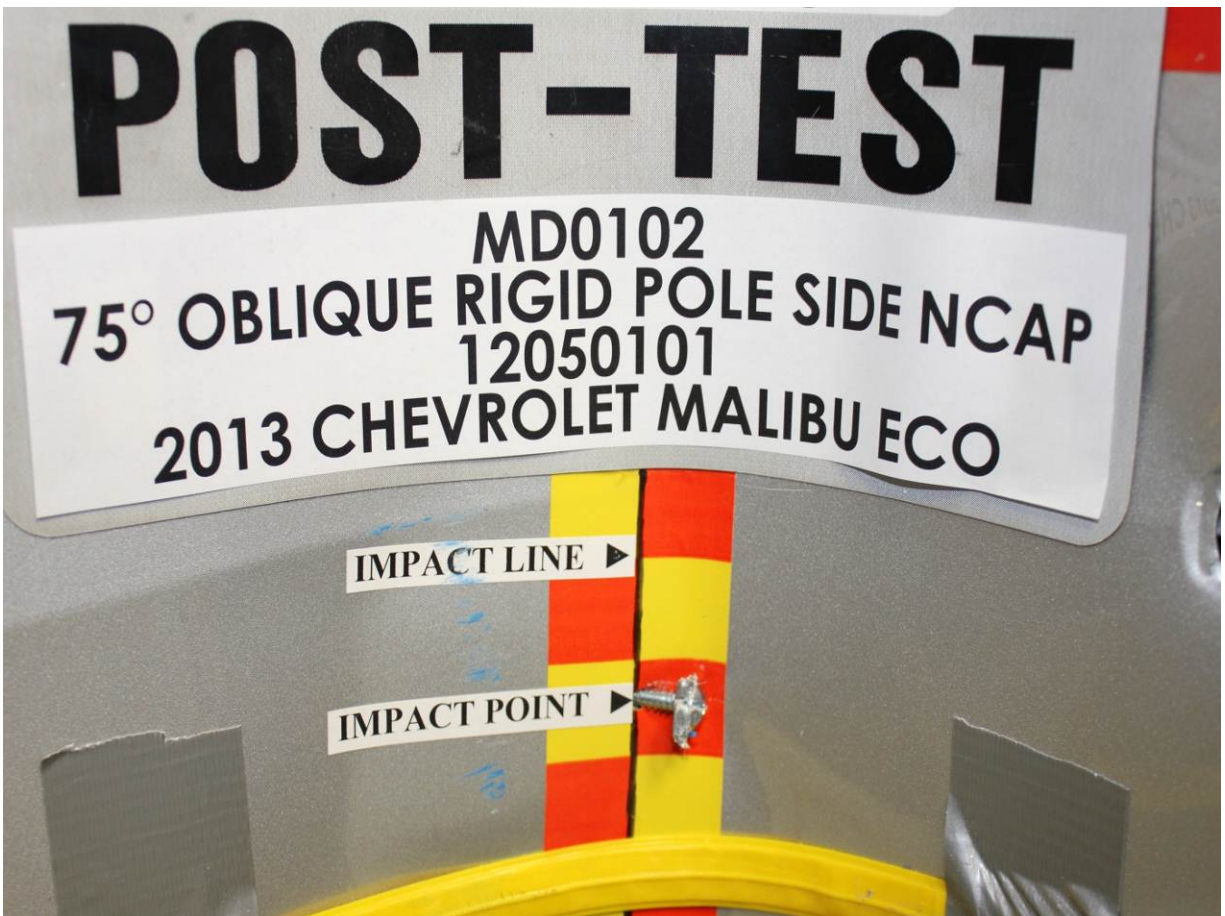
Post-Test Close-Up View of Impact Point Target Showing Impact Location

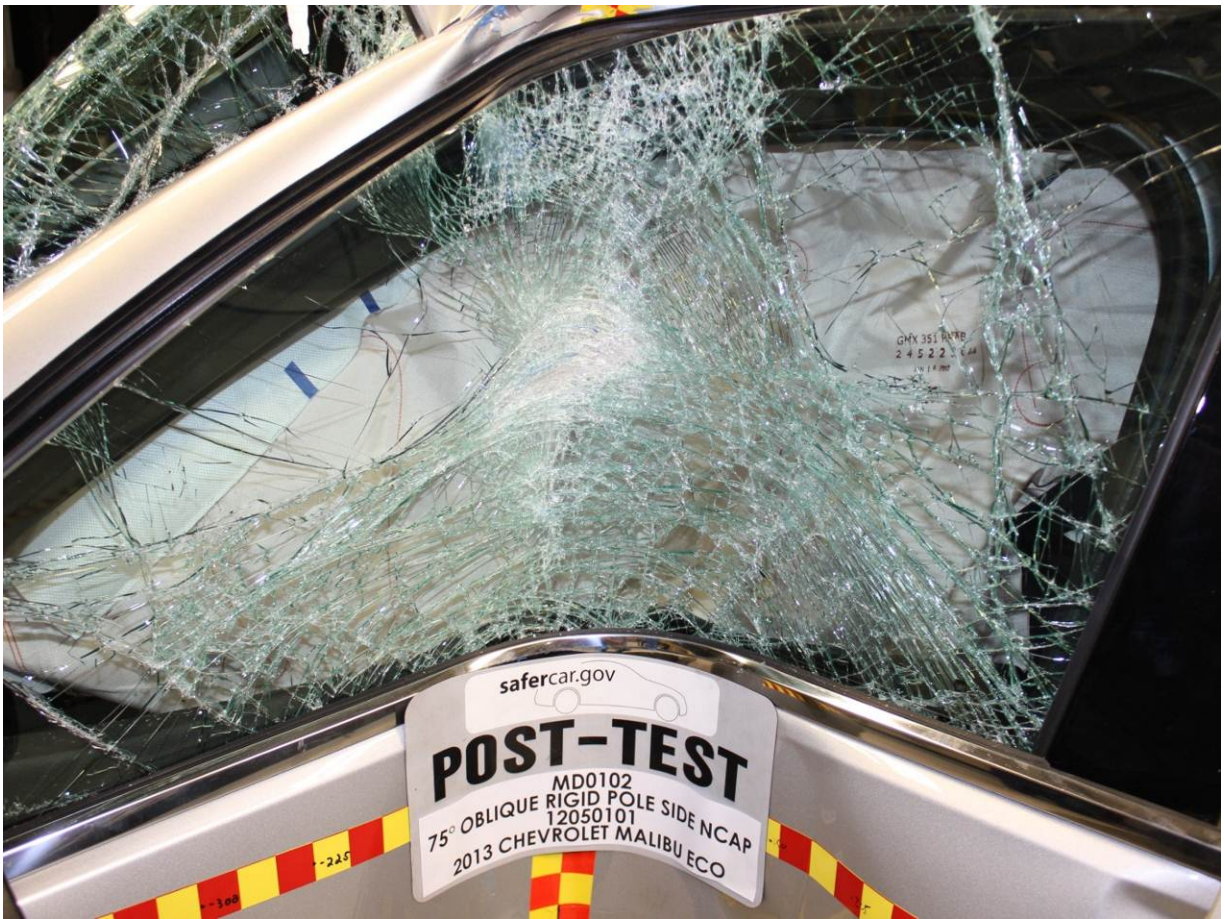
Post-Test Left Side View of Dummy Shoulder and Door Top View

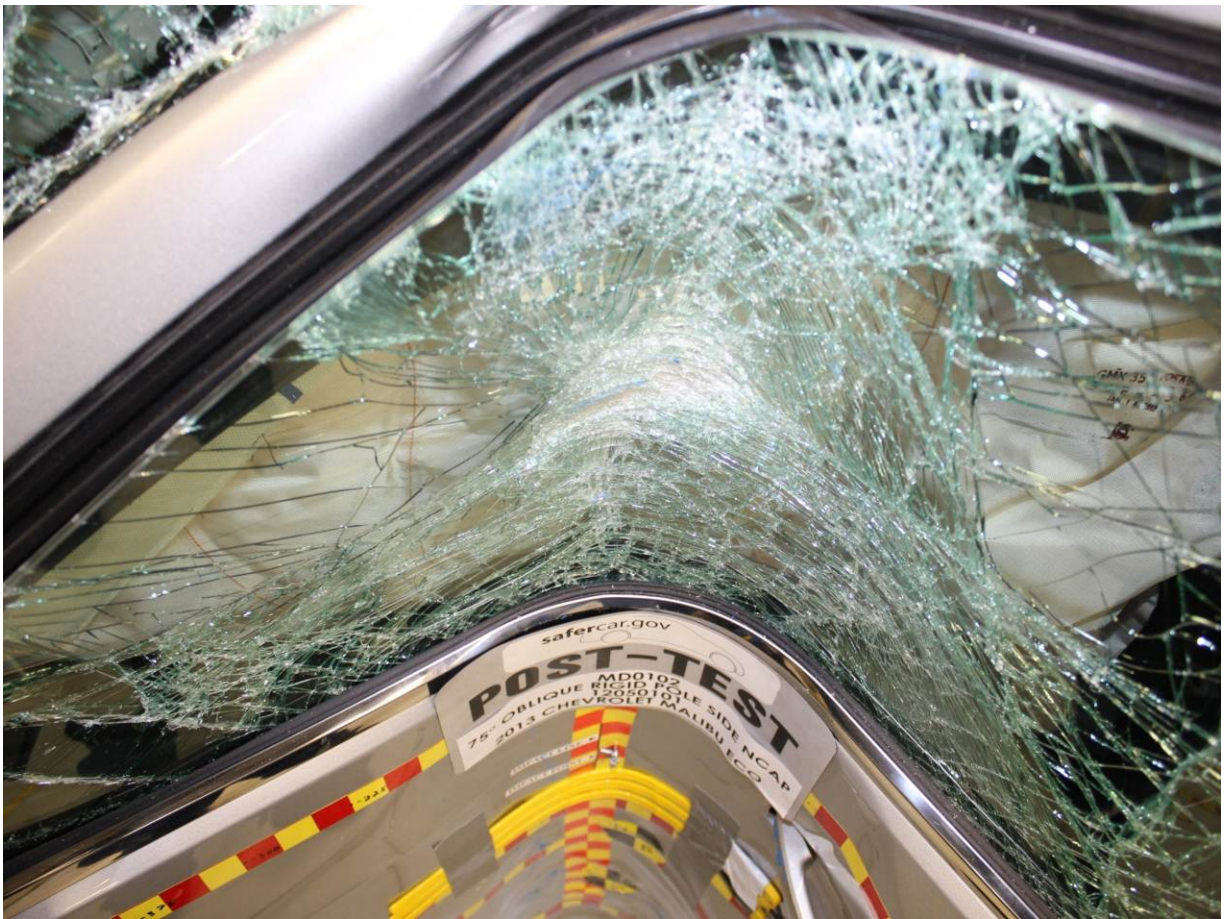
Post-Test Dummy and Door Clearance View

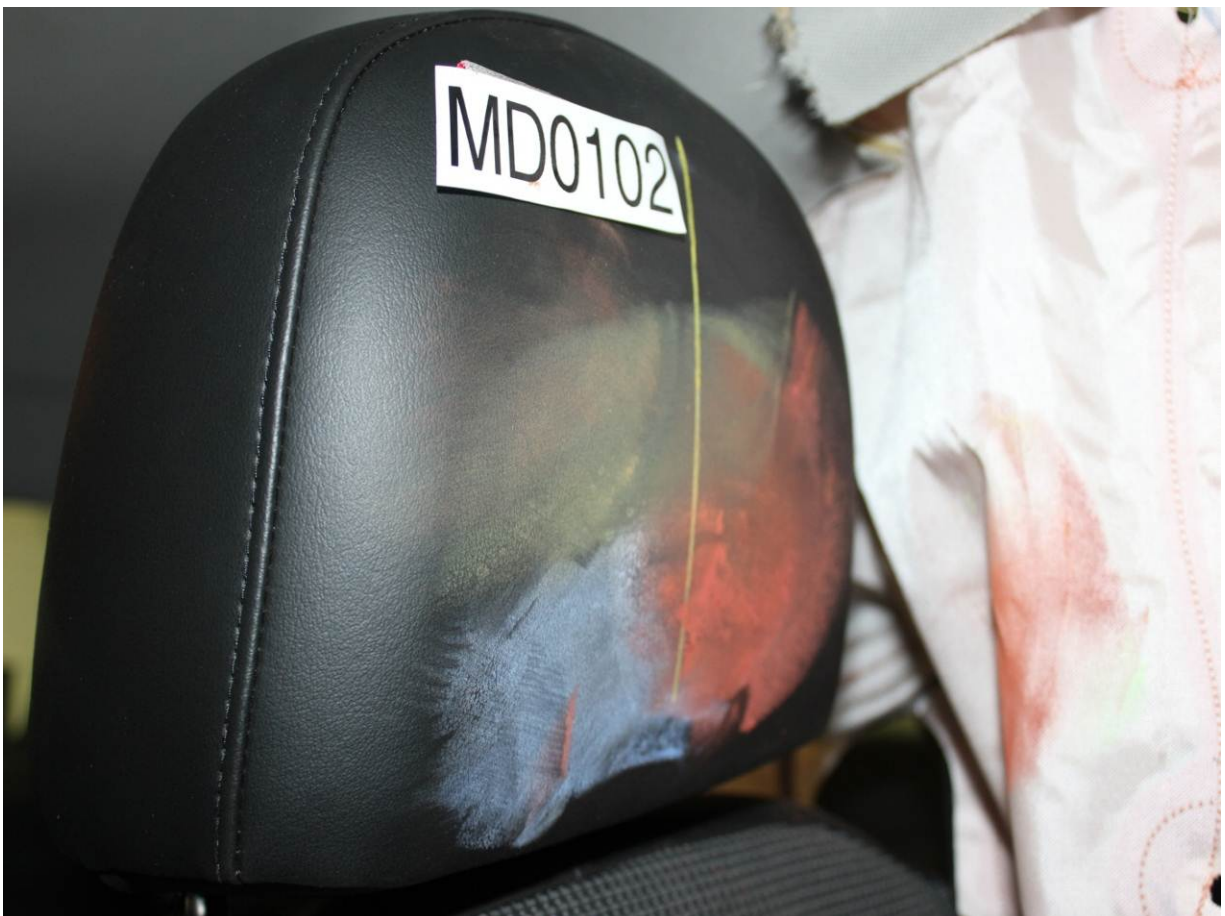
Post-Test Dummy Close-Up Head Contact with Vehicle Interior View

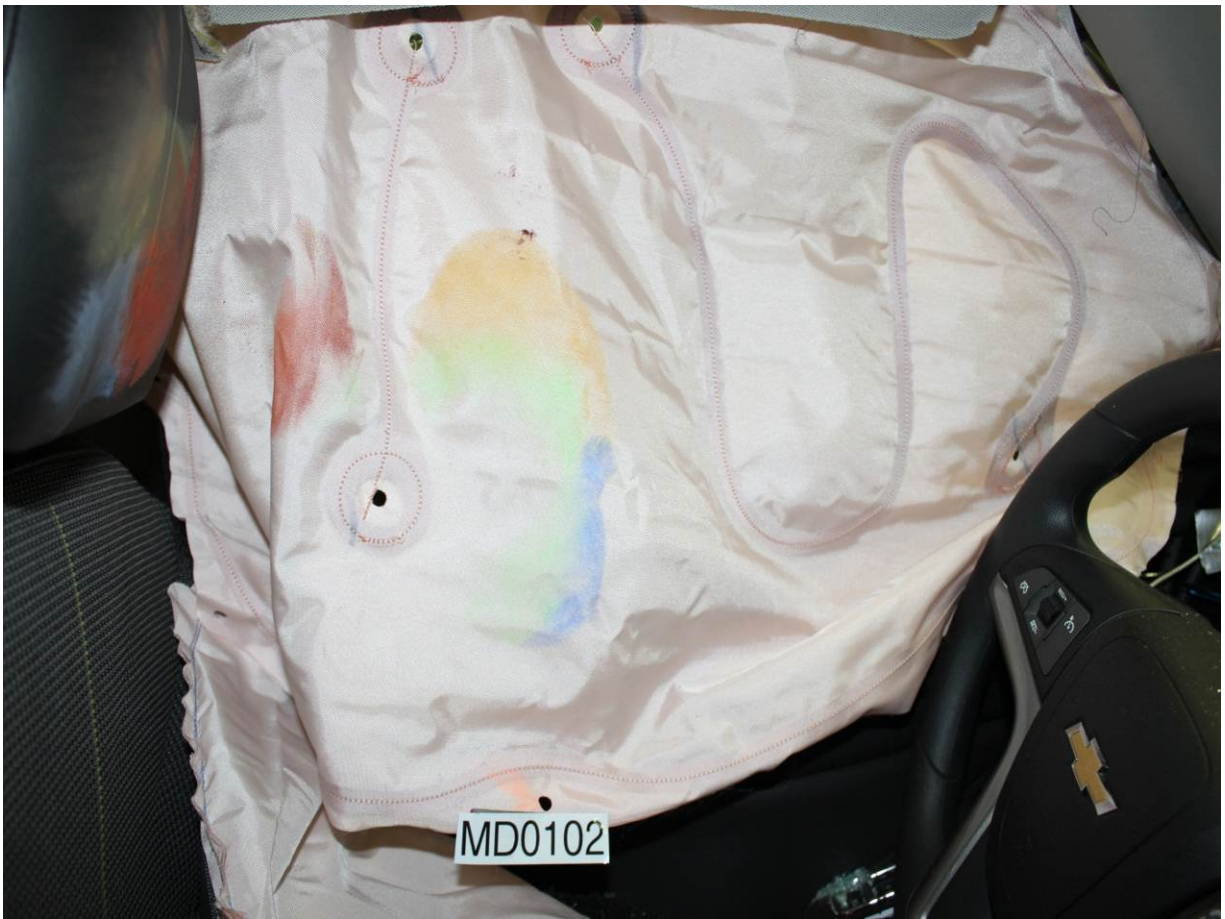
Post-Test Dummy Close-Up Head Contact with Side Air Bag View

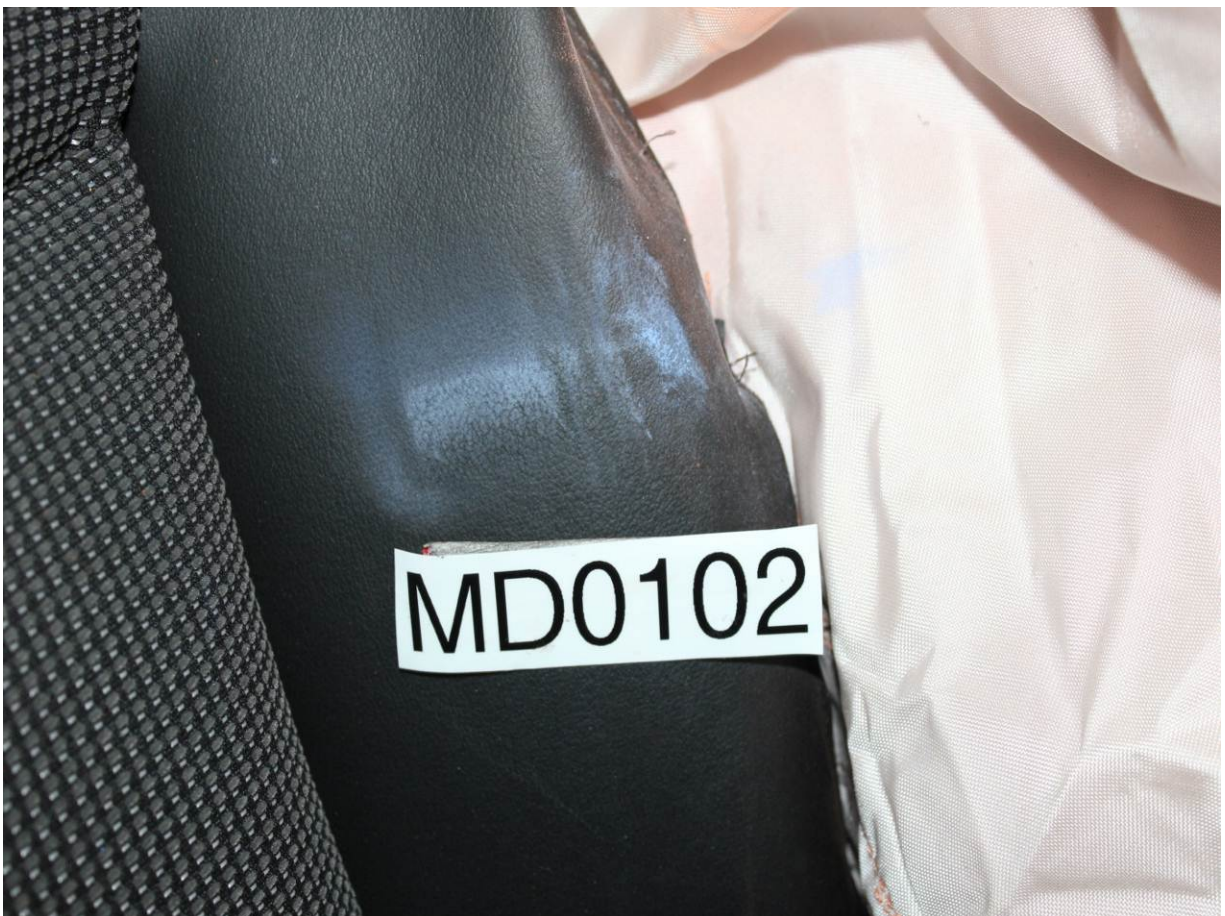
Post-Test Dummy Close-Up Torso Contact with Vehicle Interior View

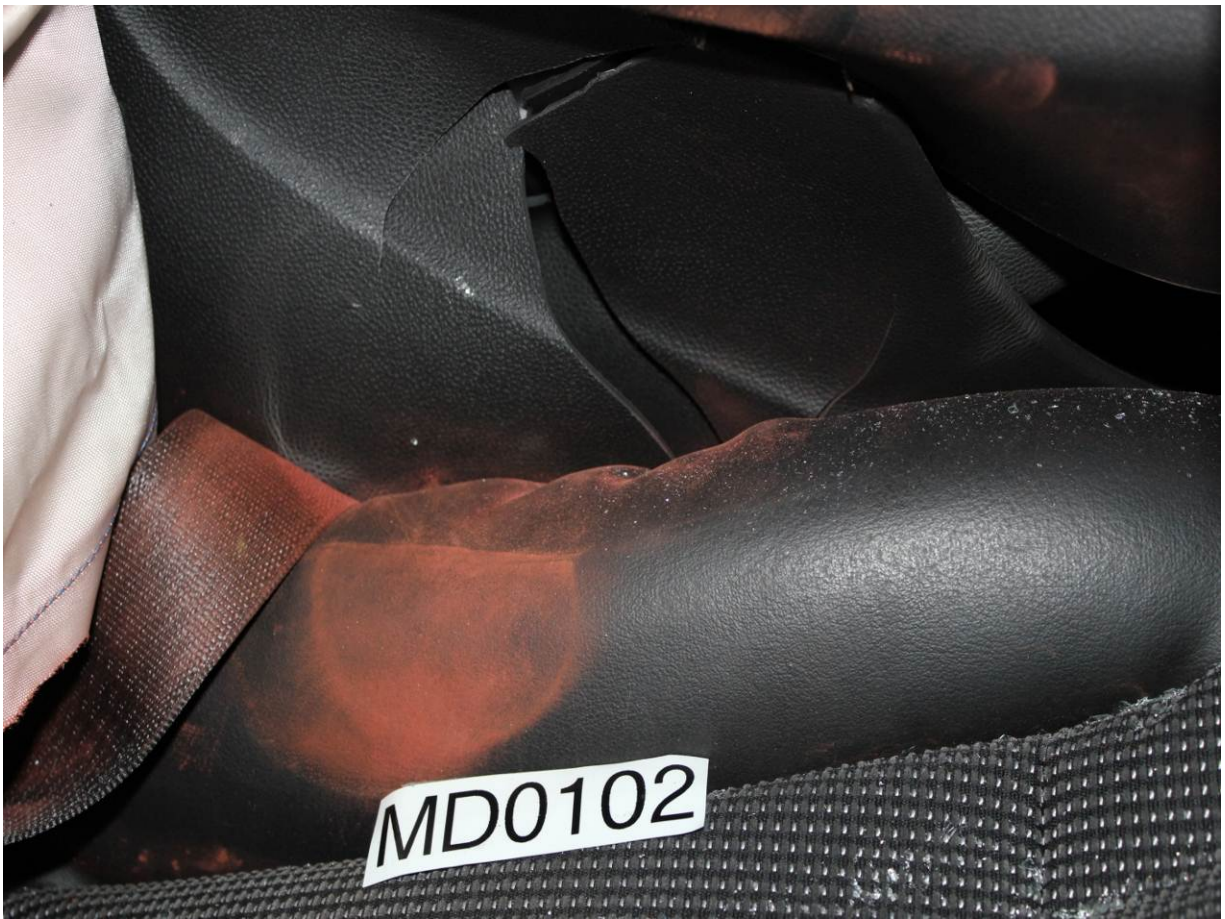
Post-Test Dummy Close-Up Pelvis Contact with Vehicle Interior View

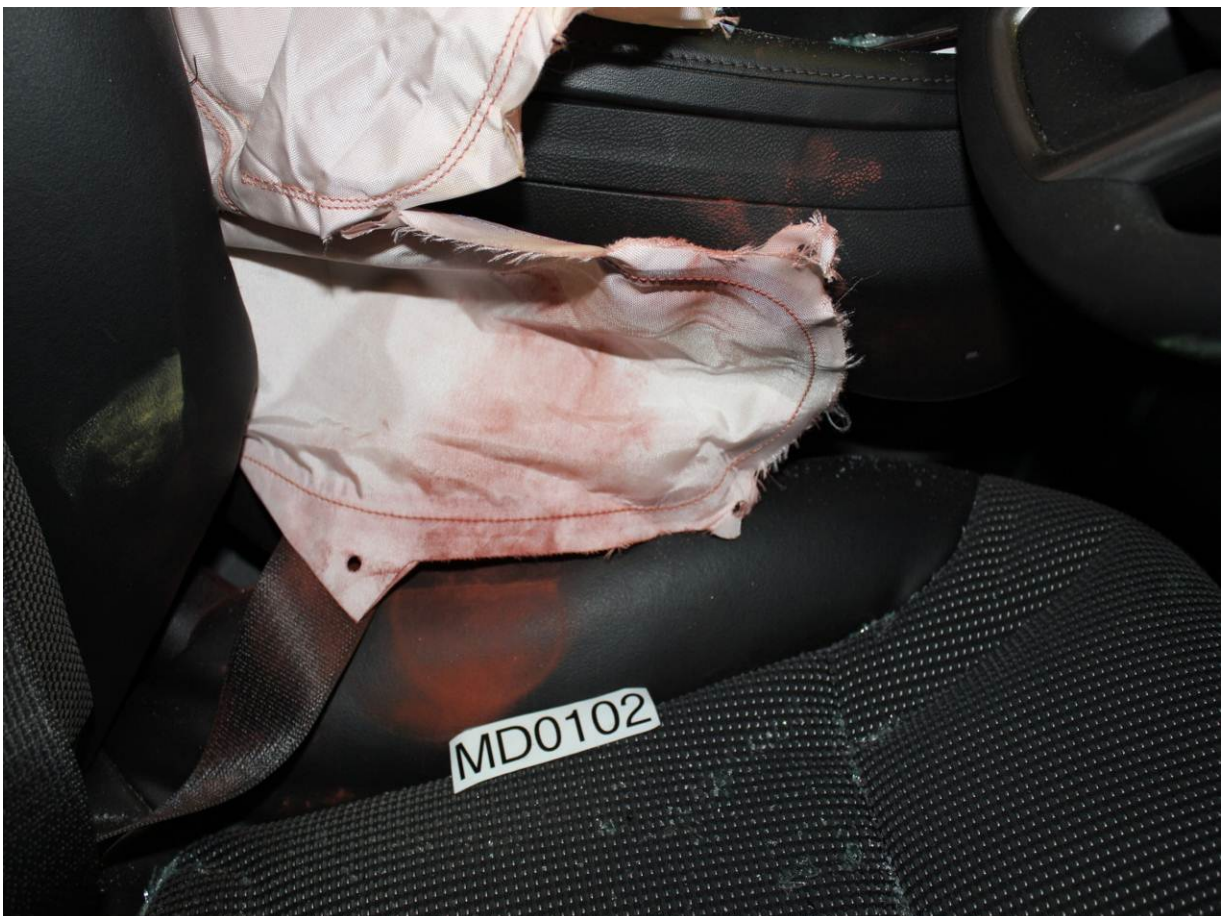
Post-Test Dummy Close-Up Pelvis Contact with Side Air Bag View
