**REPORT NUMBER: SINCAP-MGA-2012-079**

**NEW CAR ASSESSMENT PROGRAM (NCAP)  
Moving Deformable Barrier Side Impact Test**

**GENERAL MOTORS LLC  
2013 Chevrolet Malibu ECO 1SA 4-Dr Sedan  
NHTSA No.: MD0101**

**FINAL REPORT**

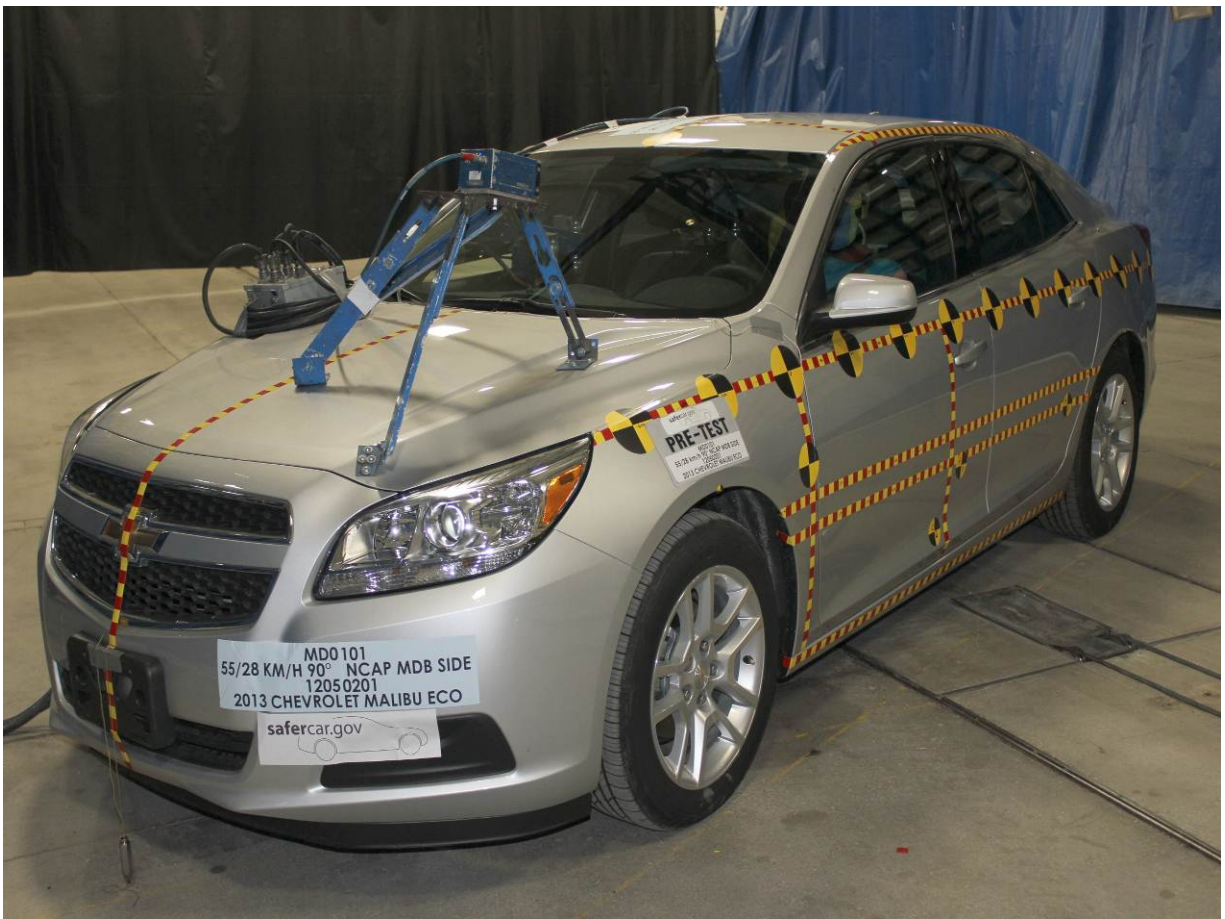
Post-Test Frontal View of Test Vehicle

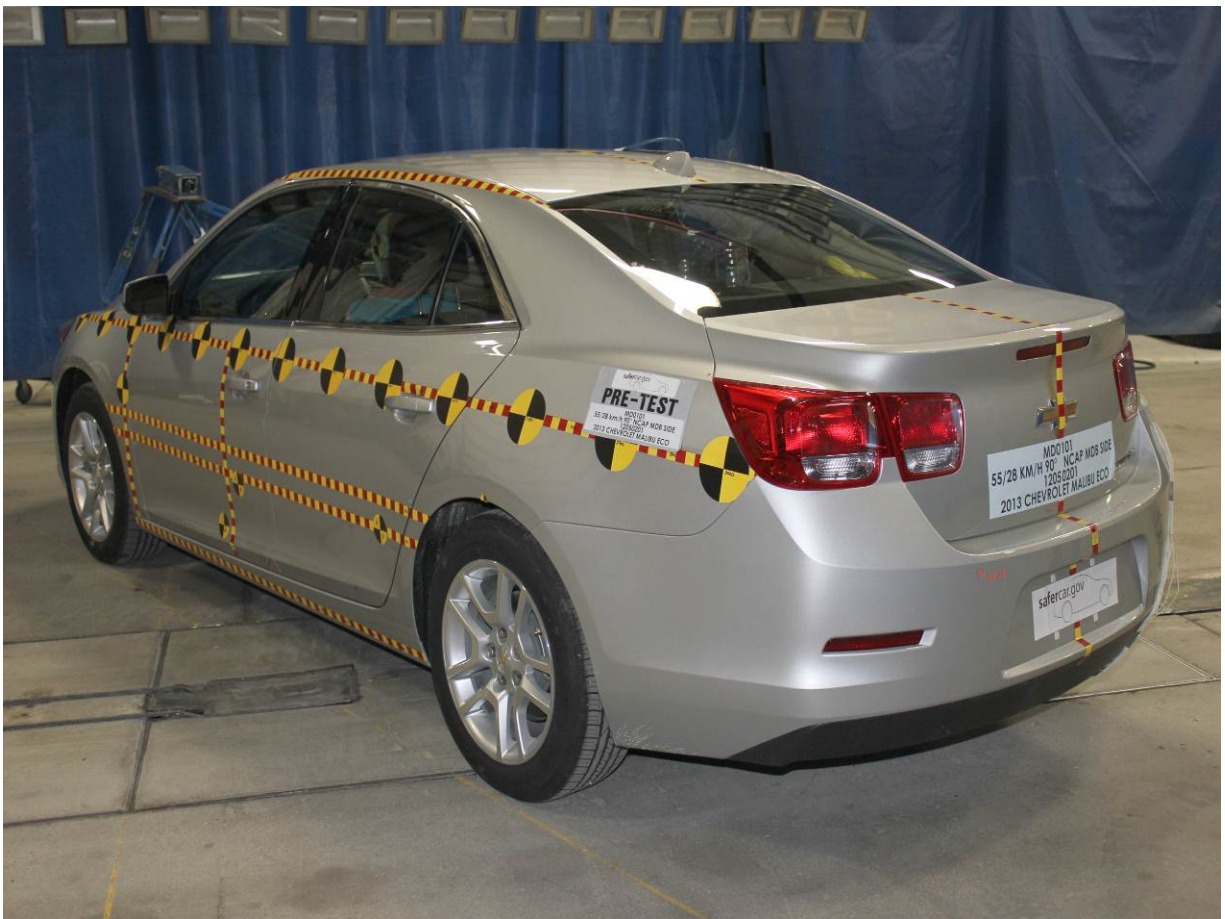
Post-Test Left Side View of Test Vehicle

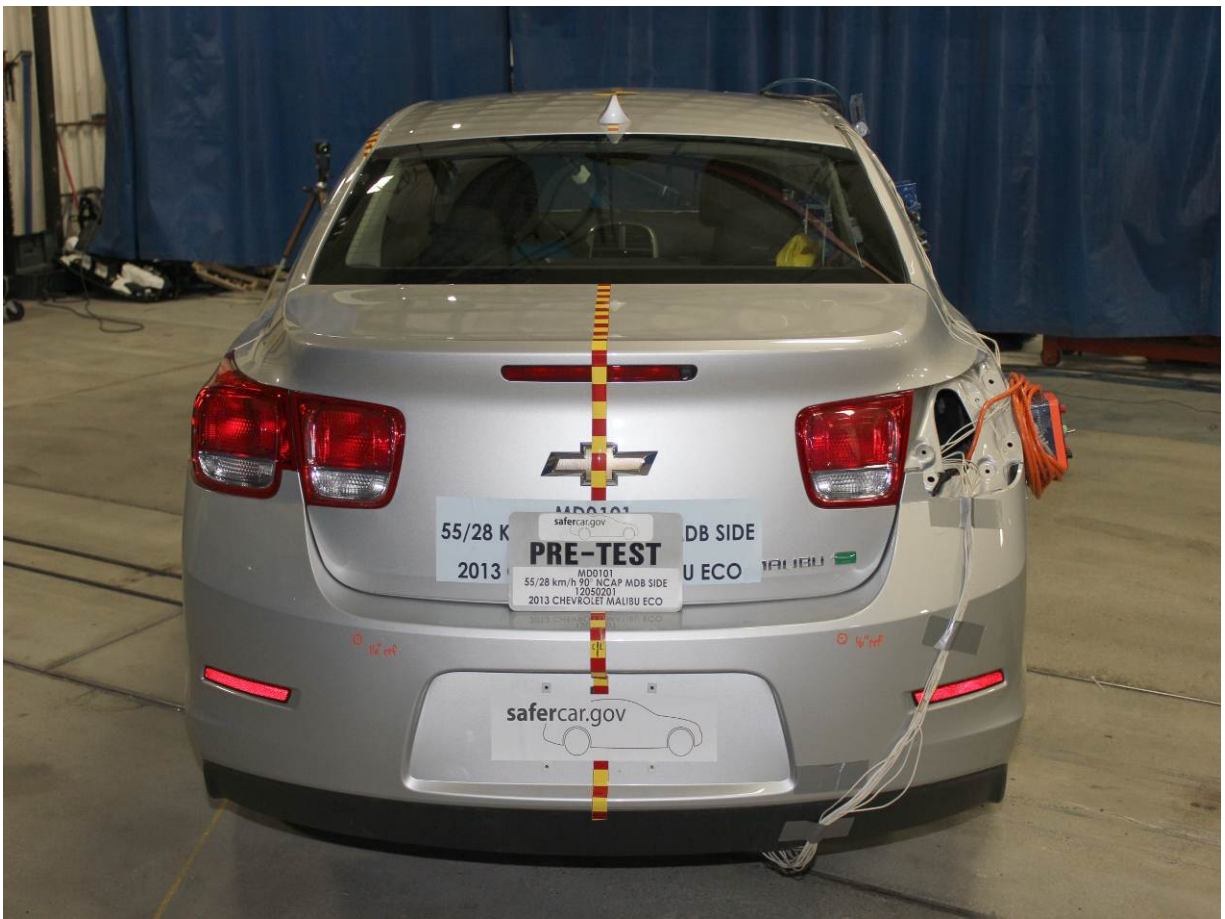
Post-Test Left Three-Quarter Rear View of Test Vehicle

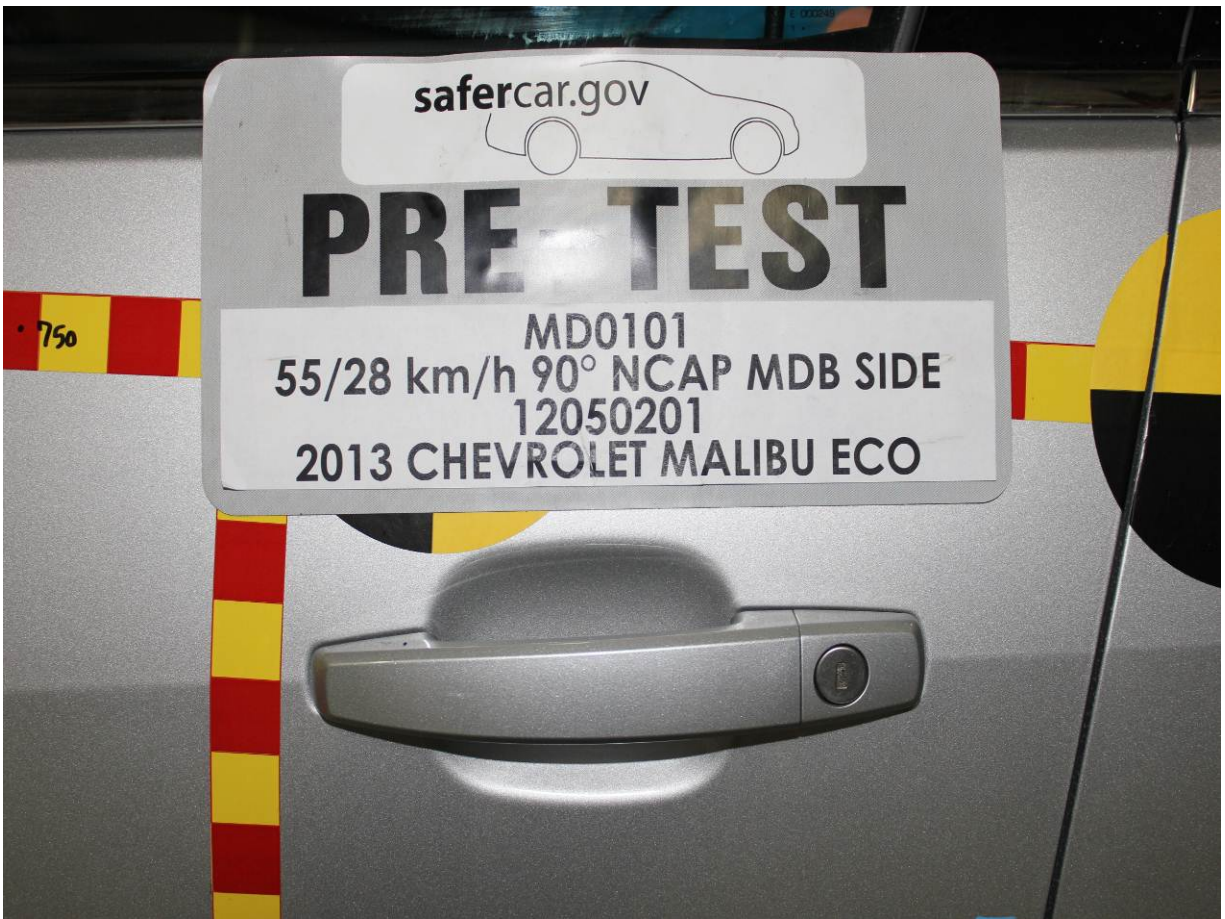
Post-Test Close-Up View of Impact Point Target

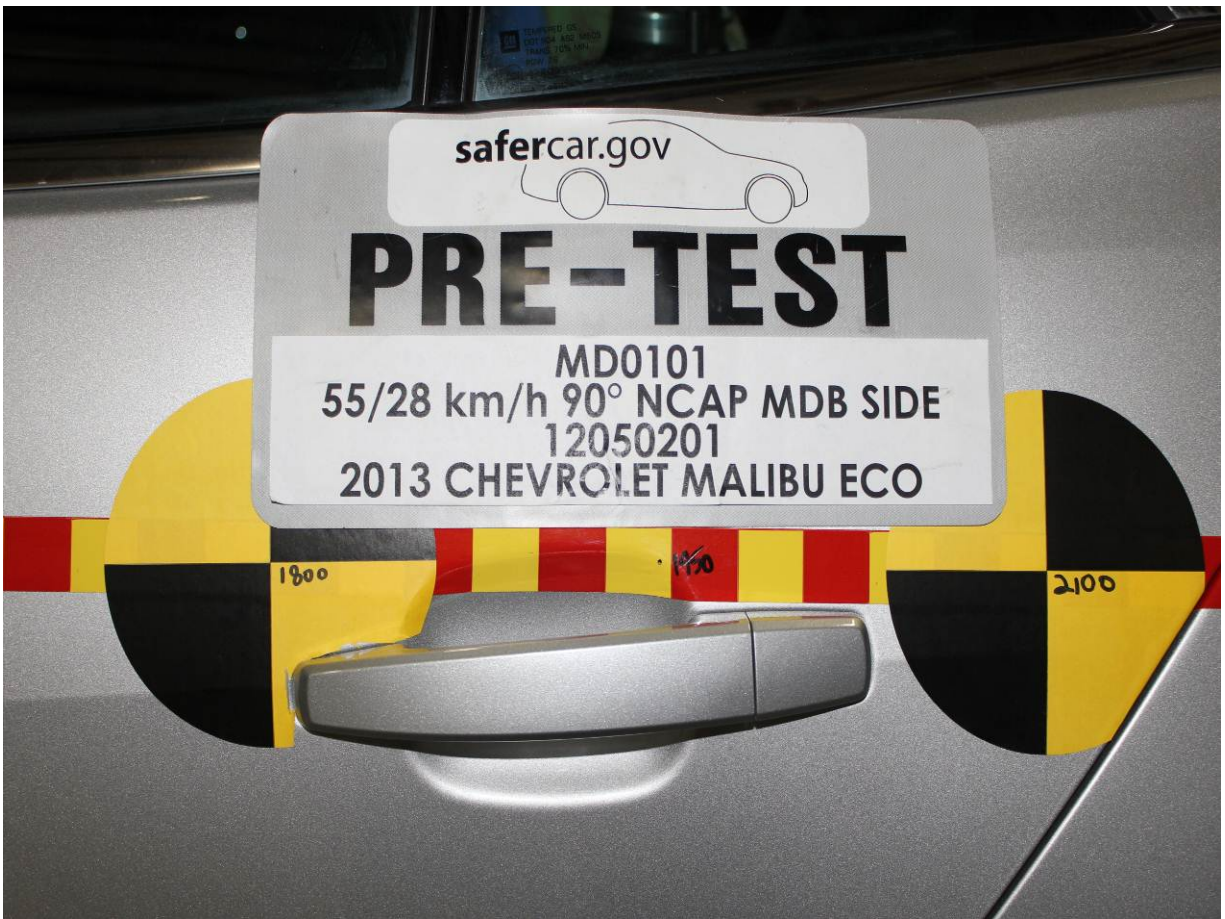
Post-Test Left Front Door Latch Close-Up

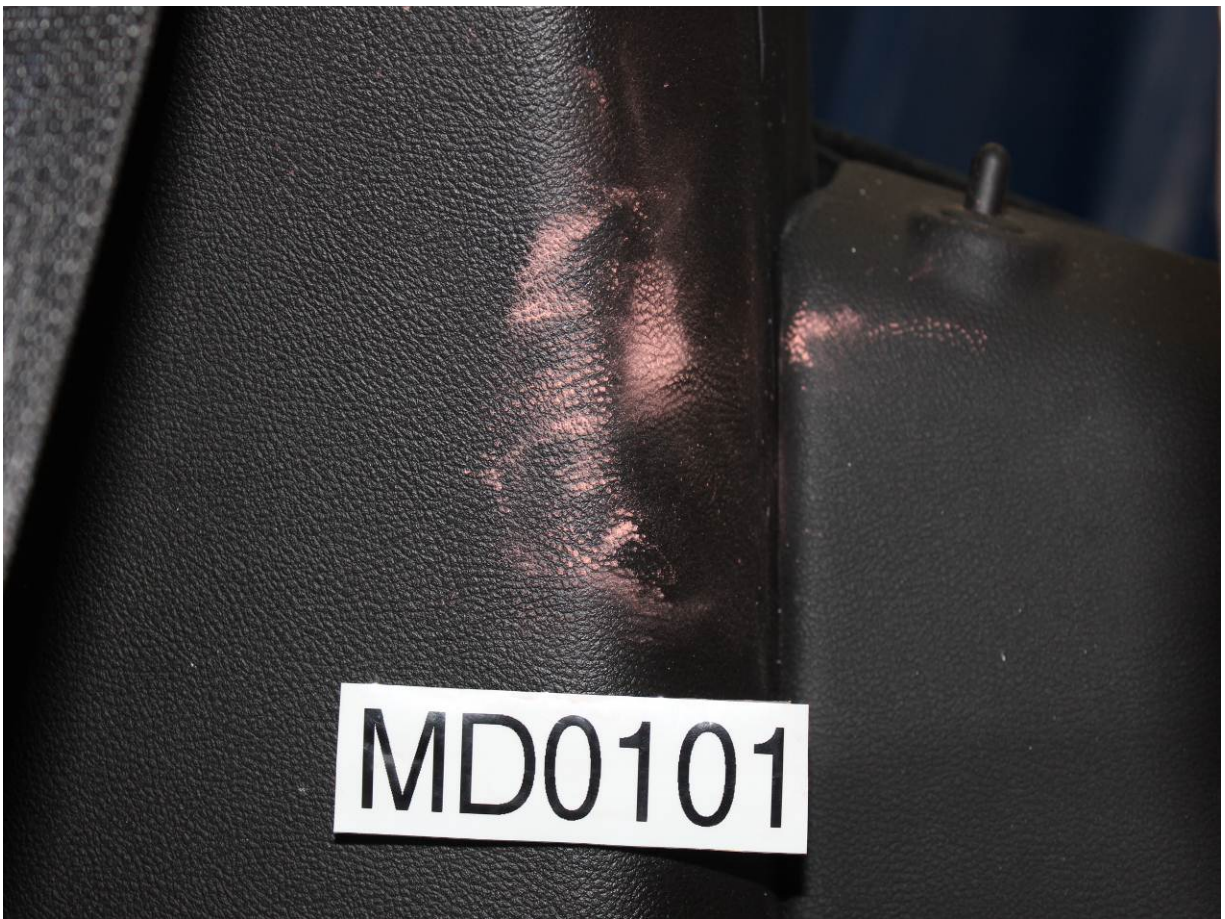
Post-Test Driver Dummy Close-up Head Contact with Side Airbag View

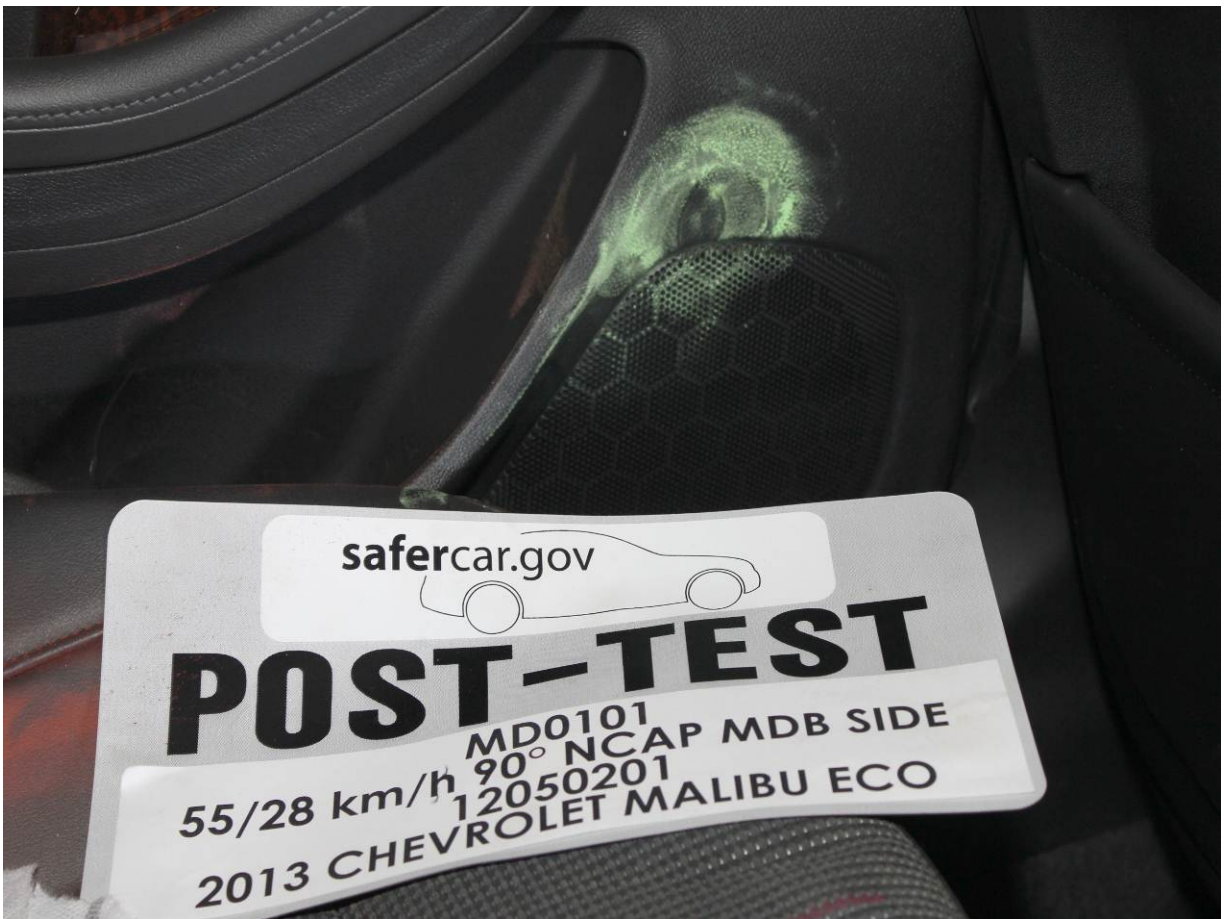
Post-Test Driver Dummy Knee Contact with Vehicle Interior View
