**REPORT NUMBER: NCAP-MGA-2012-080**

**NEW CAR ASSESSMENT PROGRAM (NCAP)  
Frontal Barrier Impact Test**

**GENERAL MOTORS LLC  
2013 Chevrolet Malibu ECO 1SA 4-Dr Sedan  
NHTSA No.: MD0100**

**MGA RESEARCH CORPORATION  
5000 Warren Road  
Burlington, WI 53105**

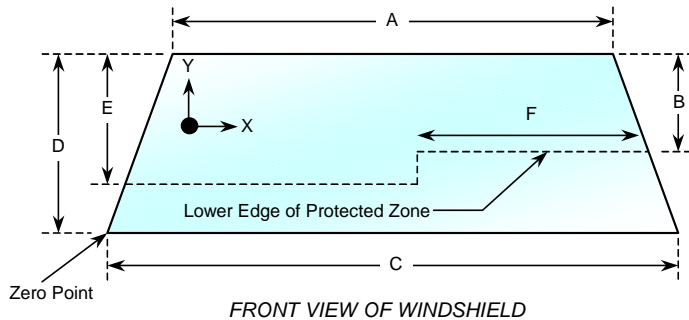
**WINDSHIELD PERIPHERY MEASUREMENTS**

Measurement	Pre-Test (mm)	Post-Test (mm)	% of Retention
Left Side	2125	2125	100
Right Side	2125	2125	100
Total	4250	4250	100

Item	Units	Value
A	mm	1206
B	mm	506
C	mm	1484
D	mm	780
E	mm	528
F	mm	539

There was 100 percent windshield retention and no intrusion into the protected zone of the windshield during the event. There was no Stoddard Solvent leakage after the event or during any phase of the static rollover.

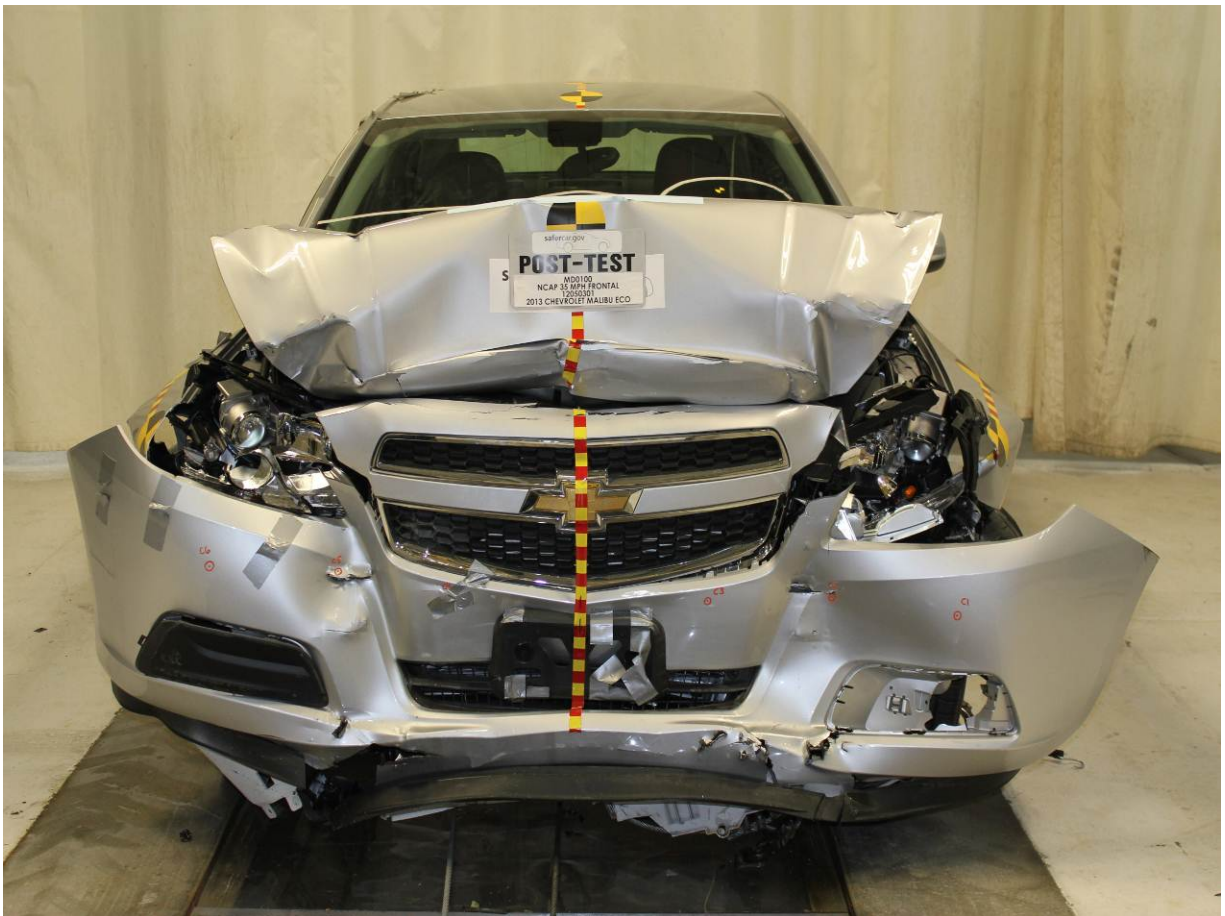
Post-Test Front View of Test Vehicle

The maximum static crush of the vehicle was 589 mm and both the driver and passenger side doors remained closed during the impact event and were operable after the impact.

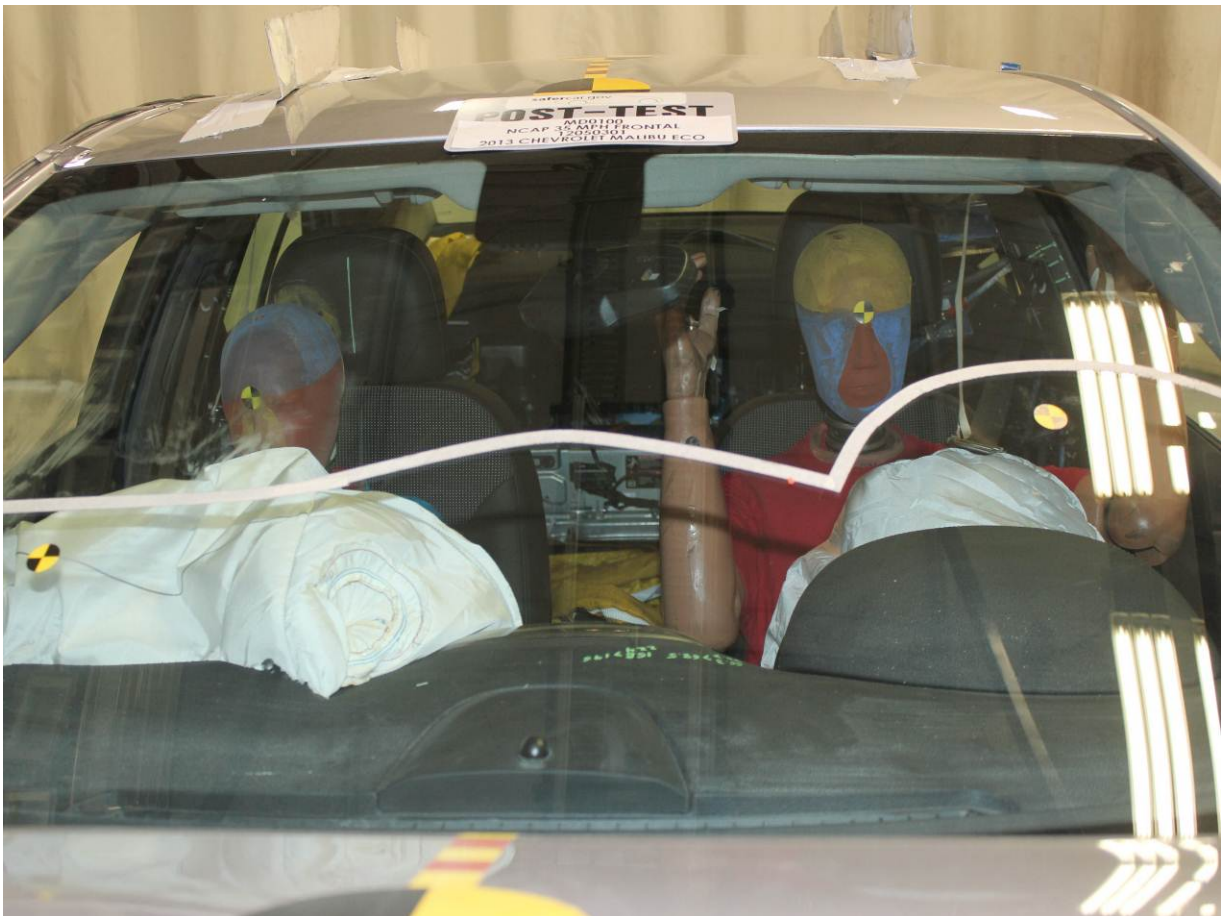
Post-Test Windshield View

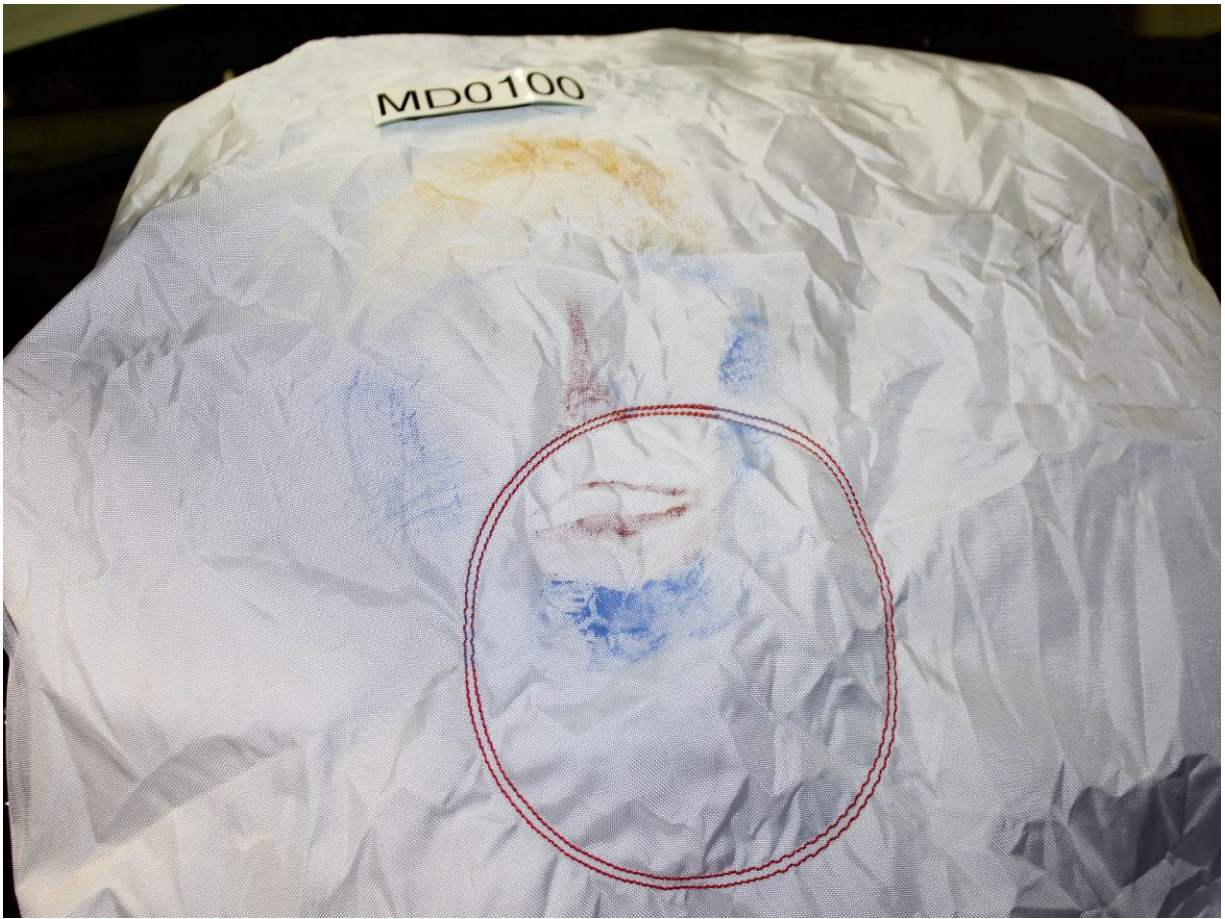
Post-Test Driver Dummy Contact with Airbag

The driver's visible contact points were as follows: The driver's head and chest contacted the airbag. The driver's head also contacted the headrest. The driver's knees contacted the knee airbag and steering column. The passenger's visible contact points were as follows: The passenger's head and chest contacted the airbag. The passenger's head also contacted the headrest. The passenger's knees contacted the knee airbag.

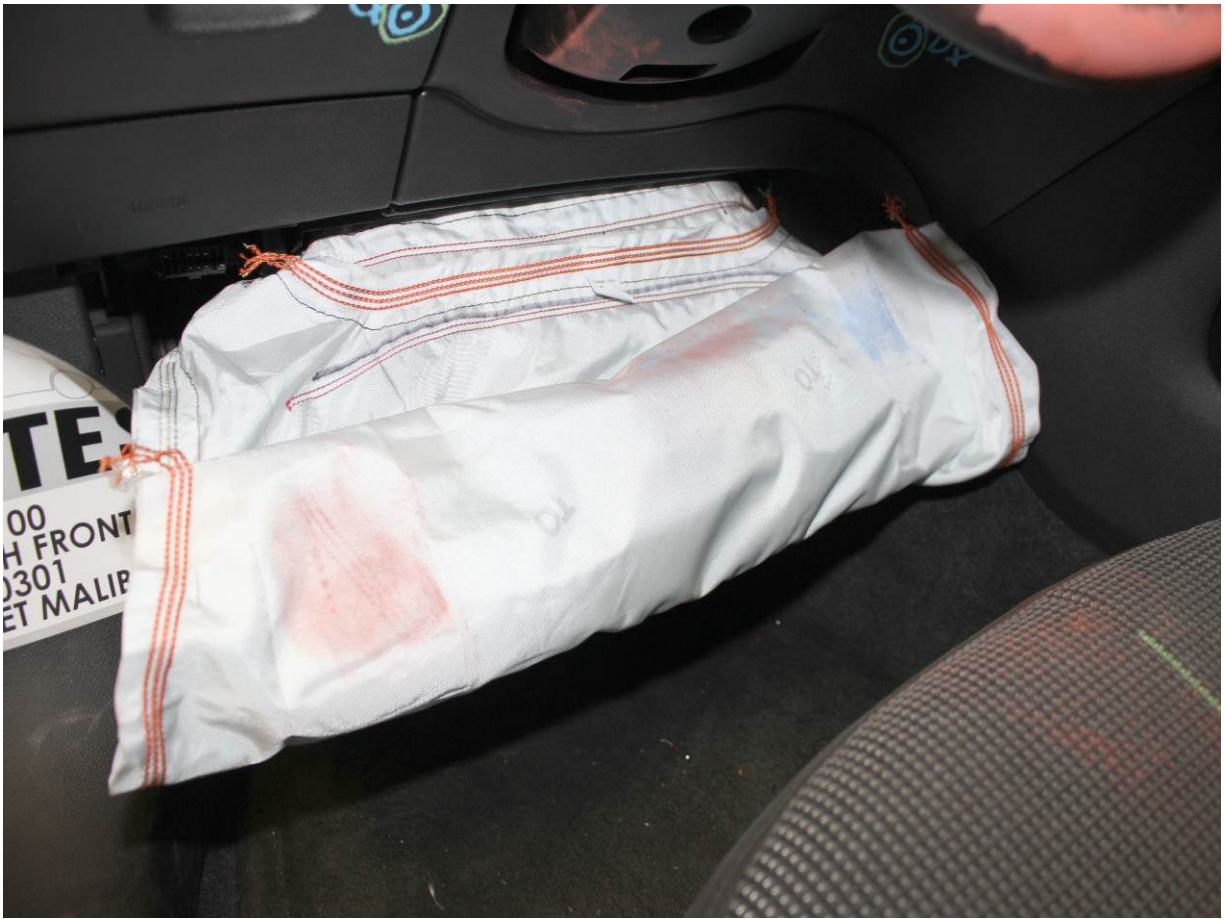
Post-Test Driver Dummy Contact with Knee Airbag

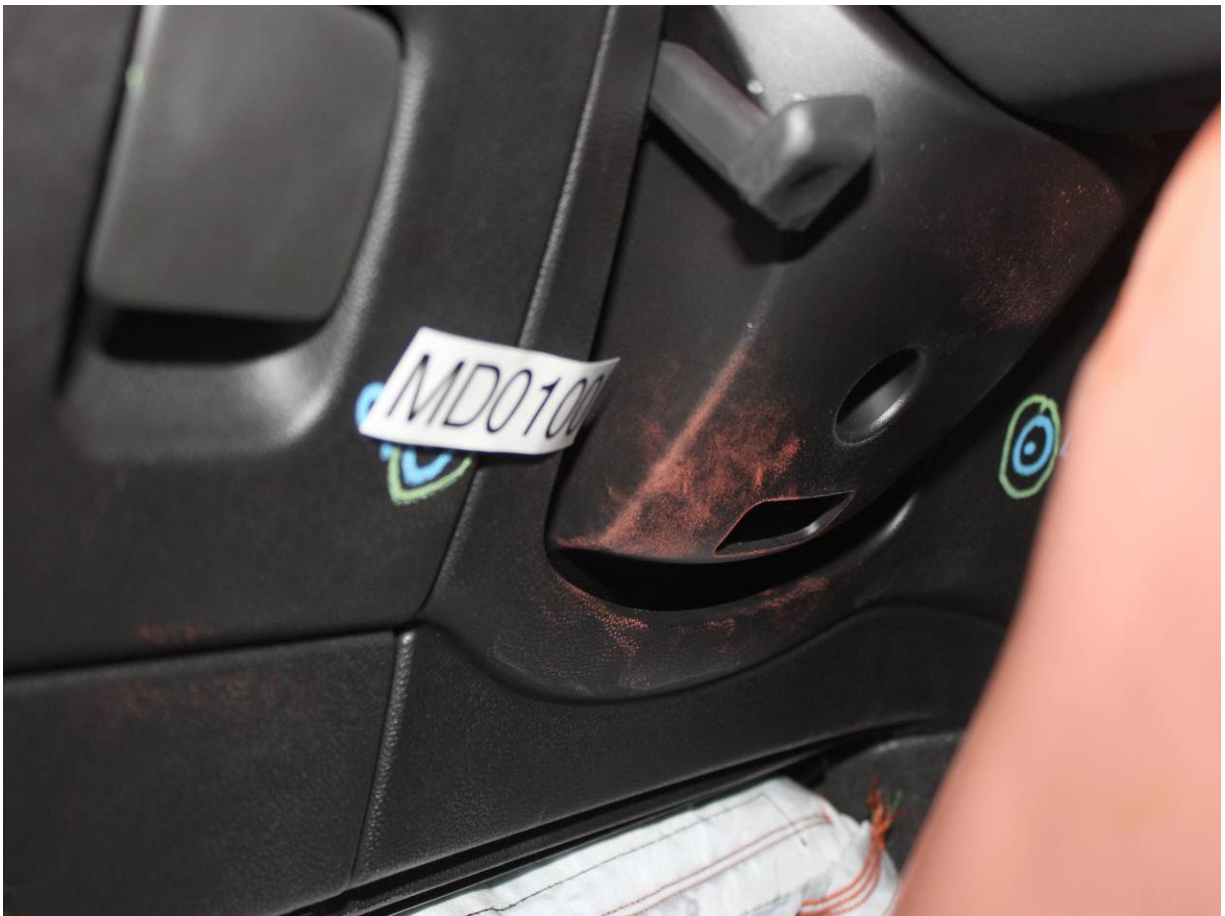
Post-Test Driver Dummy Contact with Steering Column

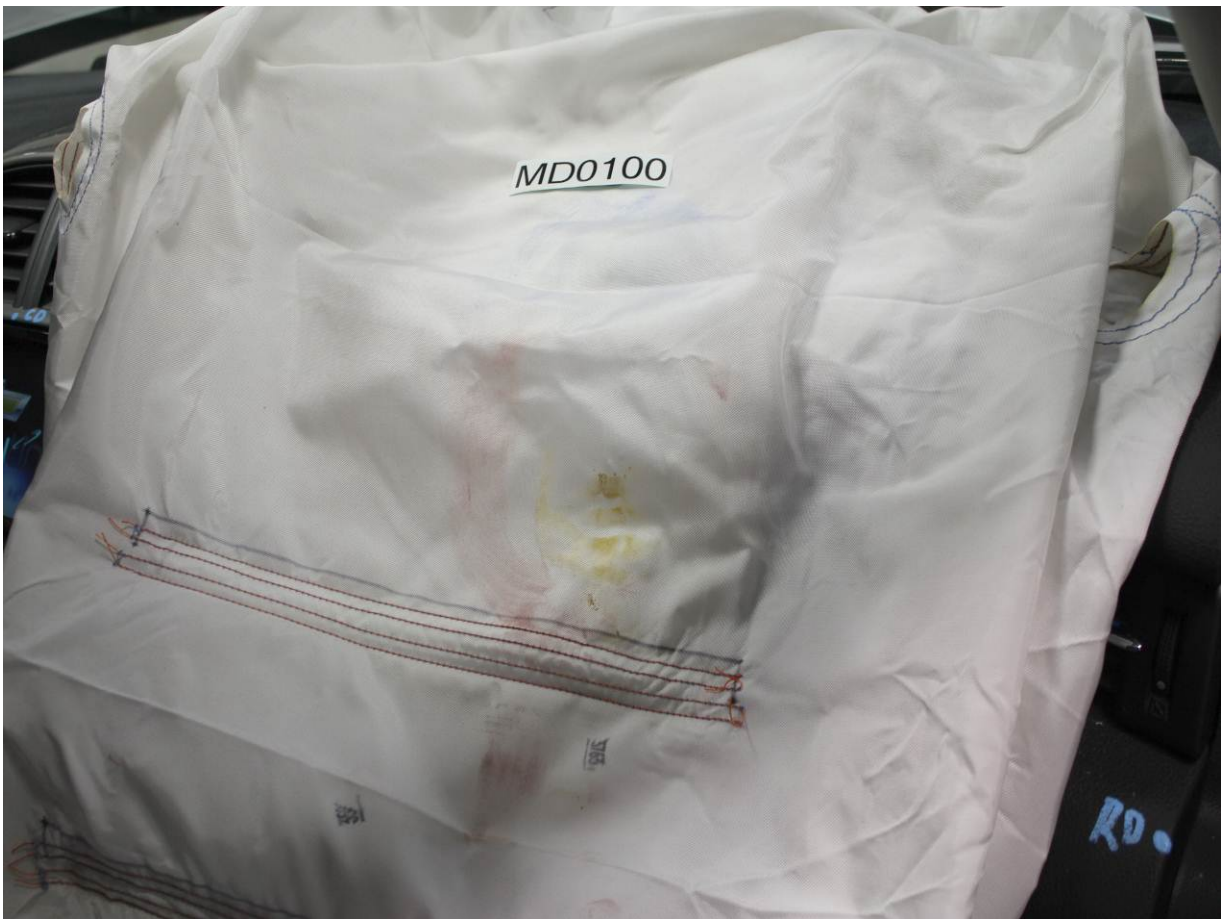
Post-Test Passenger Dummy Contact with Airbag

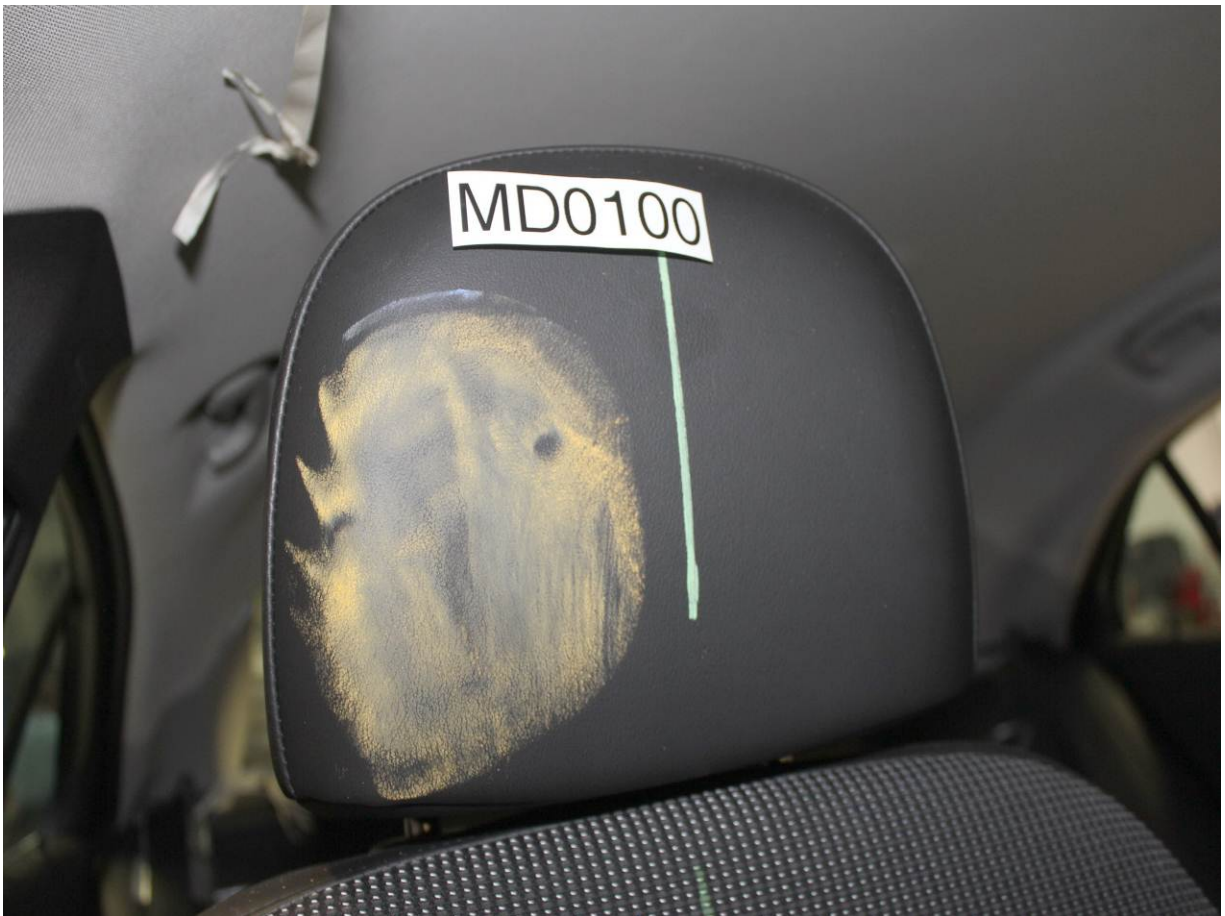
Post-Test Passenger Dummy Contact with Headrest

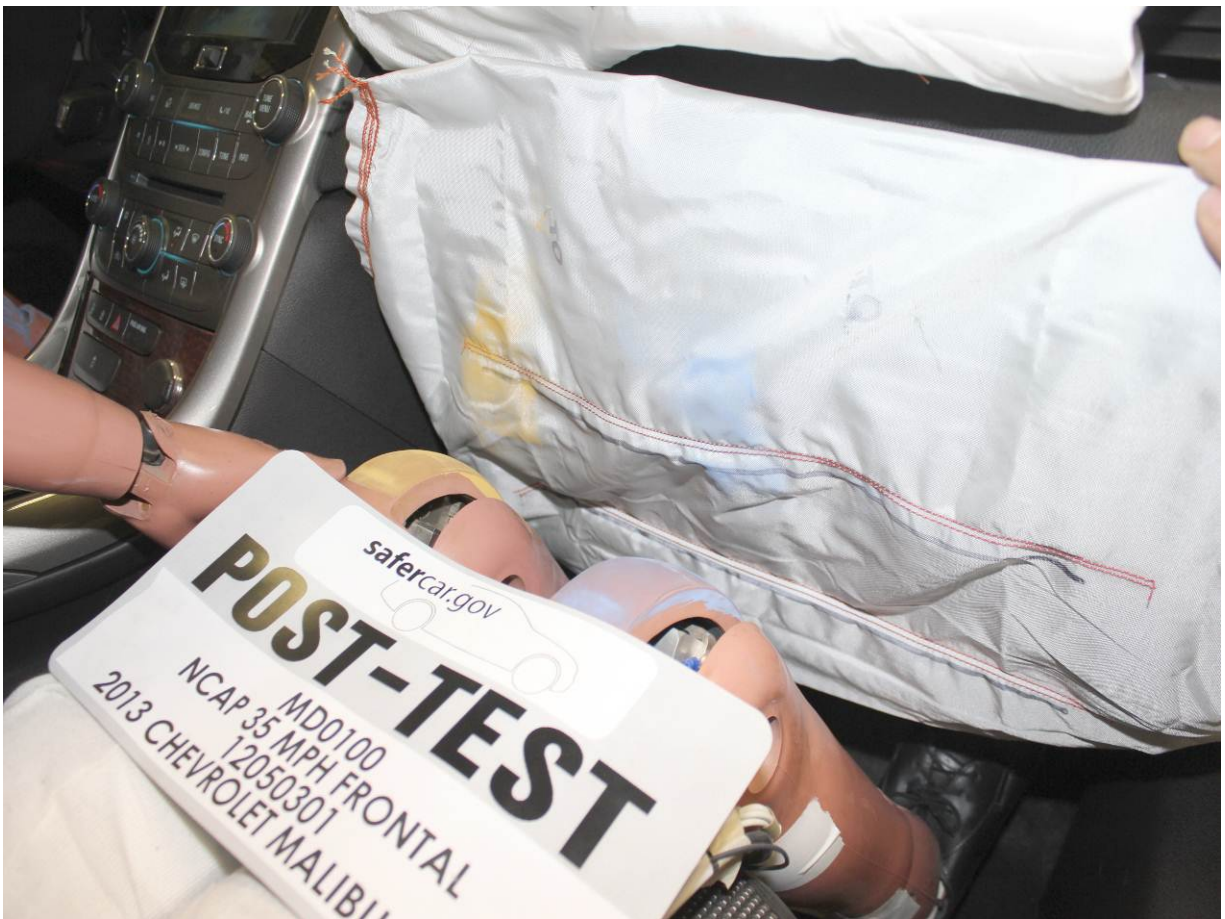
Post-Test Passenger Dummy Contact with Knee Airbag

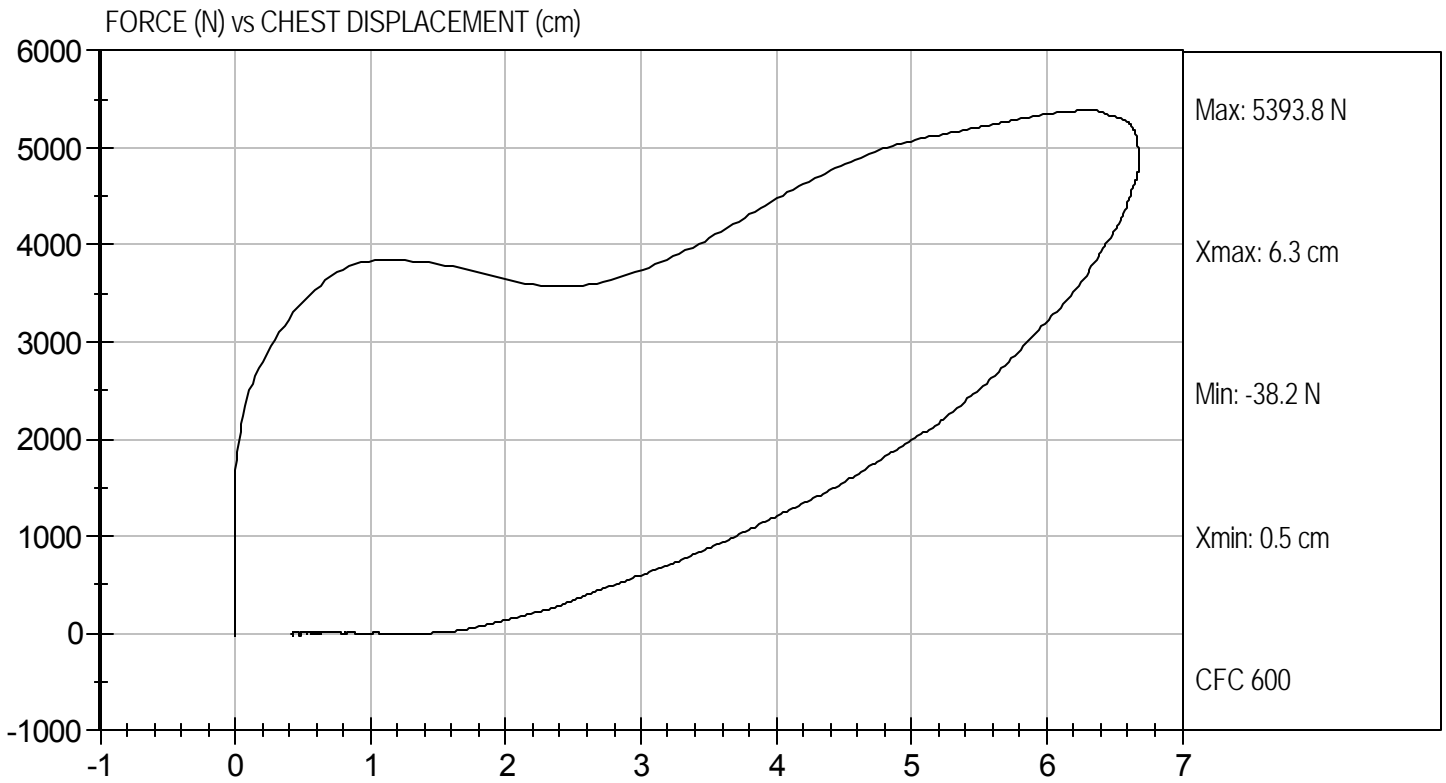
Test Desc: Thorax Impact  
Component ID: D121574

Test Date: 5/1/12  
Velocity: 22.22 ft/s, 6.77 m/s

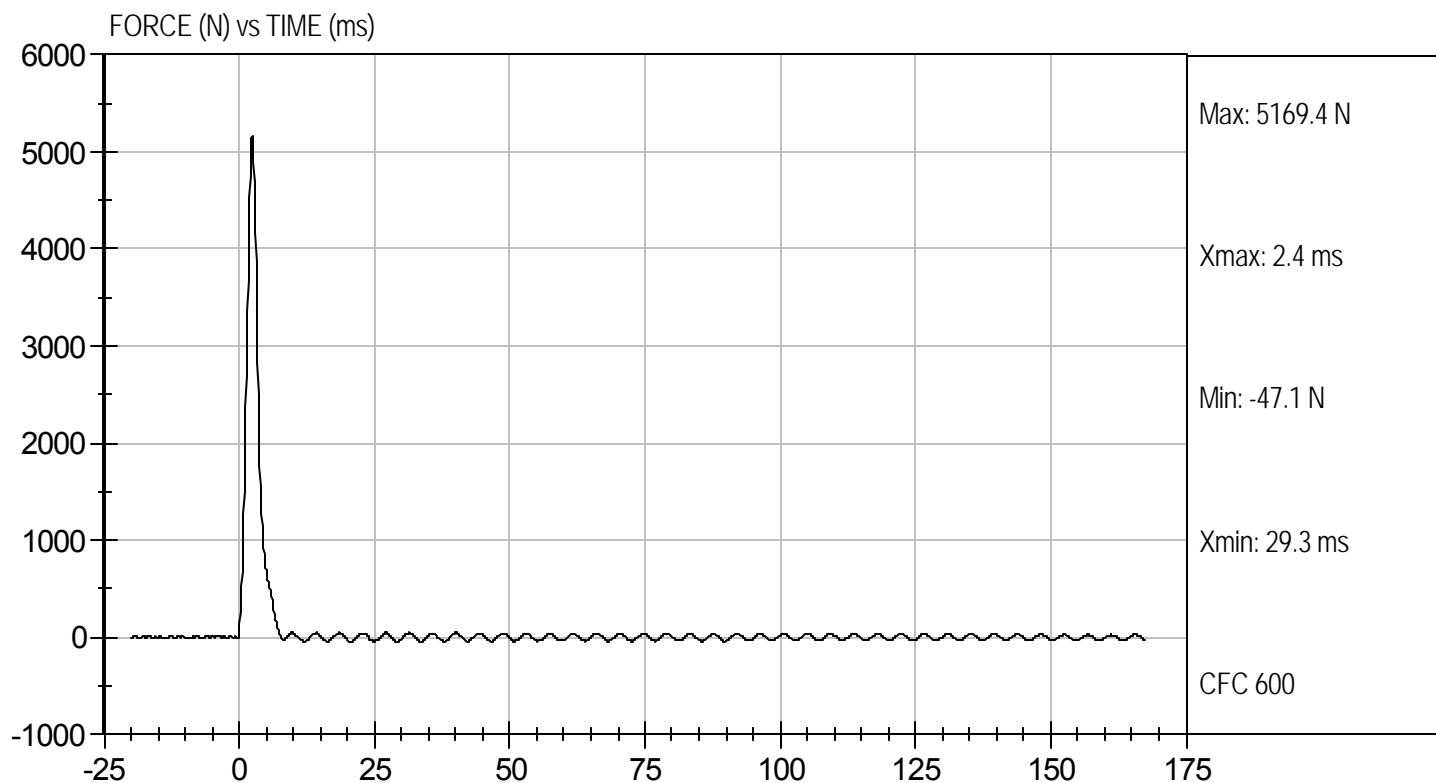
Test Desc: Right Knee  
Component ID: D121575

Test Date: 4/30/12  
Velocity: 6.97 ft/s, 2.12 m/s

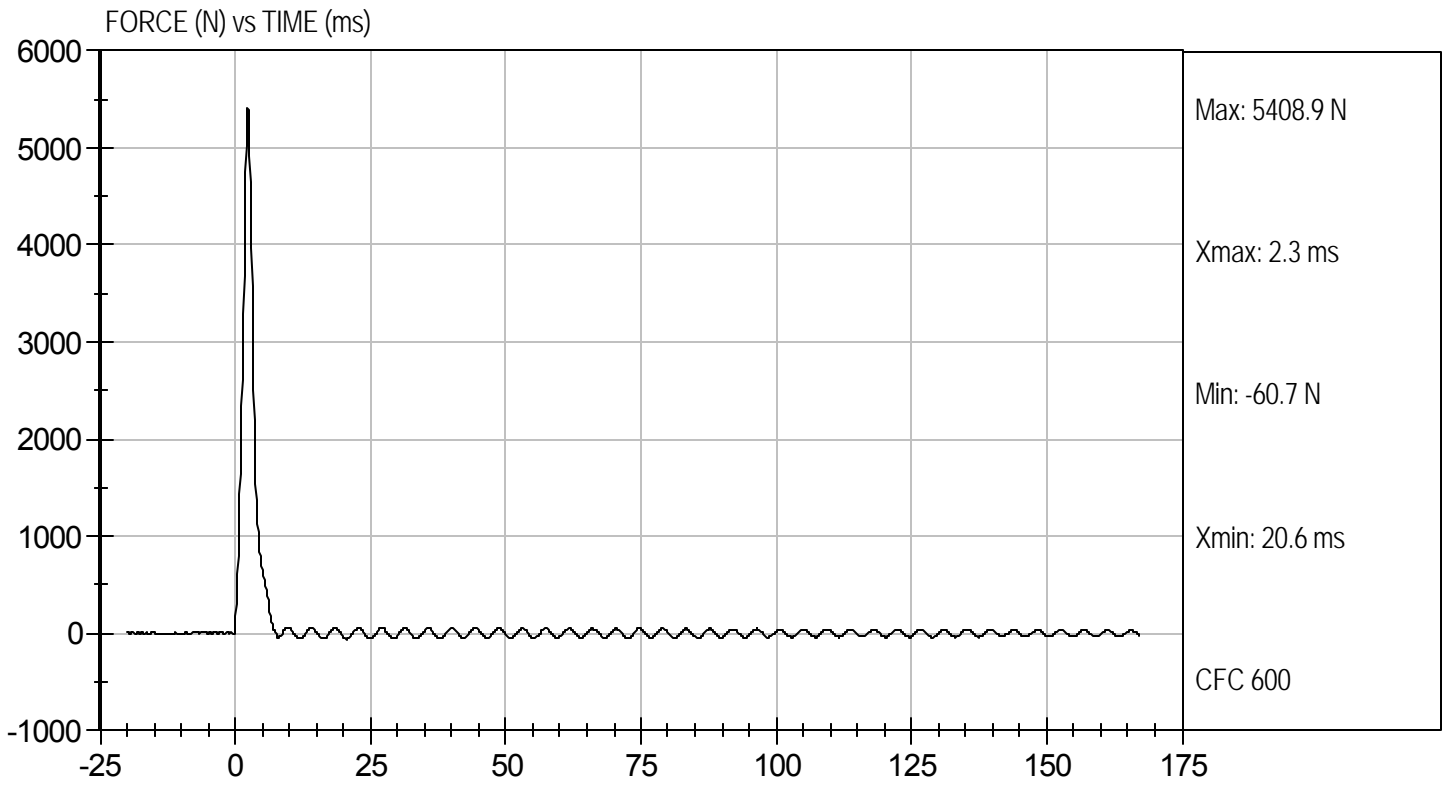
Test Desc: Left Knee  
Component ID: D121576

Test Date: 4/30/12  
Velocity: 6.97 ft/s, 2.12 m/s

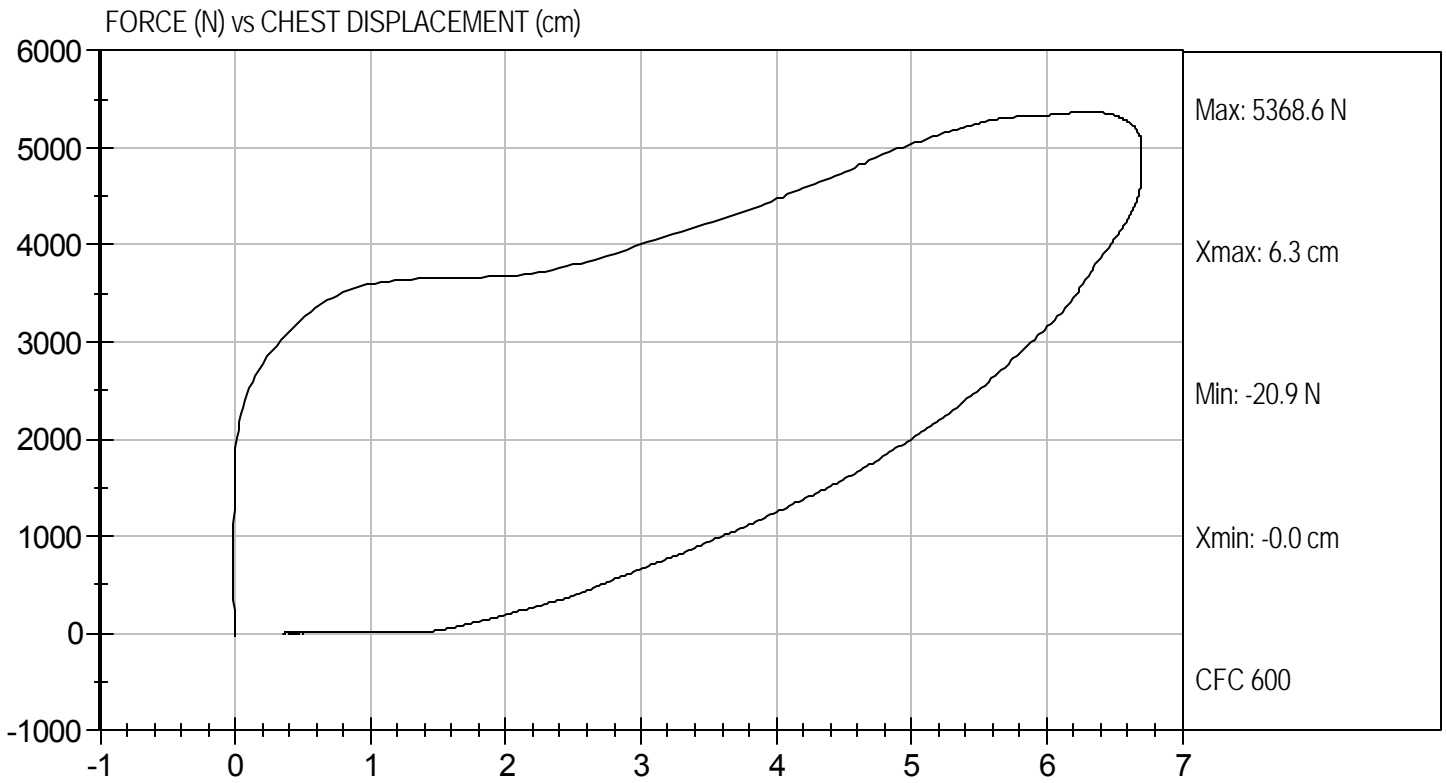
Test Desc: Thorax Impact  
Component ID: D121614

Test Date: 5/3/12  
Velocity: 21.93 ft/s, 6.68 m/s

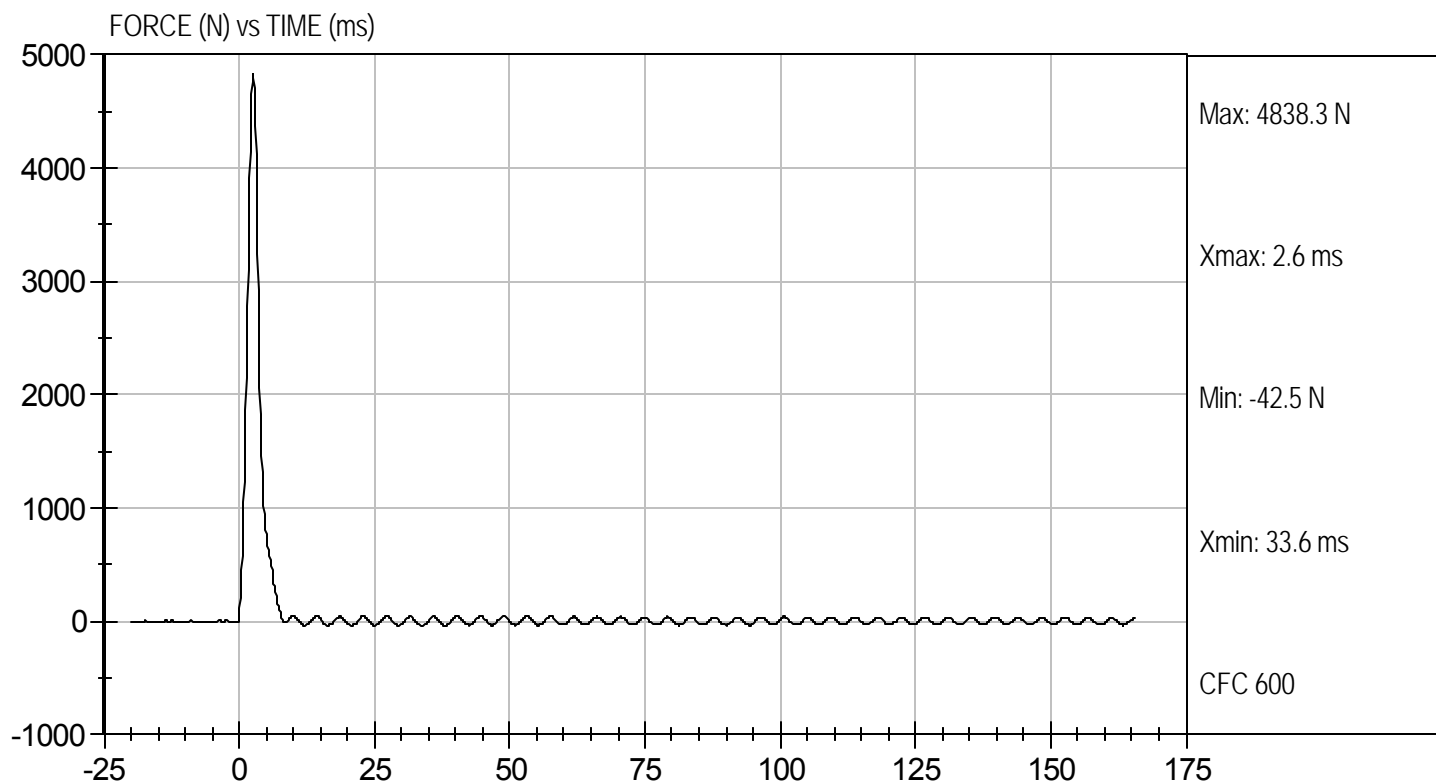
Test Desc: Right Knee  
Component ID: D121615

Test Date: 5/3/12  
Velocity: 6.97 ft/s, 2.12 m/s

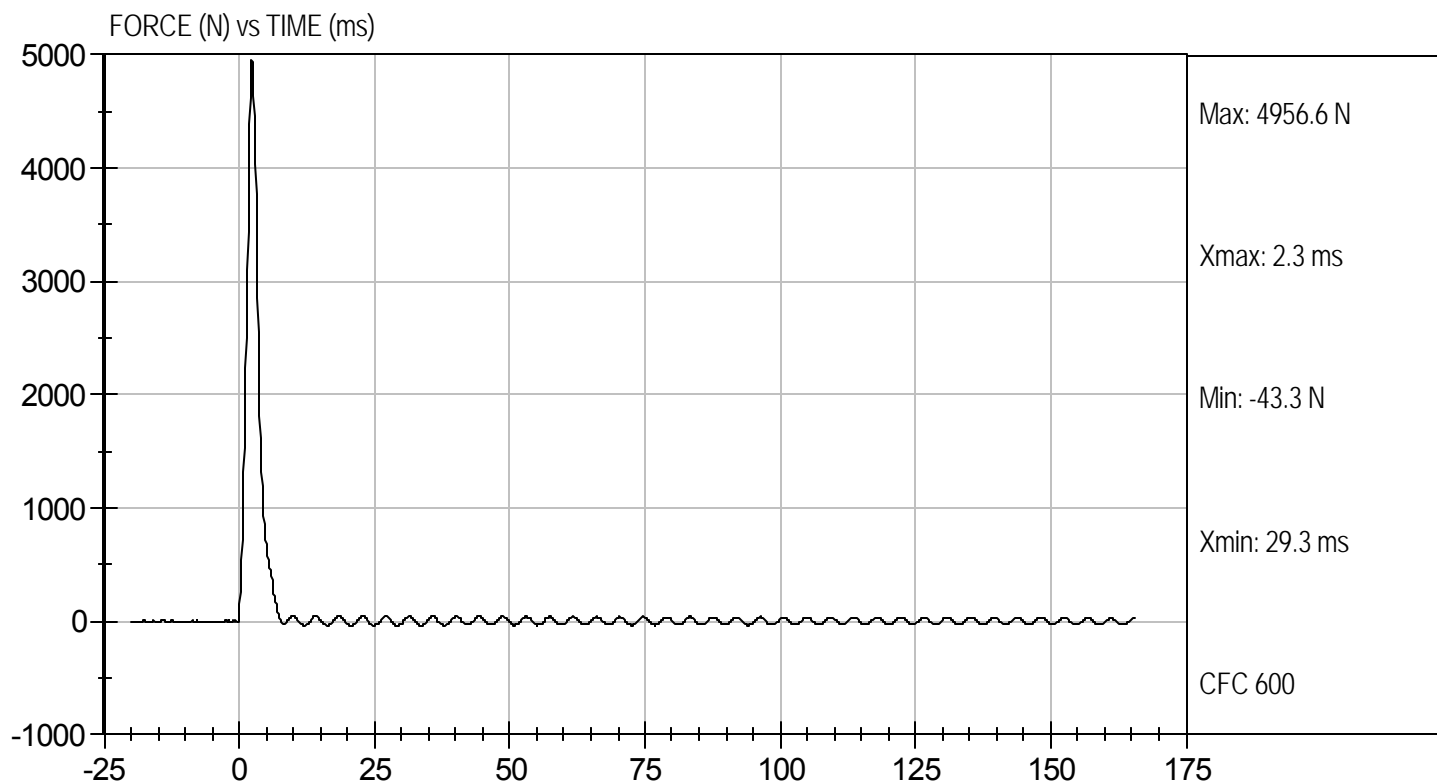
Test Desc: Left Knee  
Component ID: D121616

Test Date: 5/3/12  
Velocity: 6.97 ft/s, 2.12 m/s

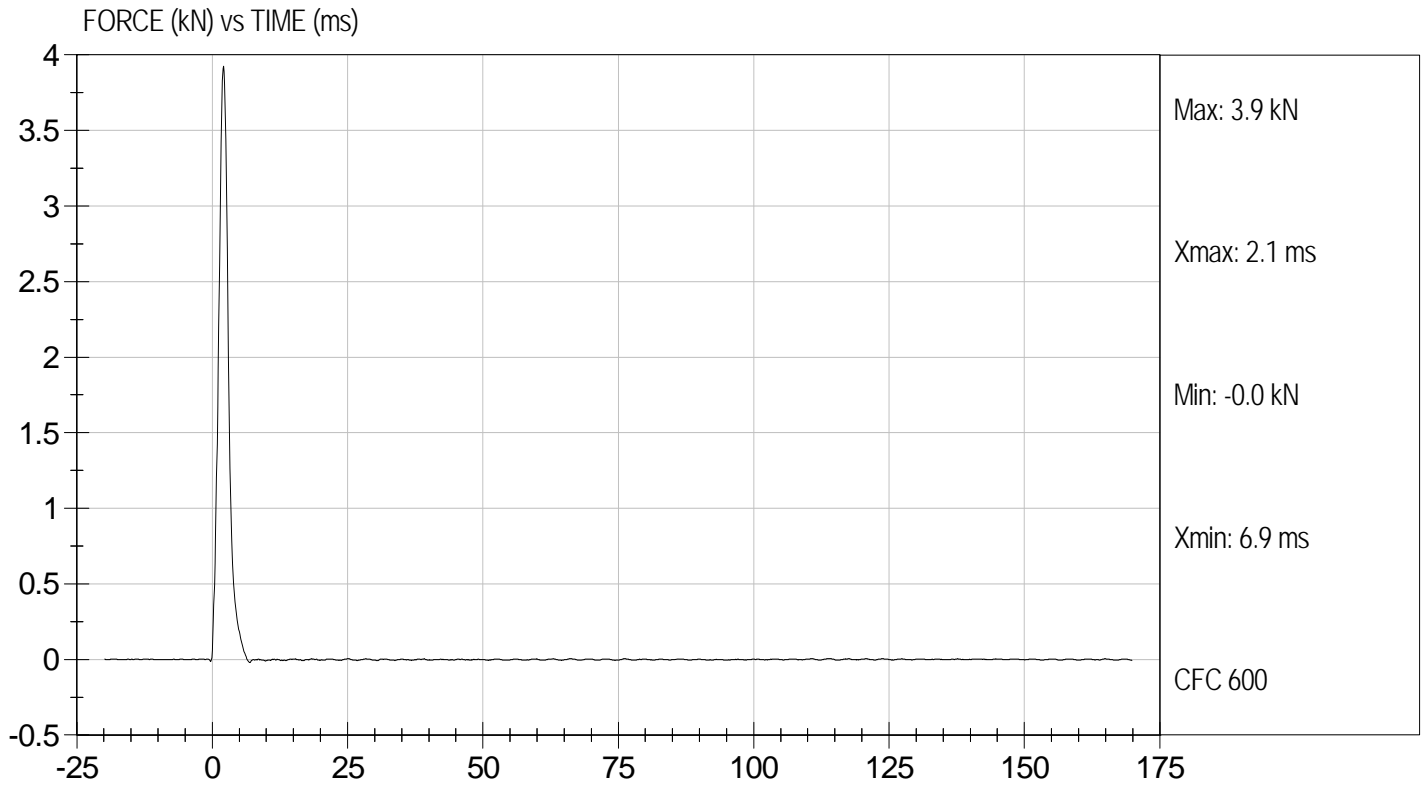
Test Desc: Right Knee  
Component ID: D12815

Test Date: 3/5/12  
Velocity: 6.97 ft/s, 2.12 m/s
