REPORT NUMBER: NCAP-KAR-12-064

**NEW CAR ASSESSMENT PROGRAM (NCAP)
FRONTAL BARRIER IMPACT TEST**

**BAYERISCHE MOTOREN WERKE AG
2012 BMW 328i 4-DOOR SEDAN**

NHTSA NUMBER: MC0518

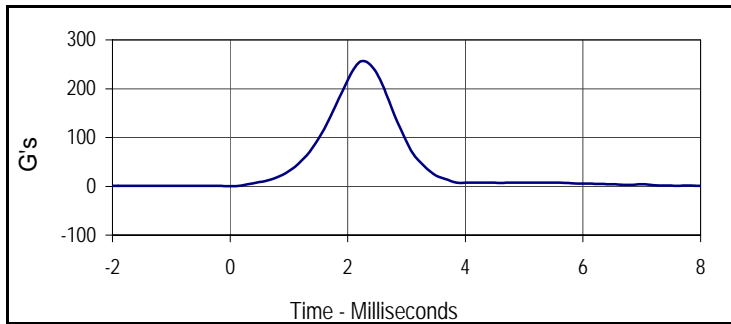
Curve Description			
Head Resultant			
Plot No.	Type	SAE Class	Units
001	RES	1000	G's
Max	Time	Min	Time
256.2	2.3	0.2	0.0

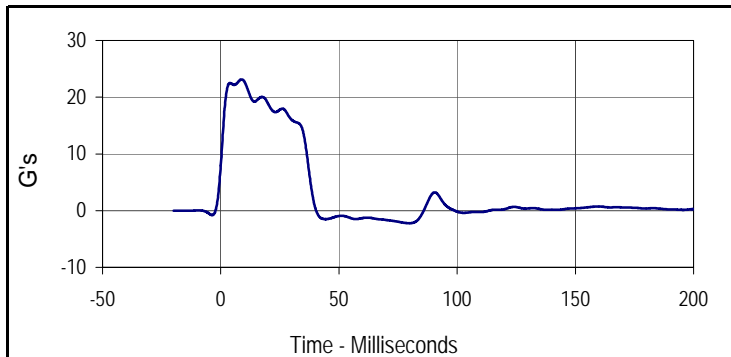
Curve Description			
Pendulum Deceleration			
Plot No.	Type	SAE Class	Units
001	FIL	60	G's
Max	Time	Min	Time
23.1	8.8	-2.2	79.8

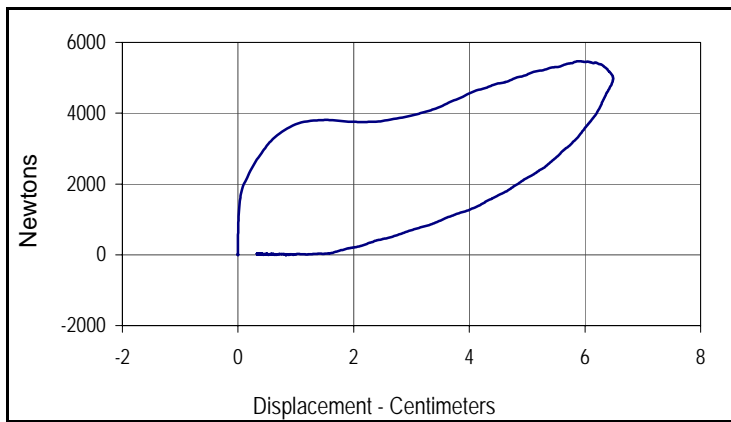
Curve Description			
Probe Force vs. Chest Deflection			
Plot No.	Type	SAE Class	Hysteresis
001	FIL	180	70.9
Peak Probe Force		Peak Chest Deflection	
5467		6.49

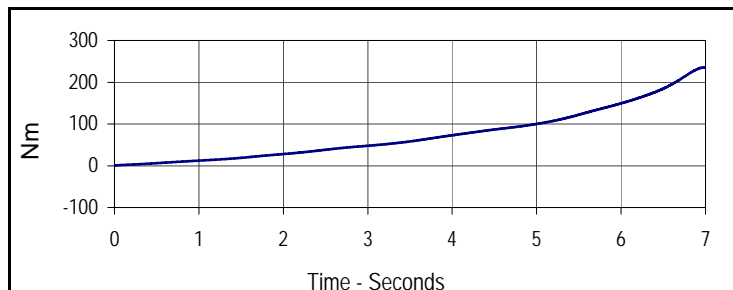
Curve Description			
Right Femur Torque			
Plot No.	Type	SAE Class	Units
004	FIL	600	Nm
Max	Time	Min	Time
235.7	7.0	1.0	0.0

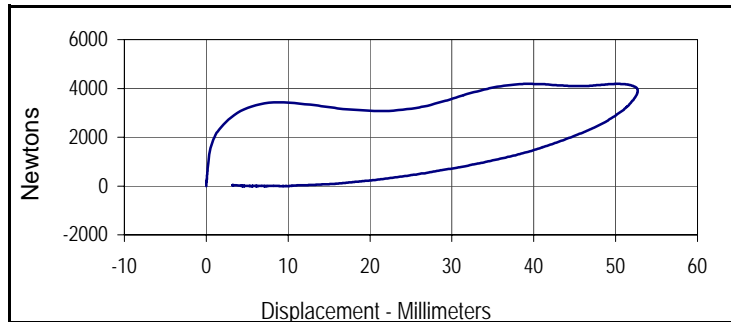
Curve Description			
Probe Force vs. Chest Deflection			
Plot No.	Type	SAE Class	Hysteresis
001	FIL	180	75.3
Peak Probe Force		Peak Chest Deflection	
4189.9		52.7

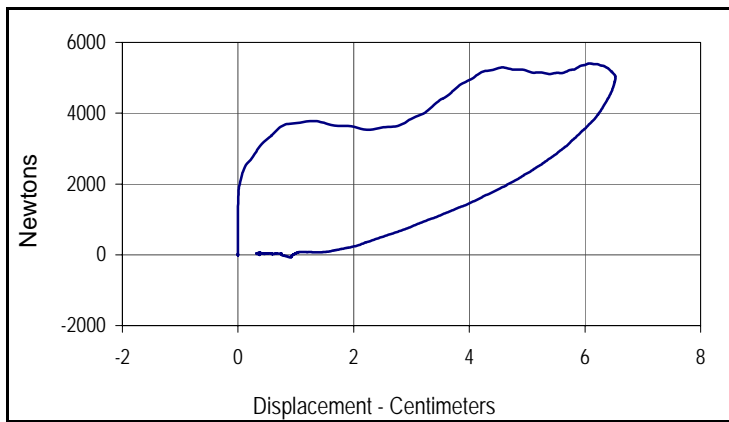
Curve Description			
Probe Force vs. Chest Deflection			
Plot No.	Type	SAE Class	Hysteresis
001	FIL	180	69.1
Peak Probe Force		Peak Chest Deflection	
5406		6.53

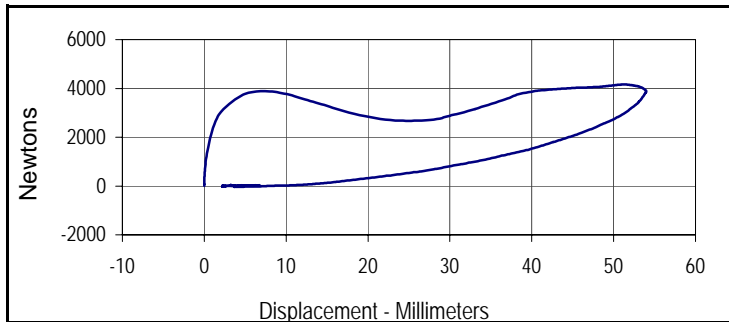
Curve Description			
Probe Force vs. Chest Deflection			
Plot No.	Type	SAE Class	Hysteresis
001	FIL	180	71.8
Peak Probe Force		Peak Chest Deflection	
4159.9		54.0
