**REPORT NUMBER: SPNCAP-KAR-12-066**

**NEW CAR ASSESSMENT PROGRAM (NCAP)  
SIDE IMPACT POLE TEST**

**BAYERISCHE MOTOREN WERKE AG  
2012 BMW 328I 4-DOOR SEDAN**

**FINAL REPORT**

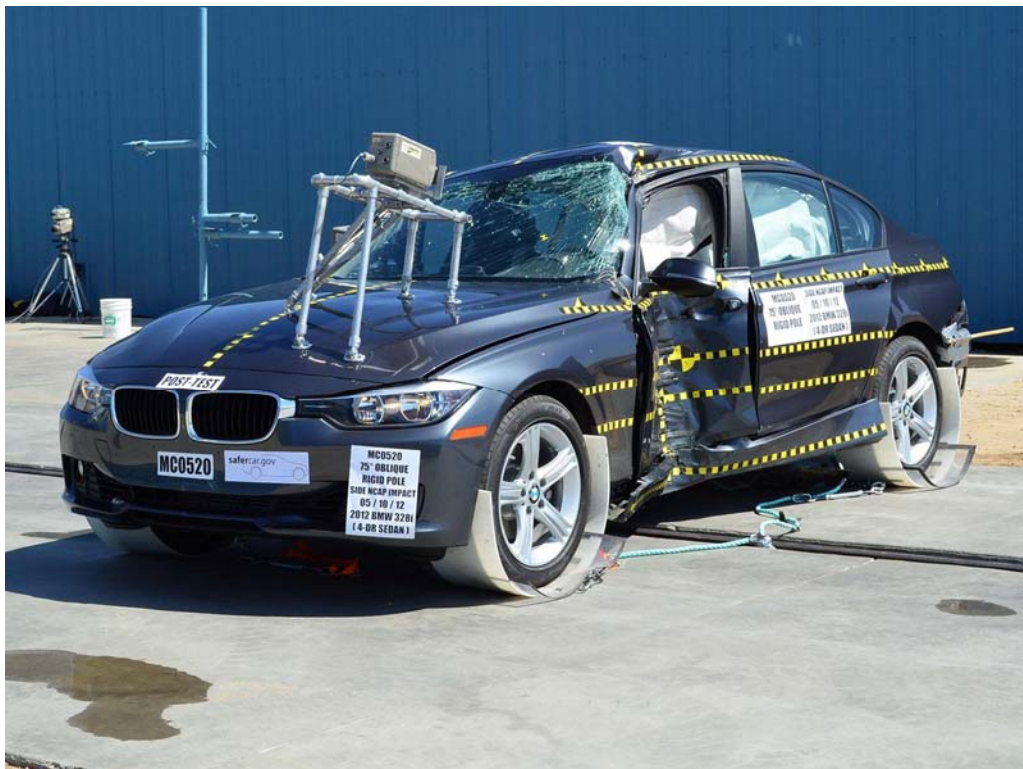
FIGURE 6. Post-Test Left Front  $\frac{3}{4}$  View of Test Vehicle

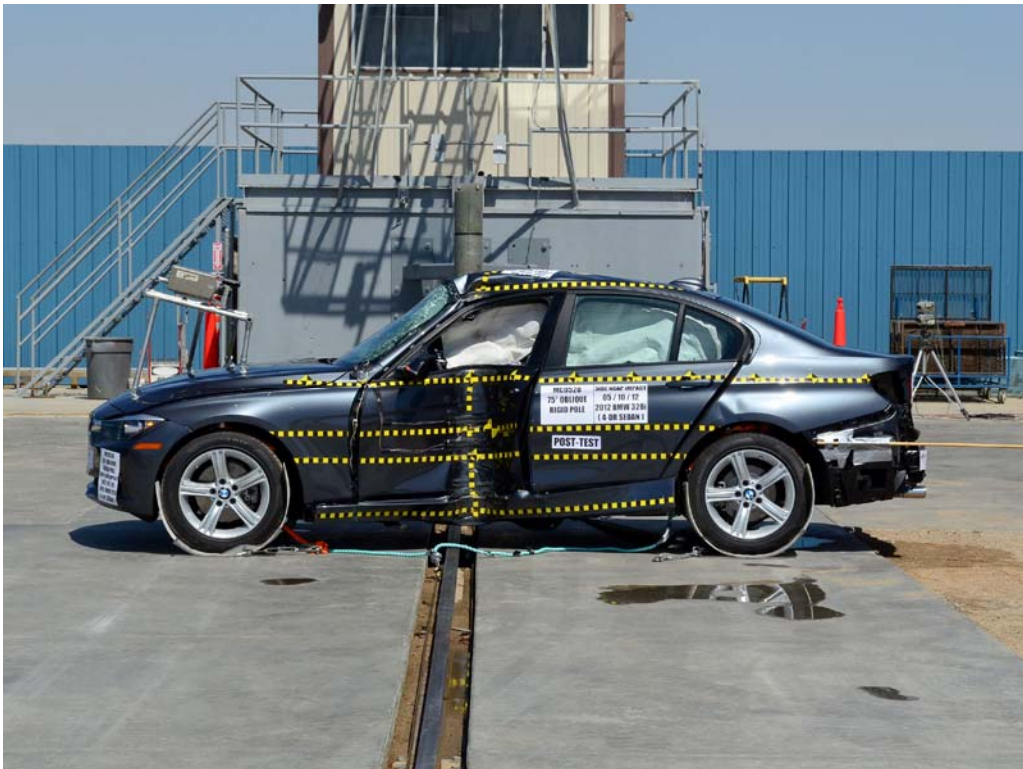
FIGURE 8. Post-Test Left Side View of Test Vehicle

Both the front and rear doors on the struck side of the vehicle remained closed and latched. There was no separation at the hinges or latches. Both doors on the non-struck side remained closed and latched. There were no ATD values that exceeded limits.

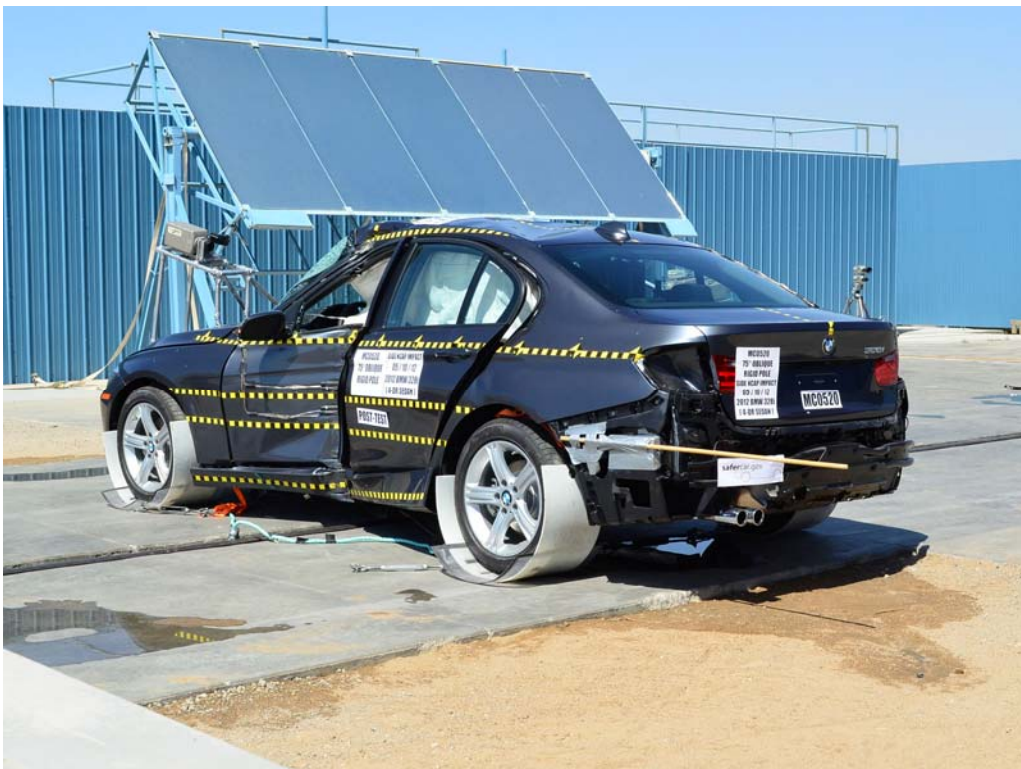
FIGURE 10. Post-Test Left Rear  $\frac{3}{4}$  View of Test Vehicle

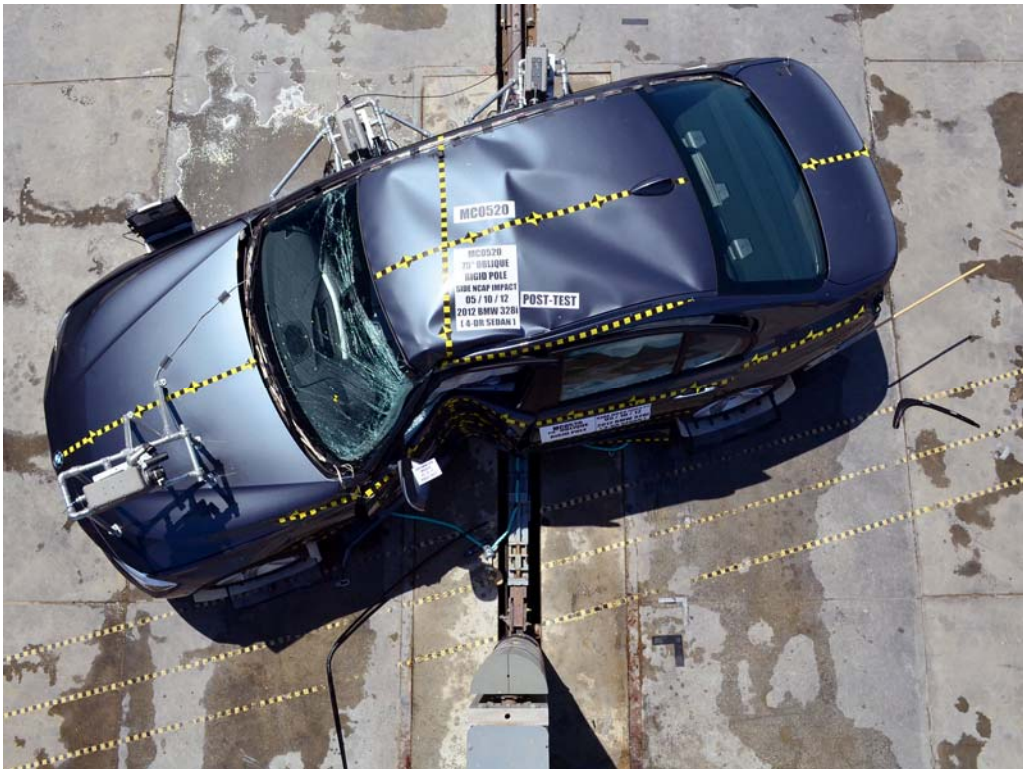
FIGURE 16. Post-Test Overhead View of Test Vehicle and Pole

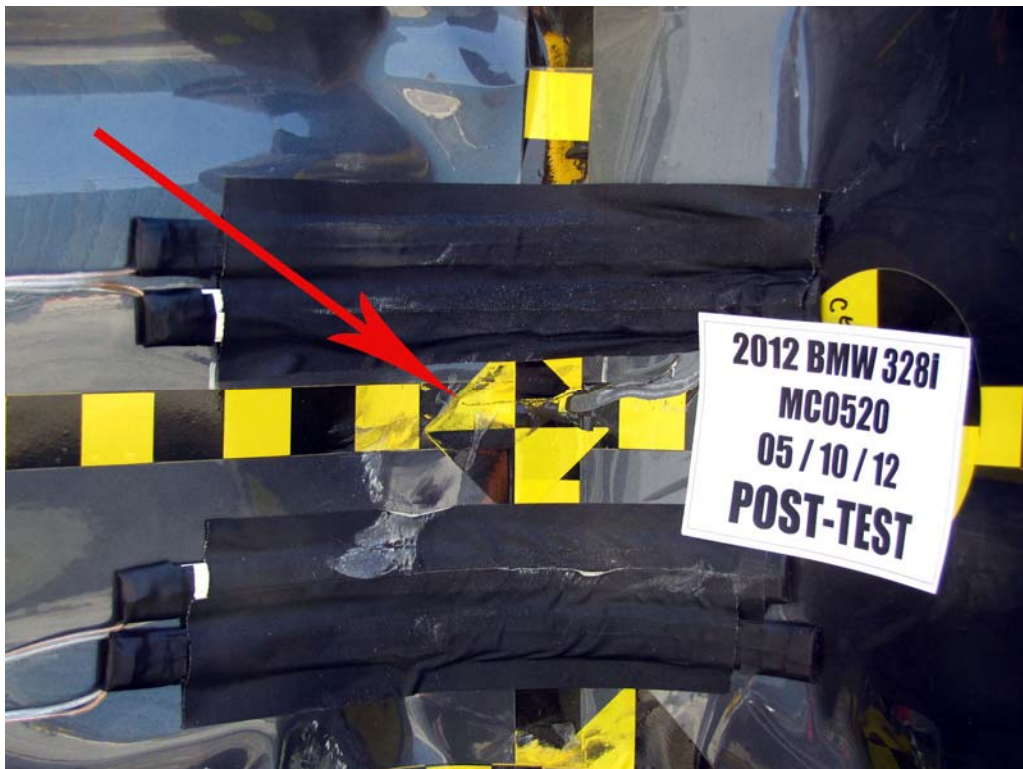
FIGURE 20. Post-Test Close-Up View of Impact Point Target Showing Impact Location

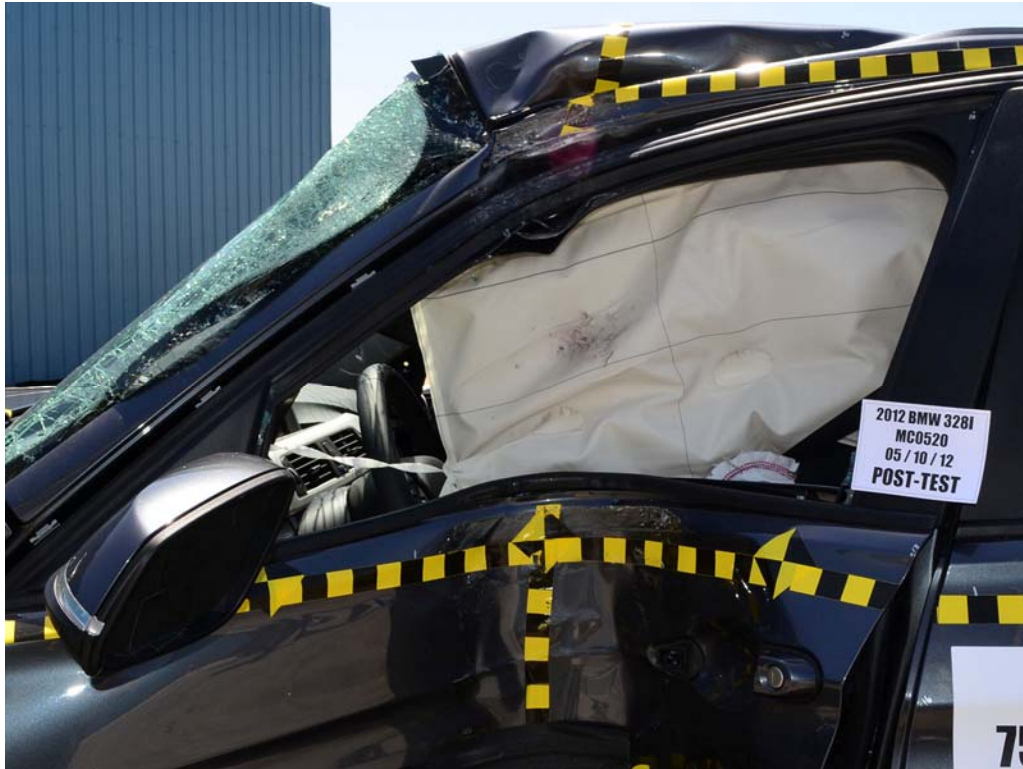
FIGURE 25. Post-Test Left Side View of Dummy Shoulder and Door Top View

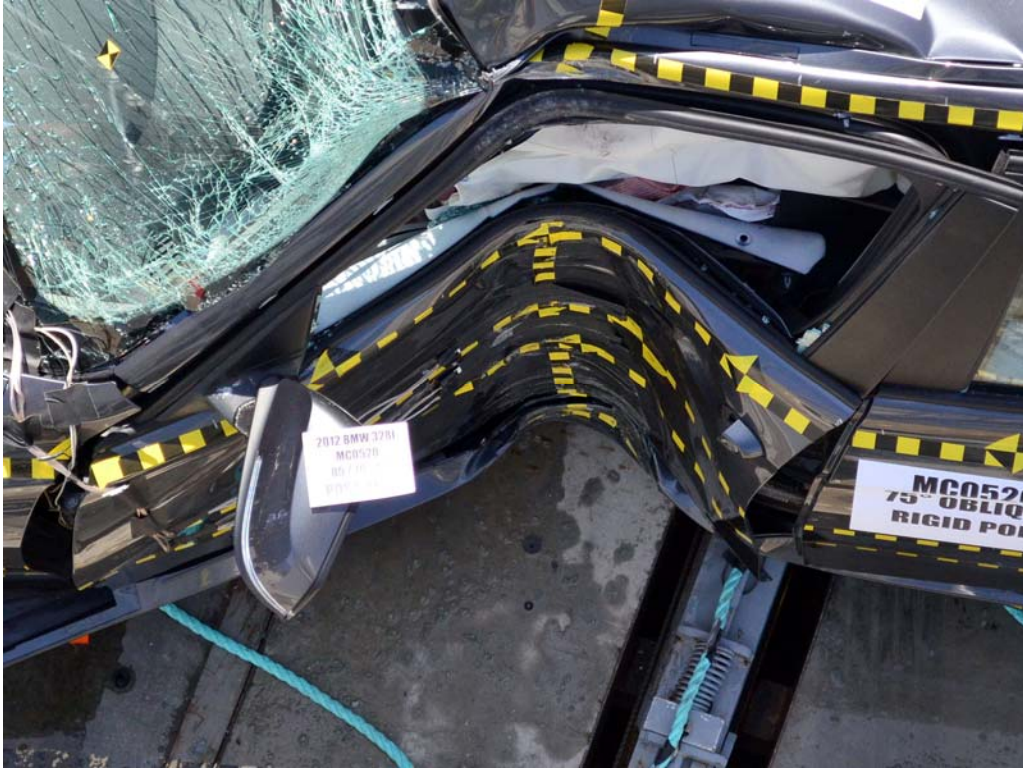
FIGURE 41. Post-Test Driver Dummy and Door Clearance

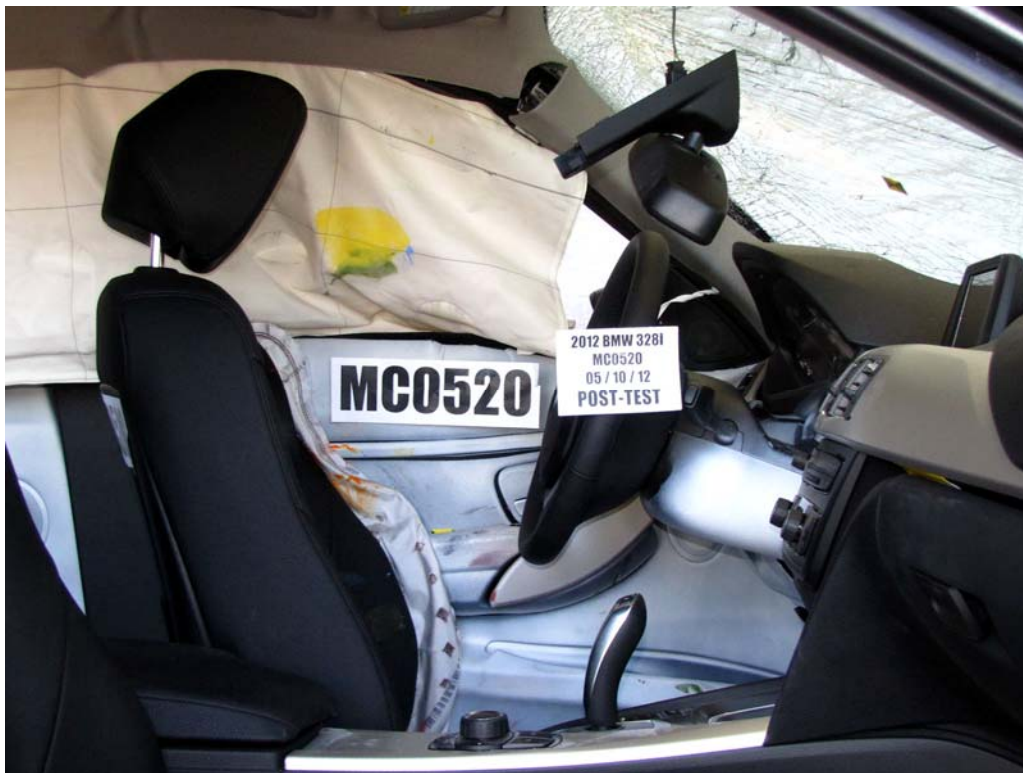
FIGURE 45. Post-Test Inner Driver Door Panel View  
Showing Dummy Contact Locations

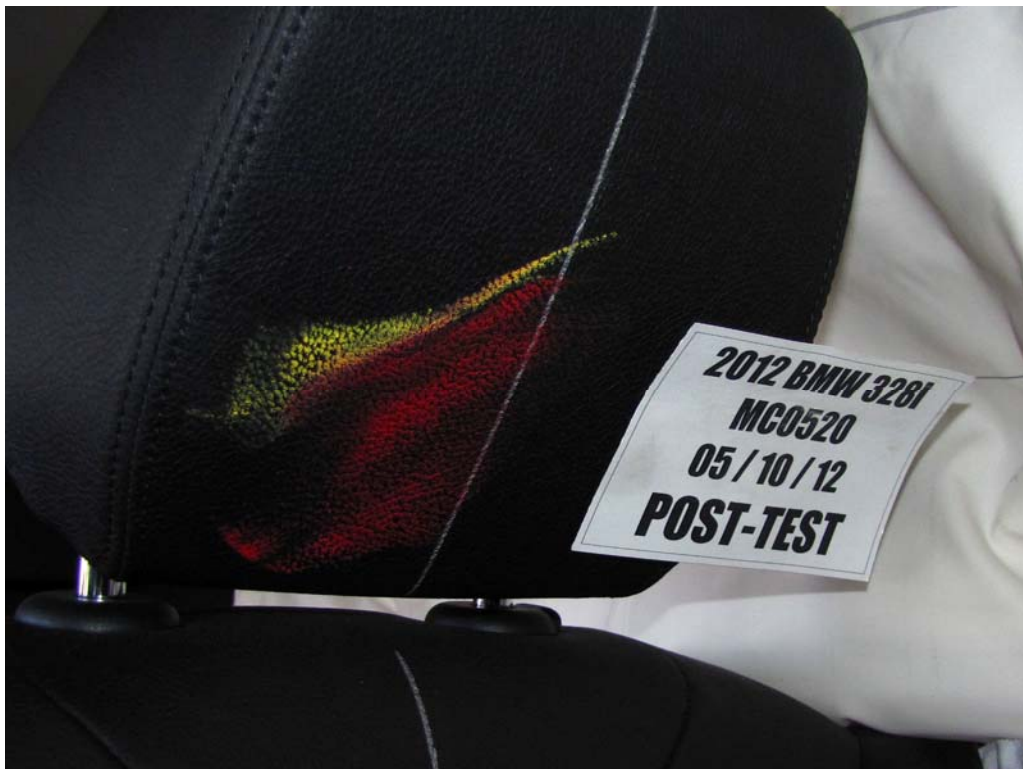
FIGURE 46. Post-Test Dummy Close-Up Head Contact with Vehicle Interior View

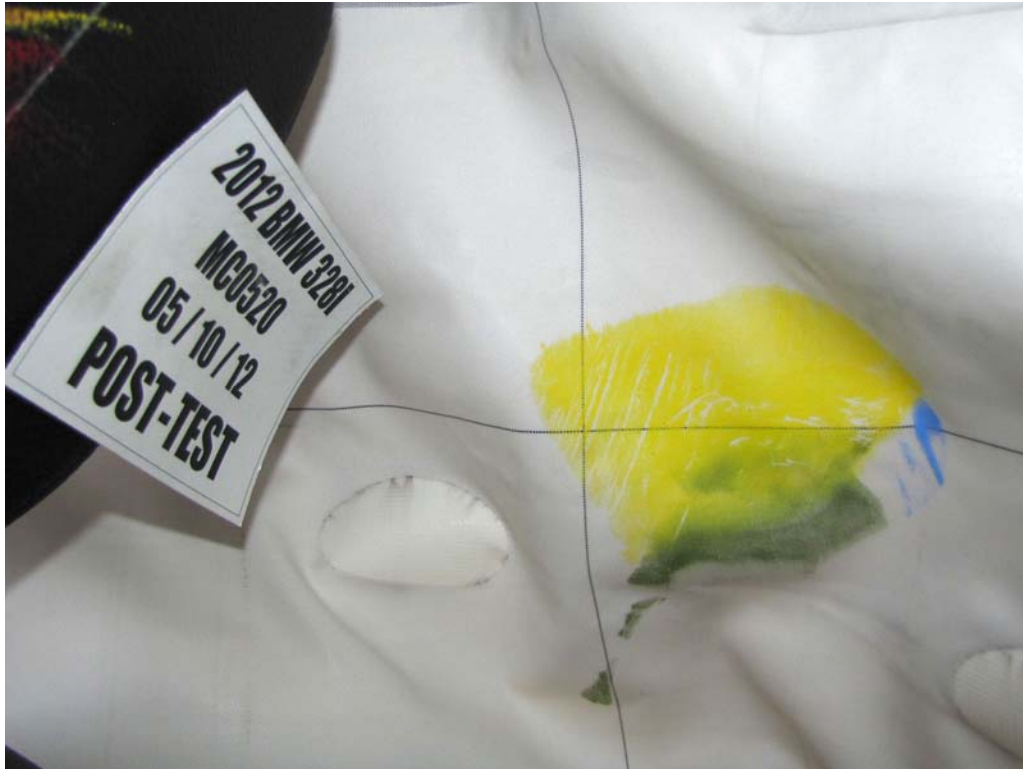
FIGURE 47. Post-Test Dummy Close-Up Head Contact with Side Airbag View

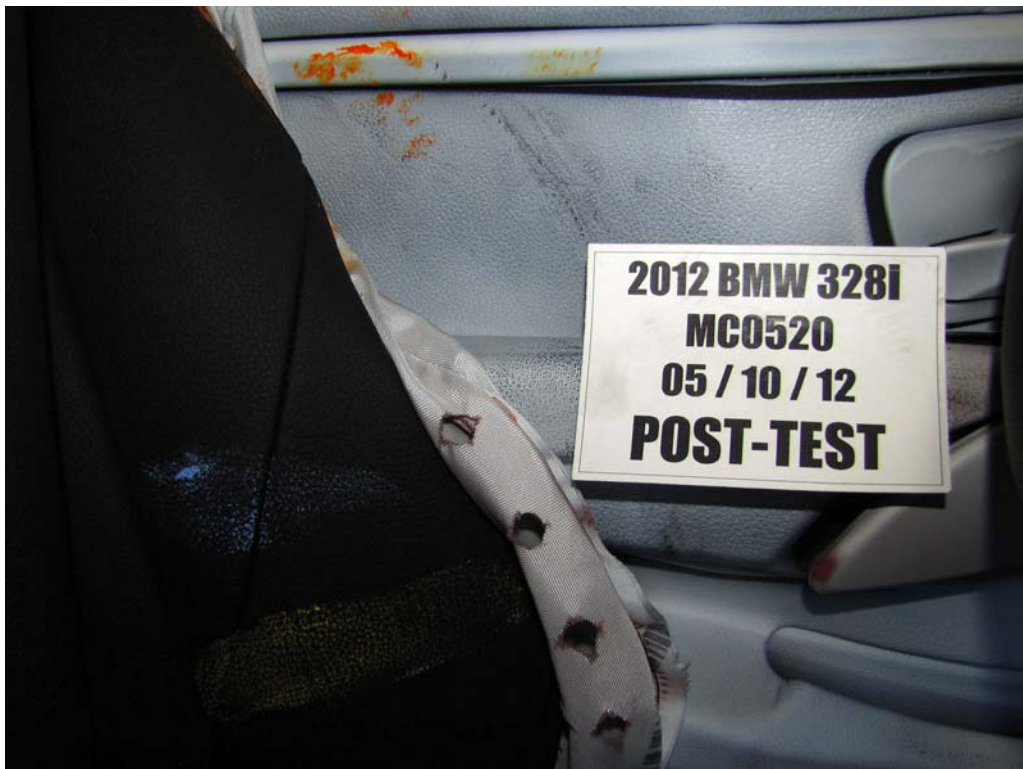
FIGURE 48. Post-Test Dummy Close-Up Torso Contact with Vehicle Interior View

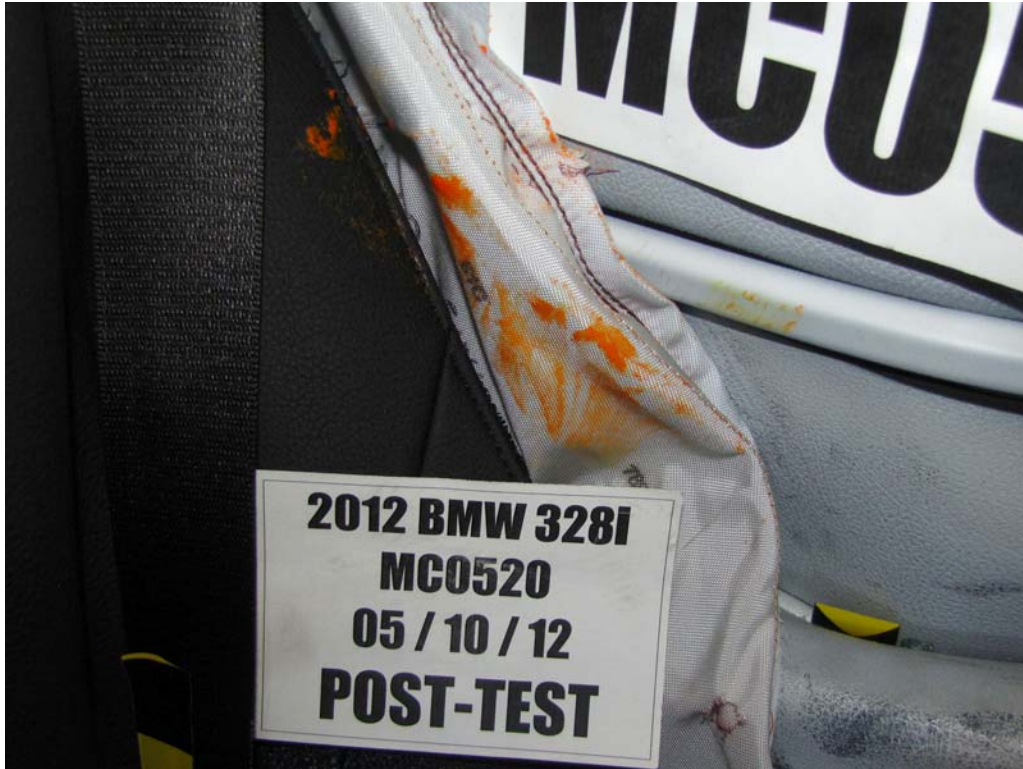
FIGURE 49. Post-Test Dummy Close-Up Torso Contact with Side Airbag View

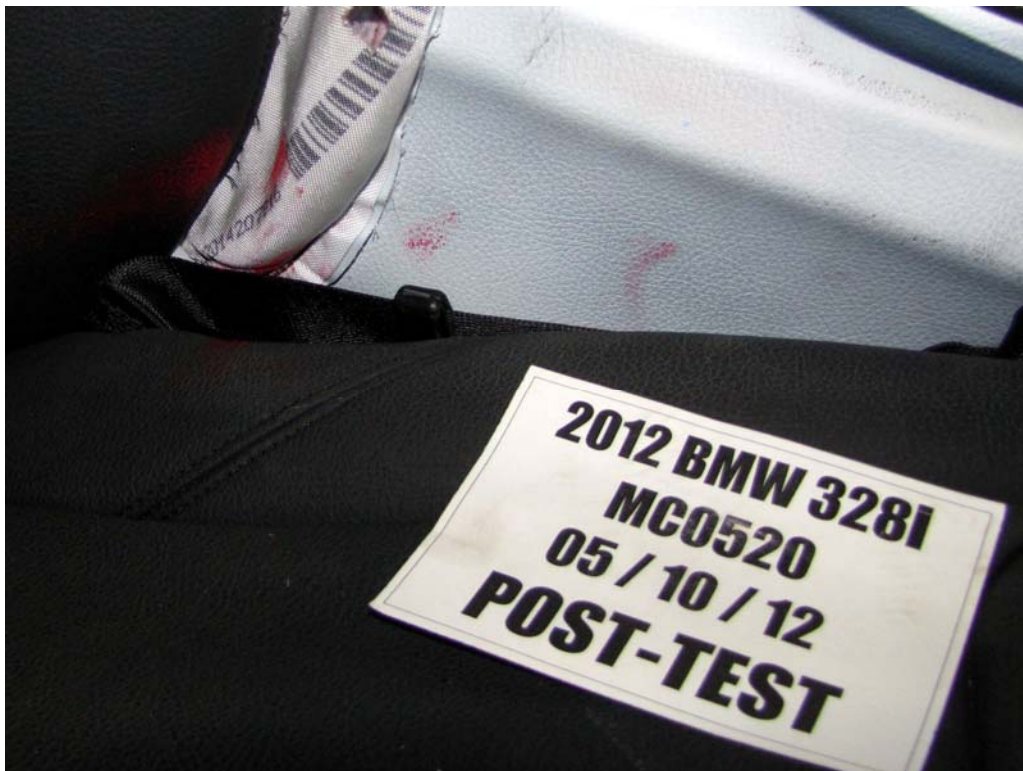
FIGURE 50. Post-Test Dummy Close-Up Pelvis Contact with Vehicle Interior View

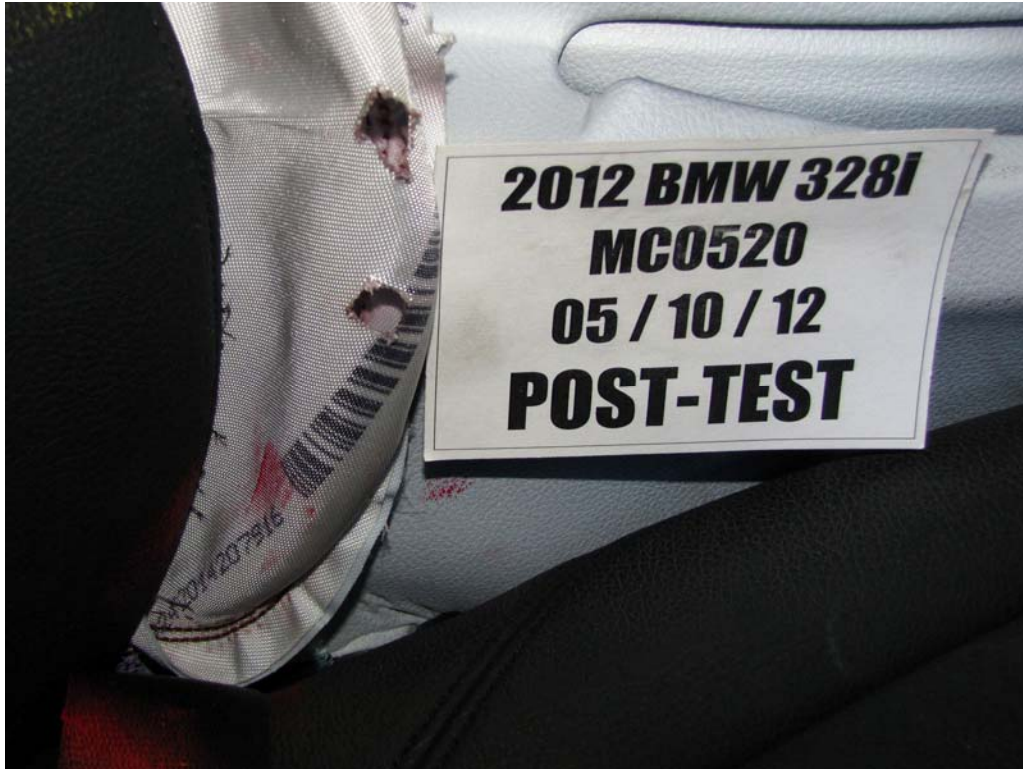
FIGURE 51. Post-Test Dummy Close-Up Pelvis Contact with Side Airbag View

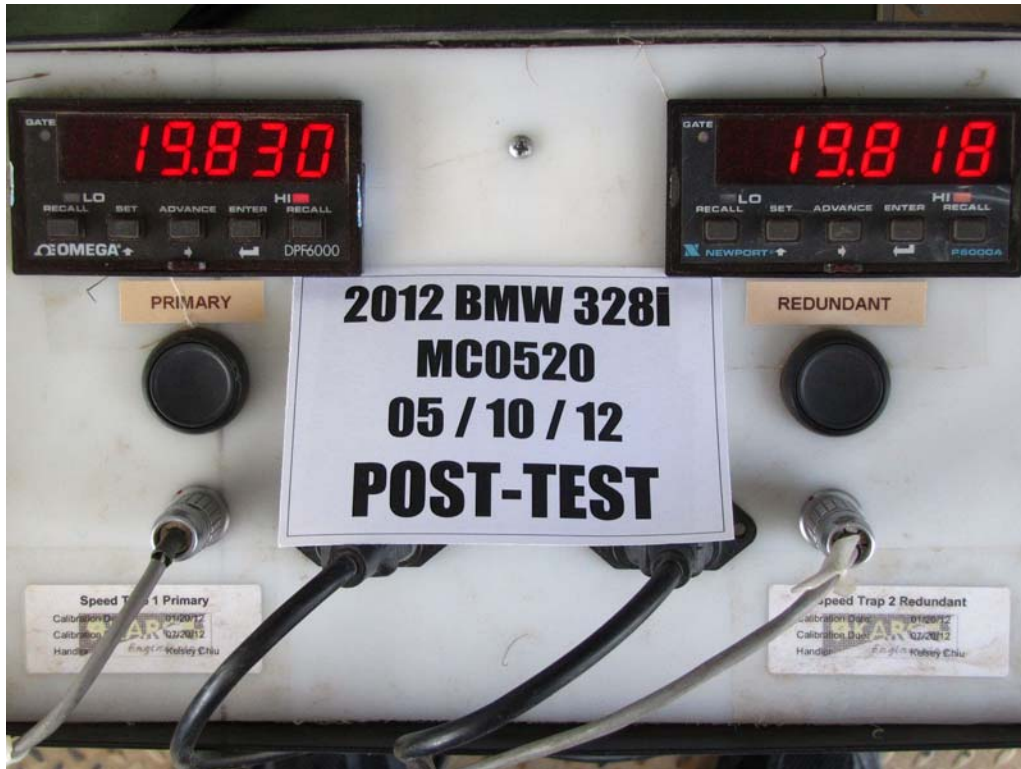
FIGURE 61. Post-Test Primary and Redundant Speed Trap Read-Out

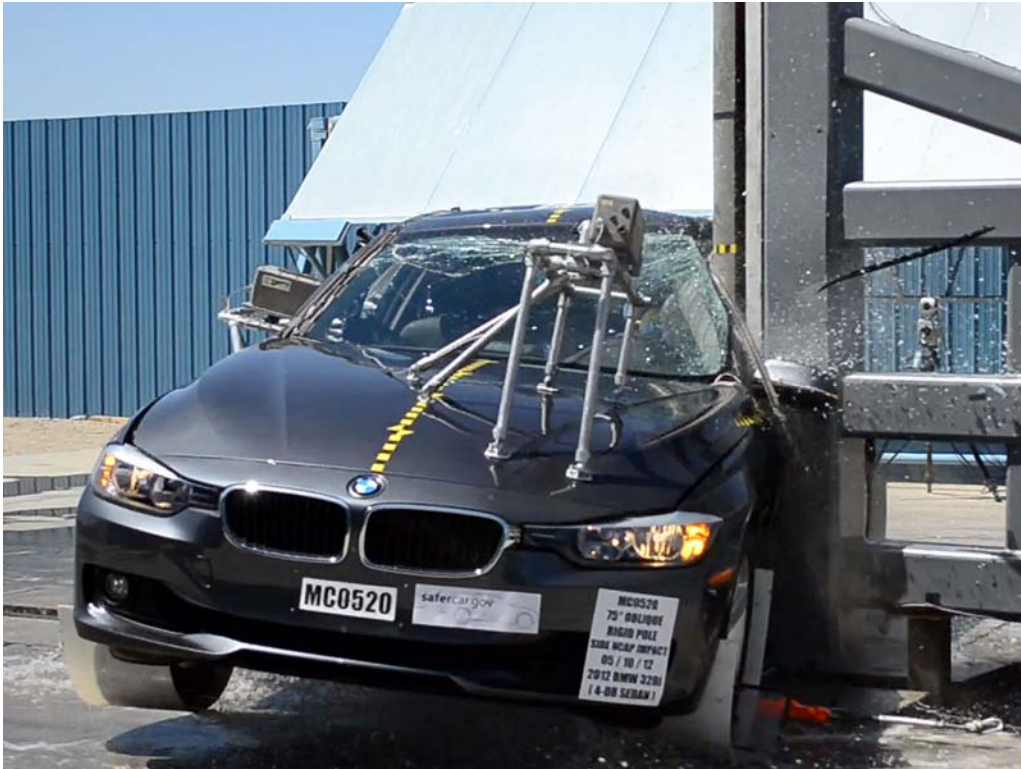
FIGURE 67. Impact Event
