REPORT NUMBER: NCAP305I-MGA-2012-010

**NEW CAR ASSESSMENT PROGRAM (NCAP)
FMVSS No. 305 Indicant Test**

**MITSUBISHI MOTORS CORPORATION, JAPAN
2012 Mitsubishi i-MiEV 5-Dr Hatchback Hybrid Sedan
NHTSA No.: MC5607**

**MGA RESEARCH CORPORATION
5000 Warren Road
Burlington, WI 53105**

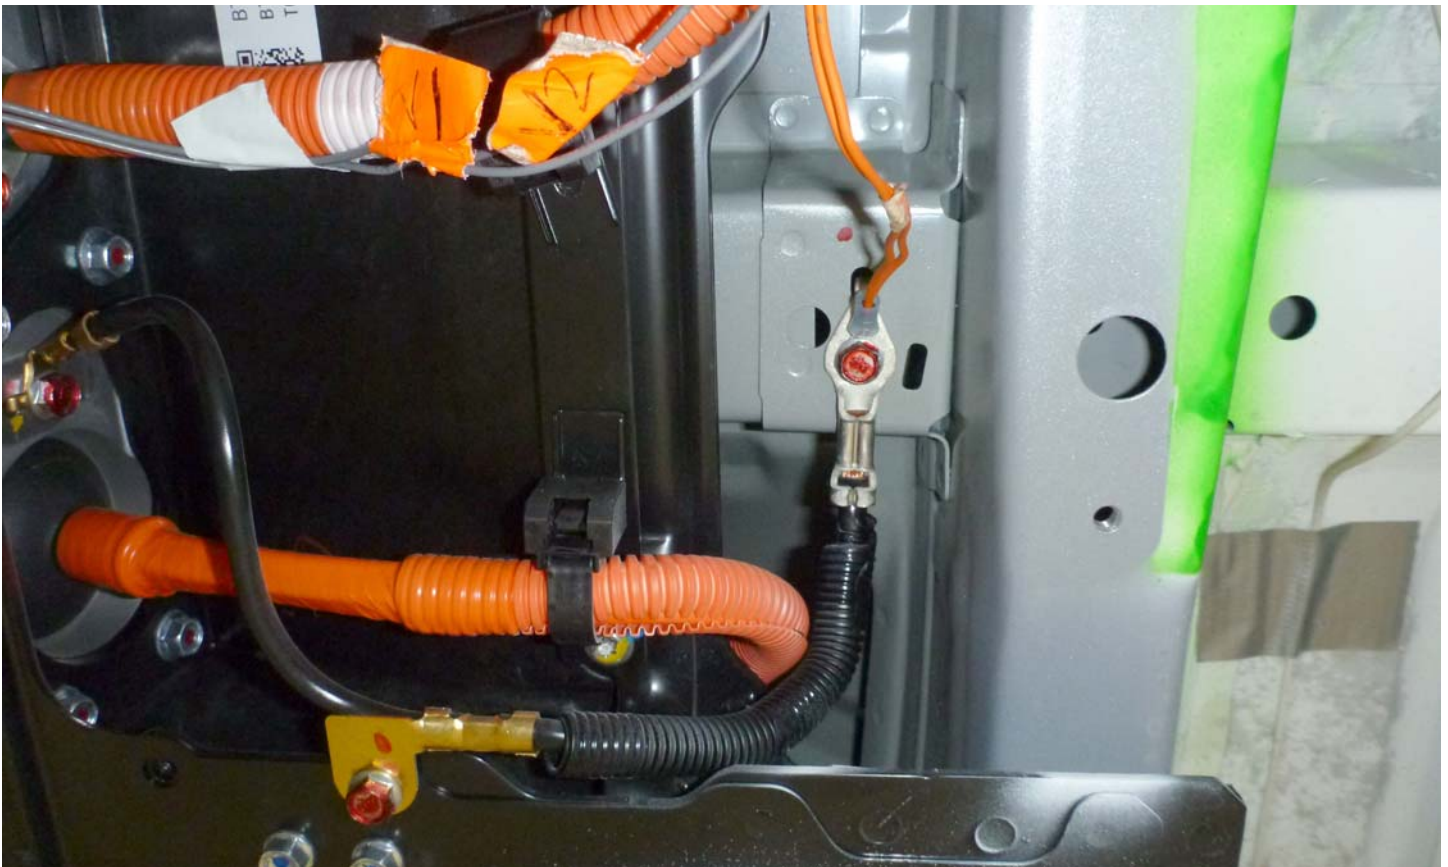
No. 021 Pre-Impact View of Ground Lead Attached

Details of Vehicle Chassis Ground Point(s) & Location(s)	Ground located on the vehicle underbody on the passenger side of the HV battery pack. Wire is connected with a 10 mm socket bolt.
--	--

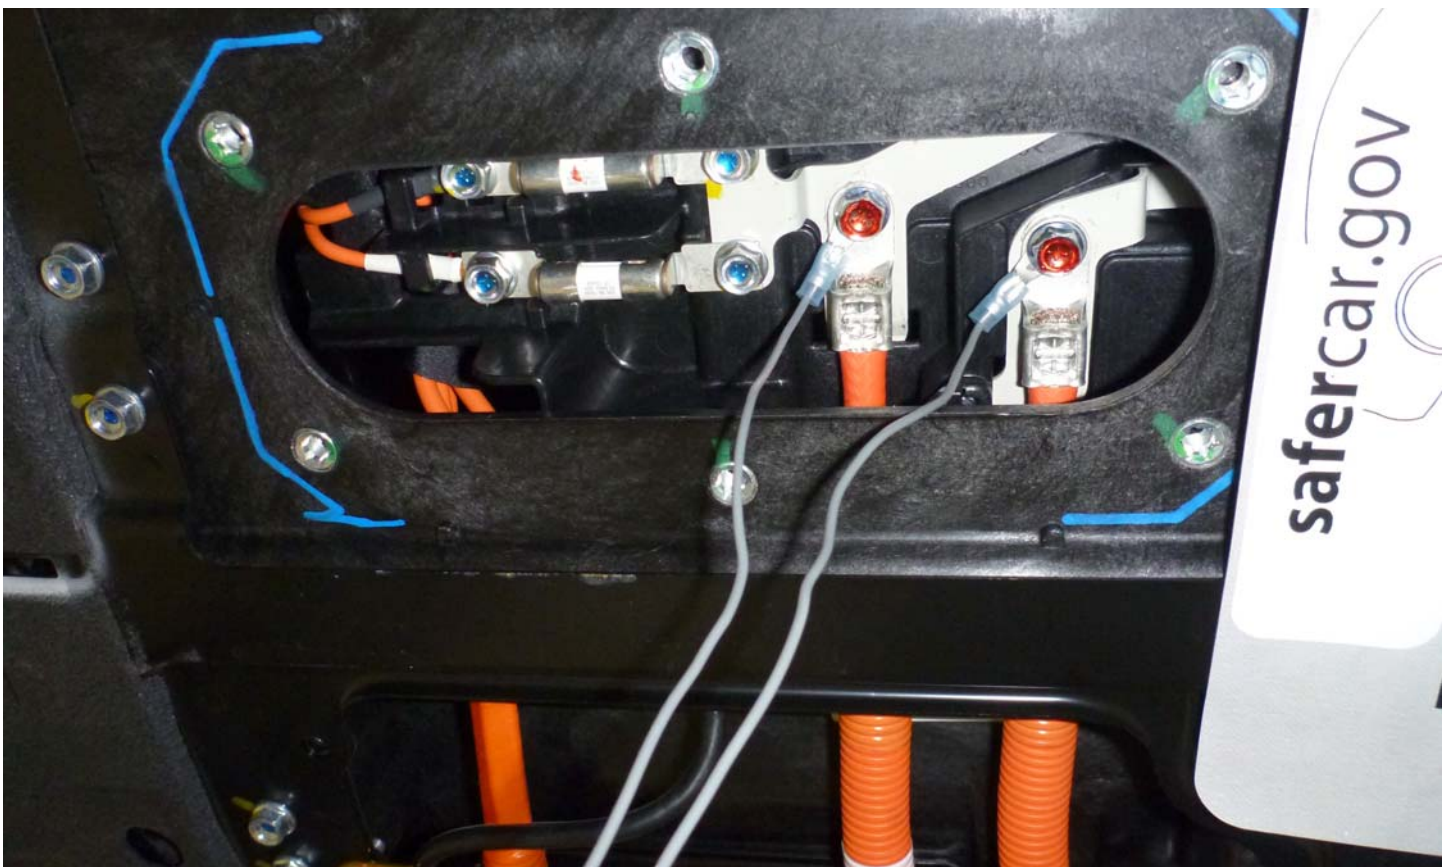
No. 022 Pre-Impact View of High Voltage Leads Attached

Details of Electric Energy Storage/Conversion System Test Points:	The access panel is on the bottom of the HV pack on the passenger side. The panel is removed to access the positive and negative terminals. The wires are connected with 10 mm socket bolts.
---	--

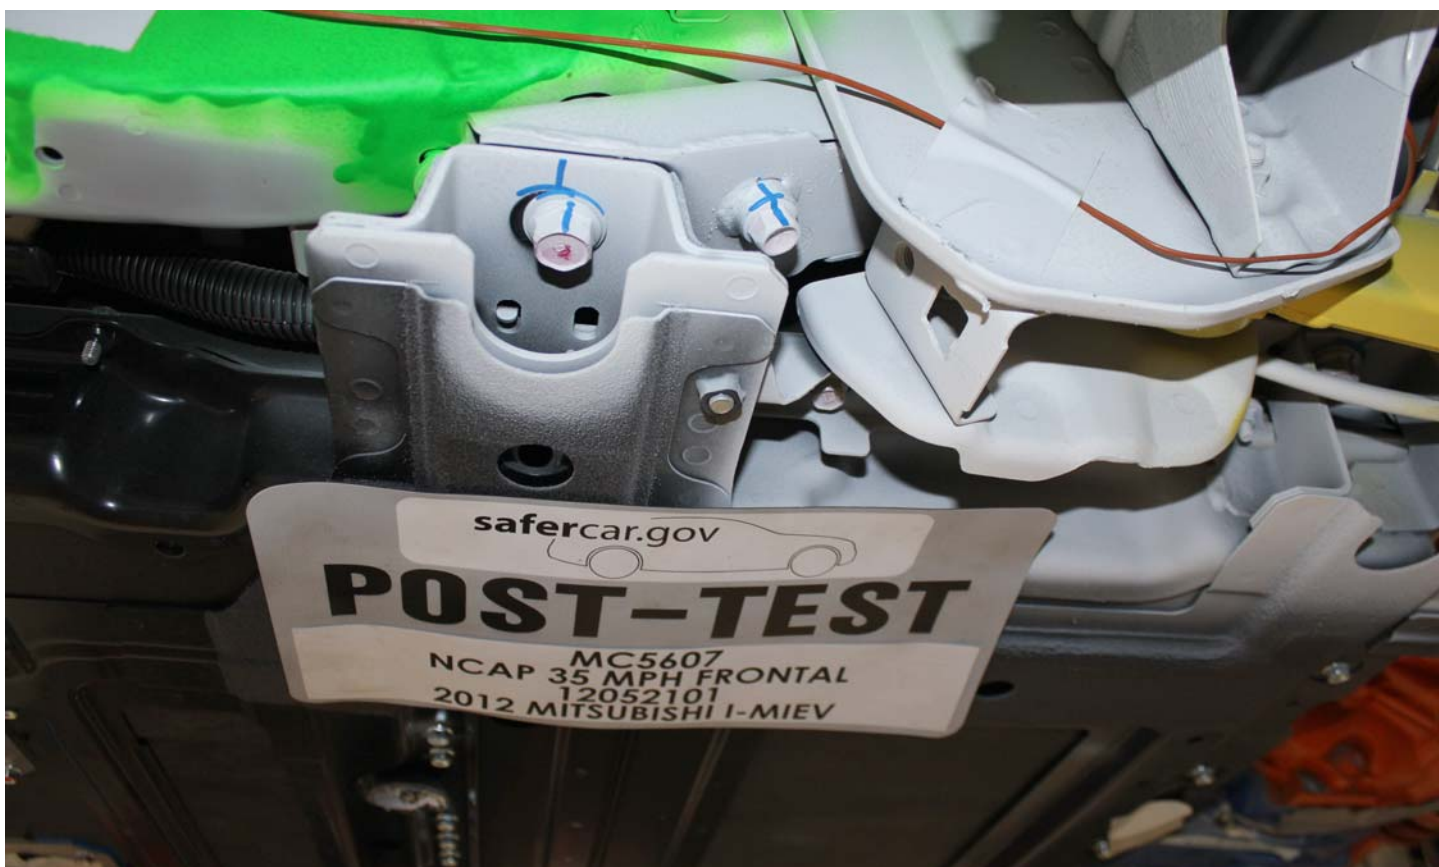
No. 036 Post-Impact View of Battery Module Movement or Retention Loss

Yes, Pass	No, Fail
All Components of Electrical Energy Storage/Conversion Device remained attached to the vehicle with at least one mounting location.	X
