REPORT NUMBER: NCAP-MGA-2012-081

**NEW CAR ASSESSMENT PROGRAM (NCAP)
Frontal Barrier Impact Test**

**MITSUBISHI MOTORS CORPORATION, JAPAN
2012 Mitsubishi i-MiEV ES 5-Dr Hatchback
NHTSA No.: MC5607**

**MGA RESEARCH CORPORATION
5000 Warren Road
Burlington, WI 53105**

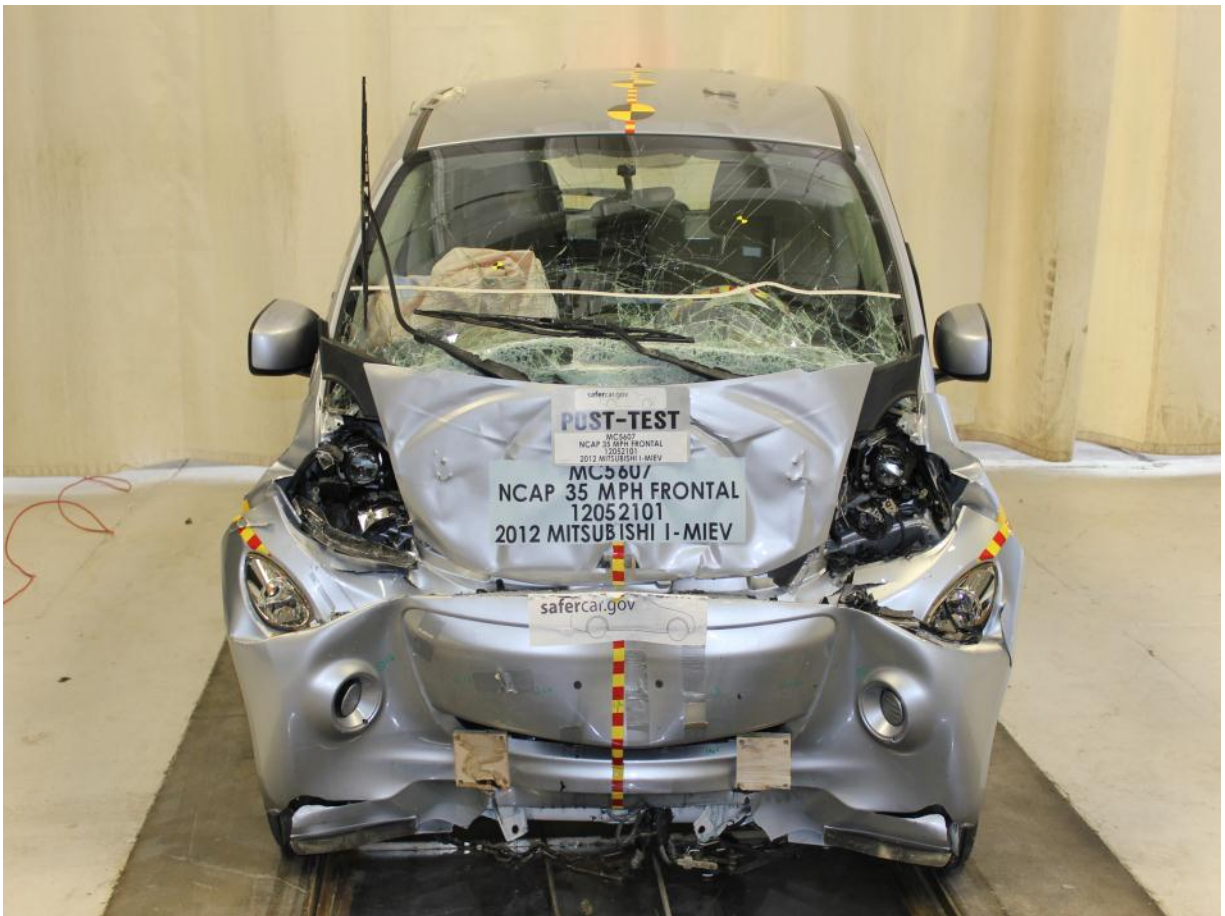
Post-Test Front View of Test Vehicle

The maximum static crush of the vehicle was 501 mm and both the driver and passenger side doors remained closed during the impact event and were operable after the impact.

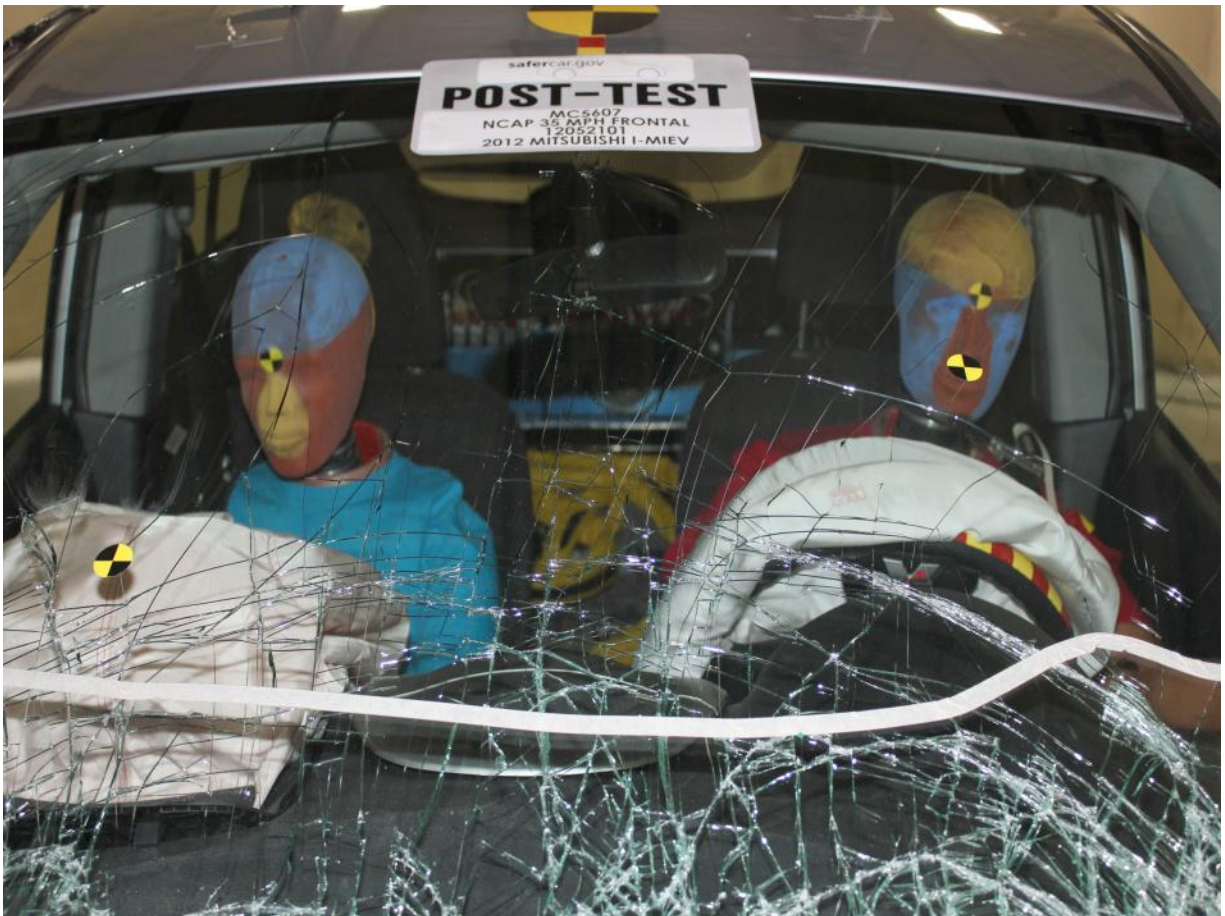
Post-Test Windshield View

There was 100 percent windshield retention and no intrusion into the protected zone of the windshield during the event.

Critical Areas of Performance	Observations and Conclusions
Windshield Damage	Cracked
Window Damage	None
Other Notable Effects	None

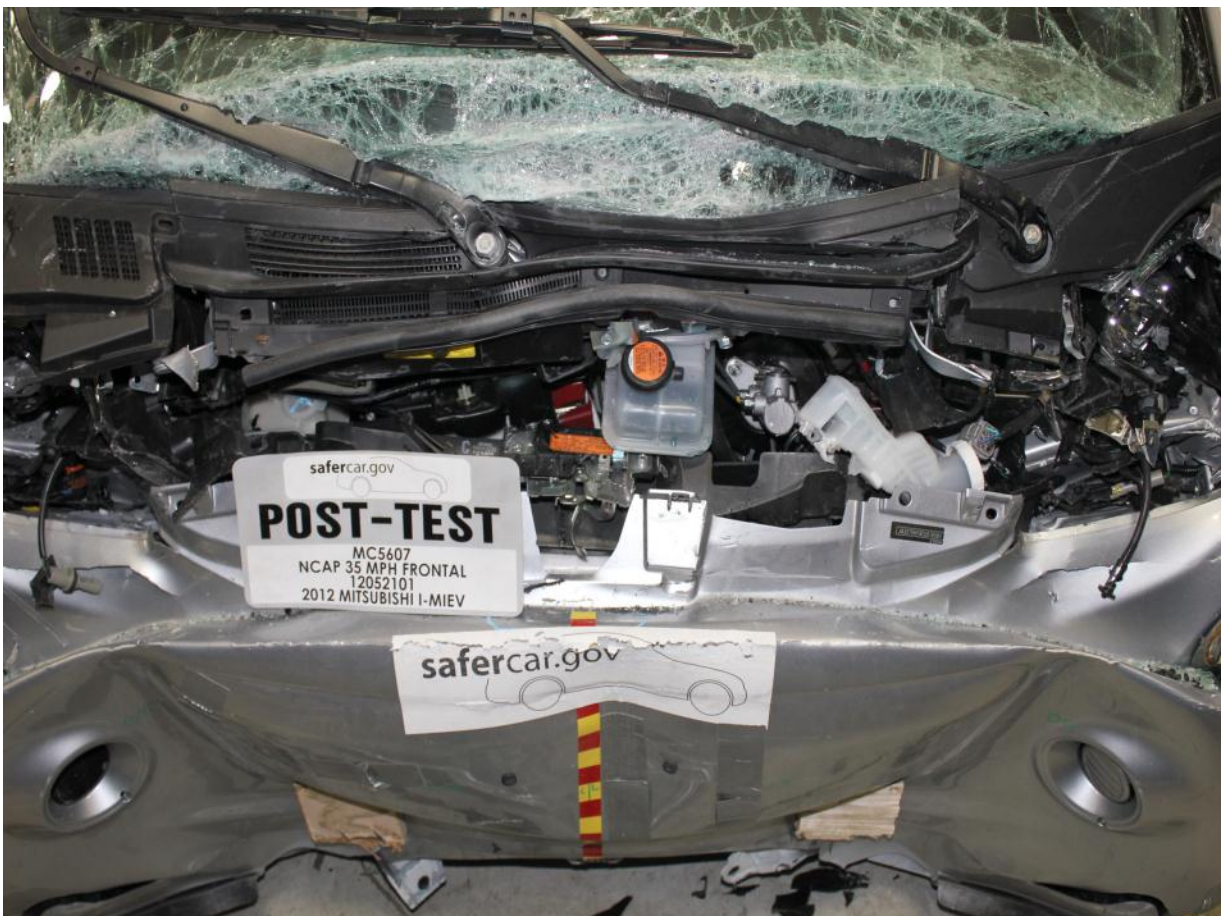
Post-Test Engine Compartment View

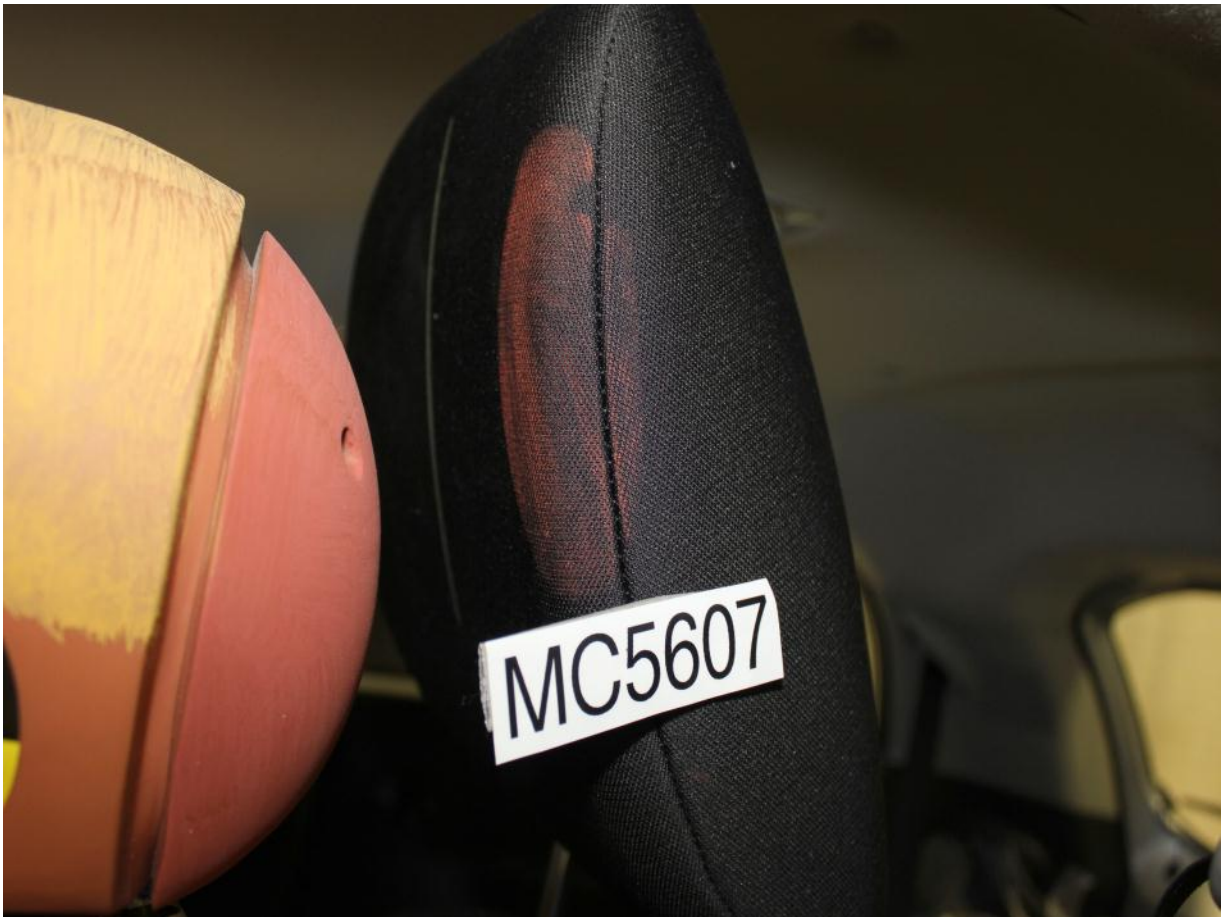
Post-Test Driver Dummy Contact with Headrest

The driver's visible contact points were as follows: The driver's head and chest contacted the airbag. The driver's head also contacted the headrest. The driver's knees contacted the knee bolster and steering column. The passenger's visible contact points were as follows: The passenger's head and chest contacted the airbag. The passenger's head also contacted the headrest. The passenger's knees contacted the glove box.

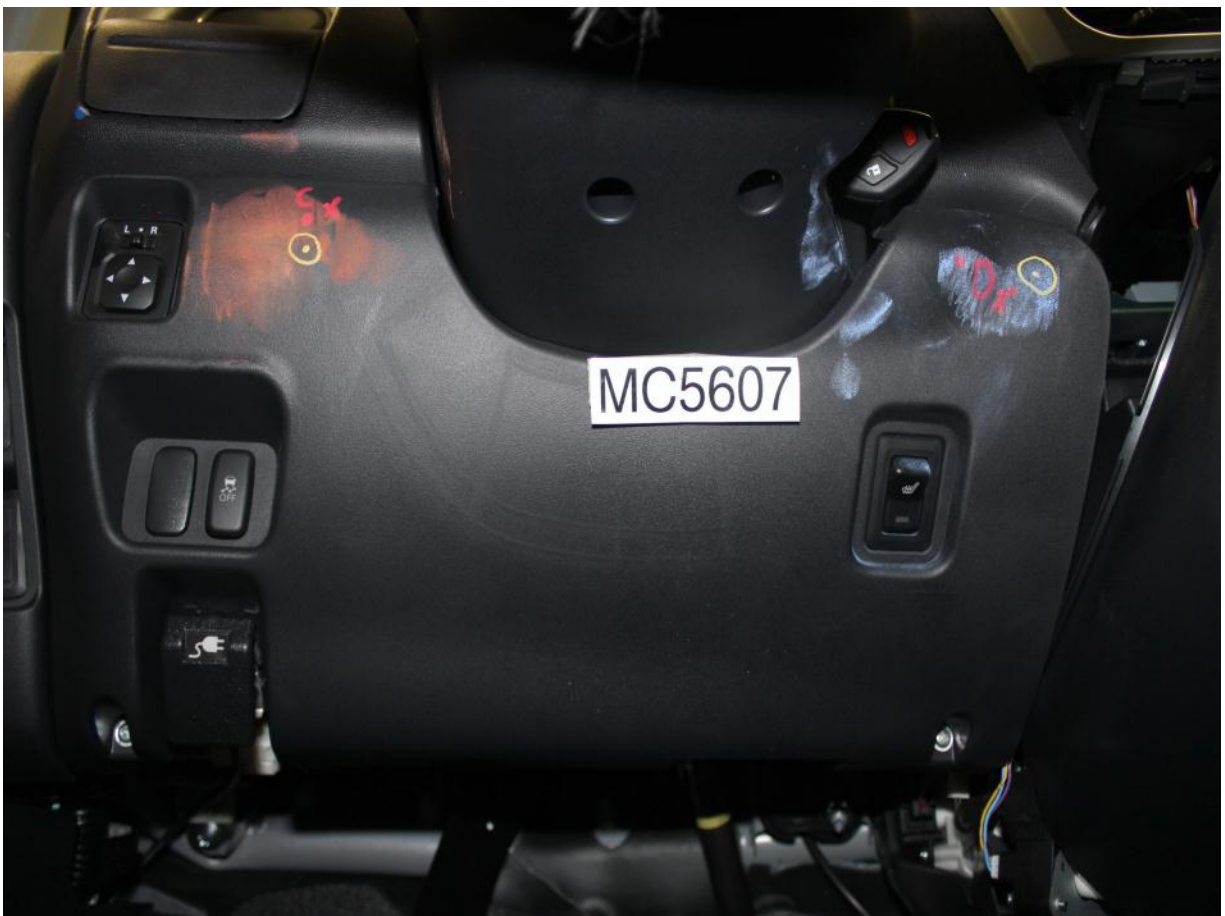
Post-Test Driver Dummy Contact with K nee Bolster

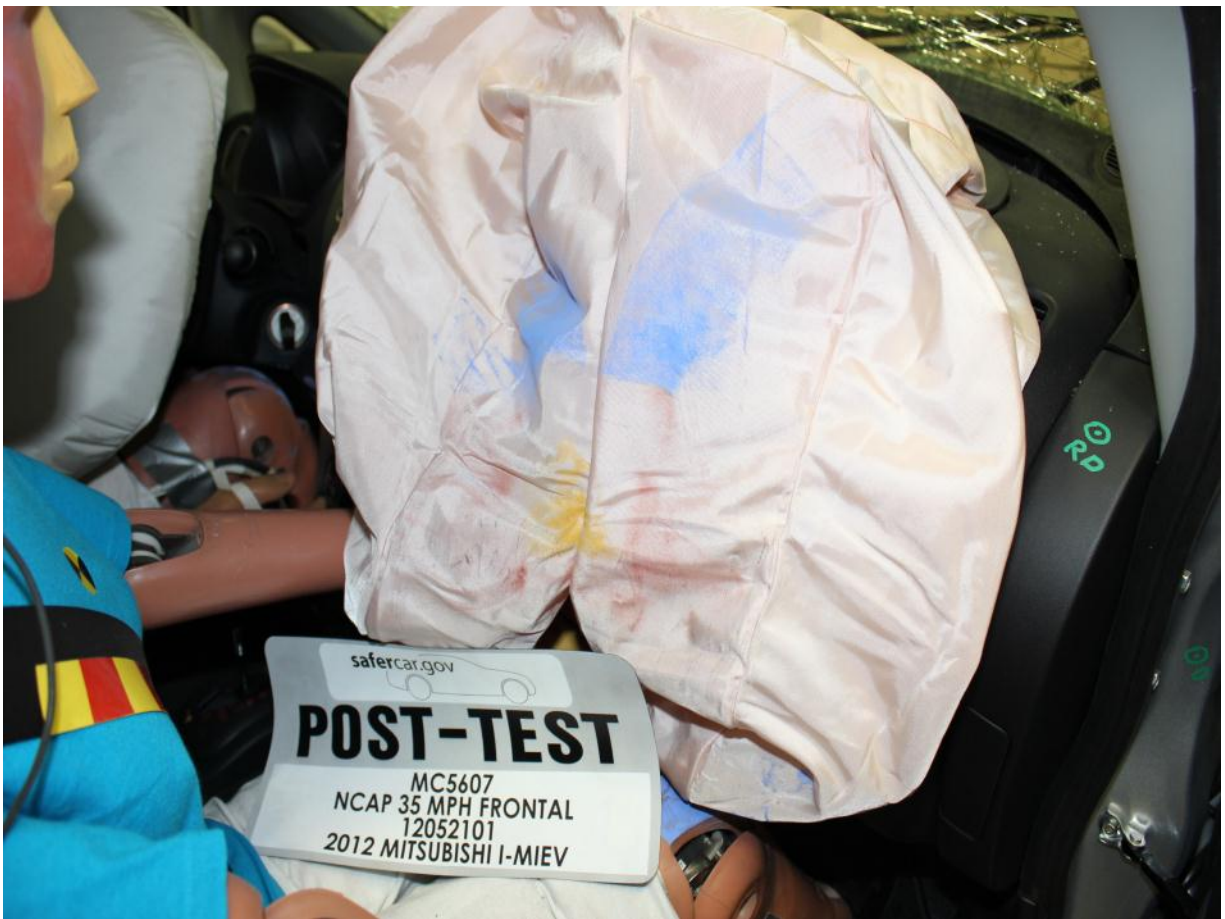
Post-Test Passenger Dummy Contact with Airbag

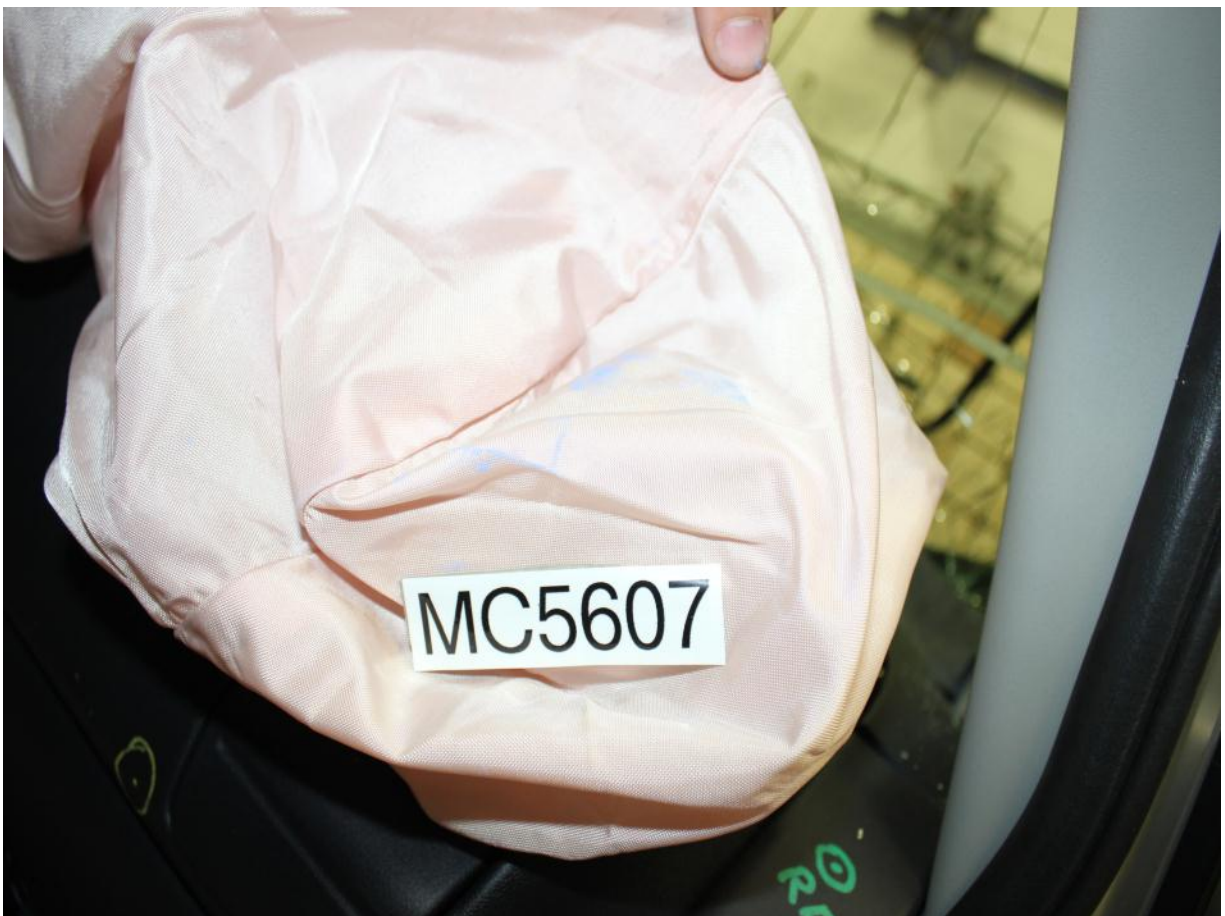
Post-Test Passenger Dummy Contact with Airbag

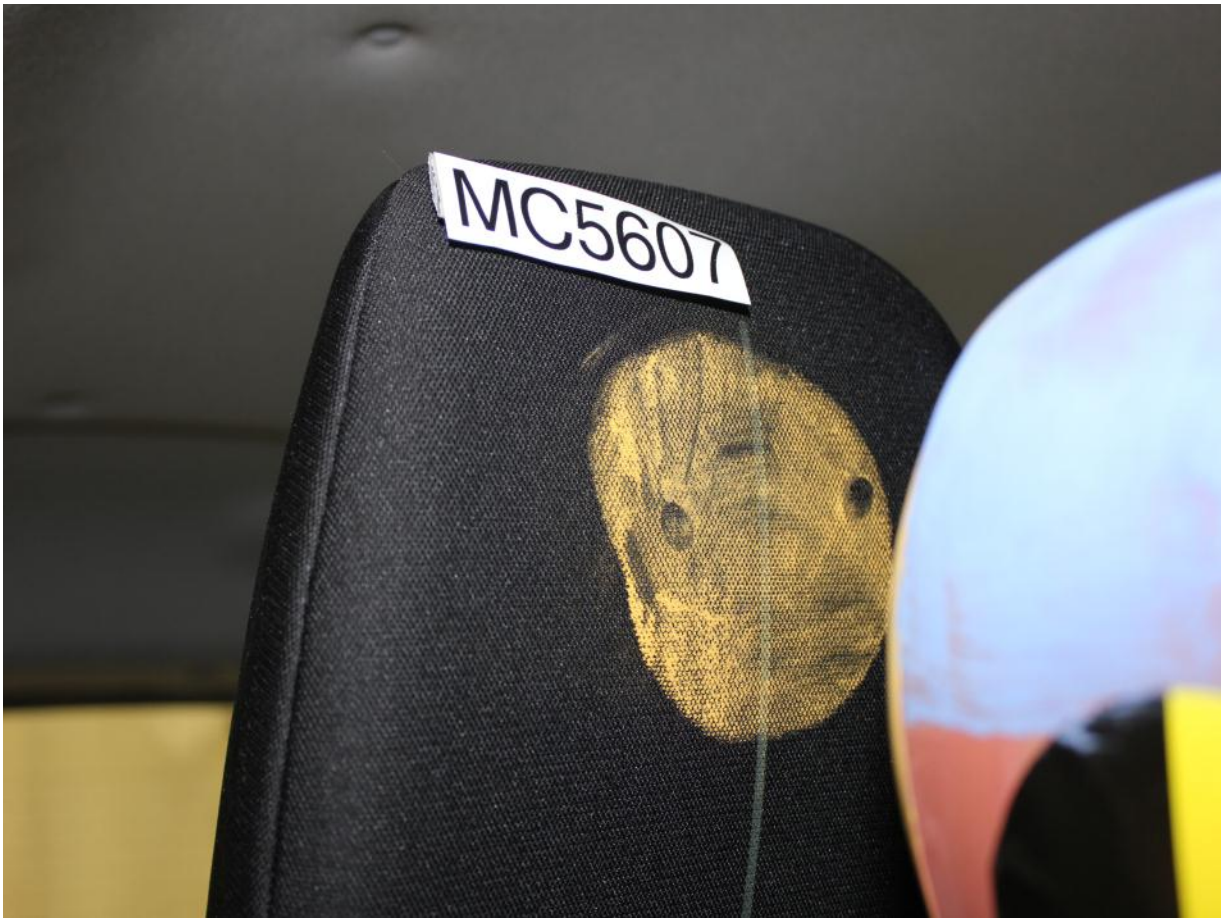
Post-Test Passenger Dummy Contact with Headrest
