**REPORT NUMBER: NCAP-KAR-13-001**

**NEW CAR ASSESSMENT PROGRAM (NCAP)  
FRONTAL BARRIER IMPACT TEST**

**FORD MOTOR CO.  
2013 FORD EXPLORER 4X4 5-DOOR MPV**

**FINAL REPORT**

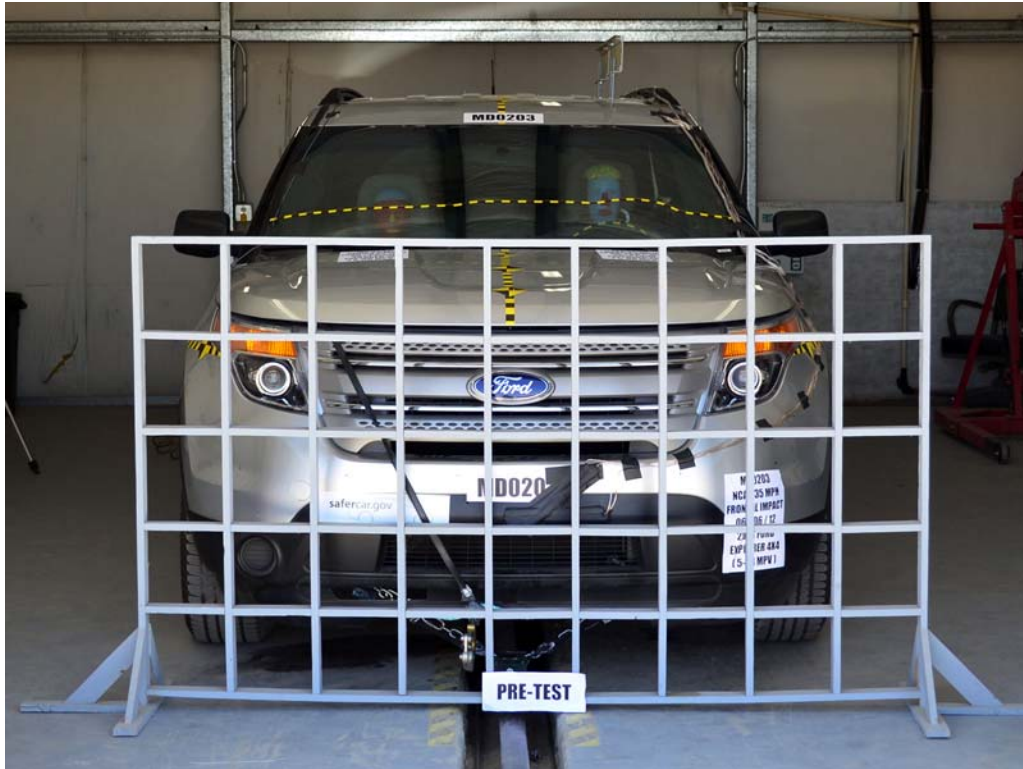
FIGURE 1. Load Cell Location

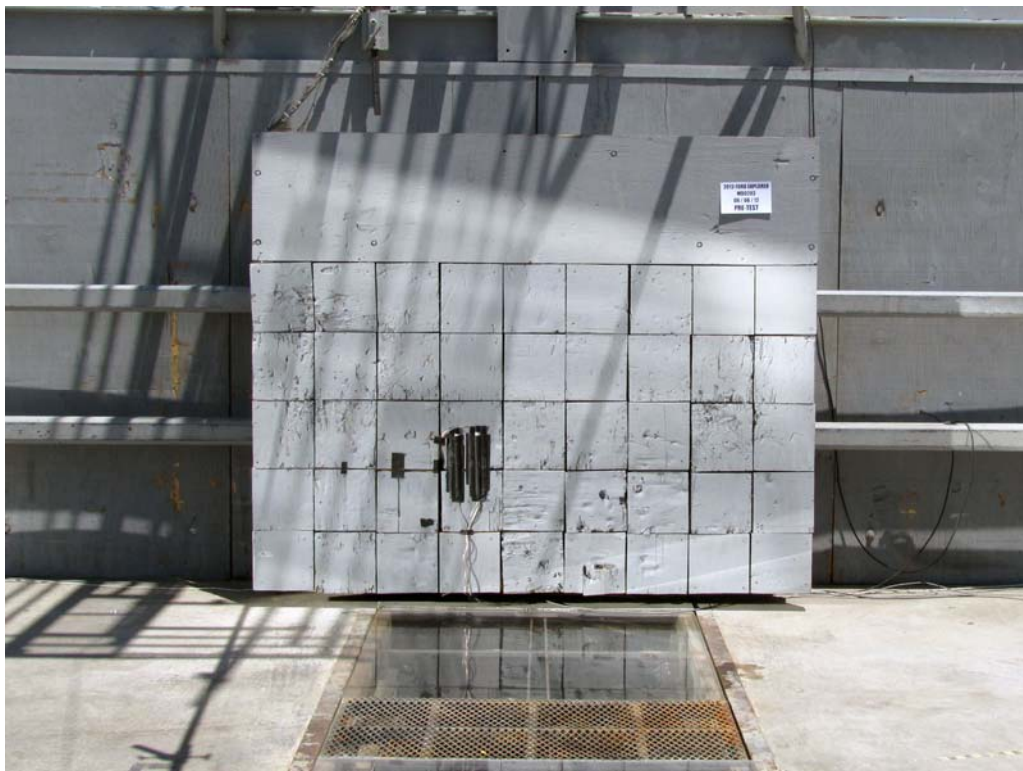
FIGURE 2. Load Cell Wall

A load cell barrier consisting of 36 load cells was impacted by a 2013 Ford Explorer 4x4 5-door MPV at a velocity of 56.16 km/h. The test was performed at KARCO Engineering, LLC. on June 06, 2012. Pre- and post-test photographs of the vehicle and dummies can be found in Appendix A of this report.

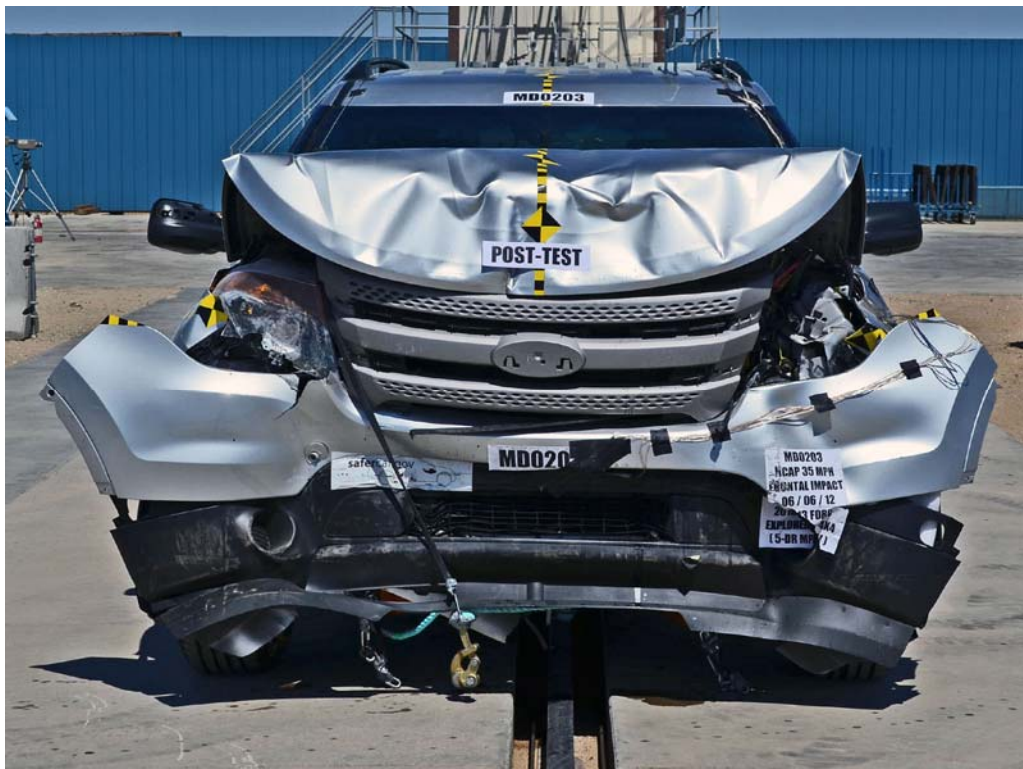
FIGURE 8. Post-Test Front View of Test Vehicle

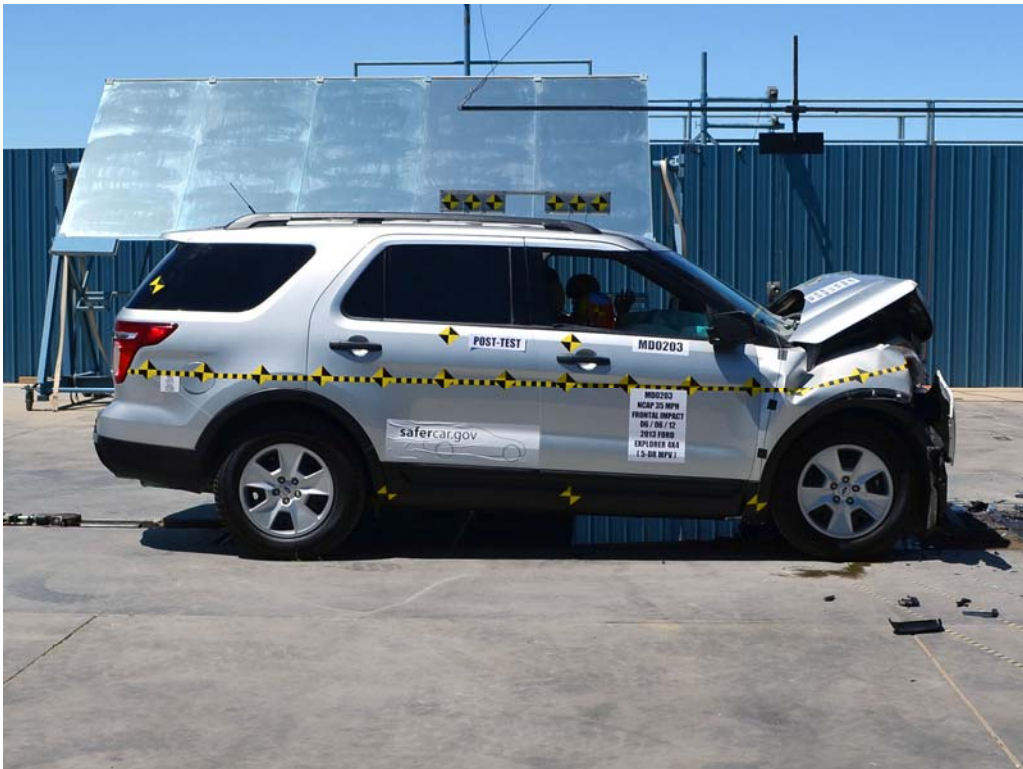
FIGURE 12. Post-Test Right View of Test Vehicle

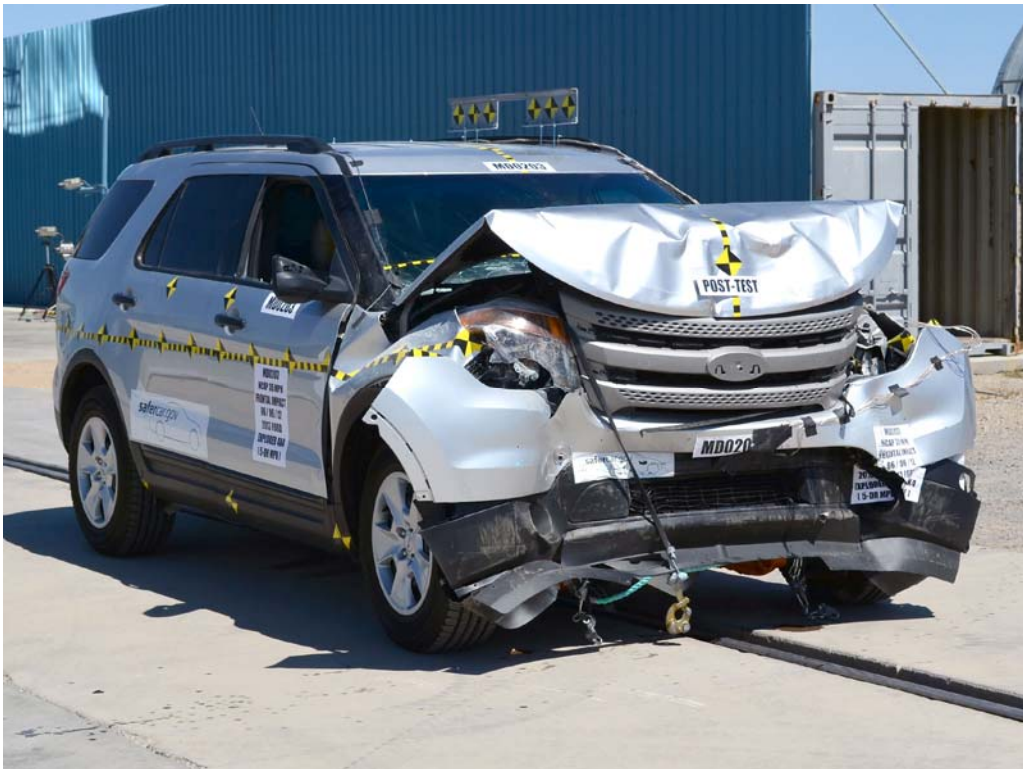
FIGURE 14. Post-Test Right Front  $\frac{3}{4}$  View

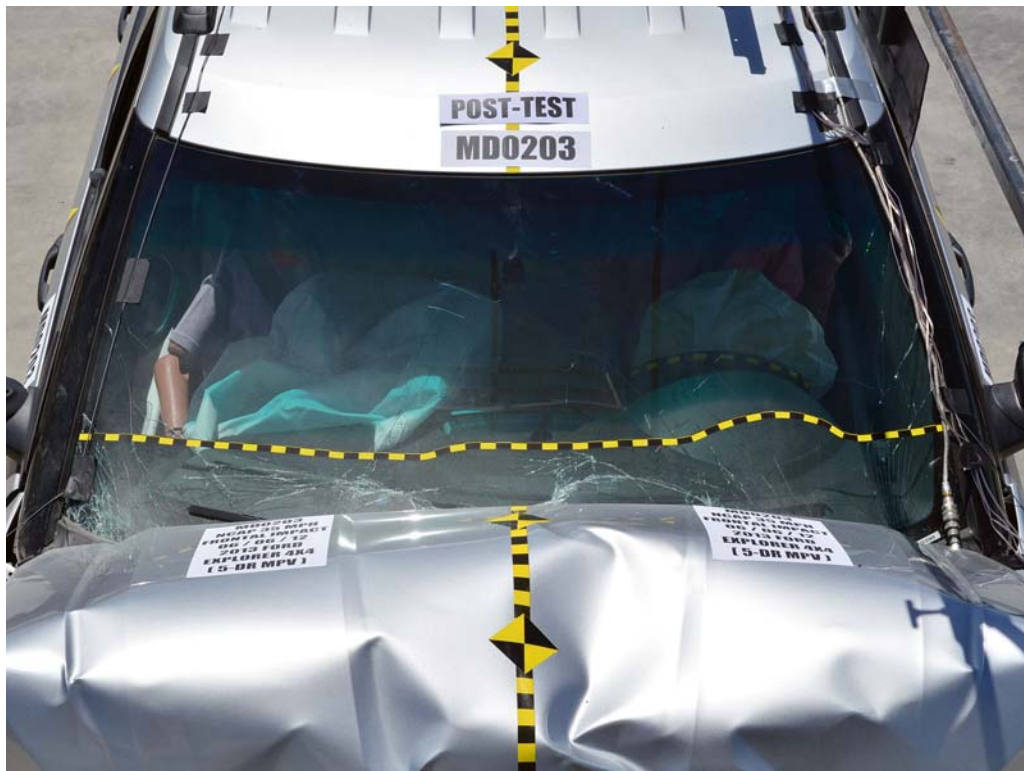
FIGURE 18. Post-Test Windshield View

There was 72.4% windshield retention and no intrusion into the protected zone of the windshield during the event. There was no Stoddard solvent leakage after the event or during any phase of the static rollover.

| Critical Areas of Performance | Observations and Conclusions |
|---|---|
| Windshield Damage | Broken |

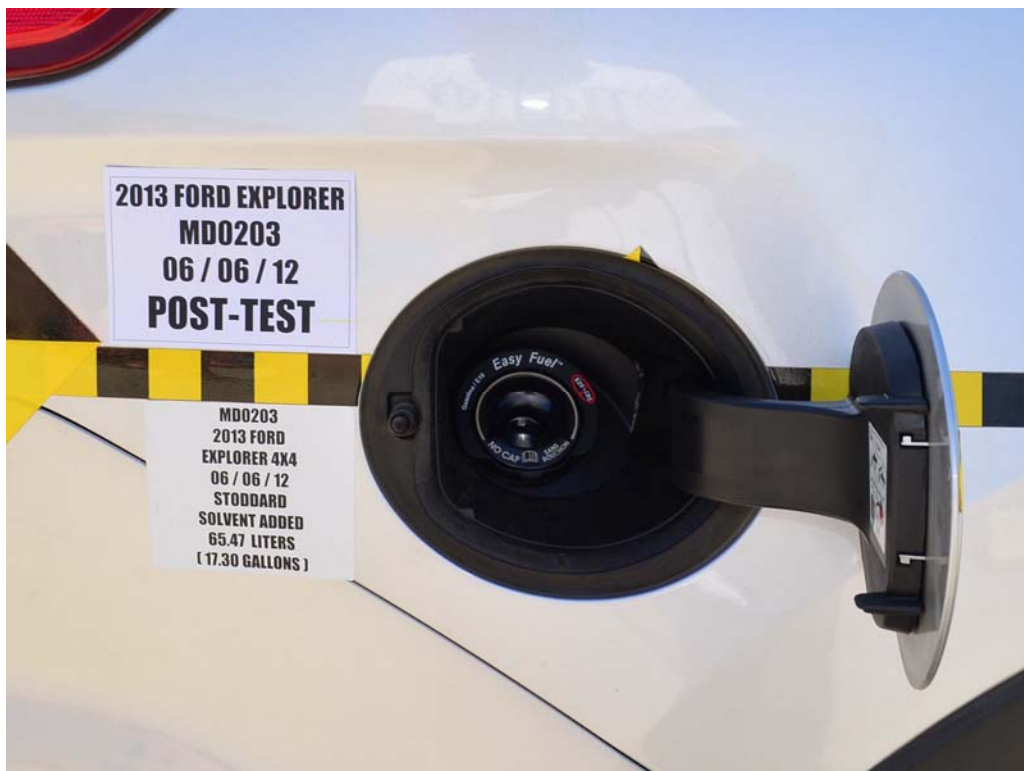
FIGURE 22. Post-Test Fuel Filler Cap View

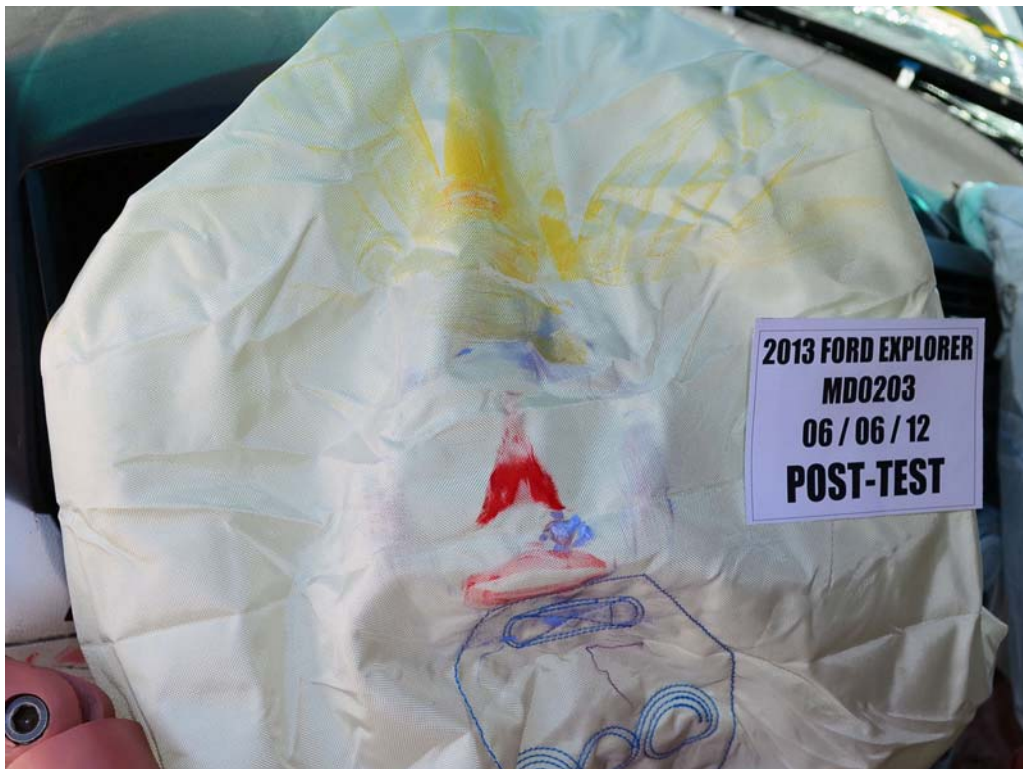
FIGURE 46. Post-Test Driver Dummy Contact With Airbag

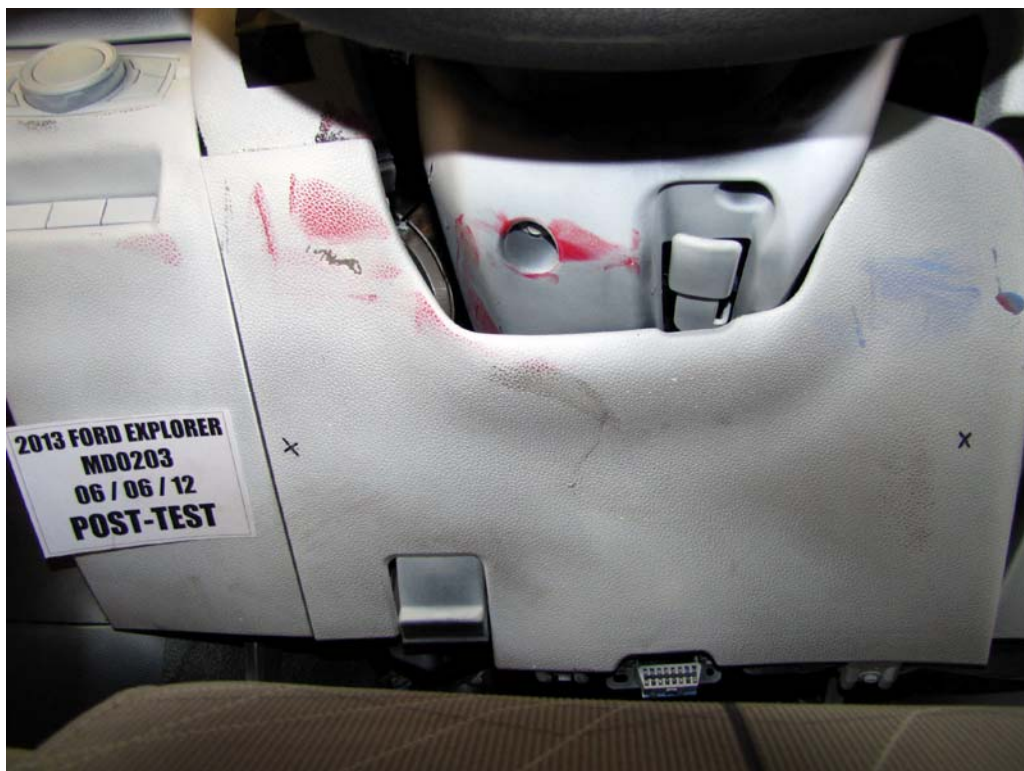
FIGURE 47a. Post-Test Driver Dummy Contact With Knee Bolster

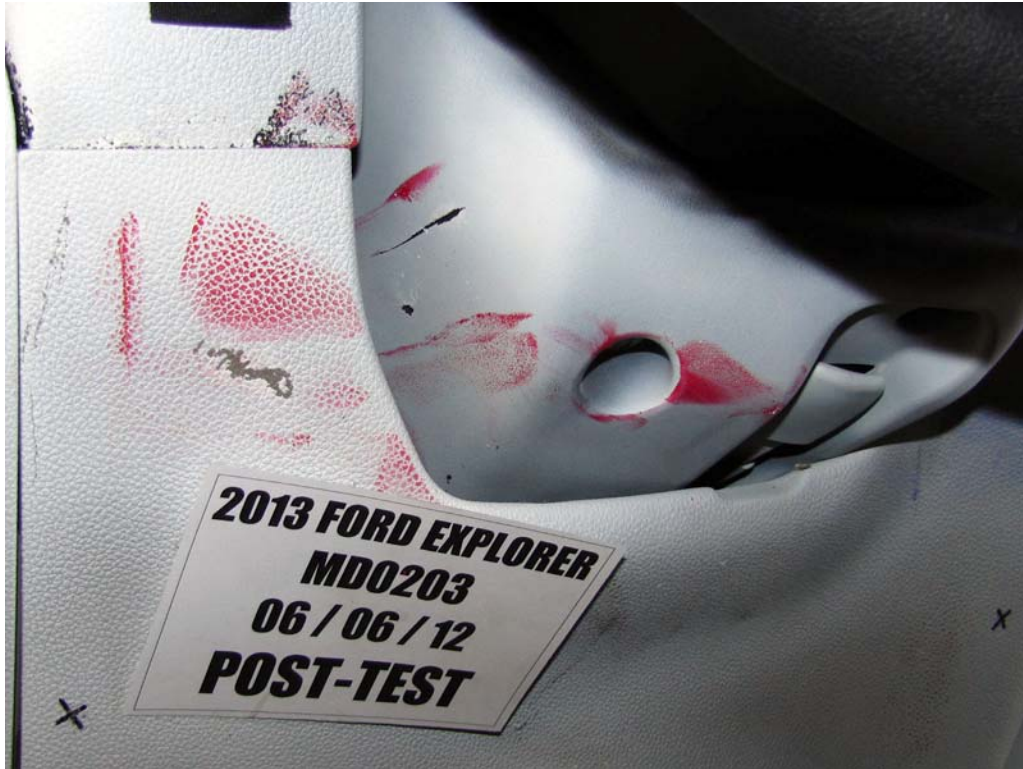
FIGURE 47b. Post-Test Driver Dummy Contact With Steering Column

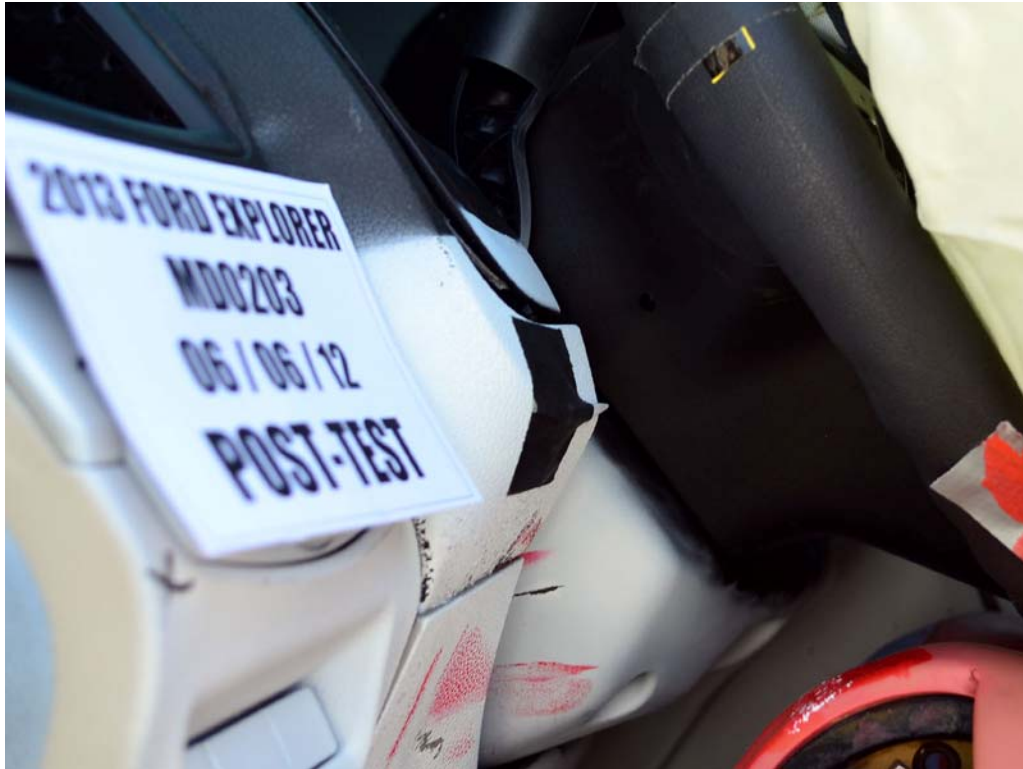
FIGURE 49. Post-Test View Of Steering Wheel

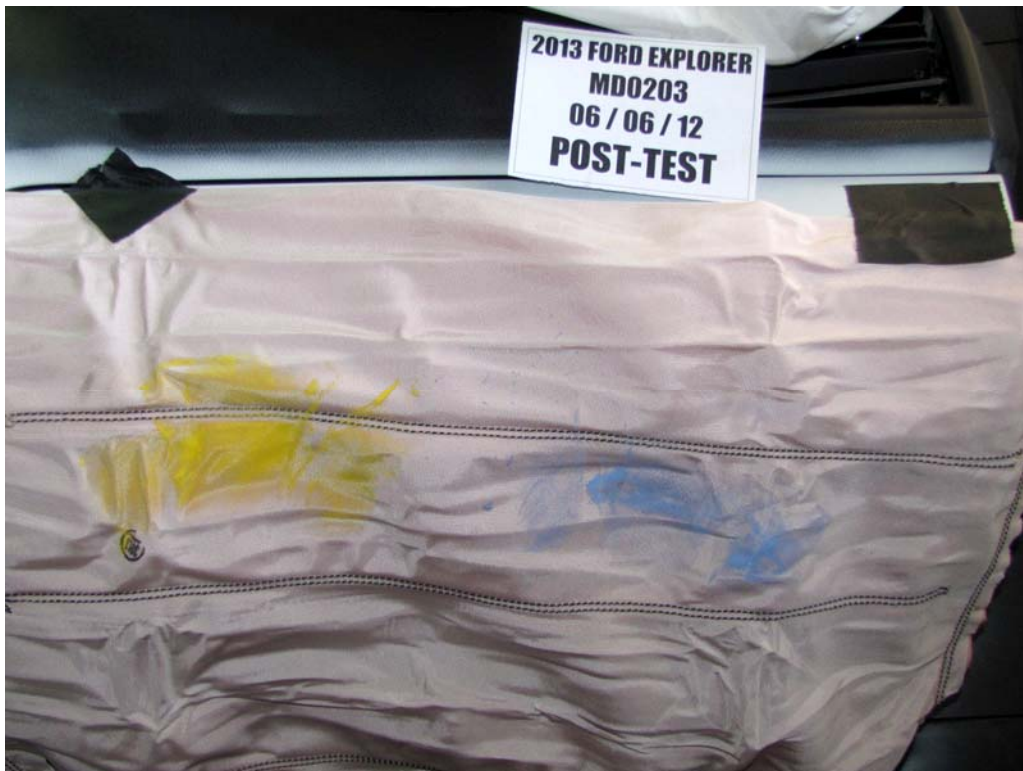
FIGURE 66b. Post-Test Passenger Dummy Contact With Knee Airbag

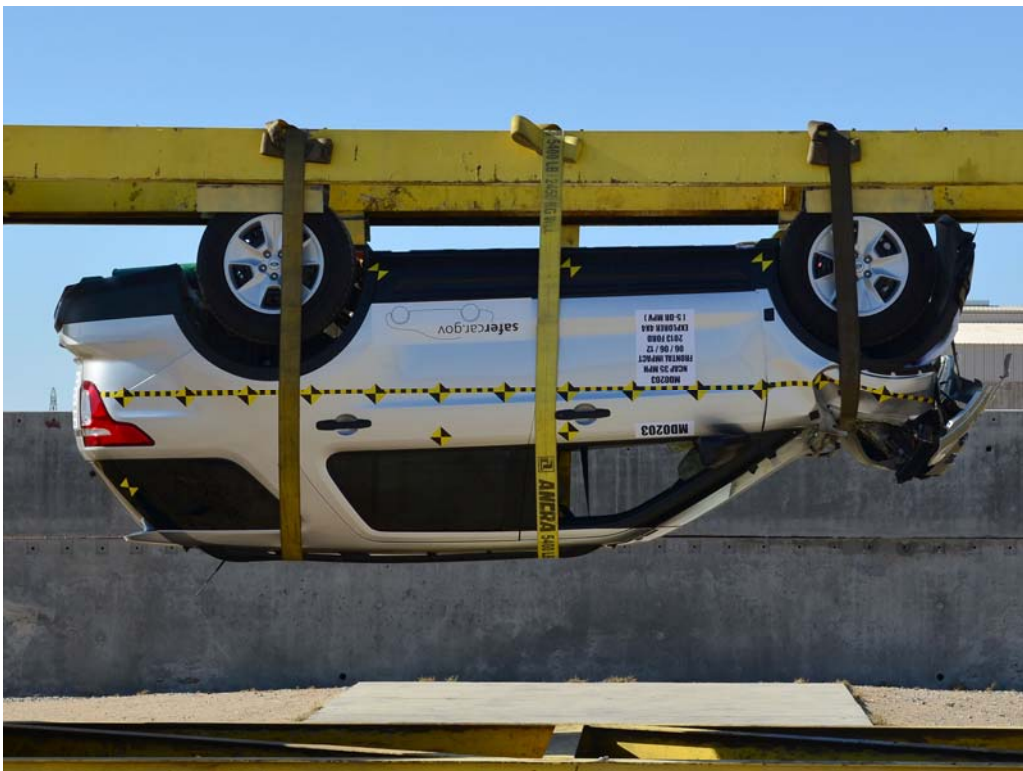
FIGURE 72. Vehicle at 180°on Static Rollover Device
