**REPORT NUMBER: SINCAP-MGA-2012-086**

**NEW CAR ASSESSMENT PROGRAM (NCAP)  
Moving Deformable Barrier Side Impact Test**

**TOYOTA MOTOR CORPORATION  
2012 Toyota Prius Plug-In Hybrid 5-Dr Hatchback  
NHTSA No.: YC5104**

**MGA RESEARCH CORPORATION  
5000 Warren Road  
Burlington, WI 53105**

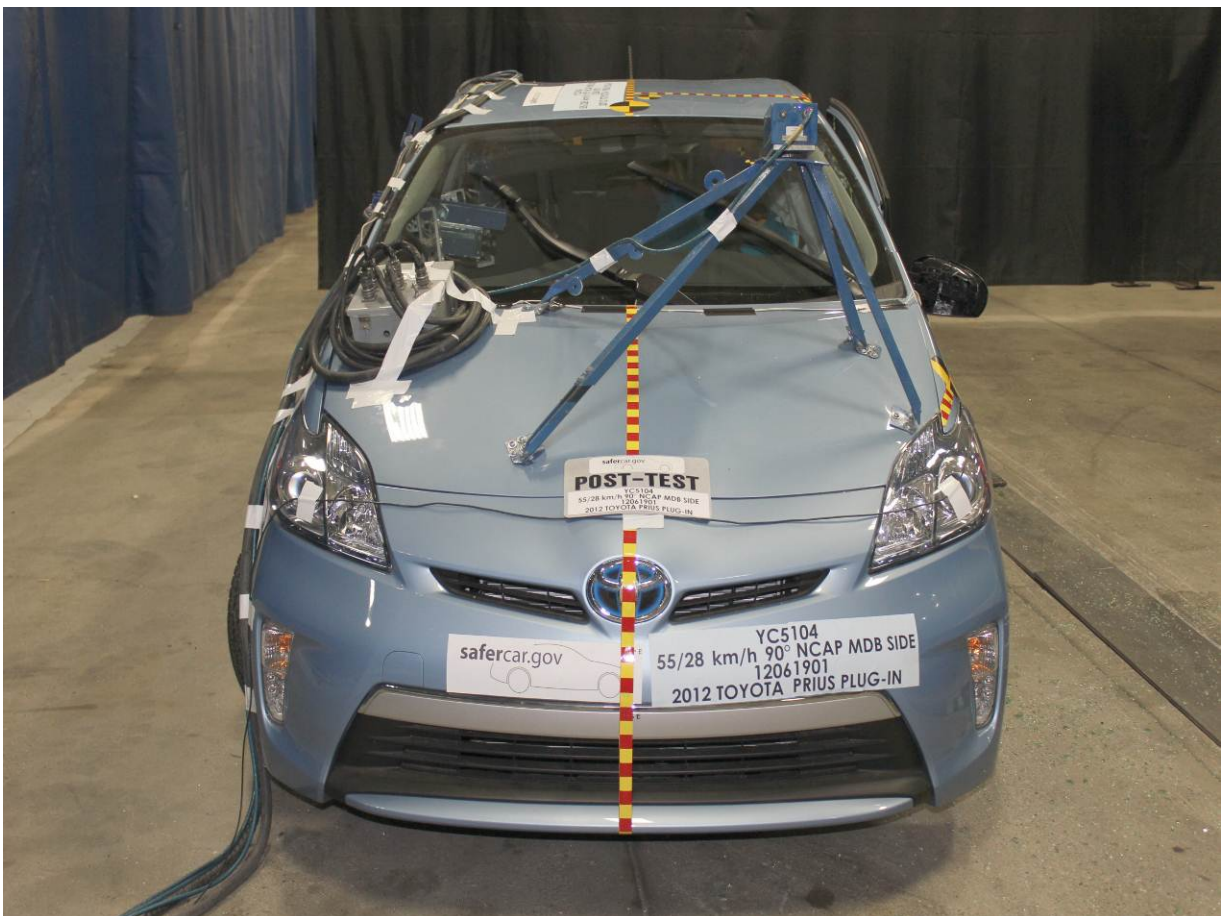
Post-Test Frontal View of Test Vehicle

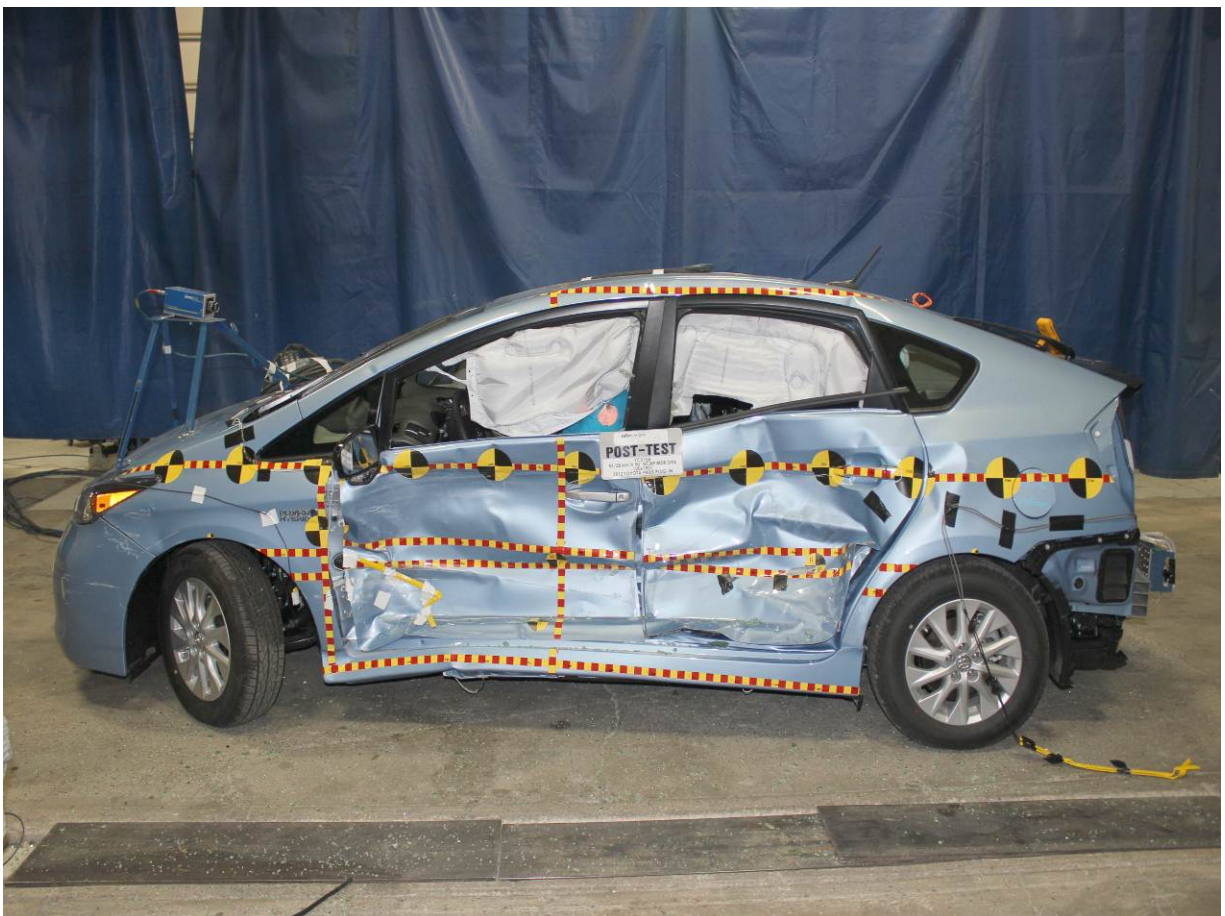
Post-Test Left Side View of Test Vehicle

| Critical Areas of Performance | Observations and Conclusions |
|---|---|
| Side Window Damage | Left Front and Left Rear Windows Broke |

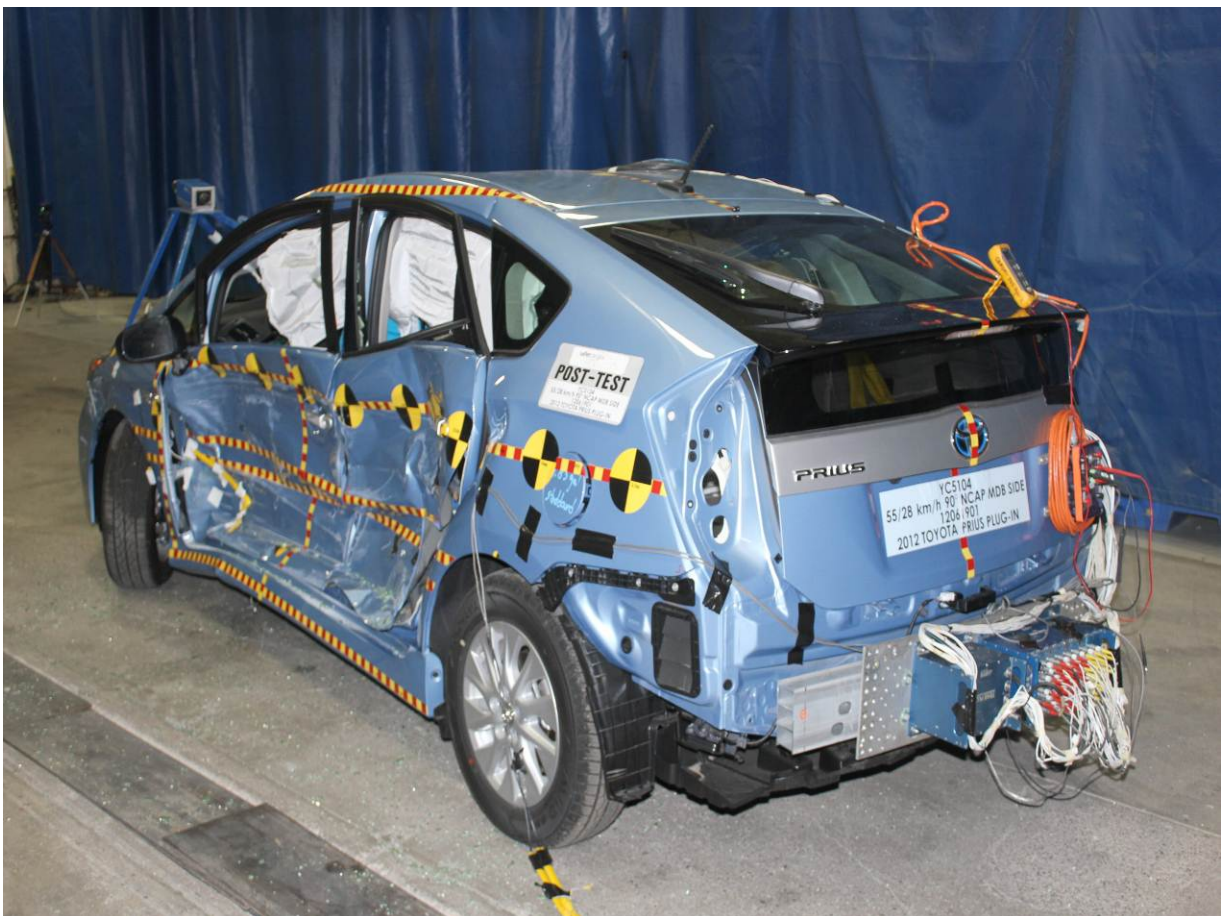
Post-Test Left Three-Quarter Rear View of Test Vehicle

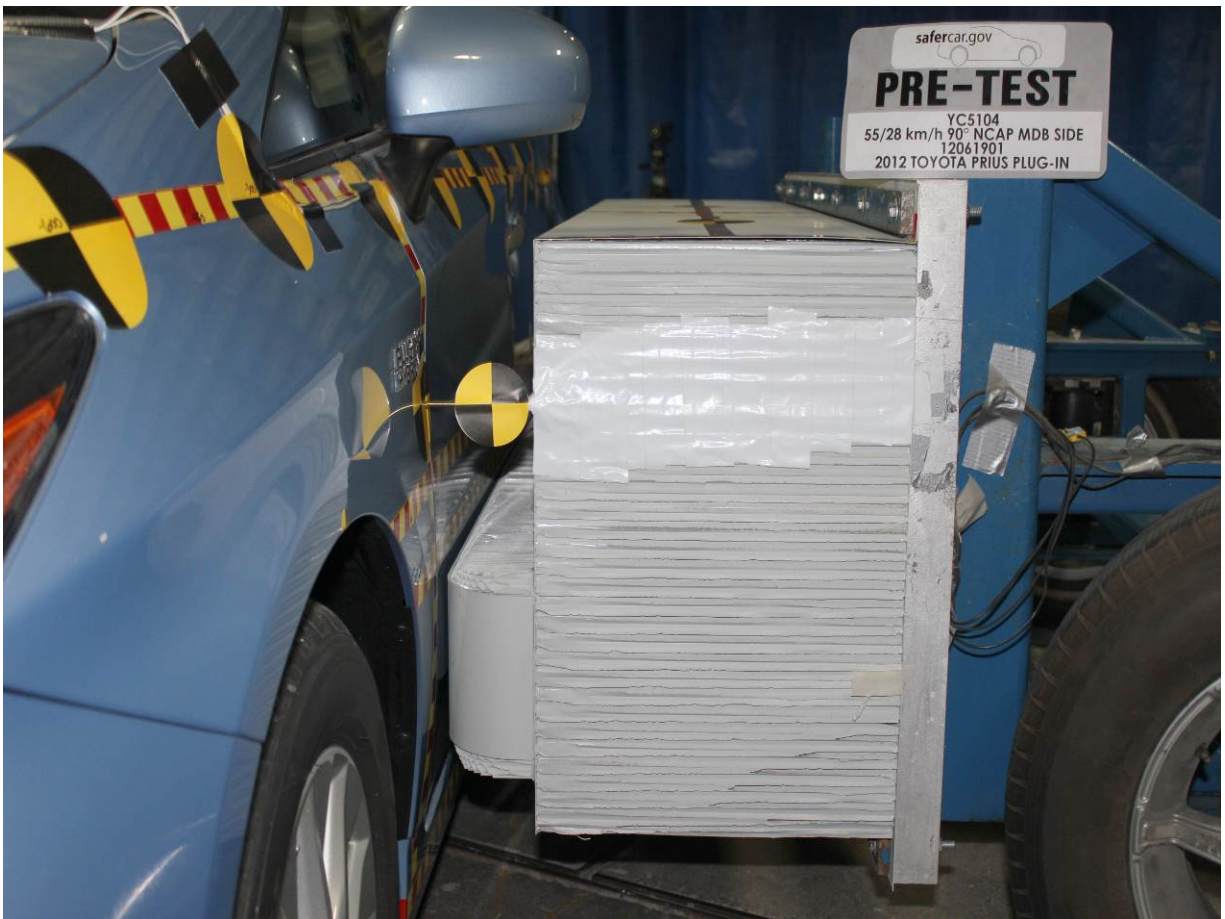
Pre-Test Left Side View of MDB Positioned Against Side of Test Vehicle

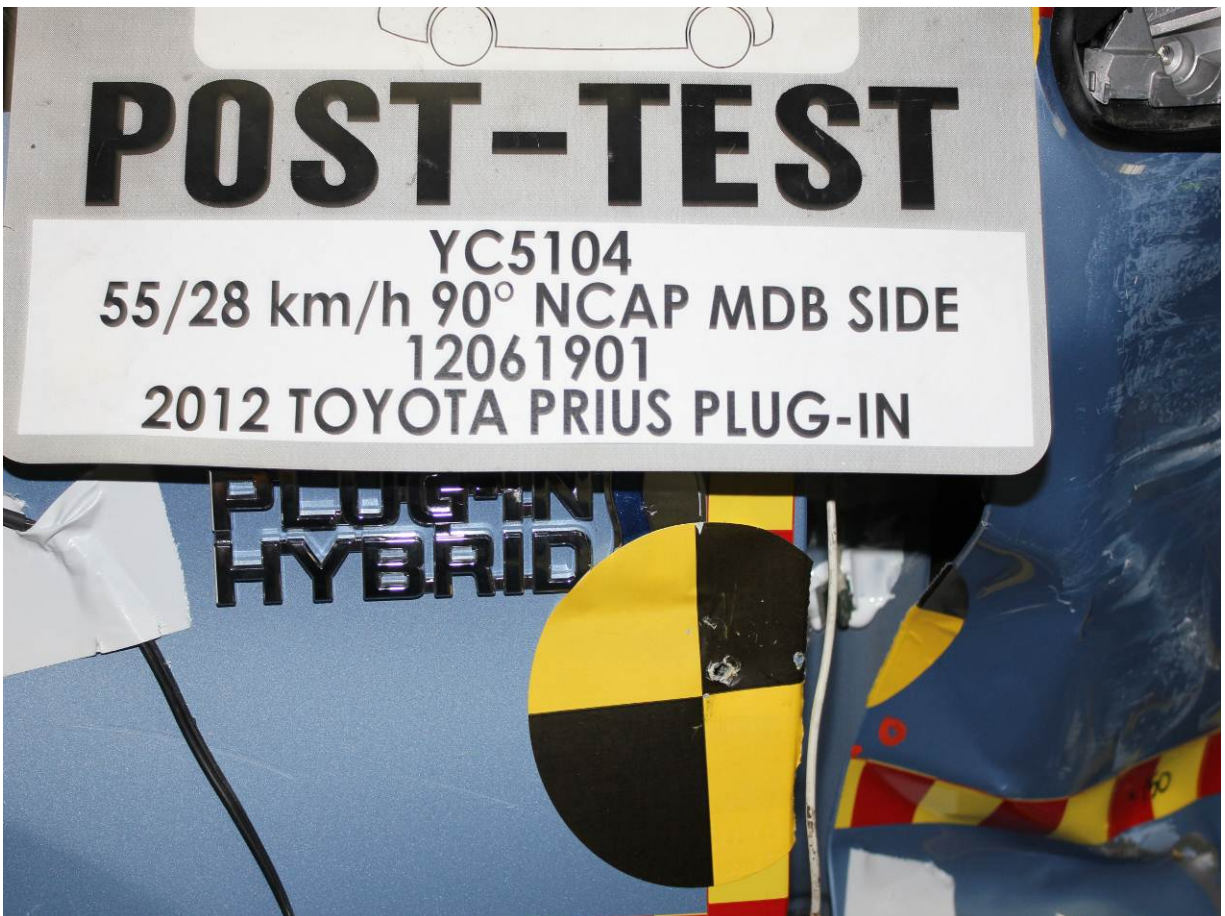
Post-Test Close-Up View of Impact Point Target

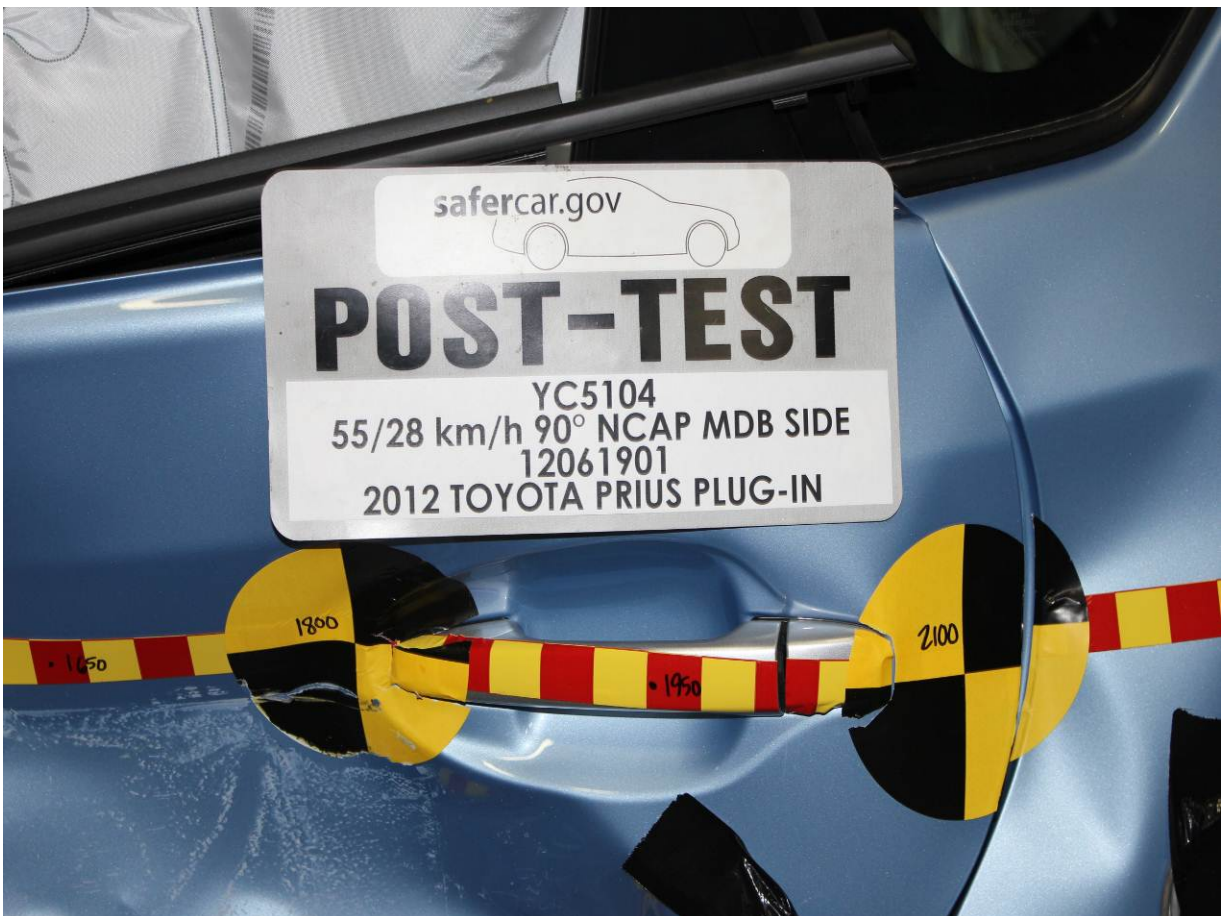
Post-Test Left Rear Door Latch Close-Up

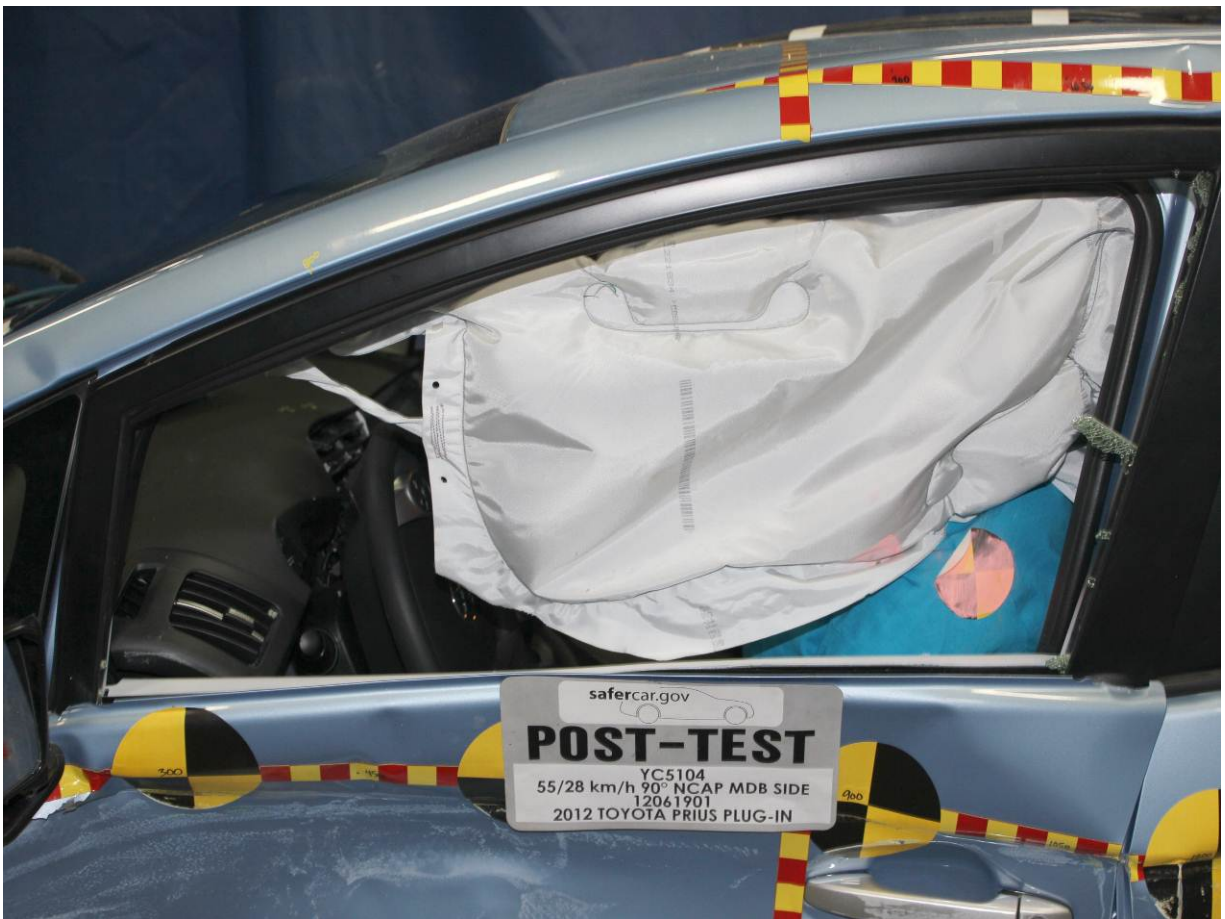
Post-Test Left Side View of Driver Dummy Shoulder and Door Top View

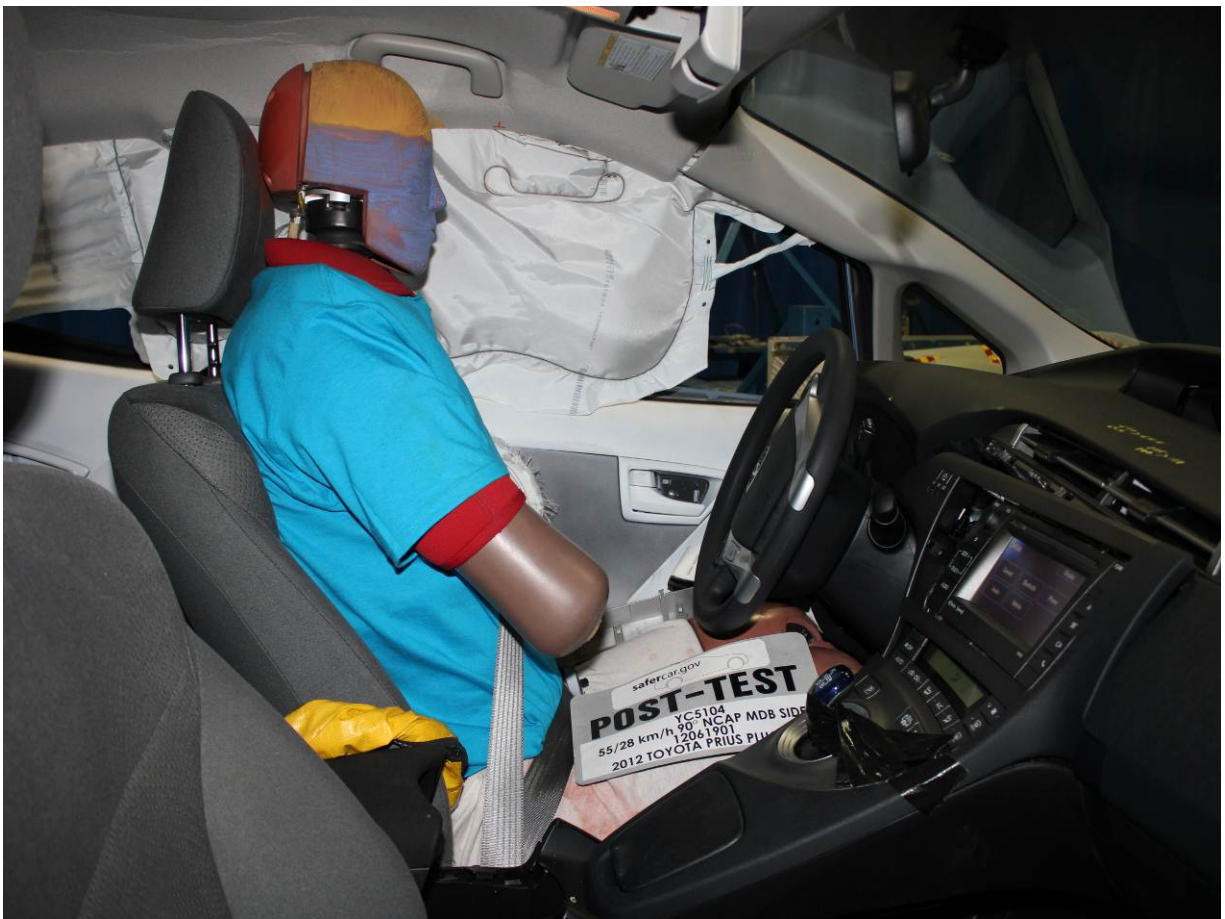
Post-Test Right Side View of Driver Dummy and Front Seat of Occupant Compartment

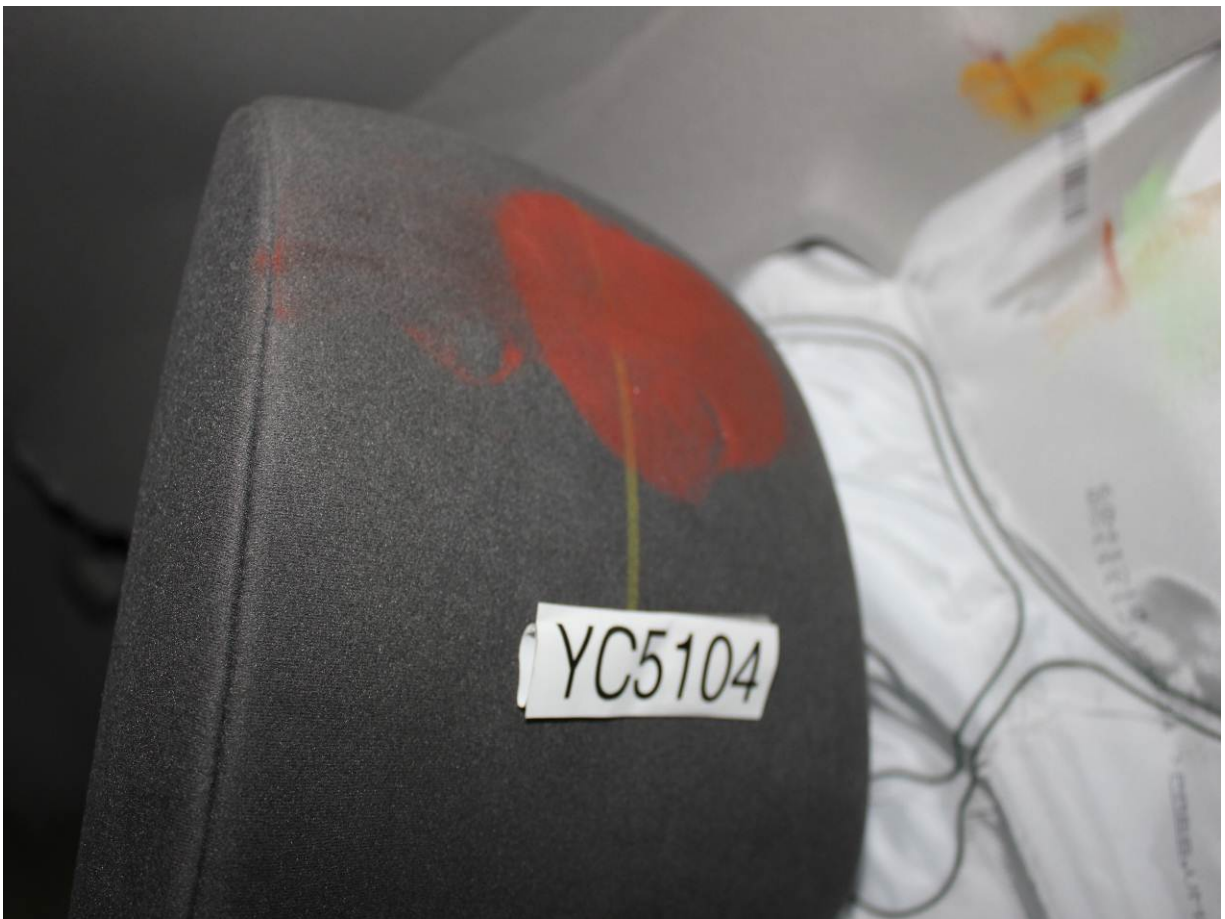
Post-Test Driver Dummy Close-up Head Contact with Vehicle Interior View

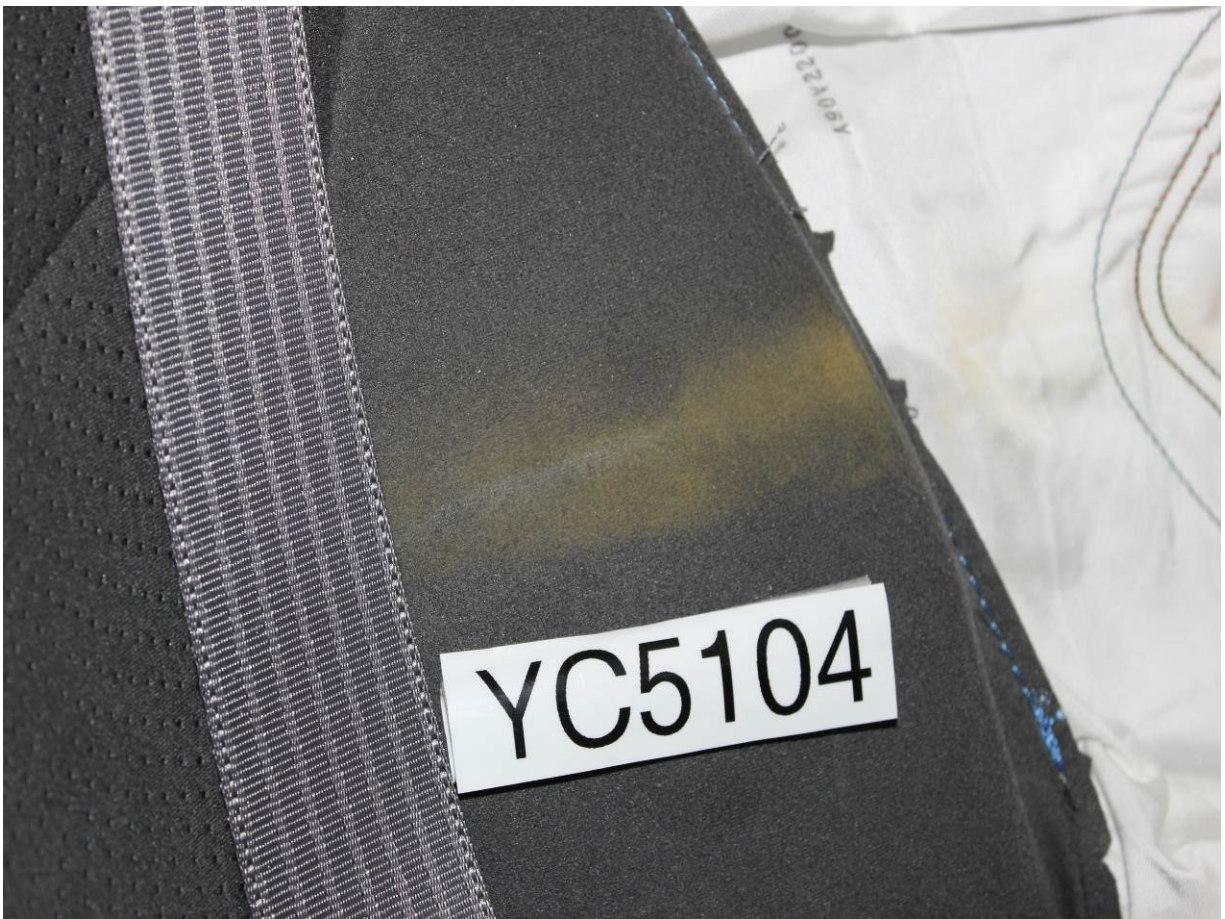
Post-Test Driver Dummy Close-up Torso Contact with Vehicle Interior View

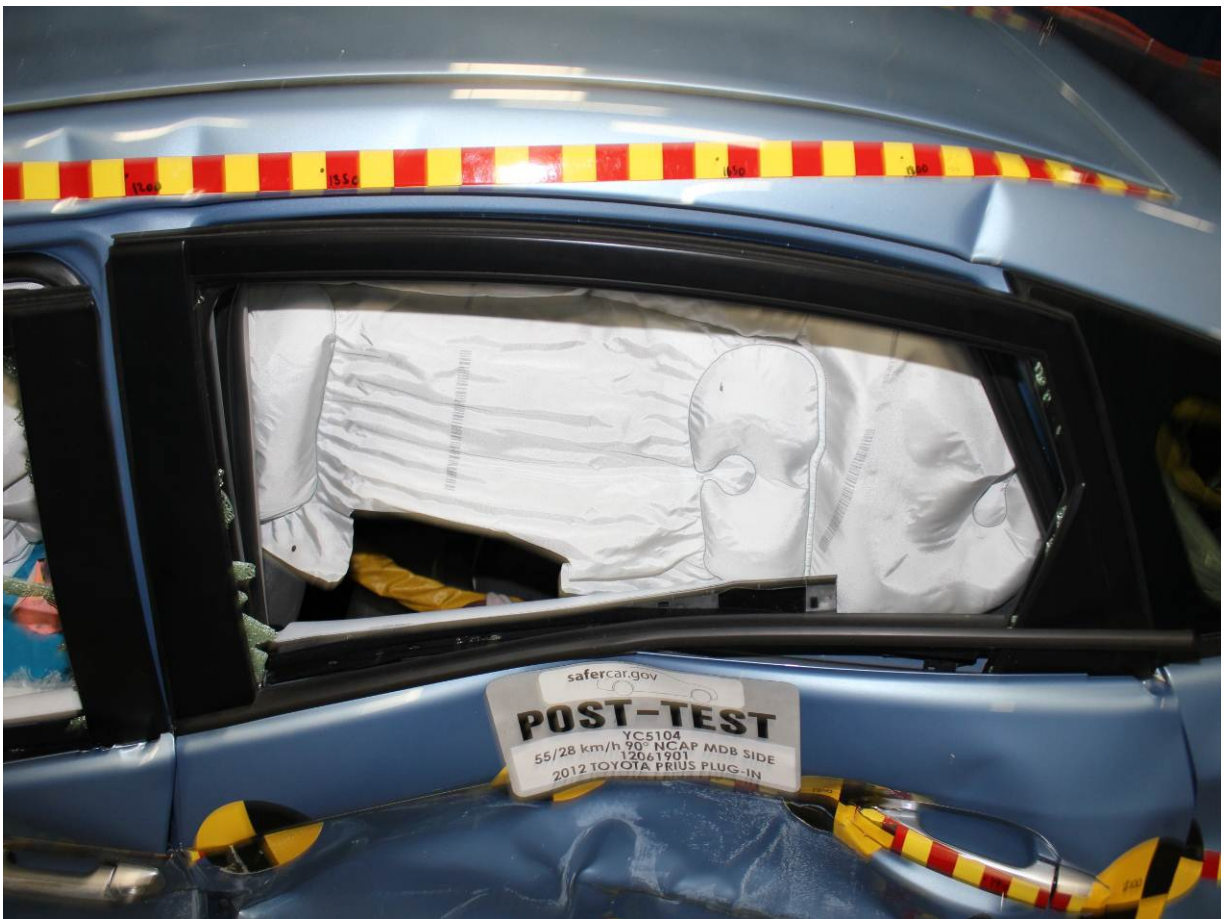
Post-Test Rear Passenger Dummy and Door Clearance View

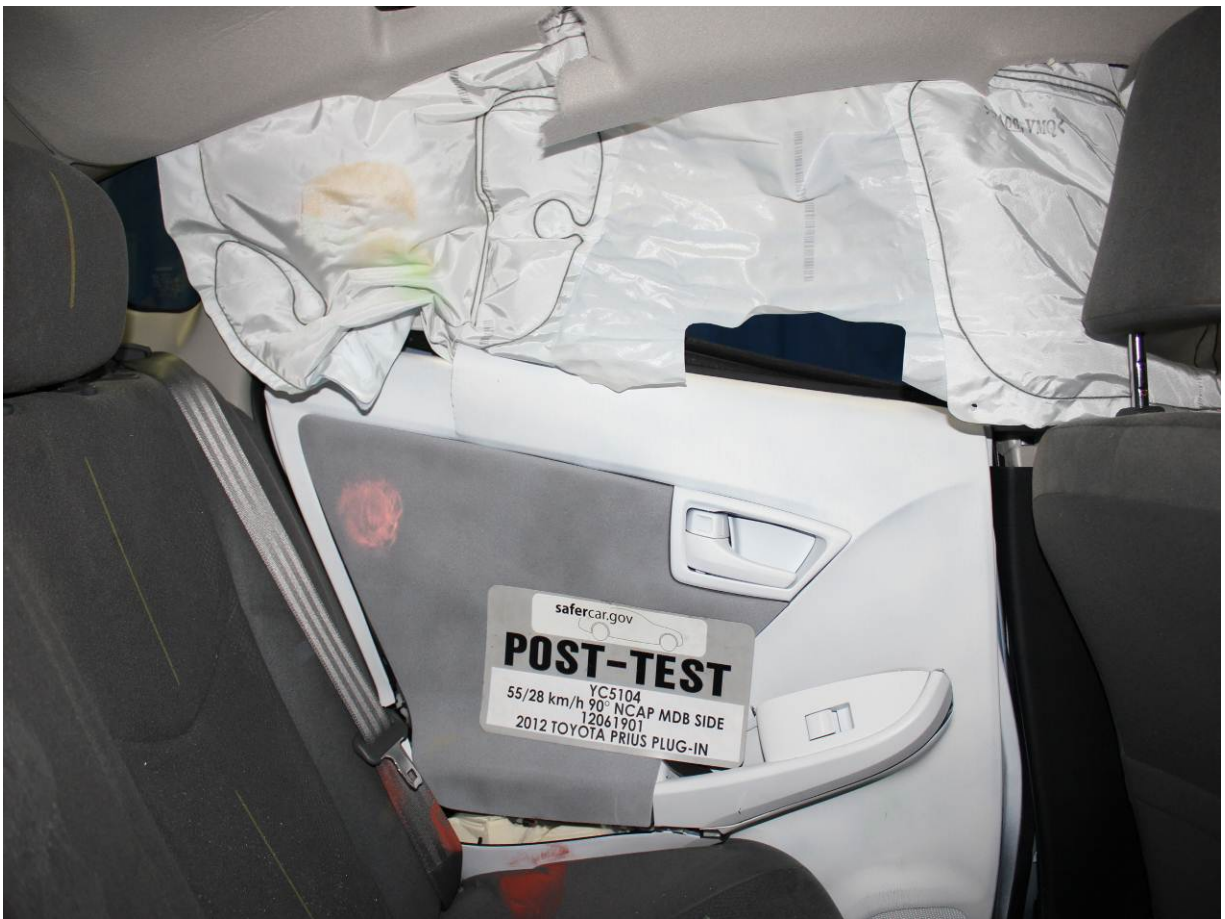
Post-Test Rear Passenger Inner Door Panel View

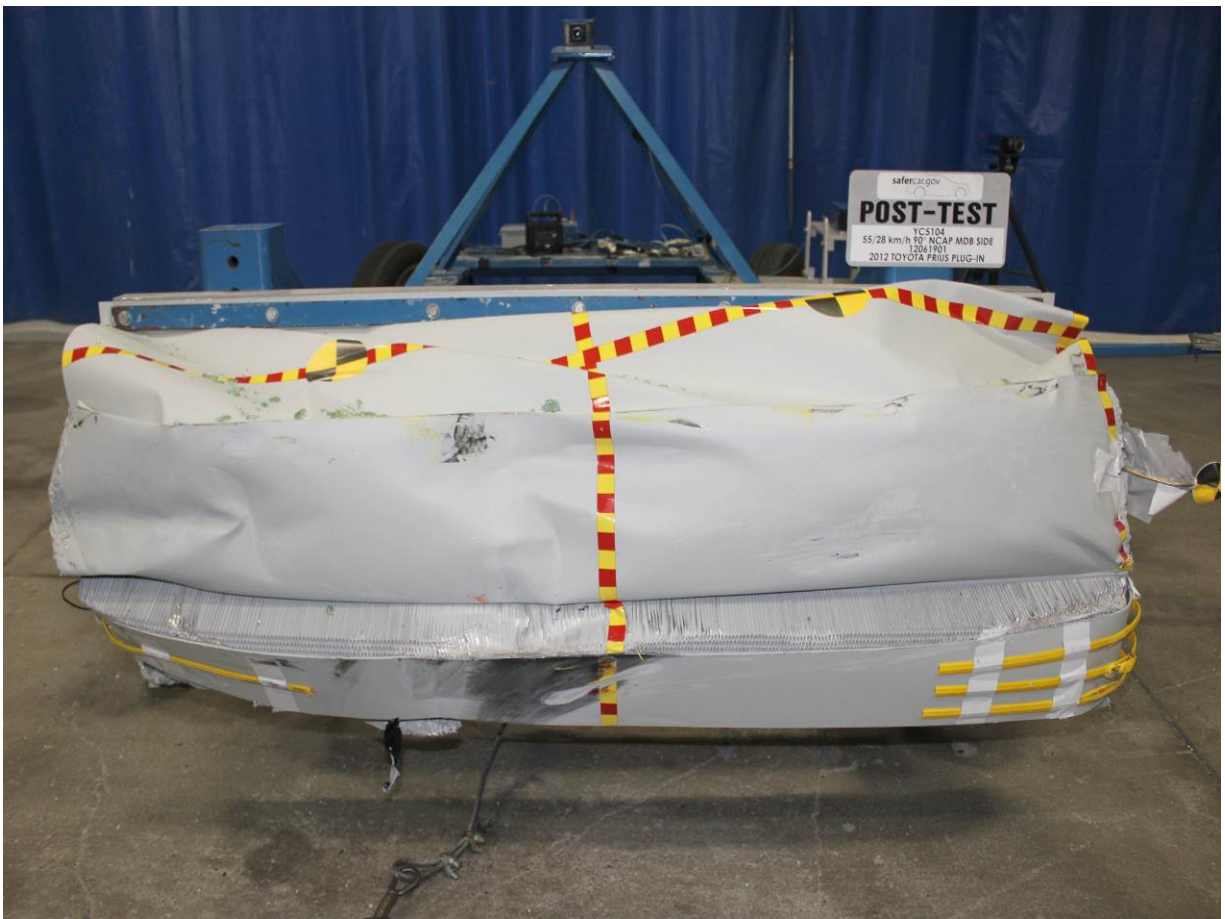
Post-Test Front View of MDB Impactor Face

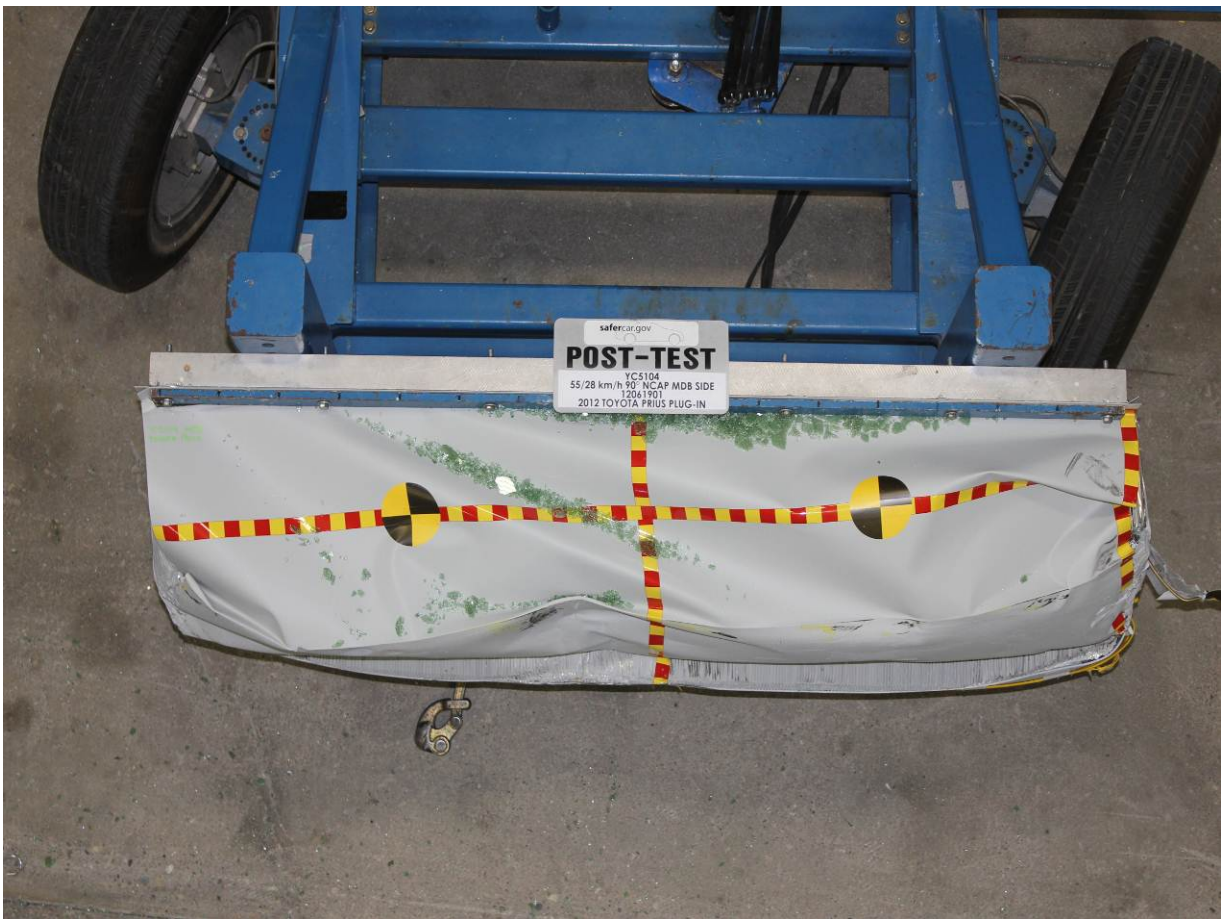
Post-Test Top View of MDB Impactor Face

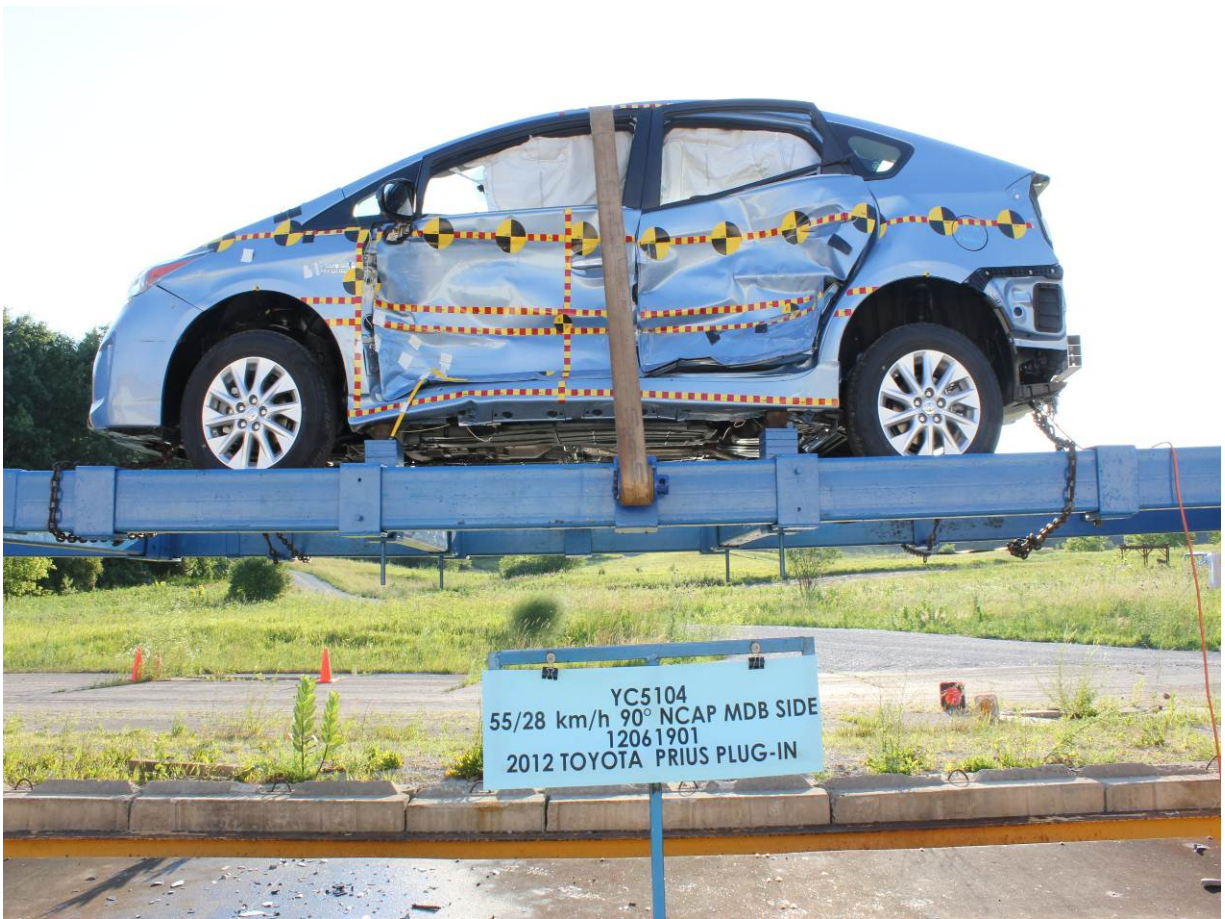
FMVSS No. 301 Static Rollover 0 Degrees

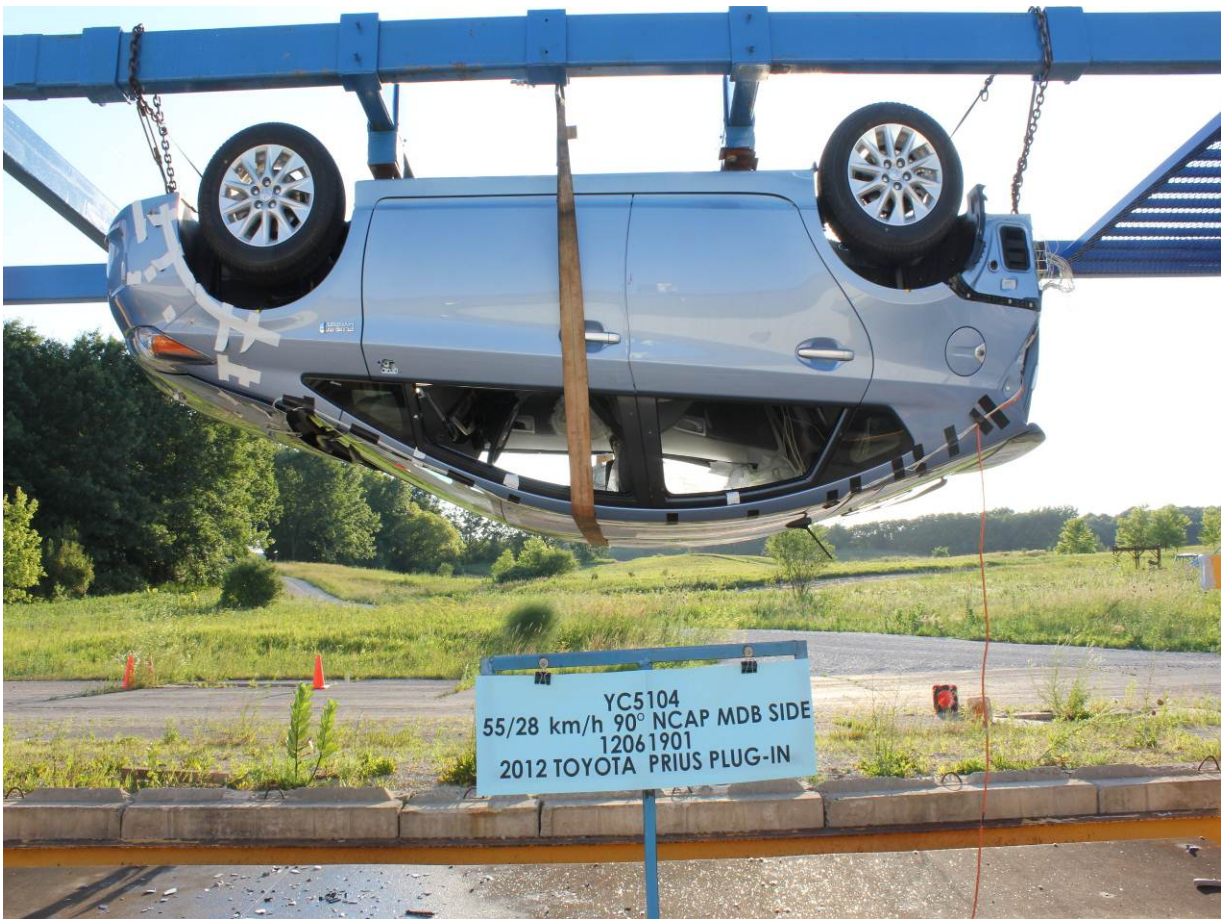
FMVSS No. 301 Static Rollover 180 Degrees

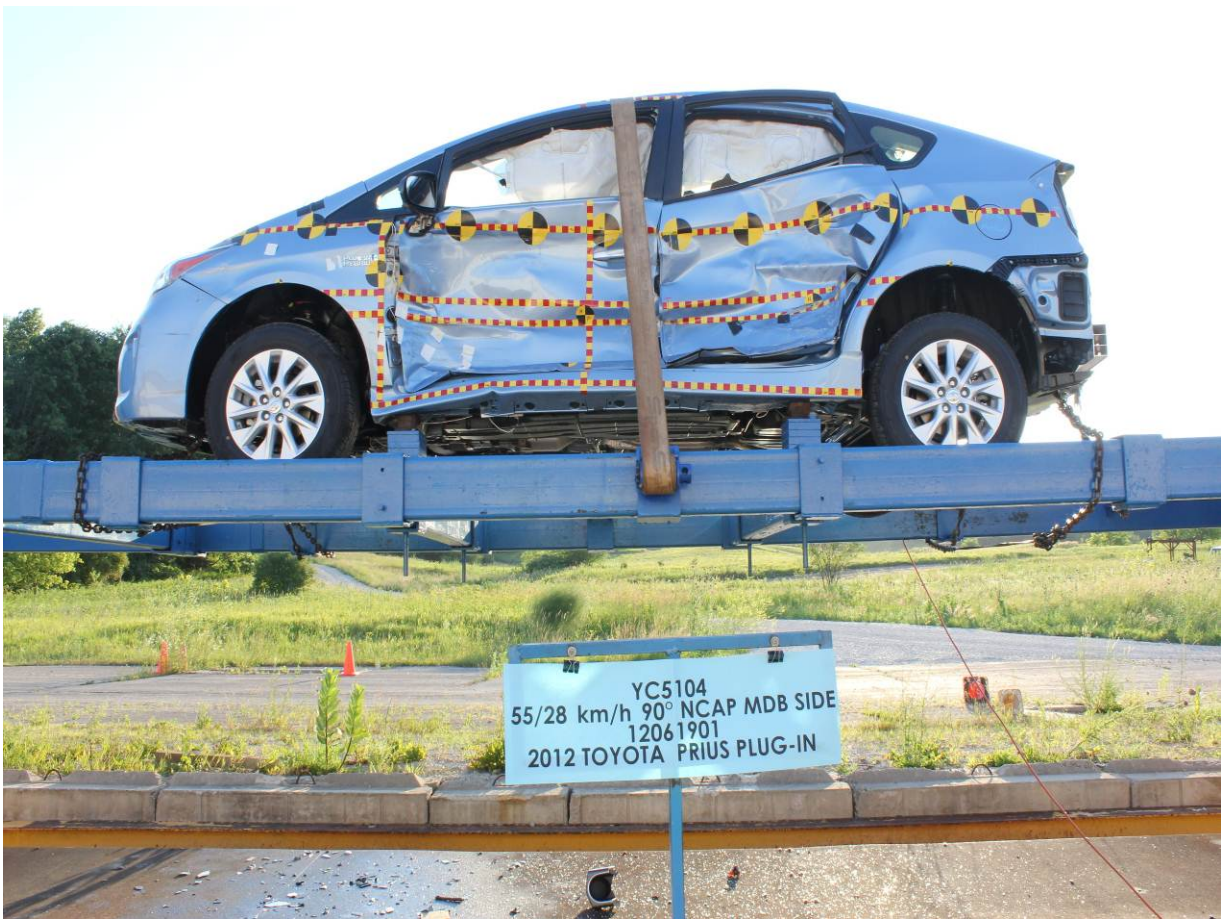
FMVSS No. 301 Static Rollover 360 Degrees

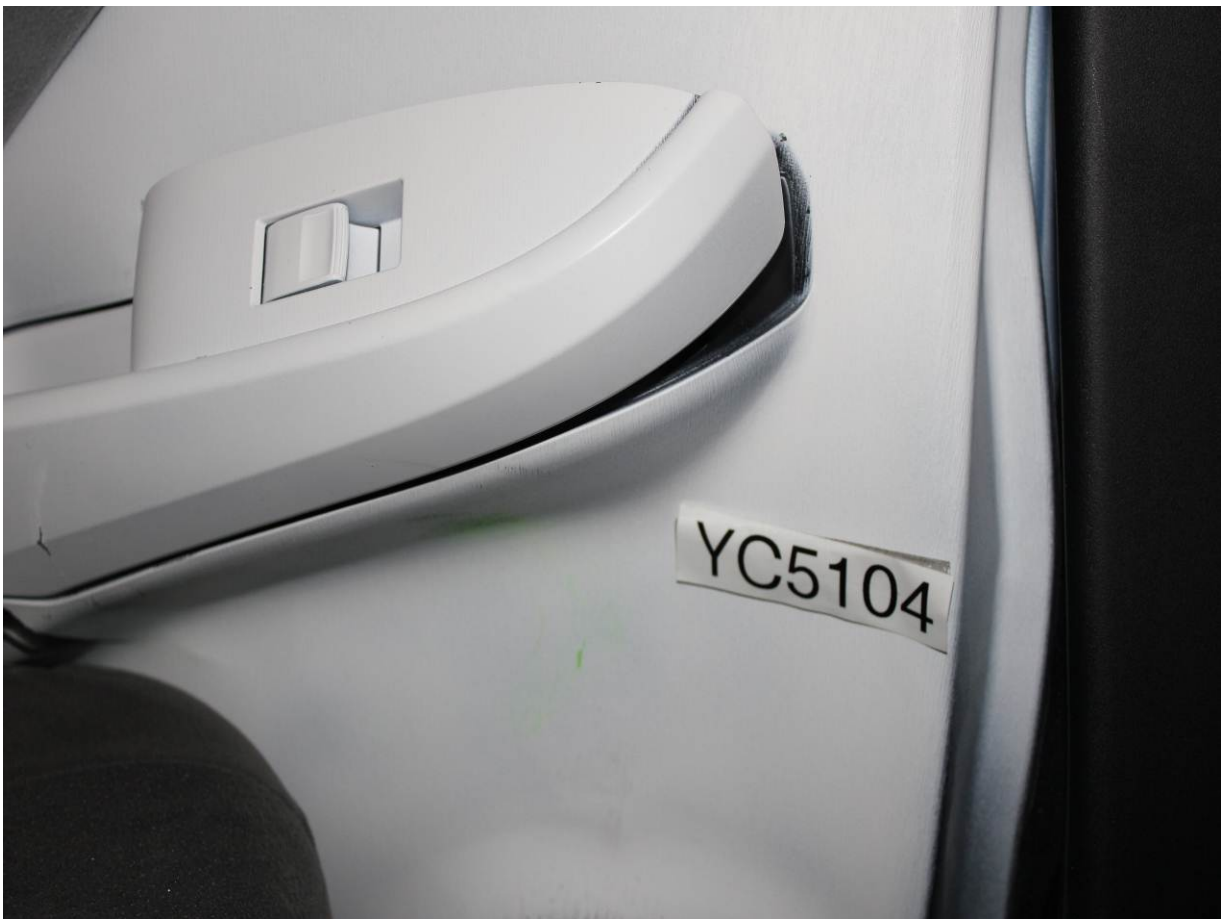
Post-Test Rear Passenger Dummy Knee Contact with Vehicle Interior View
