**REPORT NUMBER: NCAP-MGA-2013-001**

**NEW CAR ASSESSMENT PROGRAM (NCAP)  
Frontal Barrier Impact Test**

**MAZDA MOTOR CORPORATION  
2013 Mazda CX-5 Sport All Wheel Drive 5-Dr SUV  
NHTSA No.: MD5400**

**MGA RESEARCH CORPORATION  
5000 Warren Road  
Burlington, WI 53105**

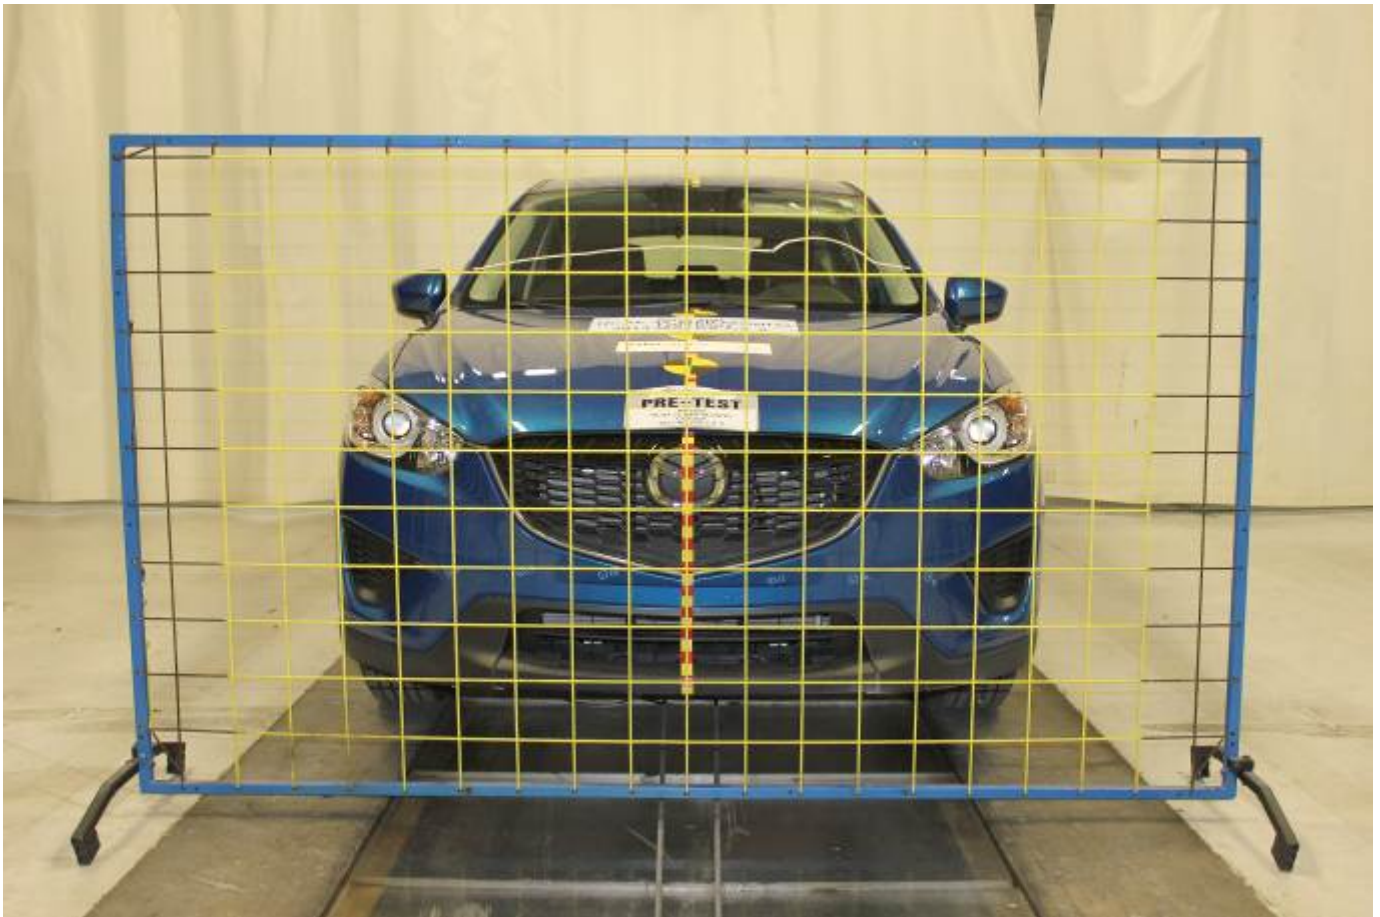
Load Cell Location

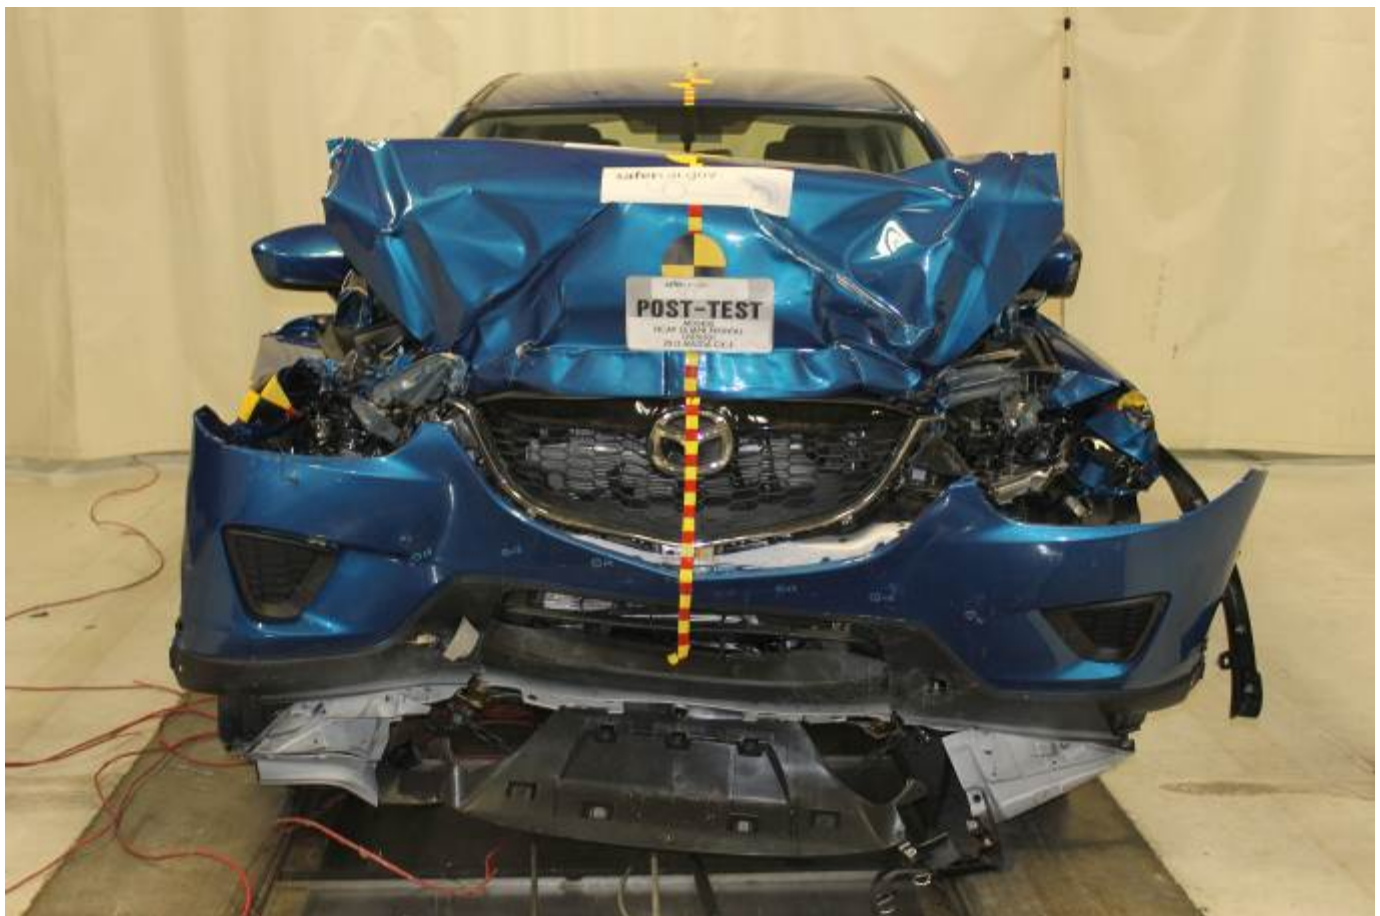
Post-Test Front View of Test Vehicle

The maximum static crush of the vehicle was 547 mm and both the driver and passenger side doors remained closed during the impact event and were operable after the impact.

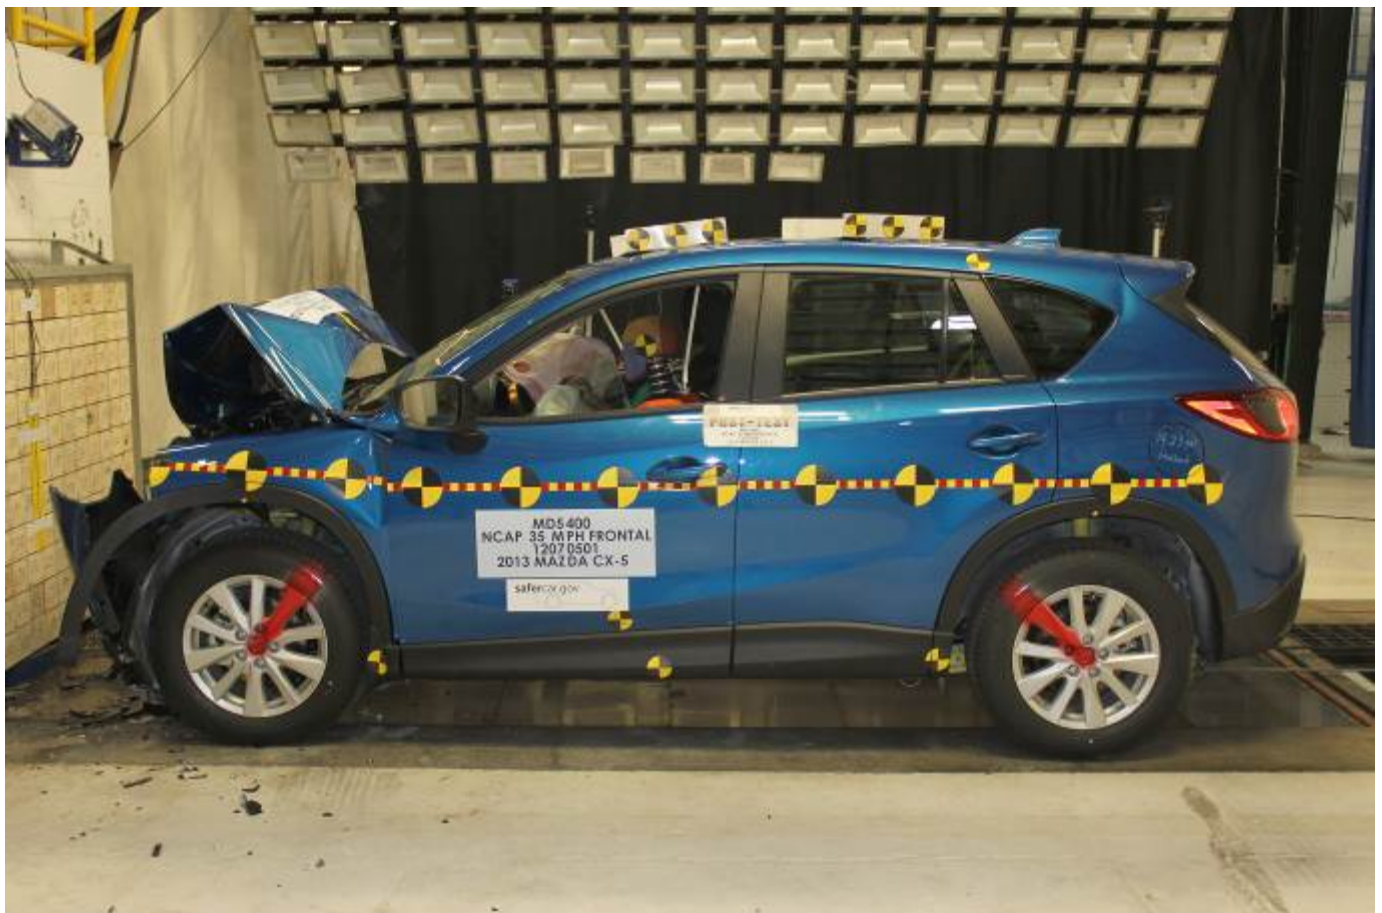
Post-Test Left View of Test Vehicle

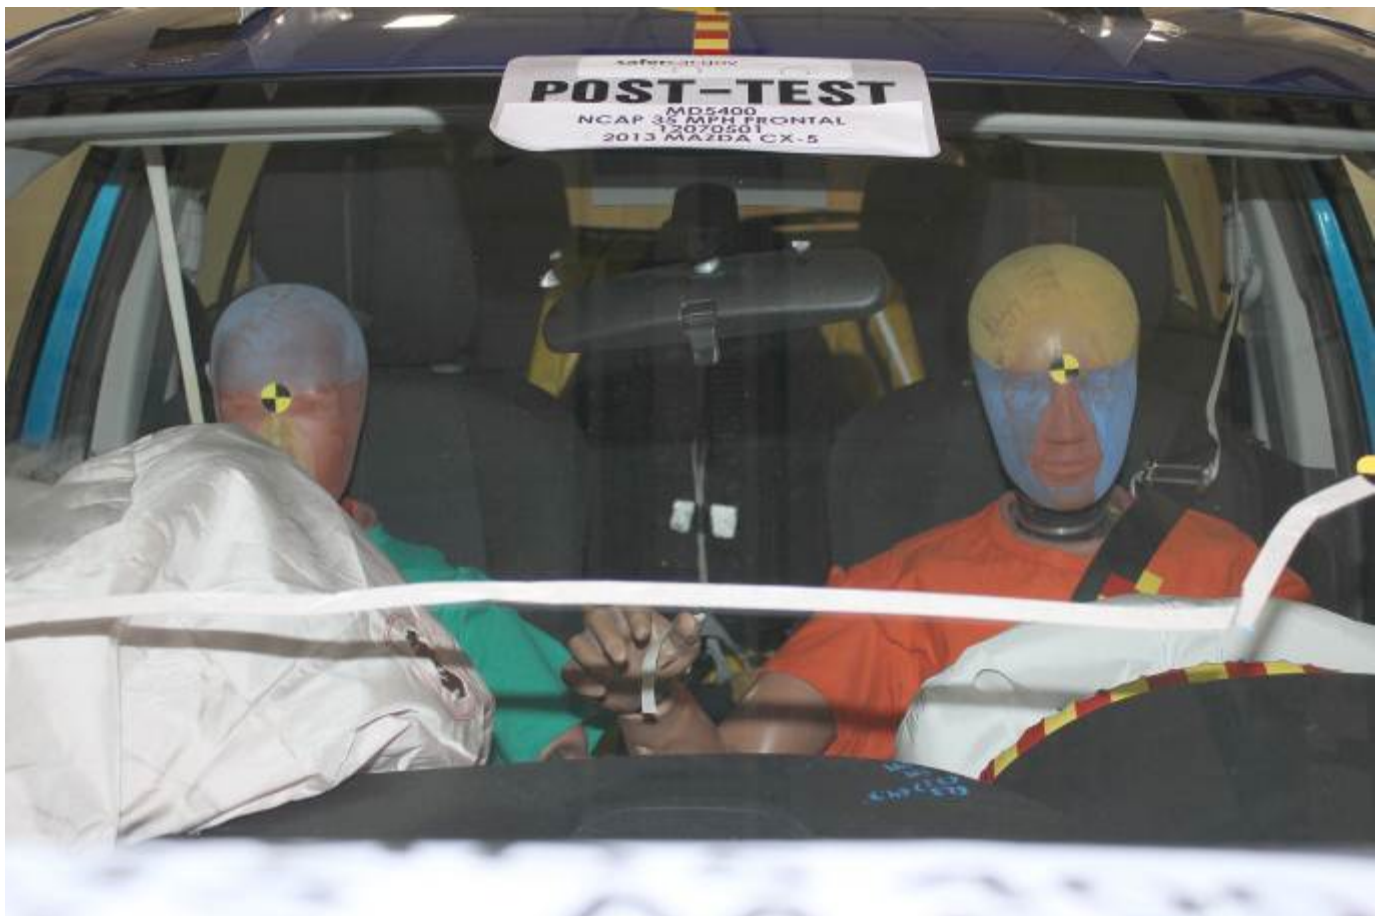
Post-Test Windshield View

There was 100 percent windshield retention and no intrusion into the protected zone of the windshield during the event. There was no Stoddard Solvent leakage after the event or during any phase of the static rollover.

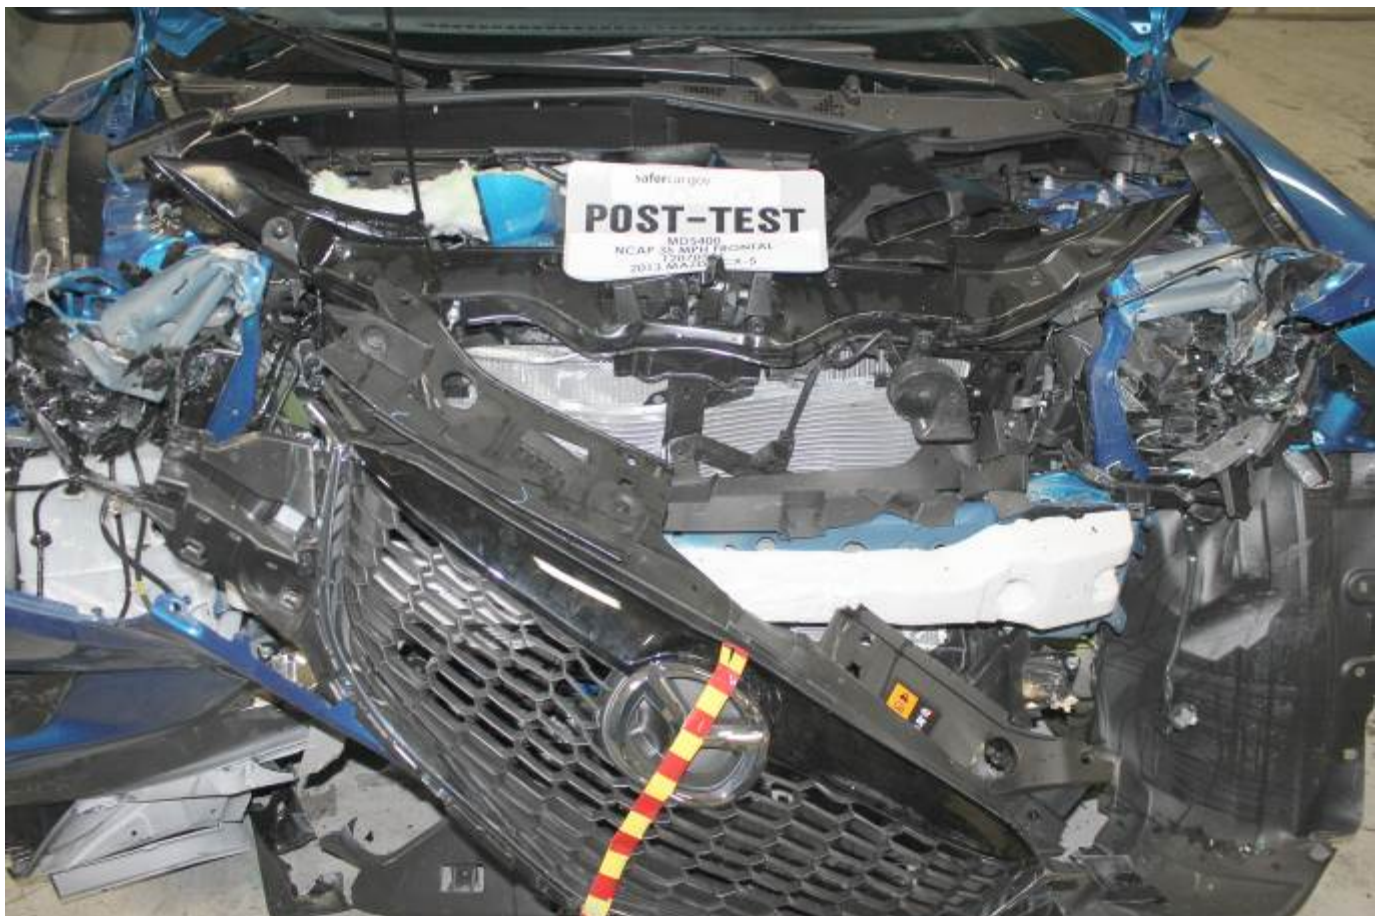
Post-Test Engine Compartment View

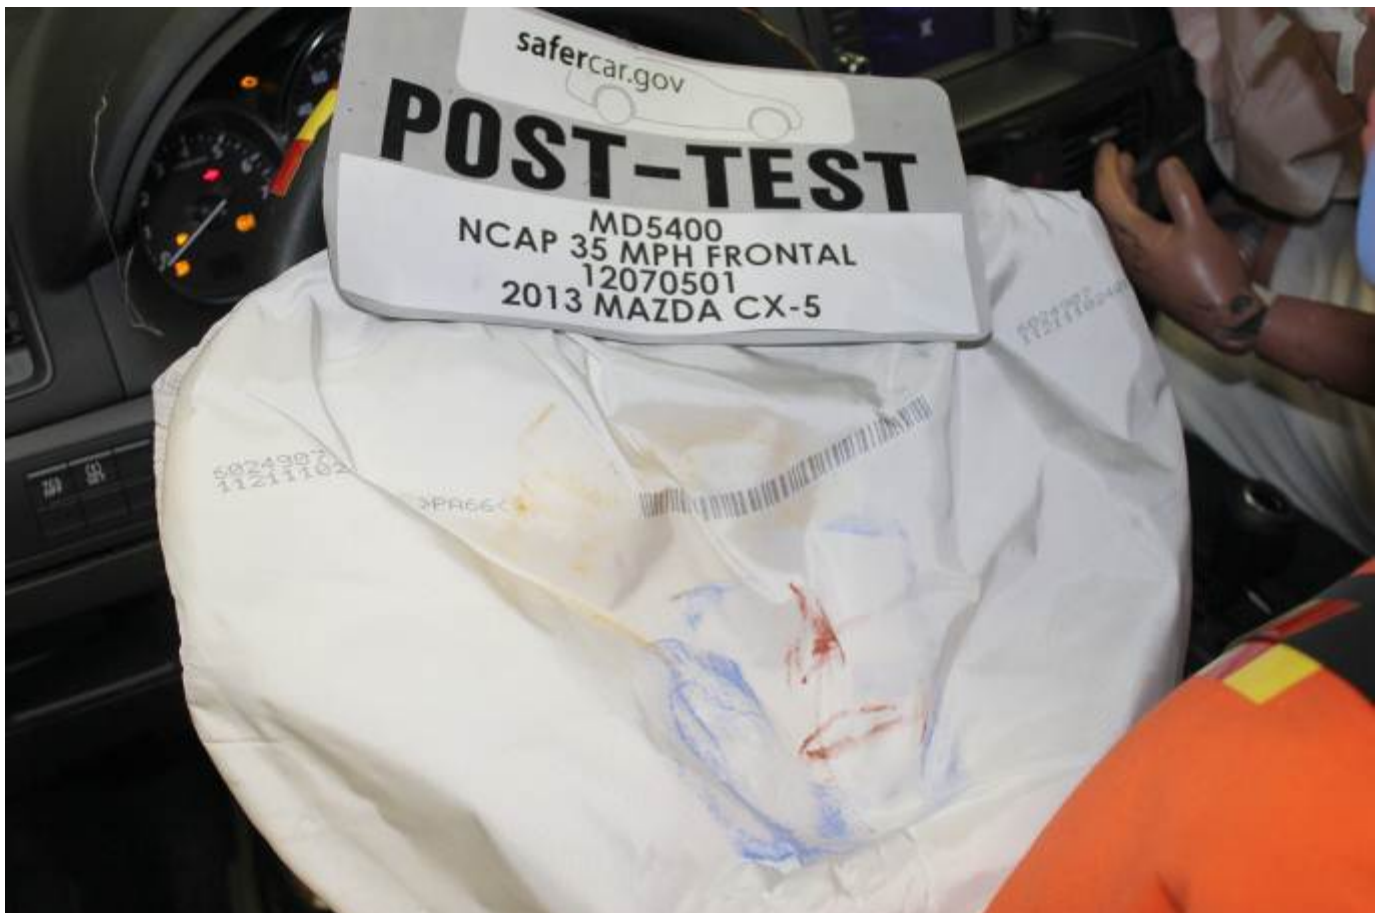
Post-Test Driver Dummy Contact with Airbag

The driver's visible contact points were as follows: The driver's head and chest contacted the airbag. The driver's head also contacted the headrest. The driver's knees contacted the knee bolster and steering column. The passenger's visible contact points were as follows: The passenger's head and chest contacted the airbag. The passenger's head also contacted the headrest. The passenger's knees contacted the glove box.

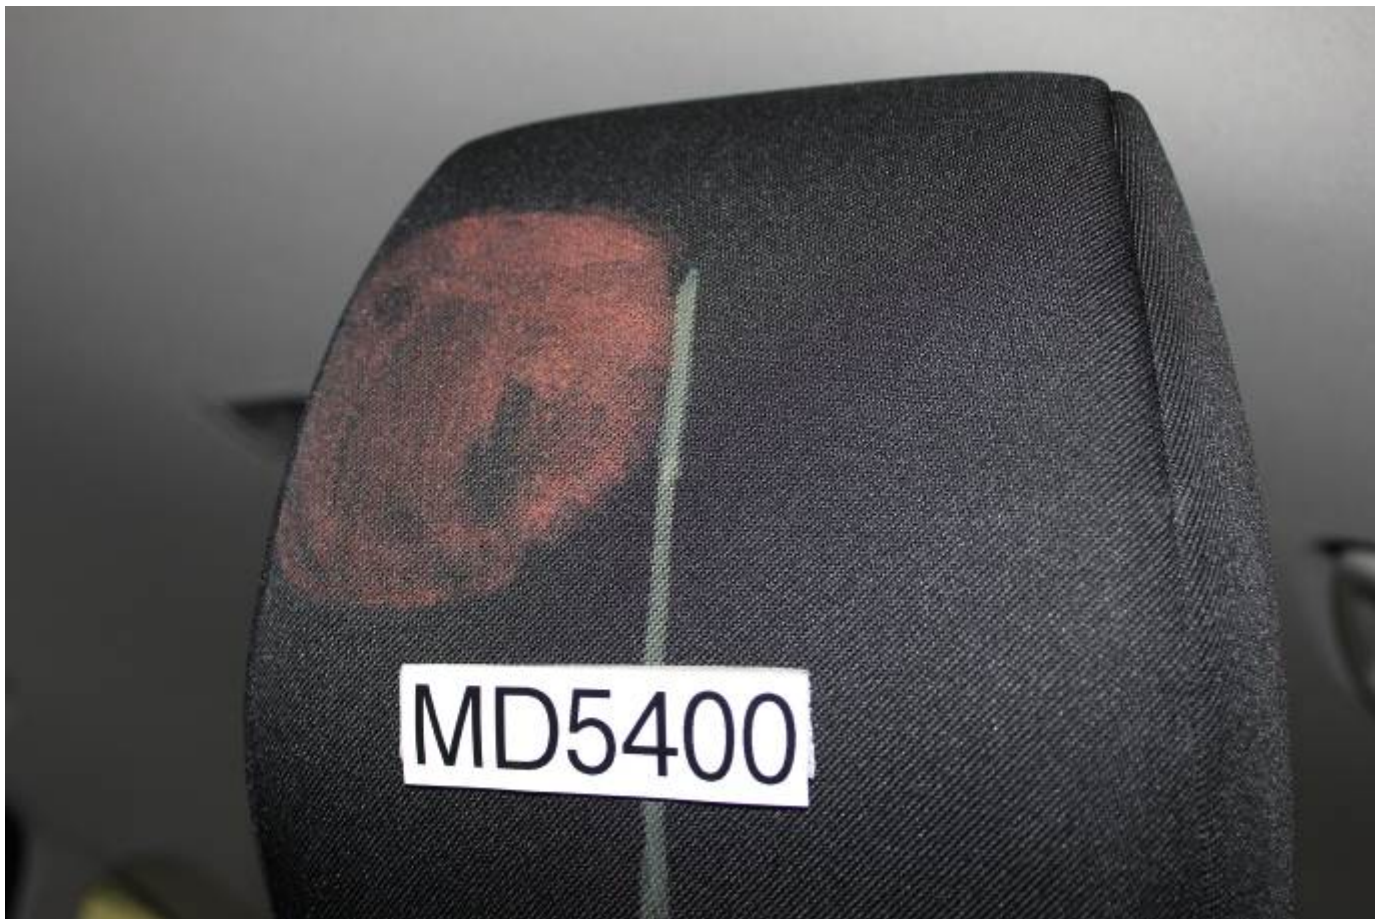
Post-Test Driver Dummy Contact with Headrest

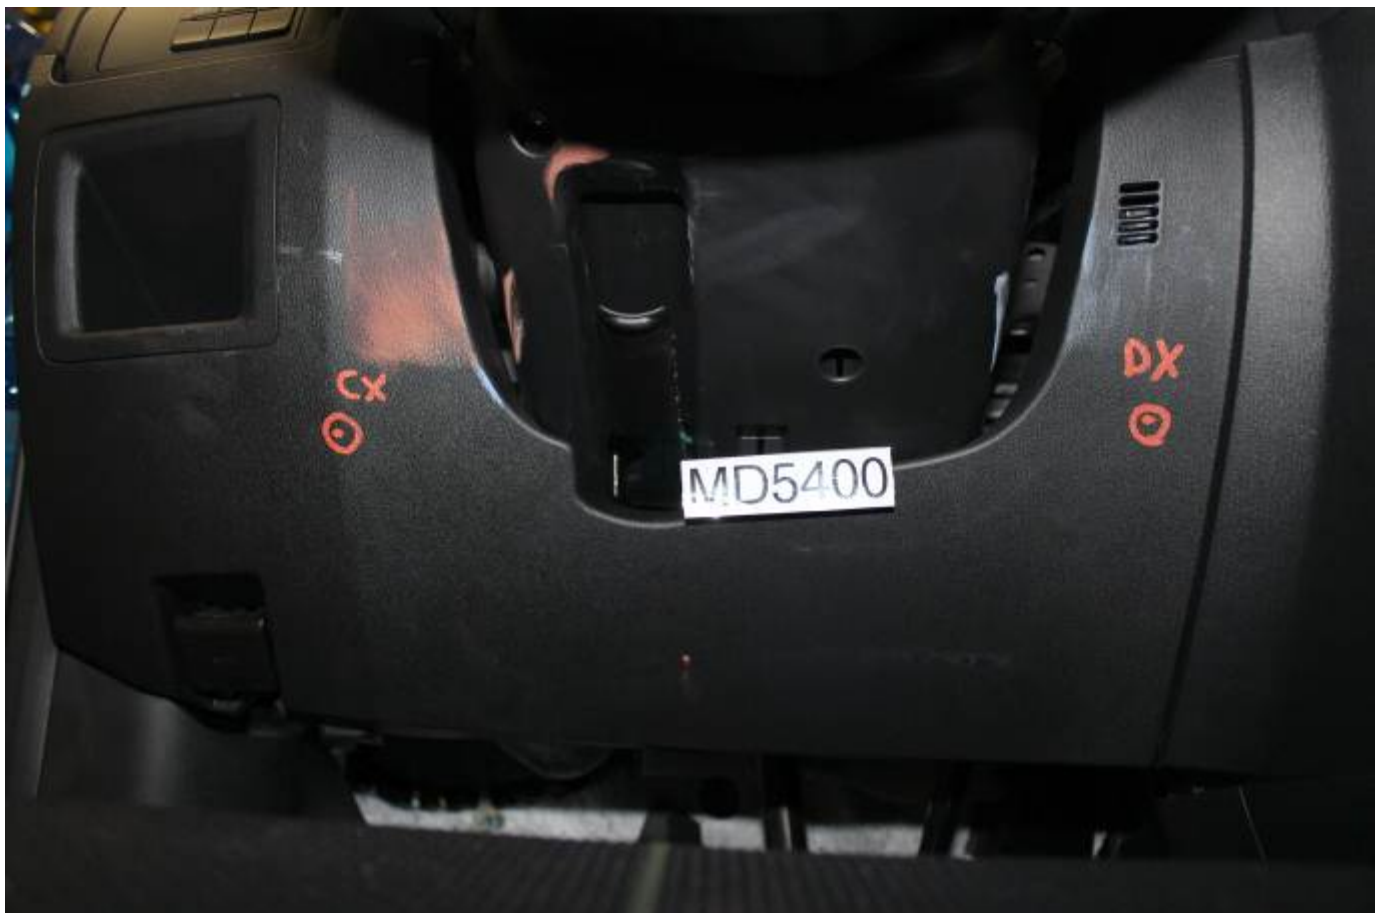
Post-Test Driver Dummy Contact with Knee Bolster

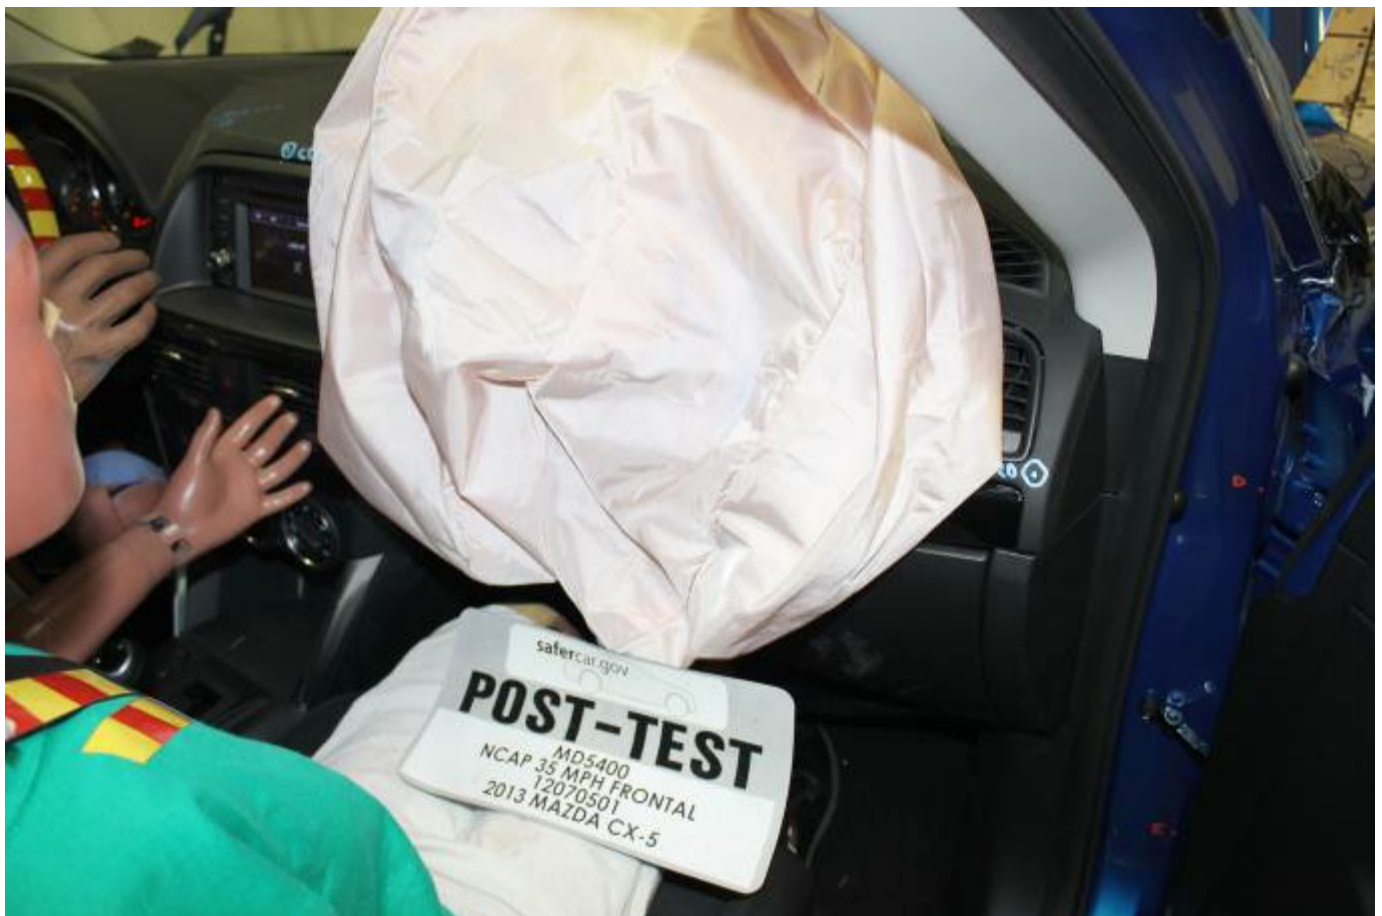
Post-Test Passenger Dummy Contact with Airbag

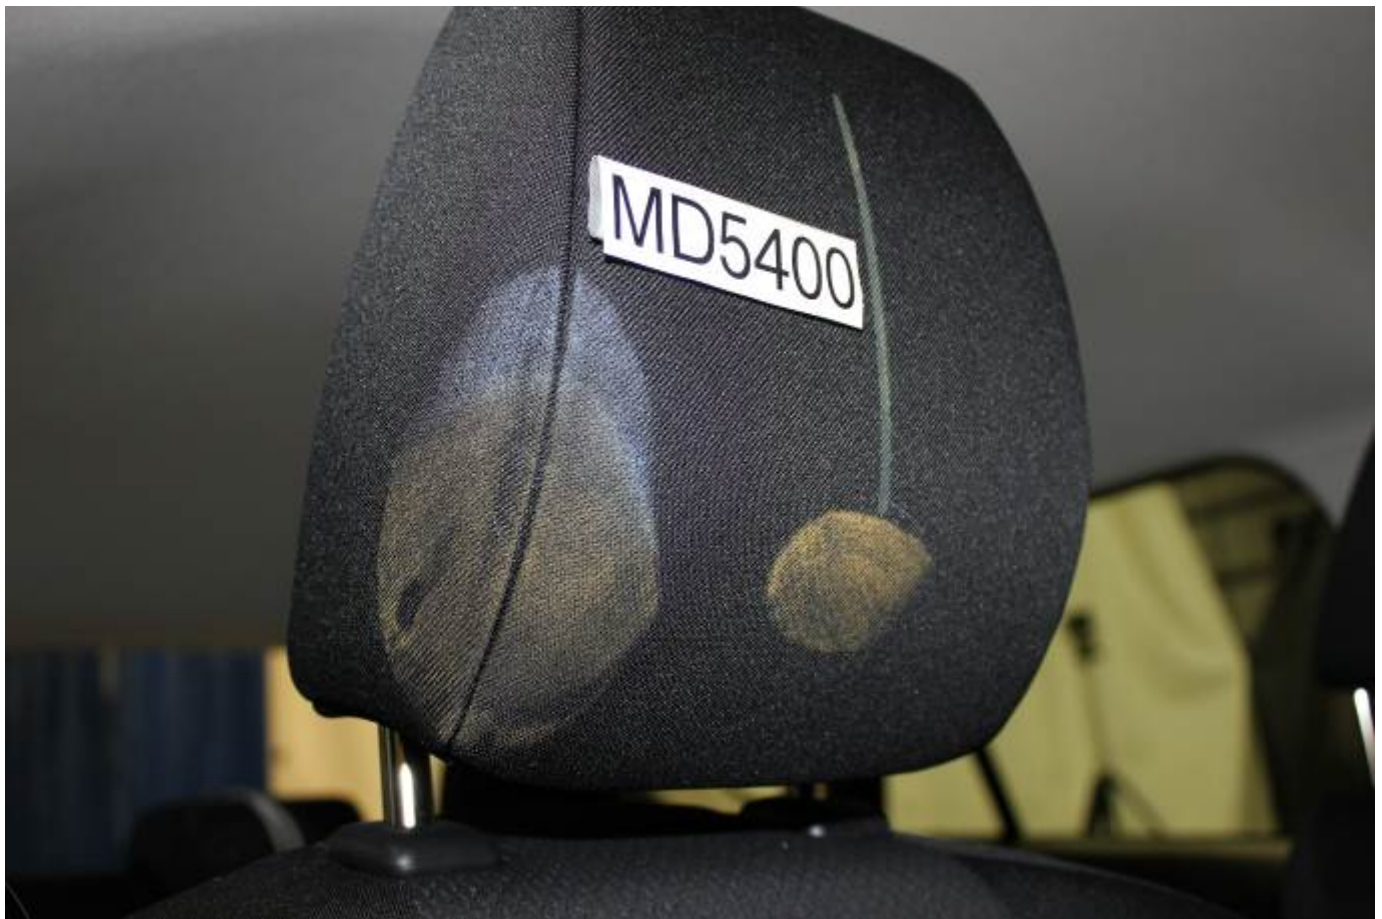
Post-Test Passenger Dummy Contact with Headrest

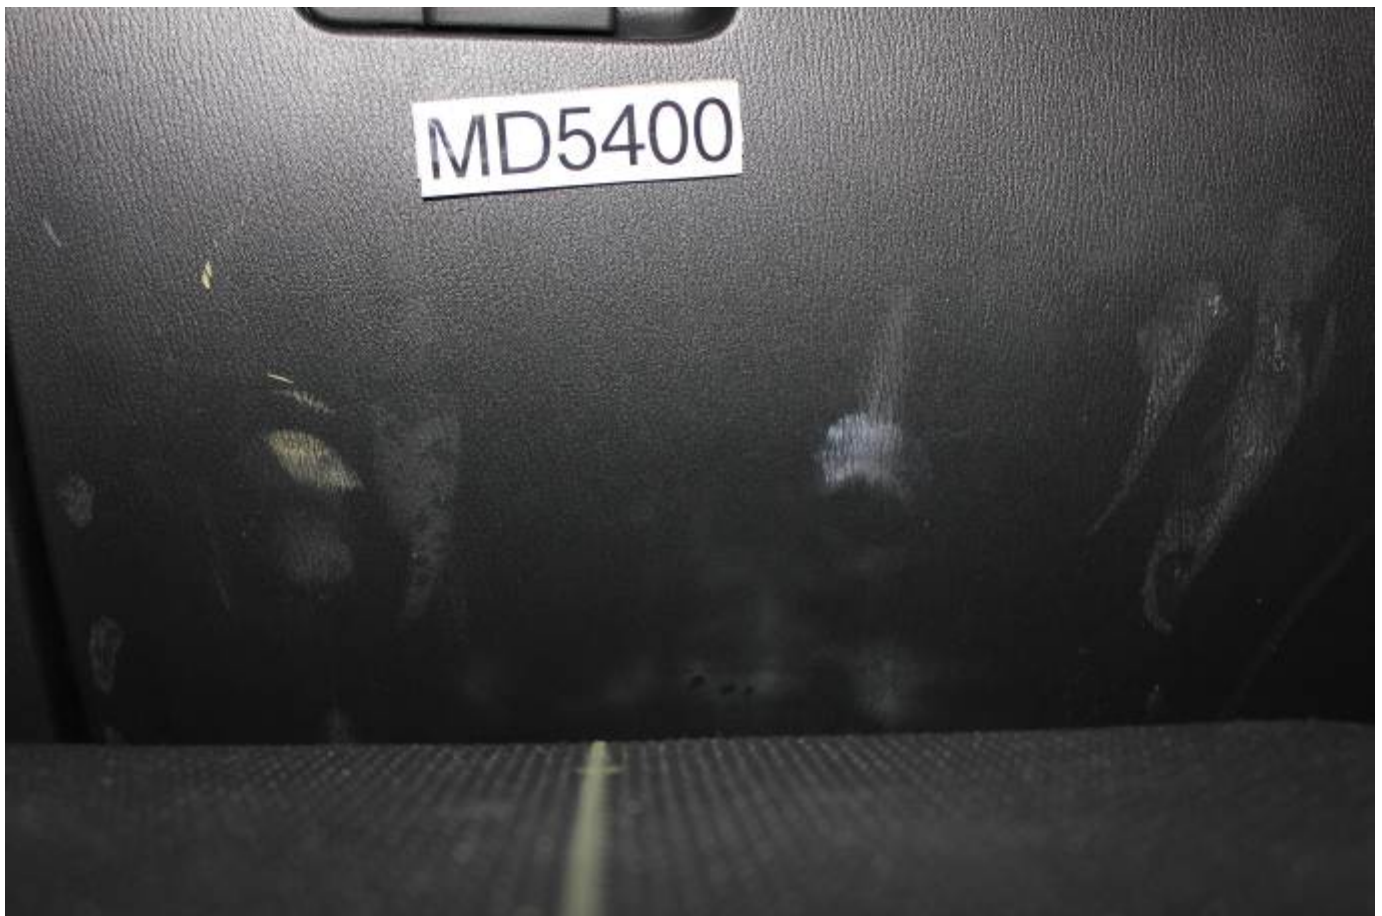
Post-Test Passenger Dummy Contact with Glove Box

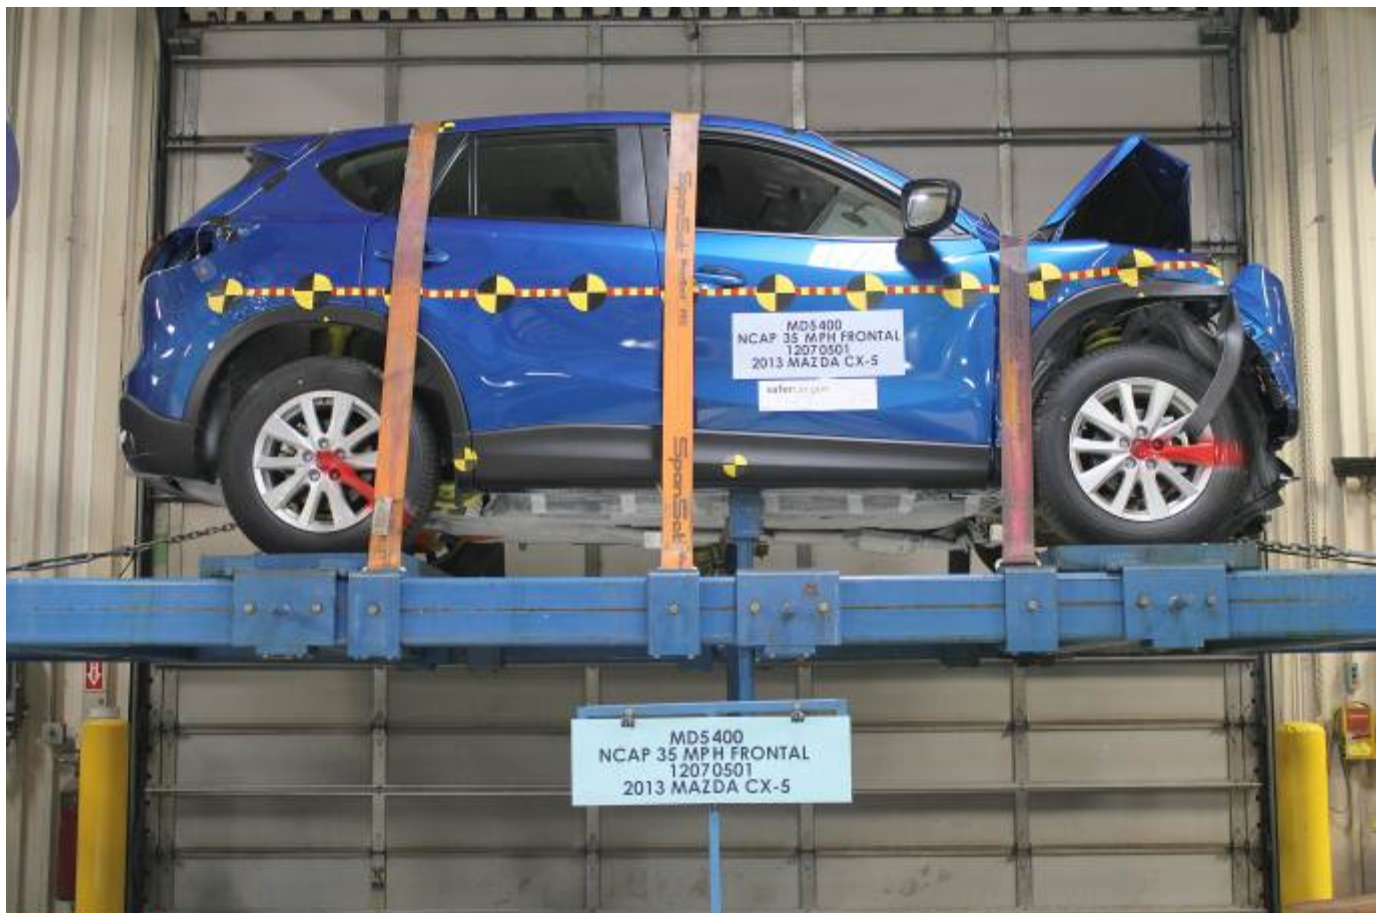
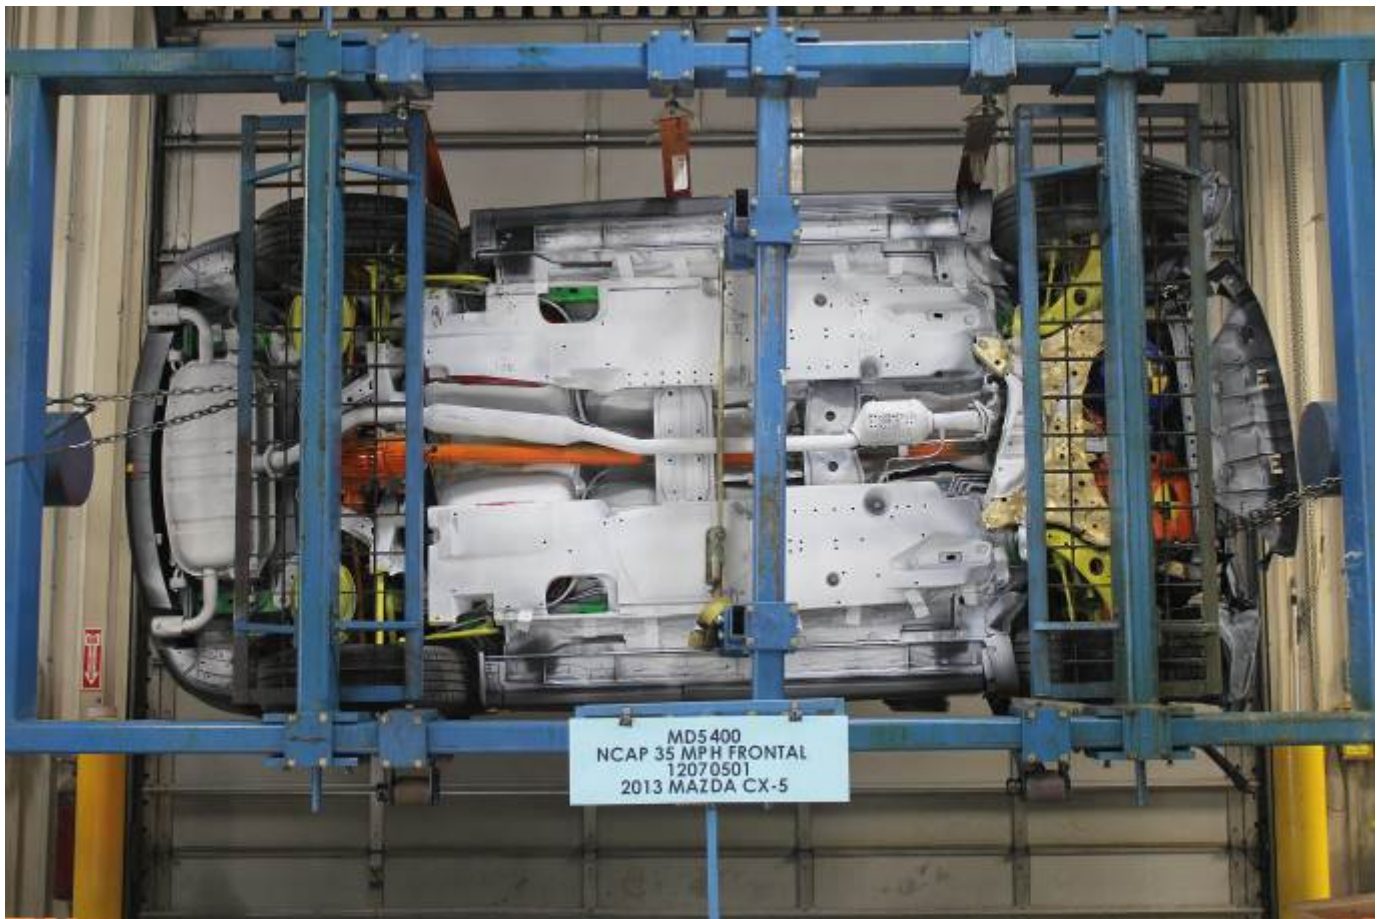
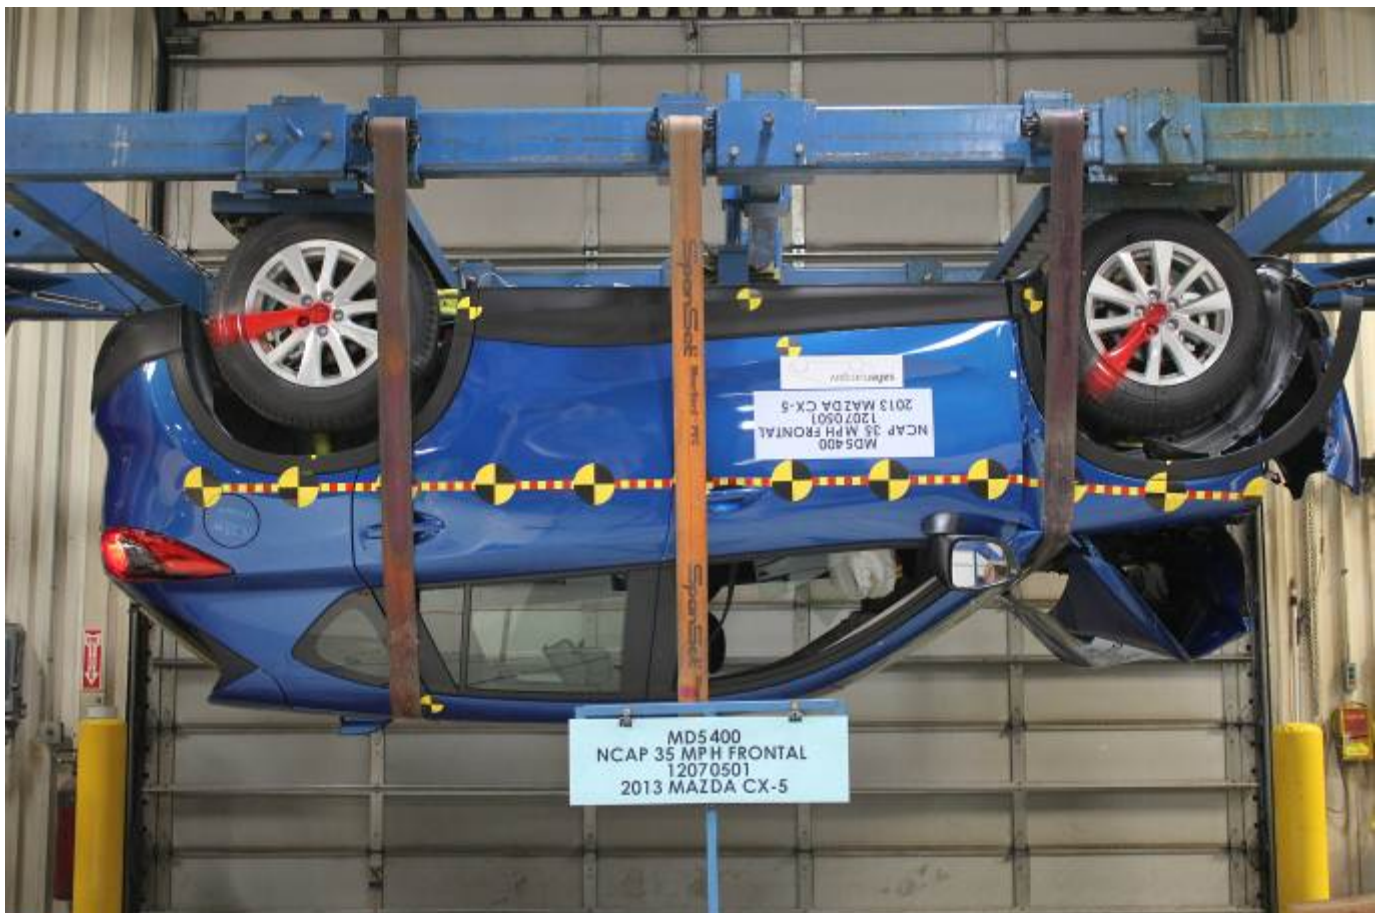
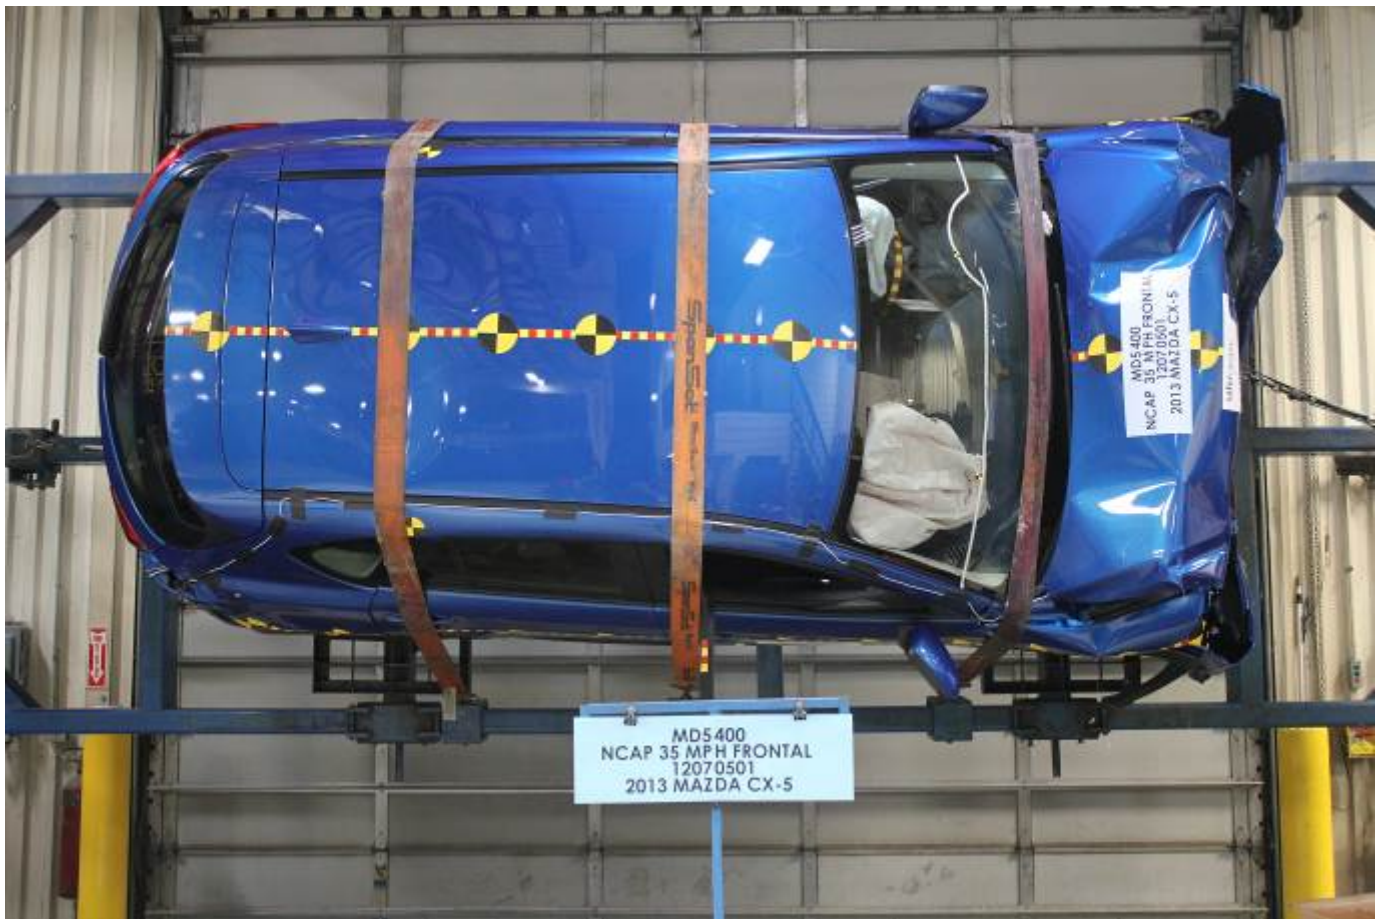
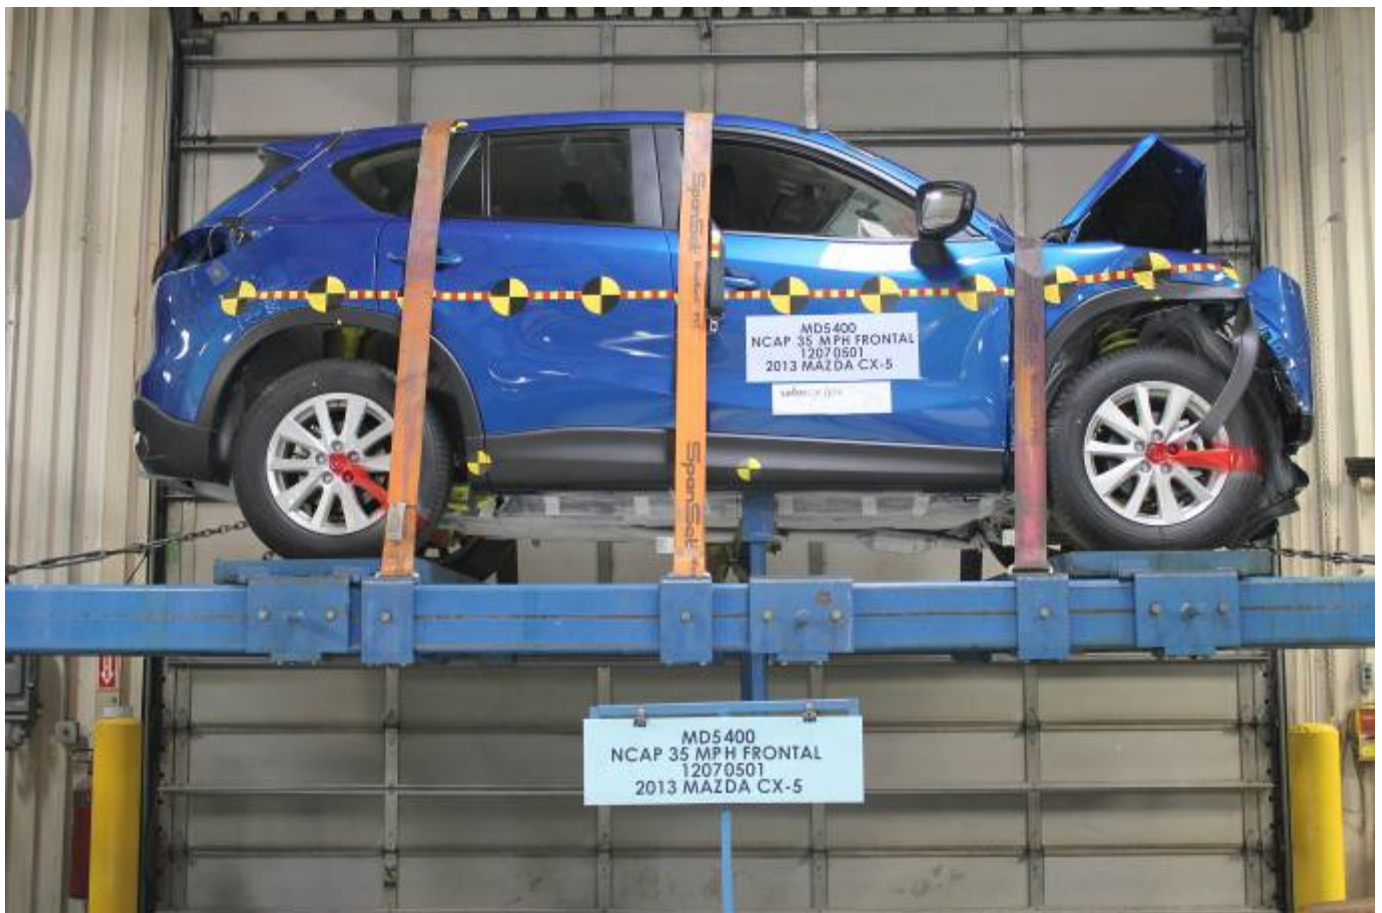
Vehicle at 0° on Static Rollover Device

Vehicle at 90° on Static Rollover Device

Vehicle at 180° on Static Rollover Device

Vehicle at 270° on Static Rollover Device

Vehicle at 360° on Static Rollover Device
