**REPORT NUMBER: SPNCAP-MGA-2013-002**

**NEW CAR ASSESSMENT PROGRAM (NCAP)  
Side Impact Pole Test**

**MAZDA MOTOR CORPORATION  
2013 Mazda CX-5 Sport Front Wheel Drive 5-Dr SUV  
NHTSA No.: MD5402**

**FINAL REPORT**

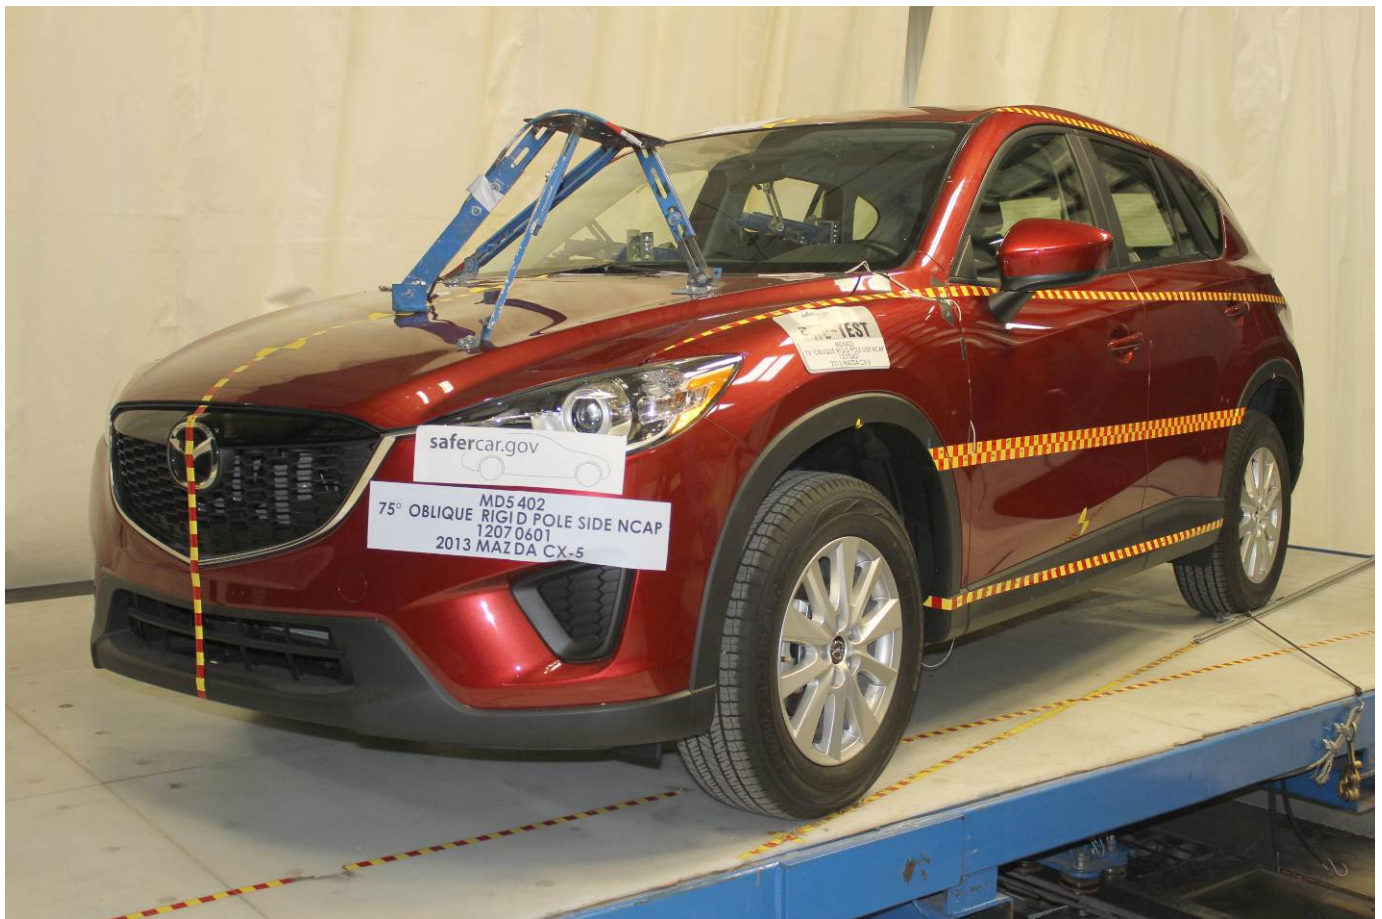
Post-Test Frontal View of Test Vehicle

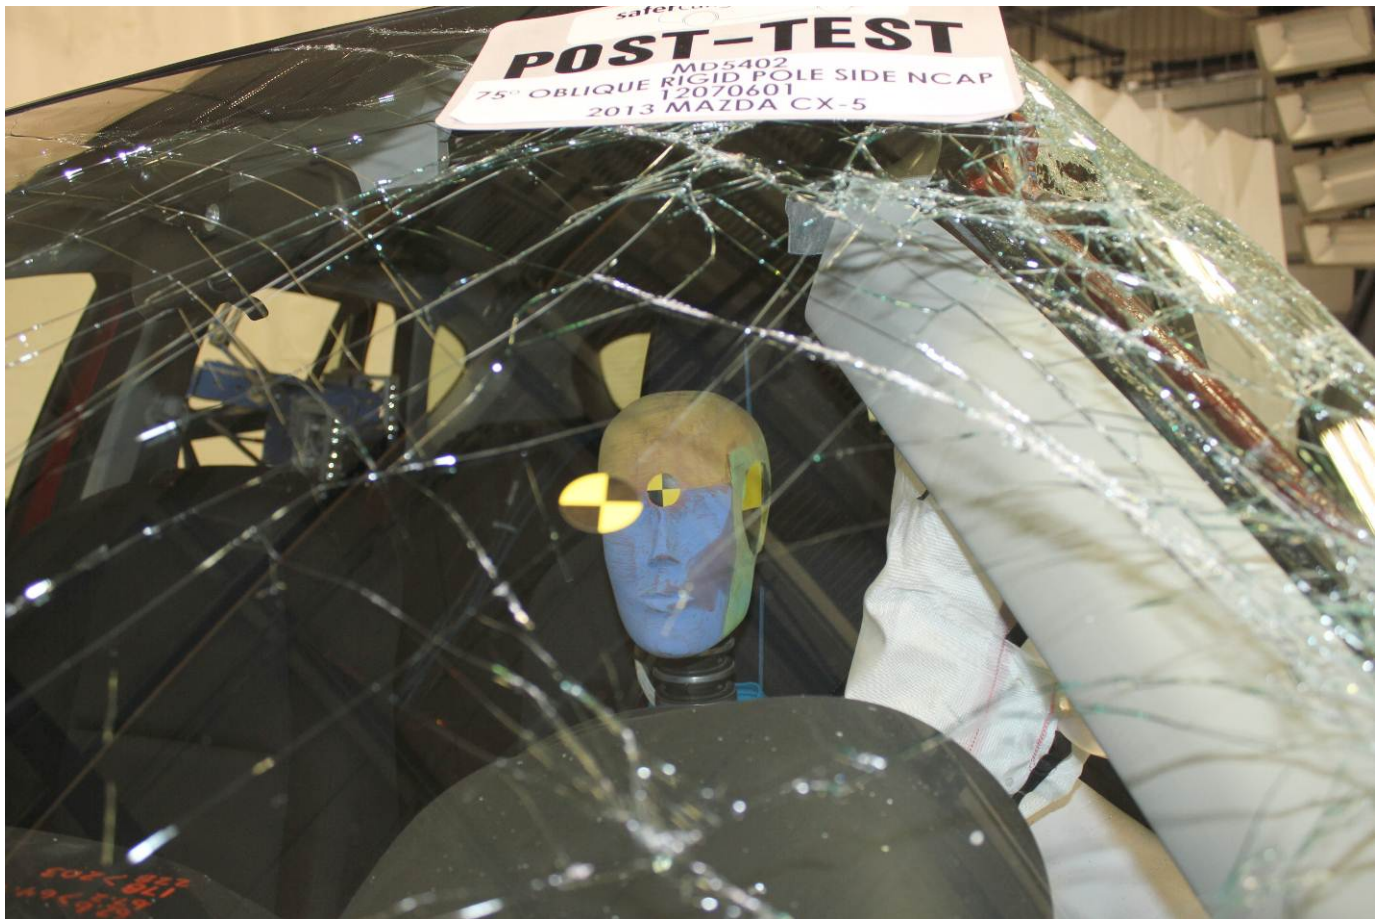
Post-Test Close-Up View of Impact Point Target Showing Impact Location

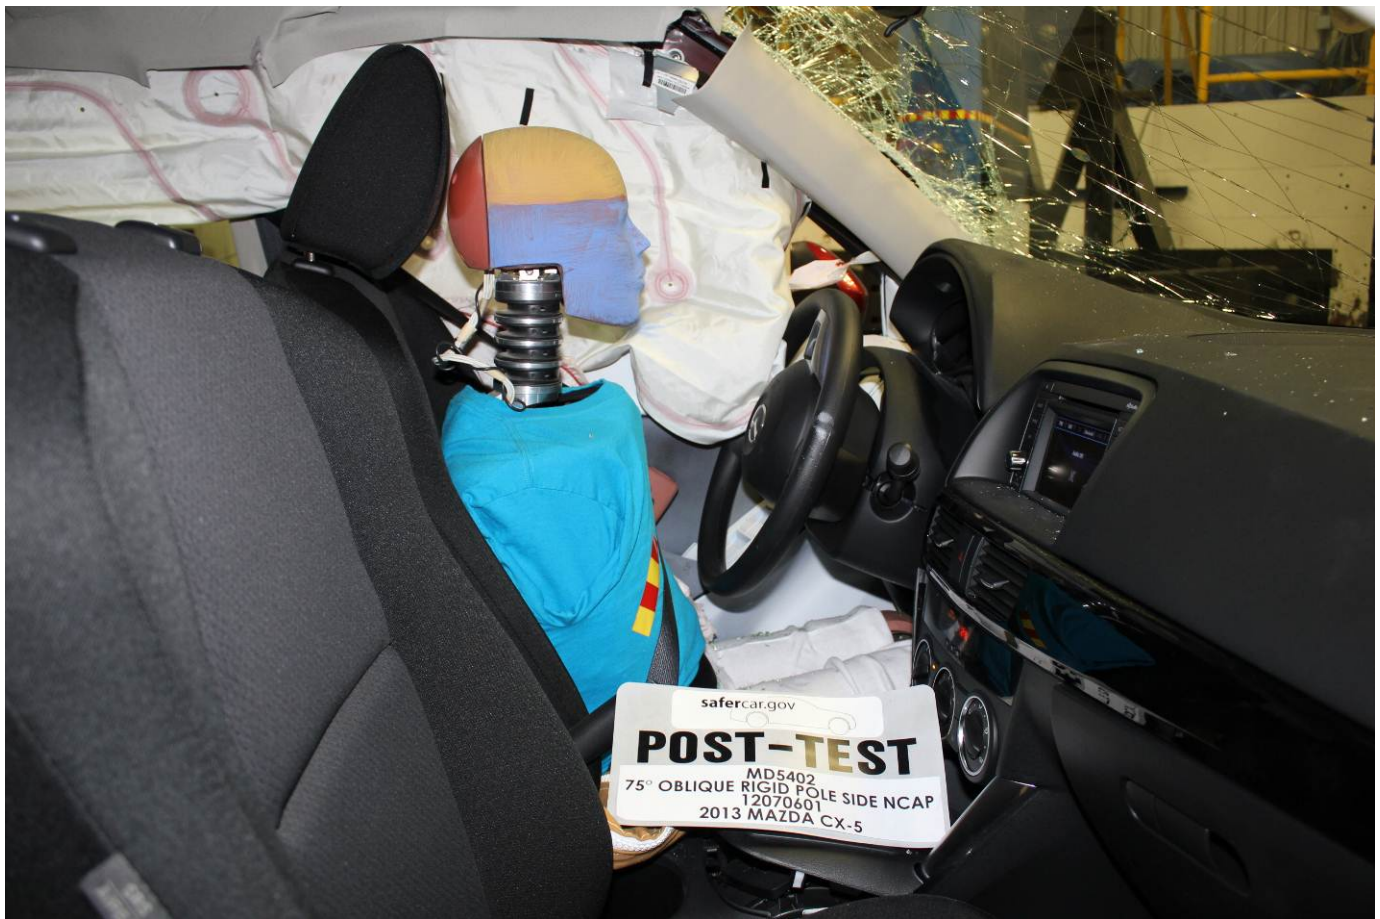
Post-Test Dummy and Door Clearance View

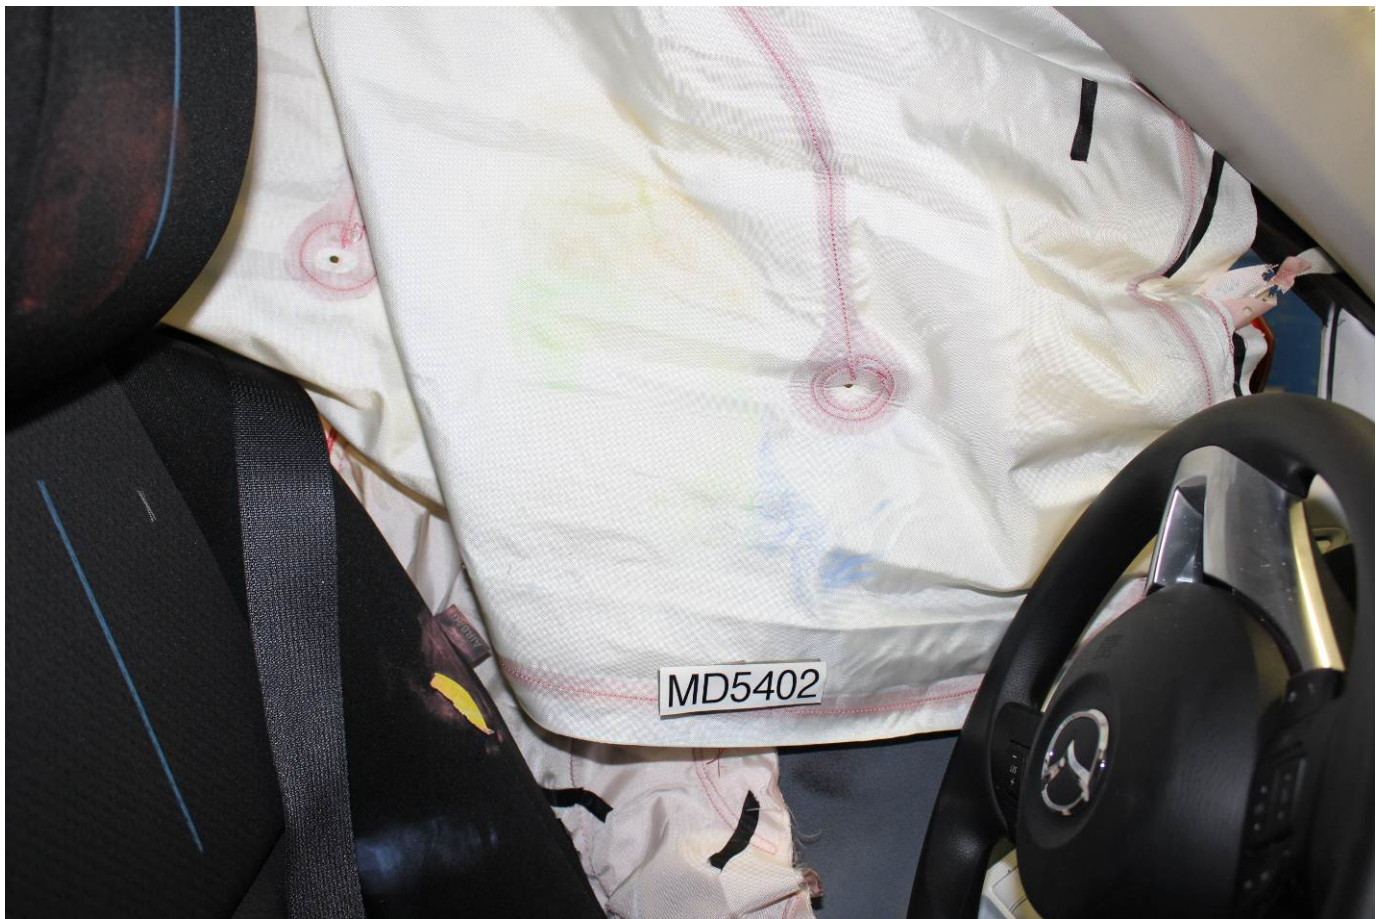
Post-Test Inner Door Panel View Showing Dummy Contact Location

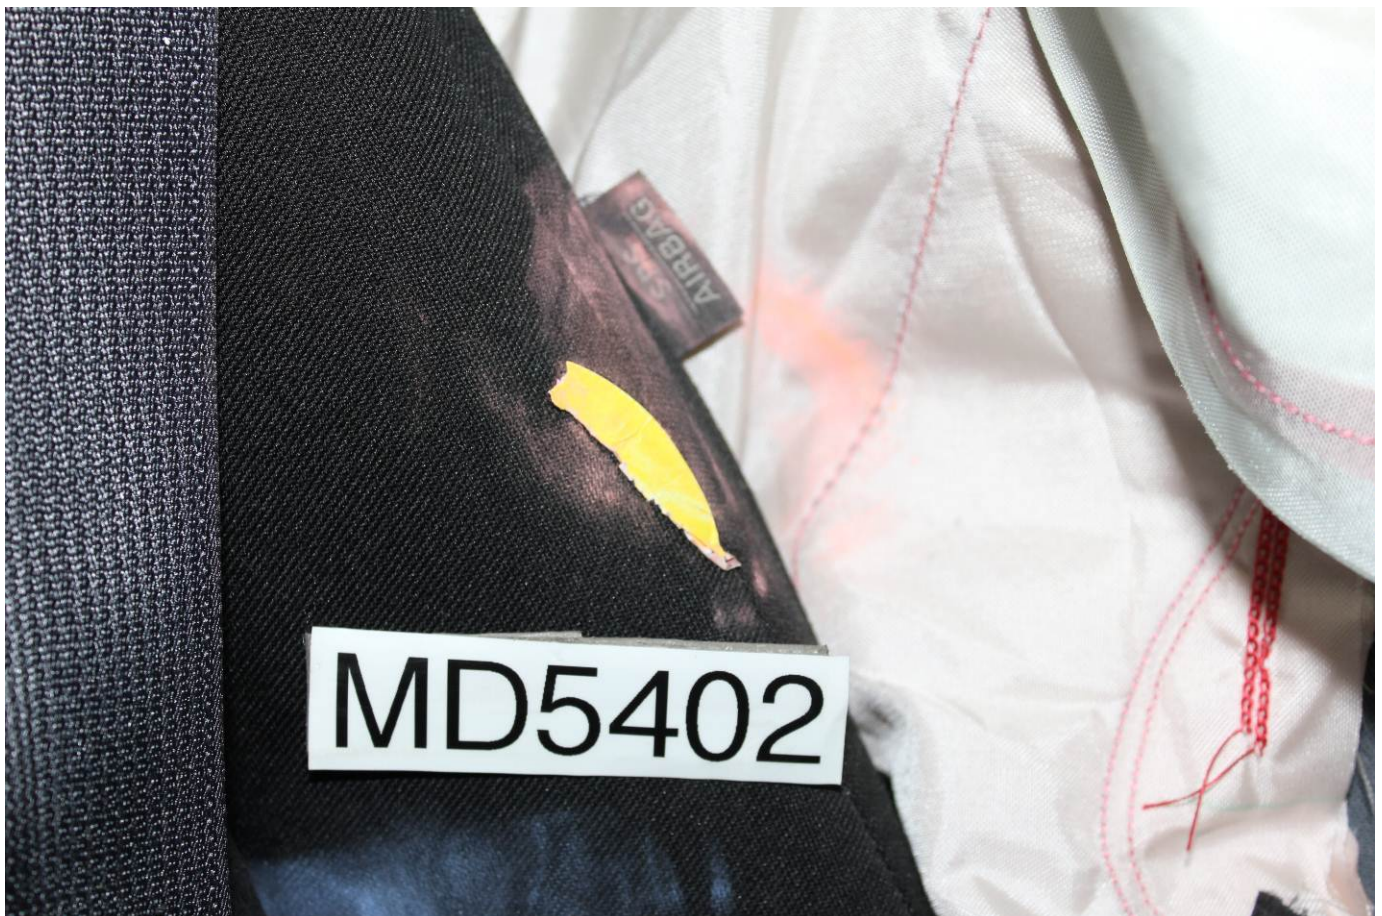
Post-Test Dummy Close-Up Head Contact with Vehicle Interior View

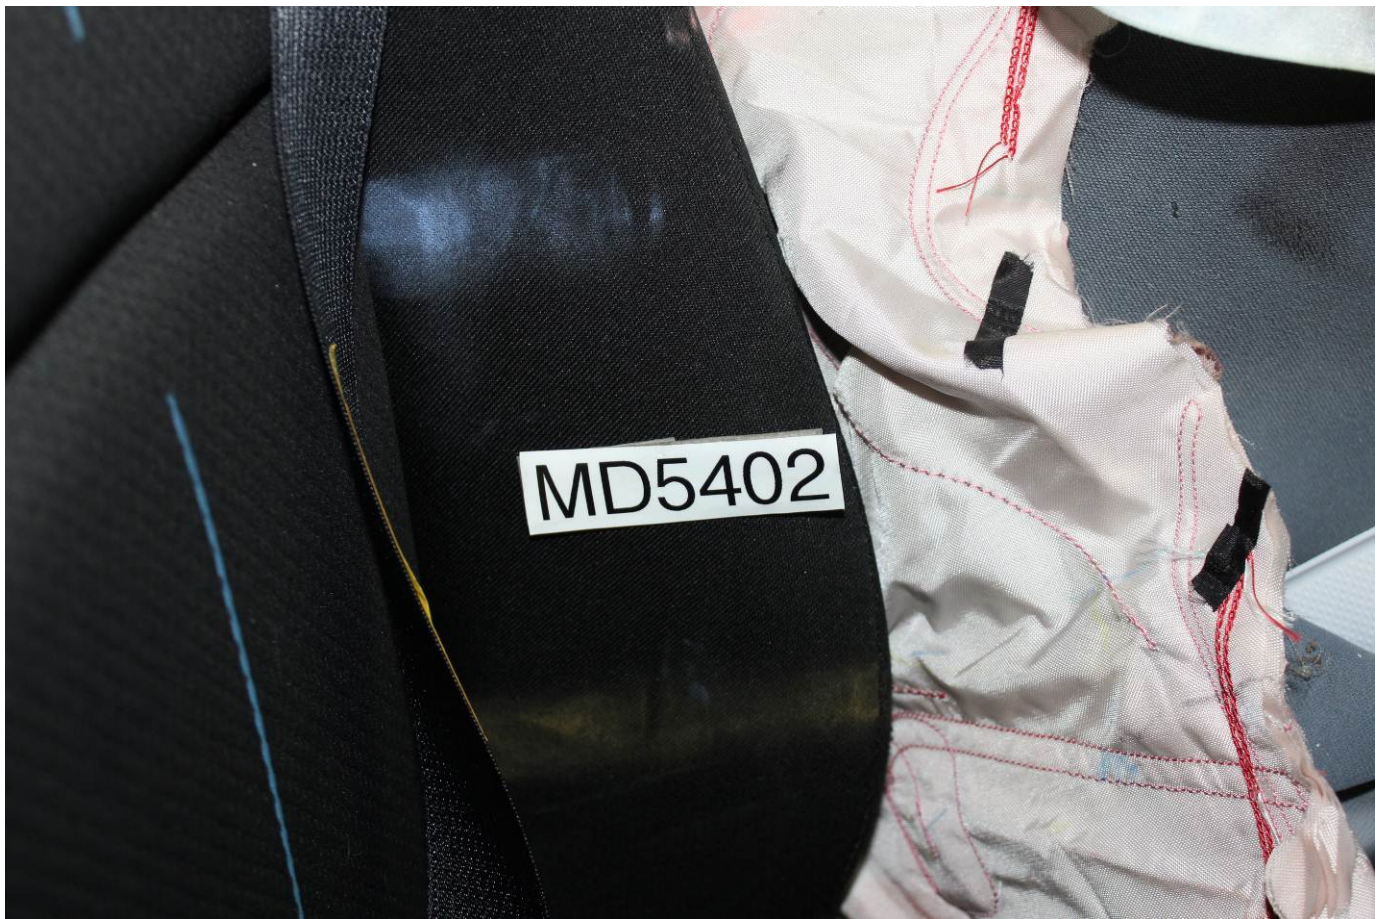
Post-Test Dummy Close-Up Head Contact with Side Air Bag View

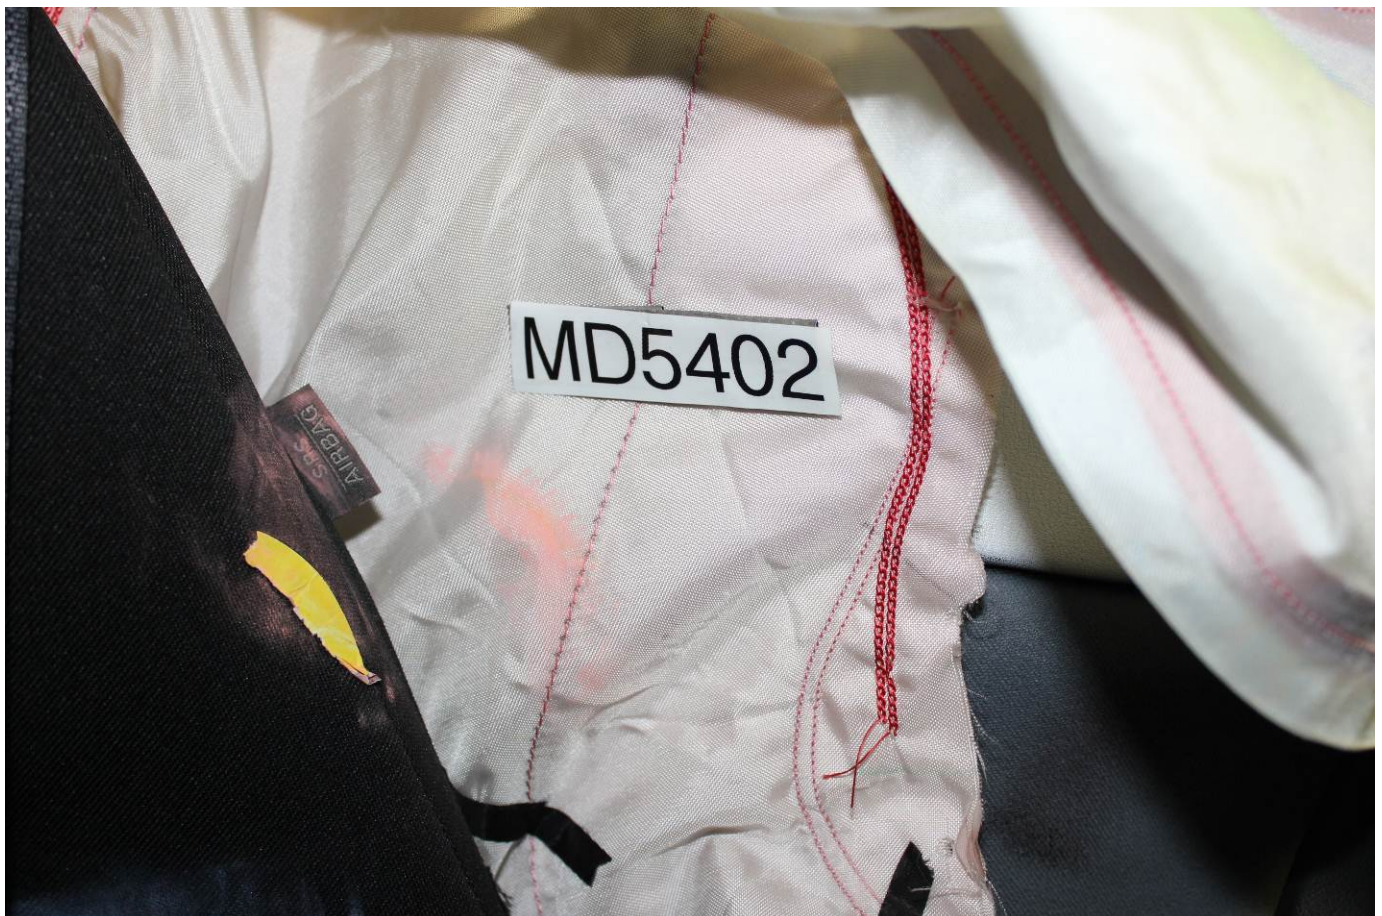
Post-Test Dummy Close-Up Torso Contact with Vehicle Interior View

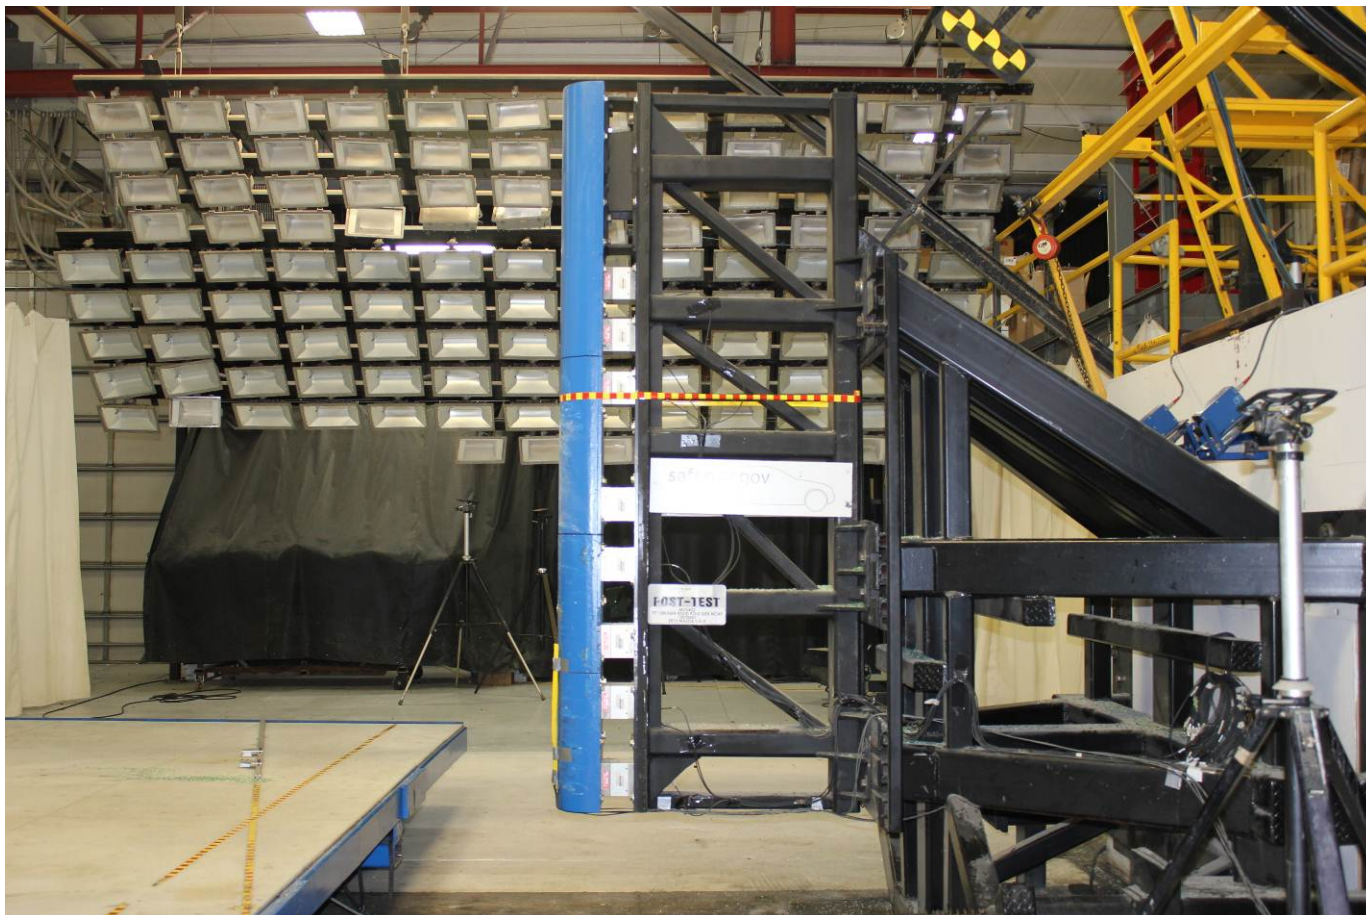
Post-Test Pole Barrier Front View
