REPORT NUMBER: NCAP-KAR-13-008

**NEW CAR ASSESSMENT PROGRAM (NCAP)
FRONTAL BARRIER IMPACT TEST**

**FORD MOTOR CO.
2013 FORD ESCAPE SE AWD 5-DOOR MPV**

NHTSA NUMBER: MD0200

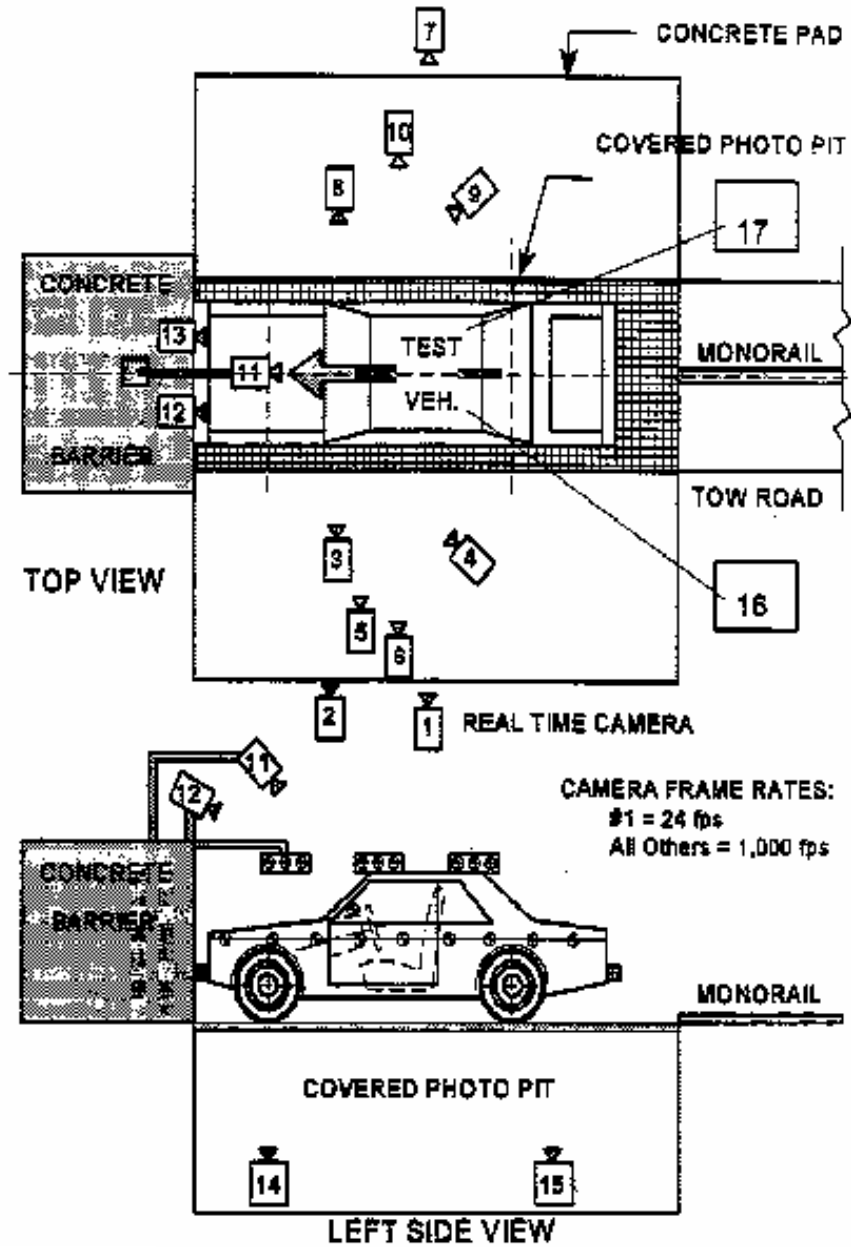
CAMERA POSITIONS FOR FRONTAL IMPACTS

Three (3) real-time cameras and fourteen (14) high-speed cameras were used to document the frontal barrier impact event. Camera locations and other pertinent camera information can be found in Data Sheet 6 of this report.

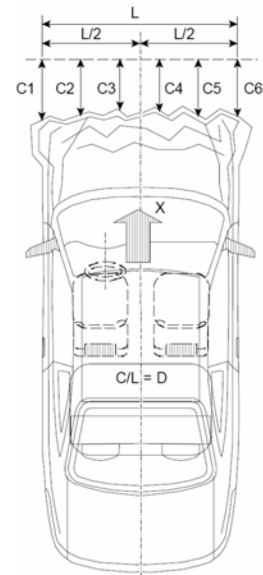
CRUSH PROFILE

Collision Deformation Classification: 12FDEW2
 Midpoint of Damage: Vehicle Centerline
 Damage Region Length (mm): 1288
 Impact Mode: Full Frontal

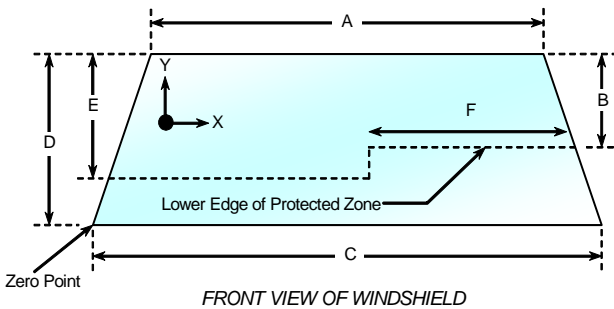
WINDSHIELD PERIPHERY MEASUREMENTS

Measurement	Pre-Test (mm)	Post-Test (mm)	% Retention
Left Side	2456	2456	100.0%
Right Side	2456	2456	100.0%
Total	4912	4912	100.0%

Item	Units	Value
A	mm	1307
B	mm	595
C	mm	1365
D	mm	1120
E	mm	627
F	mm	533

There was 100% windshield retention and no intrusion into the protected zone of the windshield during the event. There was no Stoddard solvent leakage after the event or during any phase of the static rollover.

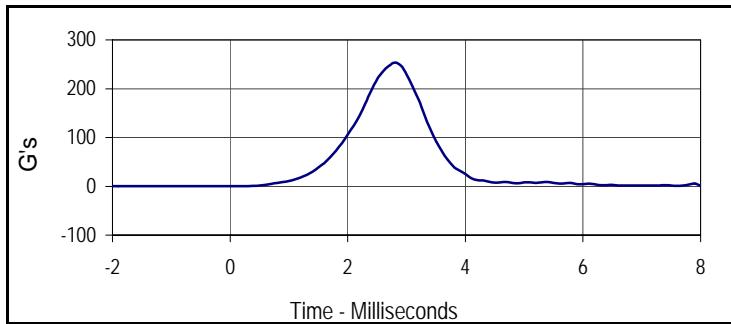
Curve Description			
Head Resultant			
Plot No.	Type	SAE Class	Units
001	RES	1000	G's
Max	Time	Min	Time
253.2	2.8	0.0	-1.7

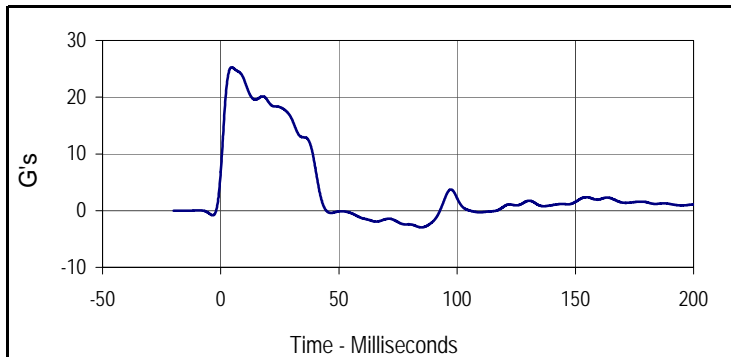
Curve Description			
Pendulum Deceleration			
Plot No.	Type	SAE Class	Units
001	FIL	60	G's
Max	Time	Min	Time
25.3	4.6	-3.0	84.9

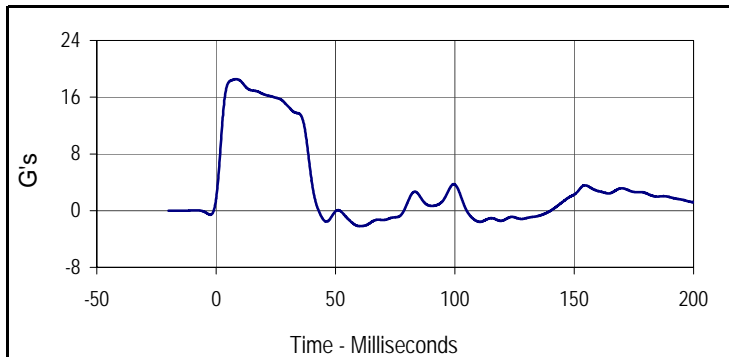
Curve Description			
Pendulum Deceleration			
Plot No.	Type	SAE Class	Units
001	FIL	60	G's
Max	Time	Min	Time
18.5	8.3	-2.2	60.2

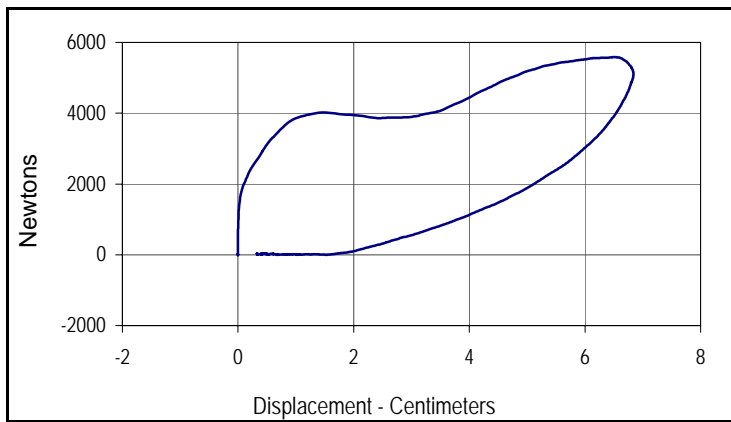
Curve Description			
Probe Force vs. Chest Deflection			
Plot No.	Type	SAE Class	Hysteresis
001	FIL	180	72.2
Peak Probe Force		Peak Chest Deflection	
5584		6.84

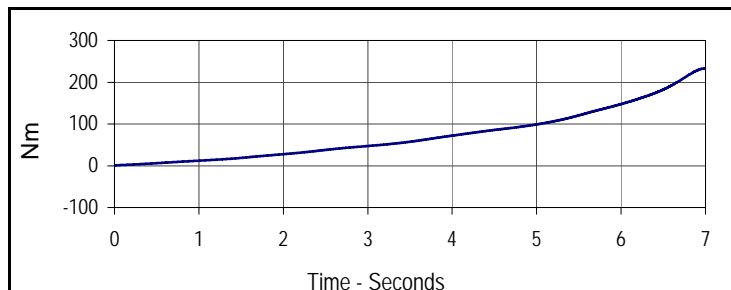
Curve Description			
Right Femur Torque			
Plot No.	Type	SAE Class	Units
004	FIL	600	Nm
Max	Time	Min	Time
232.9	7.0	1.0	0.0

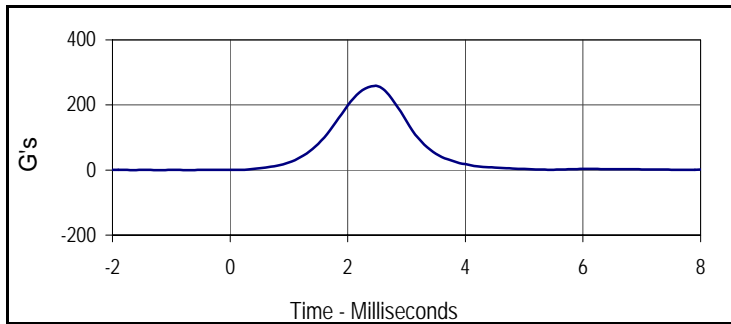
Curve Description			
Head Resultant			
Plot No.	Type	SAE Class	Units
001	RES	1000	G's
Max	Time	Min	Time
258.3	2.5	0.0	-0.6

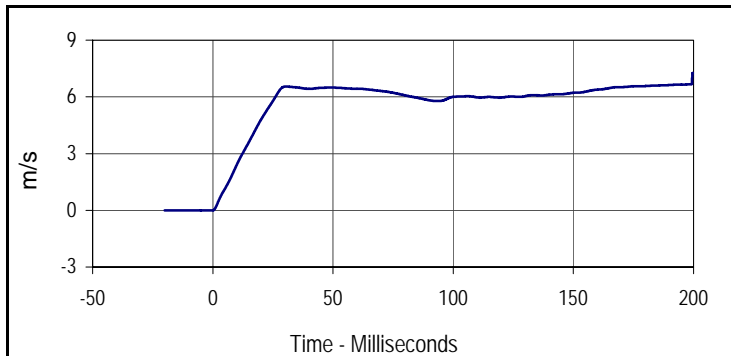
Curve Description			
Pendulum Velocity			
Plot No.	Type	SAE Class	Units
001	FIL	180	m/s
Max	Time	Min	Time
7.3	200.0	0.0	-0.4

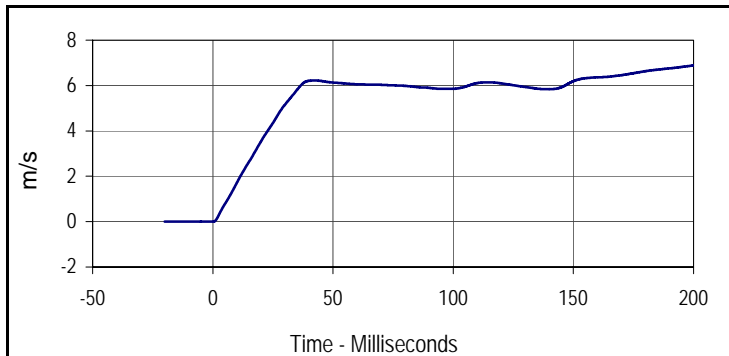
Curve Description			
Pendulum Velocity			
Plot No.	Type	SAE Class	Units
001	FIL	180	m/s
Max	Time	Min	Time
6.9	200.0	0.0	-0.2

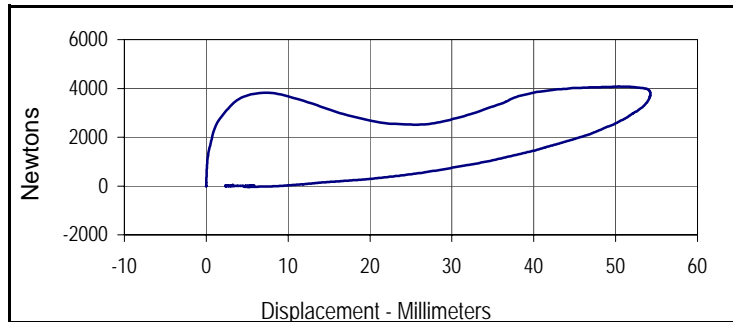
Curve Description			
Probe Force vs. Chest Deflection			
Plot No.	Type	SAE Class	Hysteresis
001	FIL	180	72.5
Peak Probe Force		Peak Chest Deflection	
4078.7		54.3

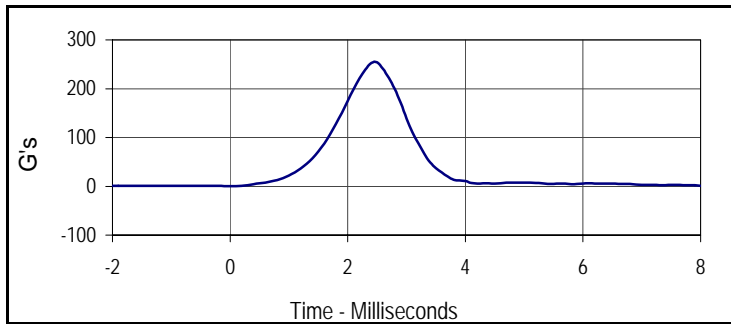
Curve Description			
Head Resultant			
Plot No.	Type	SAE Class	Units
001	RES	1000	G's
Max	Time	Min	Time
254.0	2.5	0.1	0.1

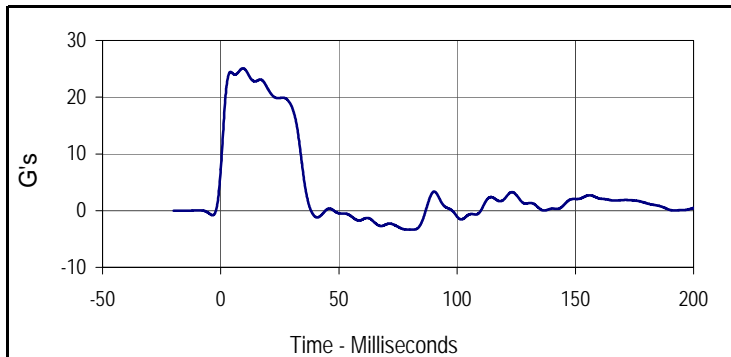
Curve Description			
Pendulum Deceleration			
Plot No.	Type	SAE Class	Units
001	FIL	60	G's
Max	Time	Min	Time
25.1	9.4	-3.3	79.1

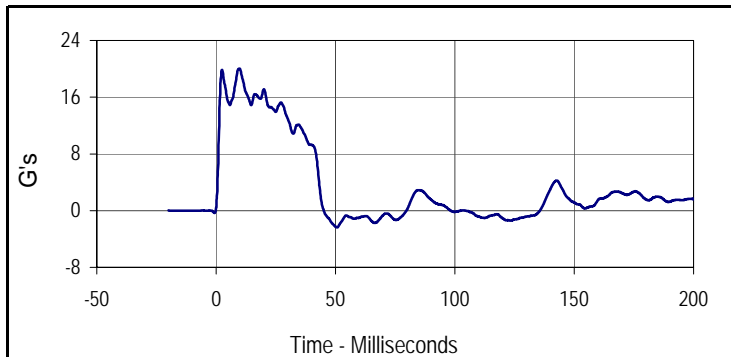
Curve Description			
Pendulum Deceleration			
Plot No.	Type	SAE Class	Units
001	FIL	60	G's
Max	Time	Min	Time
20.0	9.8	-2.4	50.6

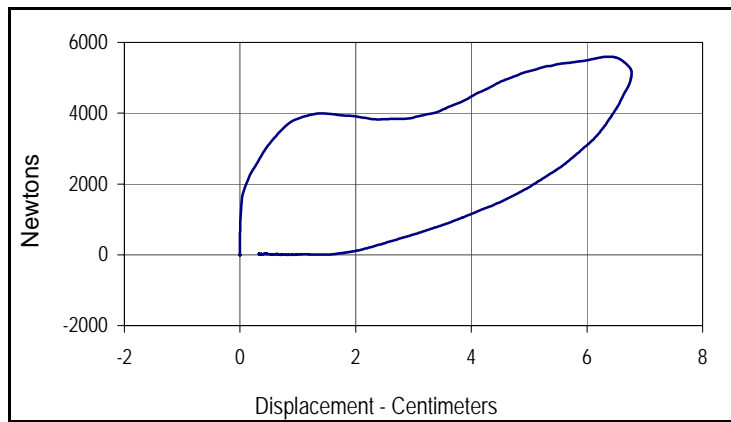
Curve Description			
Probe Force vs. Chest Deflection			
Plot No.	Type	SAE Class	Hysteresis
001	FIL	180	72.1
Peak Probe Force		Peak Chest Deflection	
5595		6.77

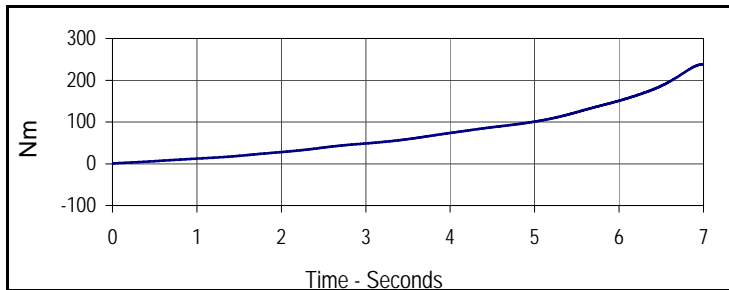
Curve Description			
Right Femur Torque			
Plot No.	Type	SAE Class	Units
004	FIL	600	Nm
Max	Time	Min	Time
238.0	7.0	1.0	0.0

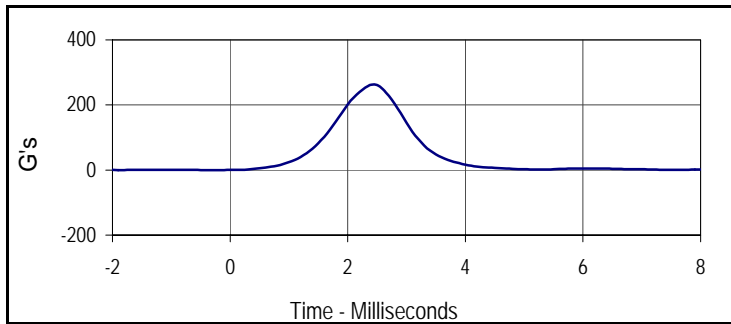
Curve Description			
Head Resultant			
Plot No.	Type	SAE Class	Units
001	RES	1000	G's
Max	Time	Min	Time
262.4	2.4	0.1	-0.3

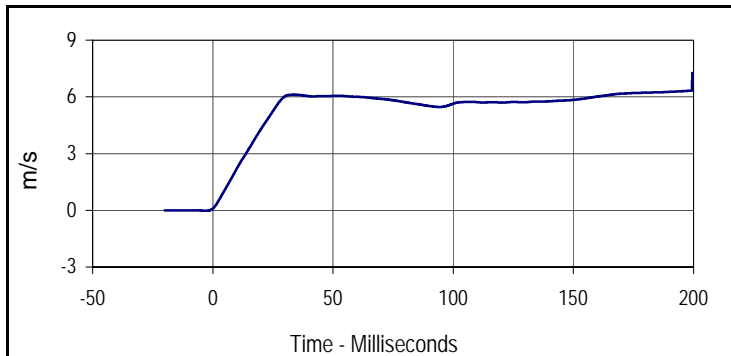
Curve Description			
Pendulum Velocity			
Plot No.	Type	SAE Class	Units
001	FIL	180	m/s
Max	Time	Min	Time
7.3	200.0	0.0	-2.7

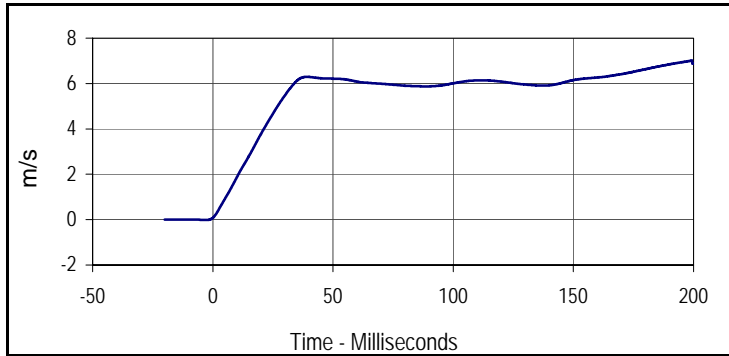
Curve Description			
Pendulum Velocity			
Plot No.	Type	SAE Class	Units
001	FIL	180	m/s
Max	Time	Min	Time
7.0	199.4	0.0	-2.8

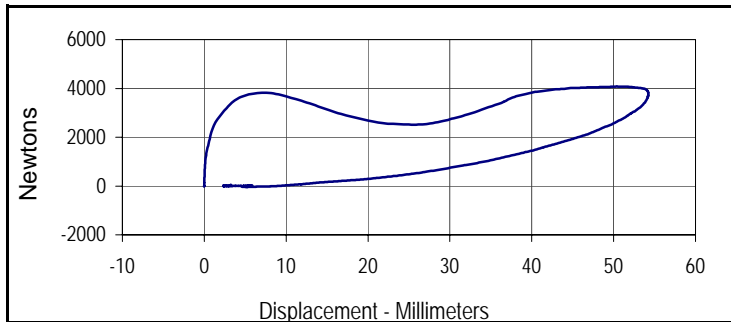
Curve Description			
Probe Force vs. Chest Deflection			
Plot No.	Type	SAE Class	Hysteresis
001	FIL	180	72.5
Peak Probe Force		Peak Chest Deflection	
4078.7		54.3
