**REPORT NUMBER: SINCAP-MGA-2013-005**

**NEW CAR ASSESSMENT PROGRAM (NCAP)  
Moving Deformable Barrier Side Impact Test**

**GENERAL MOTORS LLC  
2012 Chevrolet Silverado 2500 LTZ Crew Cab  
NHTSA No.: GC0100**

**MGA RESEARCH CORPORATION  
5000 Warren Road  
Burlington, WI 53105**

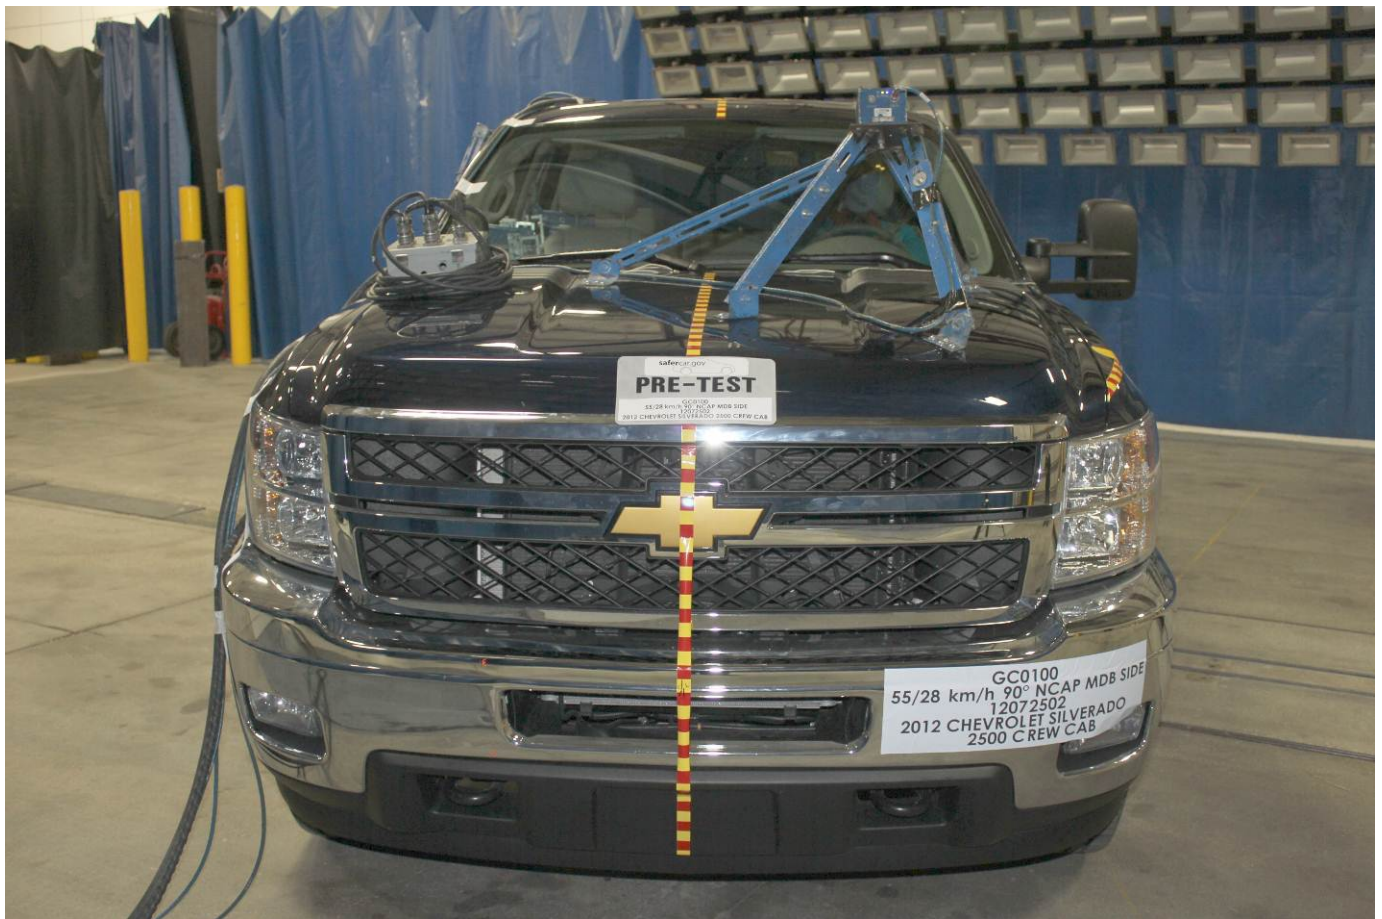
Pre-Test Frontal View of Test Vehicle

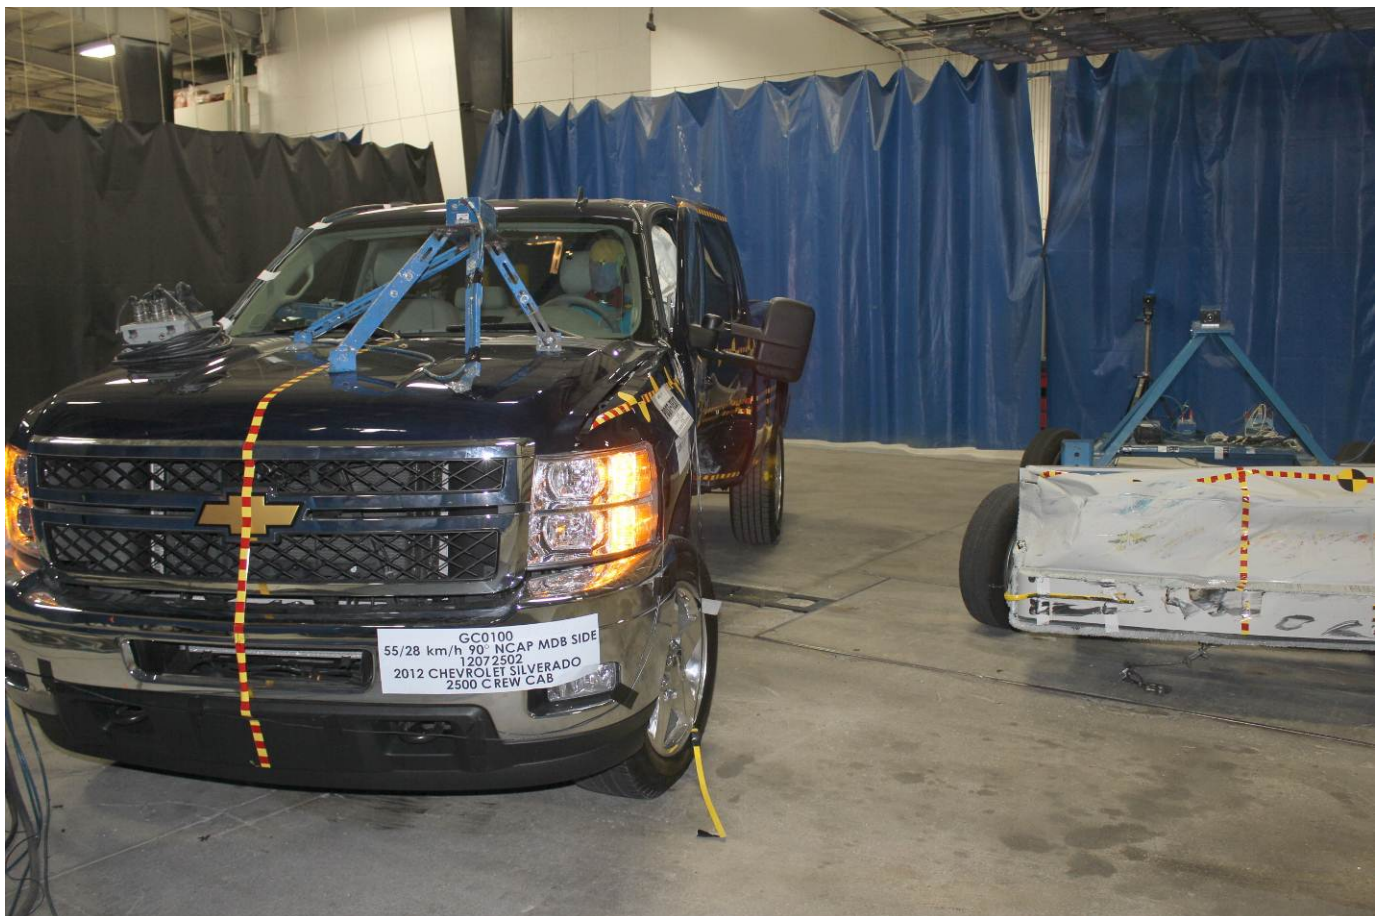
Post-Test Frontal View of Test Vehicle

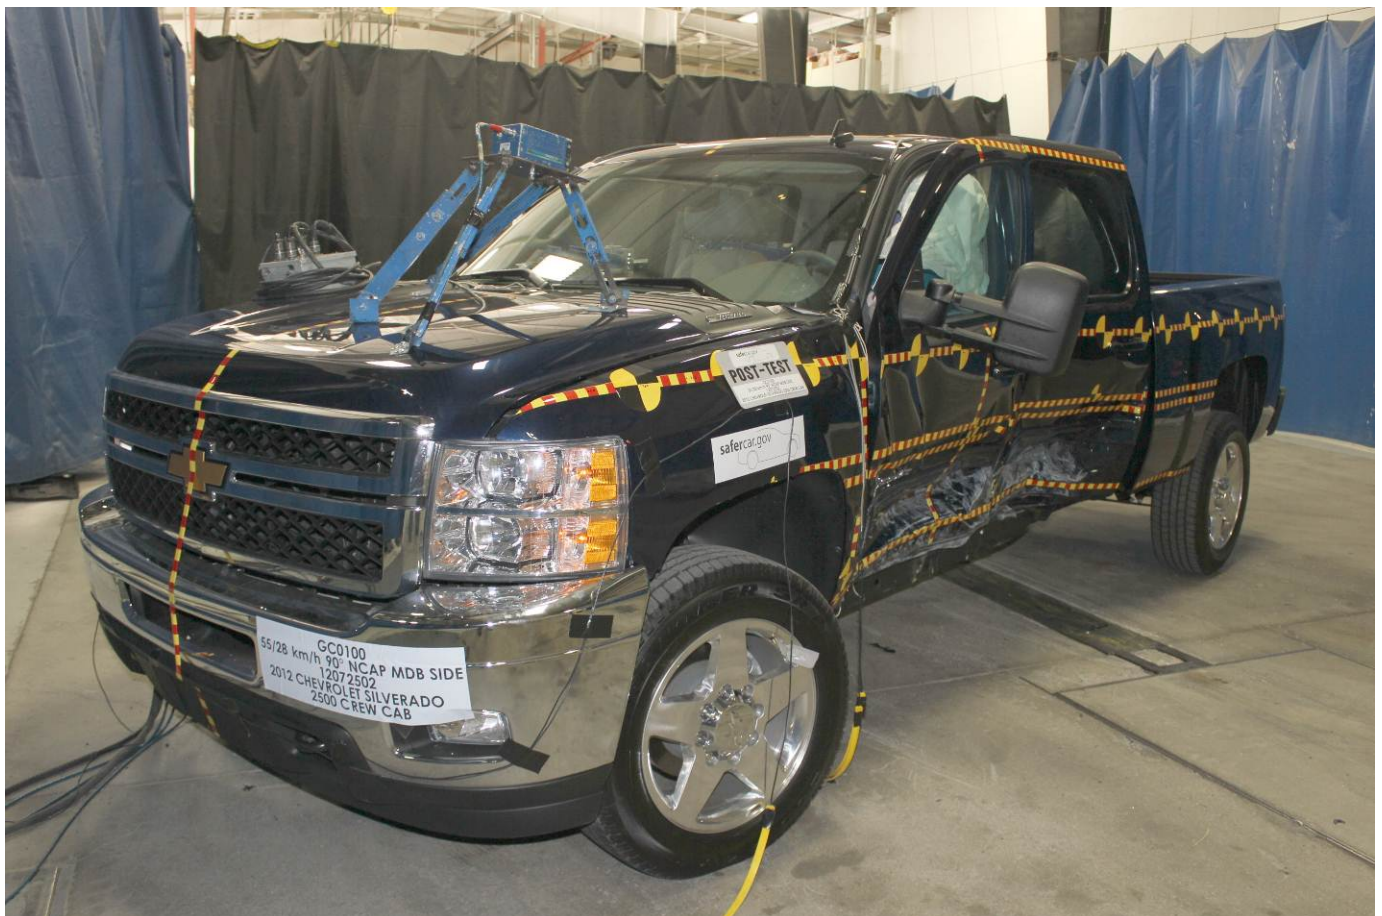
Post-Test Left Front Three-Quarter View of Test Vehicle

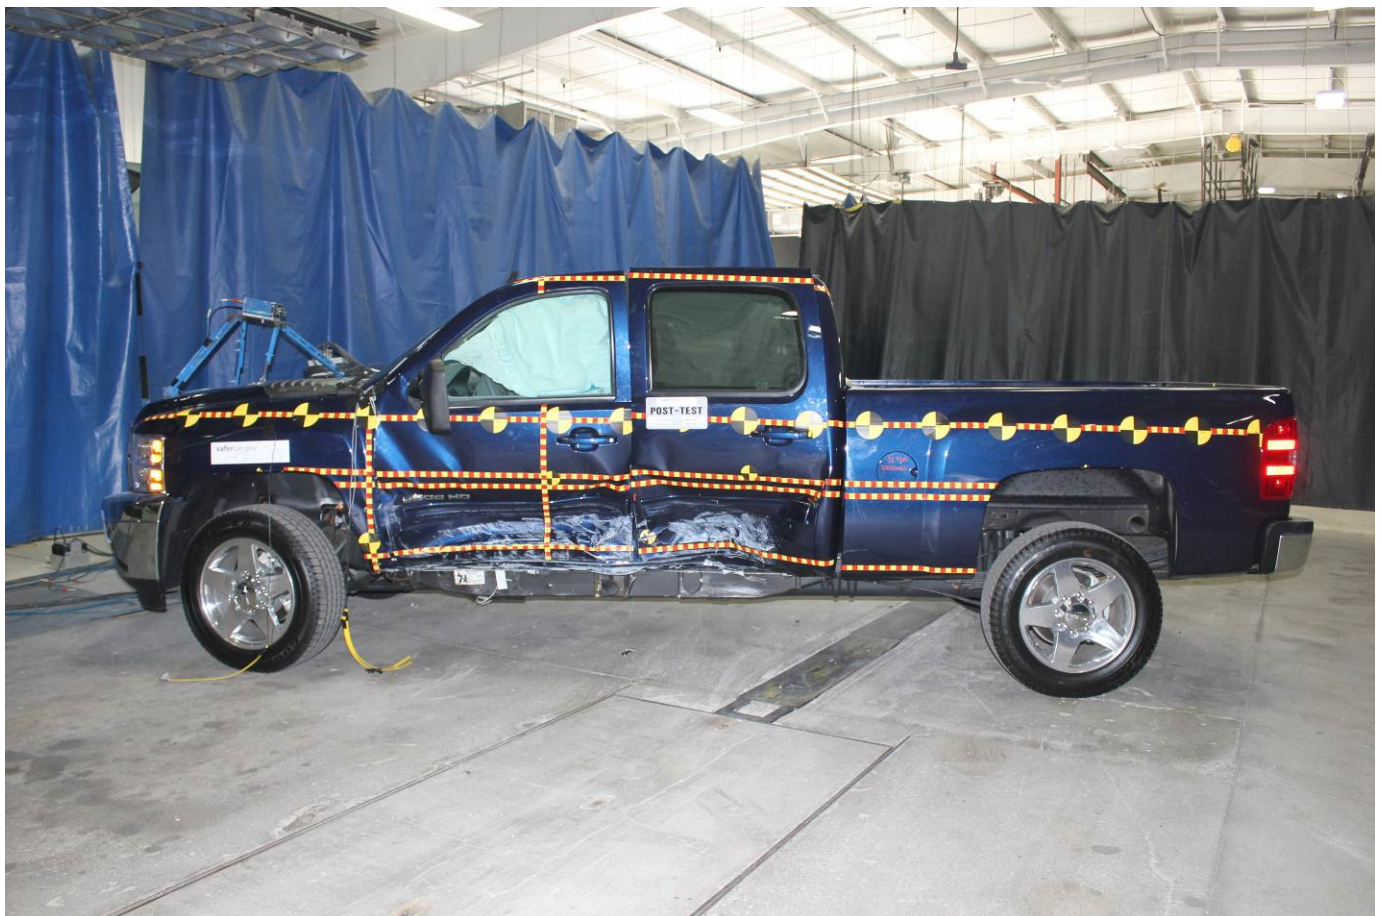
Post-Test Left Side View of Test Vehicle

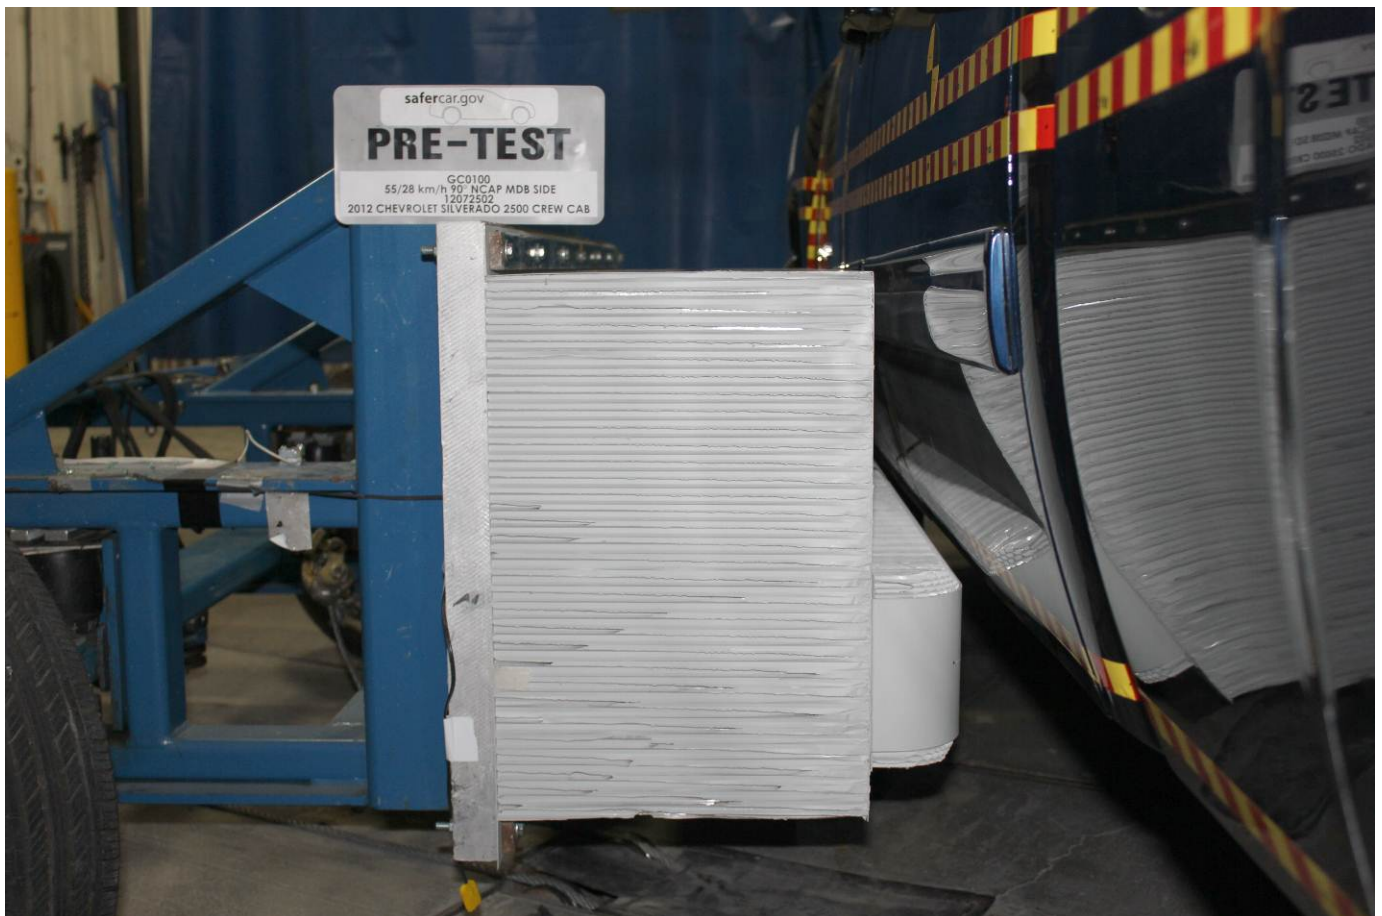
Pre-Test Right Side View of MDB Positioned Against Side of Test Vehicle

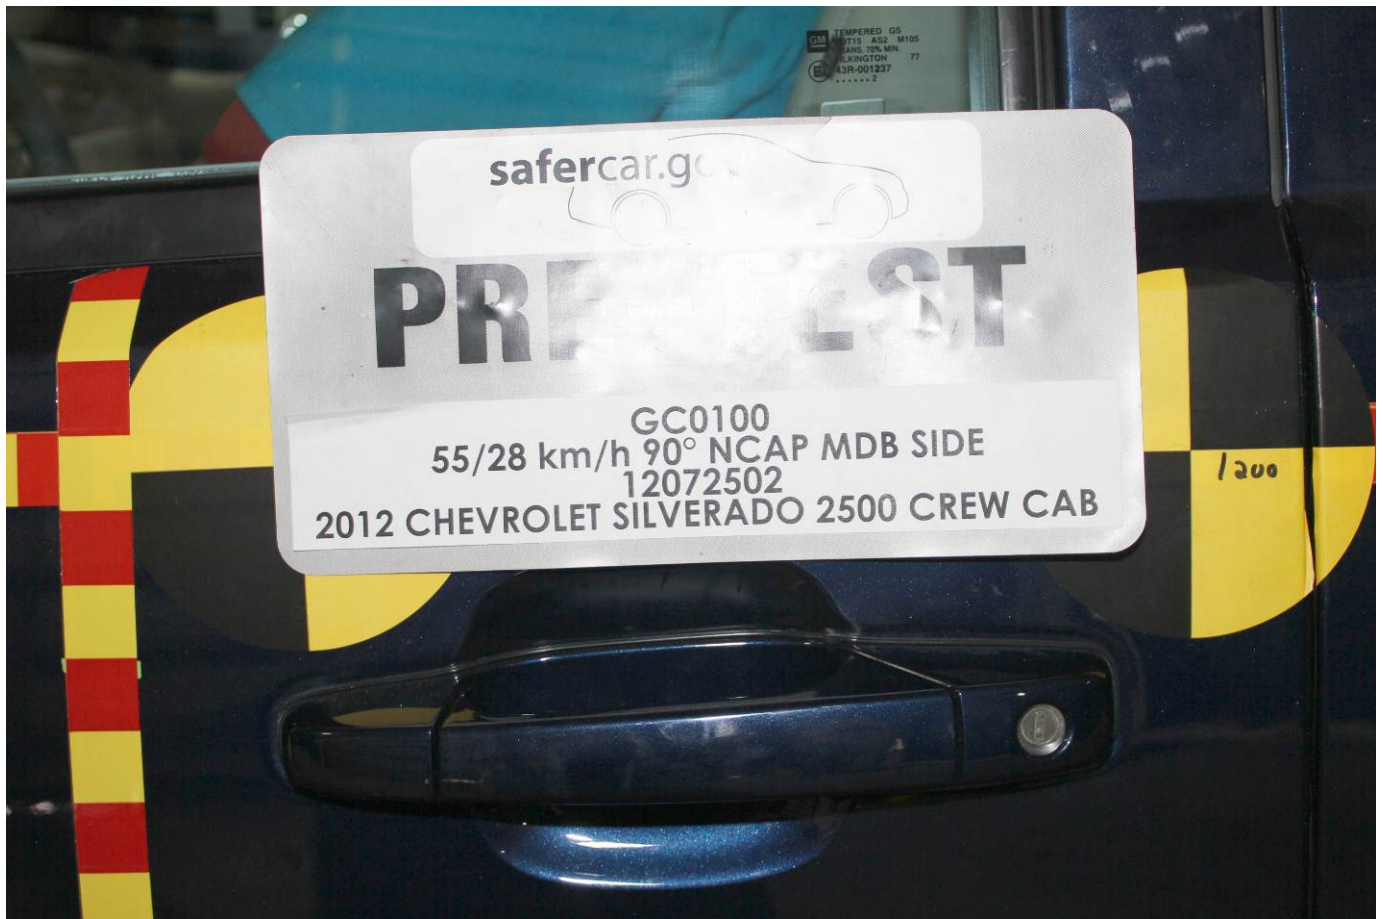
Pre-Test Left Front Door Latch Close-Up

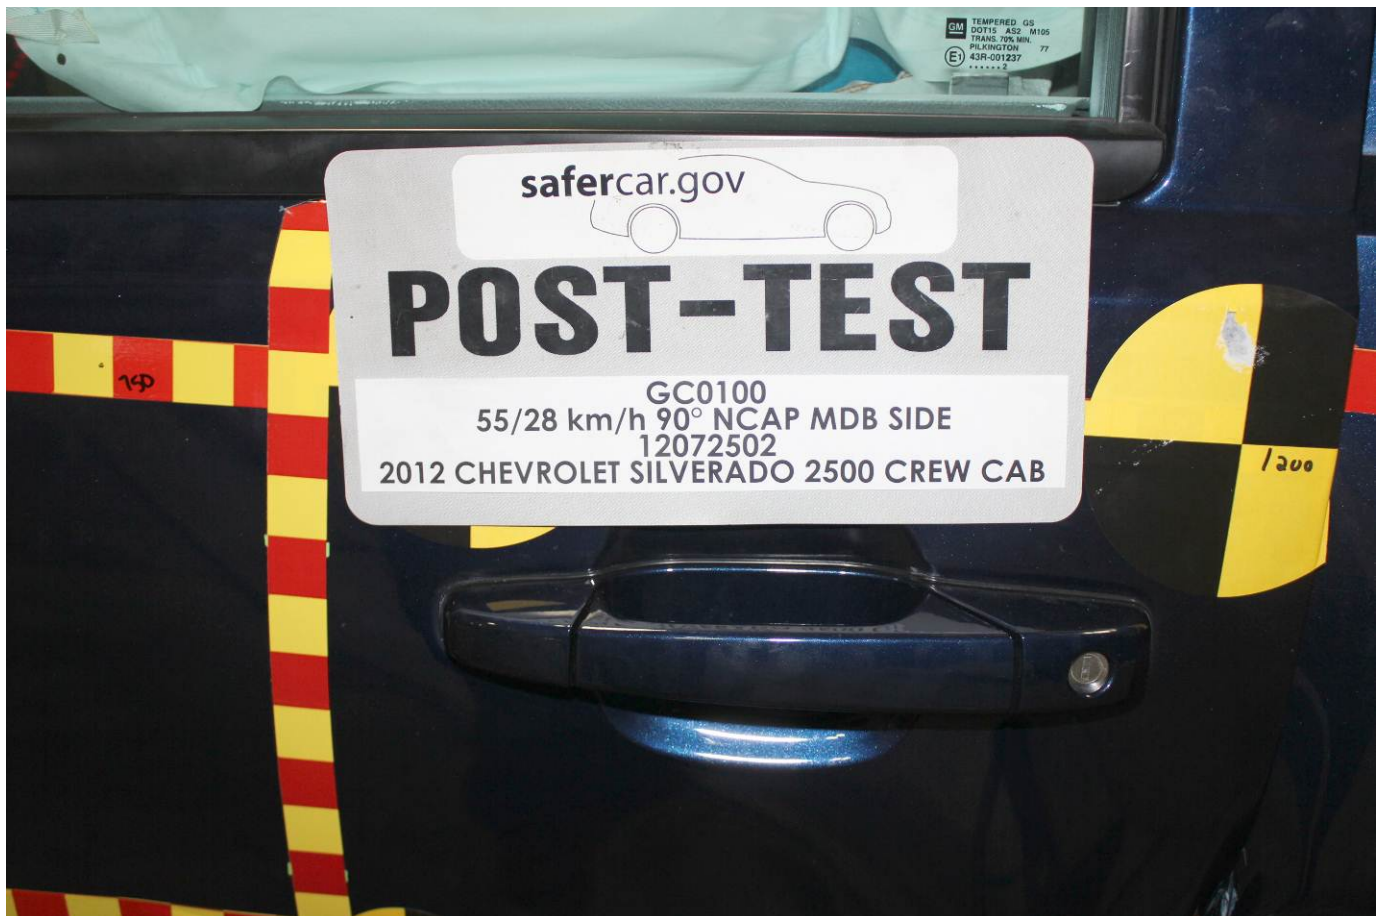
Post-Test Left Front Door Latch Close-Up

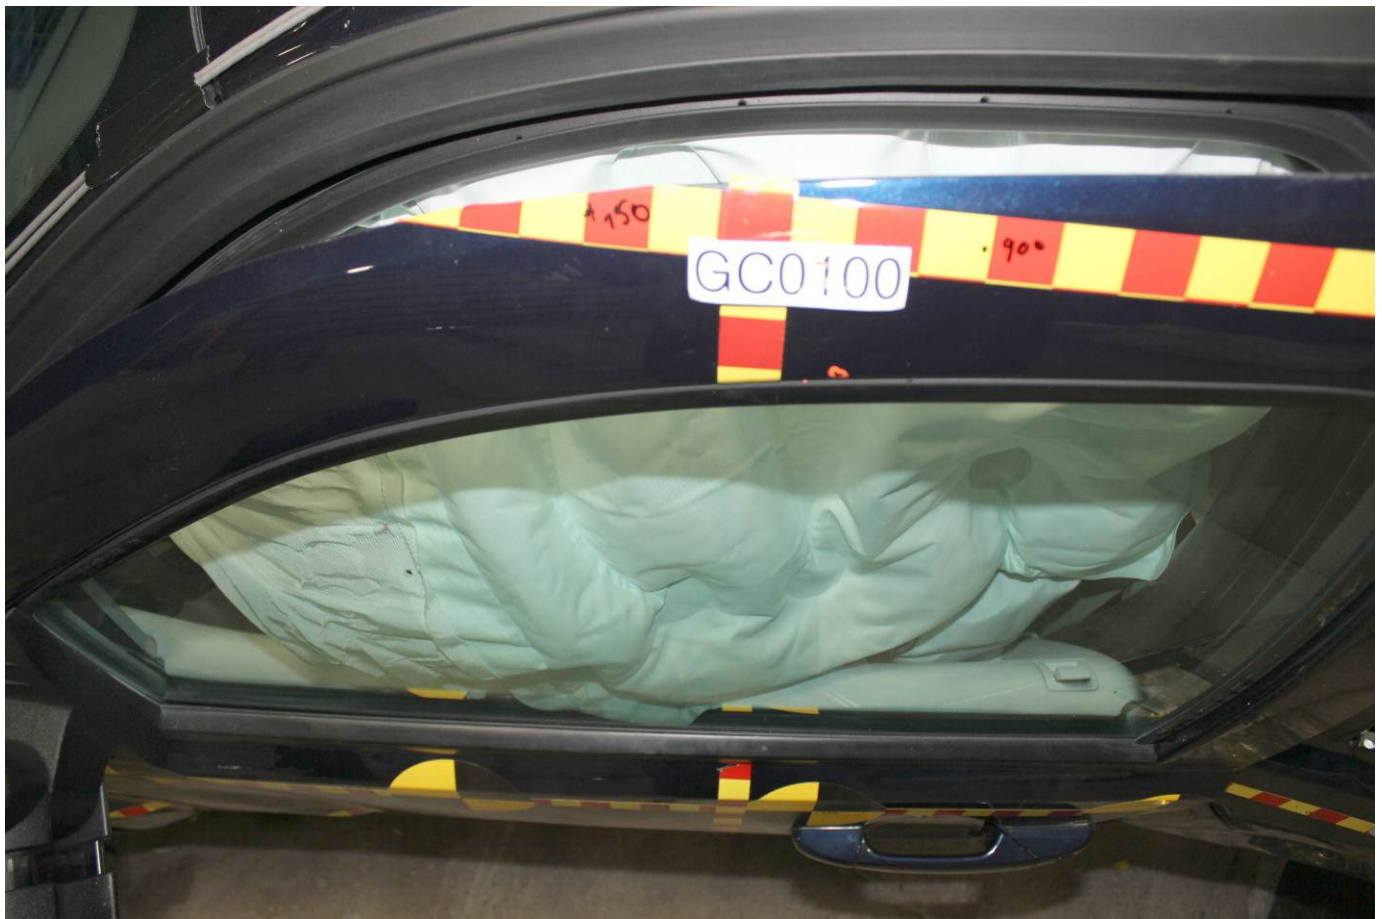
Post-Test Driver Dummy and Door Clearance View

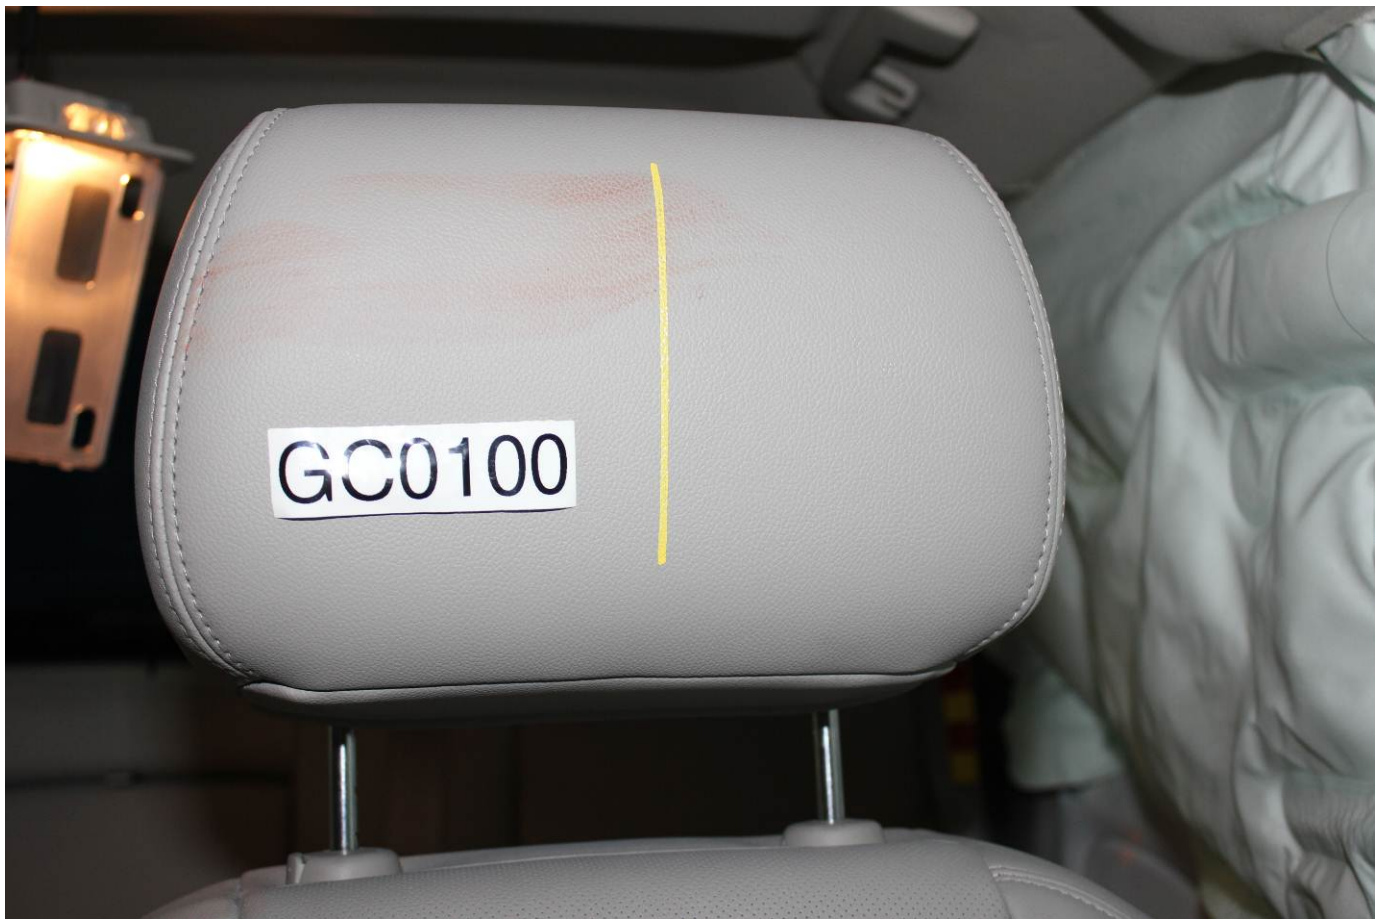
Post-Test Driver Dummy Close-up Head Contact with Vehicle Interior View

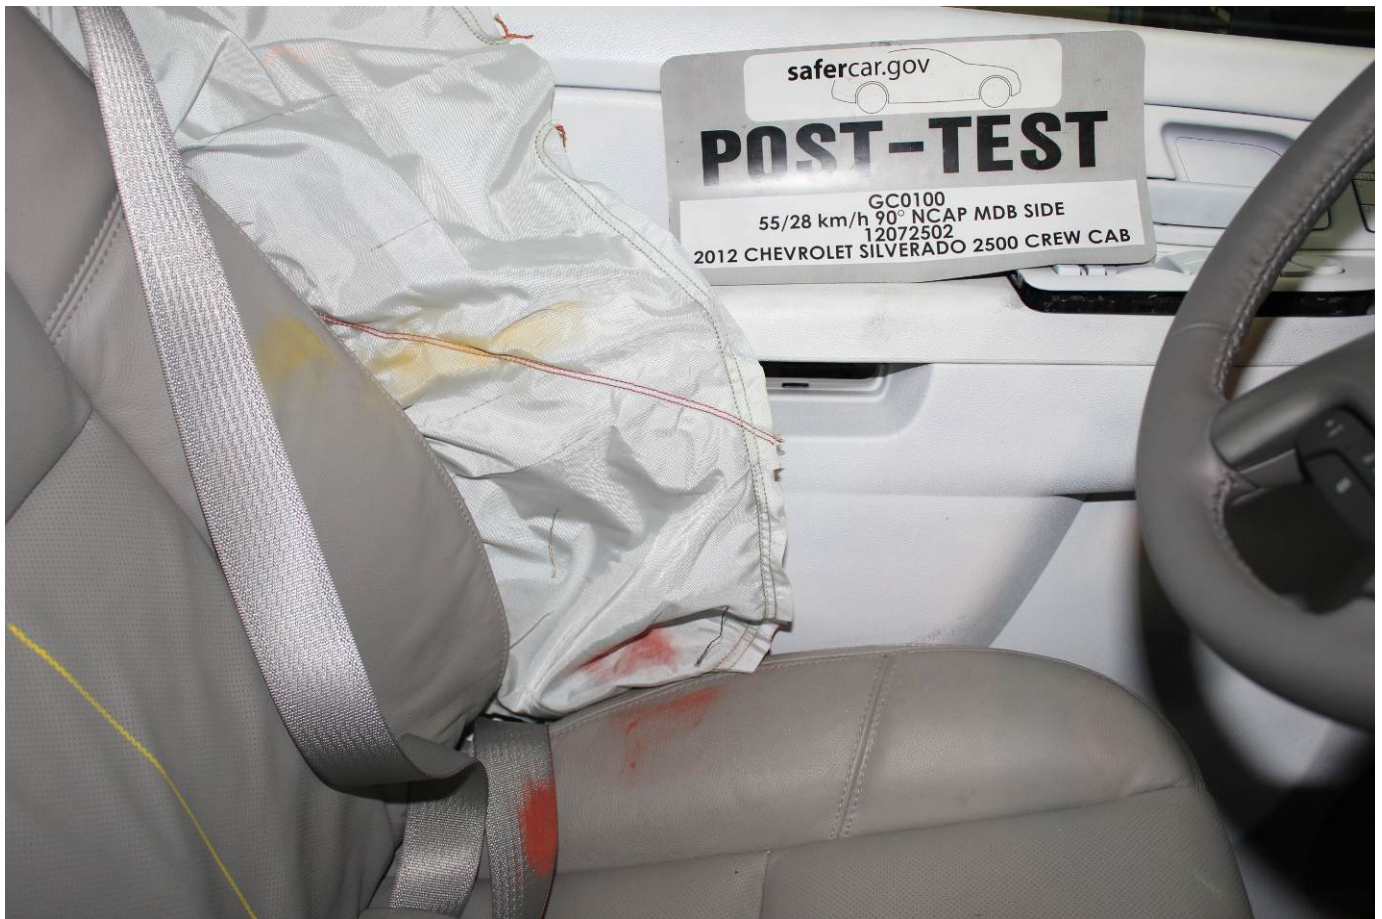
Post-Test Driver Dummy Close-up Torso Contact with Vehicle Interior View

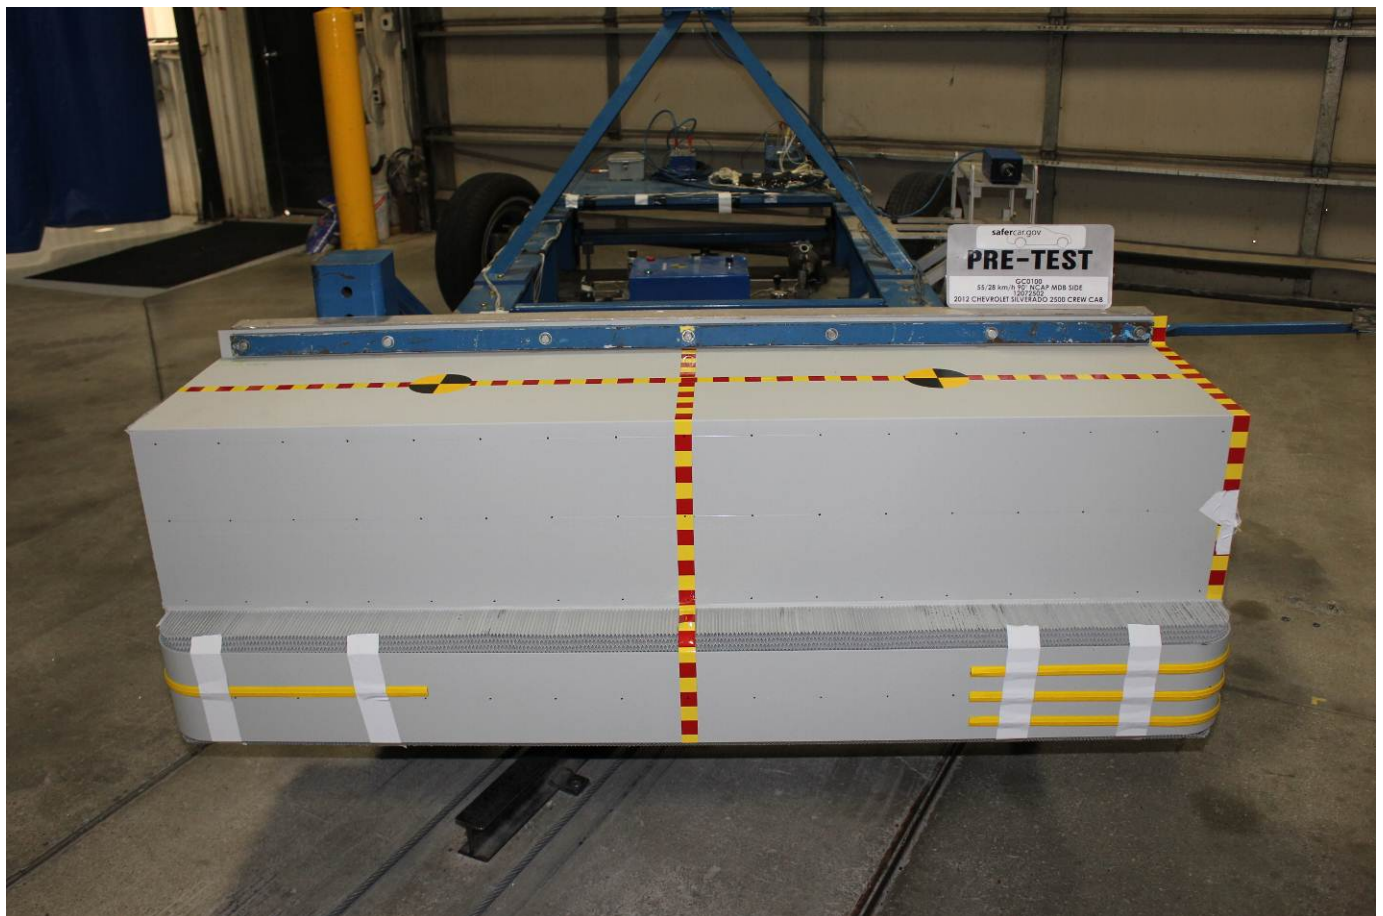
Pre-Test Front View of MDB Impactor Face

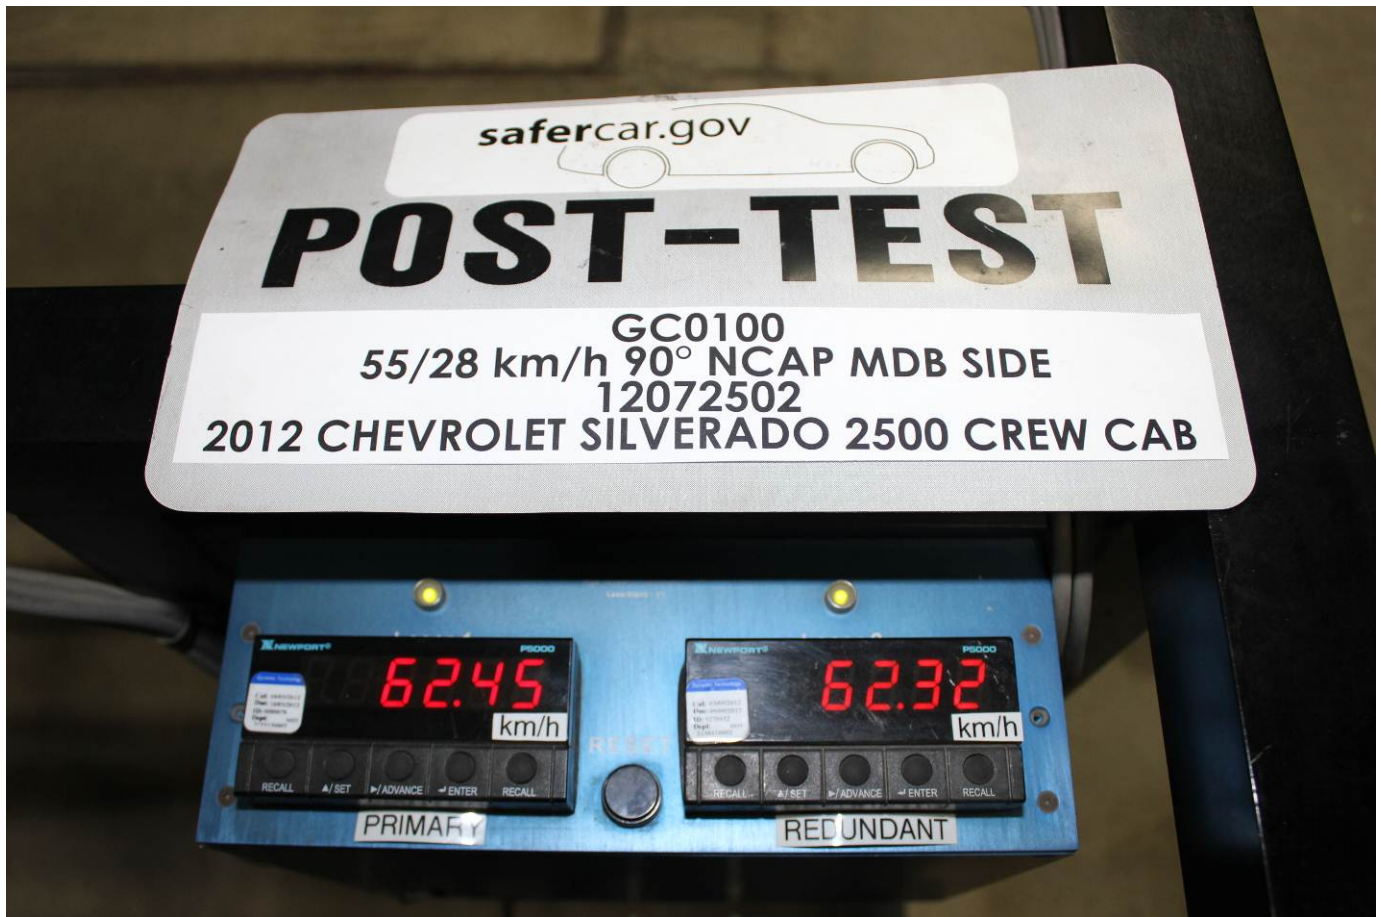
Post-Test Primary and Redundant Speed Trap Read-Out
