REPORT NUMBER: NCAP-KAR-13-009

**NEW CAR ASSESSMENT PROGRAM (NCAP)
FRONTAL BARRIER IMPACT TEST**

**CODA AUTOMOTIVE
2012 CODA 4-DOOR SEDAN**

FINAL REPORT

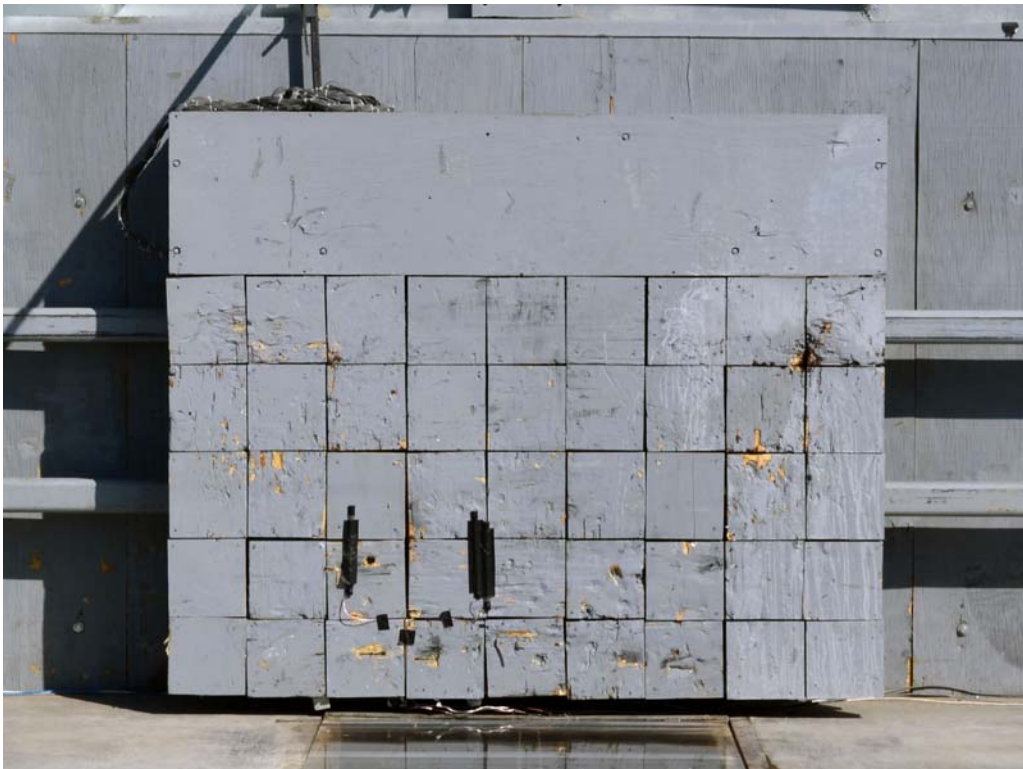
FIGURE 2. Load Cell Wall

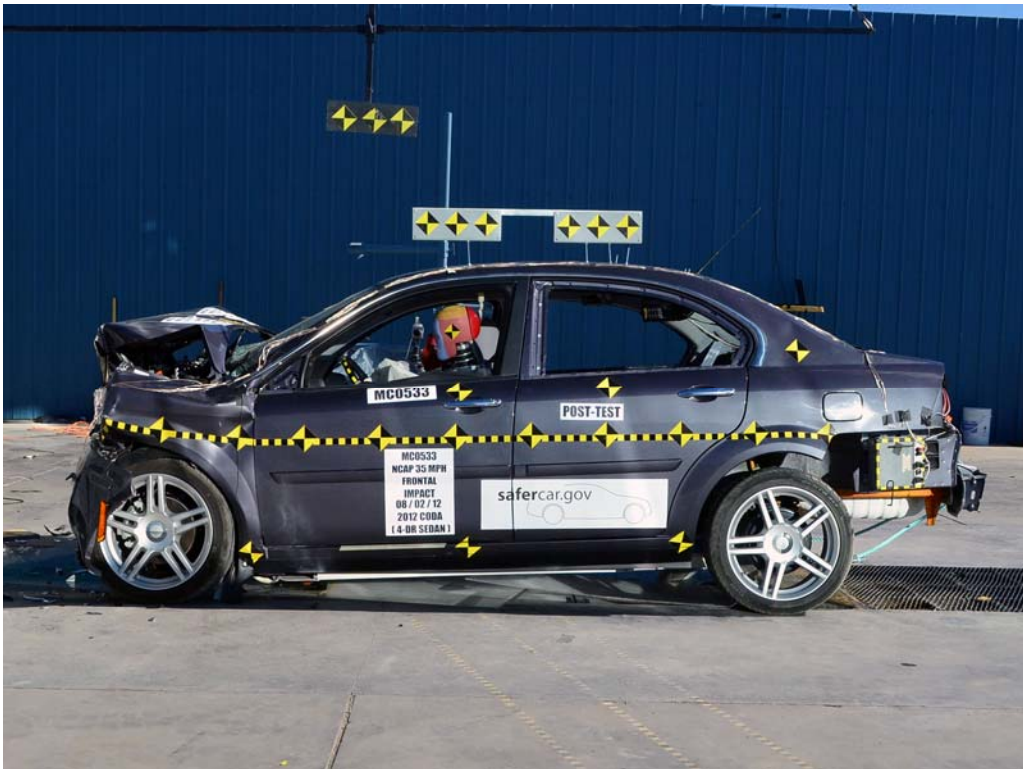
FIGURE 10. Post-Test Left View of Test Vehicle

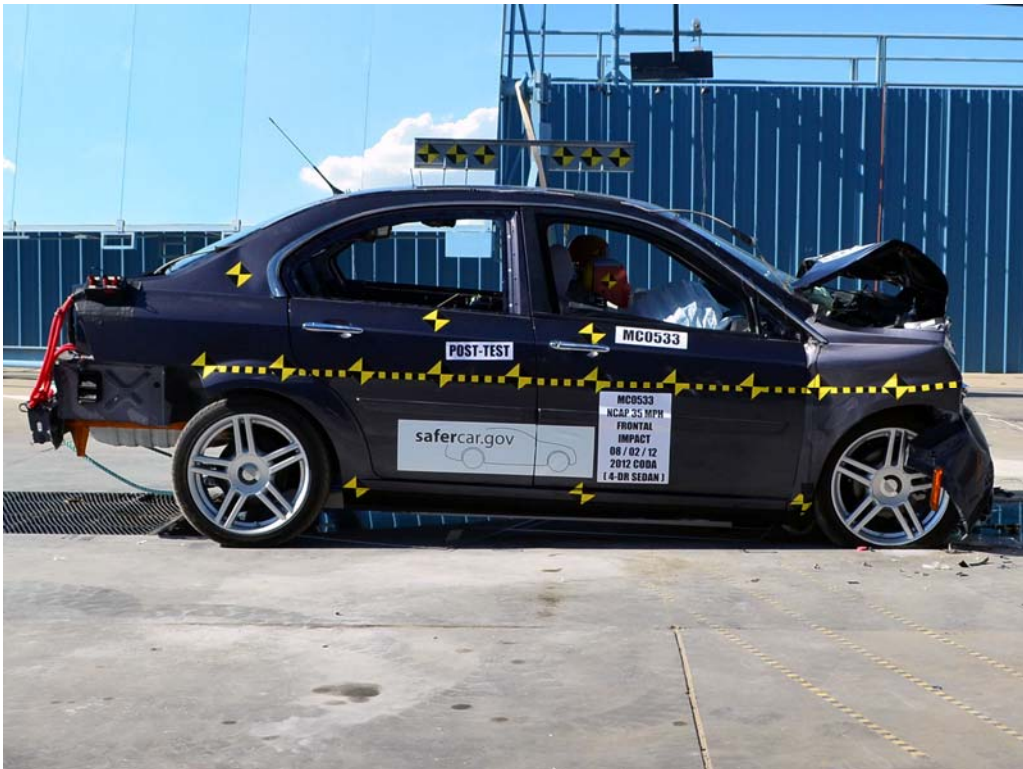
FIGURE 12. Post-Test Right View of Test Vehicle

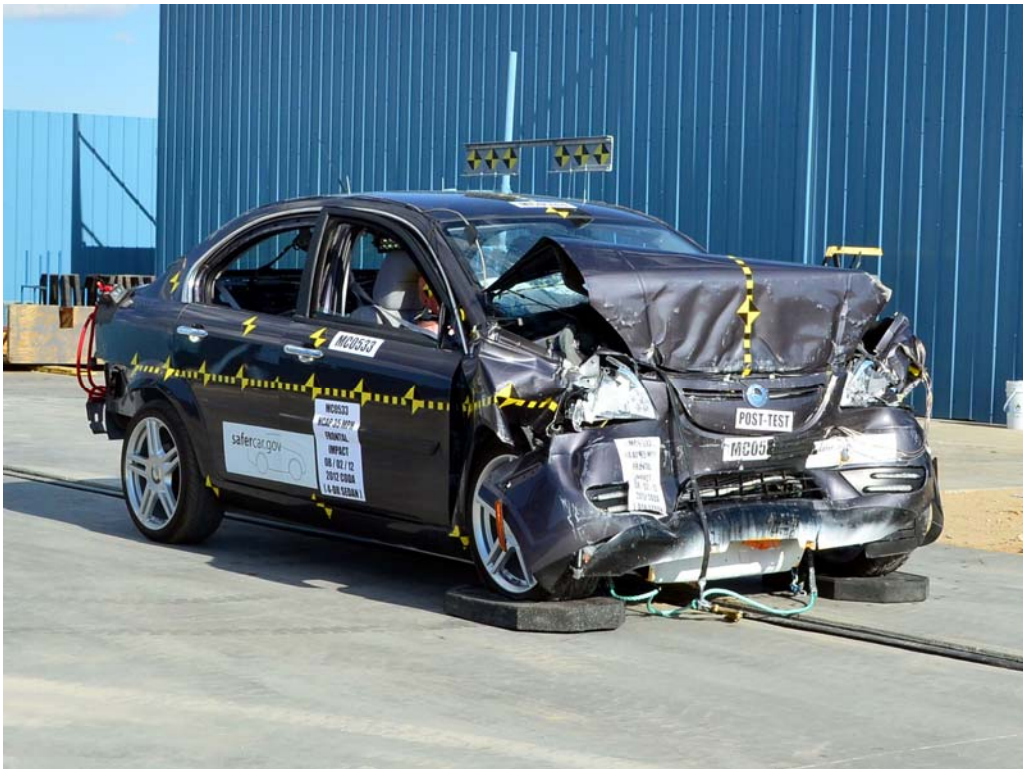
FIGURE 14. Post-Test Right Front 3/4 View

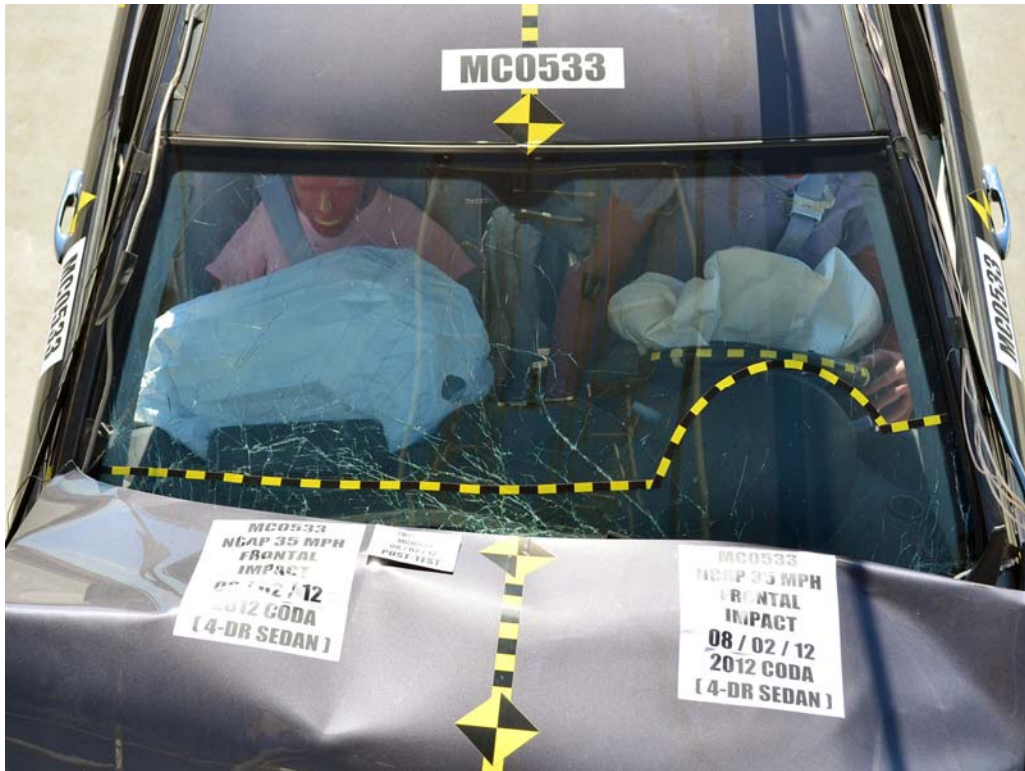
FIGURE 18. Post-Test Windshield View

Critical Areas of Performance	Observations and Conclusions
Windshield Damage	Broken
Window Damage	None
Other Notable Effects	None

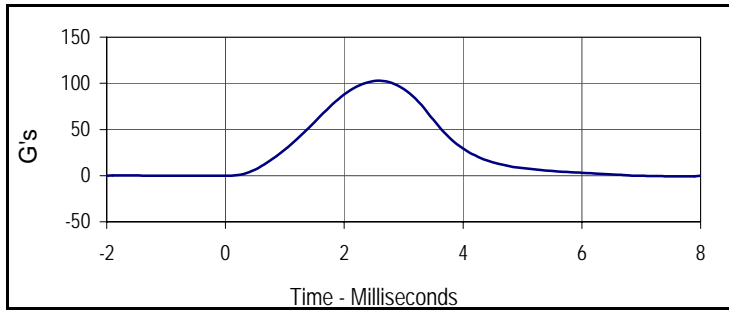
Curve Description			
Left Knee Acceleration			
Plot No.	Type	SAE Class	Units
002	FIL	600	G's
Max	Time	Min	Time
102.8	2.6	-0.8	7.8

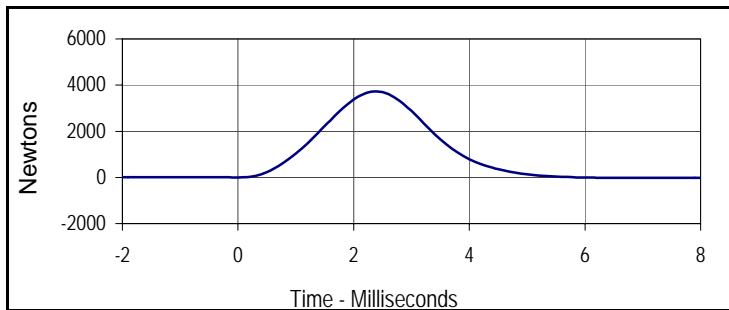
Curve Description			
Right Knee Probe Force			
Plot No.	Type	SAE Class	Units
003	FIL	600	Newtons
Max	Time	Min	Time
3729.5	2.4	-20.8	7.7
