REPORT NUMBER: SPNCAP-KAR-13-012

**NEW CAR ASSESSMENT PROGRAM (NCAP)
SIDE IMPACT POLE TEST**

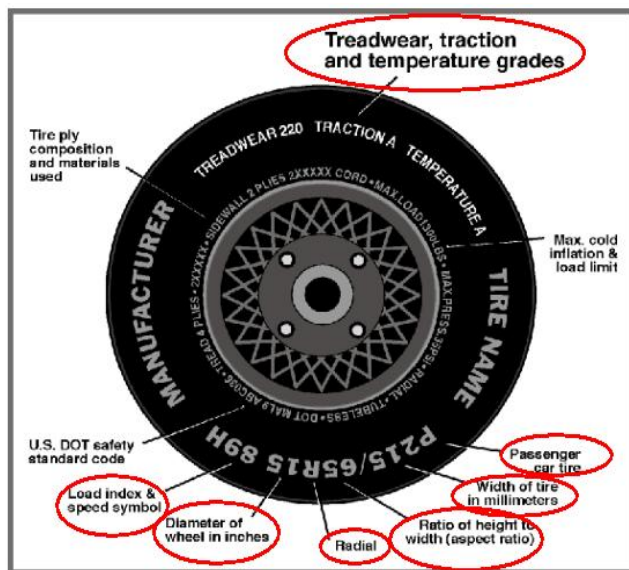
TIRE PLACARD INFORMATION
