REPORT NUMBER: NCAP-MGA-2013-008

**NEW CAR ASSESSMENT PROGRAM (NCAP)
Frontal Barrier Impact Test**

**NISSAN MOTOR CO., LTD.
2013 Nissan Altima S 4-Dr Sedan
NHTSA No.: MD5200**

**MGA RESEARCH CORPORATION
5000 Warren Road
Burlington, WI 53105**

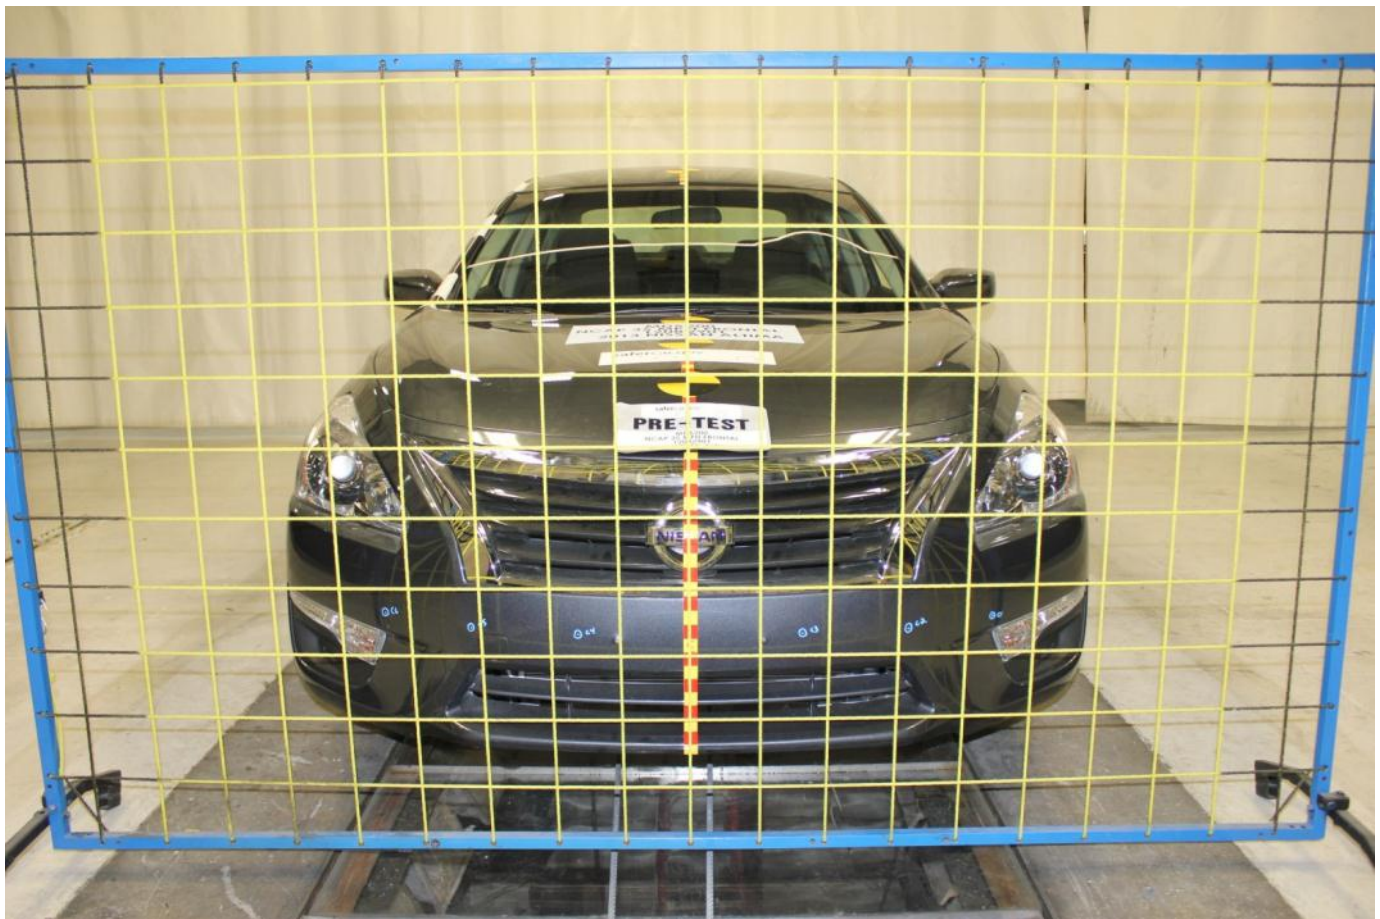
Load Cell Location

A load cell barrier consisting of 176 load cells was impacted by a 2013 Nissan Altima S 4-Dr Sedan at a velocity of 56.2 km/h. The test was performed at MGA Research Corporation on August 29, 2012. Pre-and post-test photographs of the vehicle and dummies can be found in Appendix A.

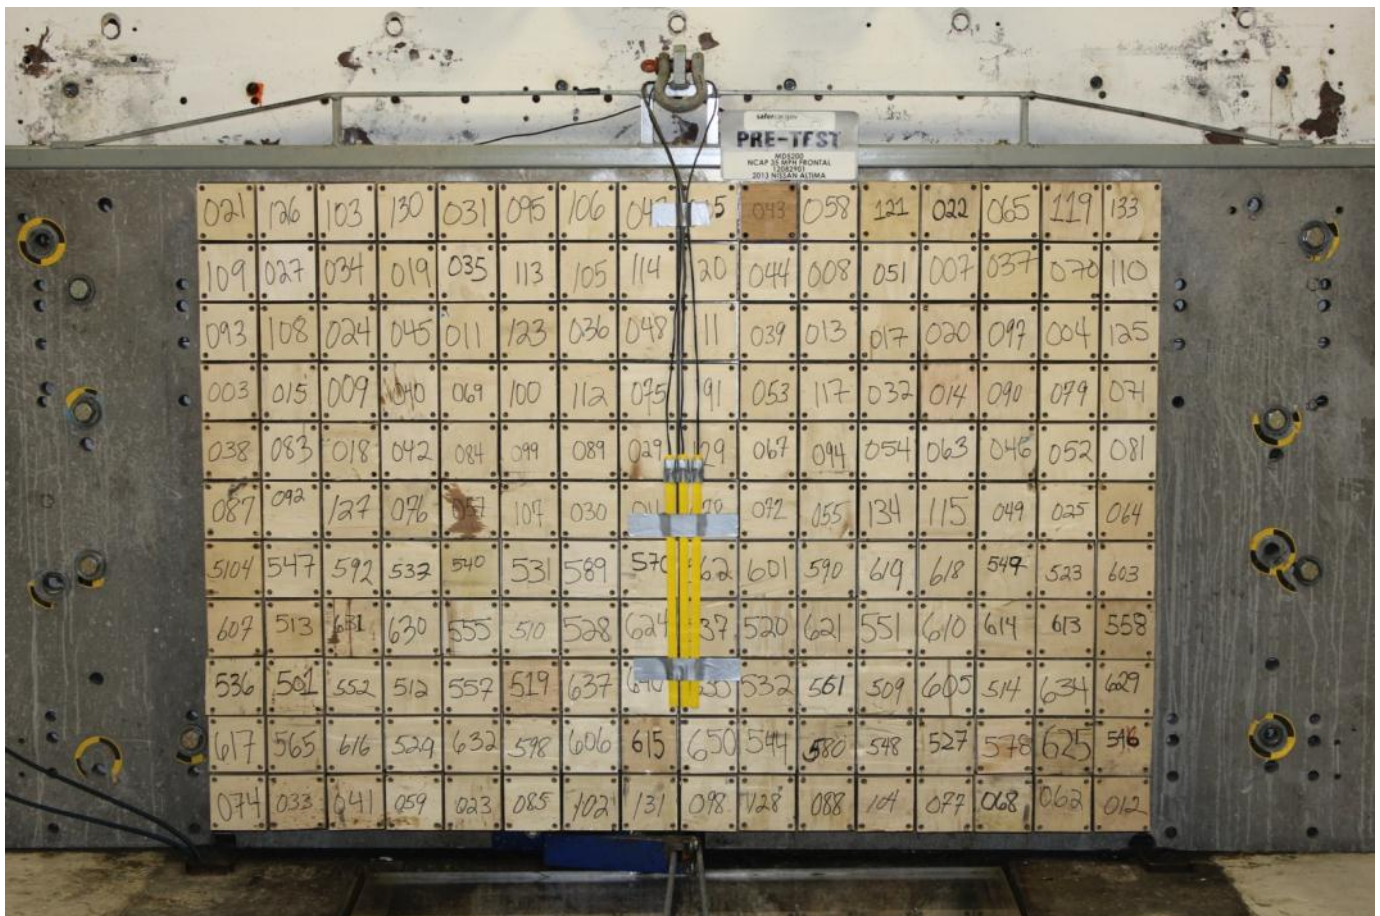
Load Cell Wall

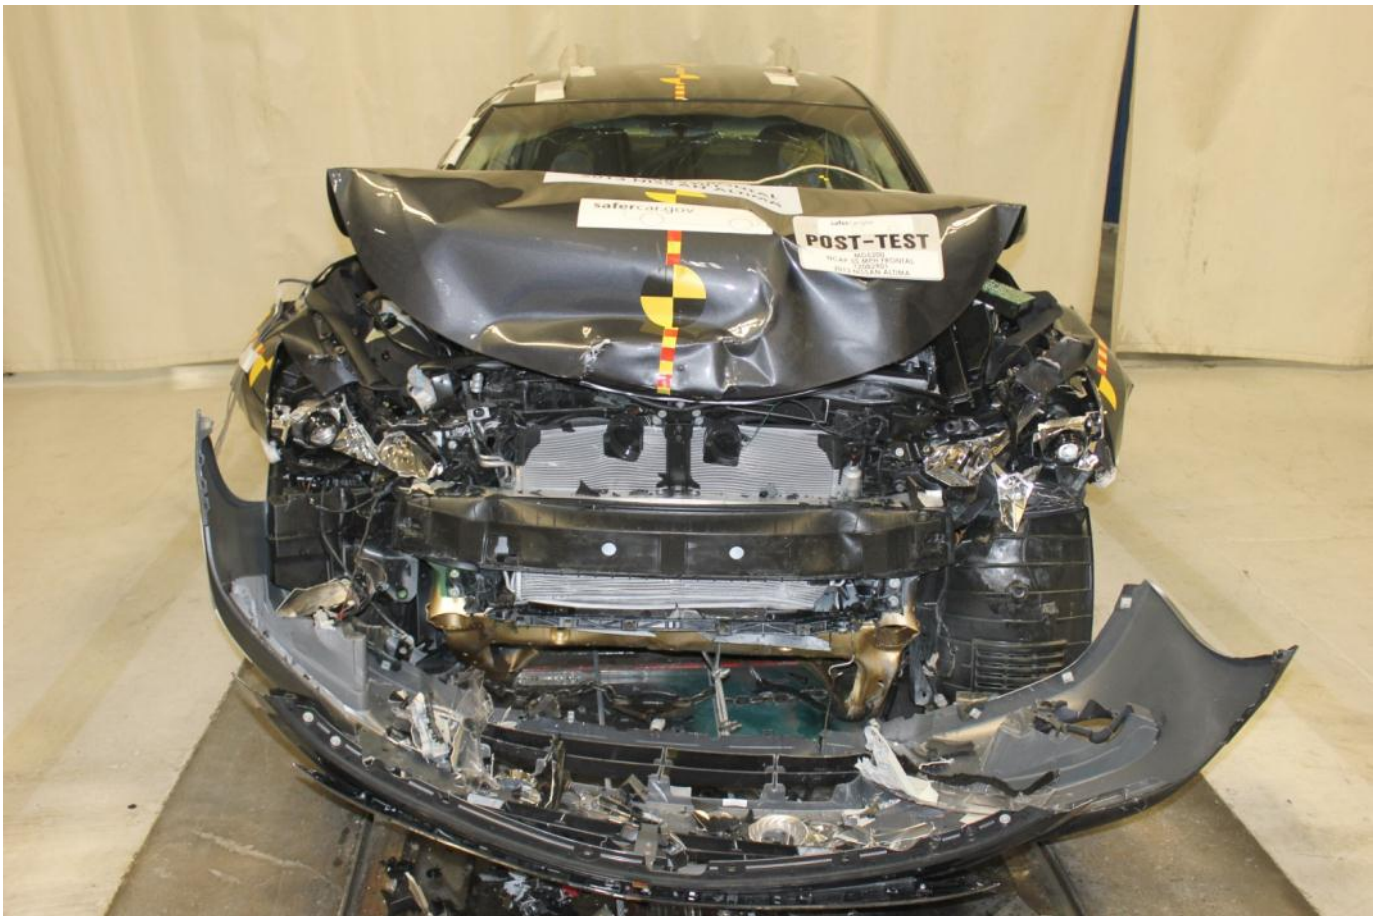
Post-Test Front View of Test Vehicle

The maximum static crush of the vehicle was 548 mm and both the driver and passenger side doors remained closed during the impact event and were operable after the impact.

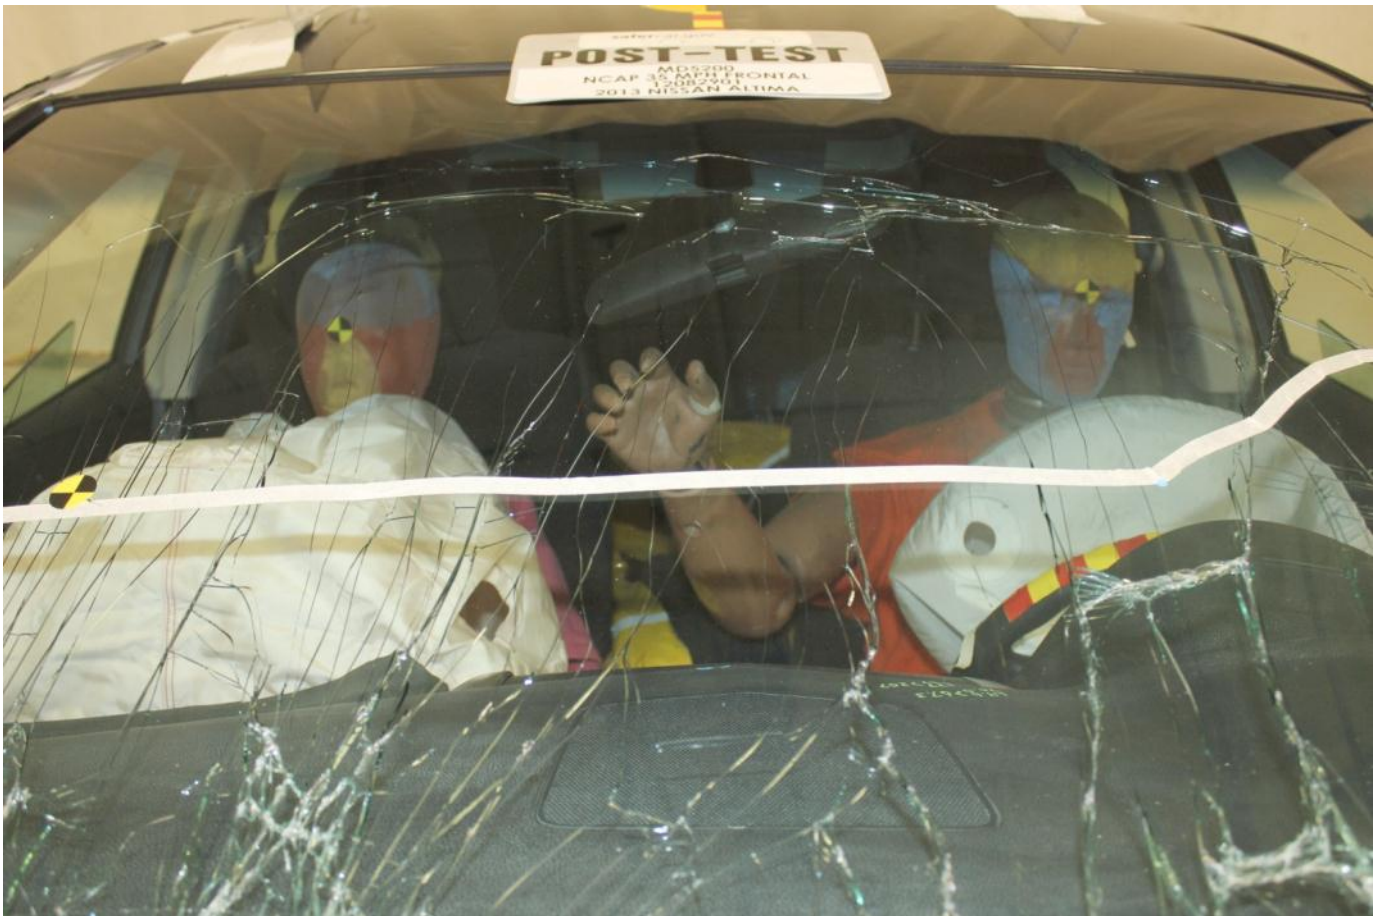
Post-Test Windshield View

There was 100 percent windshield retention and no intrusion into the protected zone of the windshield during the event. There was no Stoddard Solvent leakage after the event or during any phase of the static rollover.

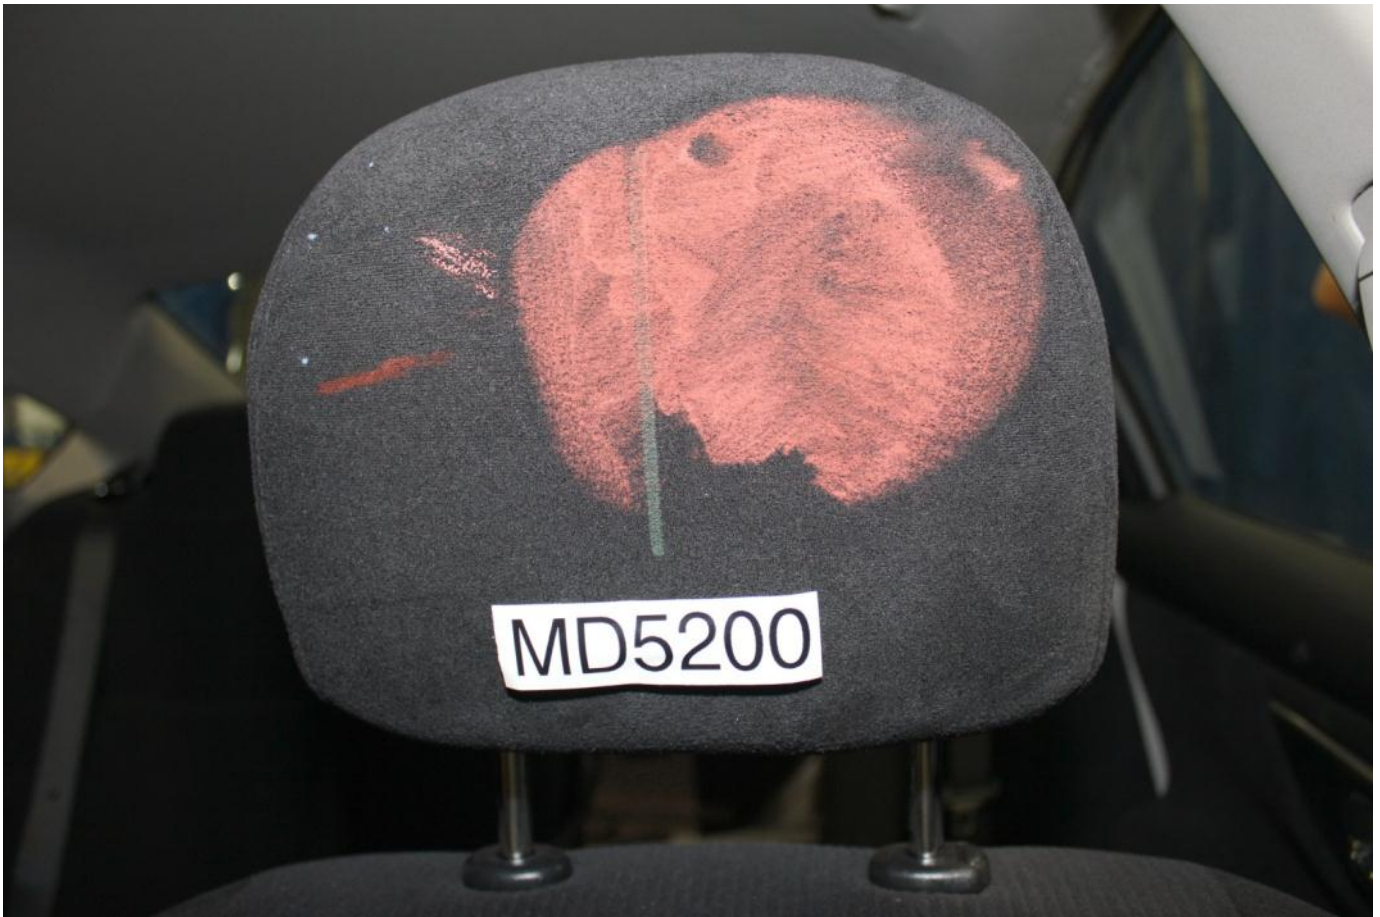
Post-Test Driver Dummy Contact with Headrest

The driver's visible contact points were as follows: The driver's head and chest contacted the airbag. The driver's head also contacted the headrest. The driver's knees contacted the knee bolster and steering column. The passenger's visible contact points were as follows: The passenger's head and chest contacted the airbag. The passenger's head also contacted the headrest. The passenger's knees contacted the glove box.

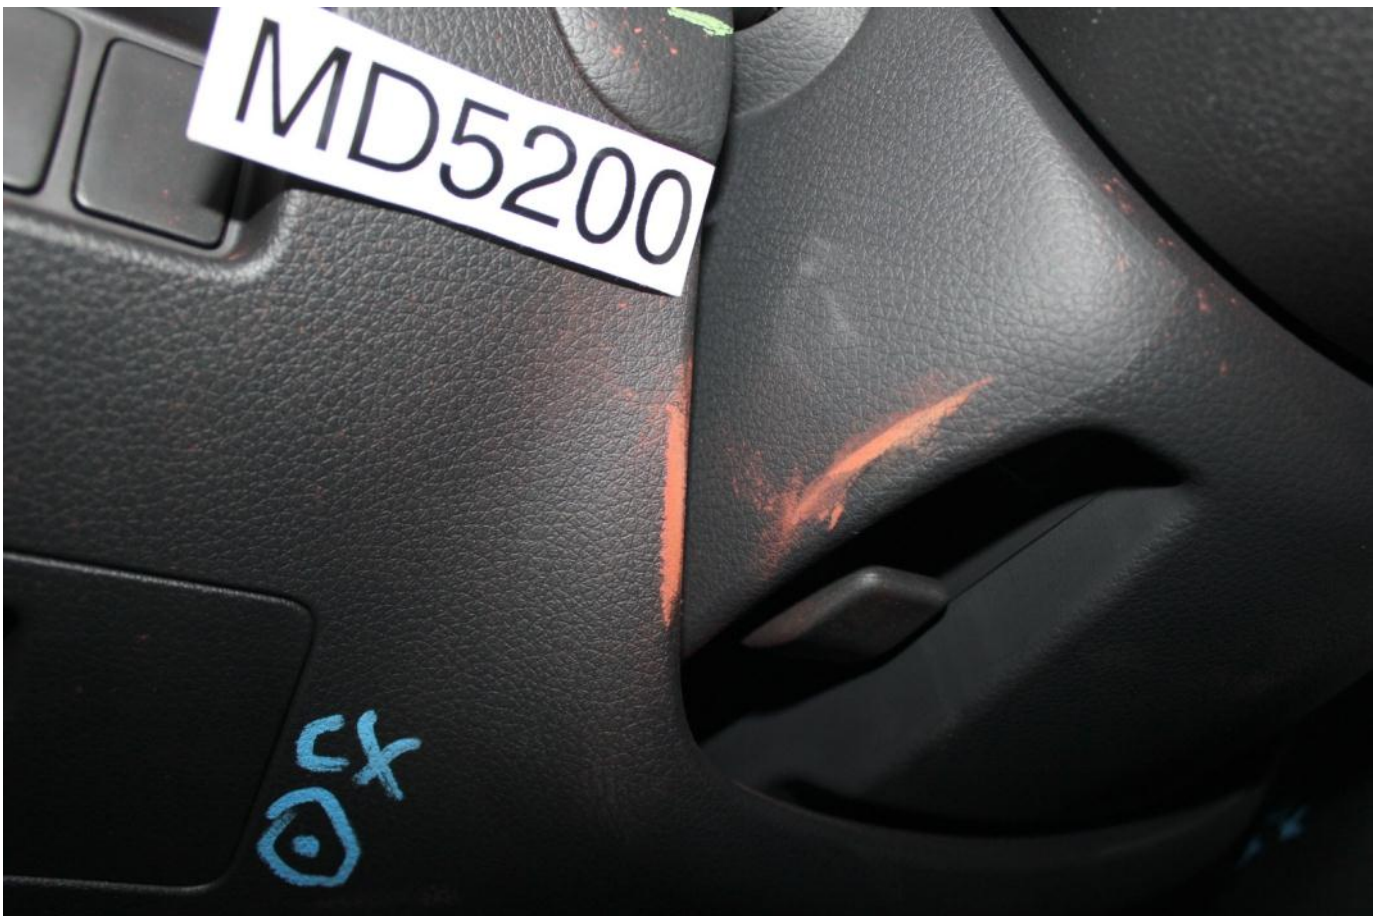
Post-Test Driver Dummy Contact with Steering Column

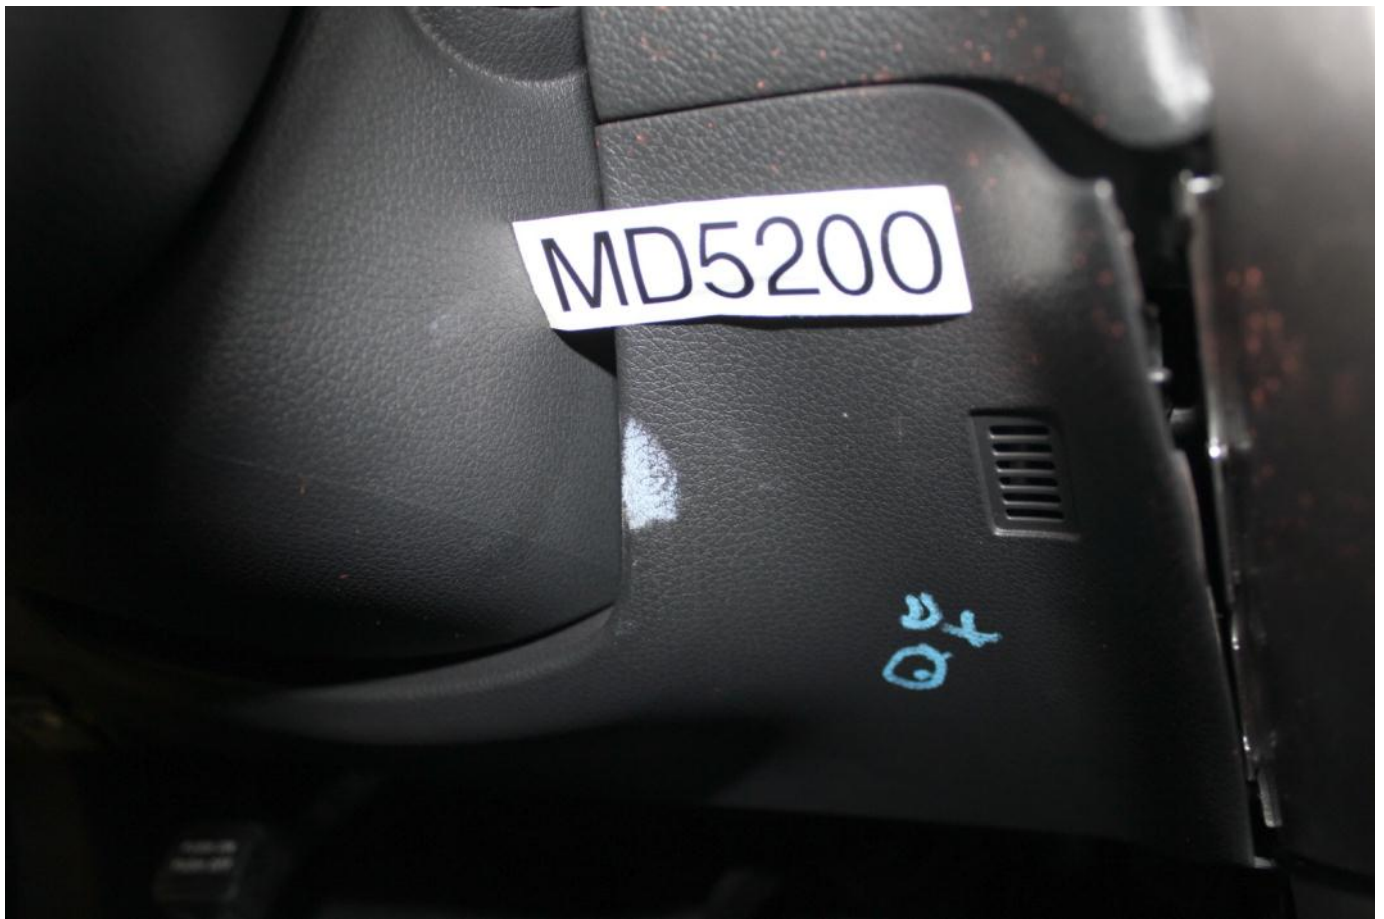
Post-Test Driver Dummy Contact with Steering Column

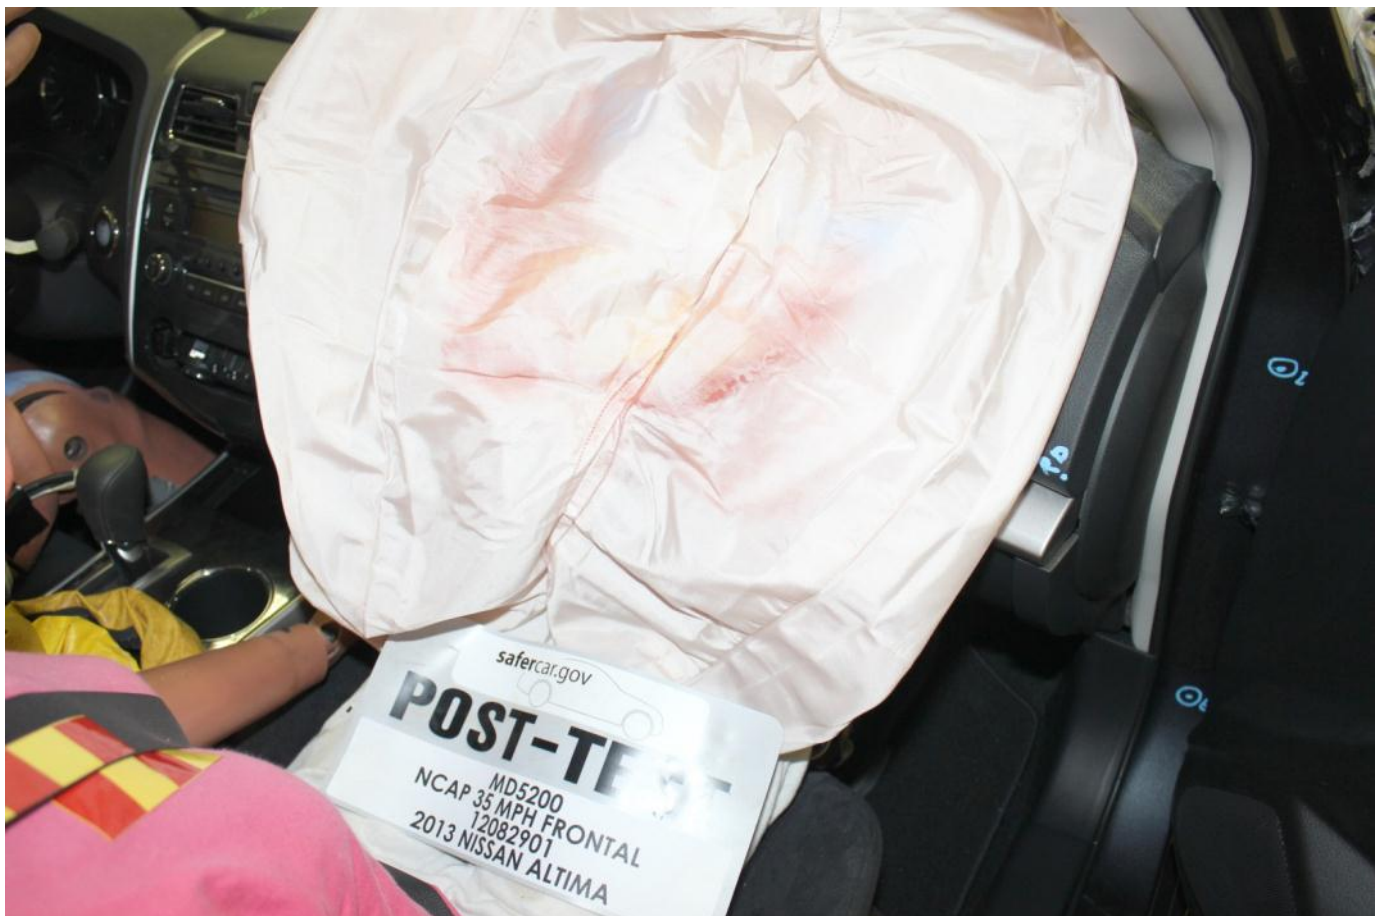
Post-Test Passenger Dummy Contact with Airbag

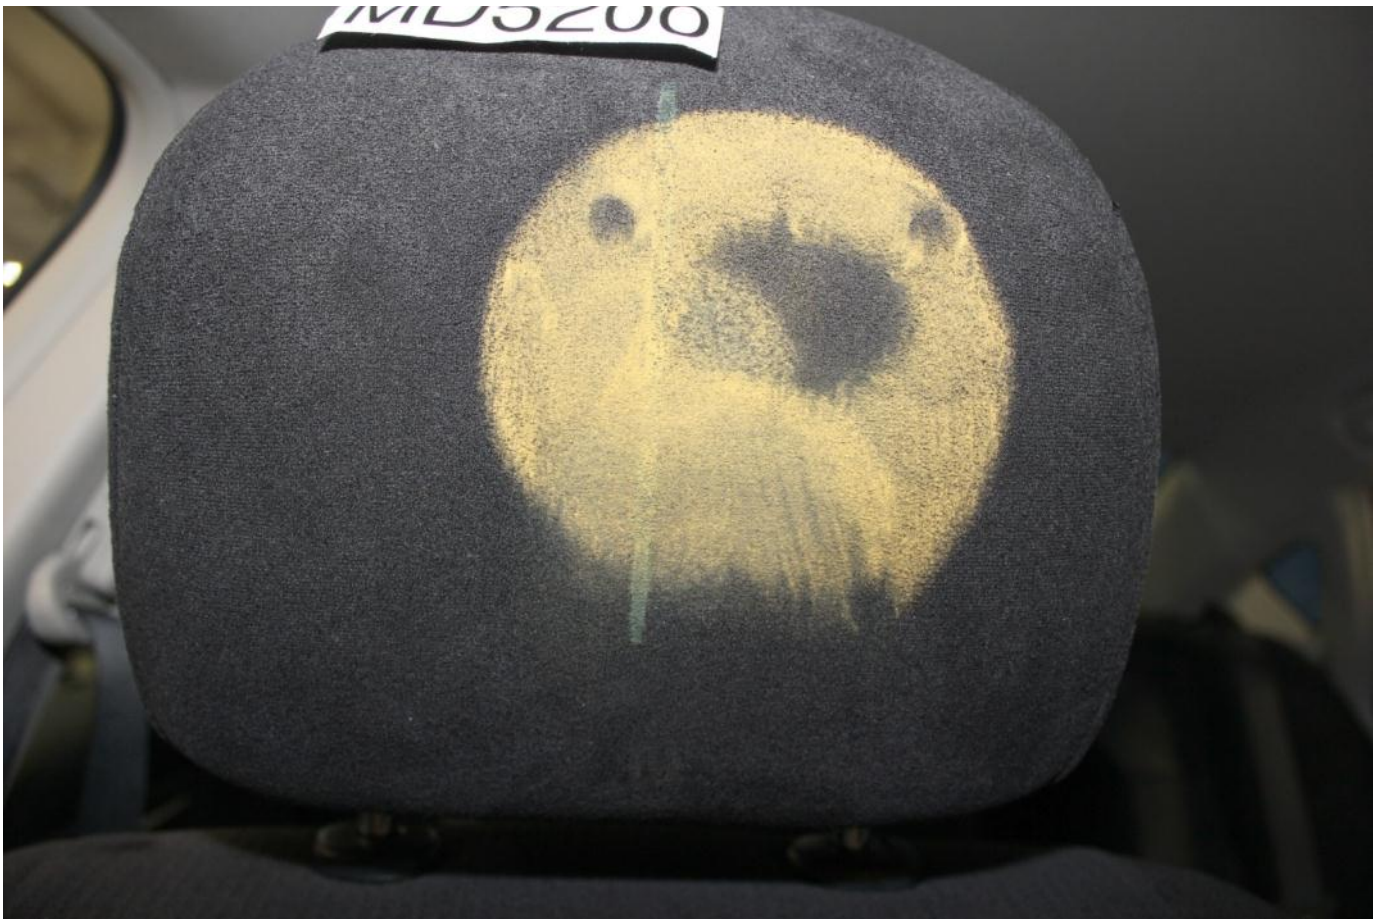
Post-Test Passenger Dummy Contact with Headrest

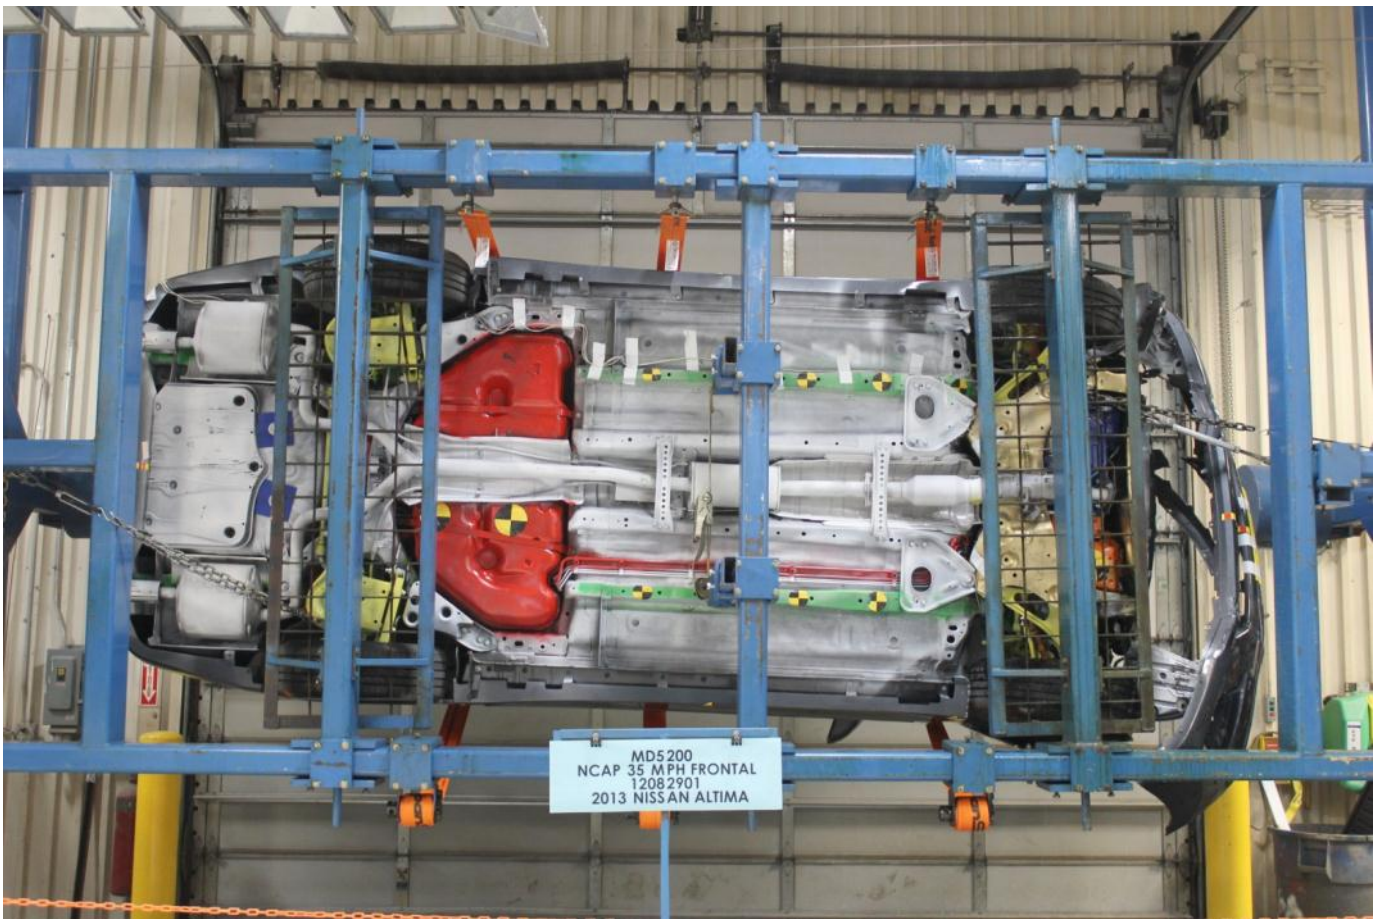
Vehicle at 90° on Static Rollover Device

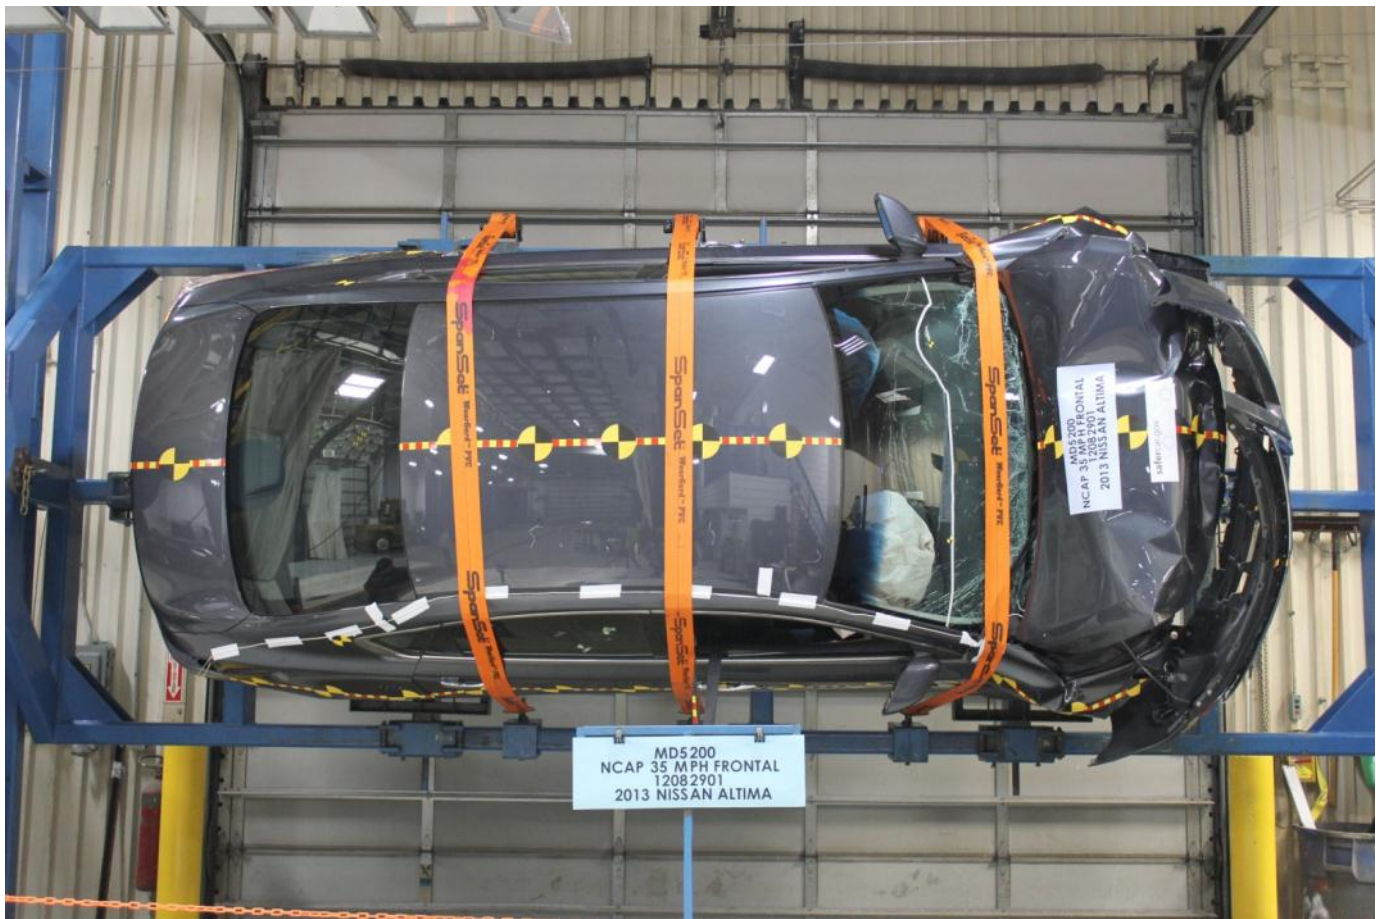
Vehicle at 270° on Static Rollover Device

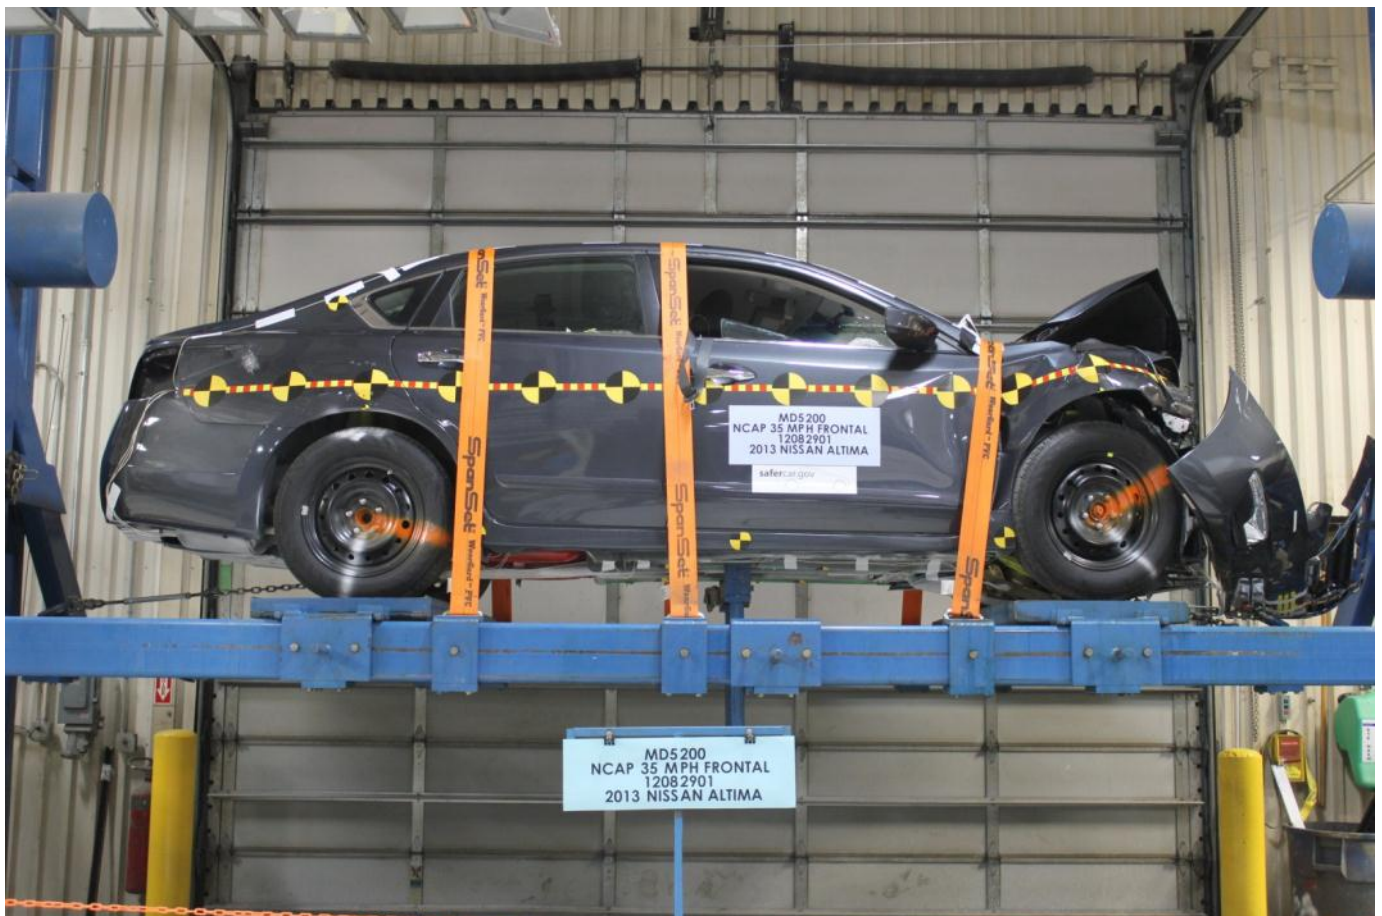
Vehicle at 360° on Static Rollover Device
